NACA TN 2996

APPRAISAL OF HAZARDS TO HUMAN SURVIVAL
IN AIRPLANE CRASH FIRES

By Gerard J. Pesman

Lewis Flight Propulsion Laboratory
Cleveland, Ohio

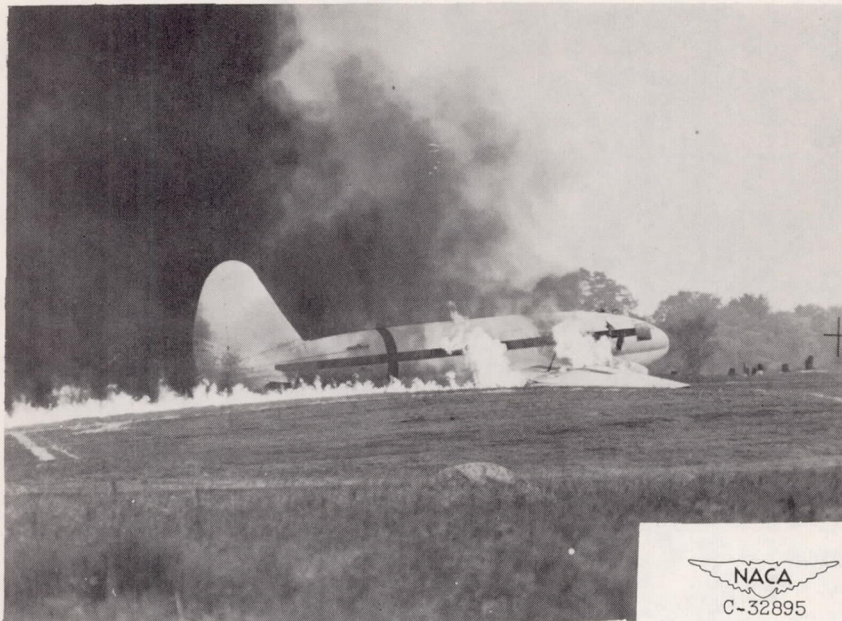
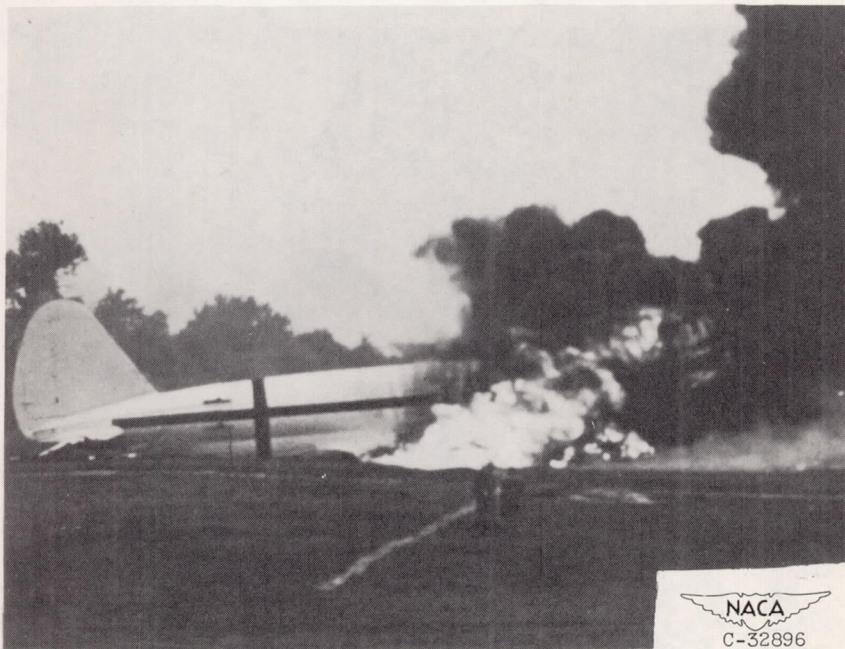
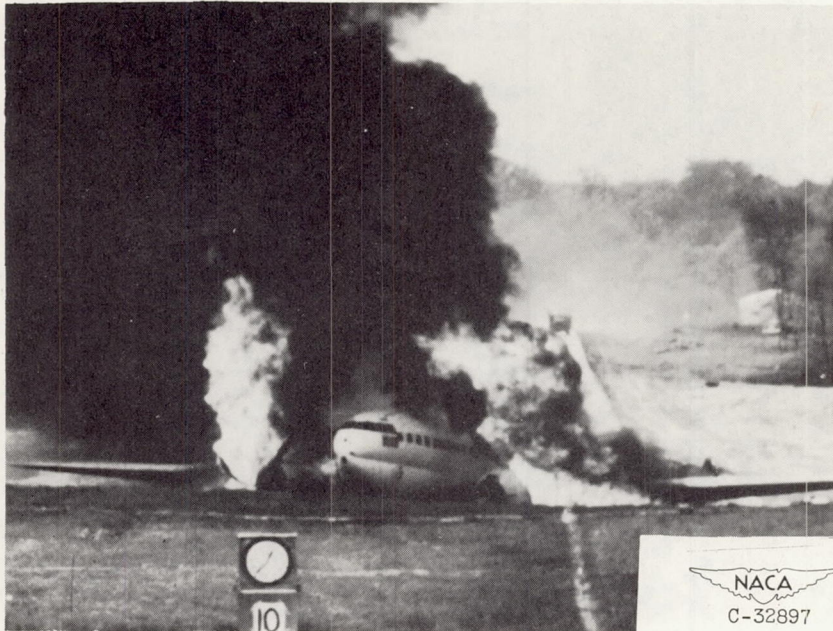
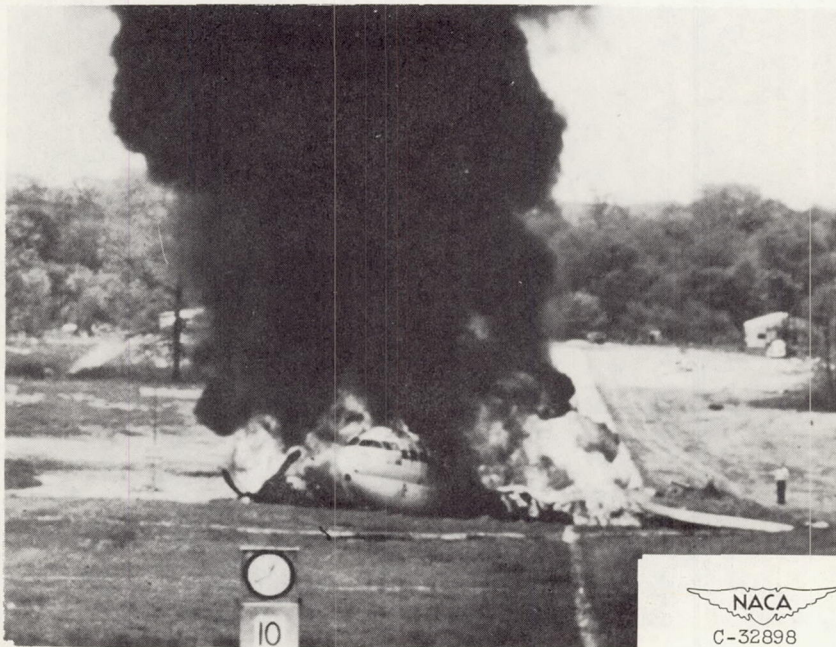
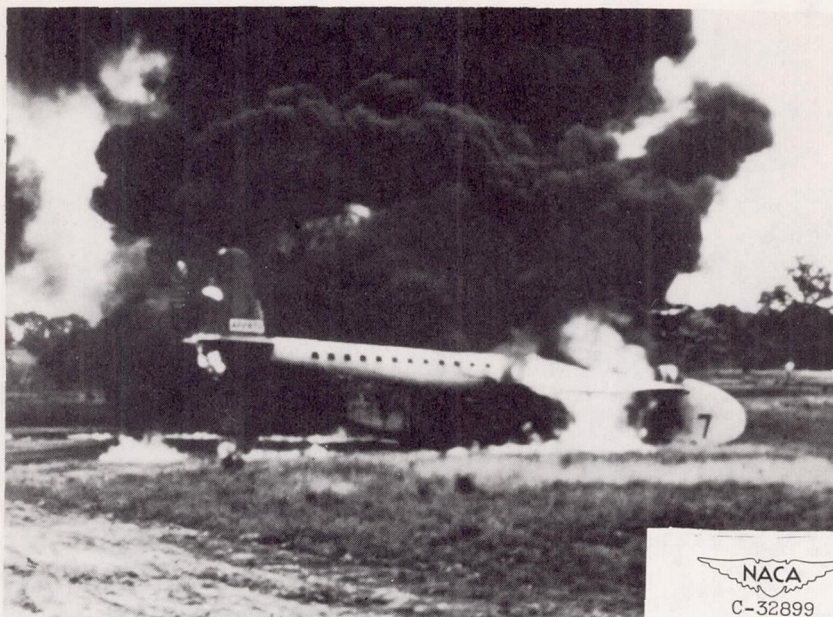
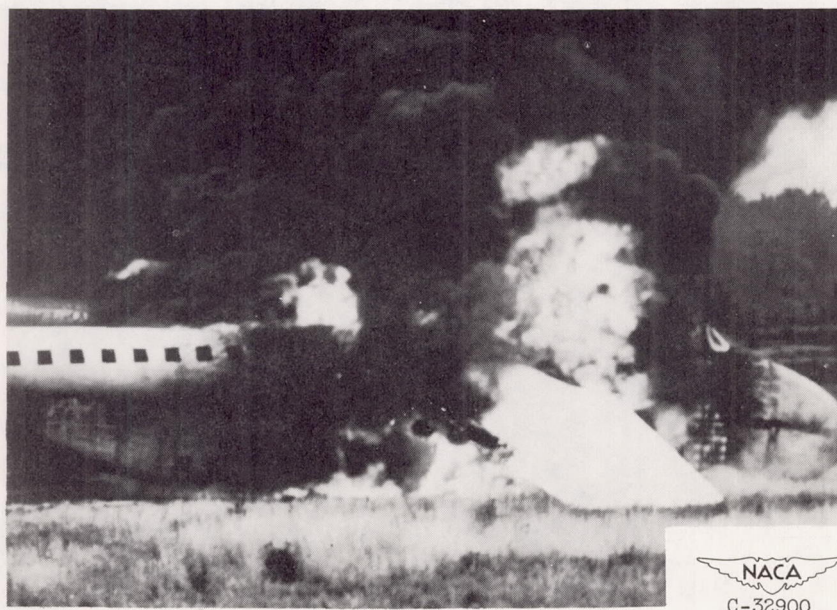
(a) Crash 1.

Figure 11. - Photographs showing development of fire during escape time. Upper photograph shows initial fire or fire shortly after airplane stopped sliding; lower photograph shows fire at end of calculated escape time.

(b) Crash 3.

(c) Crash 7.

These temperature histories represent the thermal conditions that resulted from crashes in which fire occurred on both sides of the airplane. In three of the four crashes large volumes of fuel mist formed when fuel tanks were ruptured while the airplane was moving rapidly (fig. 9). When this fuel mist was ignited while the airplane was sliding, large mist fires developed. Figure 10 shows the extent of such a mist fire. These mist fires burn away in 15 to 20 seconds, leaving fires burning from fuel on the ground, on the wetted airplane structure, and pouring from the tanks. The size and extent of these fires are shown by the upper photographs of figure 11. In from 2 to 5 minutes these fires subsequently develop to the size shown by the lower photographs on this same figure.

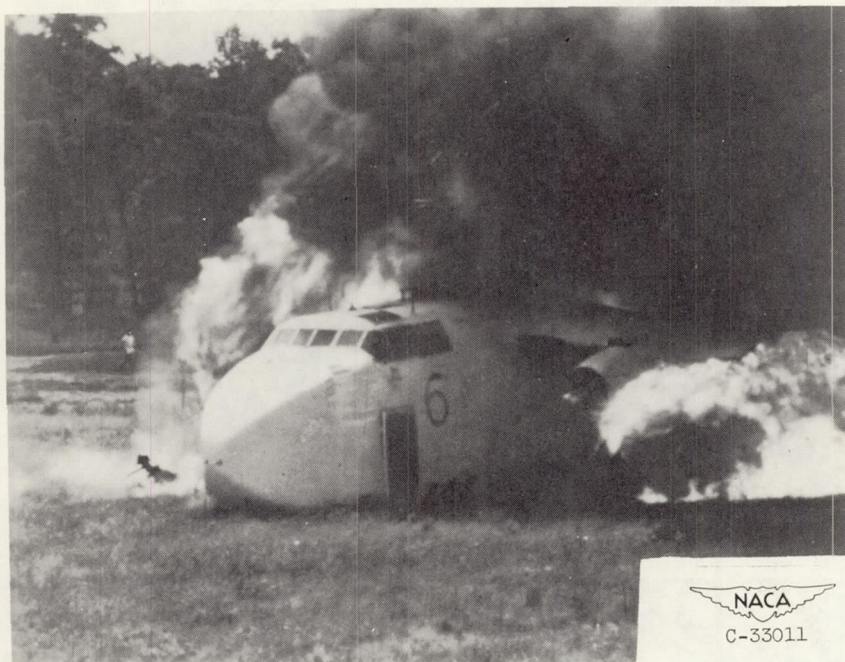
Figure 12. - Location of fire and wind direction such that fuselage is bathed in flame but pilot's compartment not enveloped.

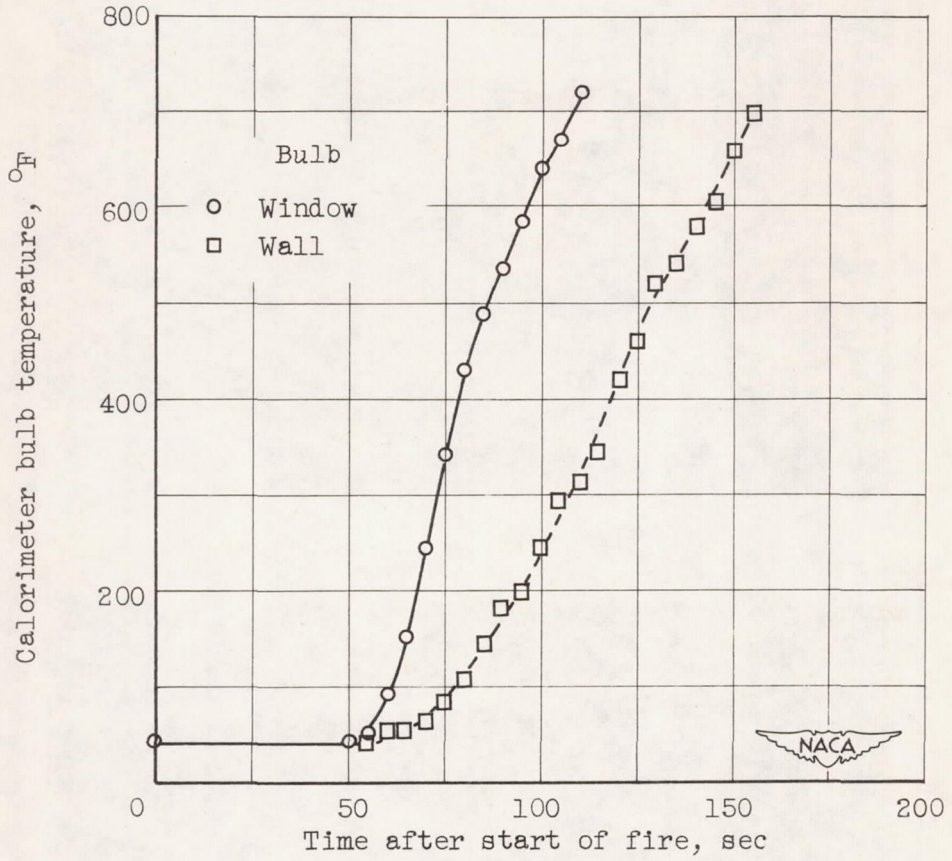
Figure 13. - Temperature histories of calorimeter bulb facing window exposed to fire and bulb facing insulated fuselage wall.

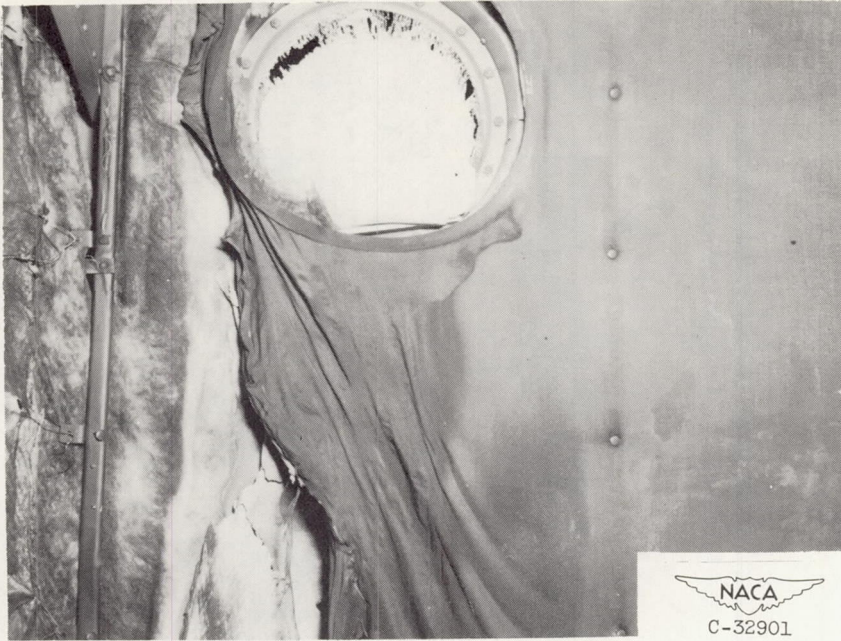
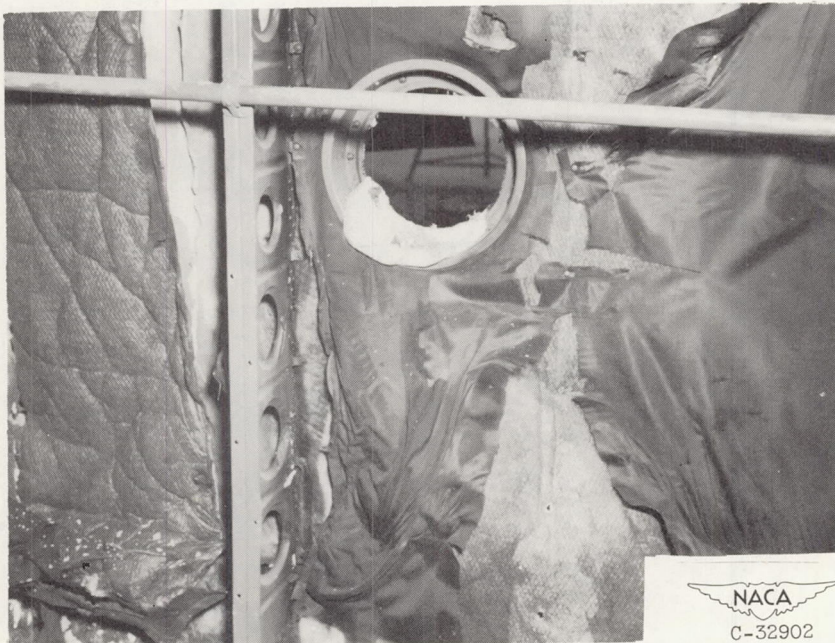
(a) Pane beginning to melt.

(b) Pane completely melted.

Figure 14. - Two stages in disintegration of plastic window pane when subjected to fire.

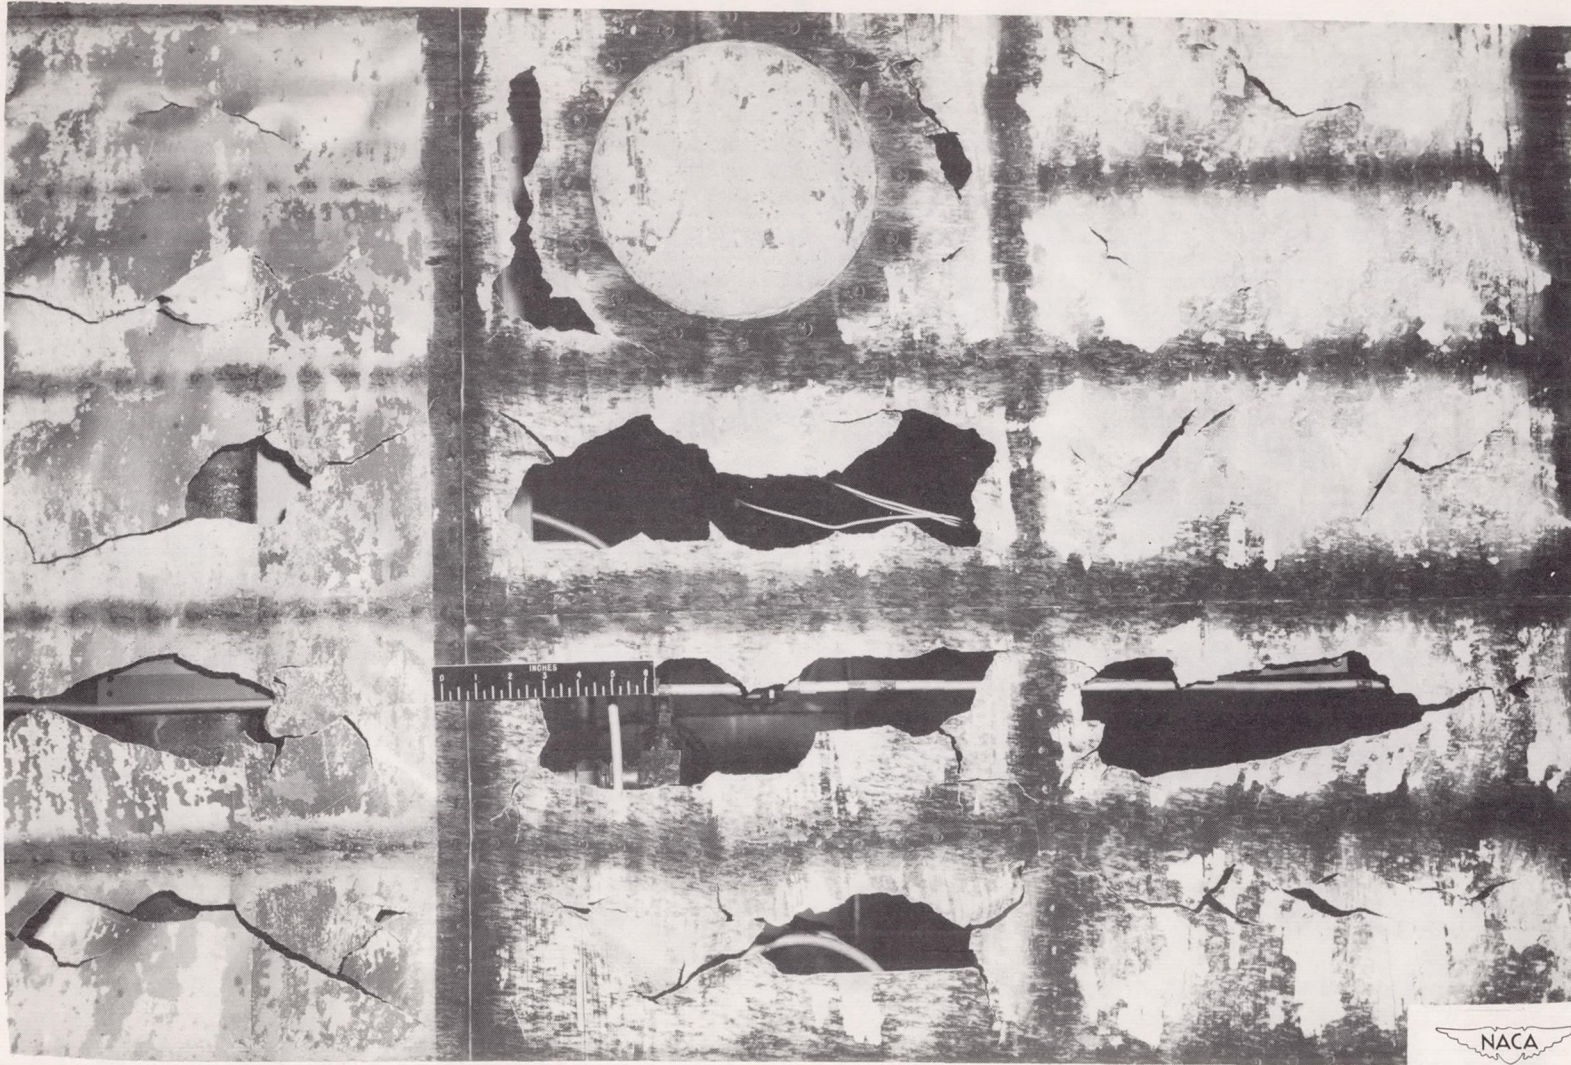
Figure 15. - Damage to fuselage skin resulting from $7\frac{1}{2}$ second contact with fire while airplane was in motion.

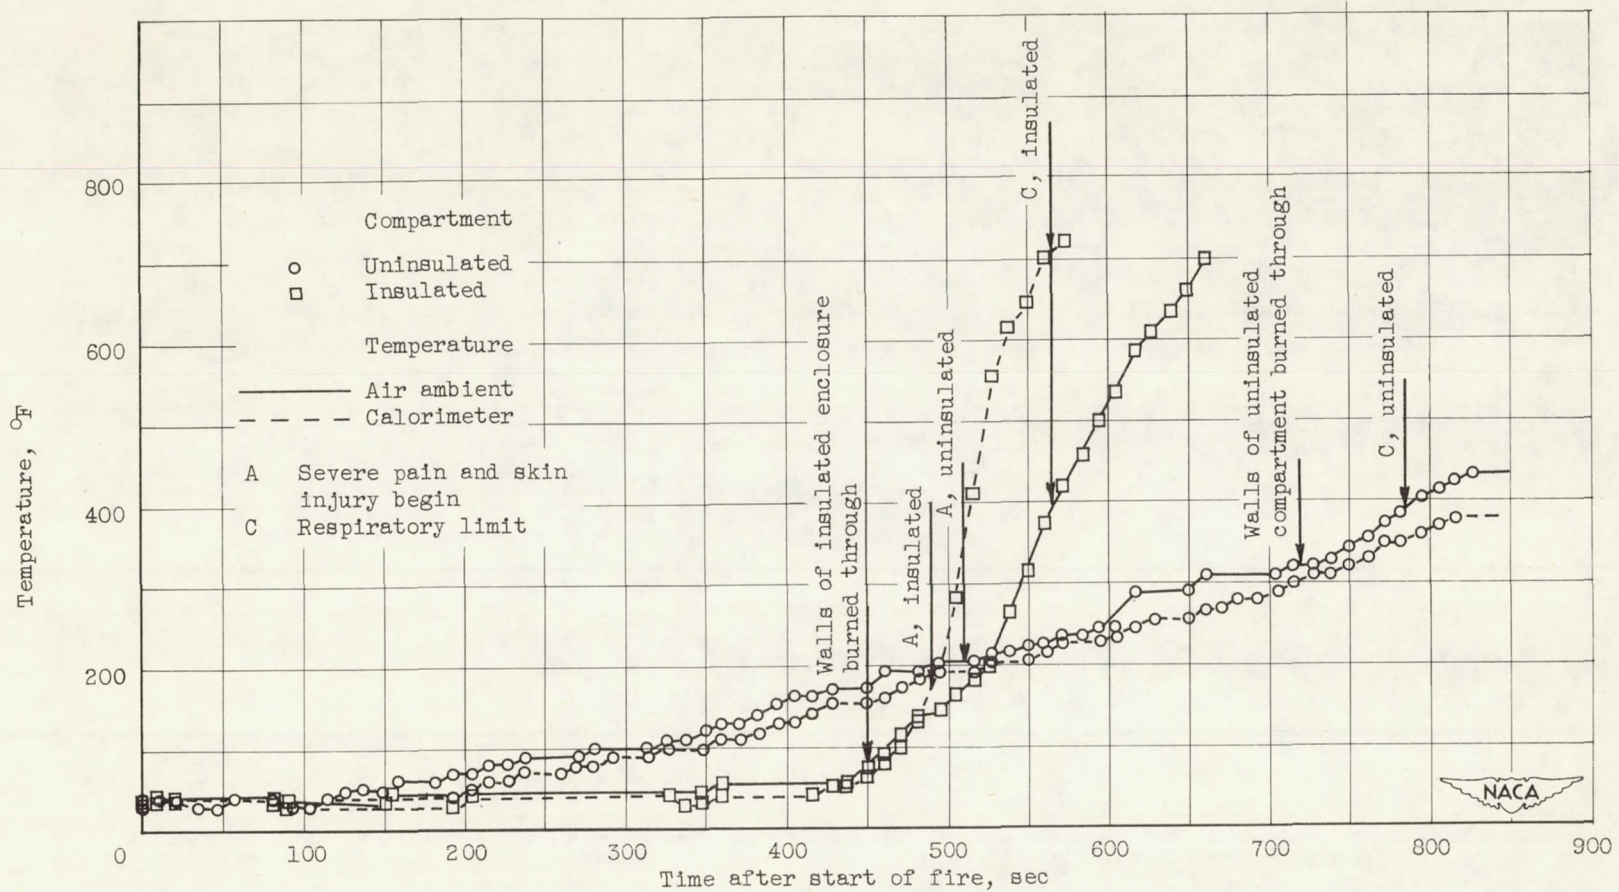
Figure 16. - Comparison of temperature histories and escape times in insulated and uninsulated enclosures.

The temperature histories for the insulated and uninsulated shells are shown in figure 16. This figure shows that in the initial stages of the fires the temperatures inside the insulated enclosure remained below those in the uninsulated enclosure. Seven and one-half minutes after the fires were started the insulated enclosure burned through. The temperatures inside this enclosure then increased rapidly and were equal to

those in the uninsulated enclosure 8 minutes after the fires were started. Thereafter, until the test was terminated, the insulated enclosure temperatures remained above those in the uninsulated enclosure. The uninsulated skin burned through 12 minutes after the test was started. Uninsulated skin melts away more slowly than insulated because heat from the fire can reradiate from the opposite skin surface.

As a result of these temperature conditions the thermal escape time for the insulated enclosure was about 8 minutes; whereas for the uninsulated enclosure, the escape time was $8\frac{1}{2}$ minutes. These escape times show that the glass wool insulation presently used in commercial transport aircraft will not increase the escape time appreciably and may decrease the available time slightly. The glass wool insulation also offers little obstruction to the passage of flame and gases because it tends to shrink and fall away from its supports when exposed to direct flame contact. The shrinkage resulting from such flame contact is shown by figure 17.

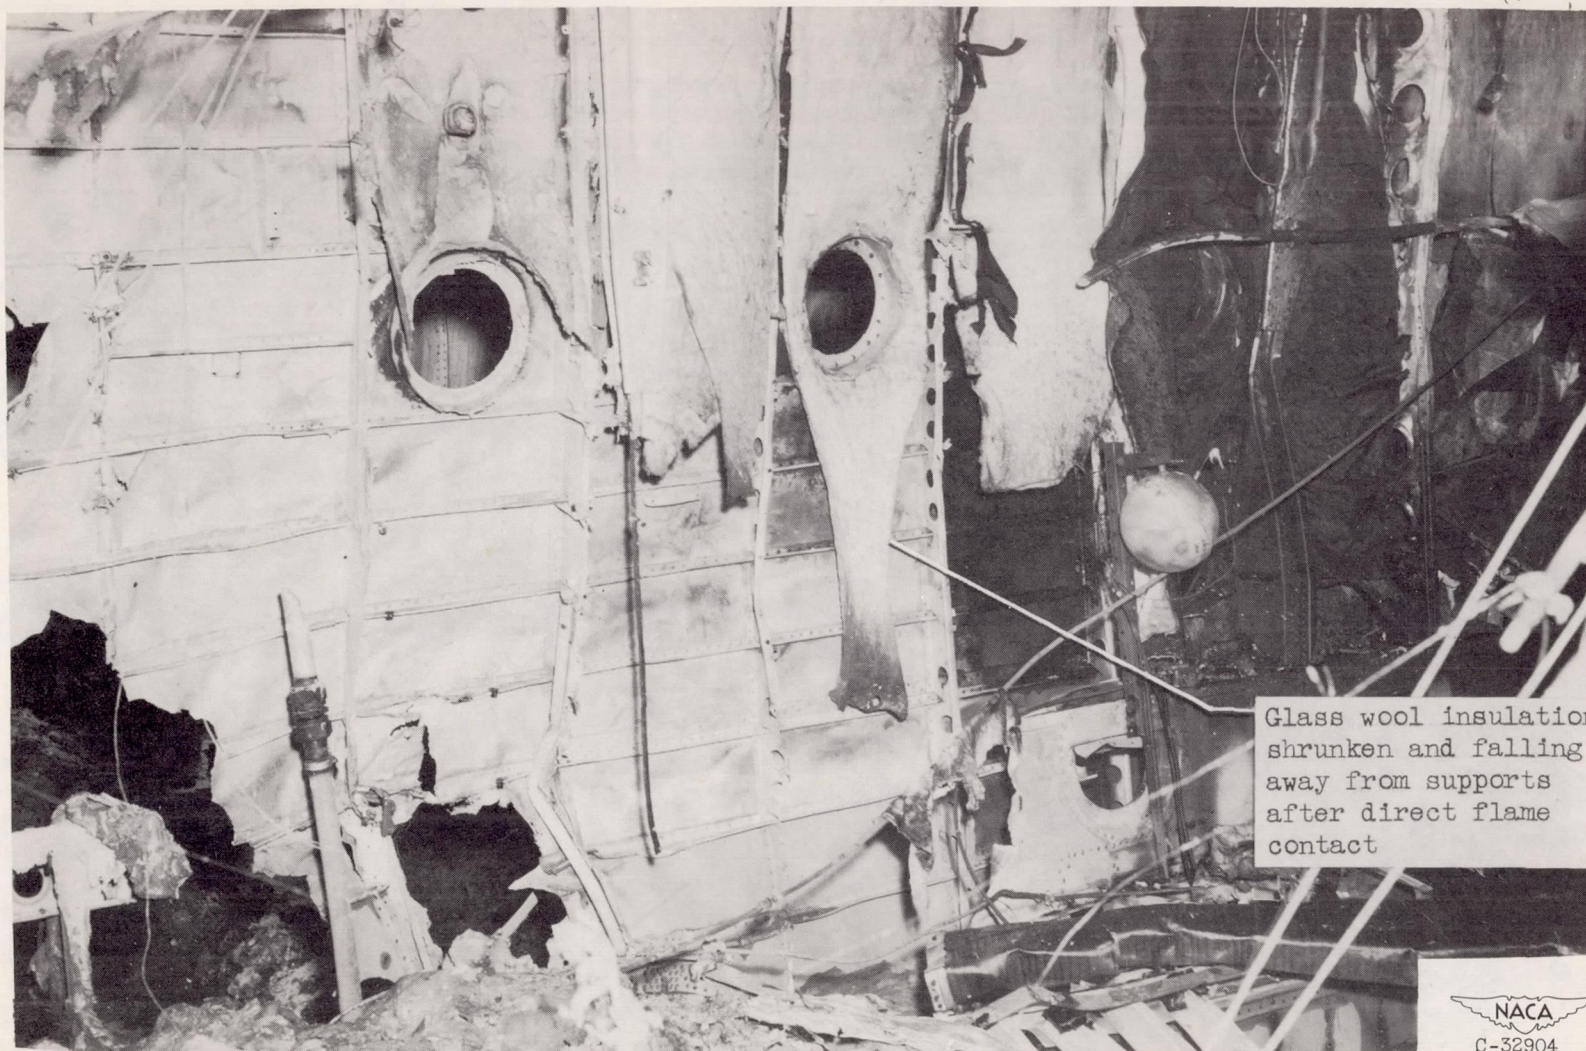
Figure 17. - Effect of direct flame contact upon some glass-wool types of thermal and sound insulation.

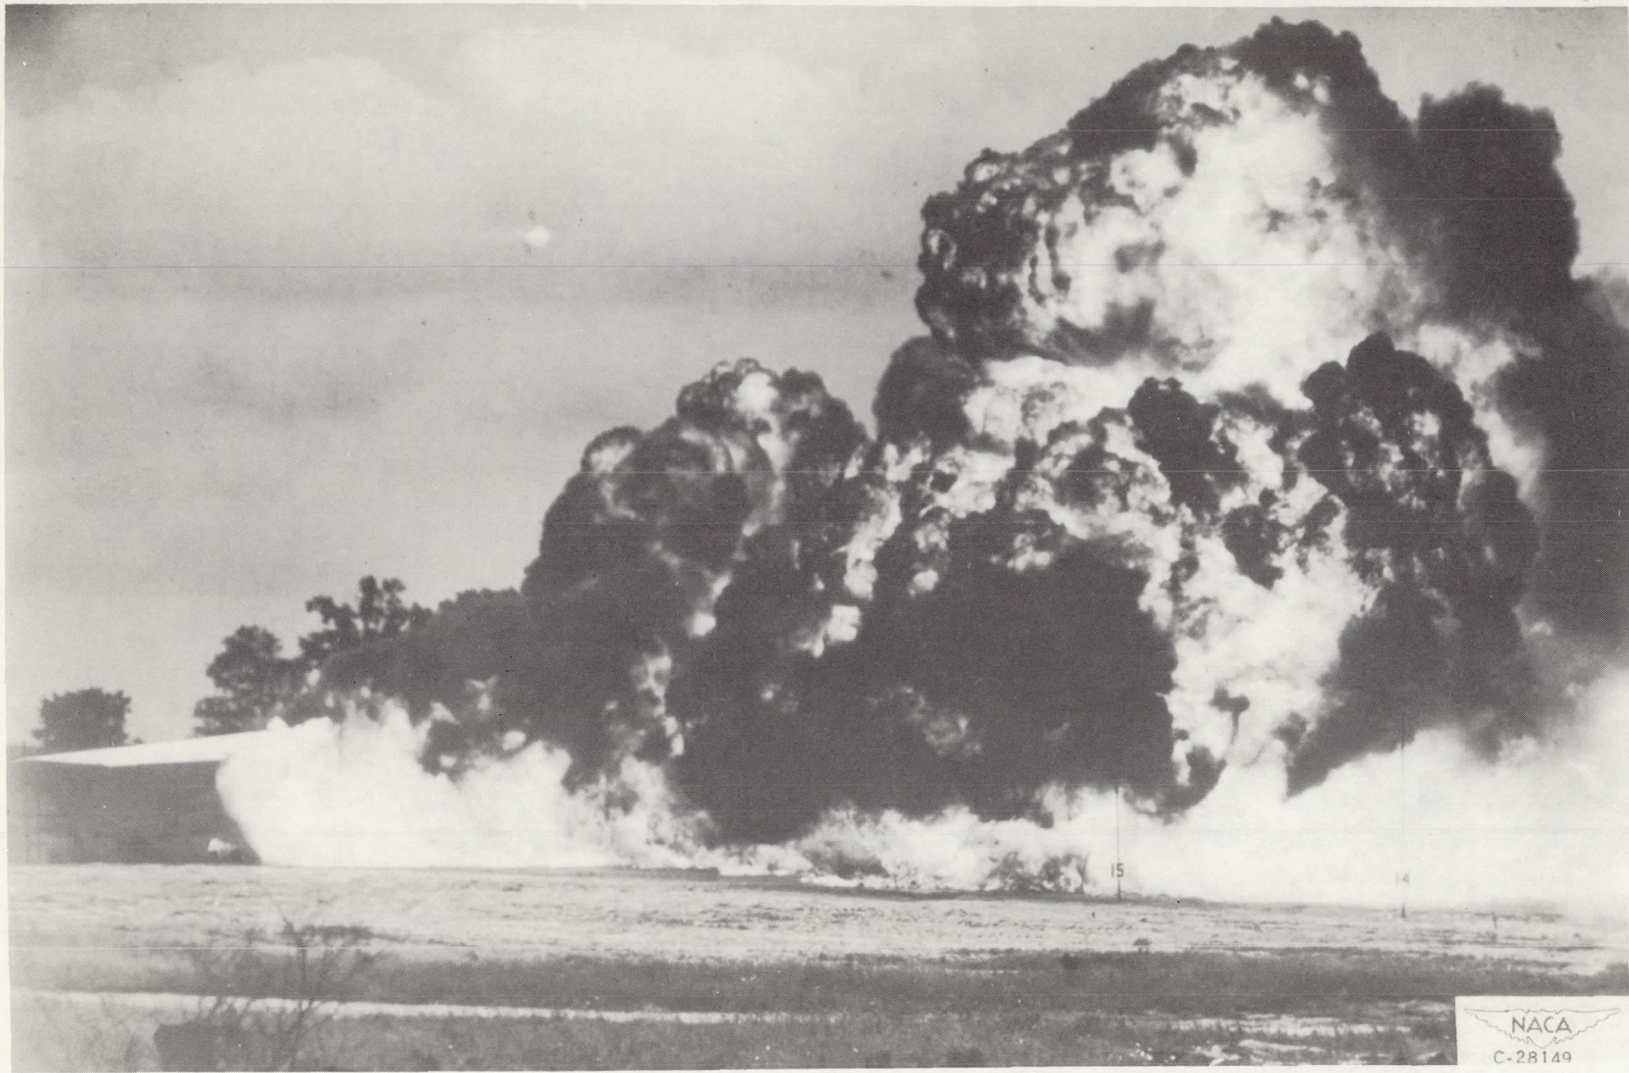
Figure 18. - Fire resulting from ignition of cloud of low-volatility fuel mist.

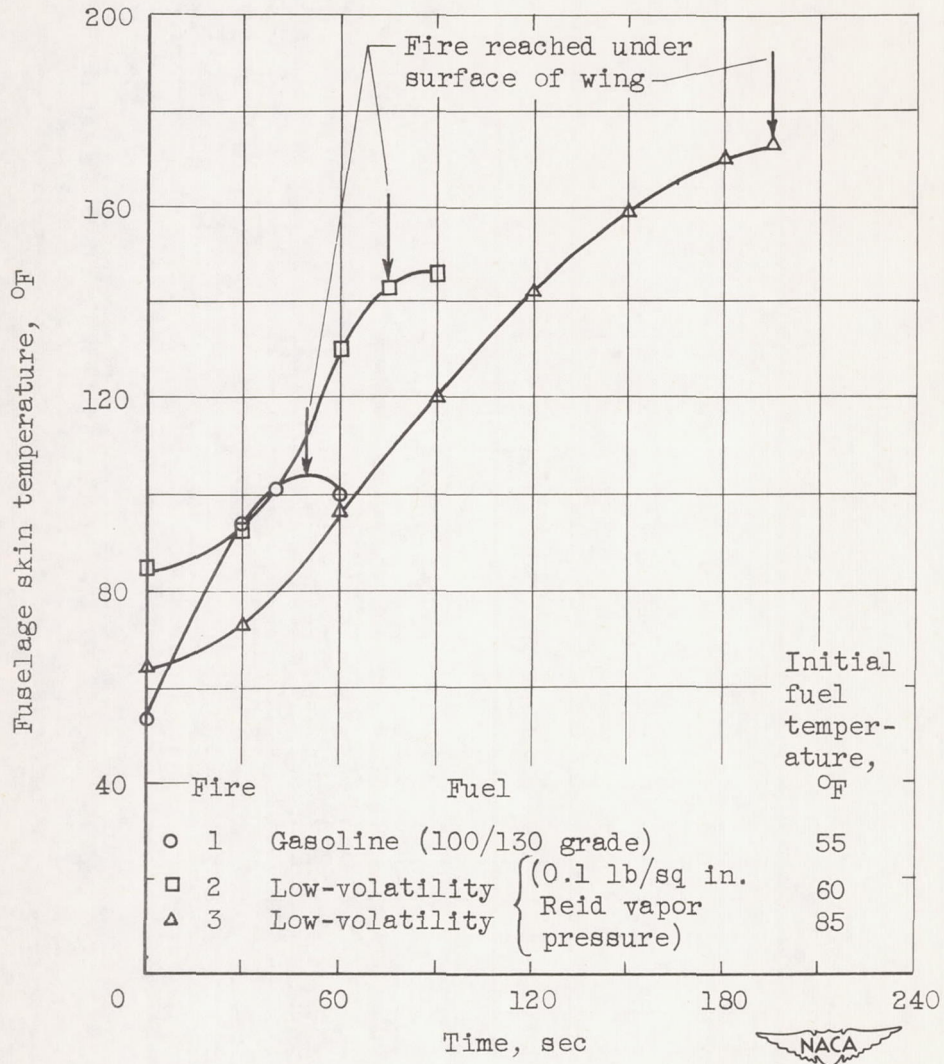
Figure 19. - Increase in fuselage skin temperature with time for three essentially similar fires but with fuel at various vapor pressures and initial temperatures.

When fire involves fuels of different volatility spilled on the ground in liquid form, however, there is a difference in the rate of fire development, and thus a difference in escape time. In figure 19 are shown the time - fuselage skin temperature relations for three fires in which the fuel was allowed to pour to the ground from ruptured tanks of an unburned wrecked airplane hulk. The fuel was ignited by a torch on the ground. The development of the fire was recorded by motion pictures, and the time history of the airplane skin temperatures, by instruments. Wind conditions and fuel spillage rate were essentially similar in all tests. In order to preserve the hulk for successive fires, fire extinguishing was started at the time fire had reached the under surface of the wing, as indicated on the curves.

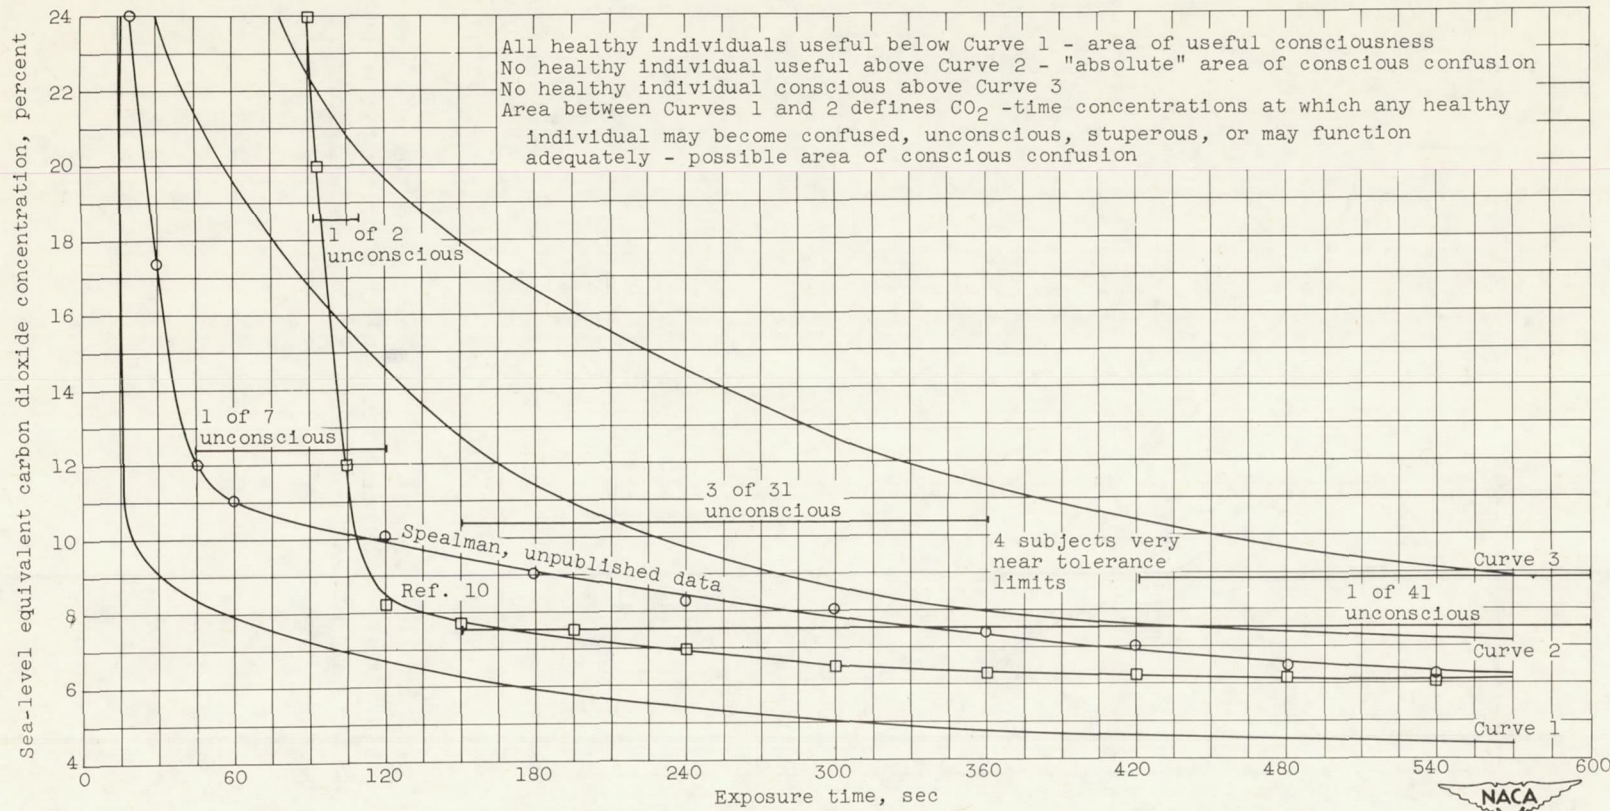
Figure 20. - Threshold curves of carbon-dioxide concentration and duration of exposure tolerable by healthy human beings. (Curves 1, 2, and 3 from ref. 9.)

Since curve 2 (fig. 20) indicates the conditions that can be tolerated by most individuals and is little more severe than the limits chosen by Spealman or King (ref. 10), this curve was chosen as the basis for escape time calculations, although the results may indicate shorter escape times than would actually exist. The escape times were determined by the graphical method recommended in appendix 1 of reference 9. This graphical method is so arranged that the quantity of carbon dioxide inhaled under the varying concentrations that occur during a fire is equated to the maximum that can be tolerated as indicated by the tolerance curve.

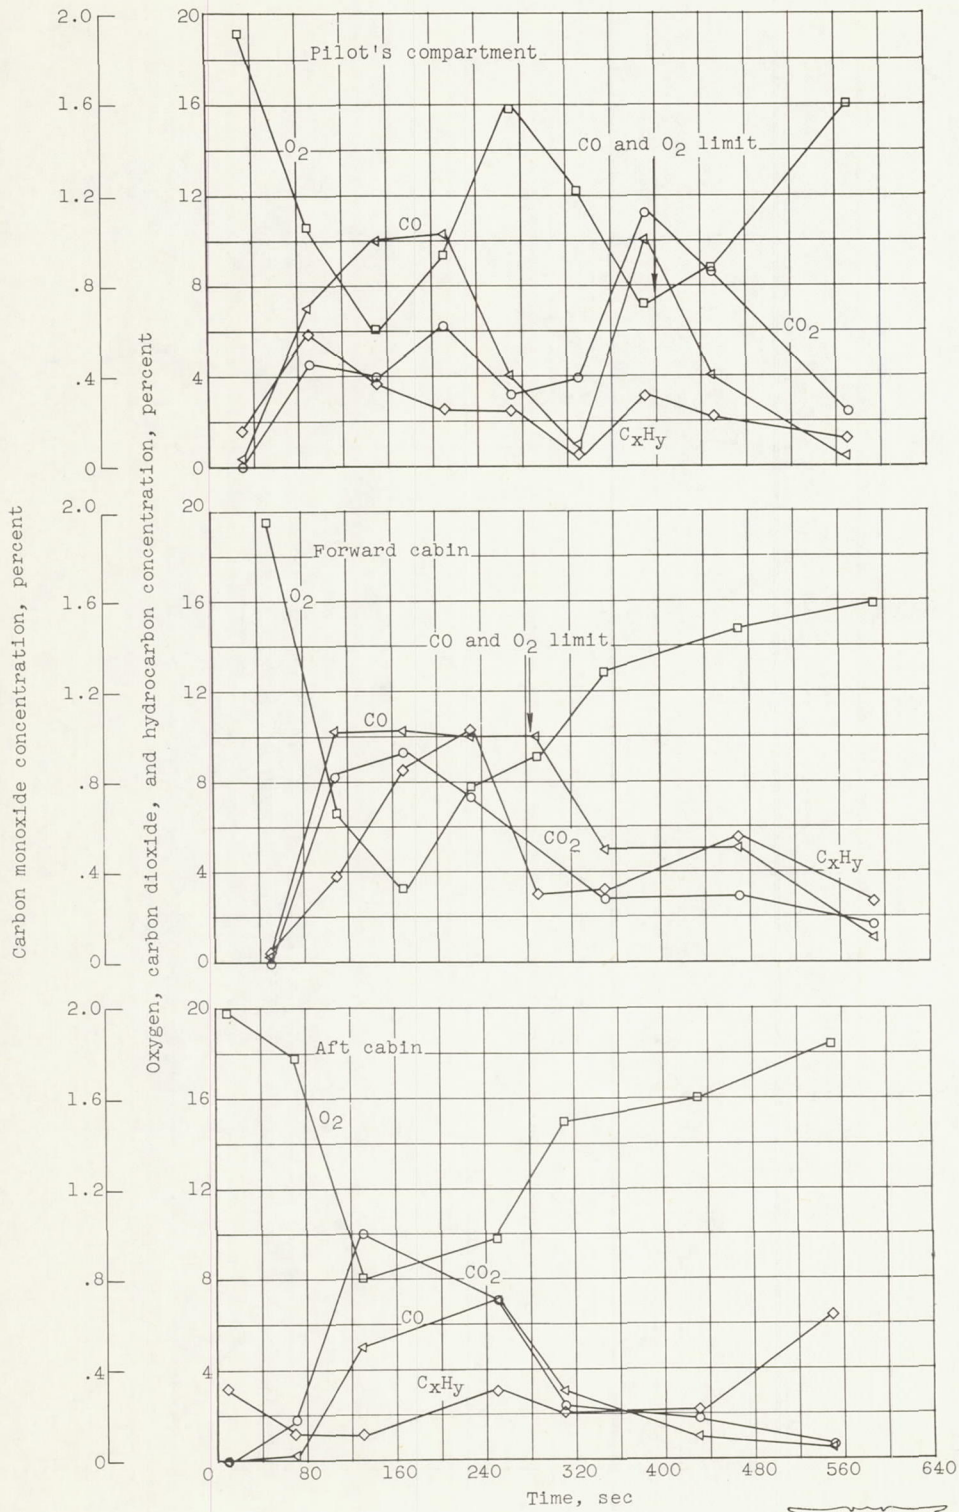
(a) Hulk fire number 1.

Figure 21. - Time histories of gas concentrations at various positions in burning airplane hulks.

(b) Hulk fire number 2.

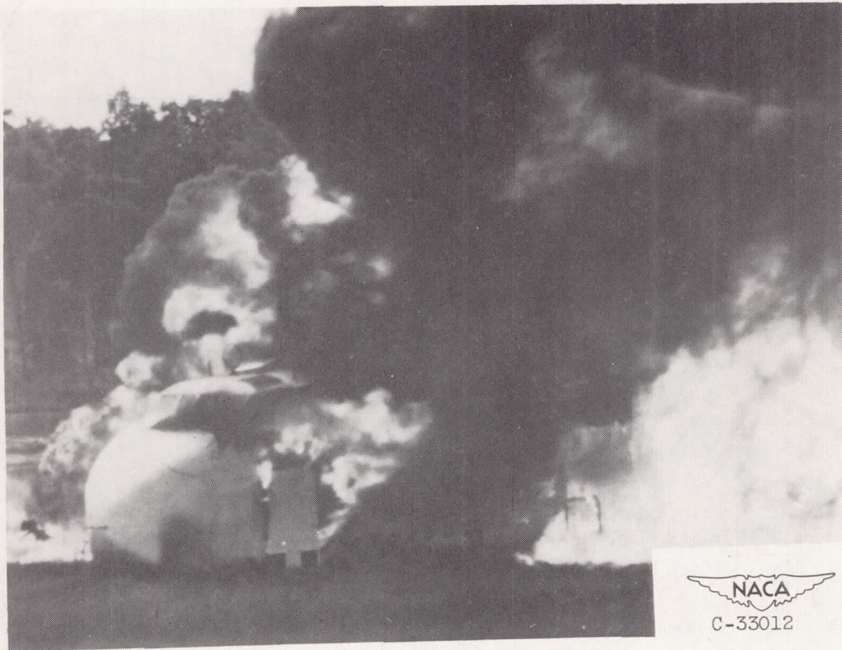
Figure 22. - Flame from explosion of hydrocarbon vapor in fuselage escaping through forward fuselage door.

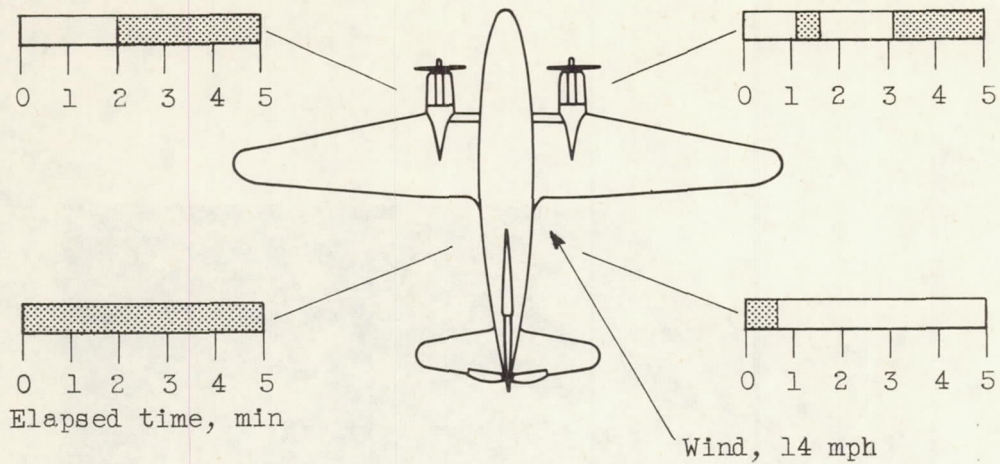
(a) Crash 1; low midwing airplane.

Figure 23. - Concluded. Time histories of escape possibility from various quarters of several transport airplanes involved in crash fire.

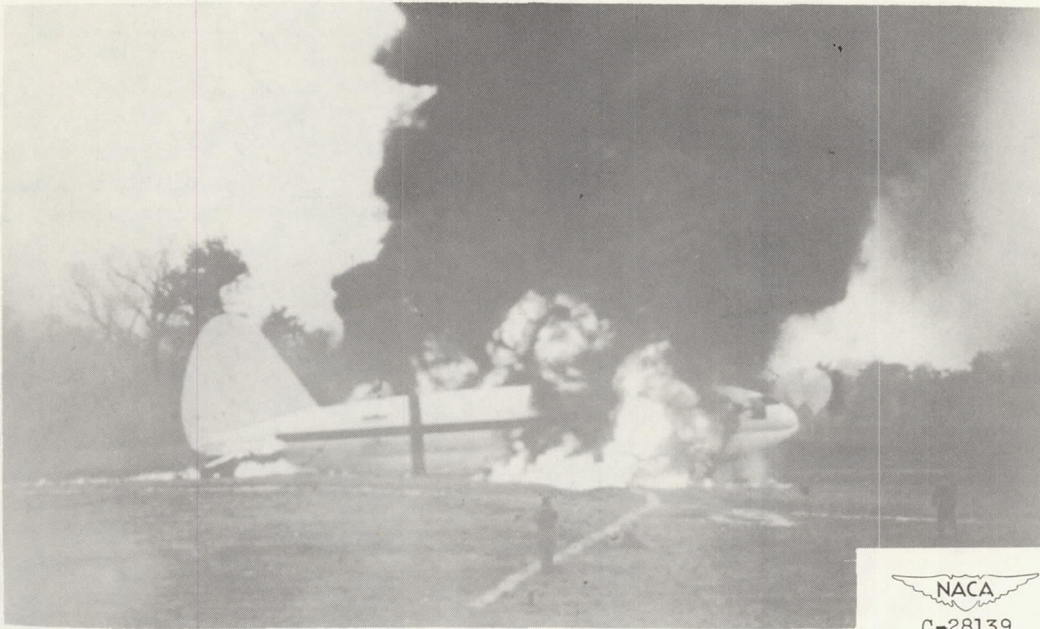
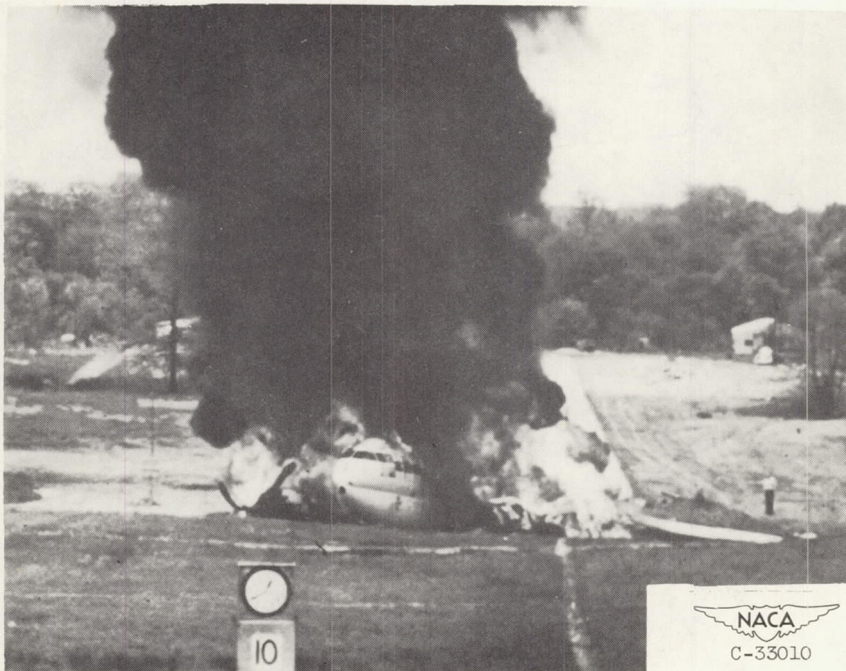
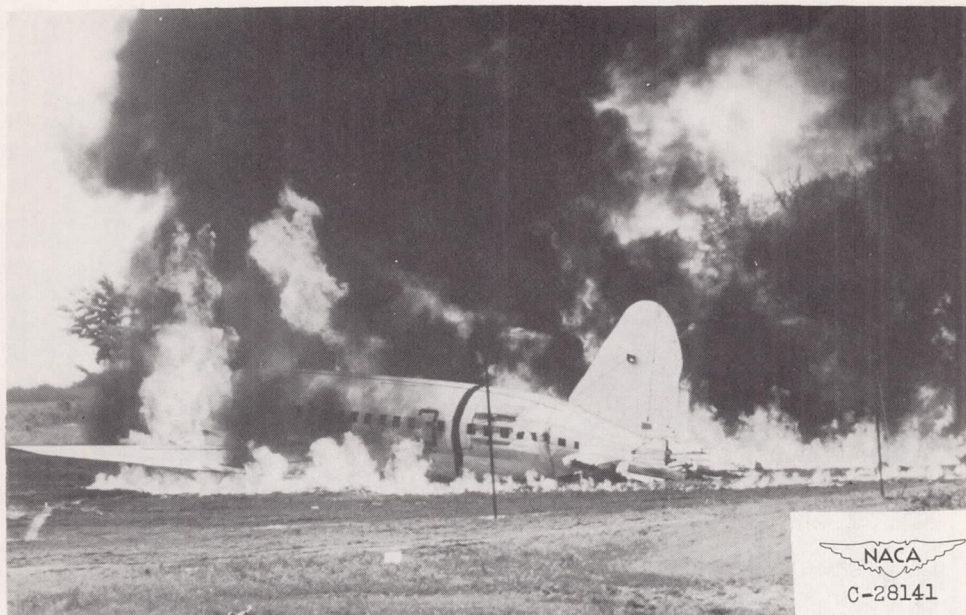
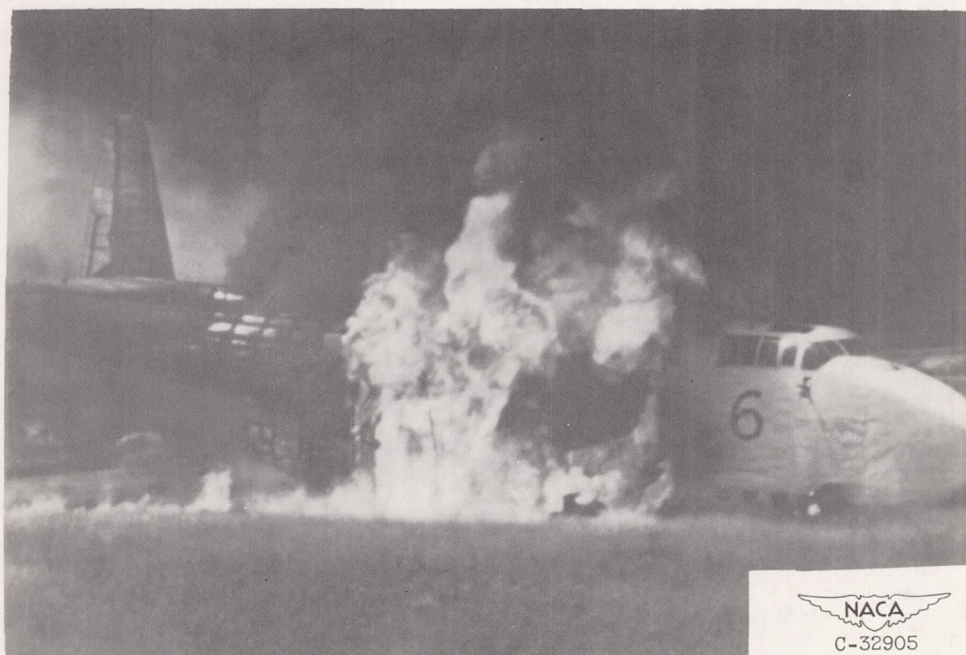
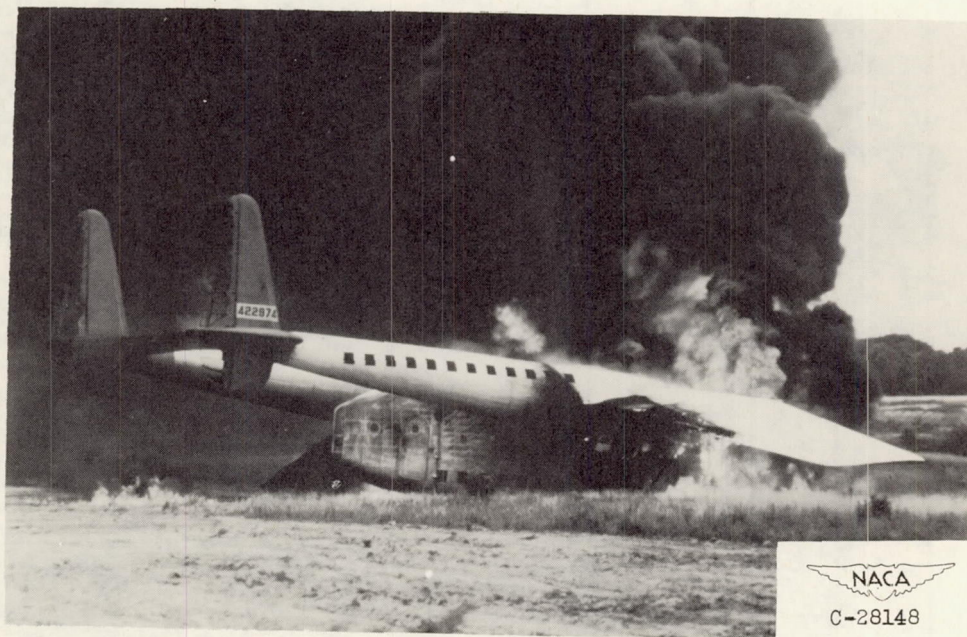
a) Escape avenue to right rear of airplane open approximately 30 seconds after impact and after fuel mist flash fire had burned away; wind from right rear; crash 1.

(b) Escape avenue to left front; wind from left rear quarter, variable at 0 to 5 miles per hour; crash 3.

Figure 24. - Escape avenues.

(c) Escape avenue to left rear after major part of spilled fuel had burned away; wind from left rear, 0 to 5 miles per hour; crash 3.

(d) Escape avenue to right front; wind from right rear, 13 to 16 miles per hour; crash 6.

(e) Escape avenue to right rear after fuel mist fire burned away; wind from right rear, 10 to 15 miles per hour; crash 7.
