NACA TN 2996

APPRAISAL OF HAZARDS TO HUMAN SURVIVAL
IN AIRPLANE CRASH FIRES

By Gerard J. Pesman

Lewis Flight Propulsion Laboratory
Cleveland, Ohio

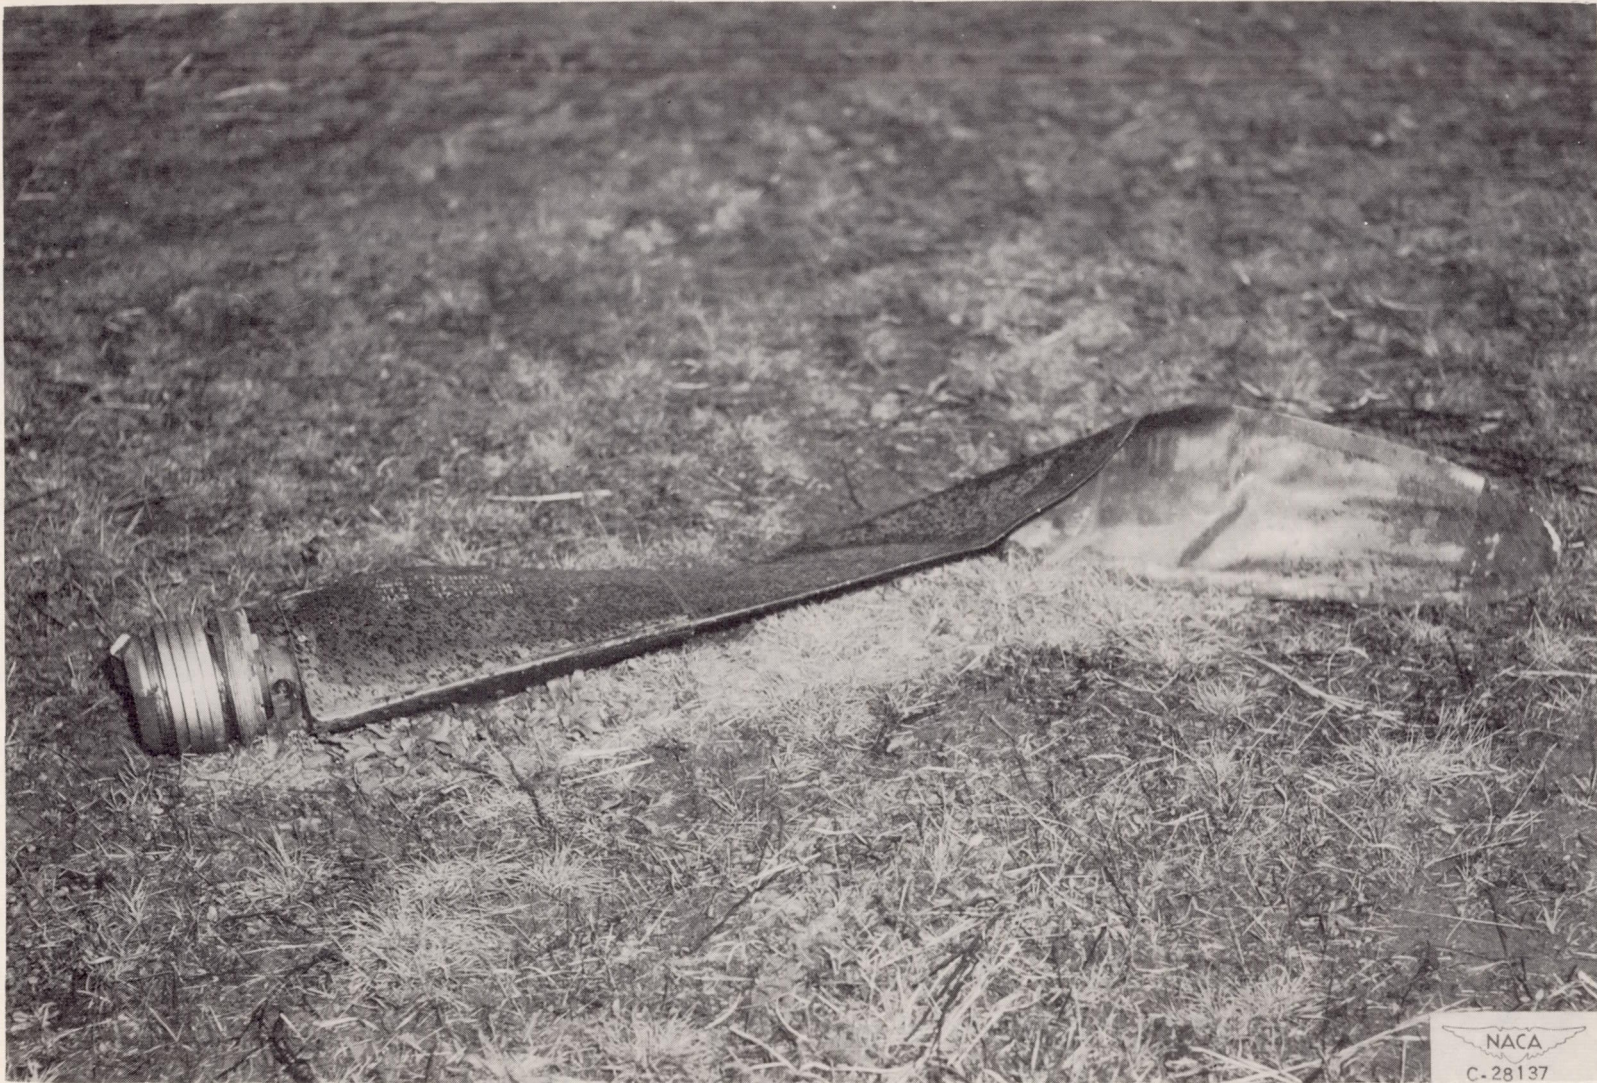
Figure 25. - Typical damage to steel propeller blade caused by impact with crash barrier.

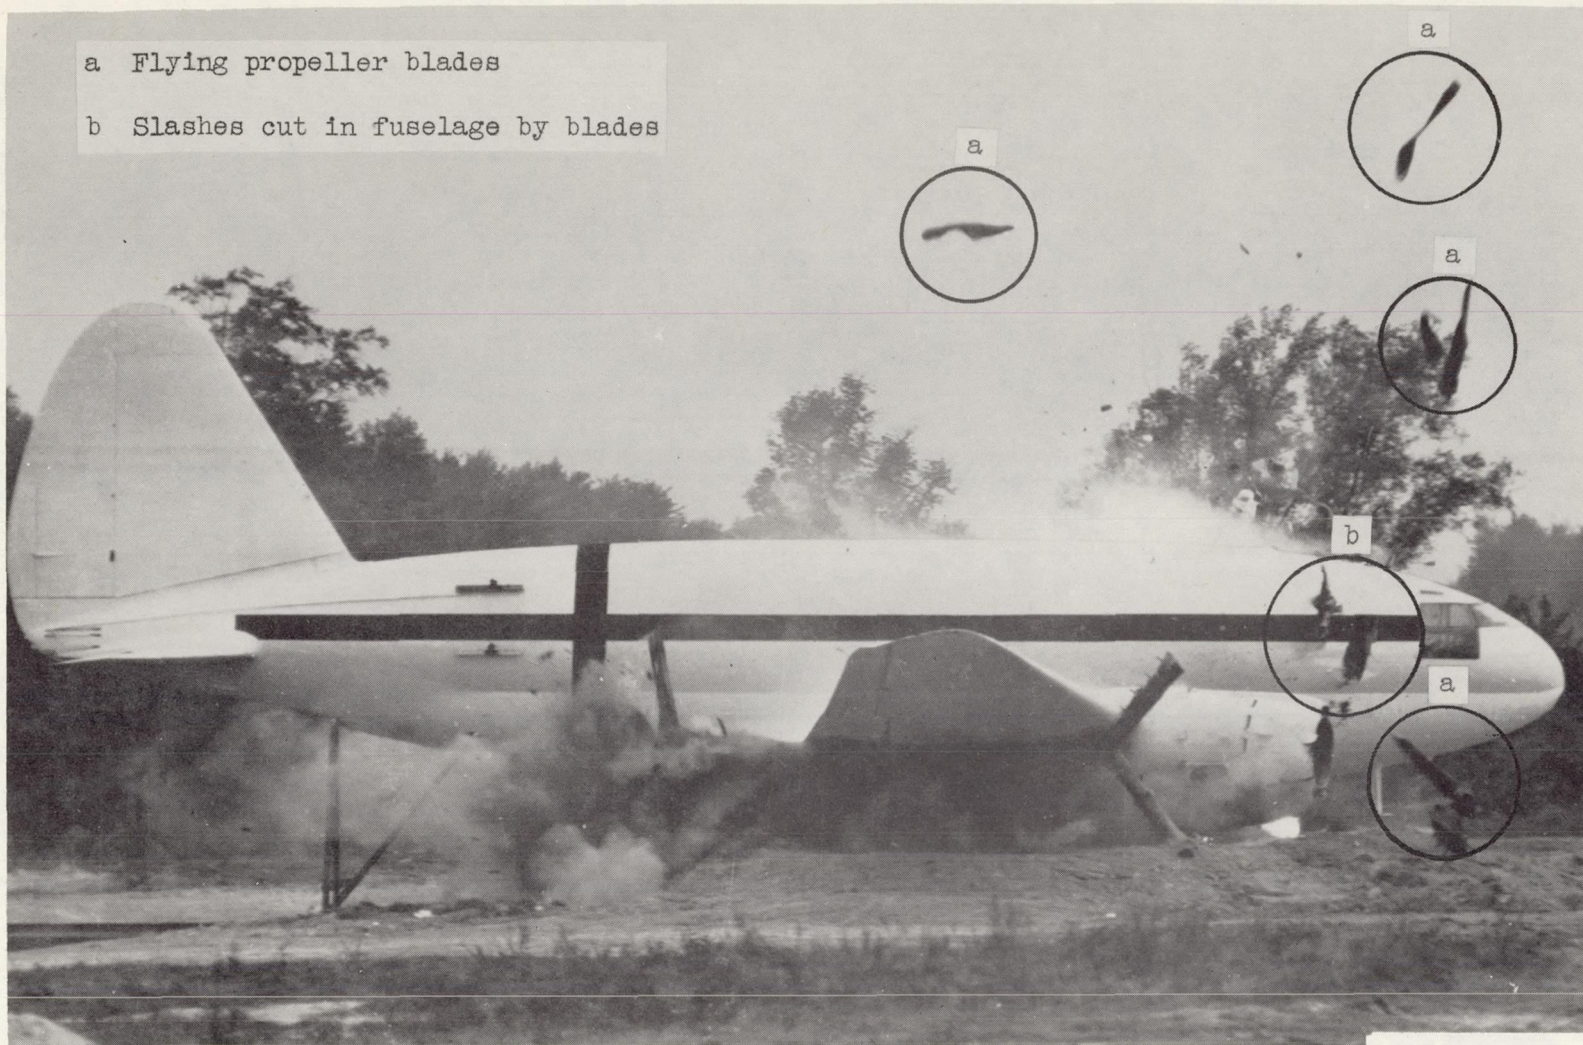
Figure 26. - Typical example of damage to fuselage by flying propeller blades.

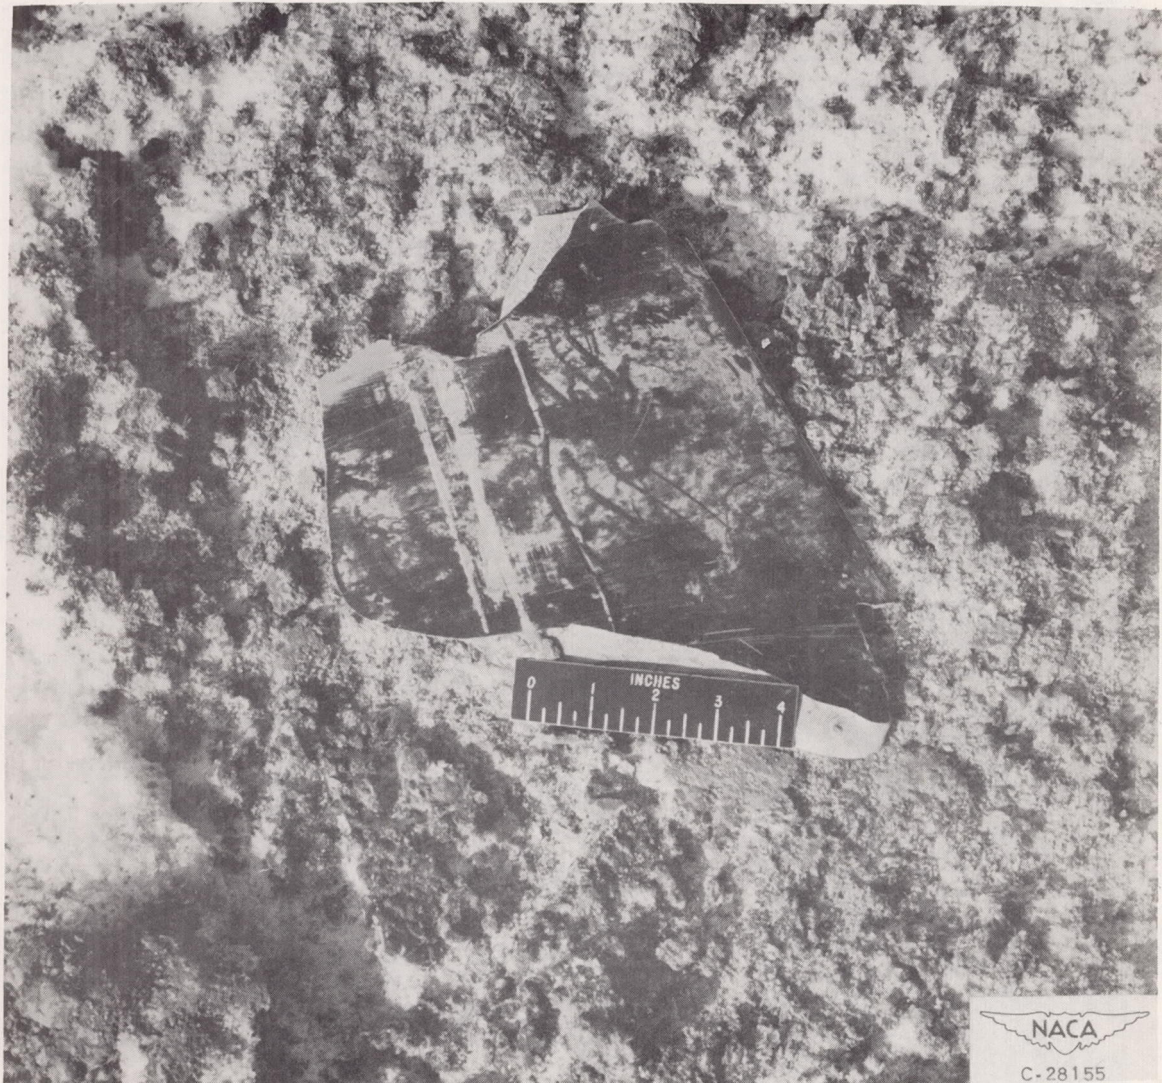
Figure 27. - Section of broken forged aluminum propeller blade caused by impact of blade with an obstacle.

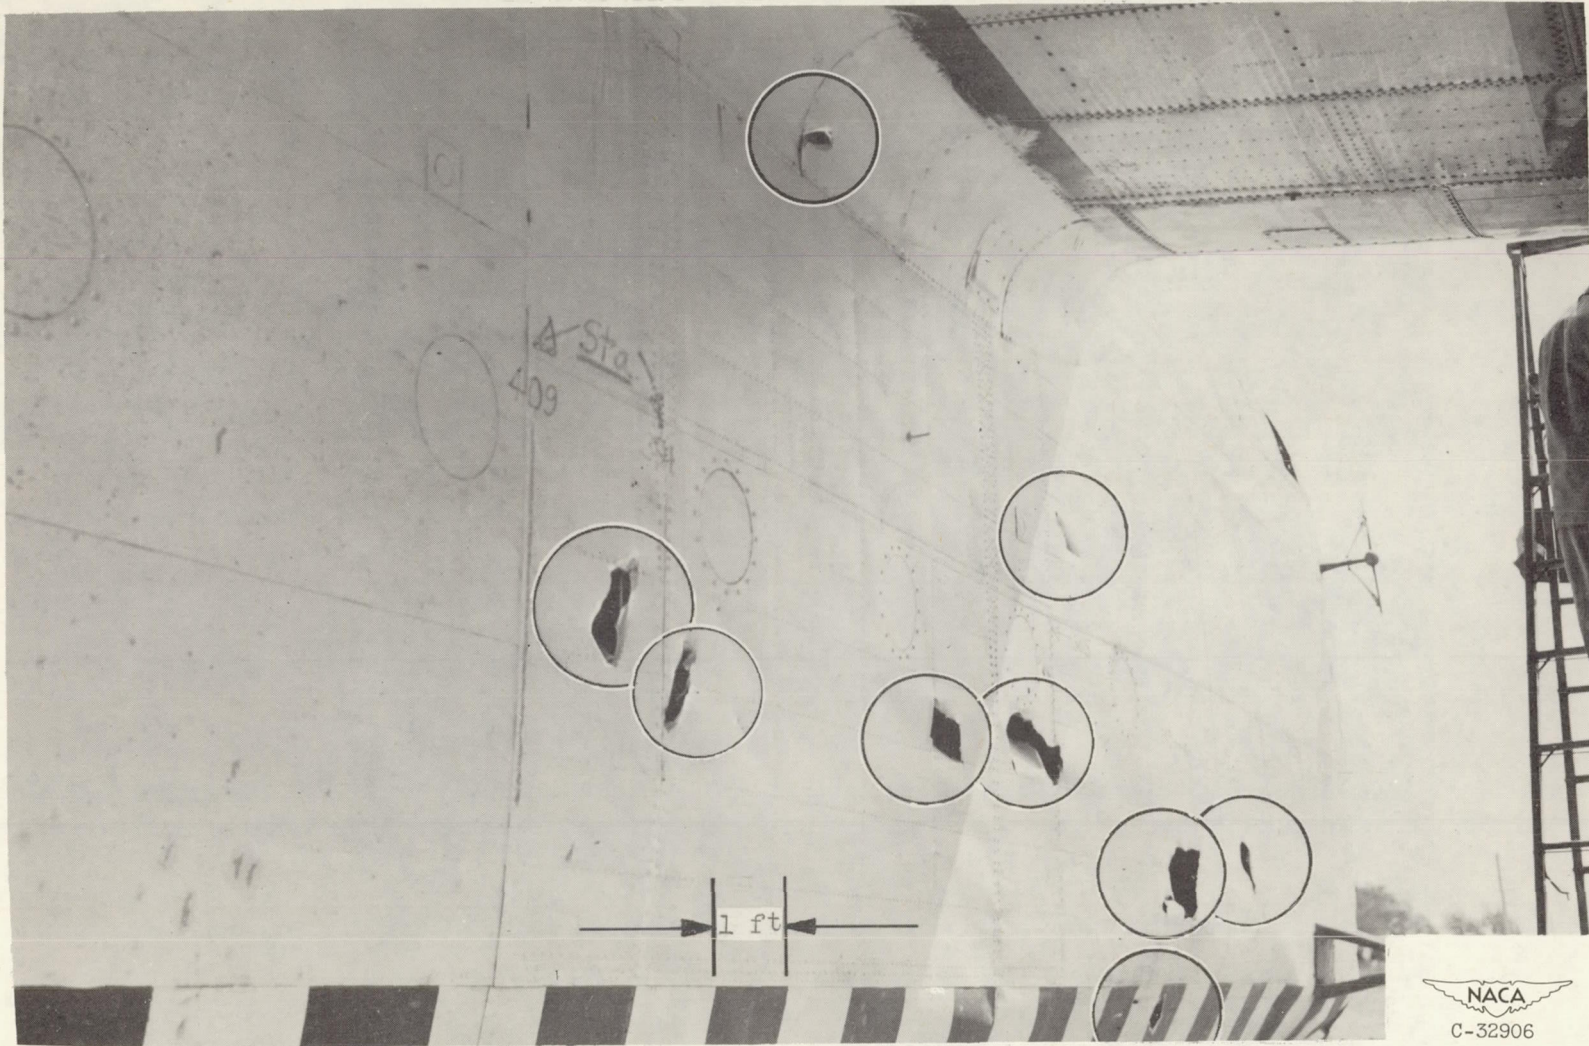
Figure 28. - Typical damage caused by flying fragments of forged aluminum propeller blades.

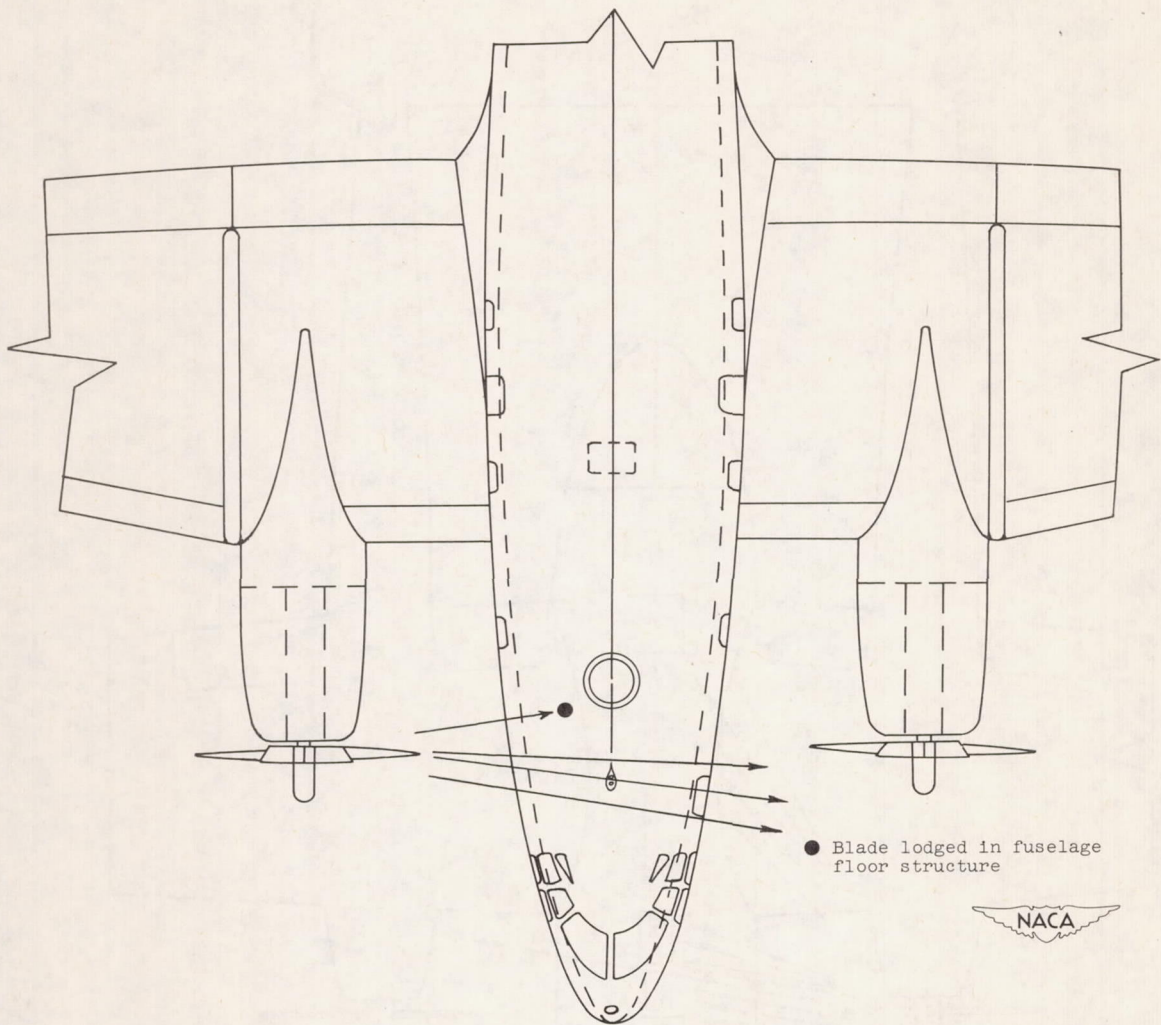
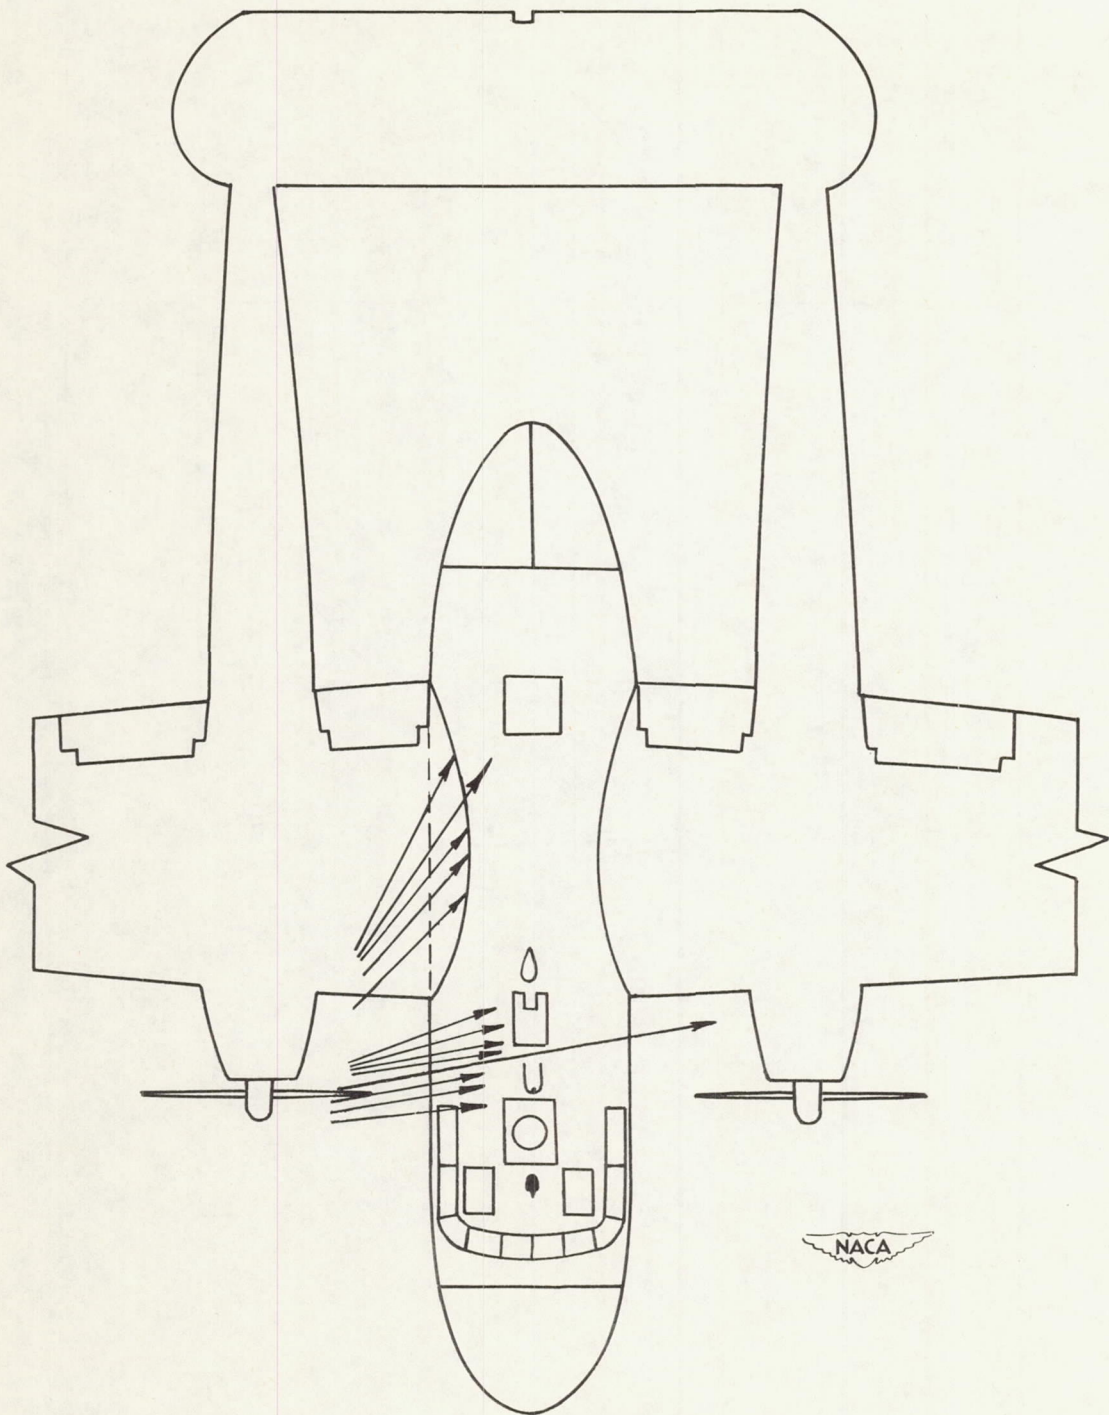
(a) Penetration by steel propeller blades during four crashes.

Figure 29. - Penetration of fuselage by propeller fragments.

(b) Penetration by forged aluminum propeller fragments during 14 crashes.

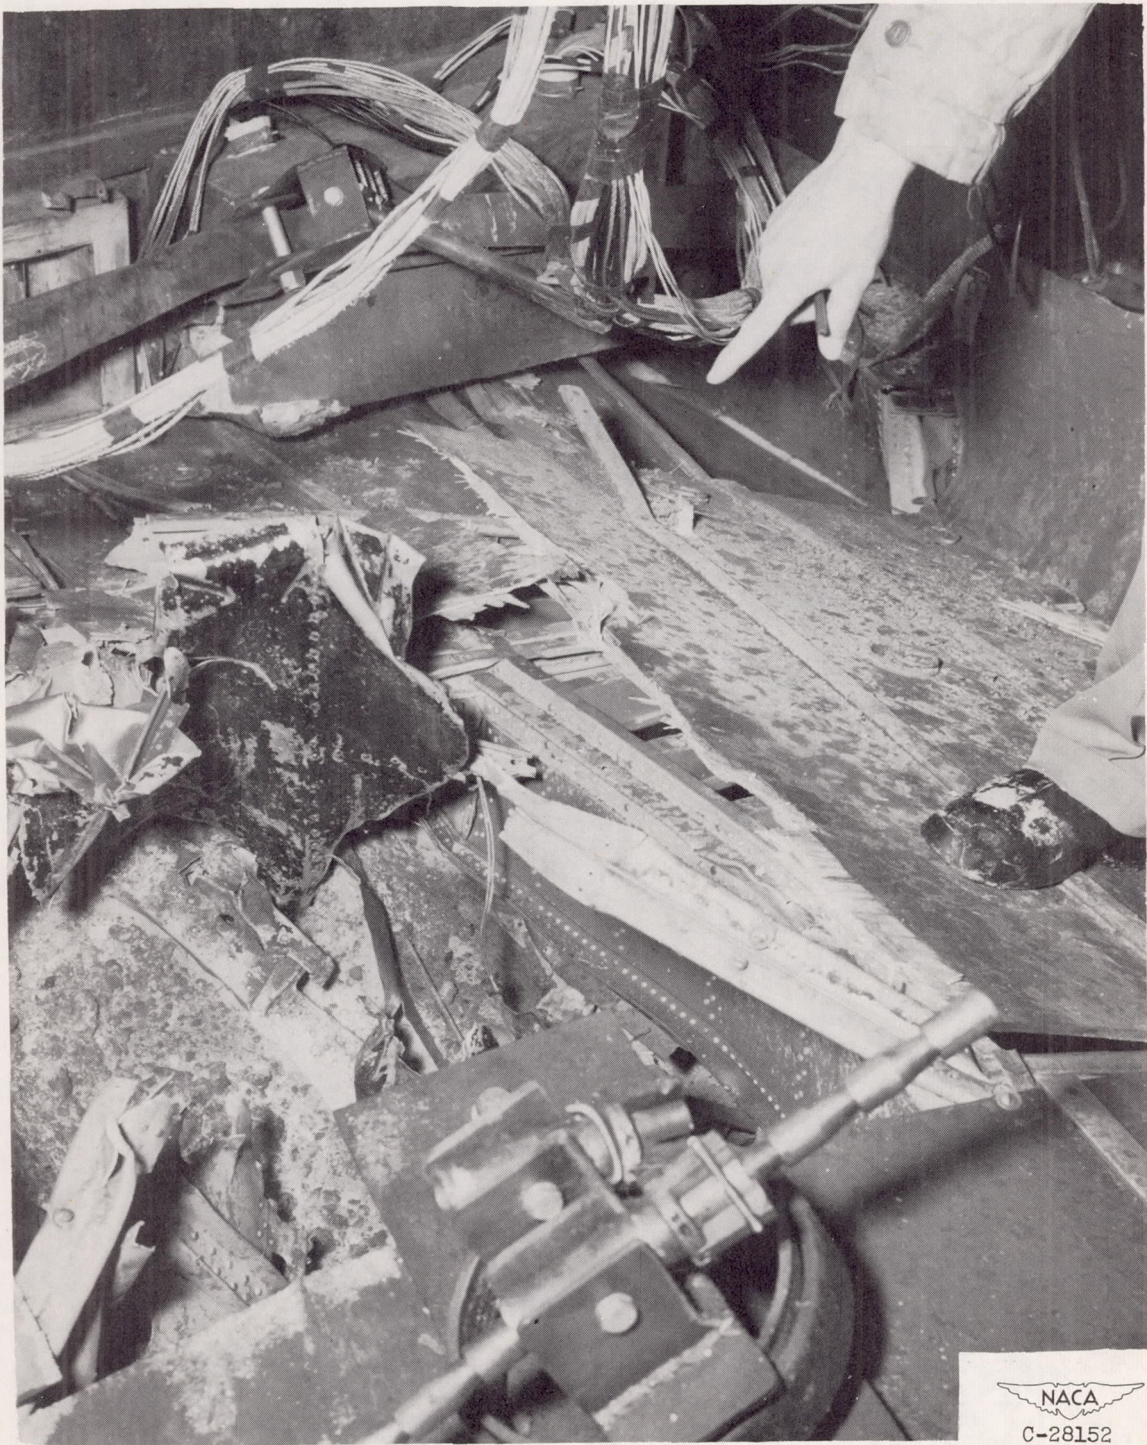
Figure 30. - Hole made in floor when front landing-gear strut and guide slipper were detached by contact with obstacle at crash barrier and penetrated floor structure.

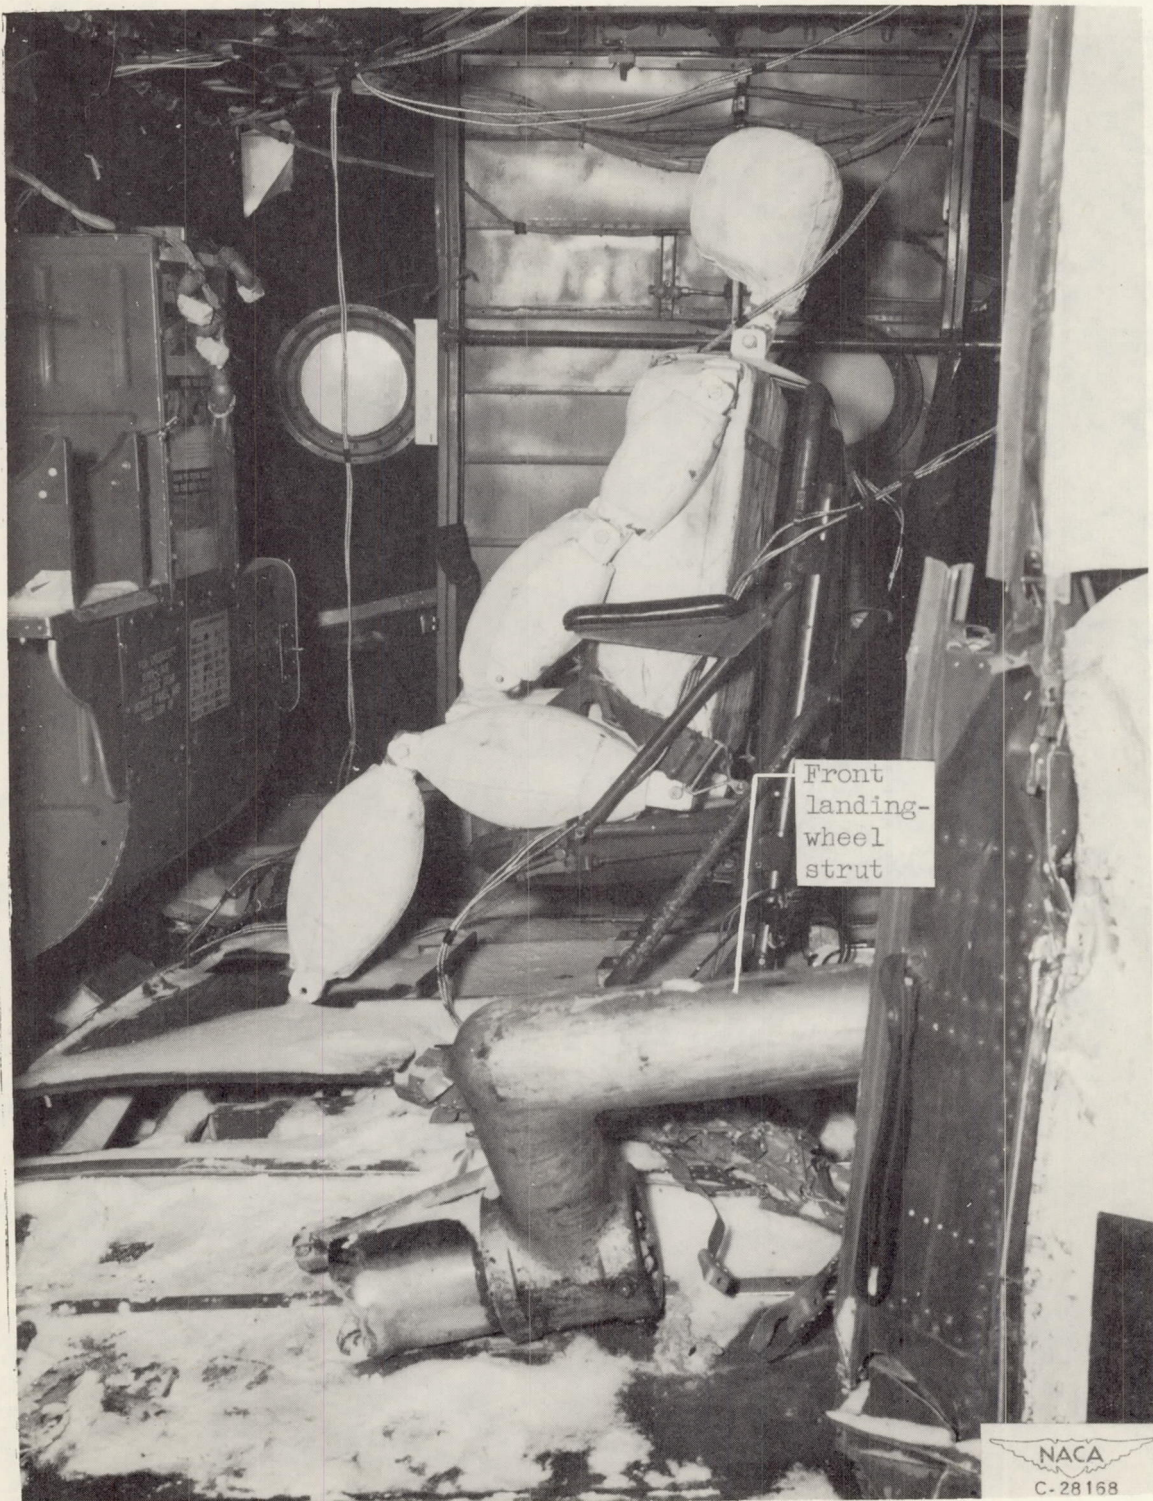
Figure 31. - Position of front landing-wheel strut after penetrating floor and rebounding from rear of cabin.

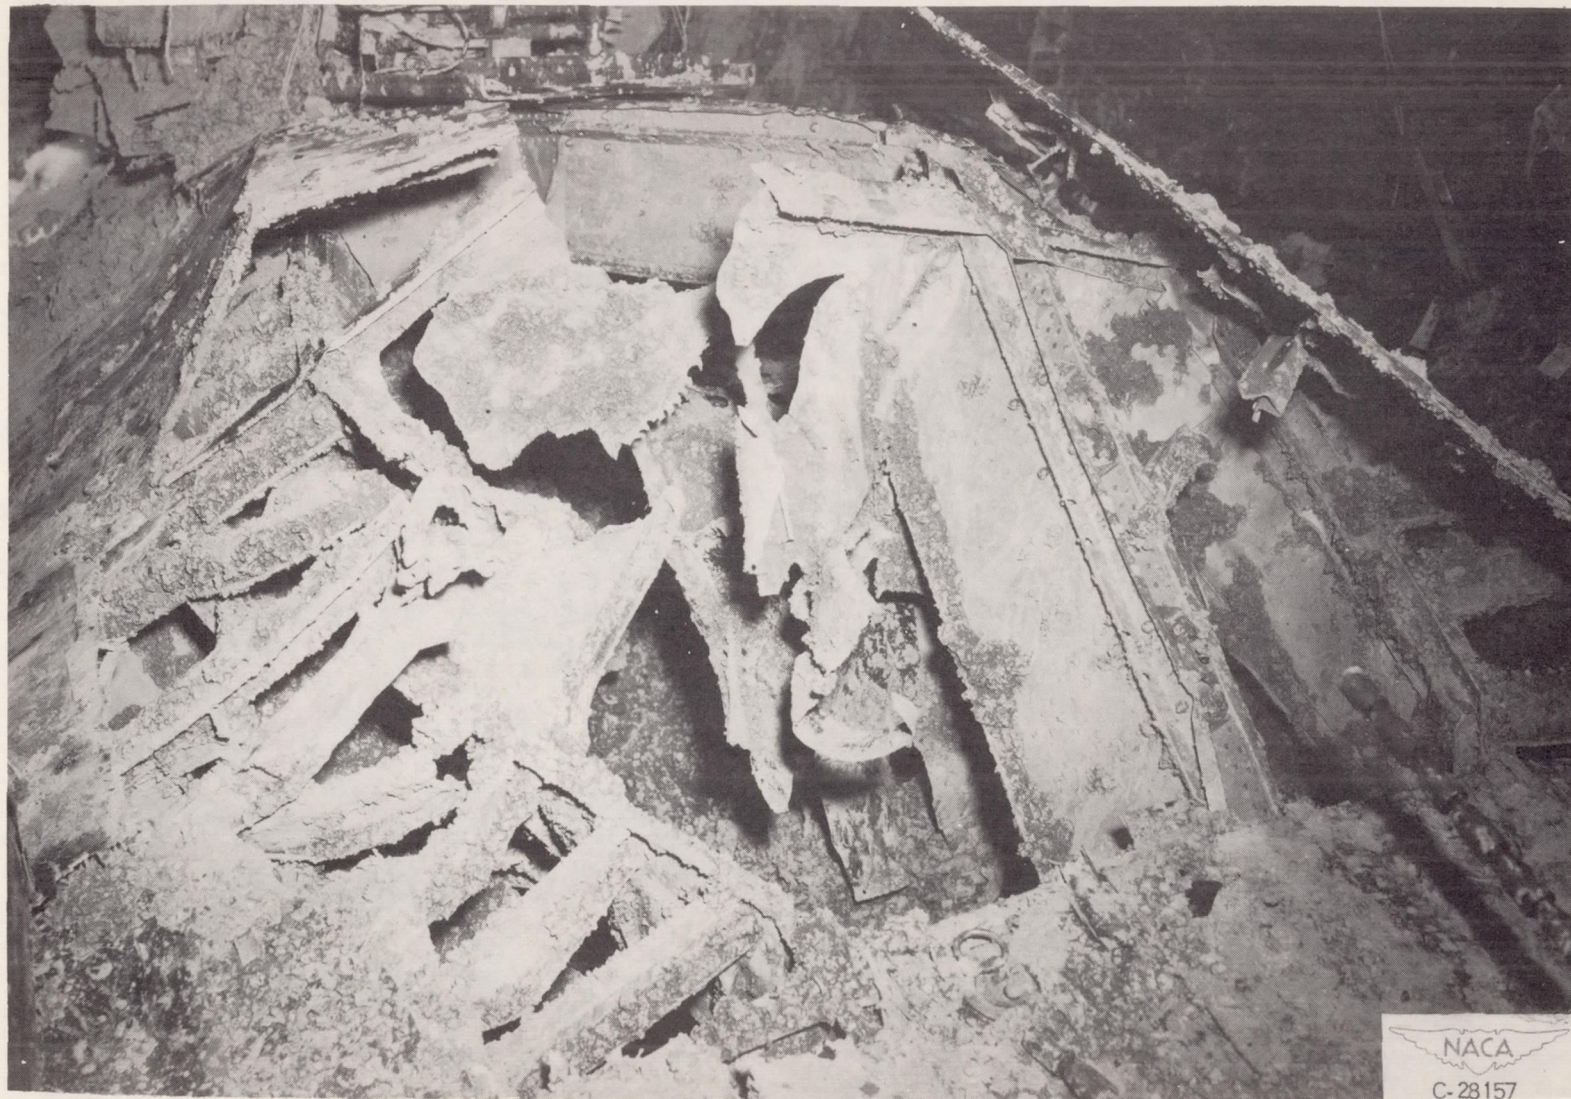
Figure 32. - Damage resulting when front landing-gear structure penetrates floor.

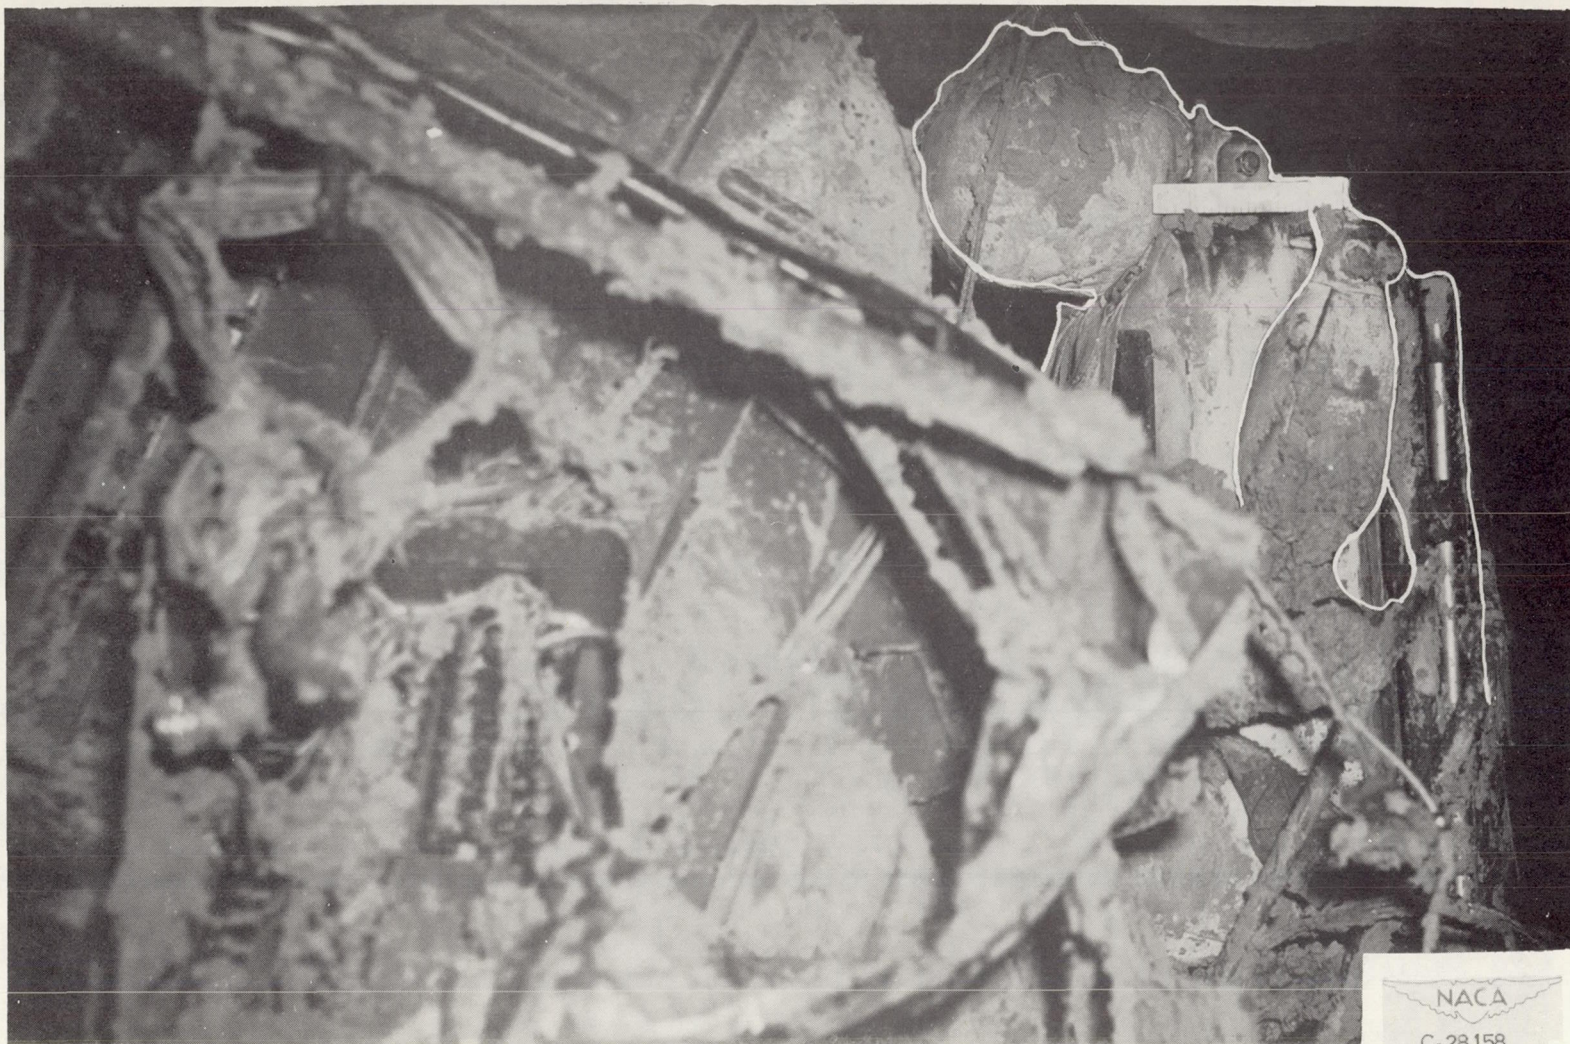
Figure 33. - Destruction of front landing-gear bulkhead and structure. Proximity to dummy shows possibility of injury to occupants seated in front part of fuselage.

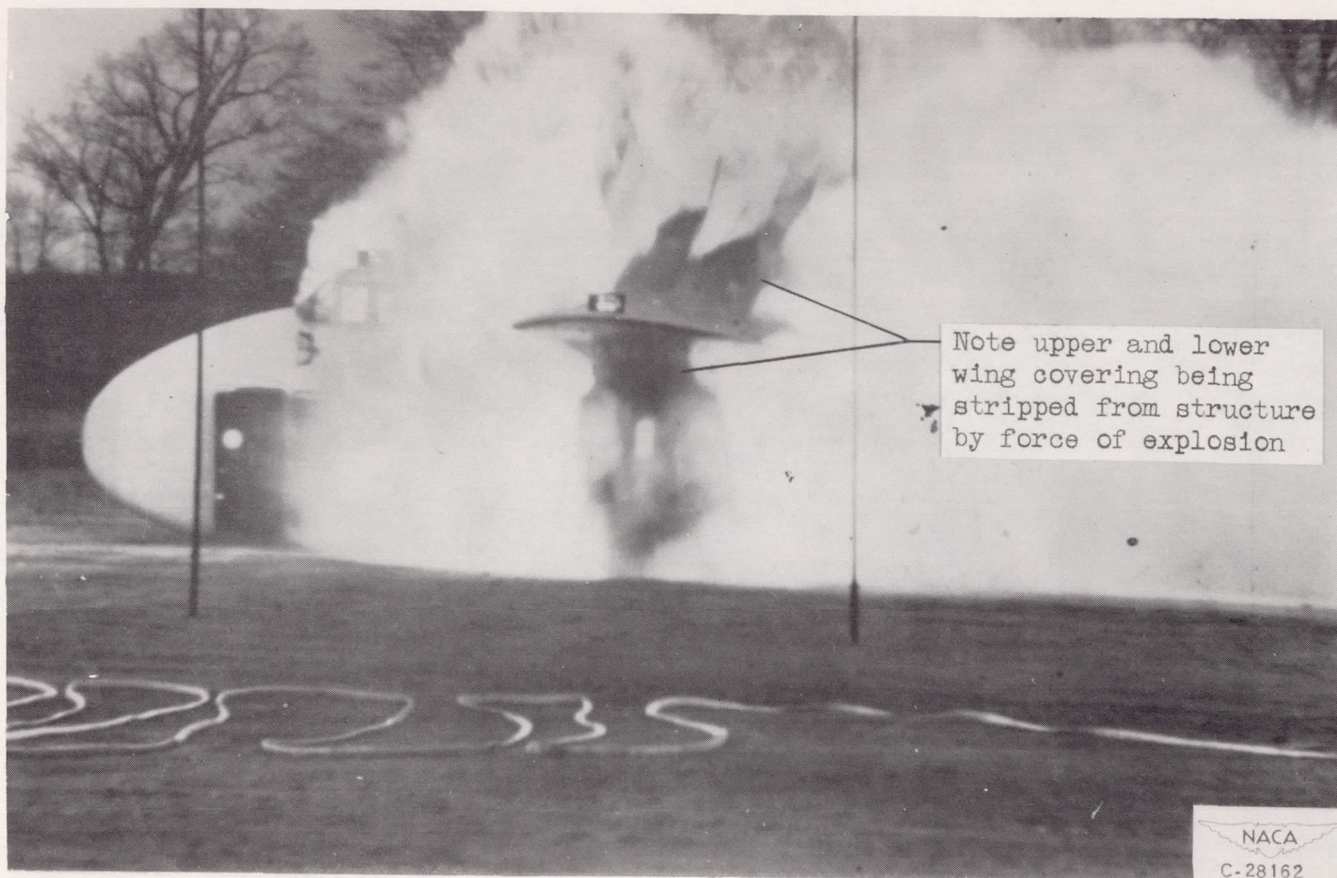
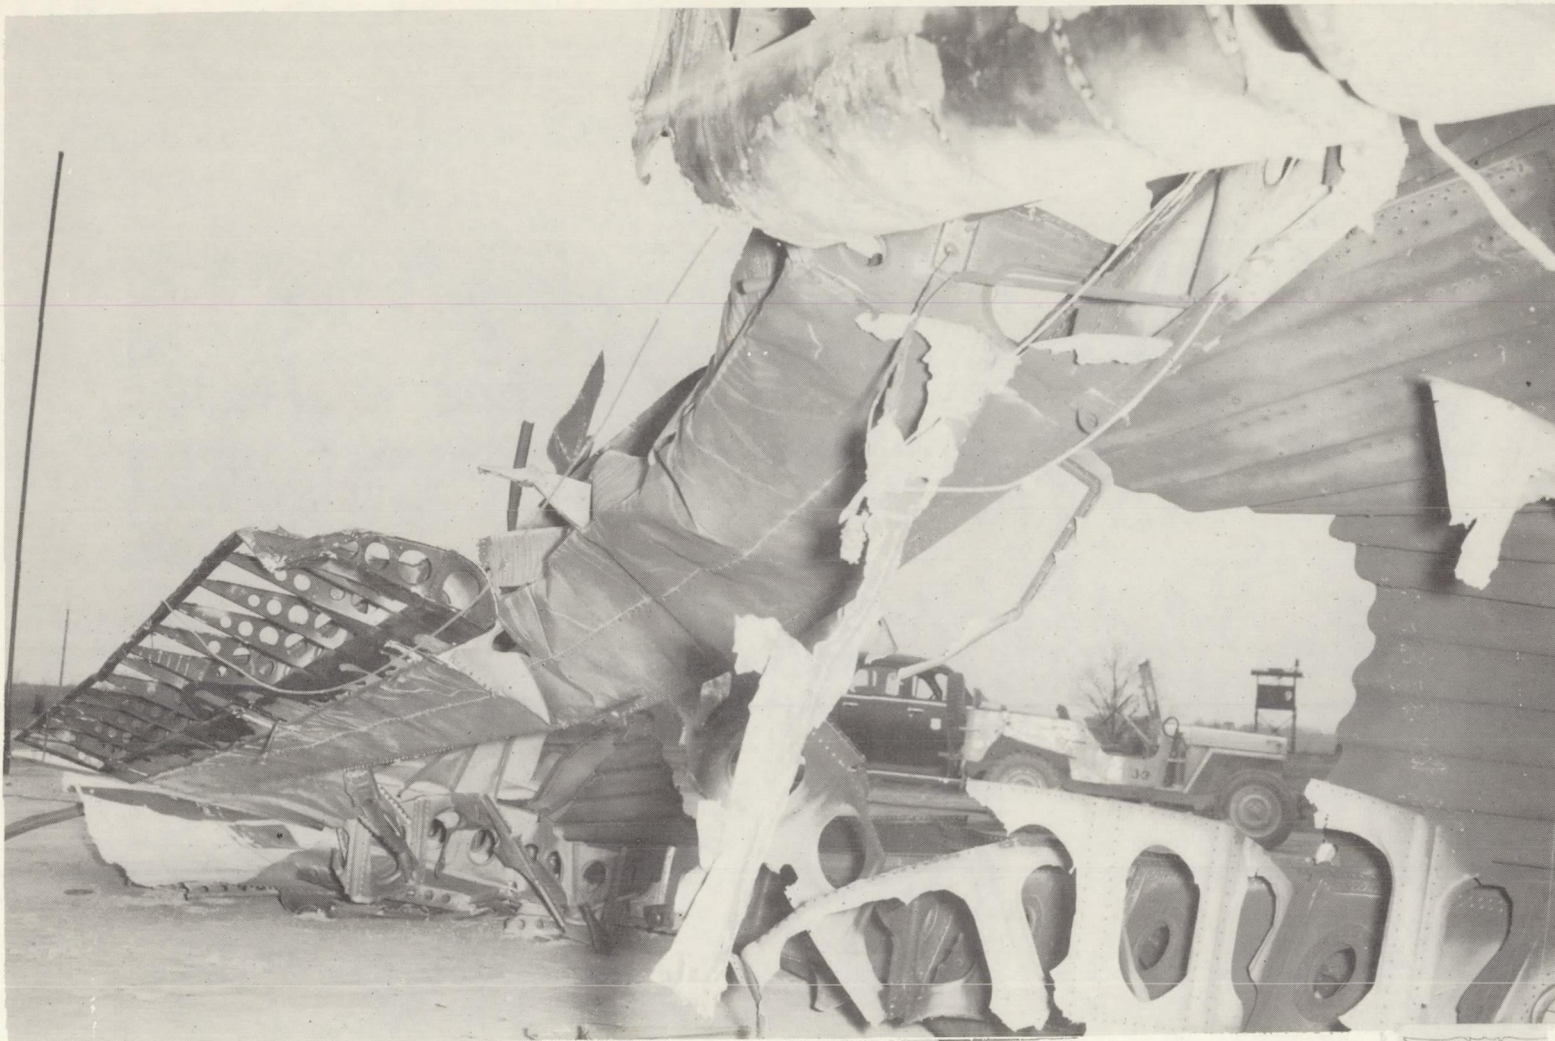
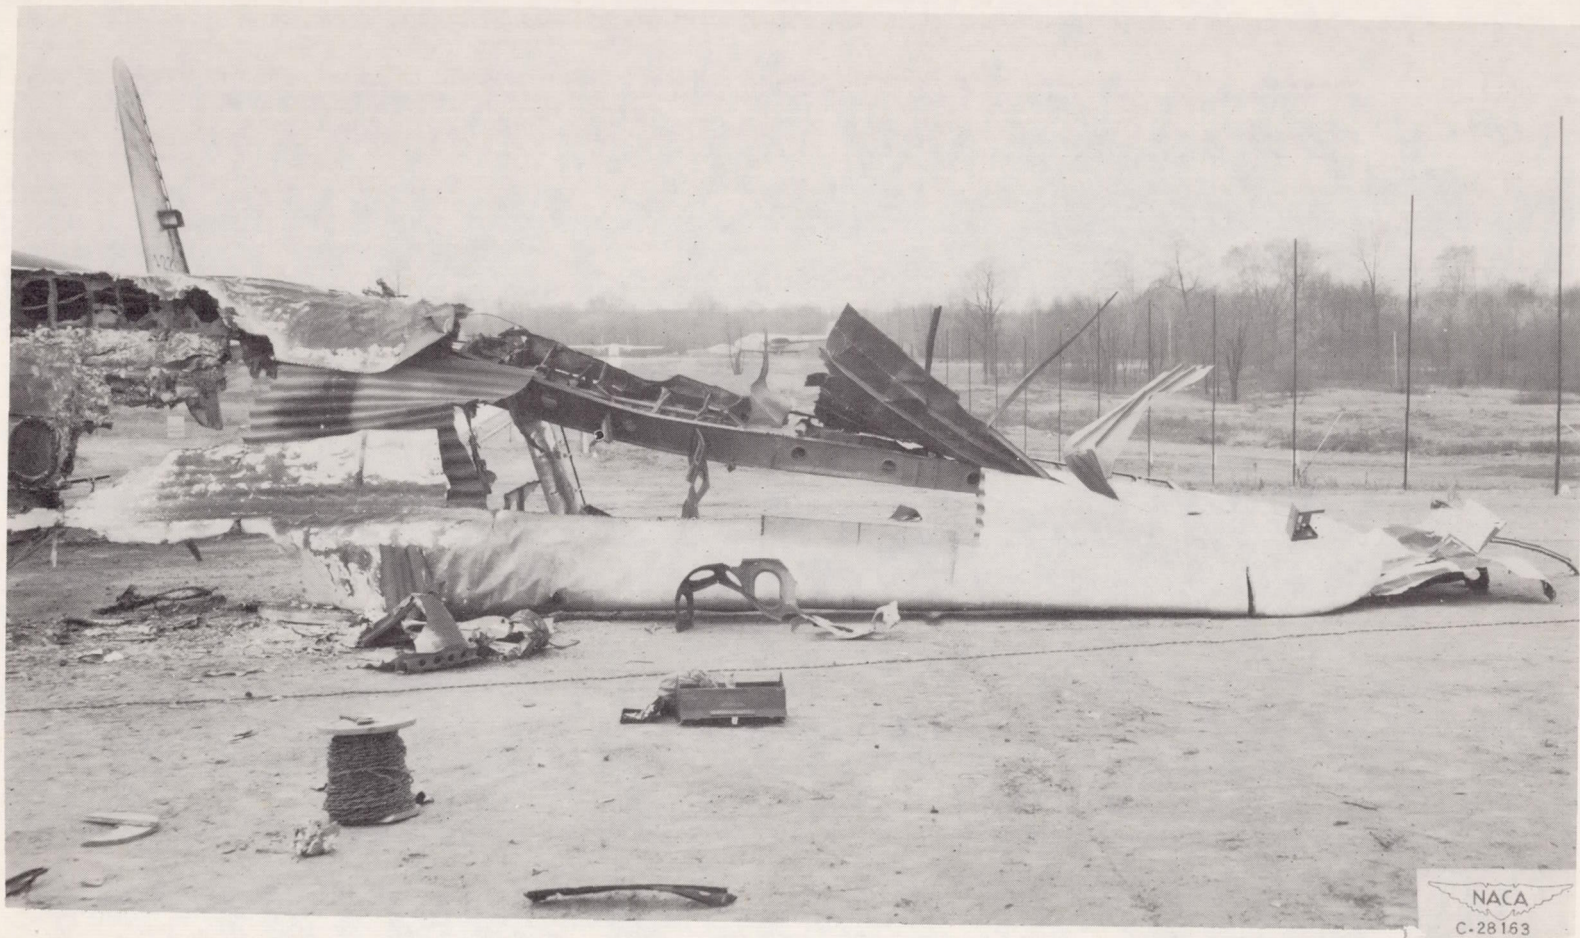
(a) Ignition $4\frac{1}{2}$ seconds after impact.

Figure 34. - Wing explosion resulting from ignition of fuel-air mixture accumulated in wing while airplane was sliding to a stop.

(b) Rear view of damage to wing structure.

(c) Front view of damage to wing structure.

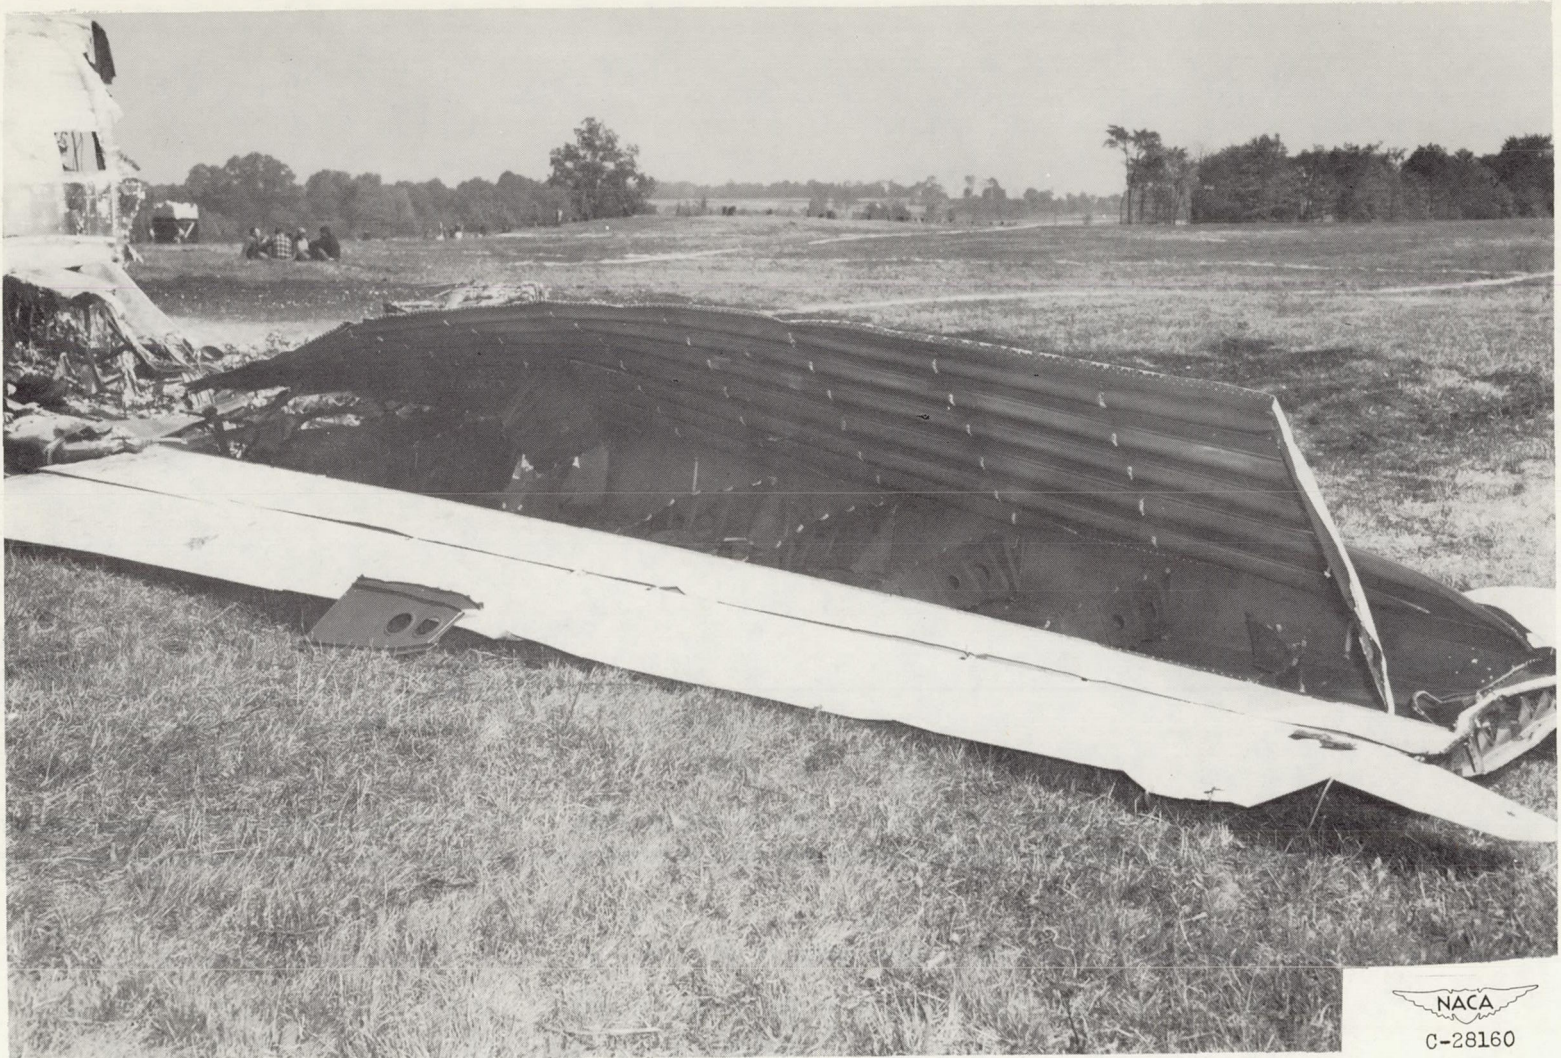
Figure 35. - Wing damage resulting from internal explosion that occurred several minutes after original fire was in progress. Explosion caused by ignition of fuel-air mixture trapped in wing.

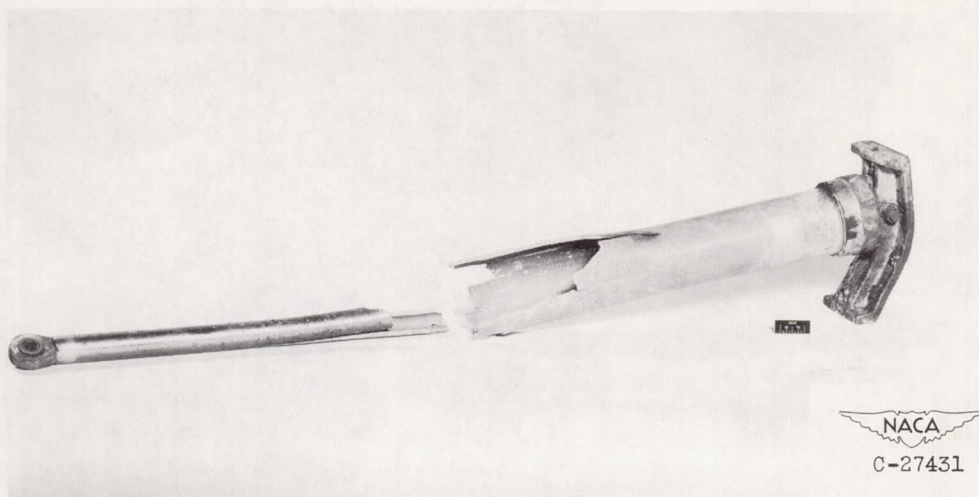
Figure 36. - Damage resulting when hydraulic shock strut was heated by aircraft fire and exploded.

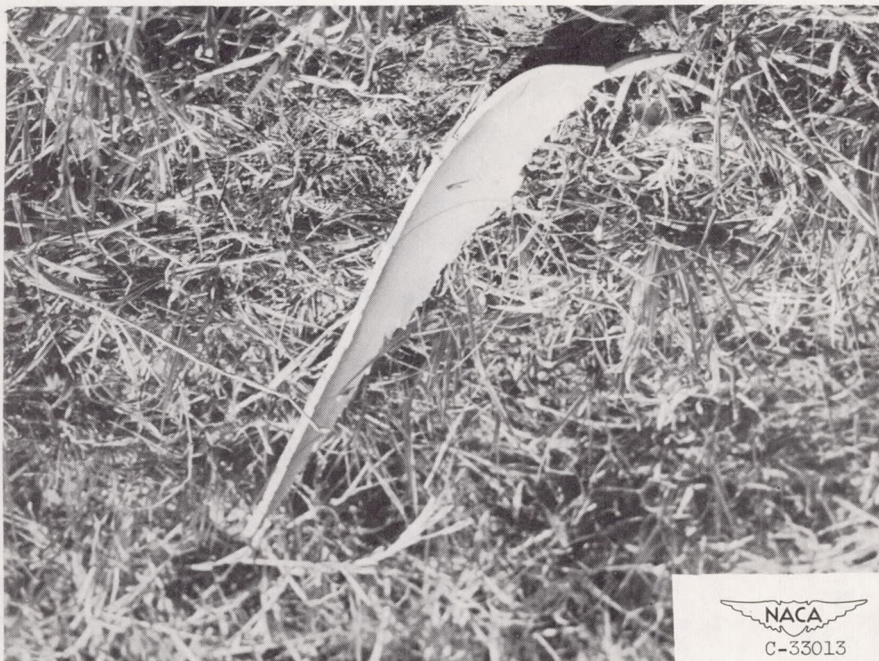
Figure 37. - Fragment of hydraulic shock strut cylinder found 150 feet from airplane after shock strut exploded because of fire.
