NACA TN 2996

APPRAISAL OF HAZARDS TO HUMAN SURVIVAL
IN AIRPLANE CRASH FIRES

By Gerard J. Pesman

Lewis Flight Propulsion Laboratory
Cleveland, Ohio

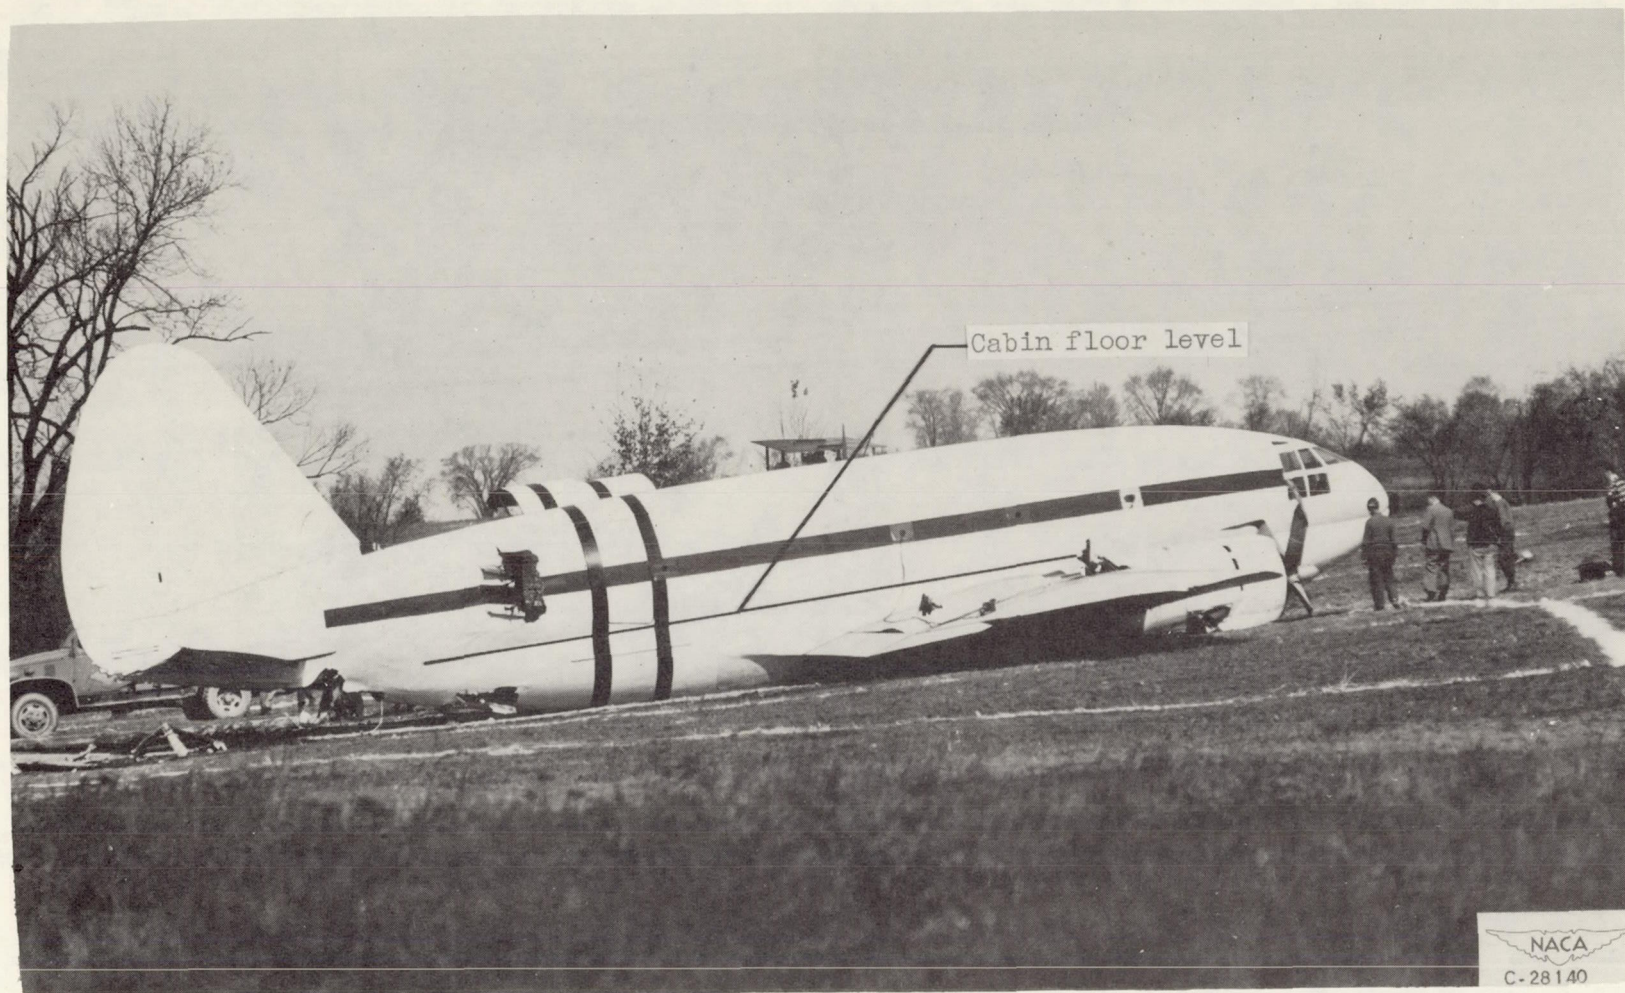
Figure 38. - Insignificant damage to floor structure of low-midwing, twin-engine type aircraft resulting from simulated take-off accident. Cabin floor lies along indented joint line between two curved sections of fuselage.

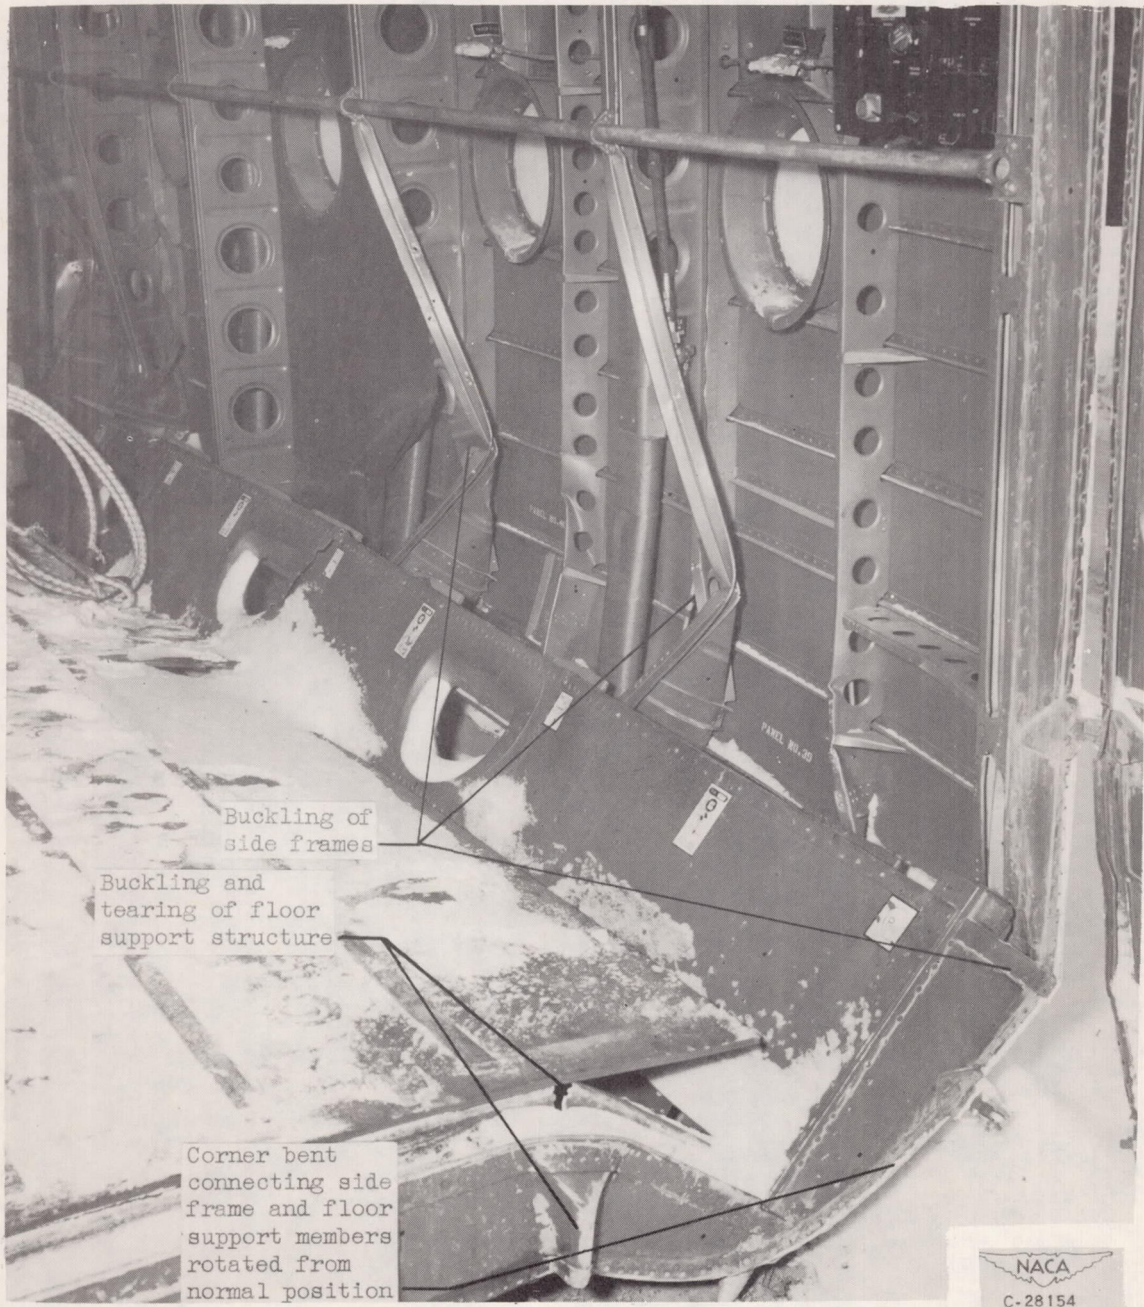
Figure 39. - Damage to packet-type cargo airplane floor structure and side framing resulting from vertical impact and sliding friction on hard ground surface.

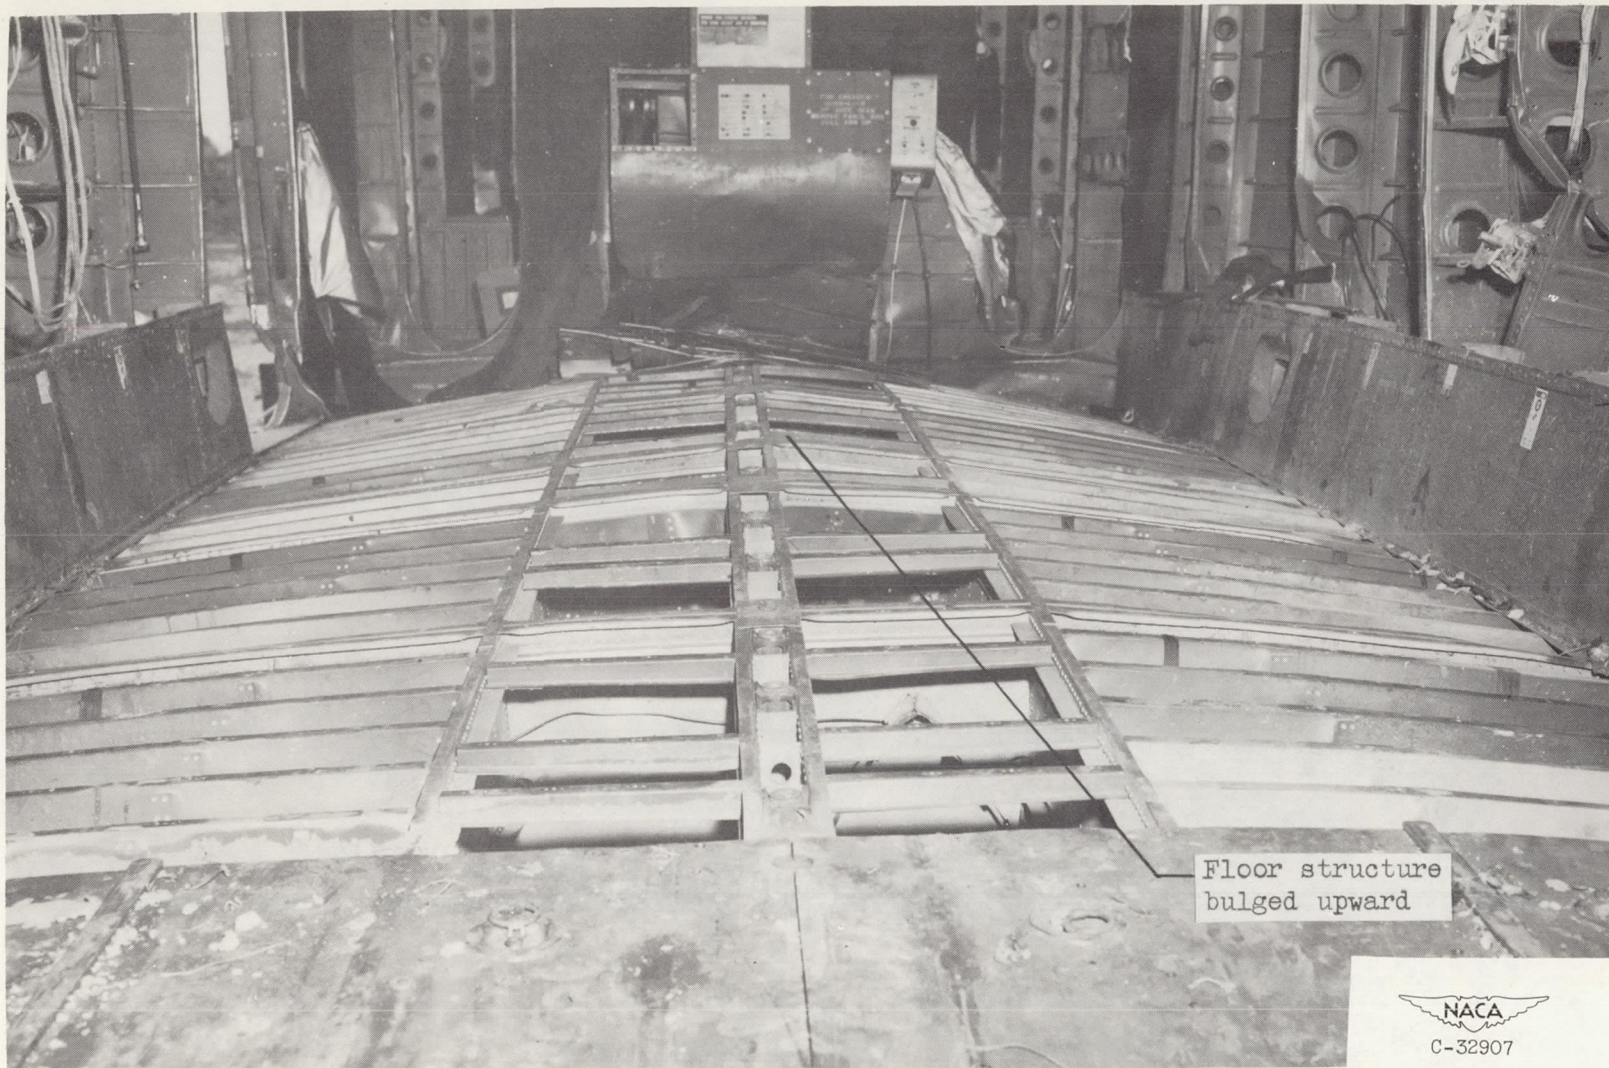
Floor structure
bulged upward

Figure 40. - Floor support structure of cargo-type airplane bulged slightly upward as a result of nose-wheel damage and landing impact upon hard dirt surface.

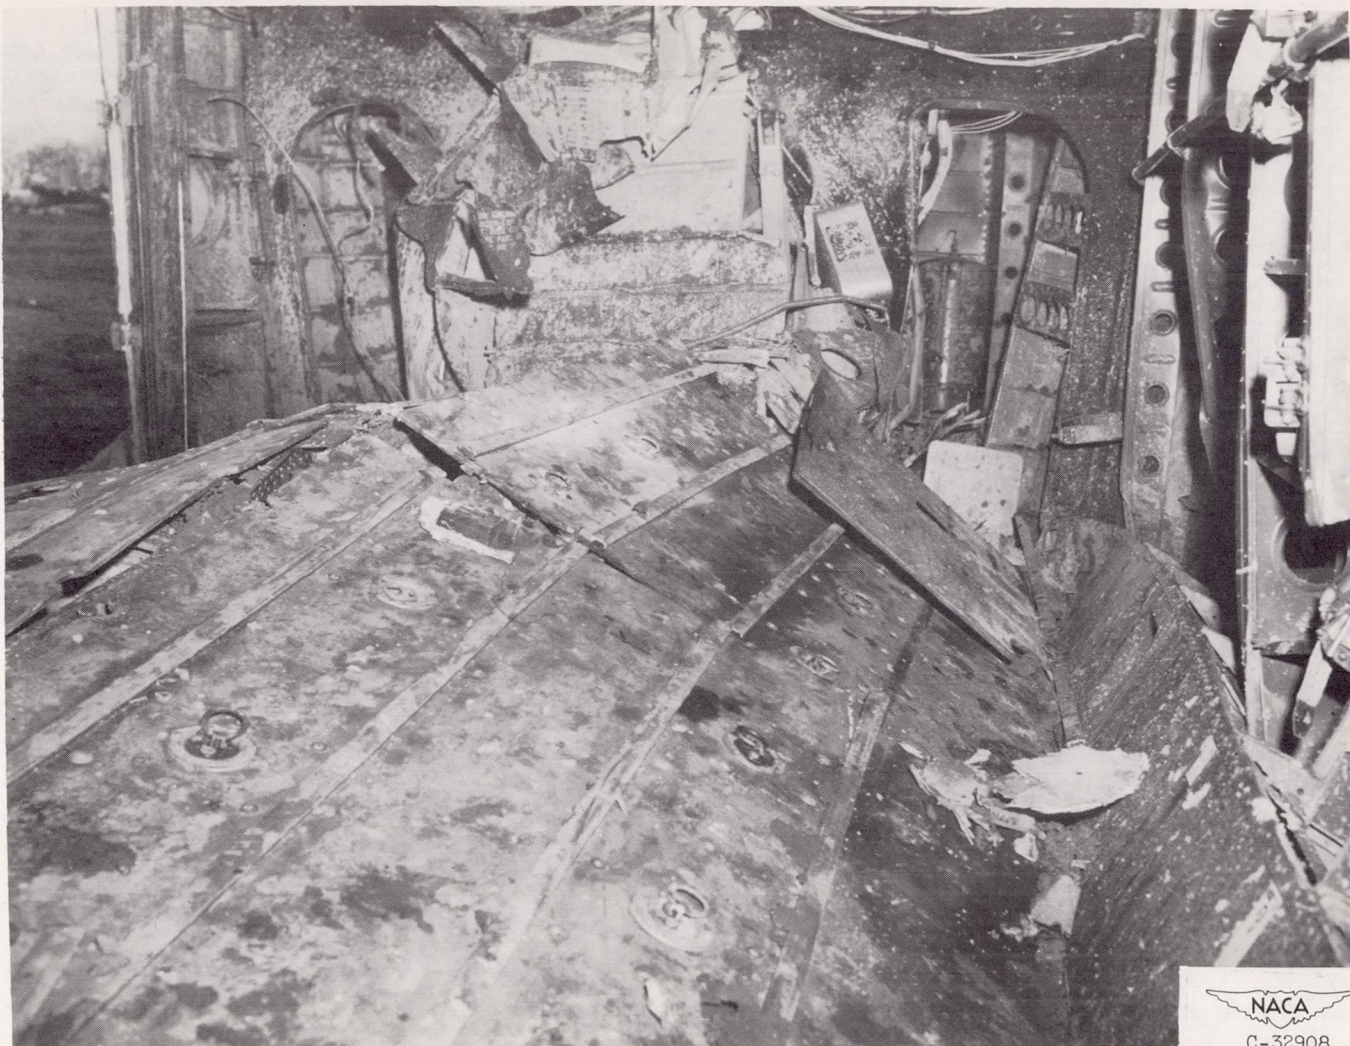
Figure 41. - Floor structure of cargo-type airplane severely damaged and bulged upward as a result of nose-wheel damage and landing upon a mud surface.

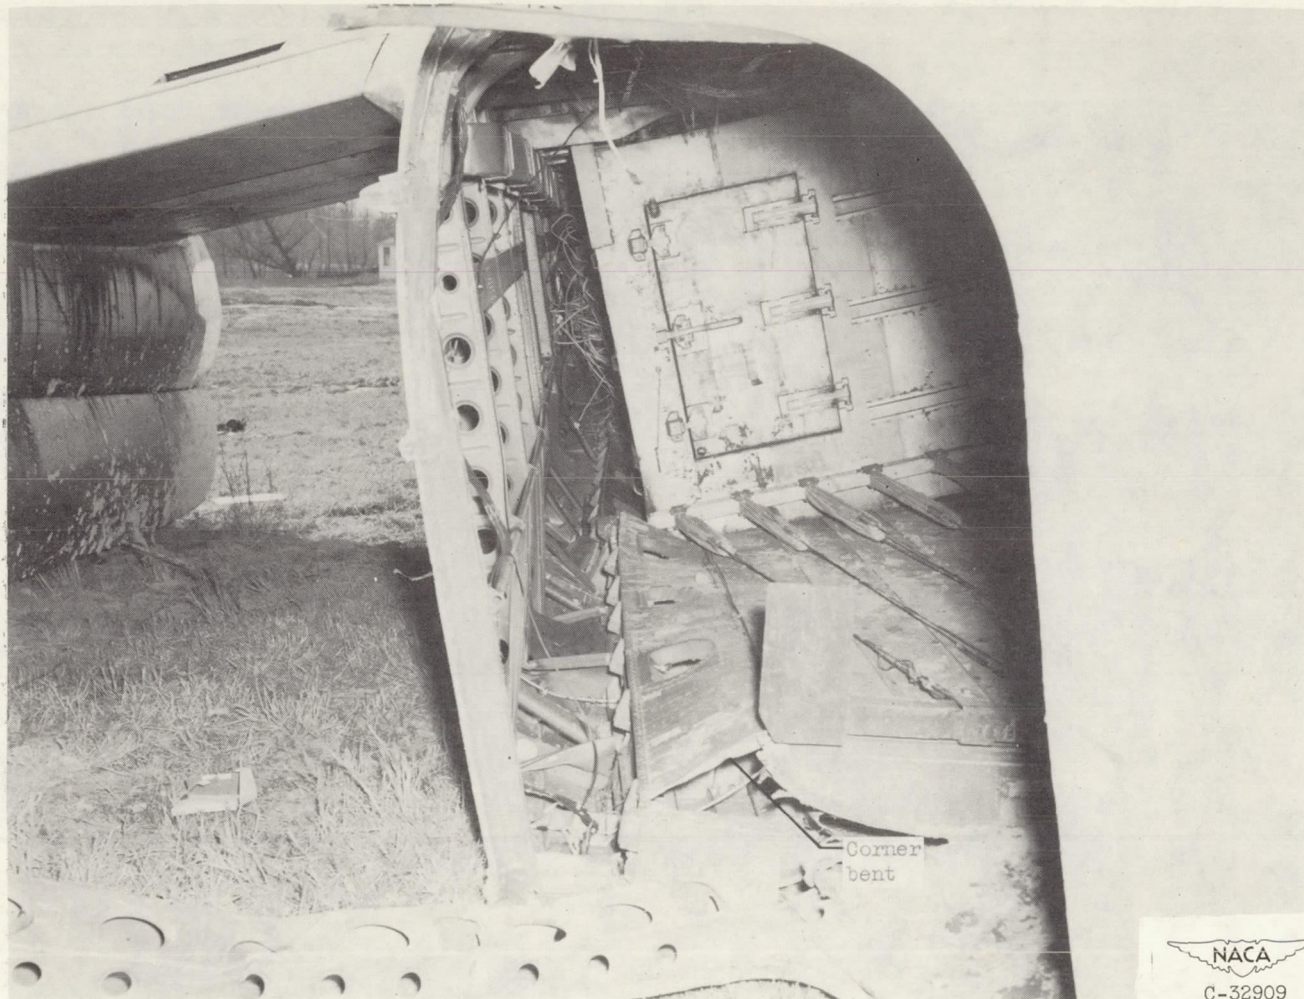
Figure 42. - Corner bent rotated from 90° to about 120° from its normal position by combined lateral and vertical forces caused by ground loop.

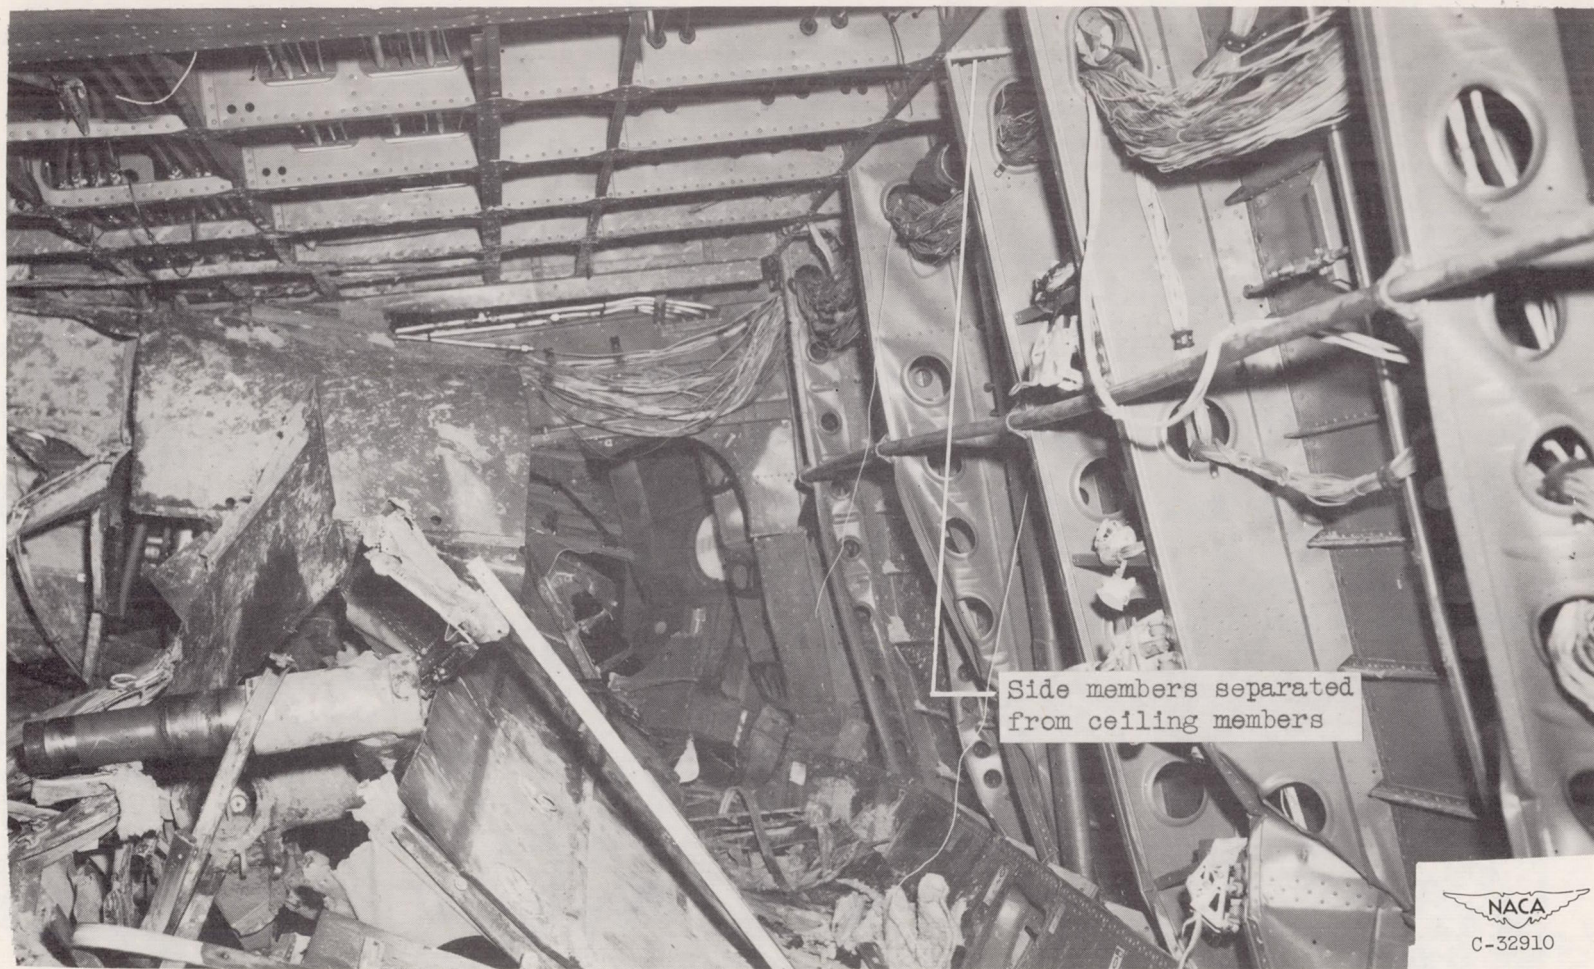
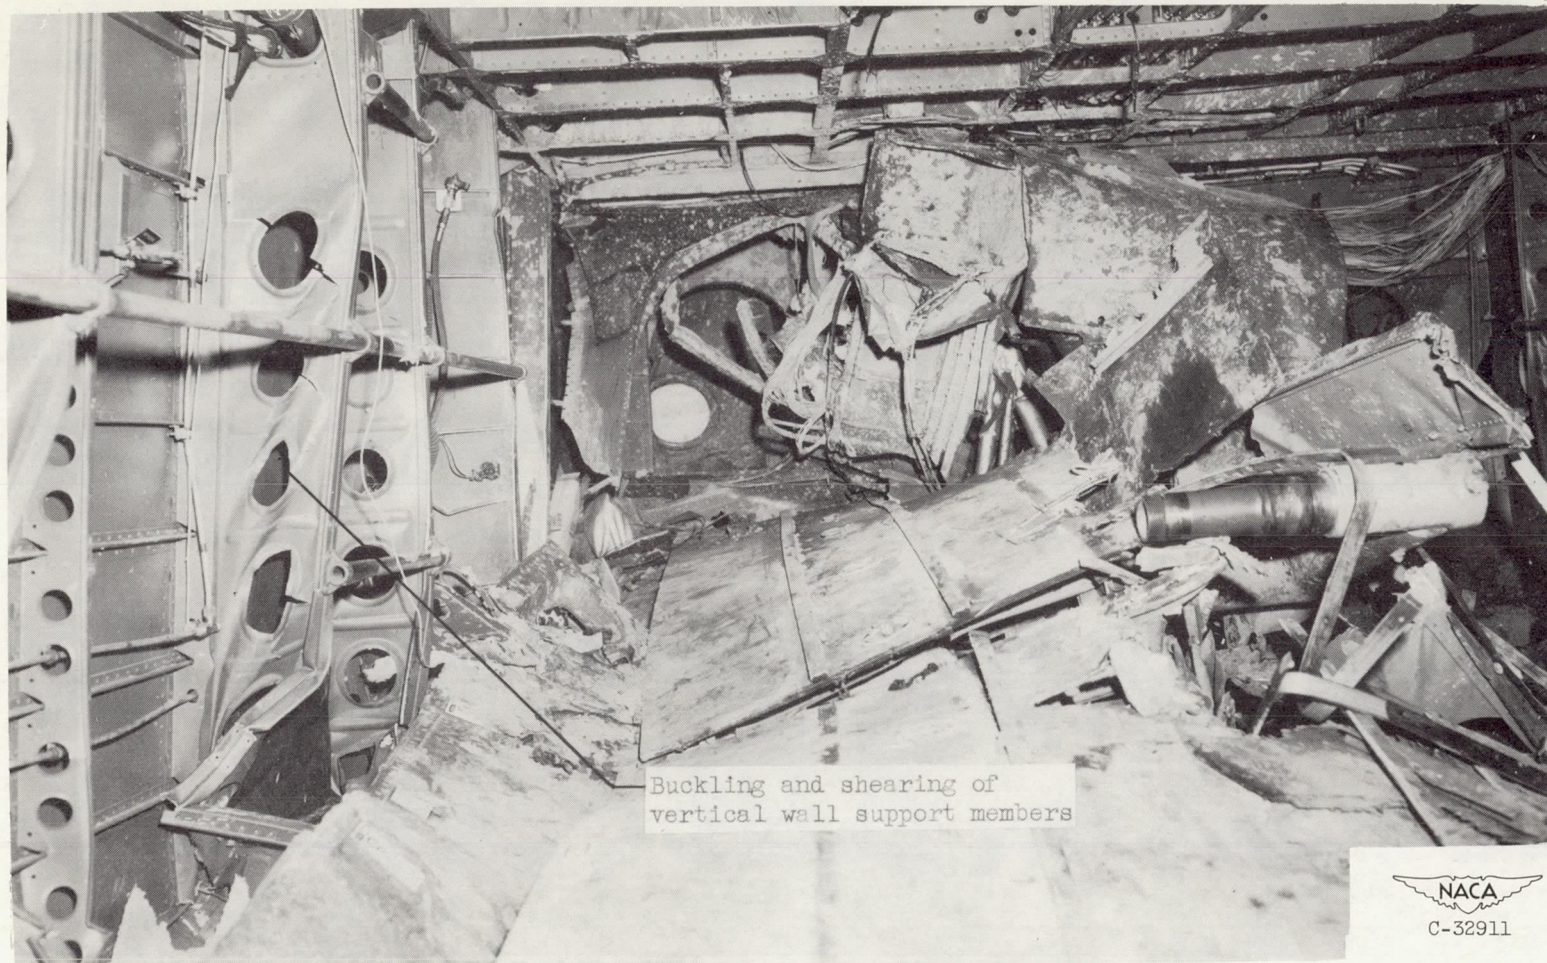
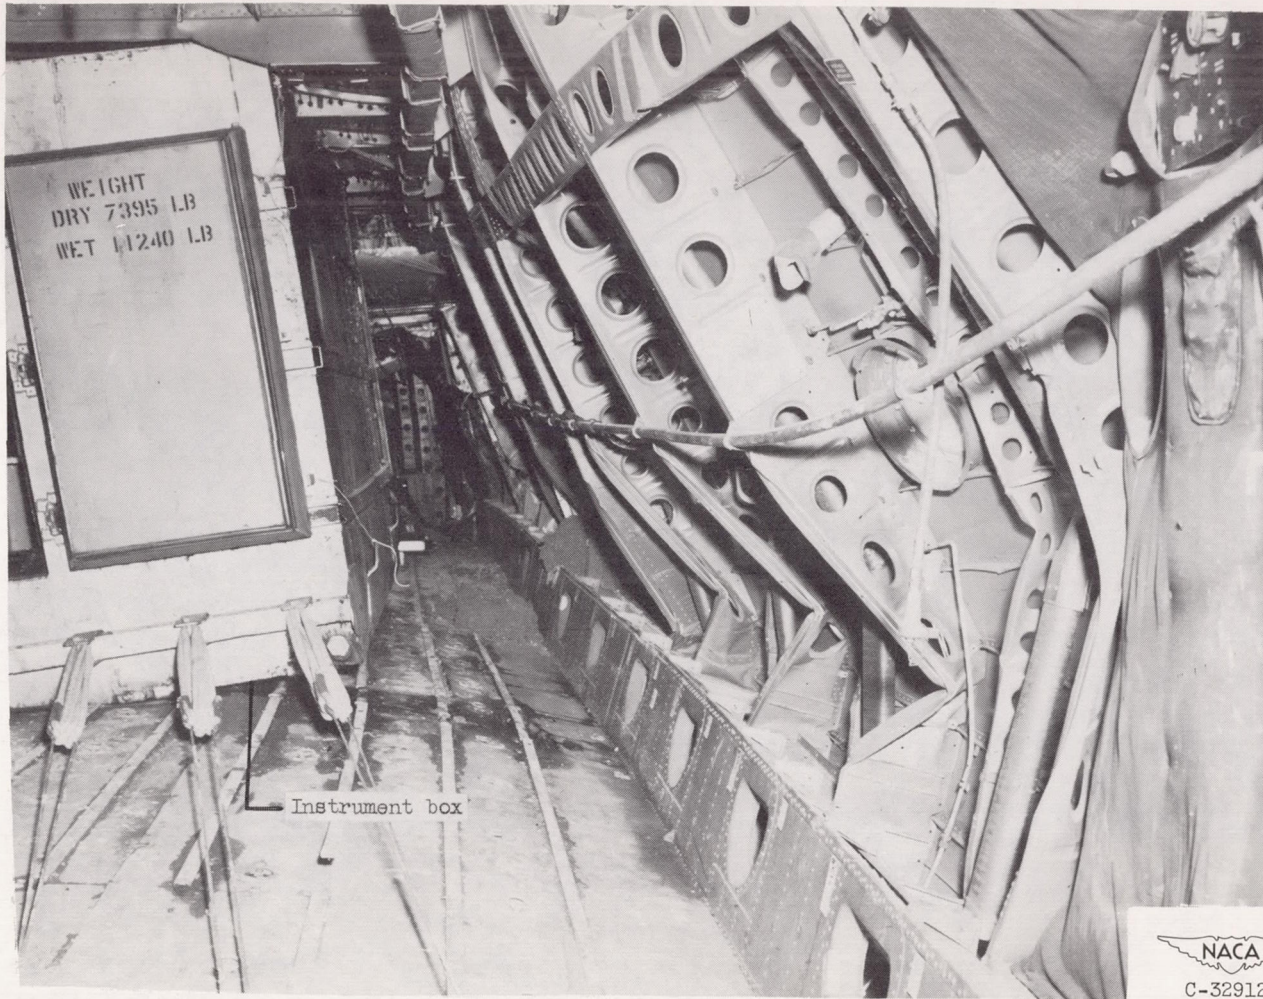
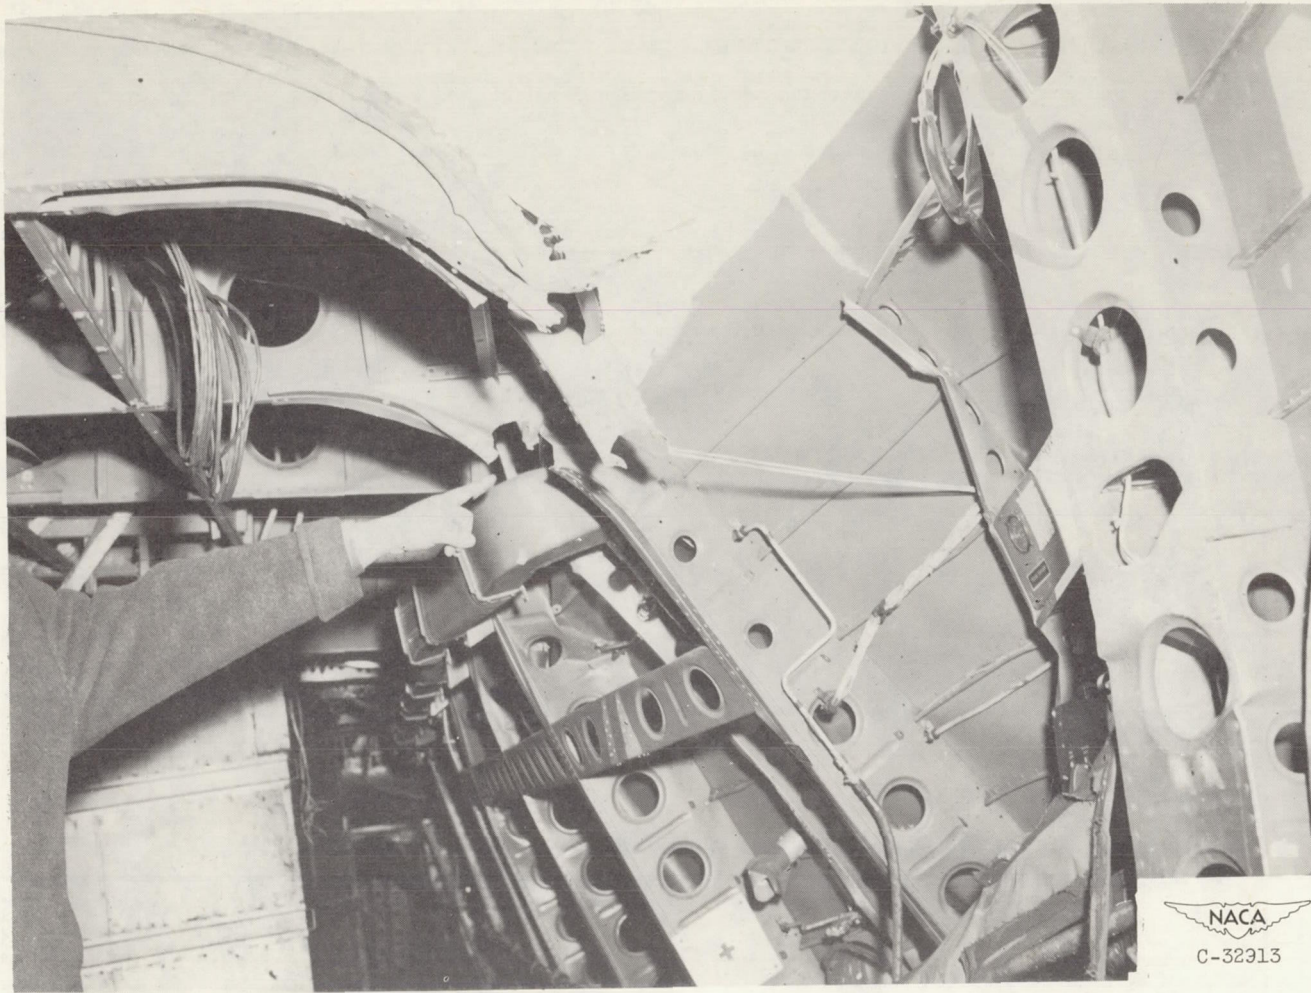
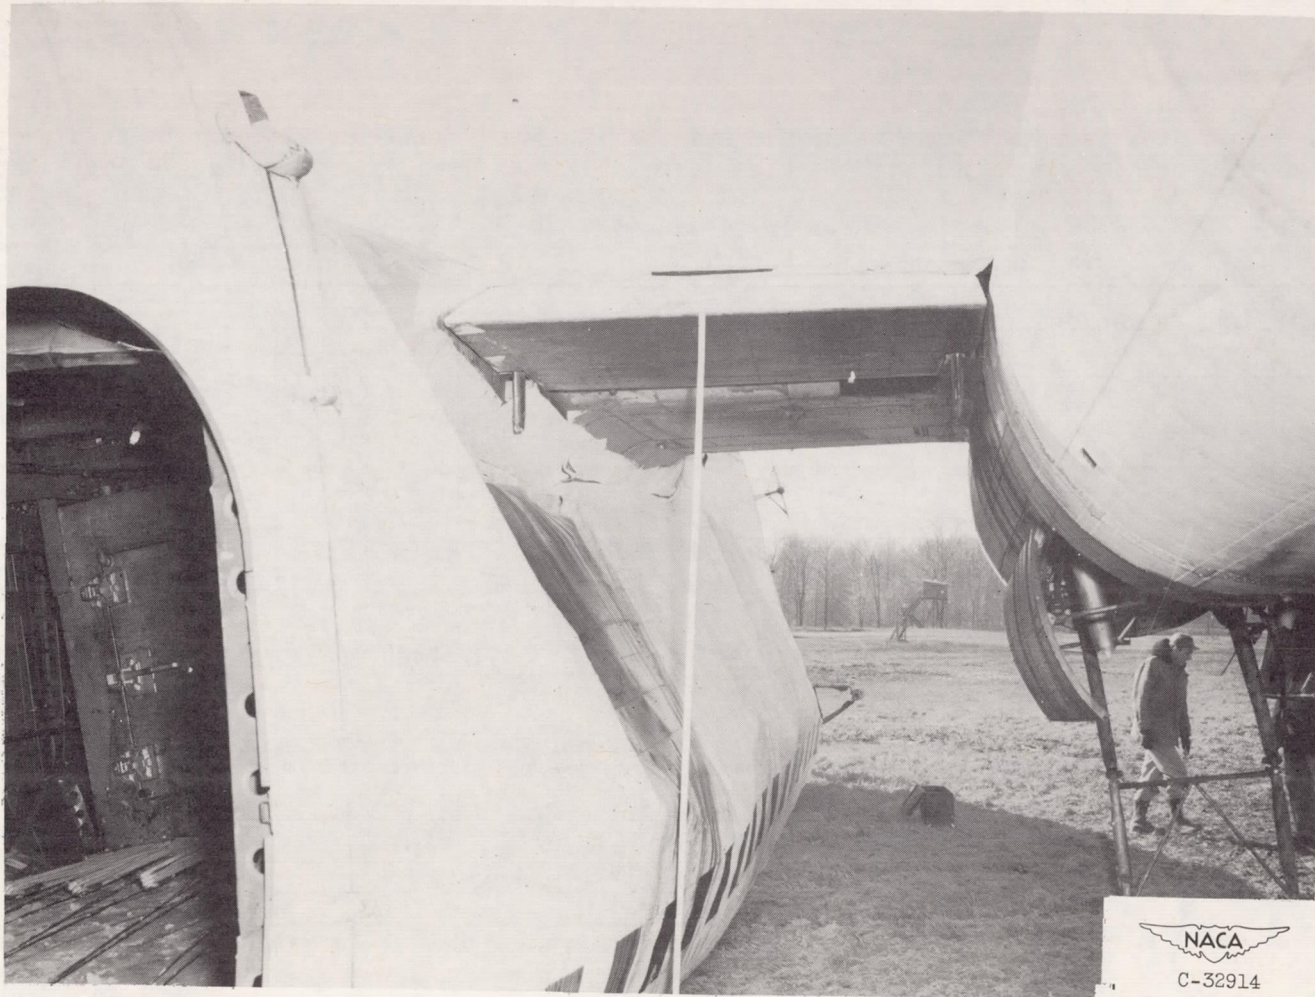
(a) Side members separated from ceiling members.

Figure 43. - Incipient lateral collapse of rectangular-type fuselage framing from lateral load imposed by ground-loop crash.

(b) Buckling and shearing of vertical wall members.

(c) Buckling of side frame structure.

(d) Fractured connection between side frame and ceiling members.

(e) Side of fuselage bulged.

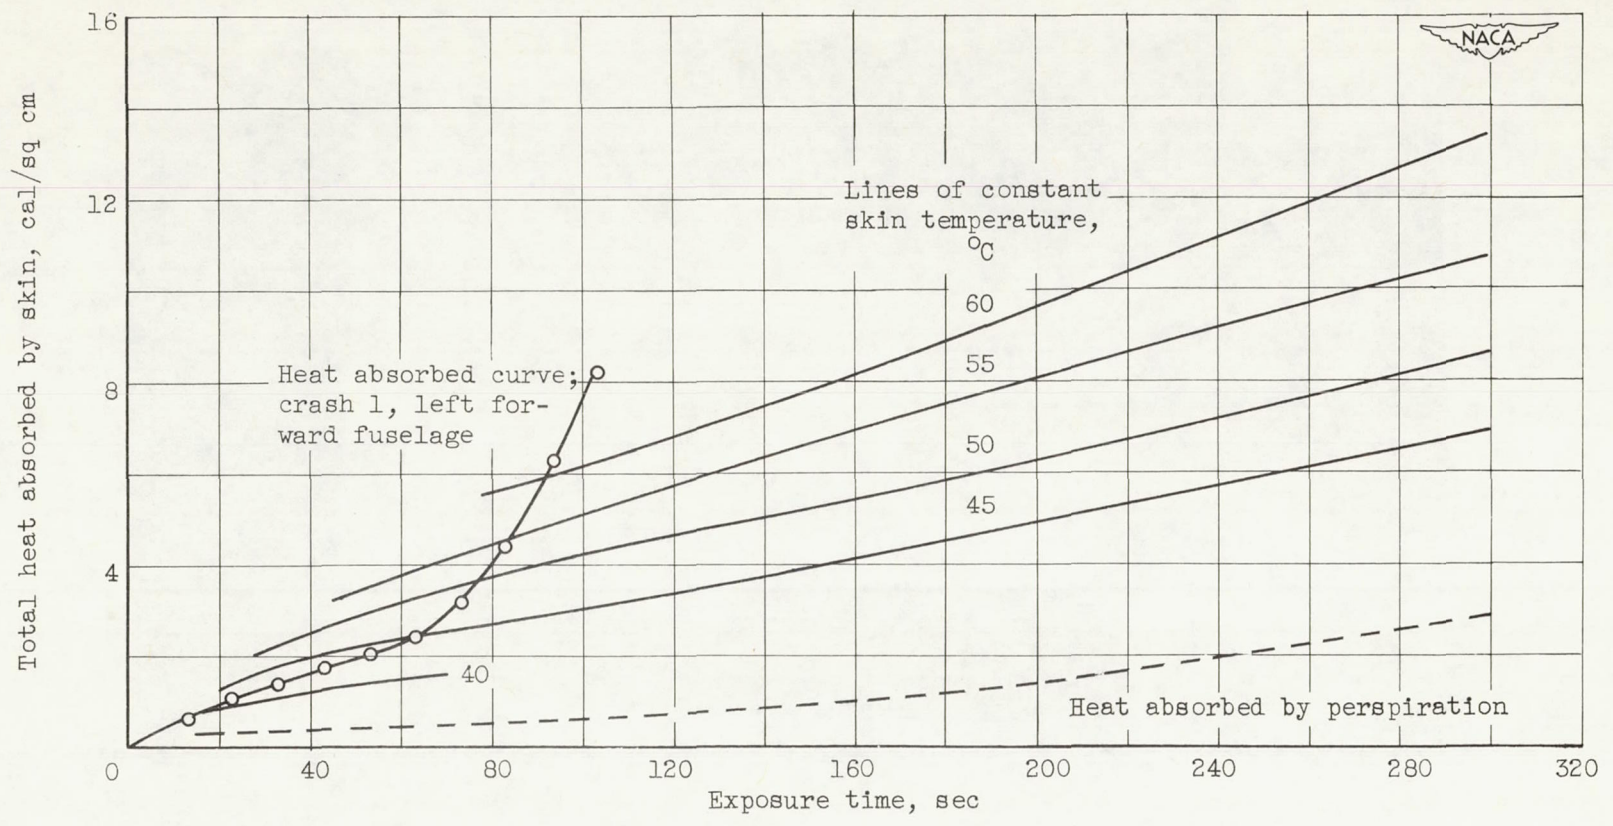
Figure 44. - Diagram showing temperature of human skin resulting from absorption of heat shown by ordinate during time interval shown by abscissa. (Diagram based on data from refs. 4 and 15.)

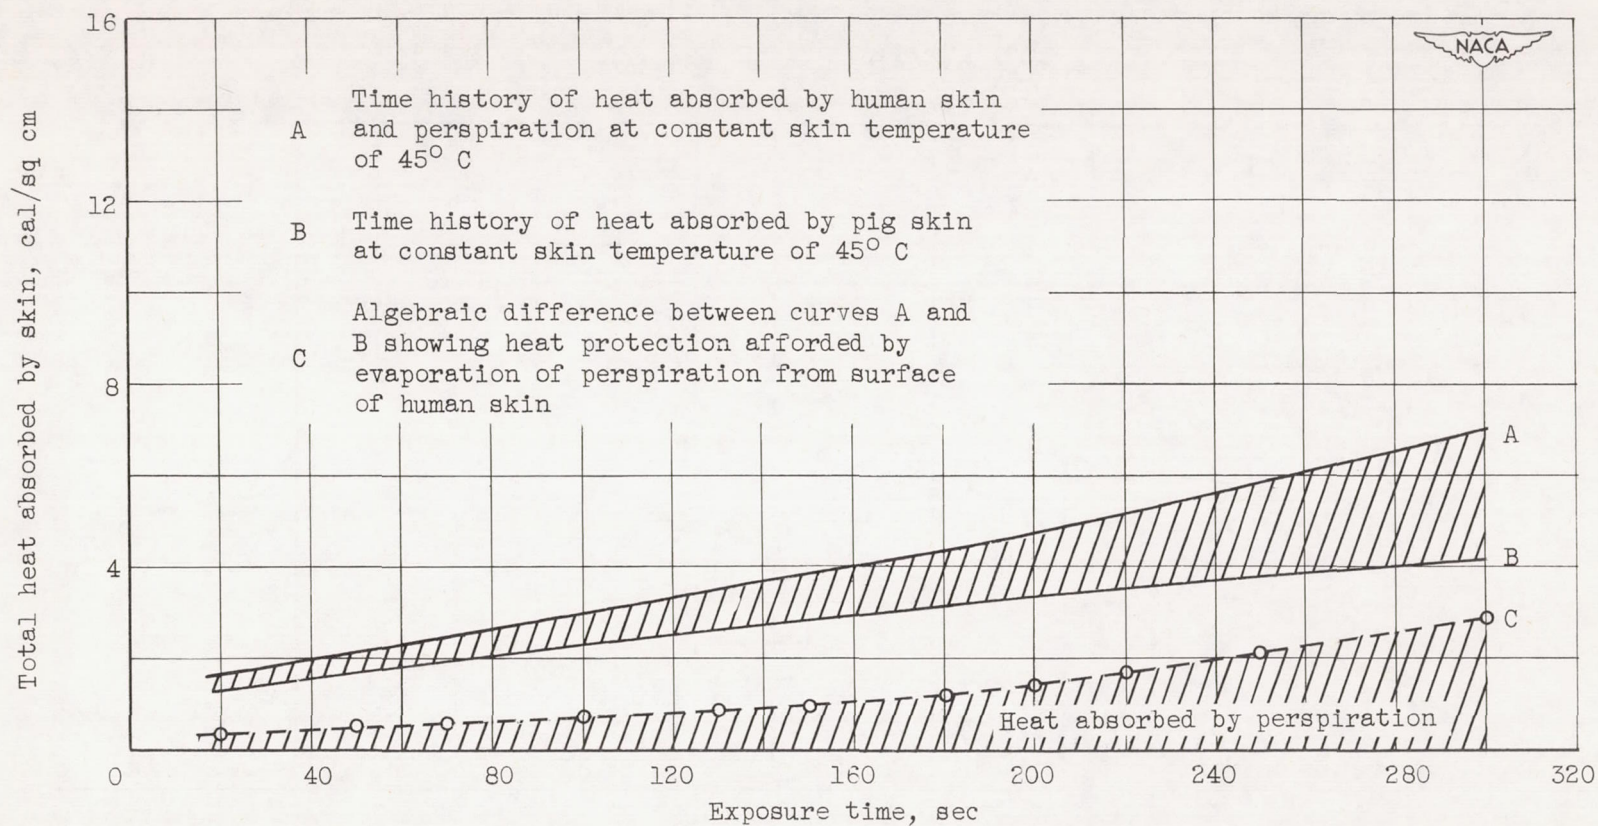
Figure 45. - Differences in heat absorption by human and pig skin attributable to perspiration.

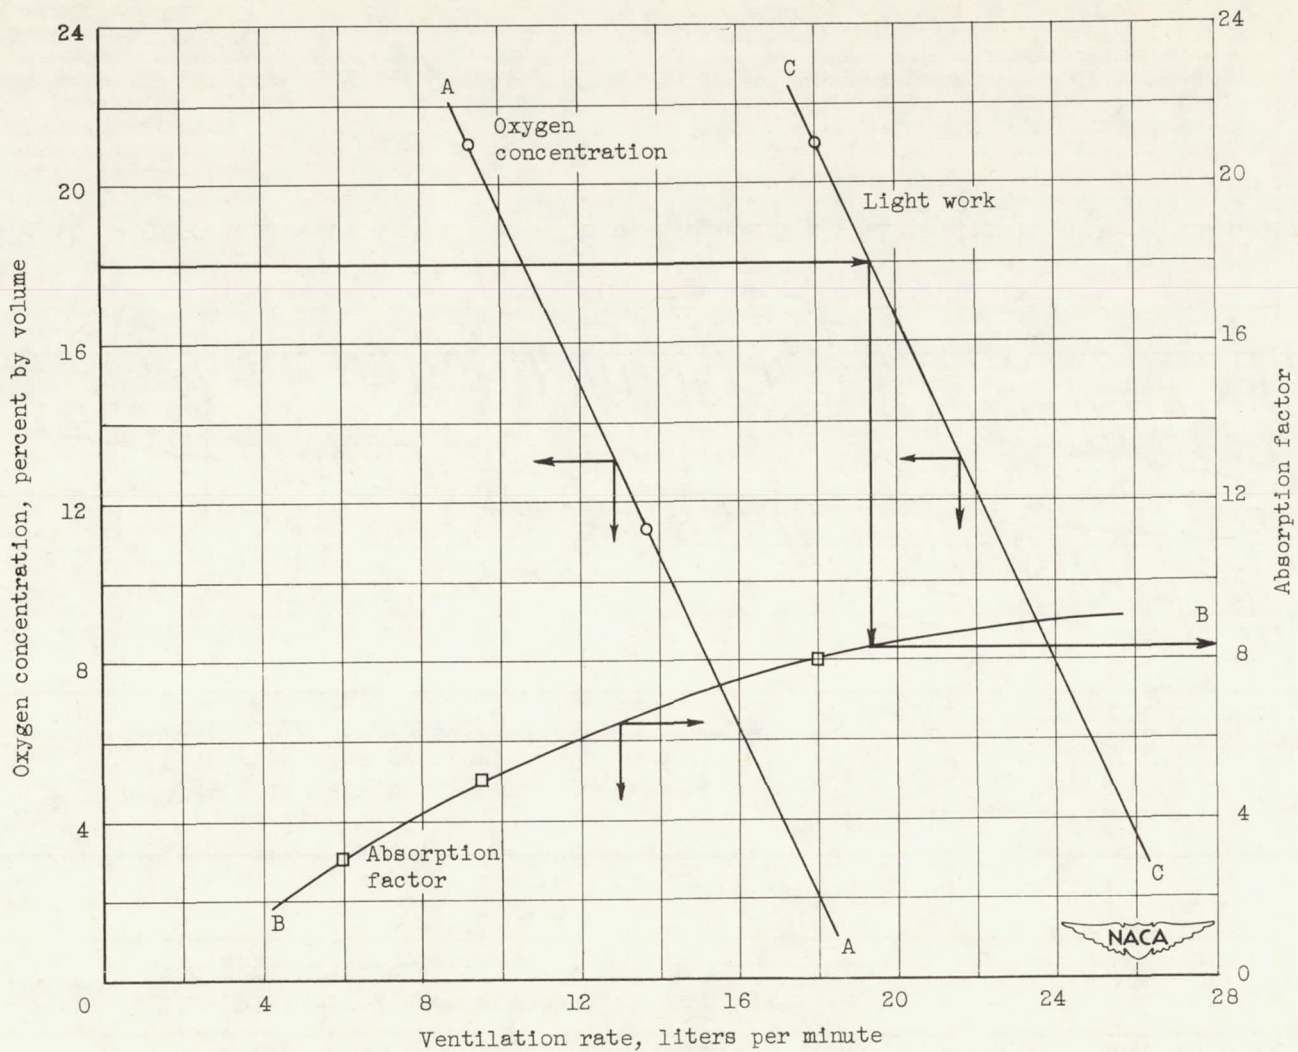
Figure 46. - Diagram for determining carbon monoxide absorption factor for a subject doing light work in various oxygen concentrations. (Based upon data presented in ref. 8.)
