NACA TN No. 1626

A STUDY OF CERAMIC COATINGS FOR HIGH-TEMPERATURE
PROTECTION OF MOLYBDENUM

By D. G. Moore, L. H. Bolz, and W. N. Harrison

National Bureau of Standards

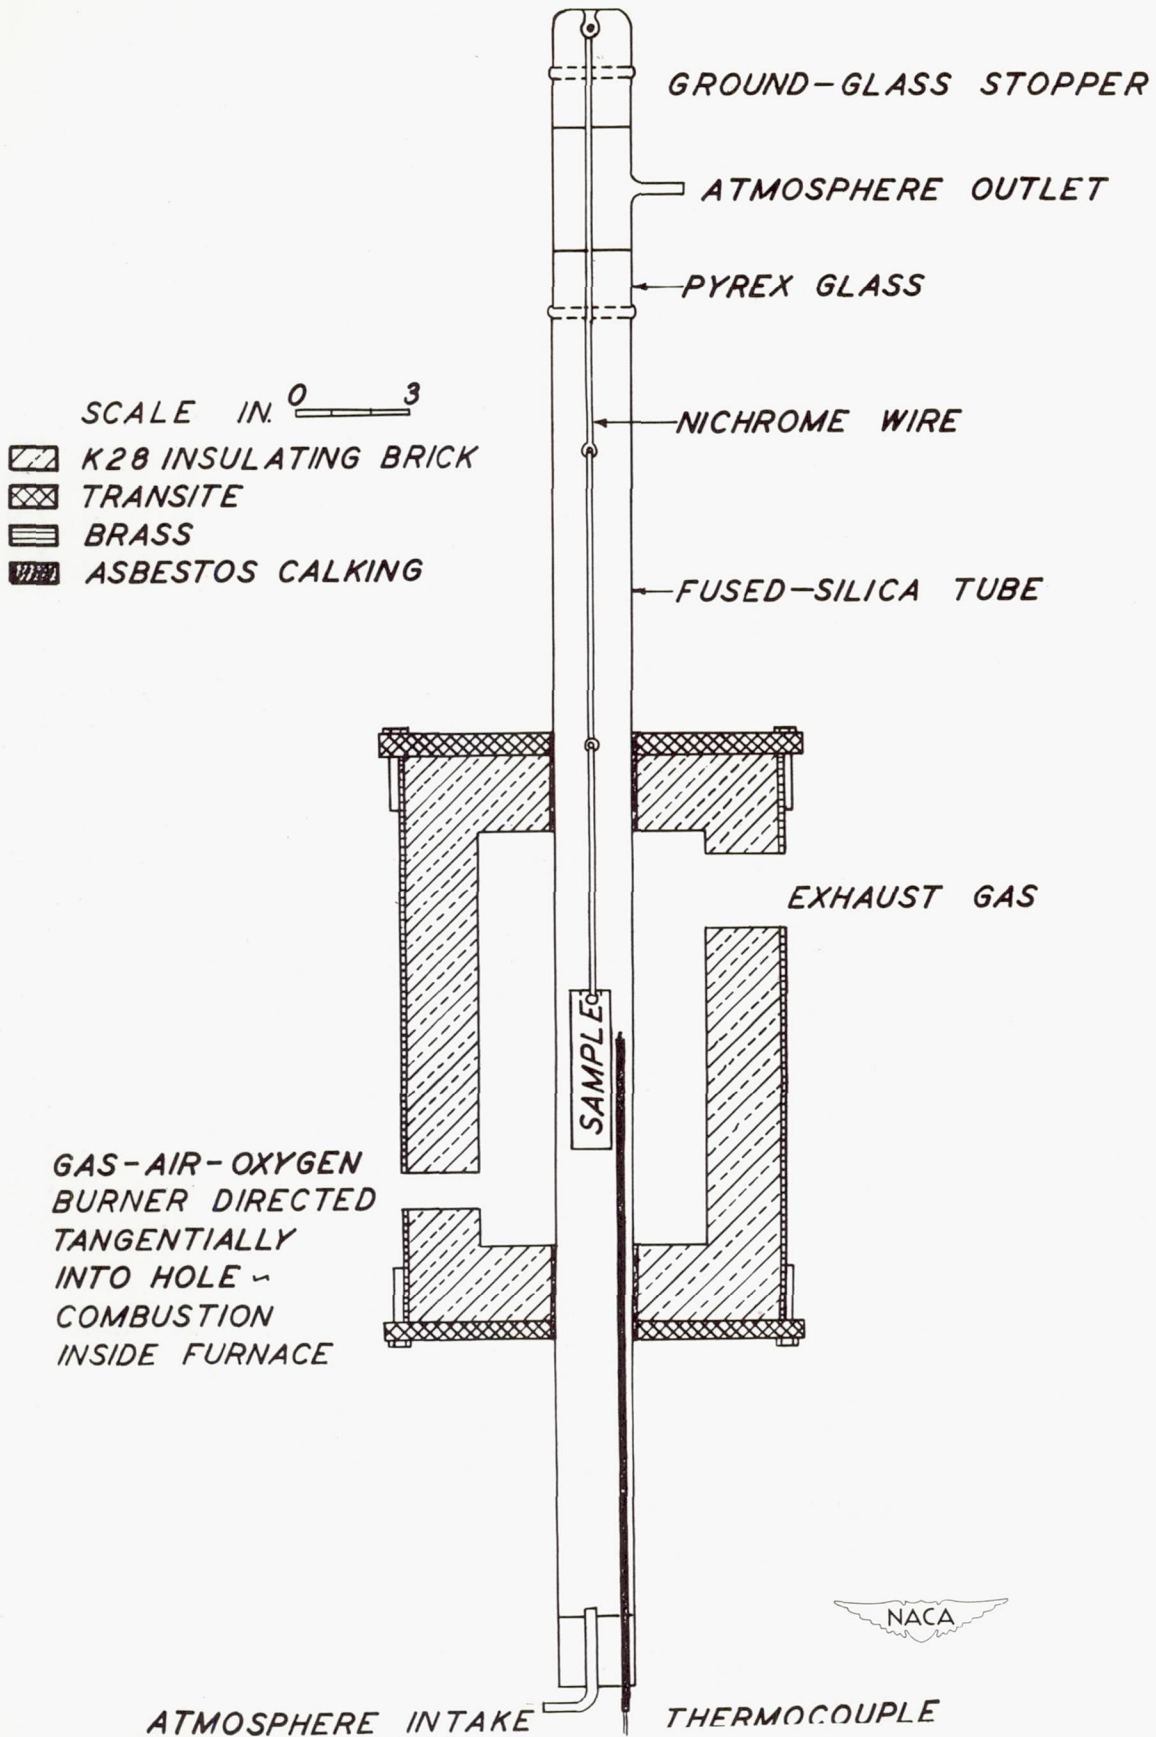
Figure 1.- Schematic diagram of fused-silica tube furnace used for controlled-atmosphere firing of ceramic coatings on molybdenum.

After drying, the test specimens were fired, many of them in a fused-silica tube furnace with controlled atmosphere. A sketch of this gas-fired furnace is shown in figure 1. Temperatures up to 2550° F inside the tube could be attained by supplementing the air supply with a slight amount of oxygen. Without extra oxygen, temperatures of 2400° F could be reached. The temperature was controlled during firing to $\pm 20^\circ$ F by manual adjustment of the gas valve. Most of the specimens used in this study were fired at 2150° F by introducing into the hot furnace, heating for about 5 minutes, removing from the furnace, and cooling in air.

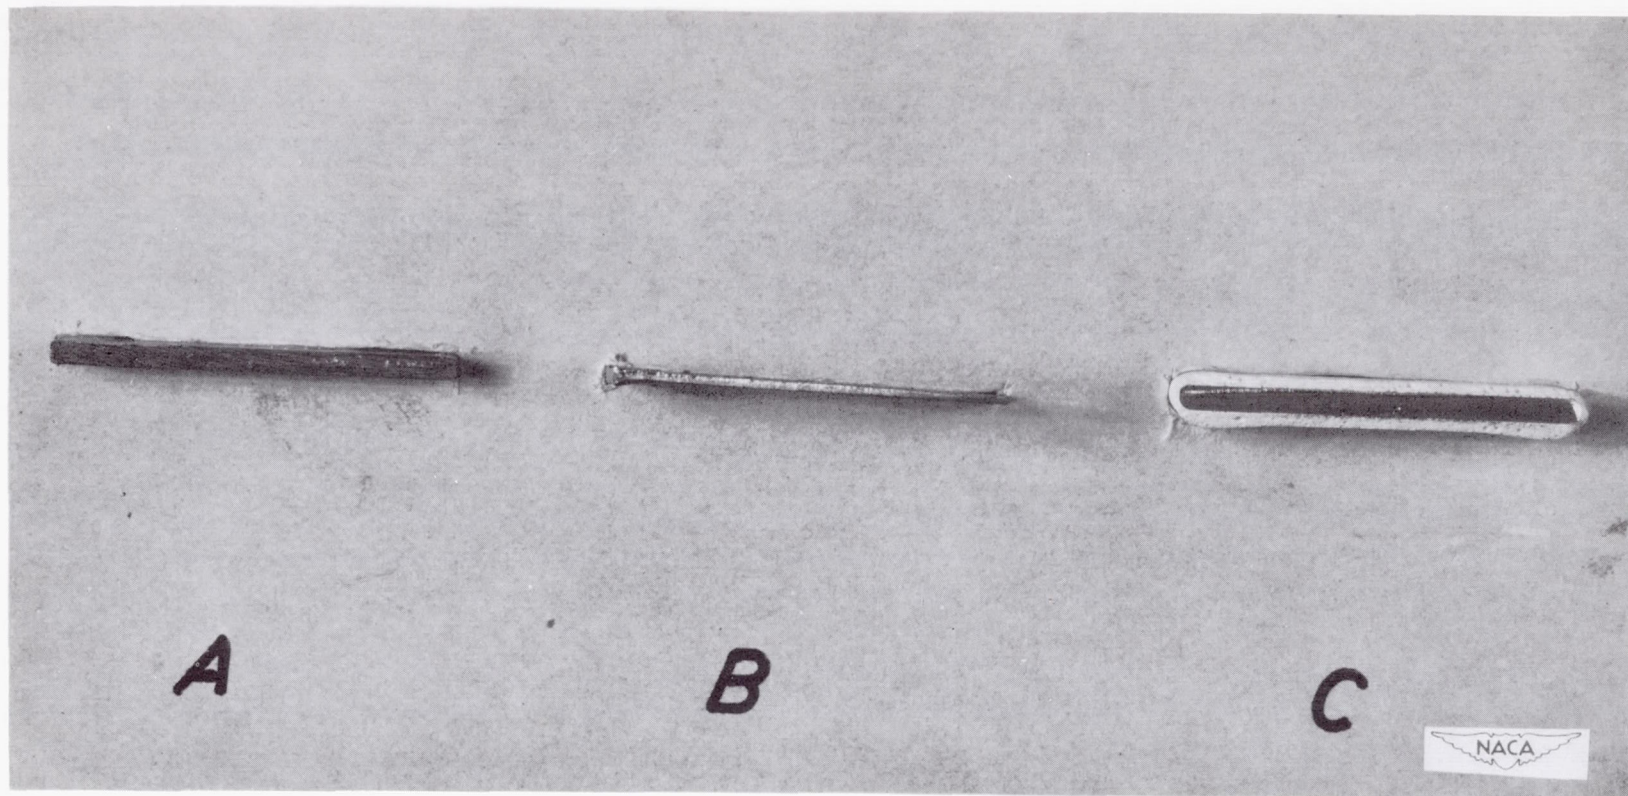
Figure 2.- Enlarged photograph (2.3X) of sections cut through coated and uncoated sheet molybdenum. Specimen A is the original uncoated molybdenum 0.040 inch thick. Specimen B is similar to A except that it has been heated for 1/2 hour in air at 1650° F, losing approximately half its thickness. Specimen C which has had a ceramic coating applied at a thickness of 0.028 inch has undergone 70 hours of heating in air at 1650° F with no evidence of oxidation of the metal.

Specimen A, in figure 2, illustrates the uncoated molybdenum metal while specimen B shows a section of the same metal after 30 minutes of heating at 1650° F. It will be noted that specimen B, with no coating, has been reduced to one-half of its original thickness in only 30 minutes of heating while specimen C has maintained its full thickness throughout 70 hours of heating.

Although the test results illustrated by figure 2 demonstrate definite potentialities, the extended use of coatings for protection of molybdenum at operating temperatures in the range from 1300° to 1800° F does not appear probable, as long as suitable heat-resisting alloys for these temperatures are available. There is no assurance, however, that the high-cobalt alloys will be available in sufficient quantity to meet a greatly expanded demand. If this demand should develop, these alloys could probably be supplemented by high-molybdenum alloys for use at temperatures beyond those now feasible provided suitable protection against oxidation could be effected by means of a ceramic coating.

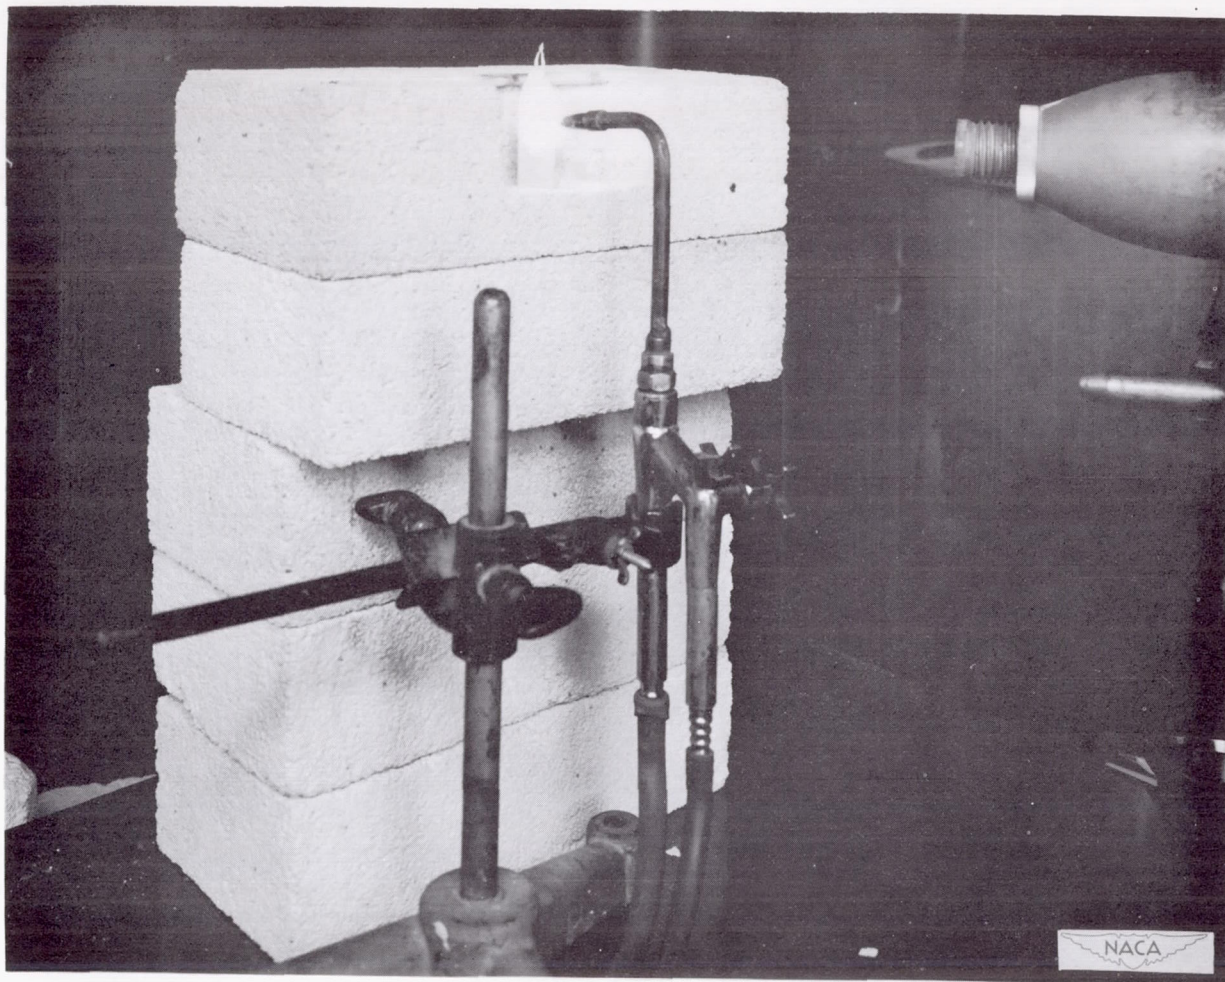
Figure 3.- Arrangement used for flame testing of coated molybdenum specimens. The welding torch operates from controlled pressures of oxygen and natural gas. Surface temperature, which is measured with a rigidly clamped optical pyrometer, is regulated by a movement of the torch toward or from the specimen and adjustment of oxygen and gas input.

Flame tests were made of coated molybdenum specimens 3/4 by 2 by 0.040 inch using the apparatus shown in figure 3. The welding torch, positioned as shown in the photograph, was operated from controlled pressures of both oxygen and natural gas and, in all cases, was adjusted to give a strongly oxidizing flame.

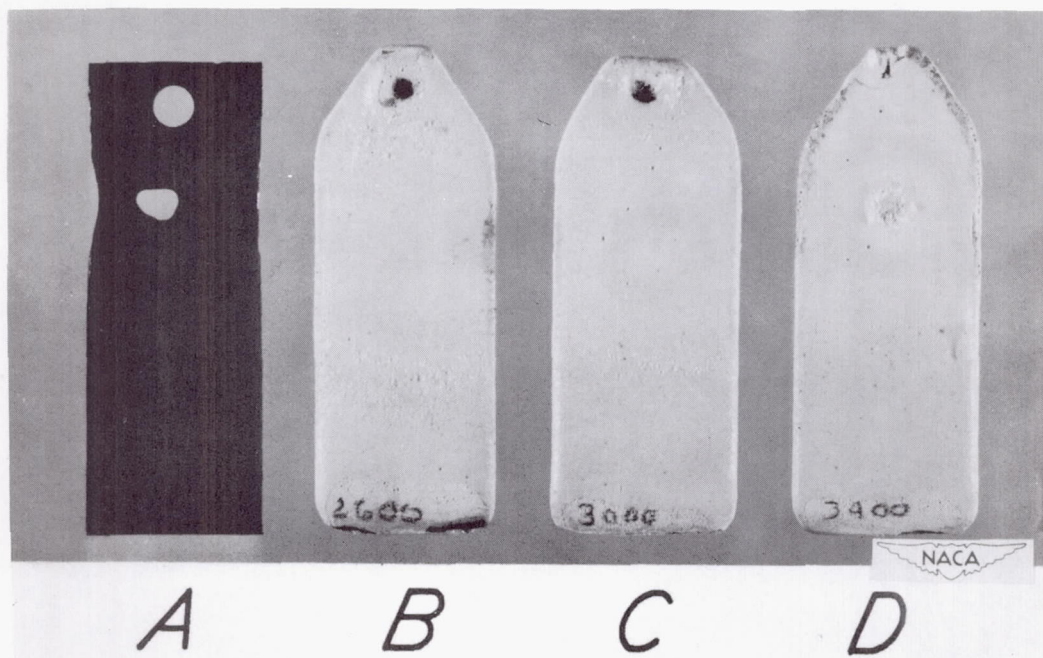
Figure 4.- Molybdenum specimens after exposure to flame testing. Specimens B, C, and D have been coated with M-13-33 at a total thickness of approximately 0.033 inch and have been treated for 30 minutes at surface temperatures of 2600^o, 3000^o, and 3400^o F, respectively. Specimen A is uncoated and the hole was burned through it when it was treated for 3 minutes under the same flame adjustment as for D.

Figure 4 shows three M-13-33 coated specimens that had been heated $1/2$ hour, instead of 5 minutes, at 2600° , 3000° , and 3400°F . No thickness loss was indicated for any of these three coated specimens. A specimen of uncoated molybdenum sheet was subjected to the same flame condition that had given a surface temperature of 3400°F on the coated specimen. During the heating, the uncoated specimen reached a temperature of 2800°F . Intense fuming of the oxide was noted under these conditions. Within 3 minutes a hole had been burned through the unprotected metal specimen, which is shown with the coated specimens in figure 4. Figure 5 shows a heavy deposit of the crystalline molybdenum oxide formed in a symmetrical pattern by sublimation on the cooler portions of the refractory supports during the heating operation.

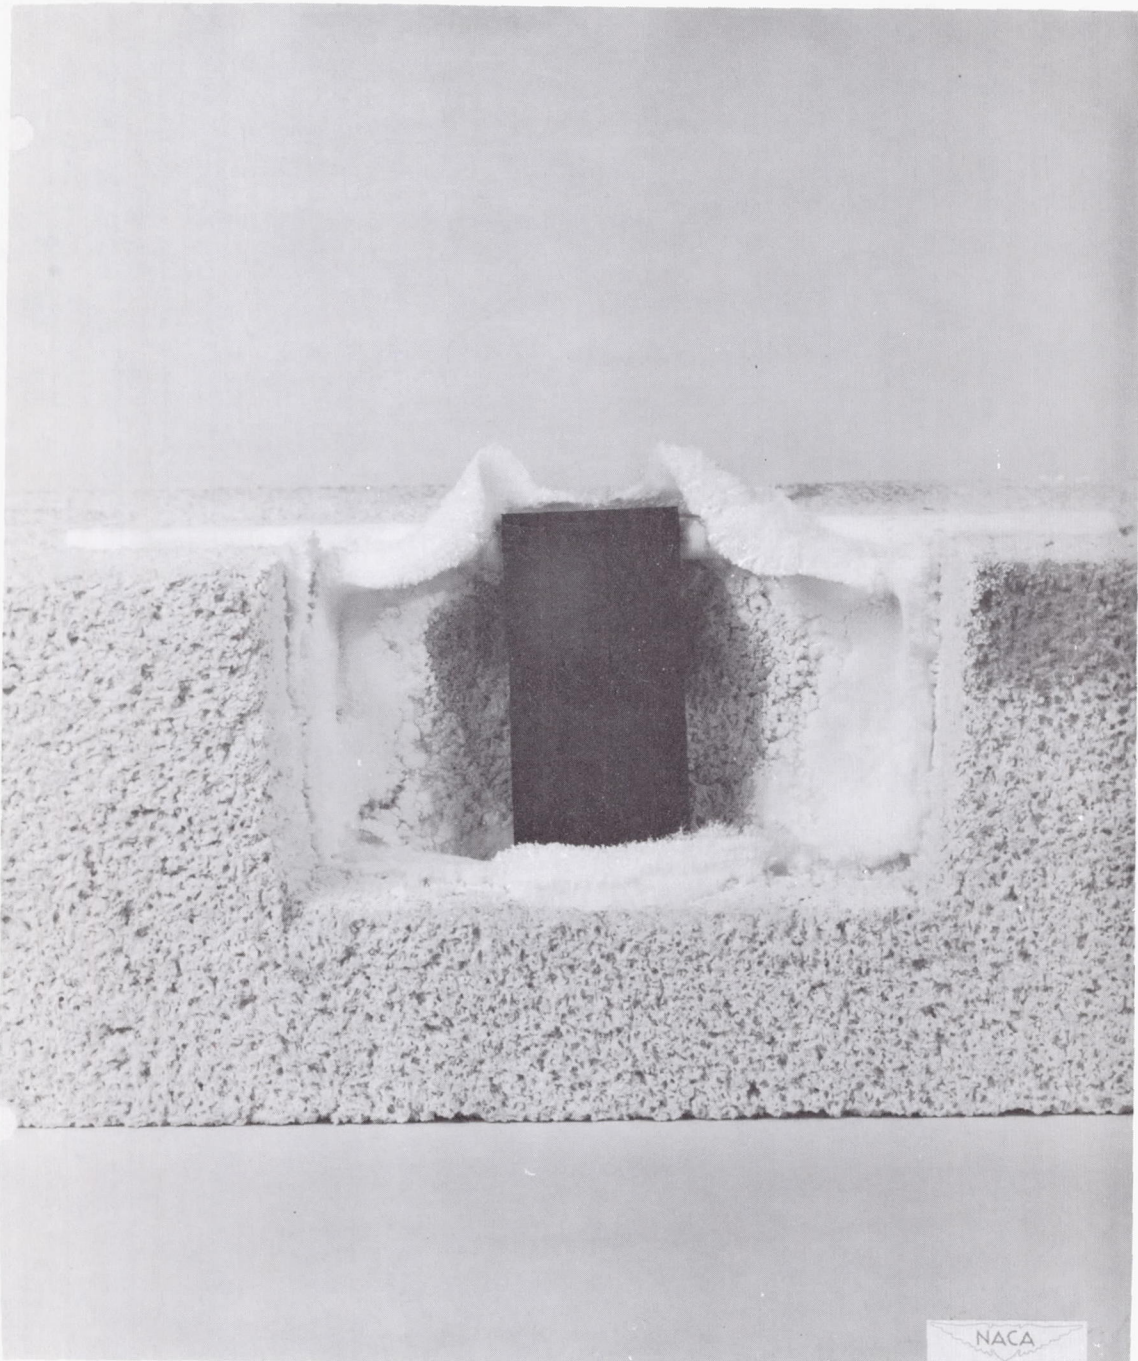
Figure 5.- Molybdenum-oxide condensate formed in a symmetrical pattern on cooler portions of refractory supporting structure by sublimation during 3 minutes of heating of an uncoated molybdenum specimen at 2800° F by oxygas flame. The test involved a voluminous production of white fumes of the volatile oxide.

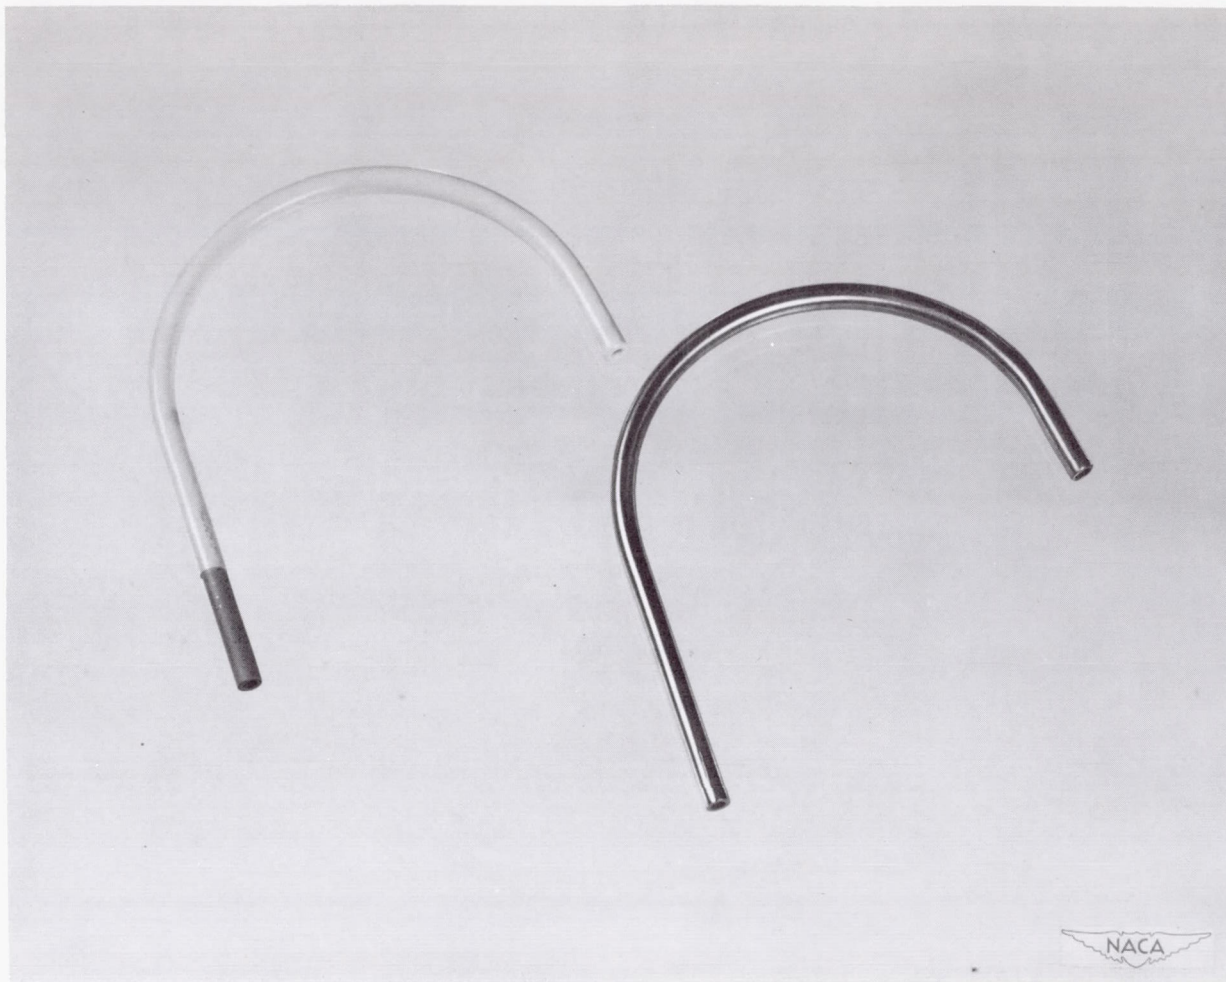
Figure 6.- Uncoated and coated molybdenum pitot tubes approximately 10 inches long, of a type used for recording pressures in the 3000^o F blast of a ram-jet engine. The white tube has been given a ceramic coating except for a distance of 1 inch at the end not heated in service.

In figure 6 are shown two molybdenum pitot tubes approximately 10 inches long, the white one of which has been given a ceramic coating, except for a distance of 1 inch at the end not heated in service. These tubes had $\frac{1}{4}$ -inch outside diameters and $\frac{1}{16}$ -inch walls. The coating was applied to both inside and outside surfaces by submersion of the specimen into the slip, followed, after drying, by a spray-coat reinforcement at the end exposed to high temperature. After the spray coat was dried, the specimen was fired at 2150° F on a Nichrome supporting rack in the oxygen-free atmosphere of the previously mentioned Hayes furnace.

Twenty-four of the tubes as shown in figure 6 were given exterior and interior coatings of the M-3-8 type and one with coating M-13-35. These were used in ram jets attached to the wings of aircraft. One tube with each type of coating was returned after undergoing this service and examined with a binocular microscope. Neither tube had failed in service, except for breaking near the end that was welded to a steel tube and which operated at a relatively low temperature.

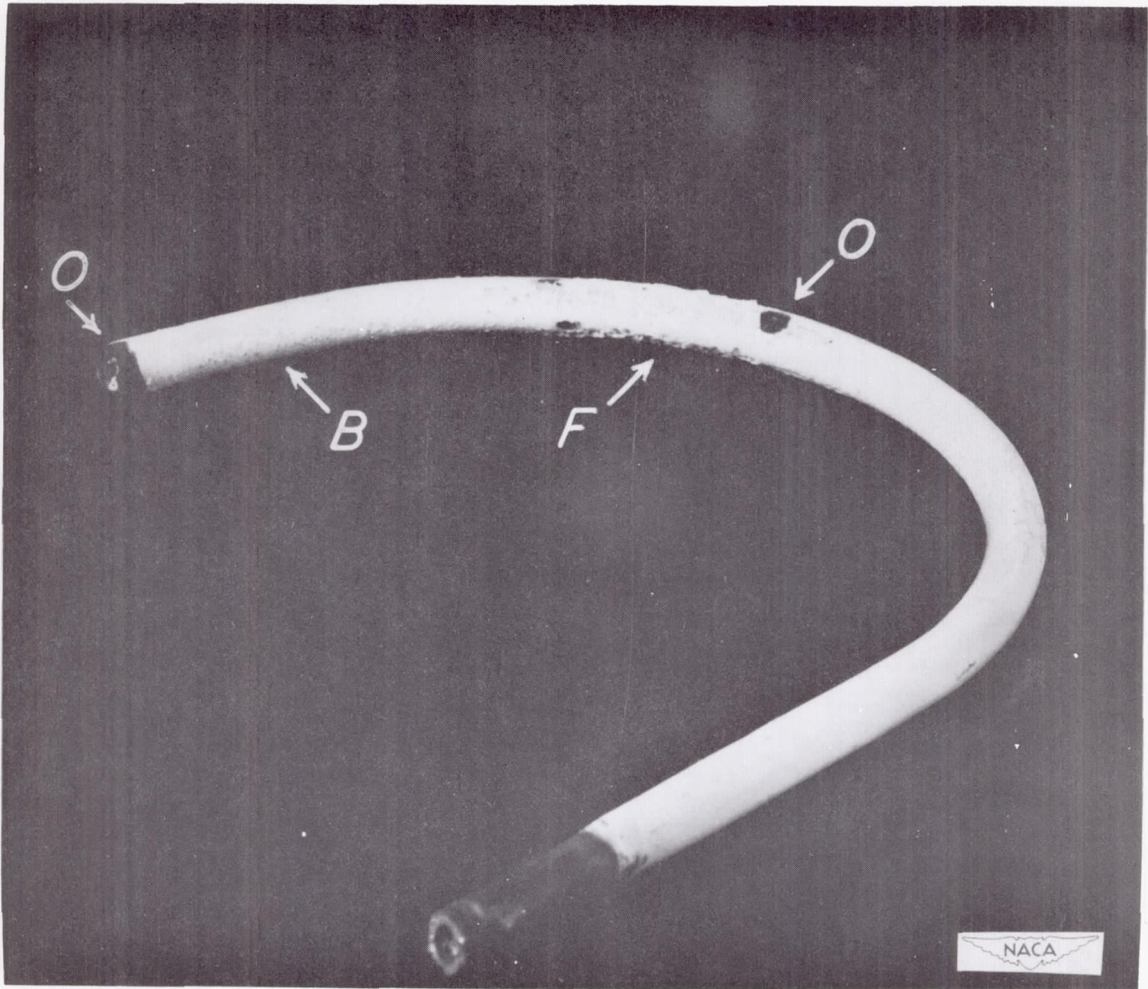
Figure 7.- Coated pitot tube of the type shown in figure 6 after 45 minutes of service operation in blast of ram jet at computed gas temperature of 3000° F. Although deterioration of the coating has occurred, the tubes have performed satisfactorily under conditions which would have caused serious oxidation of uncoated parts.

The M-13-35 tube (coating thickness, 0.008 in.) had undergone 45 minutes of service without any considerable oxidation of the metal except at two spots. One of these spots, shown as O at the upper end of the tube in figure 7, was originally not so well protected as on the M-3-8 tube inasmuch as it had not been reinforced with extra coating at the tip. As a result, the protection at this point terminated during the test and considerable oxidation occurred. The dark area indicated as O at the central section of the tube was believed to have resulted from damage to the coating during installation. Oxidation had progressed sufficiently at this area to halve the thickness of the tube wall. No serious damage had occurred elsewhere, although several small spots appeared to have lost the coating, possibly near the end of the 45-minute test period.

The speckled appearance of the coating on the tube at B in figure 7 is caused by healed blisters in the coating. There is evidence also of flow of the coating, which is apparent at F in the photograph as ripples in the surface. This flow was believed to have occurred at the moment the blisters formed. The blisters caused added obstruction to the smooth flow of the high-velocity gases. The flow of the coating reduced this obstruction.
