No. 1224

FLIGHT TESTS OF A DOUBLE-HINGED HORIZONTAL TAIL SURFACE WITH REFERENCE
TO LONGITUDINAL-STABILITY AND -CONTROL CHARACTERISTICS

By Carl M. Hanson and Seth B. Anderson

Ames Aeronautical Laboratory
Moffett Field, Calif.

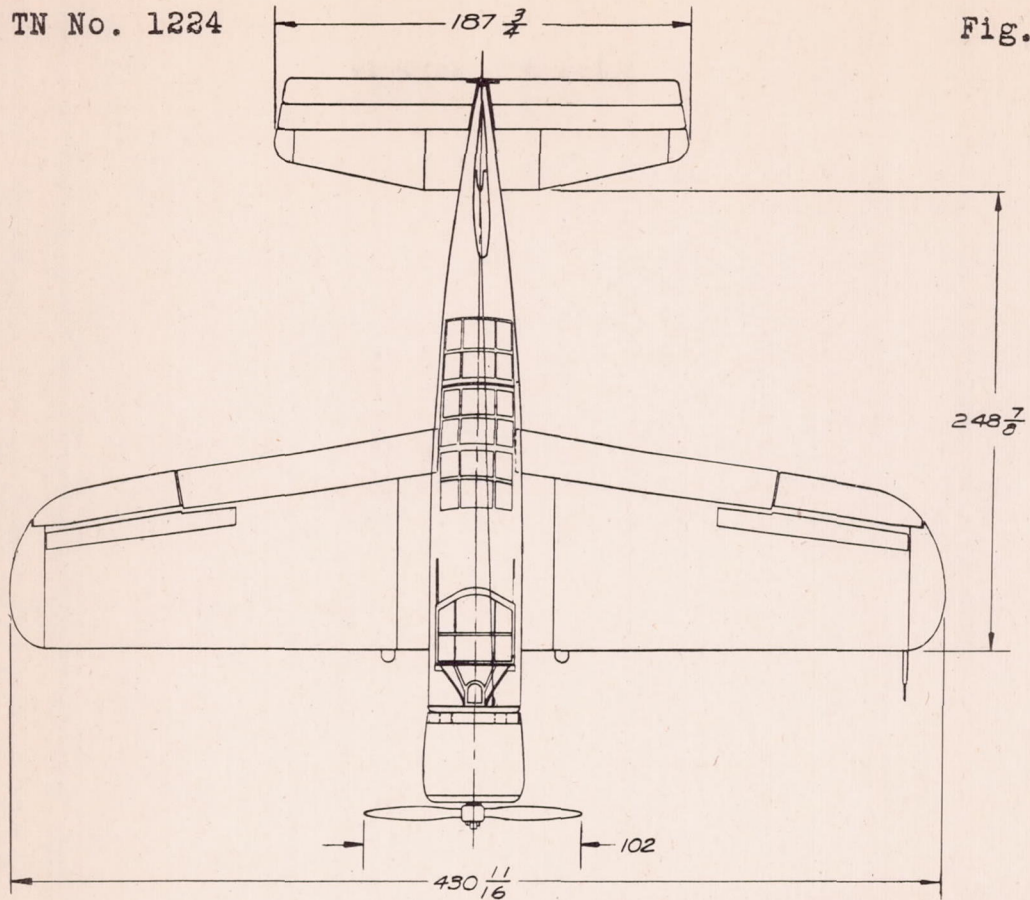
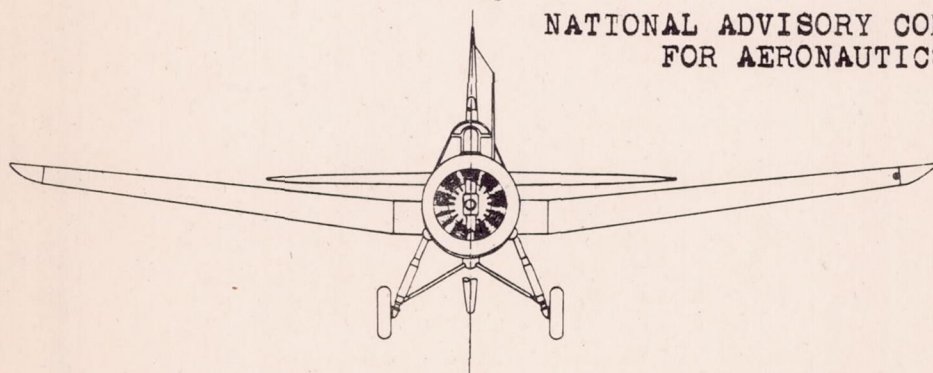
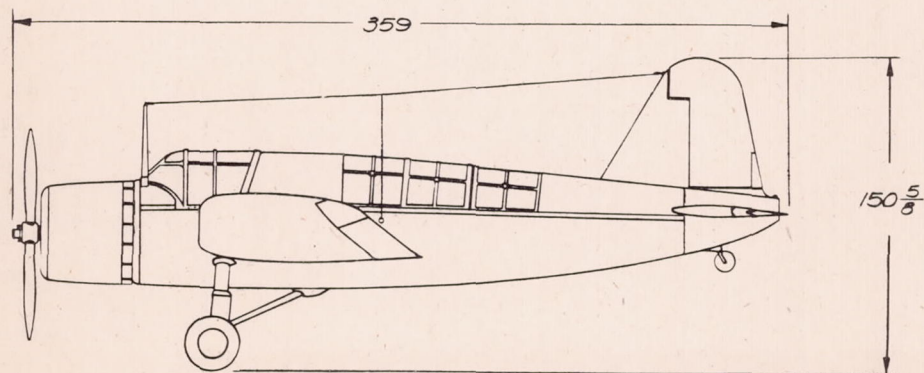
Figure 1.- Three-view drawing of the test airplane equipped with a double-hinged horizontal tail.

A three-view drawing of the airplane is shown in figure 1. A photograph of the airplane instrumented for flight tests is given in figure 2, and figure 3 is a photograph showing various positions of the horizontal control surface. To eliminate any tendency of the separate halves of the elevator to assume different angles (because of play inherent in the actuating mechanism), the two portions of the elevator were connected rigidly together by a strip at the elevator trailing edge. The mechanics of the elevator system were such that the range of elevator deflection (relative to the trimmer) was independent of the trimmer setting. Friction in the elevator control system was less than one-half pound, as measured when the control was moved slowly through the neutral position with no load on the surfaces. The variation of elevator angle with stick position as measured on the ground with no load applied to the surfaces is shown in figure 4. The trimmer drive mechanism was hand-operated from the cockpit through a cable-chain system. The mechanical advantage was such that 1.0 turn of the control handle (on a 5-inch arm) was required to change the trimmer angle 1°. Plan and section views of the horizontal tail are shown in figures 5 and 6, respectively.

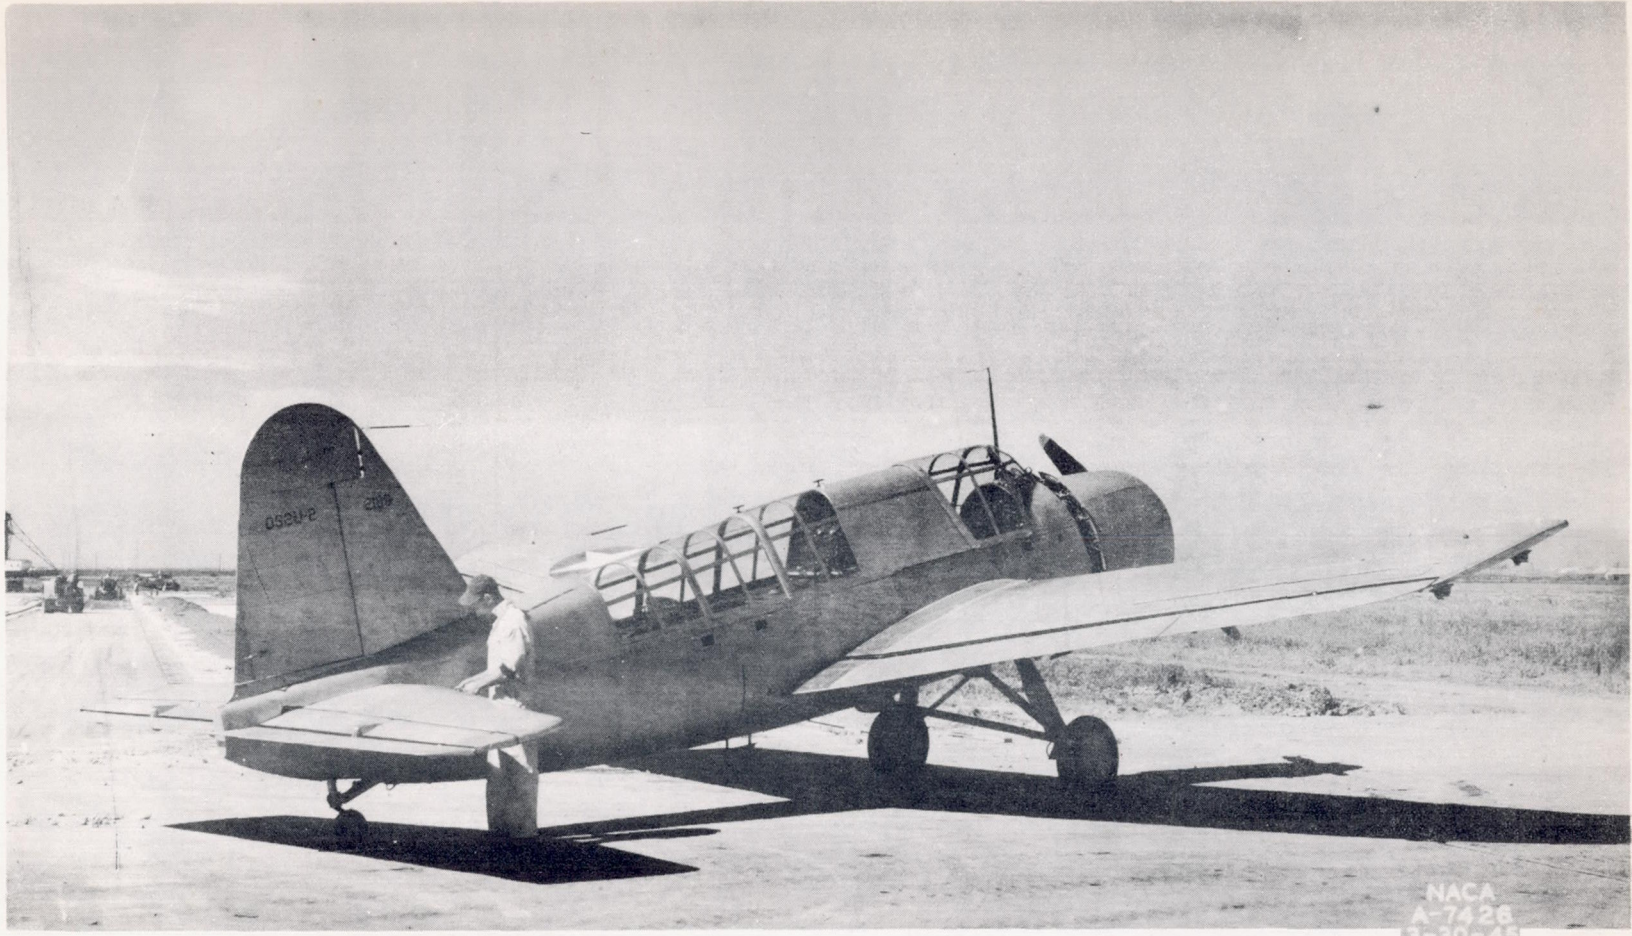
Figure 2.- The double-hinged horizontal-tail surface installed on the test airplane.

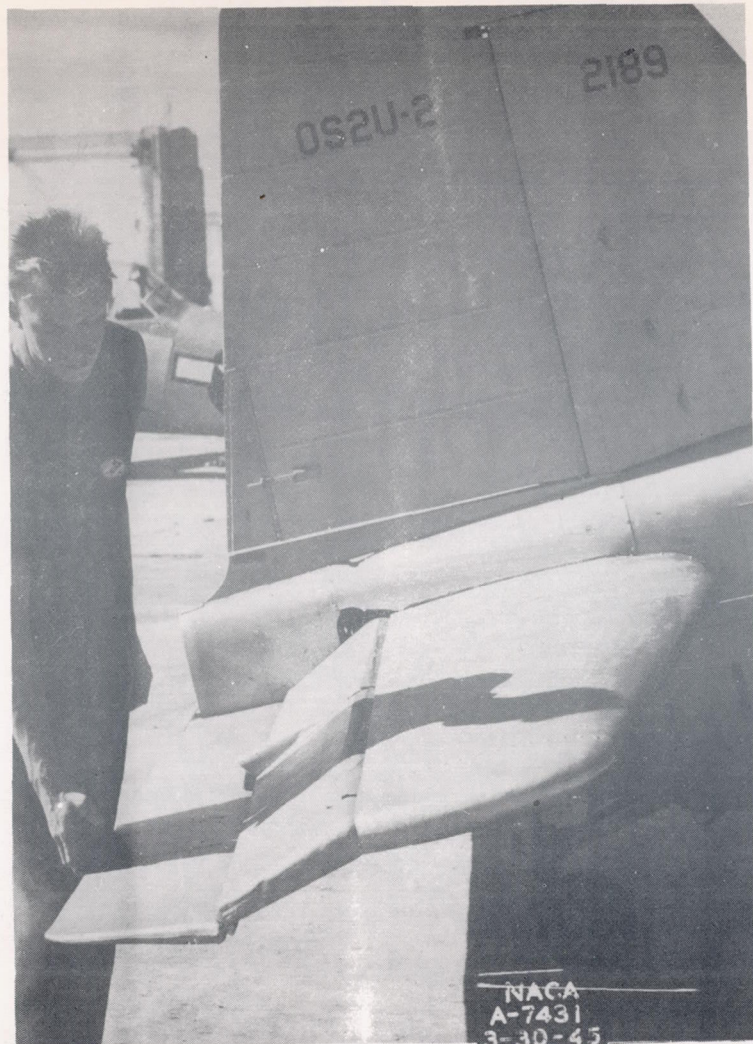
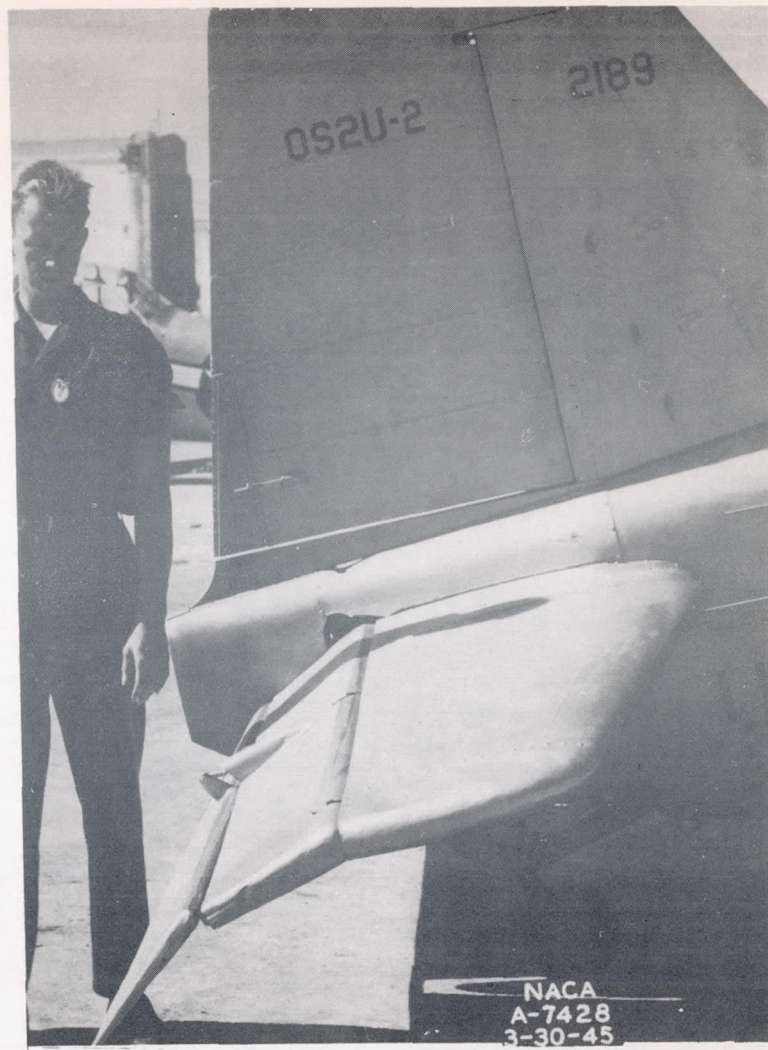
(a) Trimmer full down, elevator full up. (b) Trimmer full down, elevator full down.
Figure 3.- Side view of the double-hinged horizontal-tail surface, trimmer and elevator deflected.

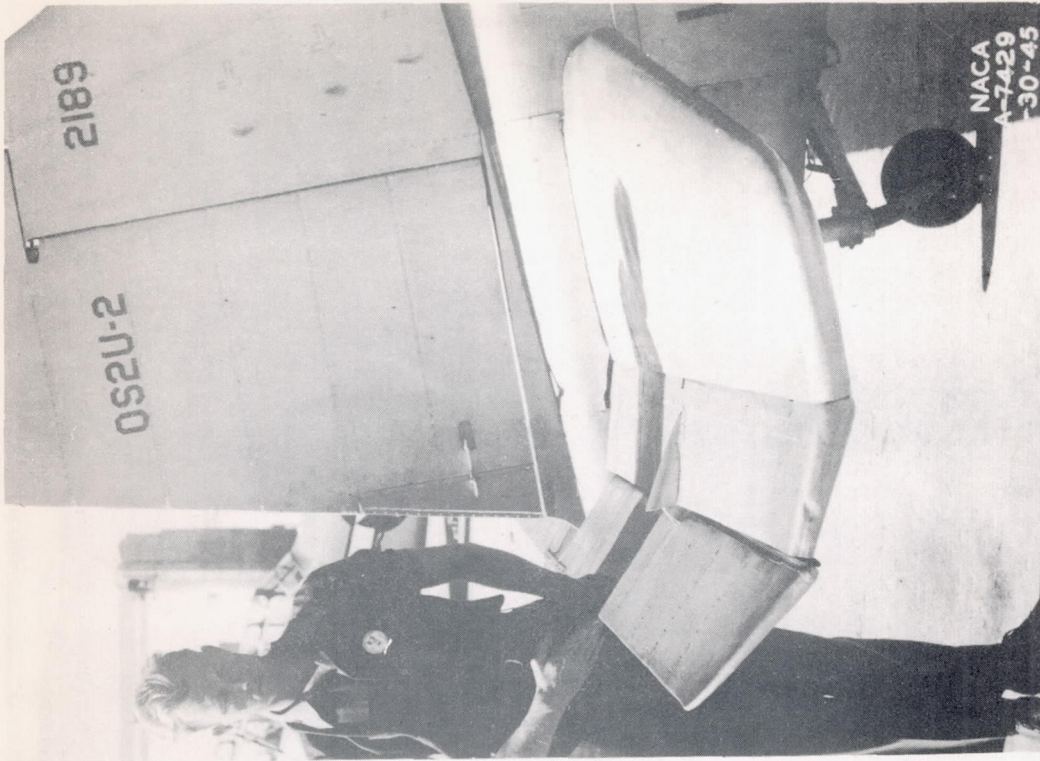
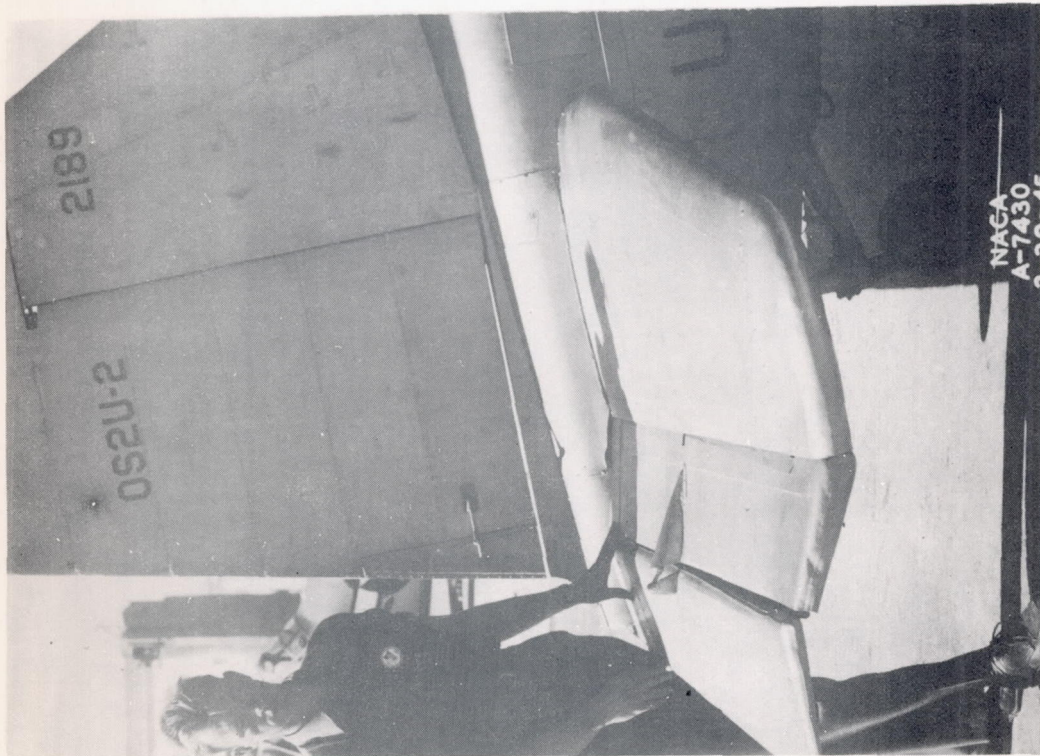
Figure 3.- Concluded.

(c) Trimmer full up, elevator full down. (d) Trimmer full up, elevator full up.

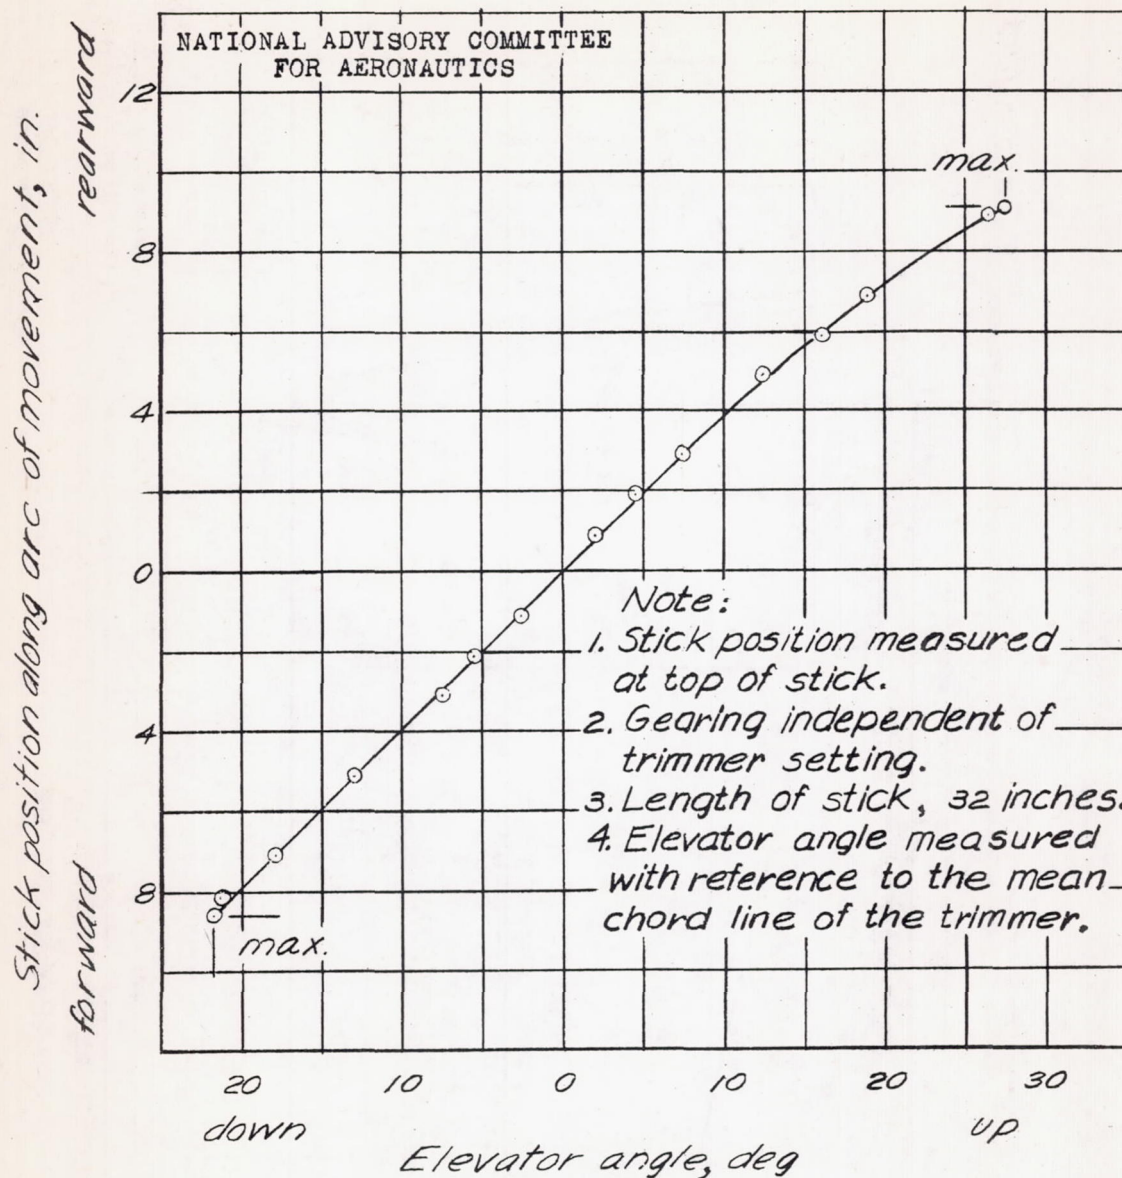
Figure 4 - Variation of stick position with elevator angle as measured on the ground with no load on the surfaces.

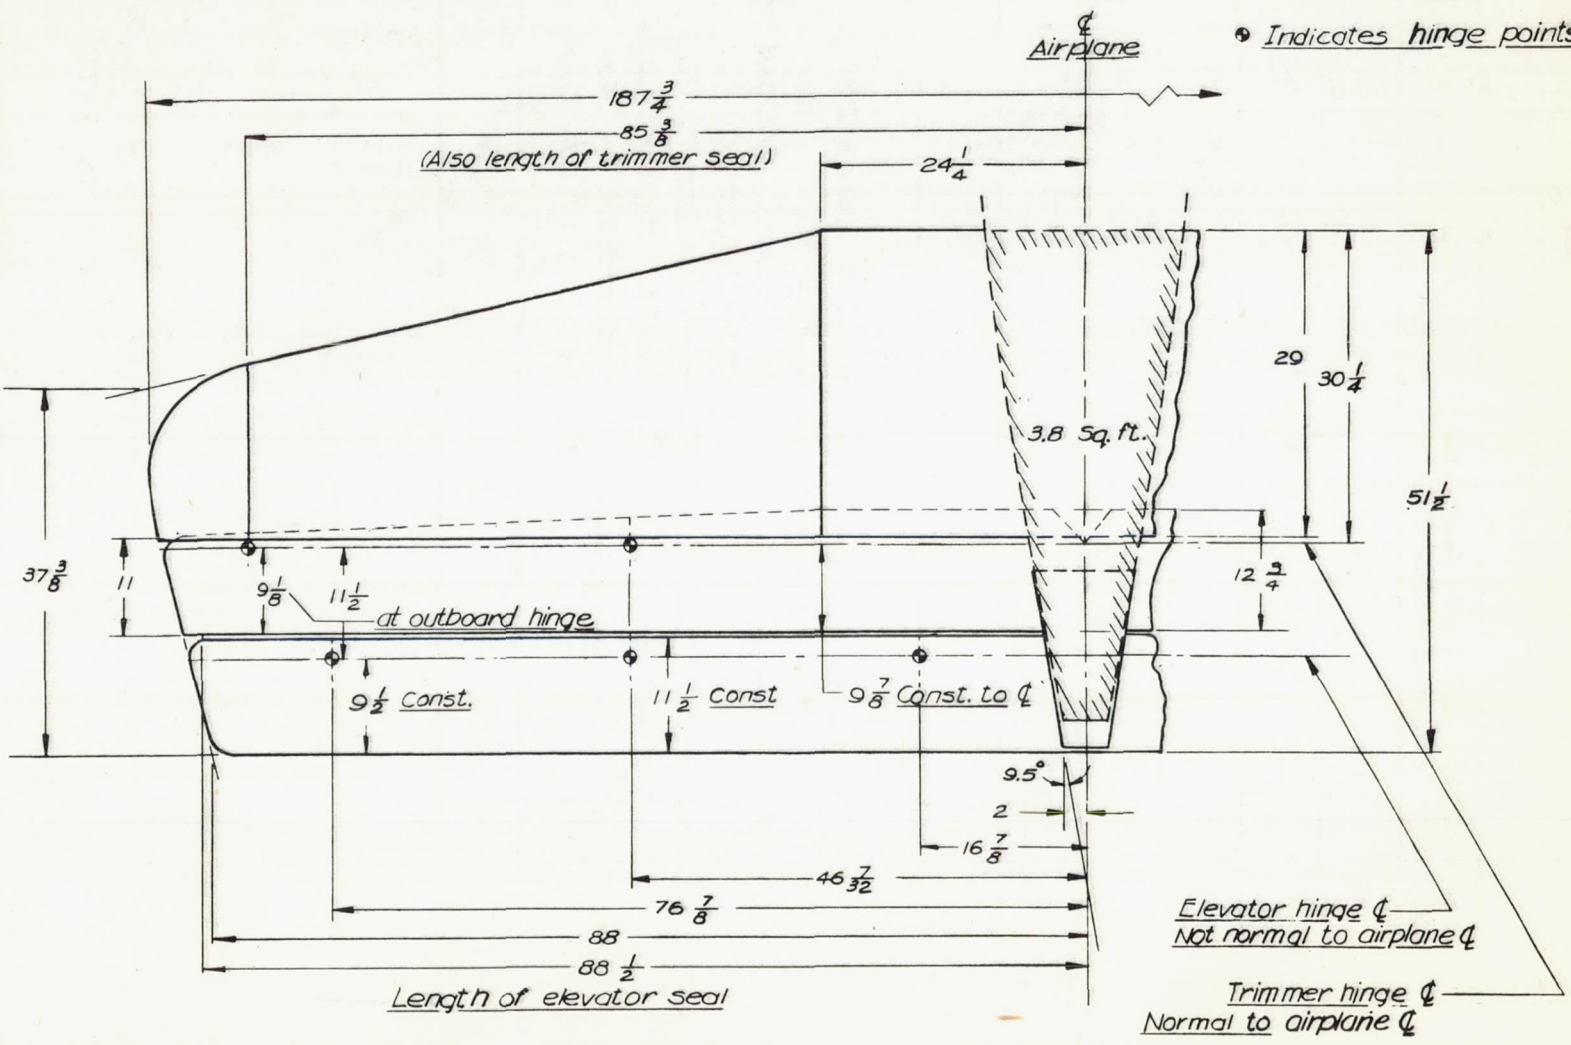
Figure 5.-Plan form of double-hinged horizontal tail.

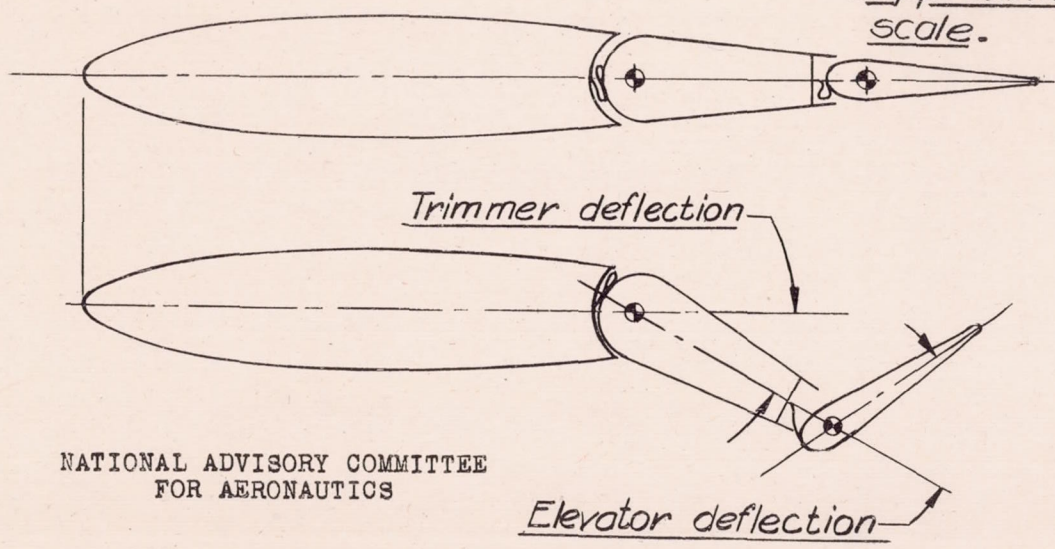
Figure 6.- Cross section of the double-hinged horizontal tail.

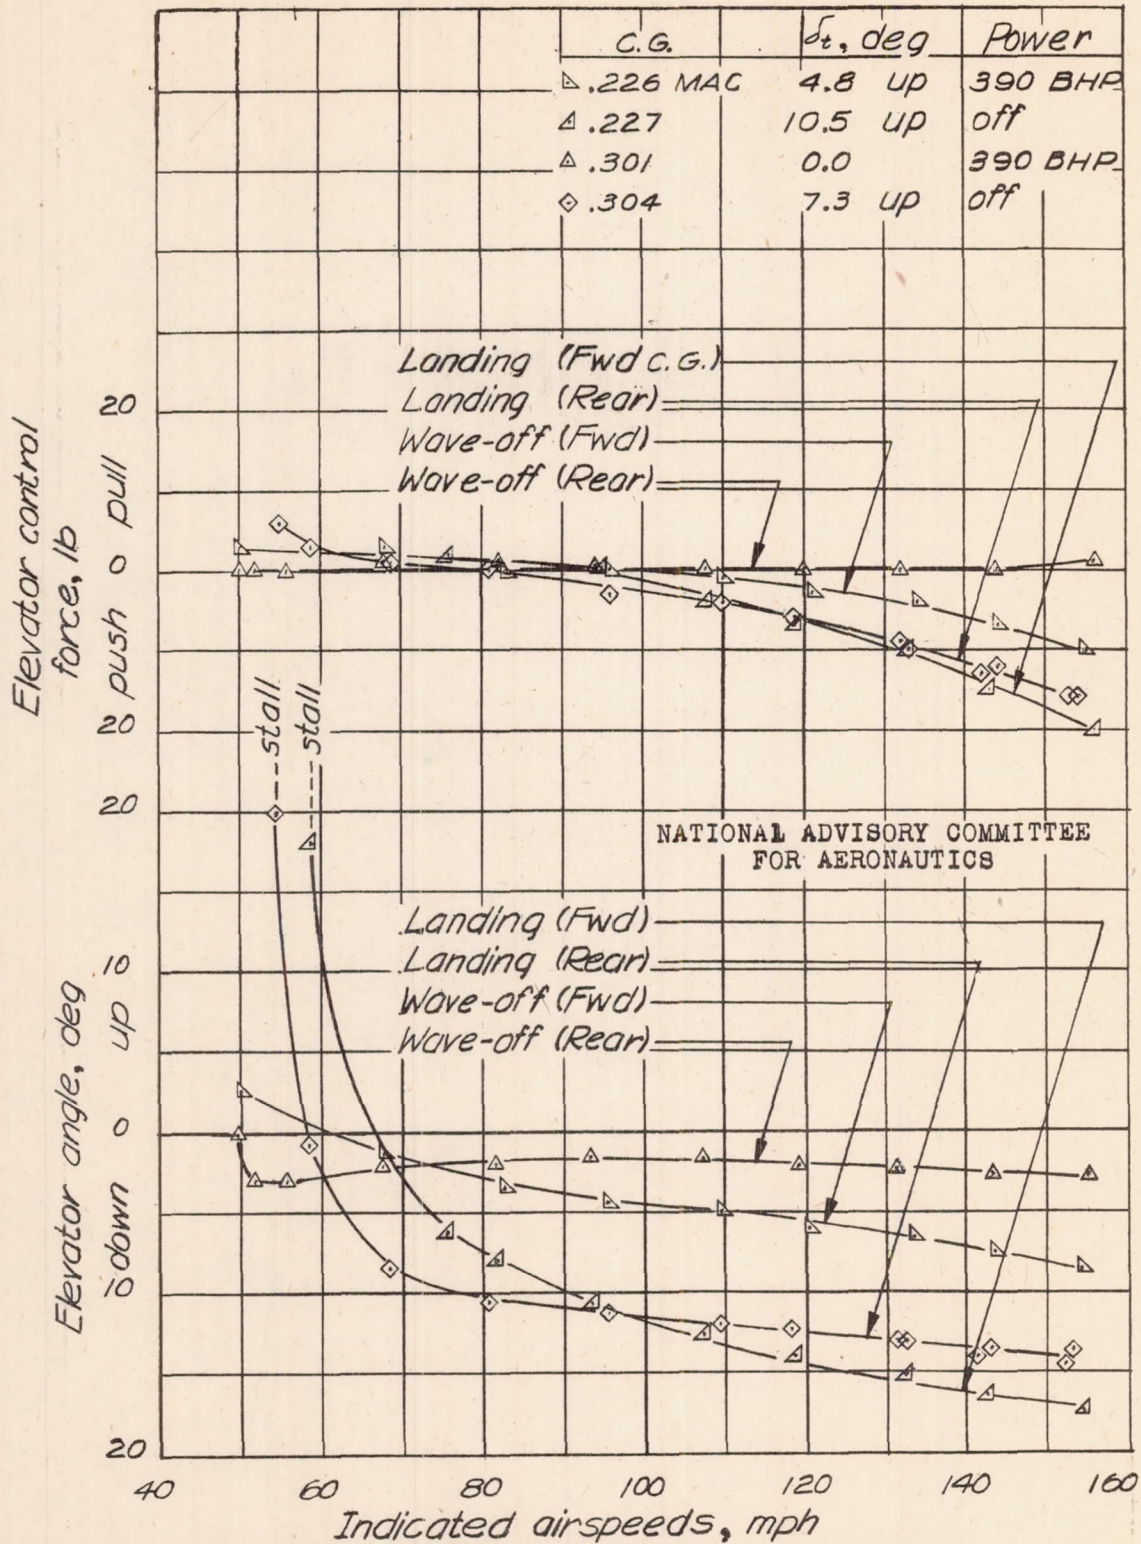
Figure 7. - Static longitudinal-stability characteristics.
Flaps down.

The results of the tests to determine the dynamic and static longitudinal-stability characteristics are presented in table I and in figures 7 and 8, respectively. The elevator control characteristics are presented in figure 9 for landings and in figure 10 for maneuvering flight. Trim changes due to variation of flaps and power are shown in table II. Figures 11 and 12 present data showing the trimming characteristics of the

Examination of the data presented in figures 7 to 12 and in tables I and II shows that the longitudinal handling characteristics of the airplane were satisfactory except for the dynamic longitudinal-stability characteristics (initiated by abruptly deflecting and releasing the elevator control) and a large forward movement of the stick (stick walking) when trimming to low speeds (flaps down, forward center of gravity).

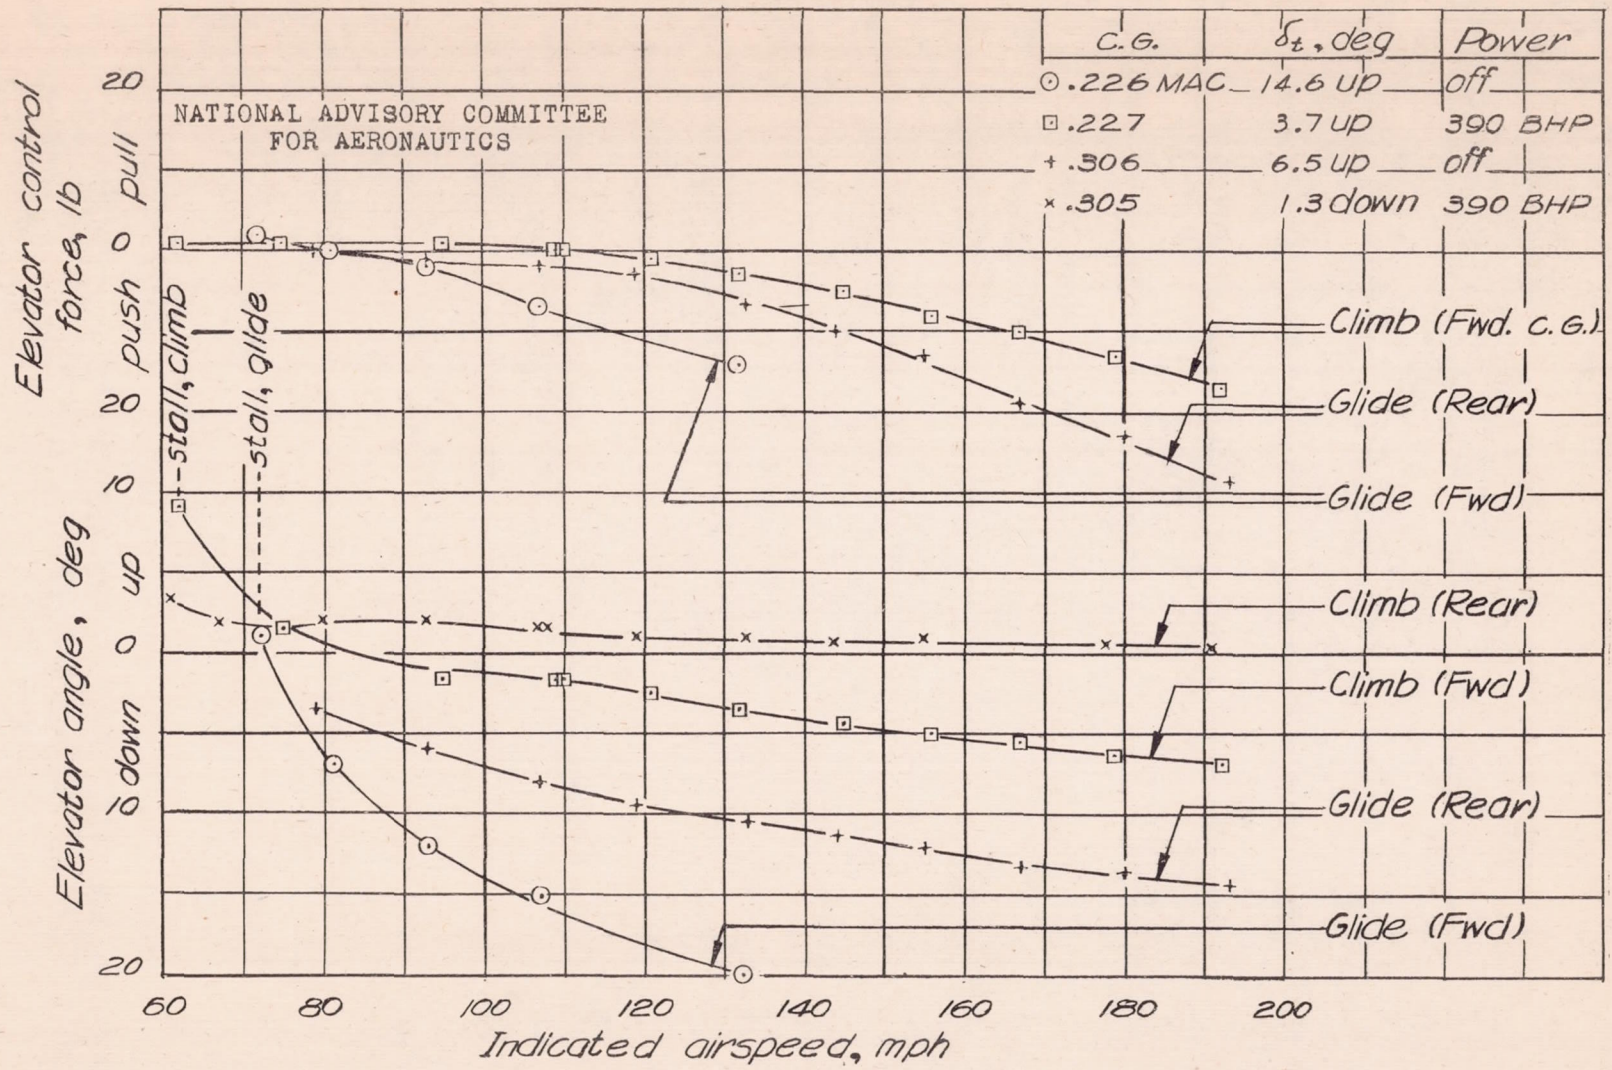
Figure 8.-Static longitudinal-stability characteristics. Flaps up.

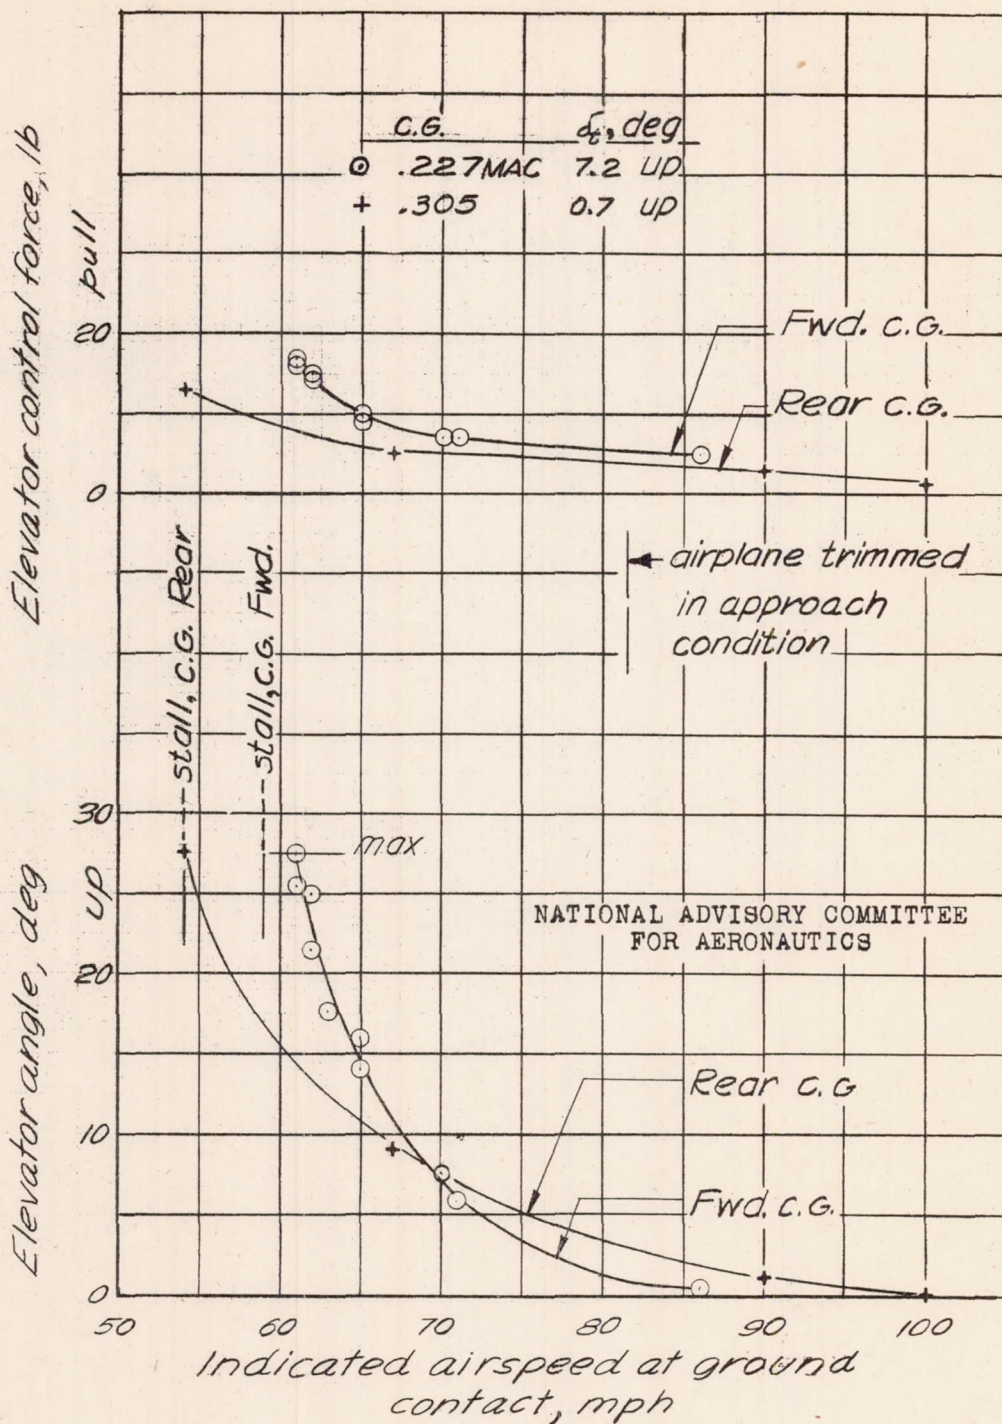
Figure 9.-Elevator angle and force required for various ground contact speeds. Flaps down, power off.

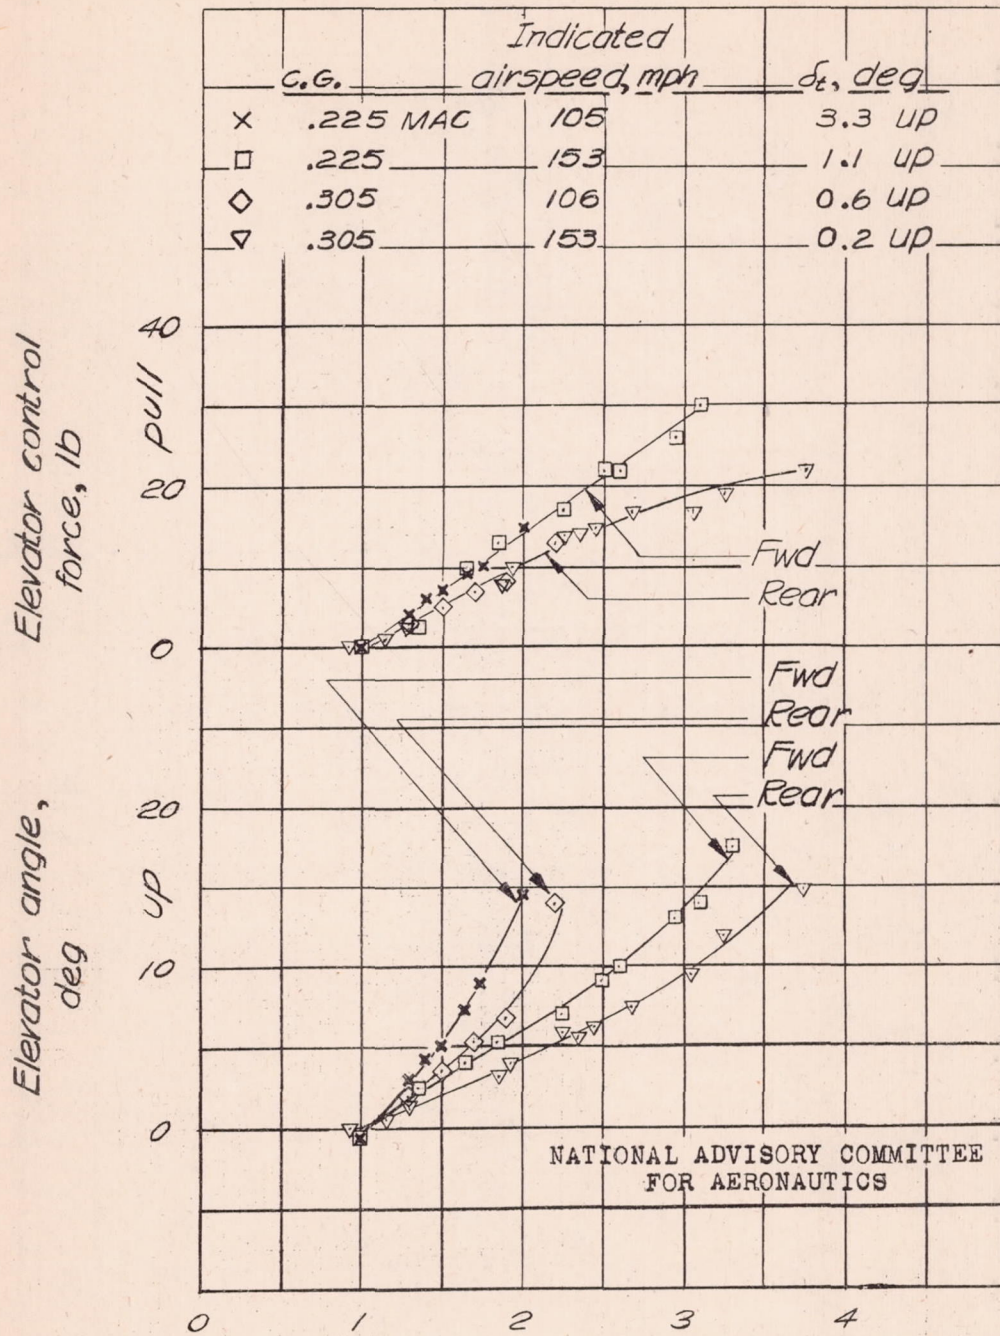
(a) Flaps up, normal rated power

Figure 10.-Longitudinal control in steady turning flight

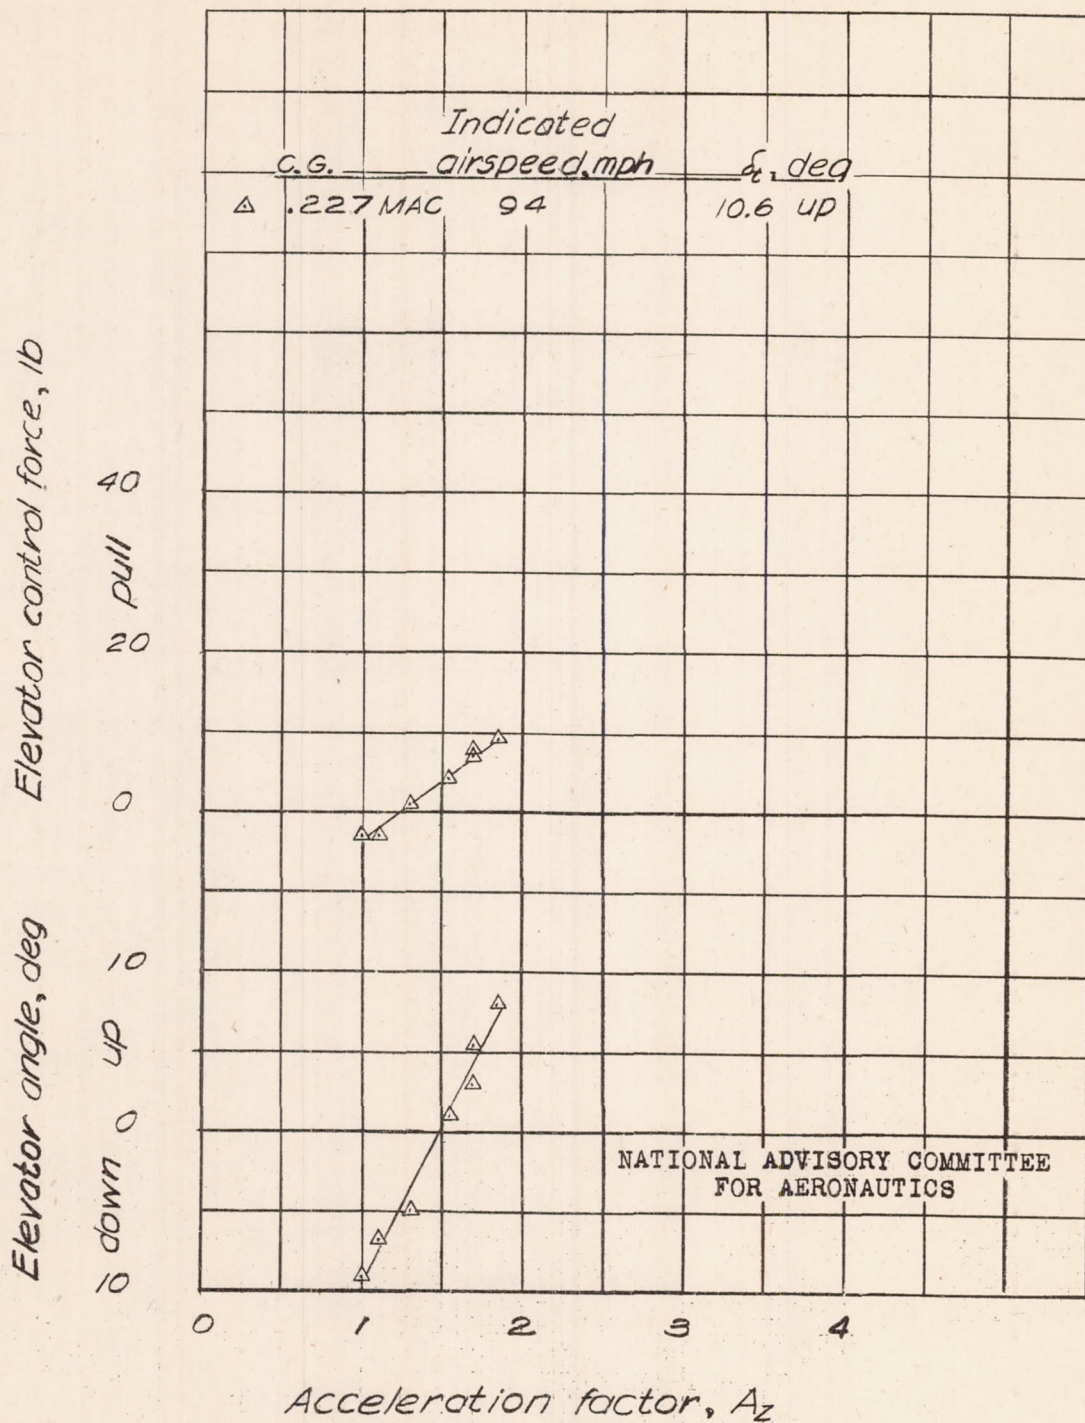
(b) Flaps down, power off
 Figure 10.- continued.

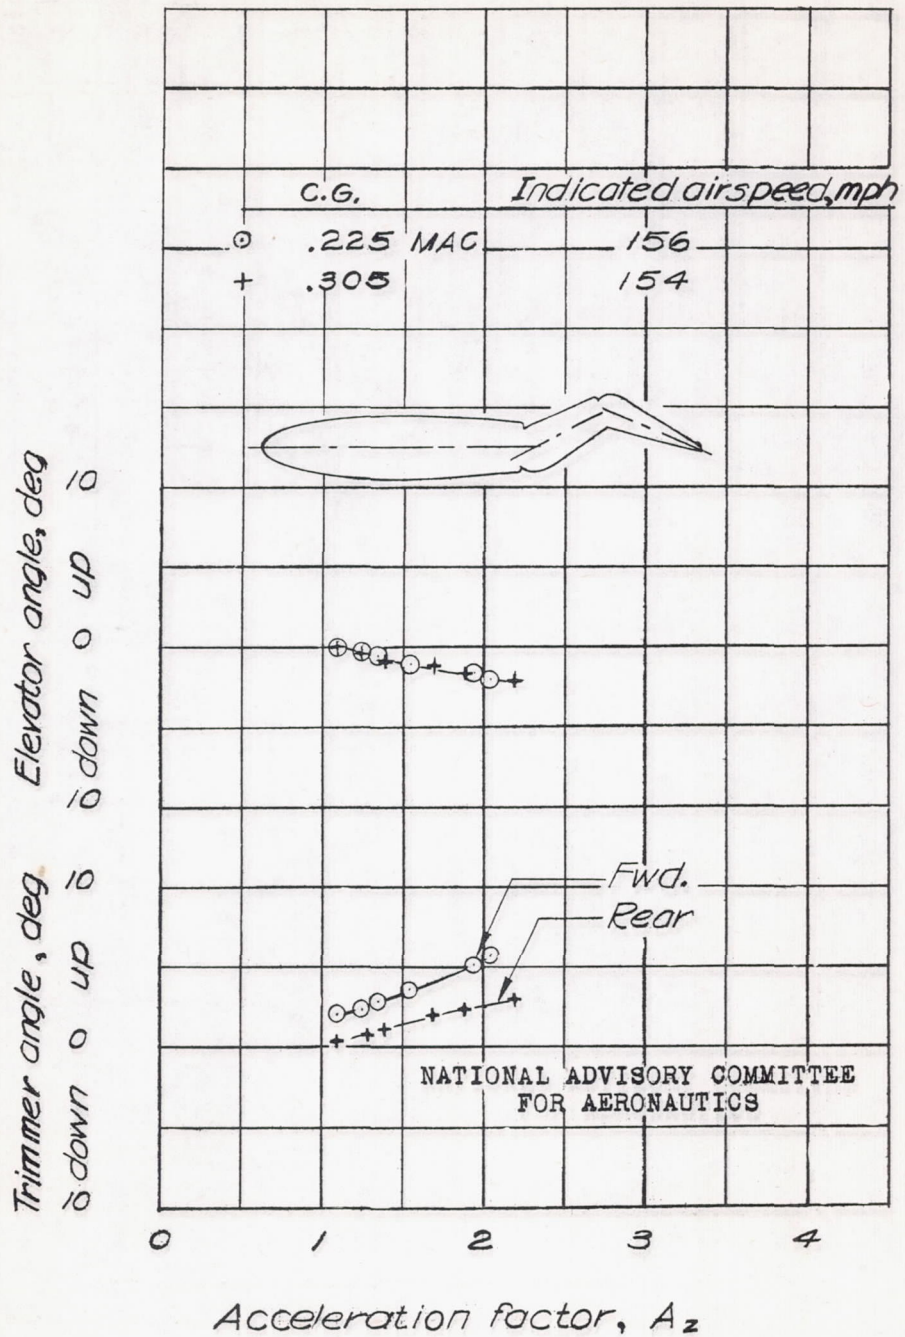
(c) Flaps up, normal rated power, using trimmer for control (stick force equal to zero)
 Figure 10.-concluded.

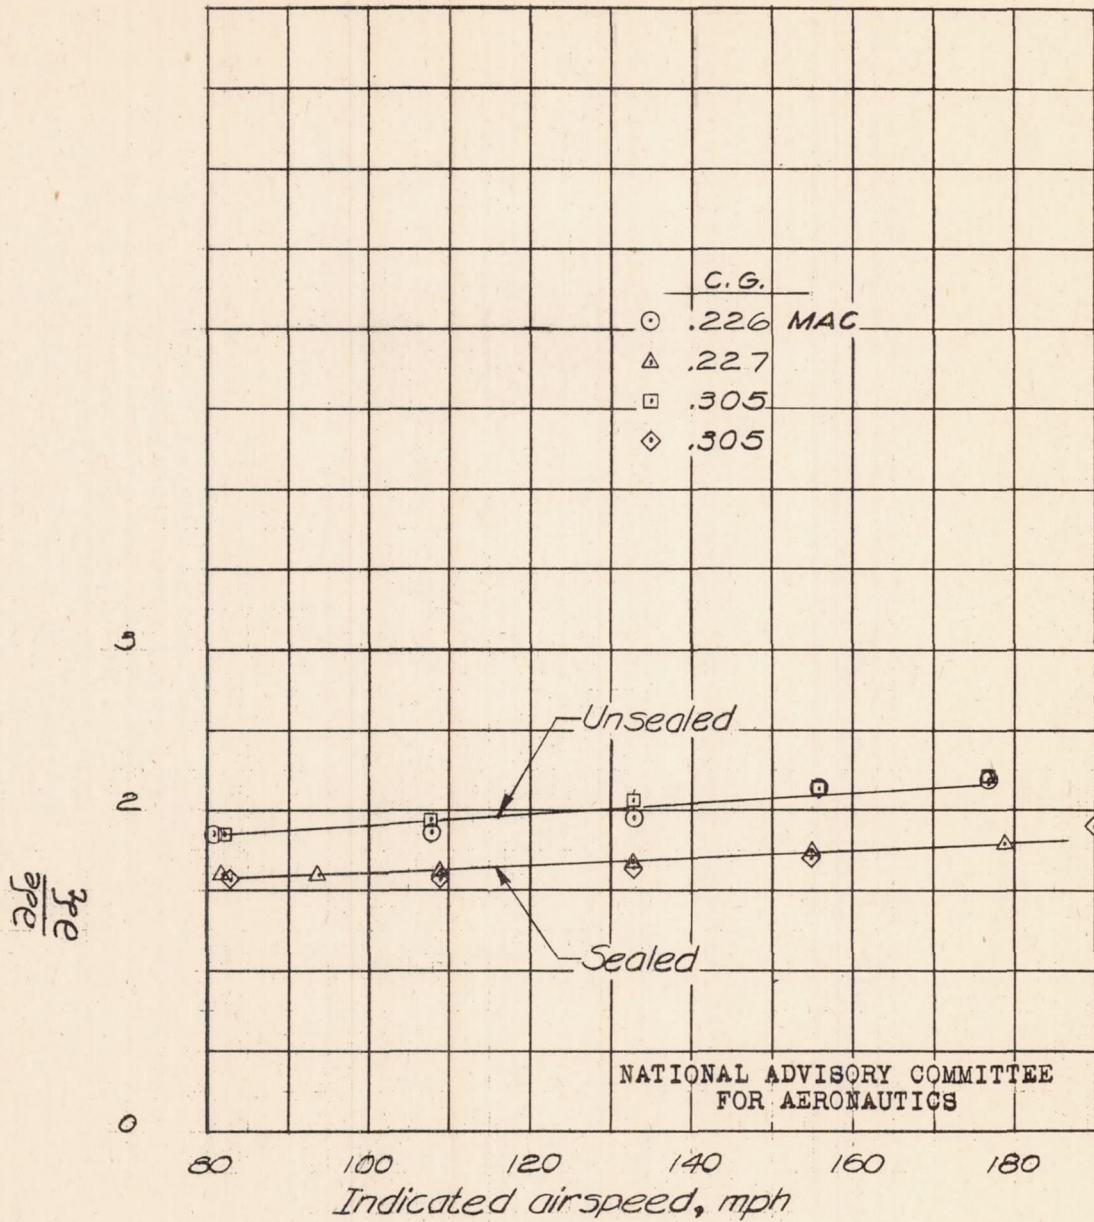
Figure 13.-Variation with airspeed of the ratio $\frac{\partial C_e}{\partial C_t}$ for steady straight flight. Flaps up, normal rated power.

double-hinged tail. The effect of removing the elevator seal is shown in figures 13, 14, and 15, and table II for various test conditions.

The effect of the removal of the elevator seal on the elevator control power, the trimmer effectiveness, and the elevator deflection required to offset a given trimmer deflection is presented in figures 13 to 15. These data indicate a marked reduction in the ability of the elevator to balance the airplane in the presence of the ground (fig. 15) when the elevator seal is removed. In addition, the effectiveness of the elevator in offsetting movement of the trimmer was reduced by 18 percent (fig. 13). However, this change had practically no effect on the ability of the trimmer to trim the airplane throughout the speed range and on the desirably low trim force changes due to power and flaps (table II). The number of cycles required to damp the short-period elevator oscillation was reduced slightly by the removal of the elevator seal (table I).
