No. 1224

FLIGHT TESTS OF A DOUBLE-HINGED HORIZONTAL TAIL SURFACE WITH REFERENCE
TO LONGITUDINAL-STABILITY AND -CONTROL CHARACTERISTICS

By Carl M. Hanson and Seth B. Anderson

Ames Aeronautical Laboratory
Moffett Field, Calif.

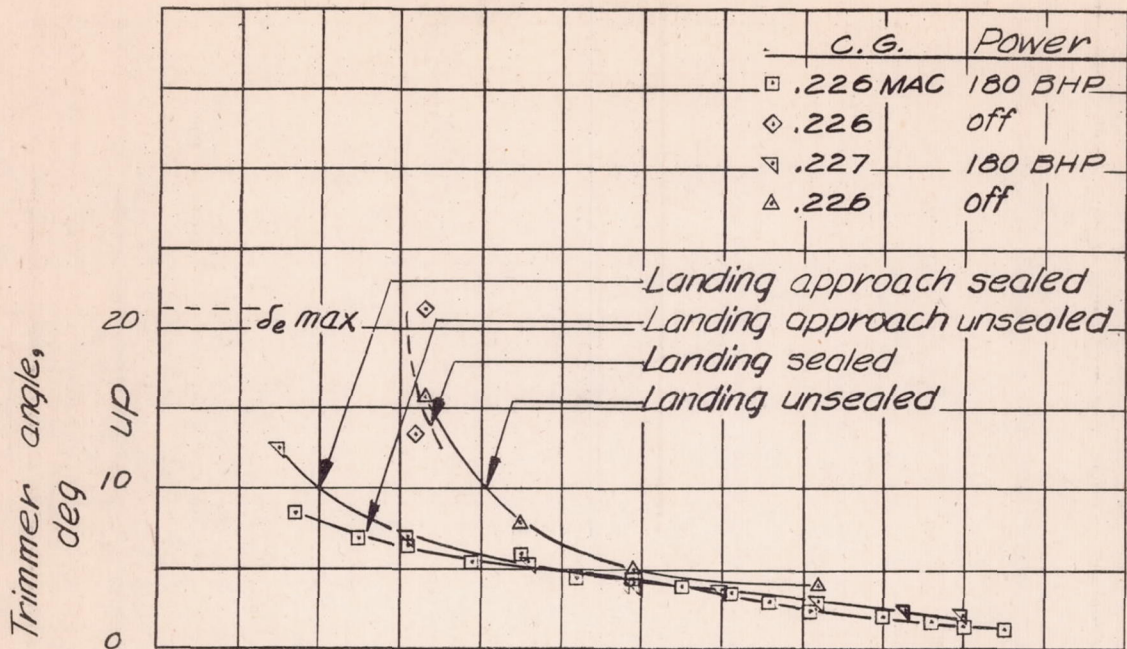
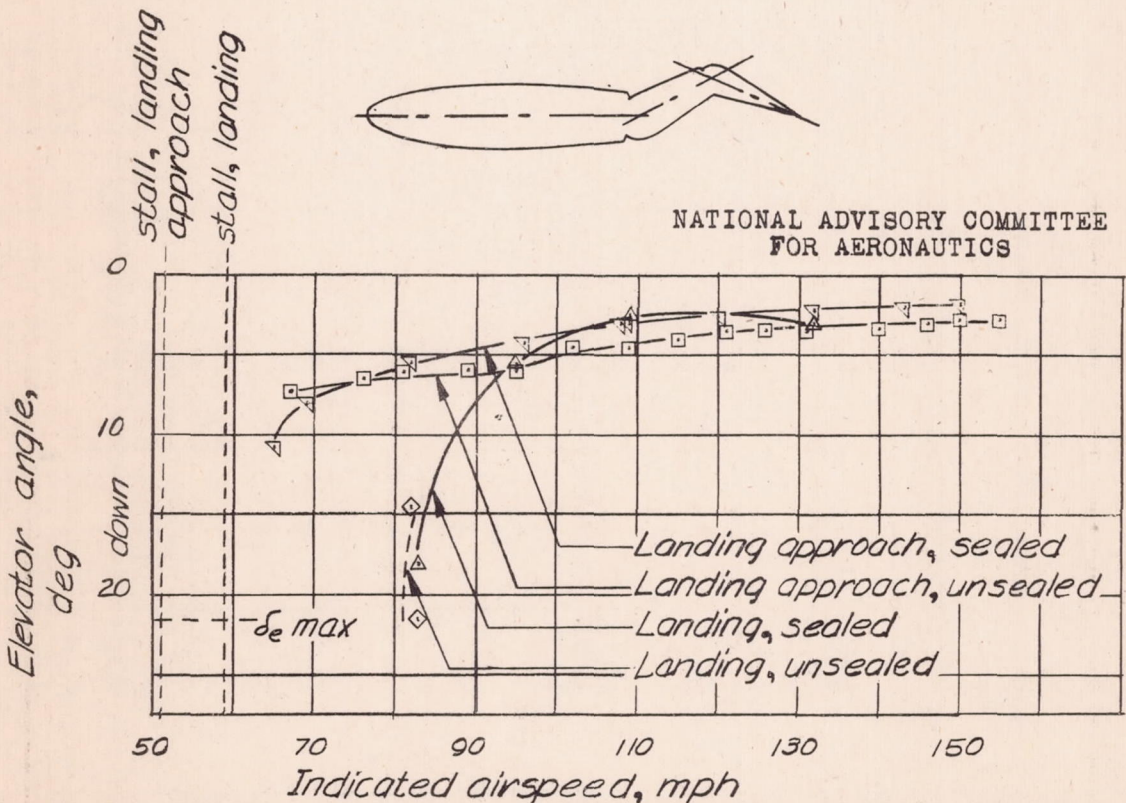
Figure 14 - Effect of elevator seal on elevator and trimmer angles required to trim for various airspeeds. Flaps down. Control force equal to zero.

double-hinged tail. The effect of removing the elevator seal is shown in figures 13, 14, and 15, and table II for various test conditions.

The effect of the removal of the elevator seal on the elevator control power, the trimmer effectiveness, and the elevator deflection required to offset a given trimmer deflection is presented in figures 13 to 15. These data indicate a marked reduction in the ability of the elevator to balance the airplane in the presence of the ground (fig. 15) when the elevator seal is removed. In addition, the effectiveness of the elevator in offsetting movement of the trimmer was reduced by 18 percent (fig. 13). However, this change had practically no effect on the ability of the trimmer to trim the airplane throughout the speed range and on the desirably low trim force changes due to power and flaps (table II). The number of cycles required to damp the short-period elevator oscillation was reduced slightly by the removal of the elevator seal (table I).

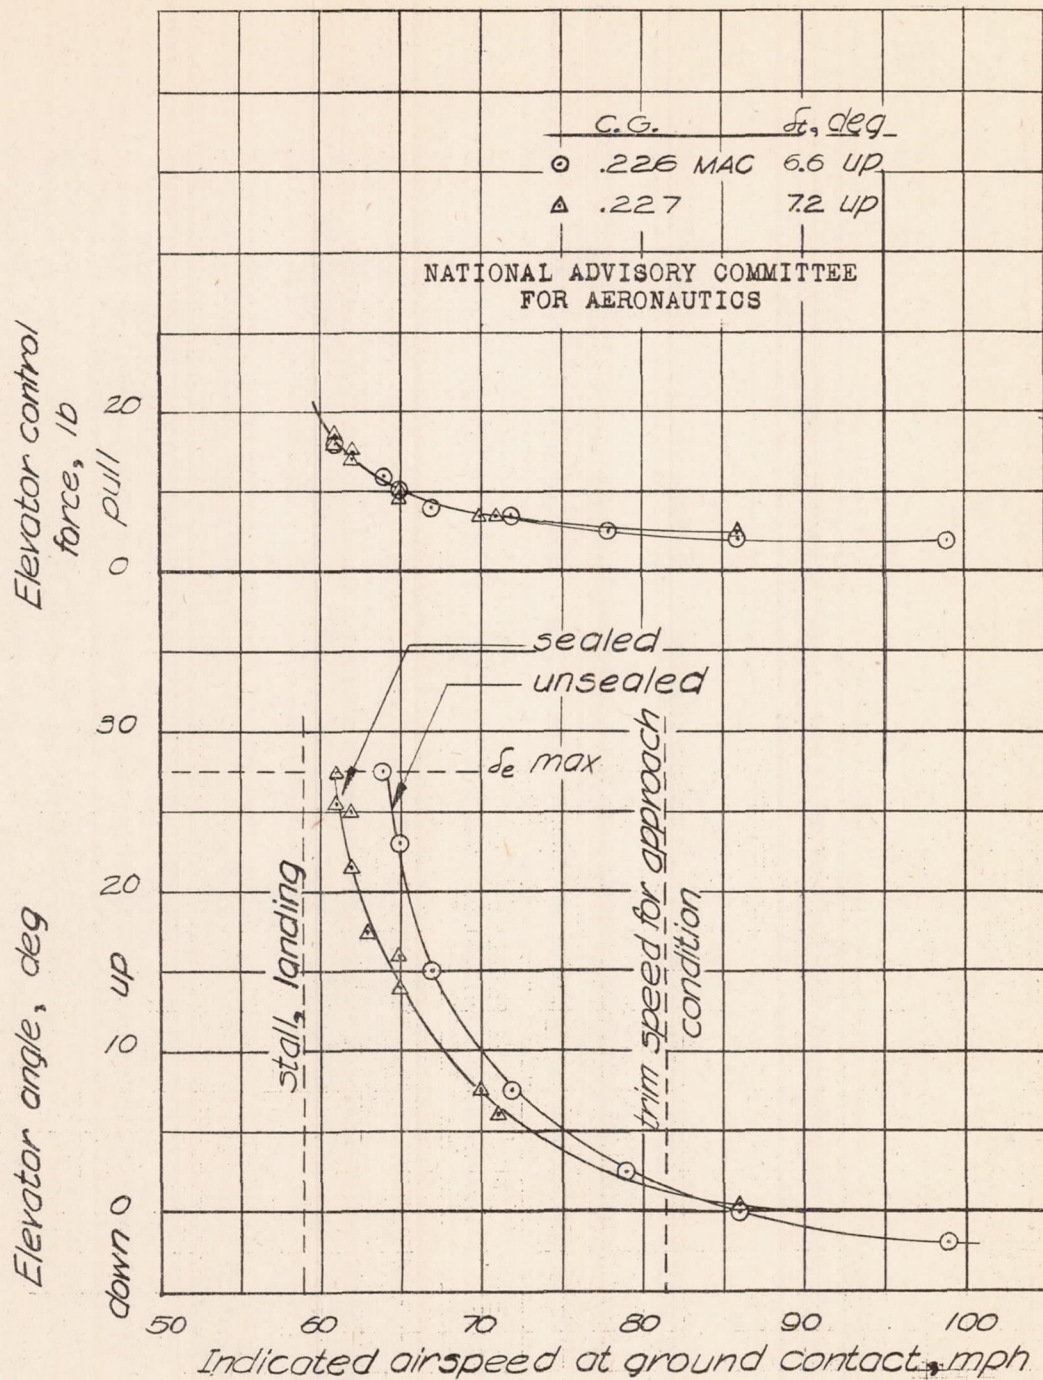
Figure 15.-Effect of elevator seal on elevator angles and elevator control force required for various contact speeds. Flaps down, power off.
