TECHNICAL NOTES

No. 603

A PRELIMINARY STUDY OF FLAME PROPAGATION
IN A SPARK-IGNITION ENGINE

By A. M. Rothrock and R. C. Spencer
Langley Memorial Aeronautical Laboratory

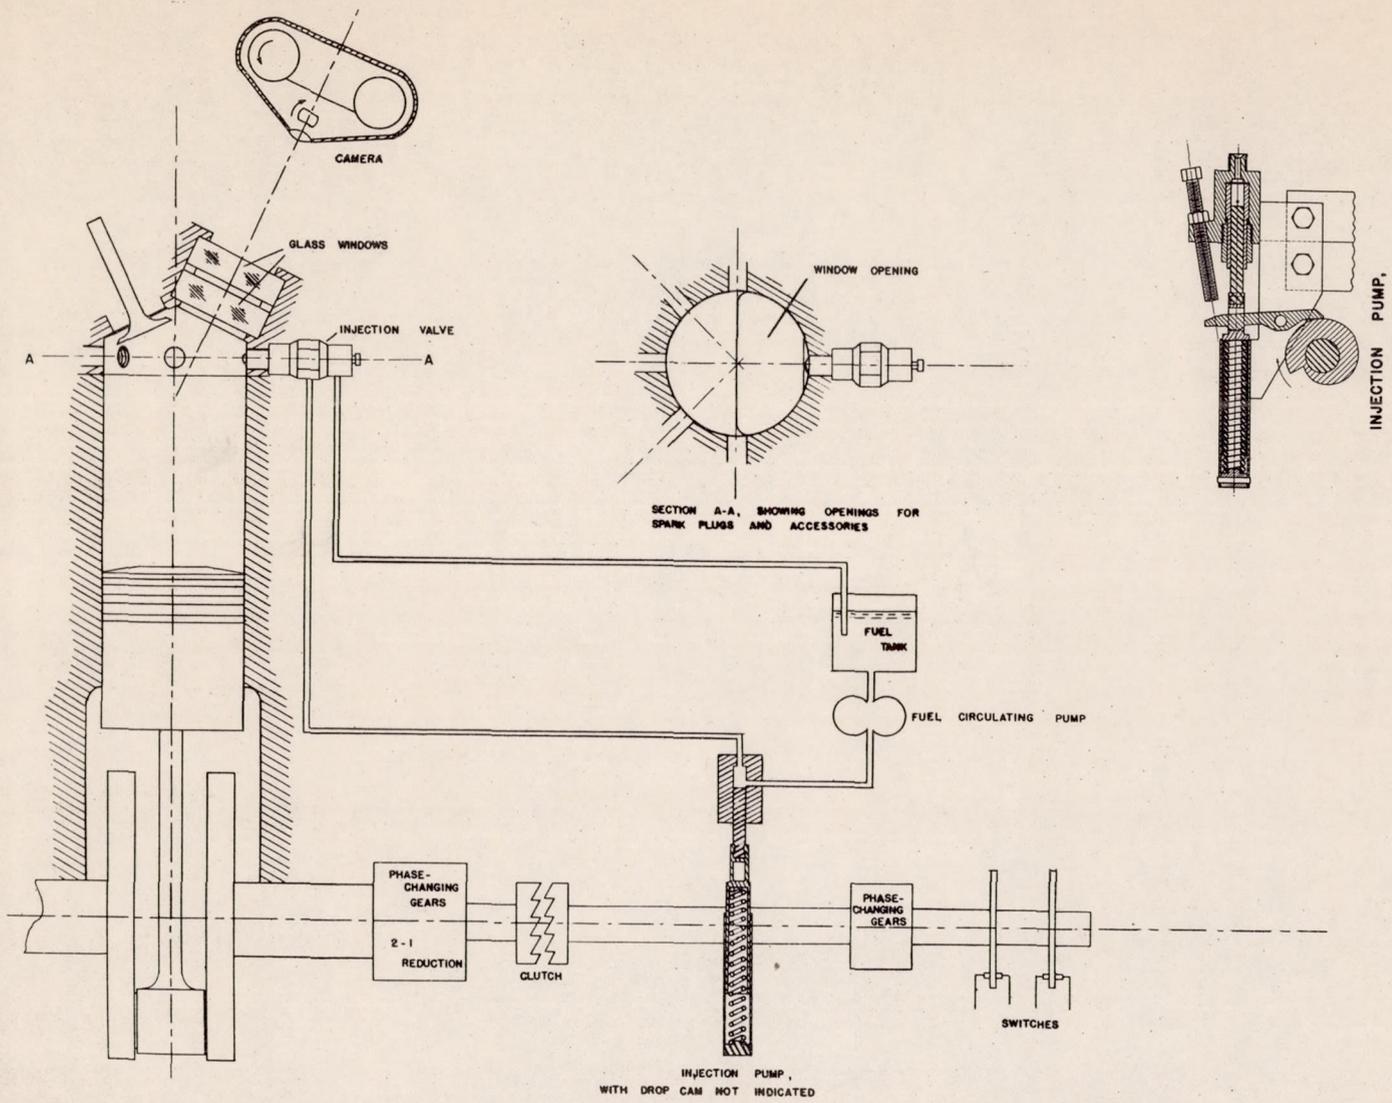
Figure 1.- Diagrammatic sketch of combustion apparatus.

A diagrammatic sketch of the apparatus is shown in figure 1. The cylinder head is of the pent-roof type and the combustion chamber is similar in shape to the one used by Schey and Young in their tests on fuel injection with spark ignition (reference 5). In the altered arrangement the space normally occupied by the two exhaust valves on one side of the head is used for the glass window. Inasmuch as the engine fires only once, the two remaining valves operate simultaneously and serve both for intake and exhaust. The valves were timed to open 55° before

The injection system, a cross section of which is included in figure 1, is spring operated. The spring is held compressed by a rocker arm, thus holding the lapped plunger retracted and leaving a port uncovered in the side of the sleeve. Fuel is circulated under pressure by a primary pump through the sleeve and thence to the injection valve, through the hollow stem in this valve and back to the fuel tank (reference 4). For the injection of the fuel, the rocker arm is released by a drop cam and the plunger is driven forward by the spring. The port is covered by the plunger at the start of travel and the fuel is delivered to the injection valve at a pressure of about 2,500 pounds per square inch. The fuel quantity is regulated by changing the length of the plunger travel. This system gives consistent fuel weights, and small changes in injection-valve opening pressure have relatively slight effect on the amount of fuel injected.

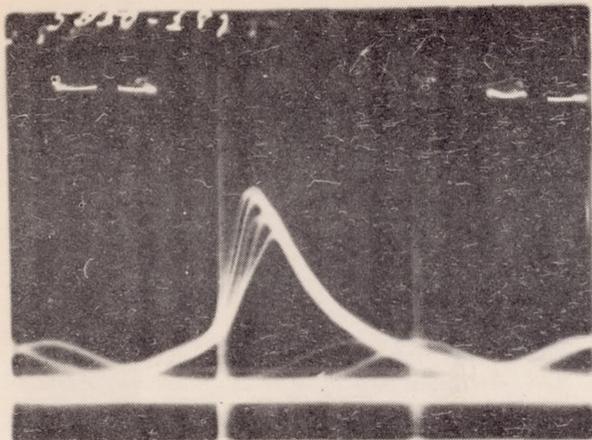
Engine speed,
 1500 r.p.m.
 Compression
 ratio, 7.0.
 Two spark plugs.
 Air-fuel ratio, 10.
 Injection start
 20° A.T.C. on
 intake stroke.
 Engine-jacket
 temperature,
 250° F.
 Spark advance, 20°

Figure 4. - Composite of eight indicator cards taken under the same conditions.

Variation in spark timing at first caused considerable differences between individual explosions but they were minimized by the installation of the condenser-discharge spark system. Even with the same spark timing and fuel weight per injection, indicator cards of successive explosions still showed considerable variation, both in maximum pressure and in rate of pressure rise. Hence it was necessary, when tests were being made, to take about 10 indicator cards at each condition. From these 10 cards, one card was selected as representative of the average explosion. The glass plates were then installed, the indicator was placed in one of the spark-plug openings, and three high-speed motion pictures of the flame formation were taken. The composite of eight indicator cards in figure 4 shows the extent of variation between successive explosions at the same conditions. Examination of various indicator cards from spark-ignition engines, made with a Farnboro indicator, indicates that the variation between successive explosions in an engine is not materially different from that between successive explosions in the combustion apparatus.

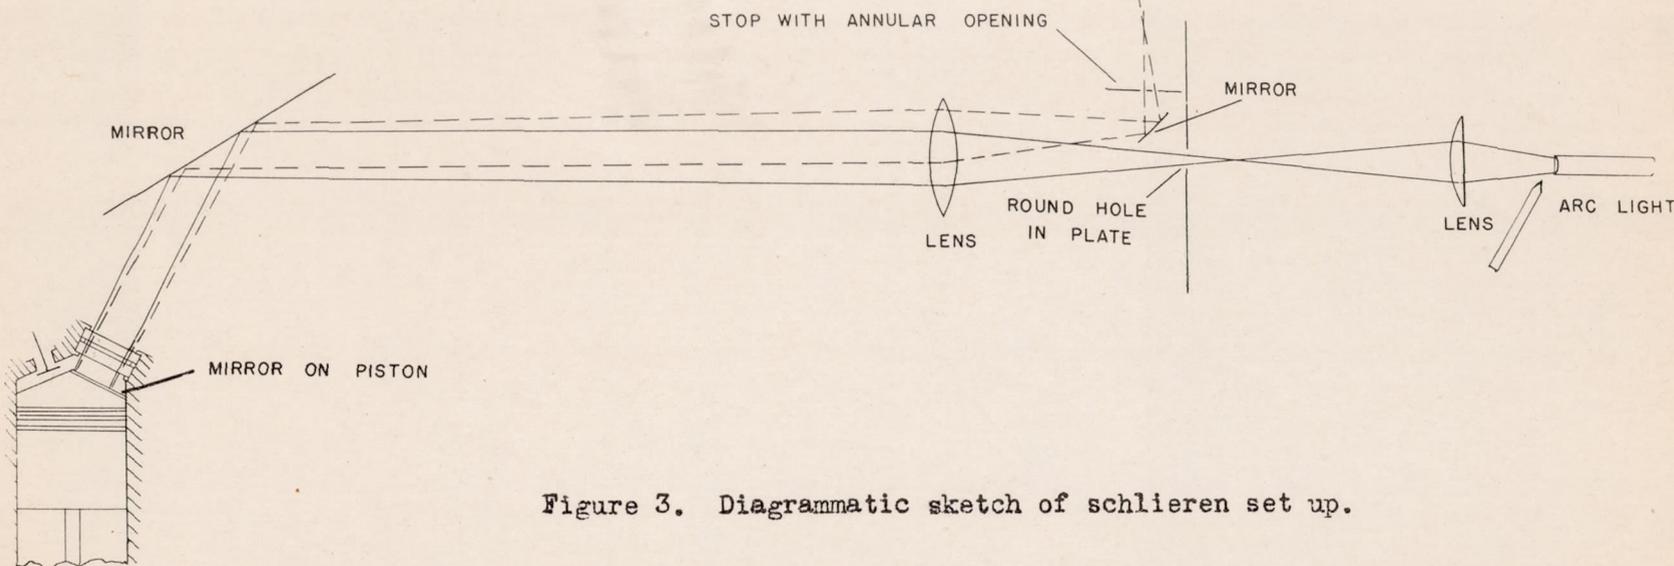
Figure 3. Diagrammatic sketch of schlieren set up.

The schlieren photographs were taken by using a high-intensity arc light as a source. A diagrammatic sketch of the optical set-up is shown in figure 3 and a description of the schlieren method is given in reference 8. A mirror was mounted on the piston because it was necessary to have the light pass through the medium being photographed. The condensing lens in front of the arc brought the light to a focus on a hole in a metal disk placed at the focus of the second lens. The diverging rays entering the second lens left this lens as parallel rays. By means of the mirrors shown, the rays passed through the gases in the combustion chamber and returned through the second lens. By a suitable adjustment of the mirrors, the image of the spot source was thrown somewhat out of line with the source. It was therefore possible to use a small mirror which reflected the rays so that the image was in a plane at a right angle to the plane of the spot source. The round stop to obtain the schlieren effect was placed in the plane of the image, allowing only an annular ring of light to pass. A plate with a hole for the main image was provided to block off the series of images from the surfaces of the windows. The stop was thus actually a plate with an annular opening. The light transmitted through this ring was directed onto a film mounted on a drum, and the image of the combustion chamber, formed by the second lens, came to a focus on the front of the drum. A mask having a 1/8-inch slit was placed in front of the drum, so that only a strip across the chamber was photographed. The part of the image transmitted by the slit corresponded to a 1/4-inch strip, parallel to and about 3/4 inch from the center line joining the two spark plugs at 90° to the injection-valve position shown in figure 1. A continuous, or streak, record was taken with this set-up instead of the high-speed motion pictures.

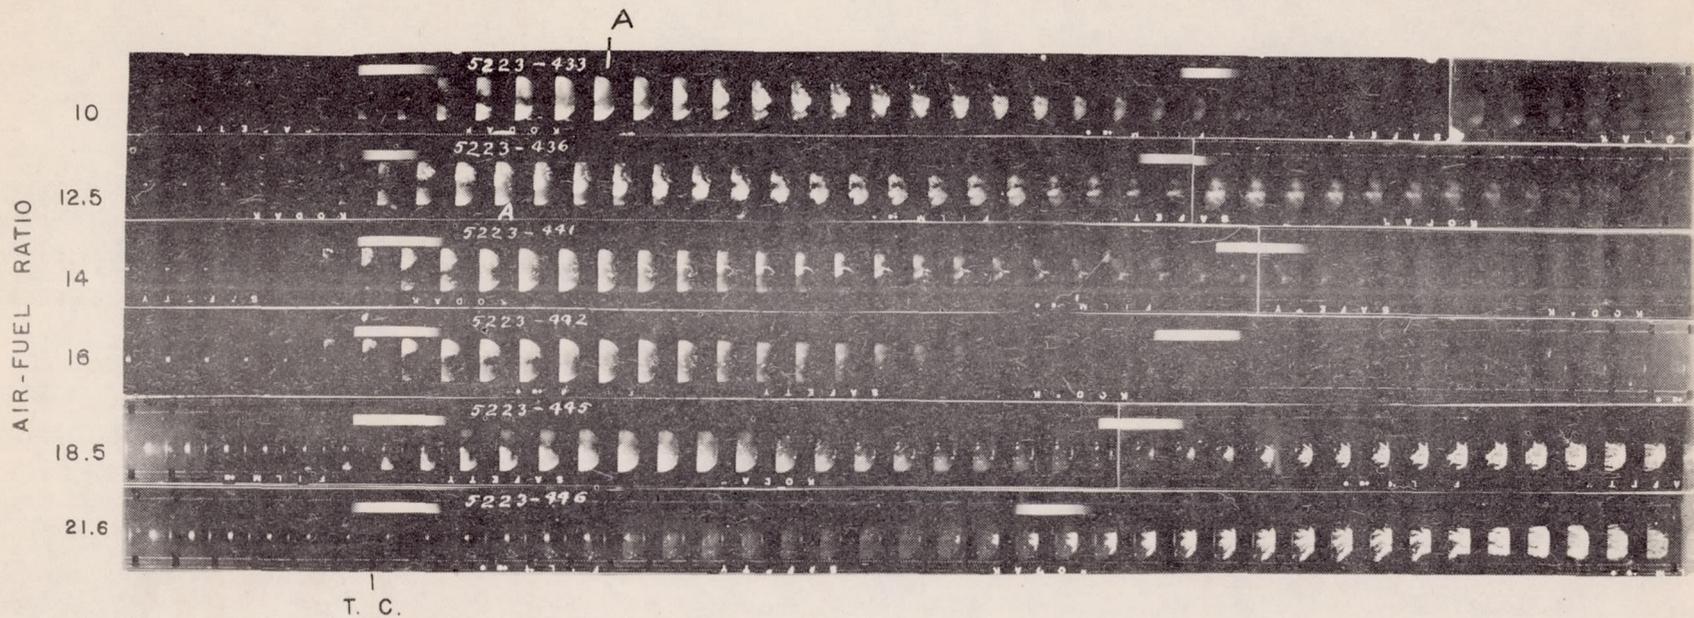
FIGURE 6 EFFECT OF AIR-FUEL RATIO ON FLAME PROPAGATION.
 WHITE MARKS ON UPPER EDGE OF EACH FILM CORRESPOND
 TO TOP CENTER AND 90° AFTER TOP CENTER.
 ENGINE SPEED, 1500 R.P.M. ENGINE JACKET TEMPERATURE, 250 °F
 COMPRESSION RATIO, 7.0 SPARK ADVANCE 20°
 TWO SPARK PLUGS
 INJECTION START, 20° A.T.C. ON INTAKE STROKE

High-speed motion pictures showing the effect of air-fuel ratio on the flame formation are reproduced in figures 6 and 7. The bright spots visible in the center of the frames before combustion begins are caused by the reflection of light from the piston crown as it rises on the compression stroke. At air-fuel ratios differing greatly from the theoretically correct one, the rate of flame propagation was somewhat slower than at the optimum ratio. The irregular flame fronts are characteristic of virtually all the photographs that have been taken. It frequently happens that when the two flame fronts approach each other, a projection on one flame front matches a corresponding indentation on the other front. (See fig. 7, air-fuel ratio of 10.) The various irregularities are never the same for any two photographs with the exception that the last part of the charge to burn is usually in the same part of the chamber.

In the frames marked A for the photographs at air-fuel ratios of 10 and 12.5 (fig. 6), an area of very bright illumination appears on the left side of the window (the point near the peak of the pent-roof cylinder head). In the succeeding frames the bright illumination spreads farther across the window and then gradually disappears.

Rassweiler and Withrow show similar photographs in reference 3 and attribute the effect to burning lubricating oil. The piston of the N.A.C.A. combustion apparatus, however, is lubricated by graphite, and the engine is operated without oil in the crankcase; hence another cause must be sought. The effect appears only at the lower air-fuel ratios and so is evidently associated with incomplete combustion.

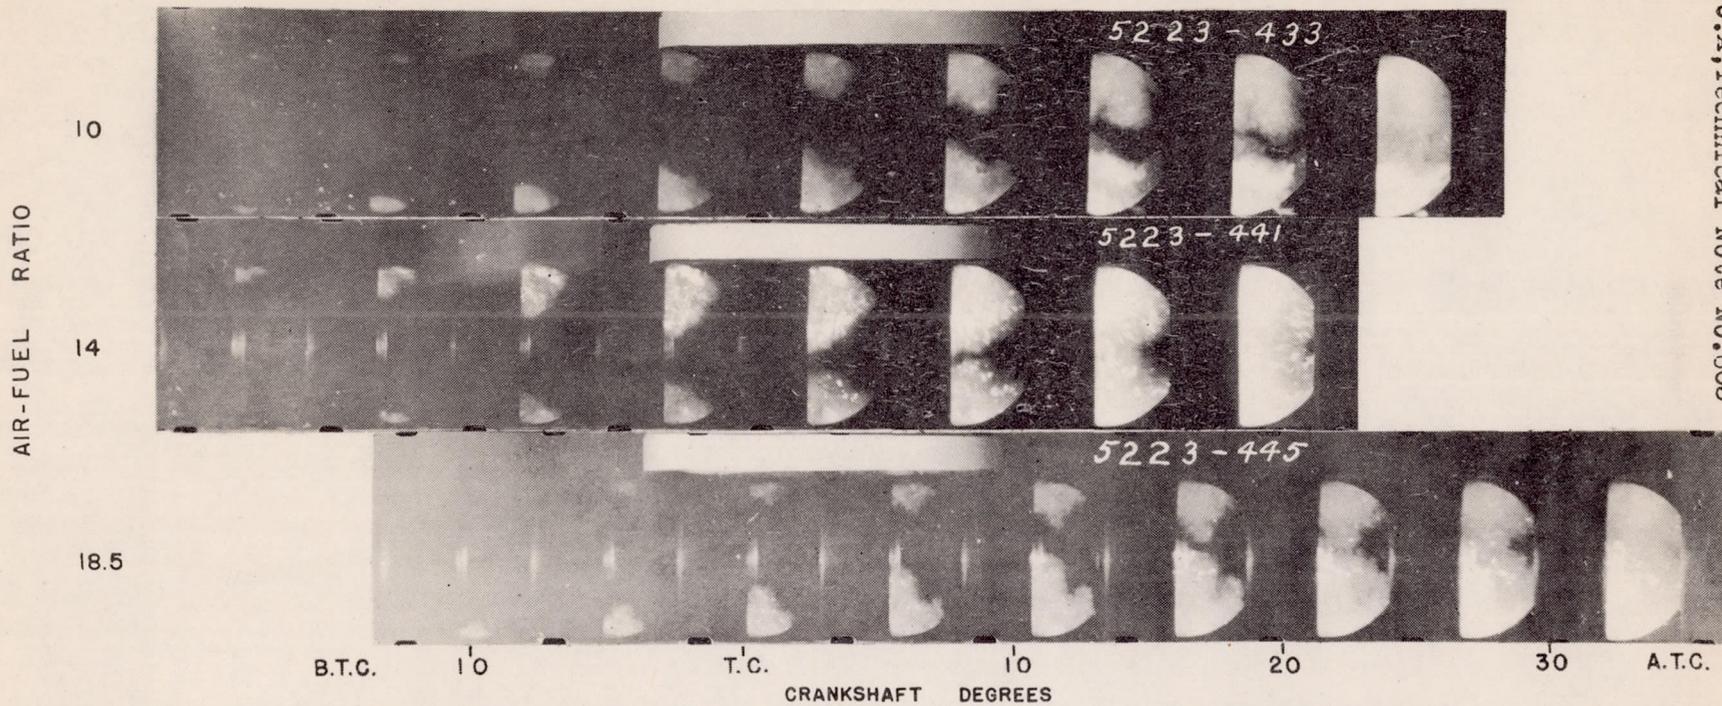
FIGURE 7.- ENLARGEMENTS OF PHOTOGRAPHS OF FLAME FORMATION AT

AIR-FUEL RATIOS OF 10, 14, AND 18.5

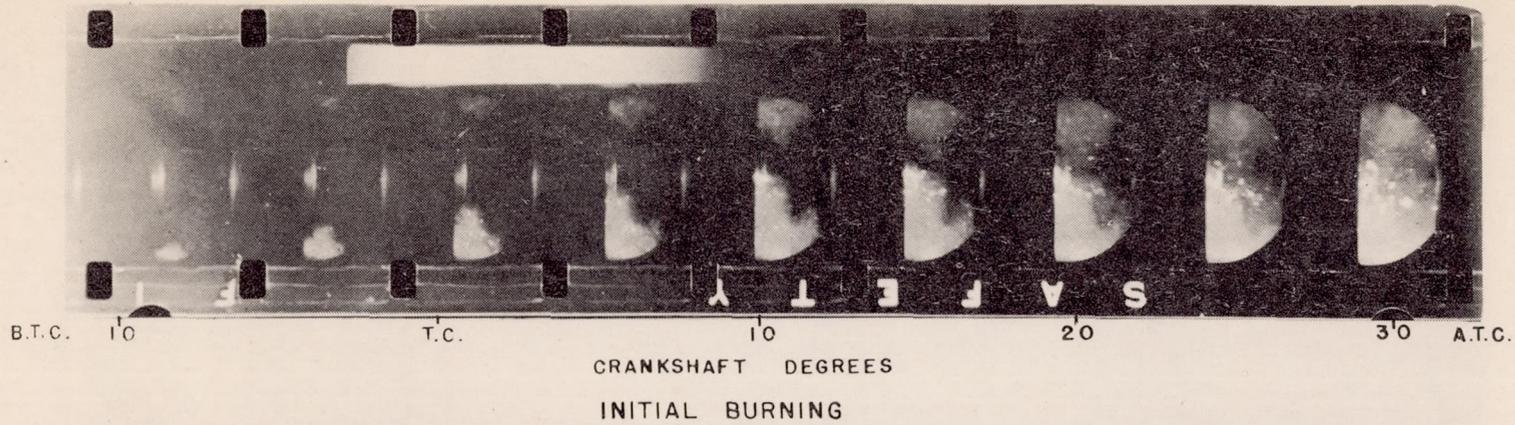
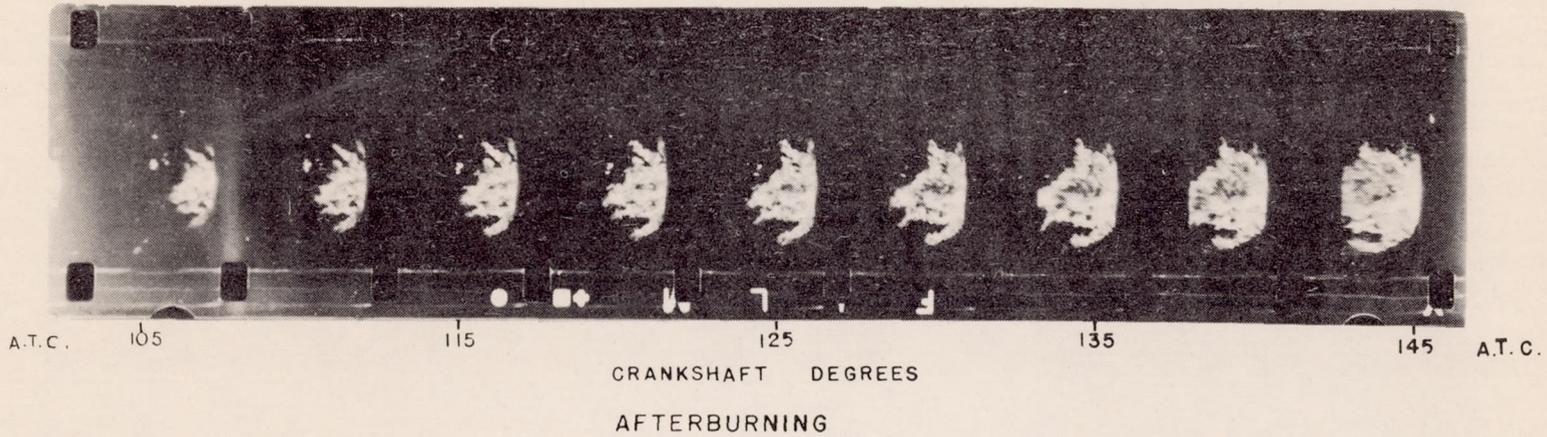
FIGURE 8. AFTERBURNING OF LEAN MIXTURE, AFTER FLAME HAS TRAVERSED CHARGE AIR-FUEL RATIO, 18.5 EXHAUST VALVES OPEN 125° A.T.C. ENGINE SPEED, 1500 R.P.M. ENGINE JACKET TEMPERATURE, 250 °F TWO SPARK PLUGS COMPRESSION RATIO, 7.0 SPARK ADVANCE 20° INJECTION START 20° A.T.C. ON INTAKE STROKE

A striking feature appeared in the photographs for the ratios of 18.5 and 21.6. Here, the flame completely traversed the chamber at a somewhat slower rate than at lower air-fuel ratios. Then, after the charge had apparently been burned, afterburning began and continued after the exhaust valve opened. To the eye this afterburning (in the exhaust) was characterized by an intense violet color. Enlargements of the photograph showing afterburning at a ratio of 18.5 are shown in figure 8, and it is seen that the flame had traversed the chamber by 30° after top center. Inasmuch as the piston had moved only $6/10$ of an inch in this time, there is little doubt but that the flame had completely traversed the charge in the vertical as well as in the horizontal direction. Hence the afterburning is evidently a reillumination of the charge. At an air-fuel ratio of 21.6, the original film shows that the flame had traversed the chamber by 50° after top center. The actinic value of the flame, however, was so weak that the flame did not show in a reproduction. The afterburning at this ratio is decidedly brighter than at a ratio of 18.5.

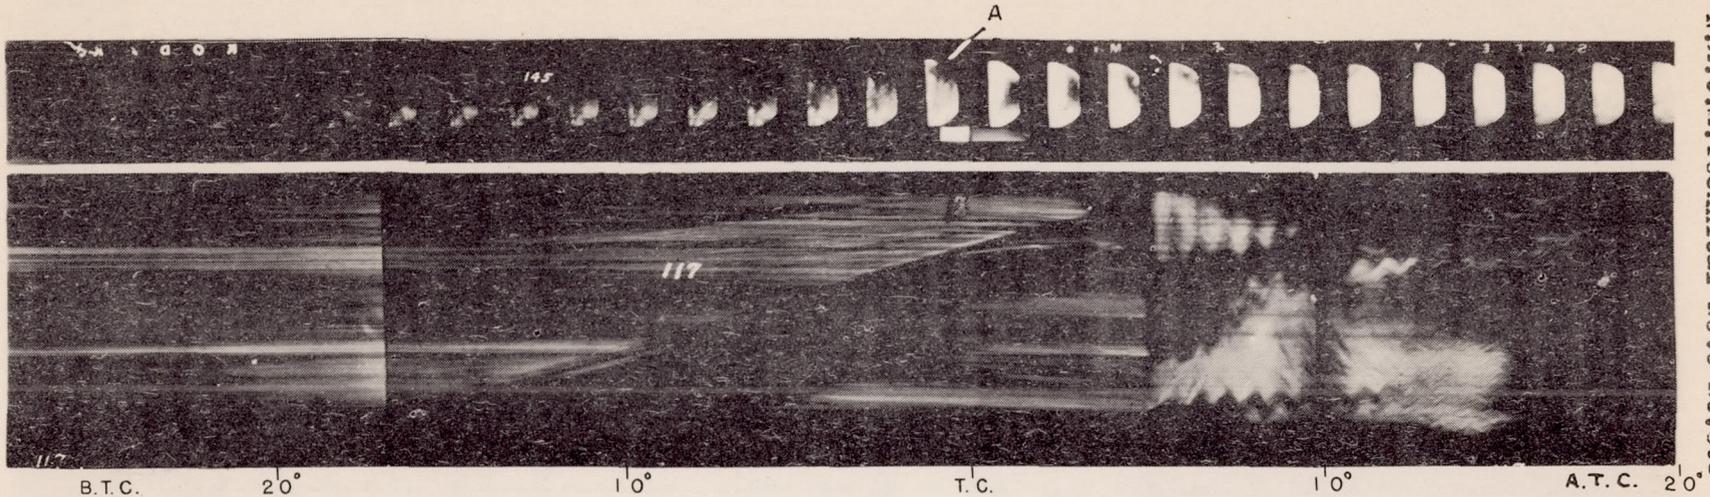
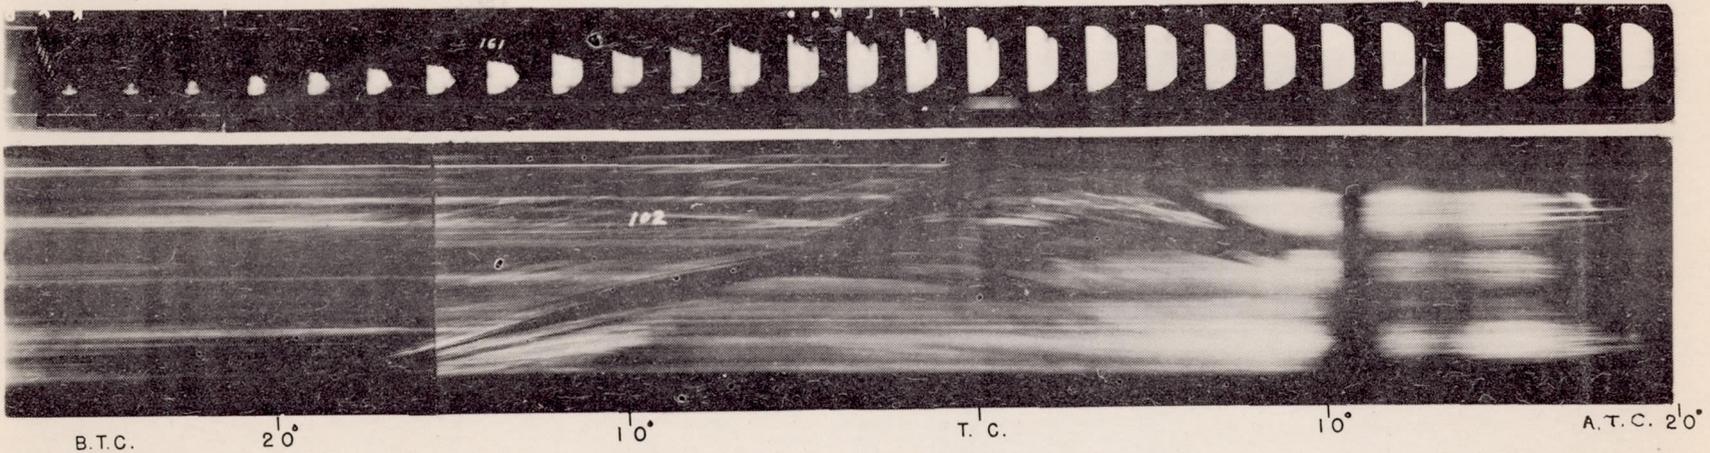
18-OCTANE FUEL, KNOCKING

100-OCTANE FUEL, NONKNOCKING

Figure 9.- HIGH-SPEED MOTION PICTURES AND SCHLIEREN PHOTOGRAPHS OF EXPLOSIONS IN A GASOLINE ENGINE. ONE SPARK PLUG
 ENGINE SPEED, 500 R.P.M. ENGINE JACKET TEMPERATURE, 250 °F COMPRESSION RATIO, 7.0
 SPARK ADVANCE, 30° INJECTION START, 20° A.T.C. ON INTAKE STROKE AIR-FUEL RATIO, 14

of knocking and nonknocking explosions are shown in figure 9. The upper strip of each pair of pictures is a high-speed motion picture, and the lower strip is a schlieren photograph. The photographs were not taken simultaneously, and the motion picture of the knocking explosion shows that the flame crossed the chamber sooner than was the case for the schlieren record for the same conditions. It should be kept in mind, when looking at the schlieren photographs, that they are records of a change in index of refraction of the charge. The combustion front is visible because of the temperature change.

The frame marked A, in the motion picture of the knocking explosion, shows a sudden large increase in the area covered by the flame. This increase is probably caused by auto-ignition of the part of the charge farthest from the spark plug. The next frame shows the chamber filled with flame and very brightly illuminated. The sudden extremely brilliant illumination is characteristic of the knocking explosions and the brilliance of the illumination apparently depends upon the violence of the knock. The flame before top center is shot through with small areas of brighter illumination.

The schlieren photograph of a knocking explosion shows that the flame front traveled almost across the chamber when some reaction caused a sudden reverse movement in the gases, followed immediately by detonation, which set up very violent waves in the chamber. The sudden backward movement in the gases is characteristic of the extremely violent knocking explosions.

Examination of the photographs of nonknocking explosions at once discloses some important differences from those under knocking conditions. For the nonknocking explosions, the burning throughout the chamber, as shown by the high-speed motion pictures, is very uniform in its illumination. The discontinuities in the schlieren record of the combustion front are not characteristic and are caused by the irregularities in the front as it advances parallel to the slit and then spreads at right angles to the general direction of travel. The reverse movement of the gases after the flame front has crossed the chamber is characteristic of all the schlieren photographs of nonknocking explosions. The discontinuity in the record, 6° or 7° after top center, was caused by a slight sidewise motion of the piston, which changed the angle of the light beam as reflected from the mirror on the piston.

In both of the schlieren records, compression waves can be distinguished ahead of the flame front, but no evidence has been seen of any wave traveling at any decidedly higher speed than the flame front, such as has been photographed by Payman and Titman in explosions of gaseous mixtures in tubes (reference 10).

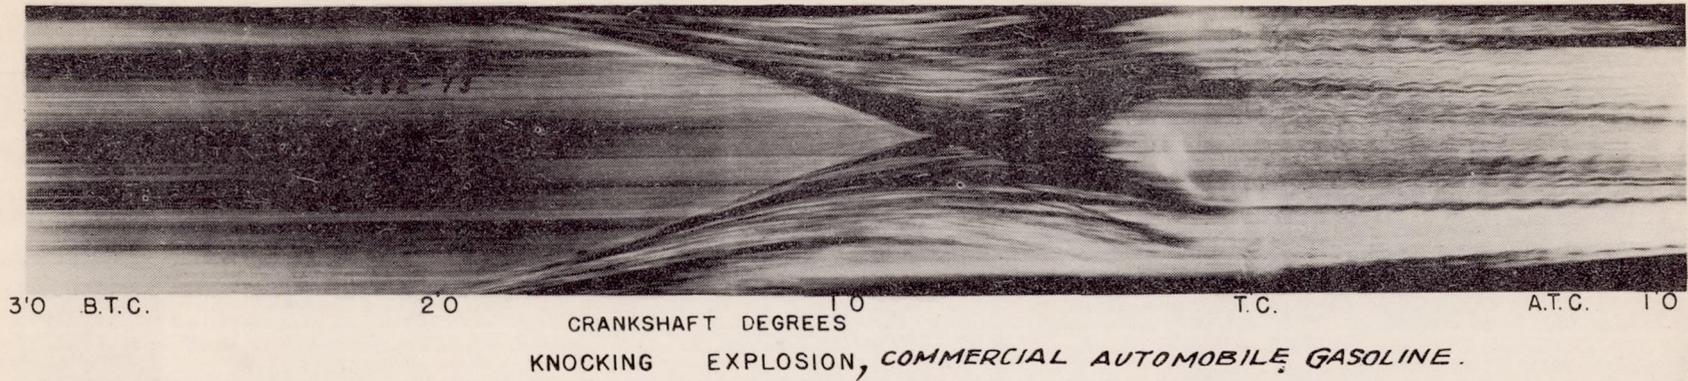
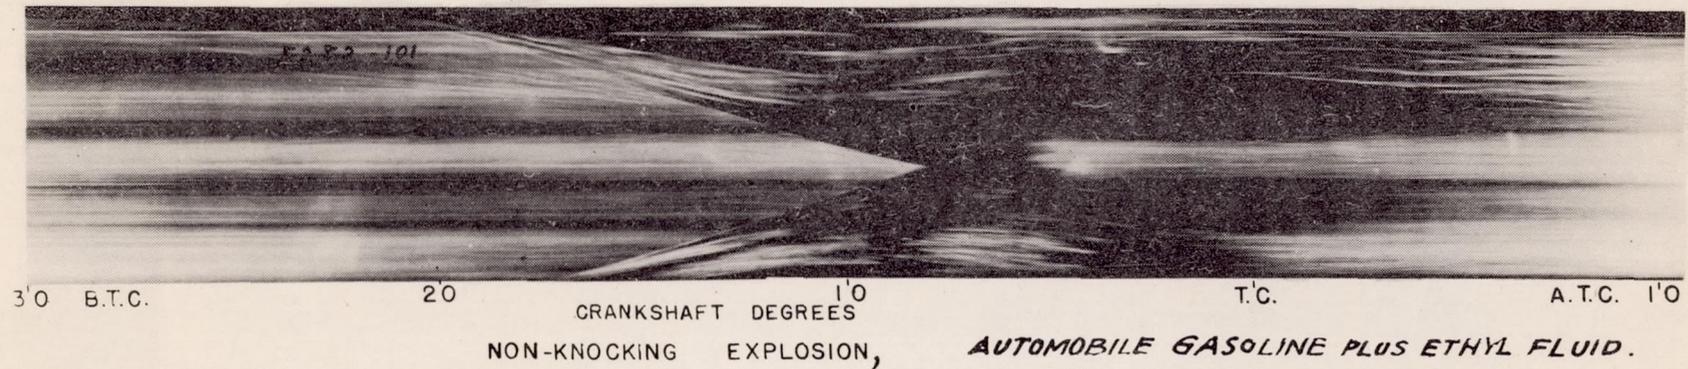
FIGURE 10. SCHLIEREN PHOTOGRAPHS SHOWING TWO FLAME FRONTS PASSING THROUGH EACH OTHER
 ENGINE SPEED, 500 R.P.M. ENGINE JACKET TEMPERATURE, 250° F
 COMPRESSION RATIO, 7.0 SPARK ADVANCE, 30°
 TWO SPARK PLUGS
 INJECTION START, 20° A.T.C. ON INTAKE STROKE

Figure 10 shows two schlieren photographs taken when the engine was operating on two spark plugs. These photographs show the combustion fronts starting at the two plugs, apparently passing directly through each other without interference, and continuing across the chamber. After traversing about half the remaining distance, the two fronts became indistinct and merged with the general pattern of the burning. Thus it is evident that some reaction, which changed the density of the charge, continued after the combustion front had passed through. The depth of the reaction zone, as measured from the negative, varied between 1 and 1-1/2 inches.
