# DEVELOPMENTS IN IMPACT DAMAGE MODELING FOR LAMINATED COMPOSITE STRUCTURES<sup>1</sup>

Ernest F. Dost, William B. Avery, and Gary D. Swanson

The Boeing Company, Seattle, Washington

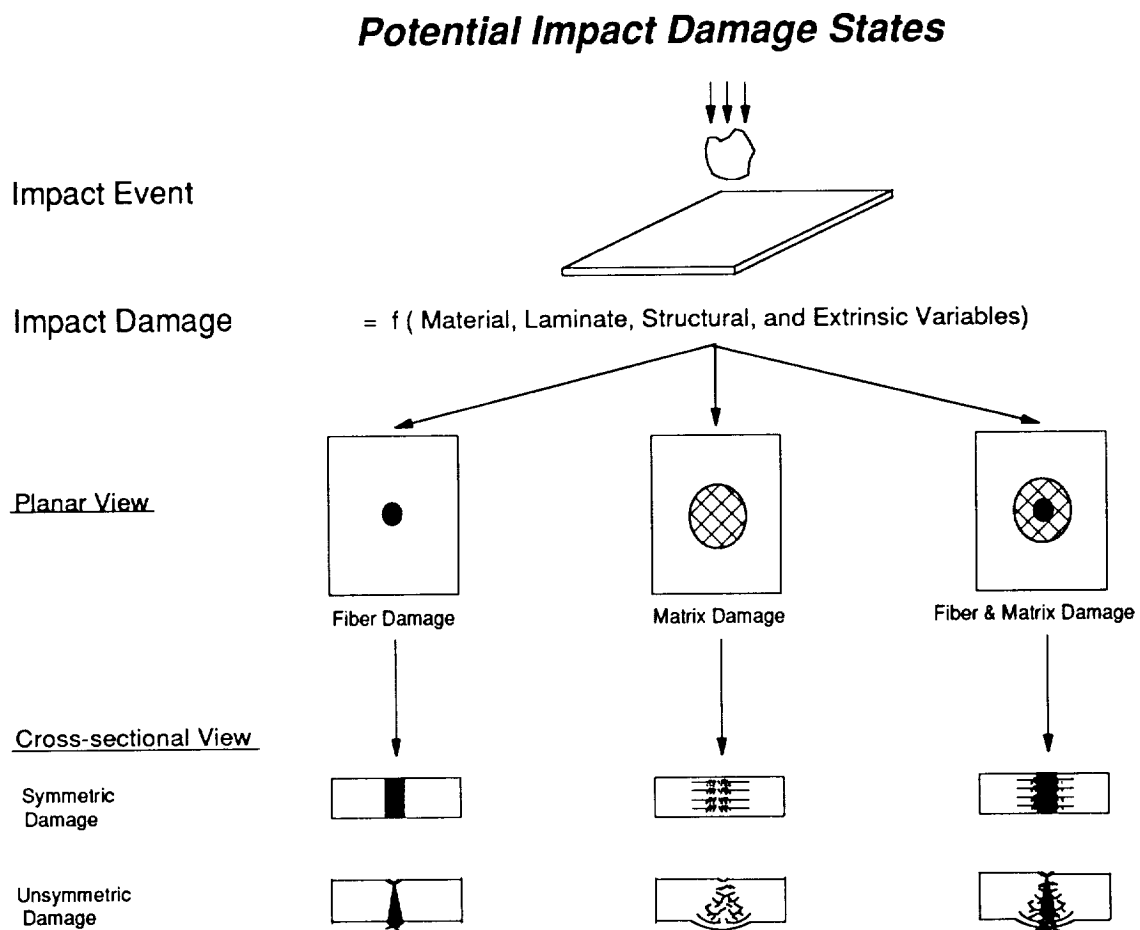
A schematic diagram classifying characteristic damage states (CDS) that have been observed in flat laminates following low-velocity impact by spherical objects is shown. Planar and cross-sectional views of CDS are given in the figure. Three classes of CDS consisting of symmetric damage through the laminate cross section are shown in this figure. Damage size and type (fiber, matrix, or combined) depend on variables such as delamination resistance and impact energy. The most common damage observed in experiments with a stacking sequence used for material screening tests (i.e.,  $[45,0,-45,90]_{nS}$ ) was matrix damage [1, 2].

Plate boundary conditions, laminate thickness, and material form are among the variables which may suppress delamination, causing damage dominated by fiber failure. Fiber damage, when present, tends to concentrate at the impact site. Matrix damage is also centered at the impact site, but tends to radiate away from this point to a size dependent on delamination resistance. The most general classification of symmetric damage involves both fiber and matrix failure.

Many factors can affect the CDS symmetry. Test observations have indicated thin laminates and heterogeneous stacking sequences tend to have unsymmetric CDS with damage concentrated opposite the impacted surface. Very thick laminates are also expected to have unsymmetric damage, but with damage concentrating closer to the impacted surface. Work by the current authors has indicated that delamination resistant materials have a stronger tendency for unsymmetric CDS than brittle materials tested with the same impact variables [3].

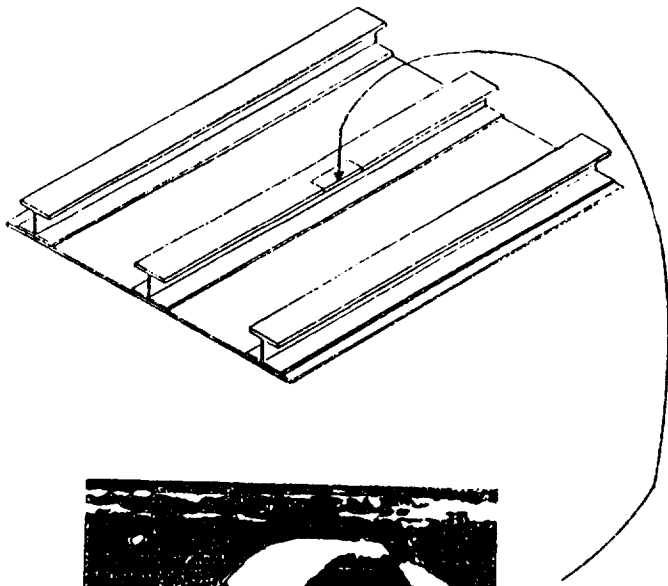
Wing Structure with Integral Stiffeners  
Impacted on Free Flange

The panel shown below is a carbon fiber reinforced plastic (CFRP) wing gauge panel impacted on the stiffener cap. The impact damage located on this stiffener cap was nonvisible. An identical panel had been impacted on the stiffener attachment flange edge. Both panels had significant reductions in strength from their undamaged strength. Analytical tools developed to predict the post-impact response of CFRP structure must have enough generality to account for different failure modes which occur during impact. The approaches presented take into account both stress redistribution and changes in panel postbuckling response due to sublaminar buckling [1-3]. The prediction of post-impact response due to local fiber failures was presented by Cairns [4].

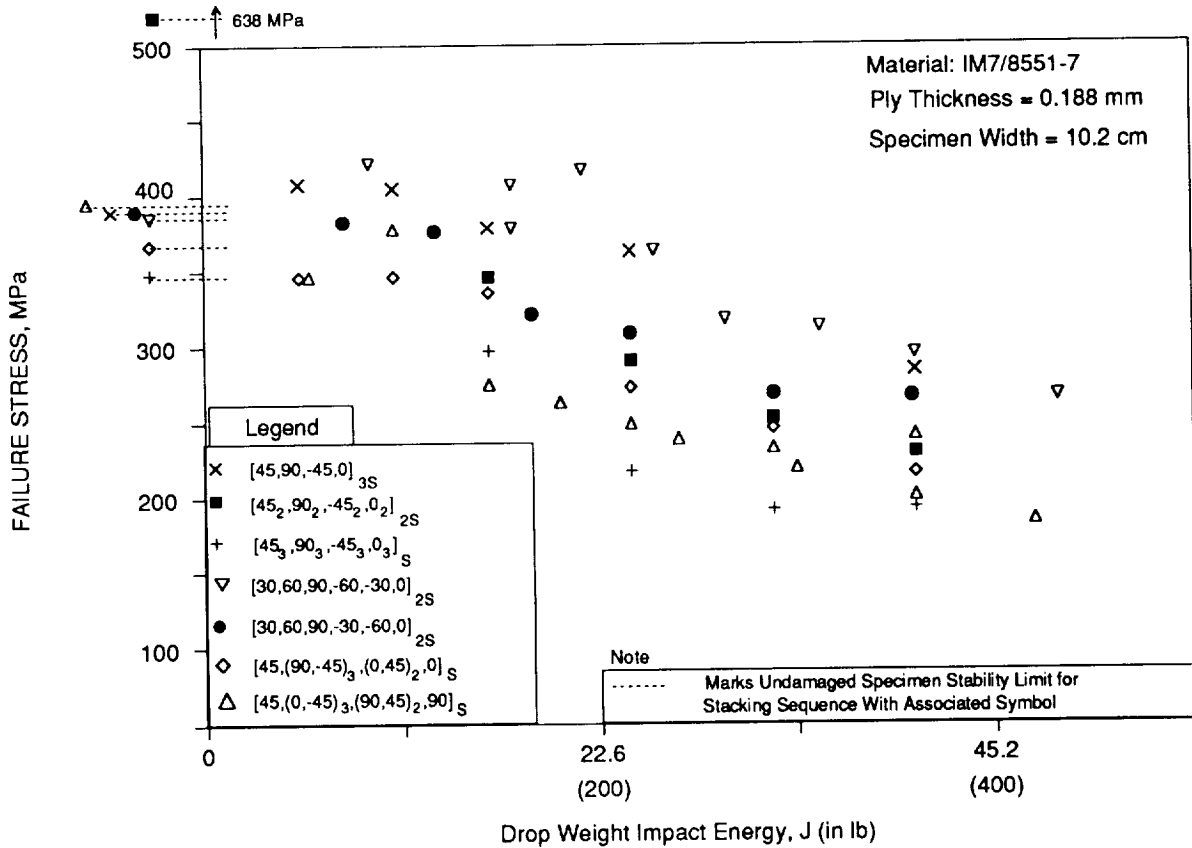
*Experimental Data Showing Post-Impact Compression Performance as a Function of Laminate Stacking Sequence*

Compression after impact (CAI) data are shown as a function of the drop weight impact energy (i.e., drop height x drop weight). Data scatter for each type of laminate layup was small compared to the total range of results. This indicated that laminate stacking sequence is critical to CAI. Note that all other material, laminate, structural, and extrinsic variables were held constant for the tests. The one exception was for the  $[45_2, 90_2, -45_2, 0_2]_{2S}$  laminate which had 32 plies instead of 24 plies. Despite the additional thickness, this laminate did not have the highest CAI for a given impact energy, again indicating the importance of stacking sequence. These data illustrate that models to predict residual strength of impacted laminates must include stacking sequence dependent CDS details [3].

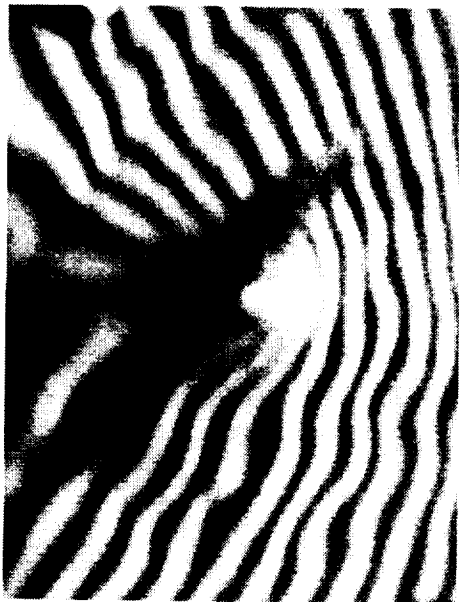
Out-of-Plane Displacement Contours

Sublaminare stability and subsequent load redistribution of compressively loaded impact damaged coupons are being examined experimentally. Moire interferometry was employed to measure both in-plane and out-of-plane displacements of impacted coupons as a function of load. A micro-Moire grid (600 lines/millimeter) used to measure inplane displacements was applied to the tool side while the other side used shadow Moire (60 lines/cm) to measure out-of-plane displacements. A typical Moire fringe pattern displaying out-of-plane displacements for a  $[45,0,-45,90]_3S$  specimen with a damage diameter of 1.28" is shown. The in-plane  $u$ -displacements are shown next to it. By examination of the in-plane displacement contours, one can discern that an inplane strain concentration occurs near the damage area.

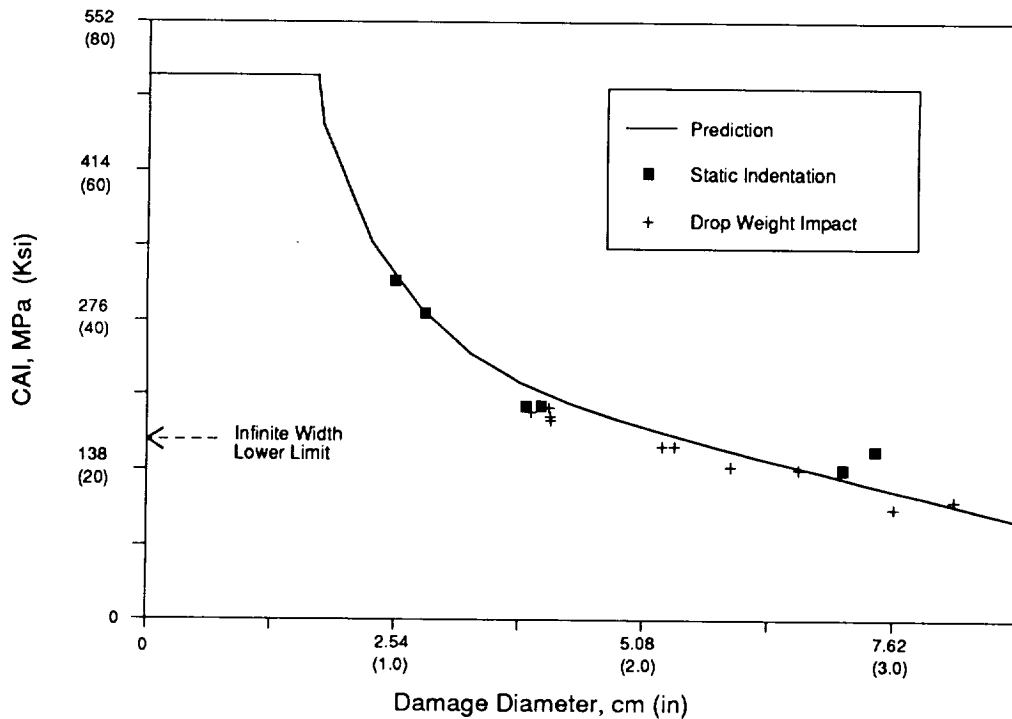
### *Sublaminare Stability/Reduced Stiffness Predictions and Experimental Results for AS6/3501-6, (45,0,-45,90) 5S*

This figure shows good comparisons between predictions and experimental results using a graphite/epoxy material (AS6/3501-6). The undamaged compressive strength was measured as 501 MPa (72.7 Ksi). Damage was created by both static indentation and drop weight impact. Finite specimen width becomes important as damage diameters increase. As shown, the model accurately predicted CAI throughout the range studied. The CAI lower limit for infinitely wide coupons would correspond to the maximum stress concentration of three for a quasi-isotropic laminate (i.e., 167 MPa).

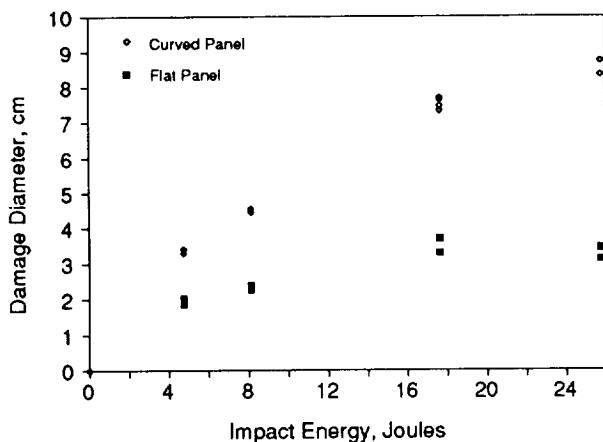
**Damage Resistance: Flat versus Curved Panel  $(45,90,-45,0)_{3S}$**

Damage area as a function of impact energy is presented in the first figure below. The flat panels exhibited a maximum damage diameter of approximately 4 cm, whereas the curved laminates exhibited damage diameters of up to 8.5 cm before significant interaction with boundaries occurred. Recalling that the total width of a coupon is 10.2 cm indicates that significant area of the coupon was damaged. The massive increase in damage area in the curved coupons is believed due to the curvature induced increase in laminate stiffness, which results in higher impact and shear loads. Further analysis of curvature effects is continuing.

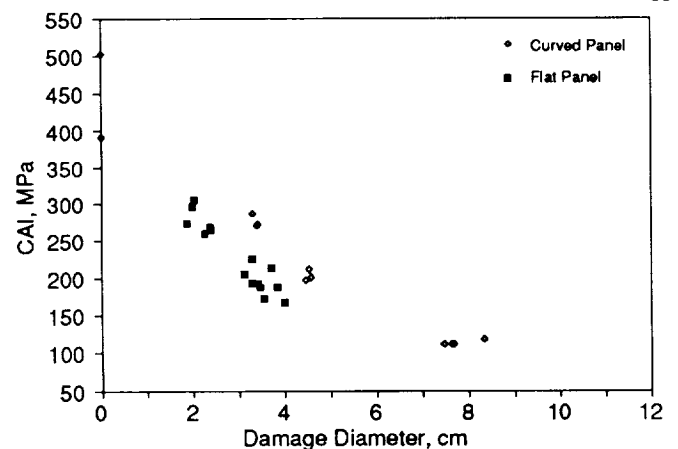
**Residual Strength: Flat versus Curved Panel  $(45,90,-45,0)_{3S}$**

Post-impact compression strength as a function of damage area is presented in the second figure. The curved panels exhibited higher CAI strength for a given damage area. This is assumed due to the increase in stability imparted by coupon curvature..

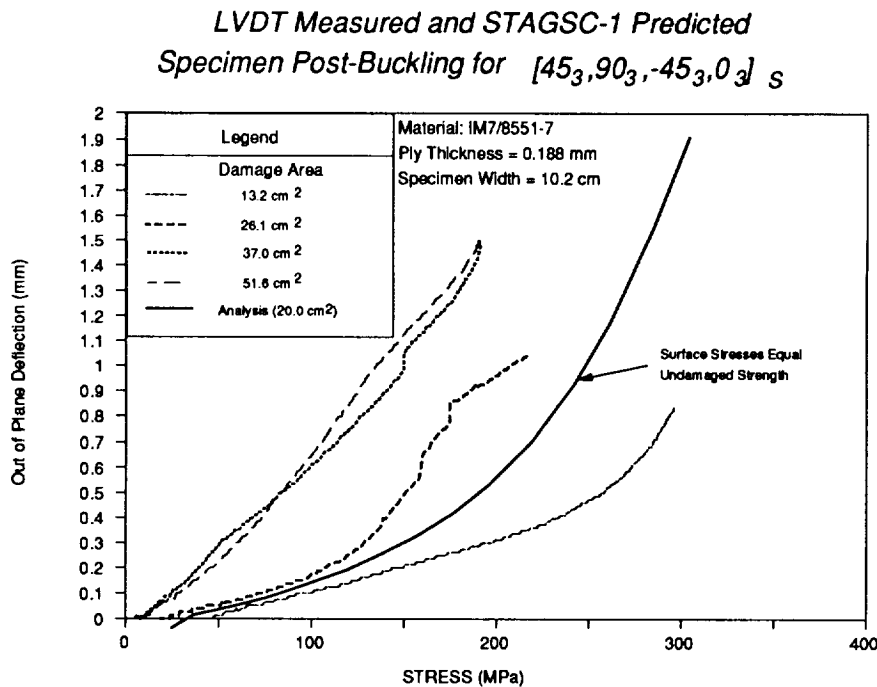
## LVDT Measured and STAGSC-1 Predicted Specimen Post-Buckling for $(45_3, 90_3, -45_3, 0_3)_S$

A STAGSC-1 [7] geometrically nonlinear finite element (FE) analysis was performed on a discrete sublaminates model using damage details described above to better understand the observed behavior. The FE results are plotted together with experimental measurements of out-of-plane displacement versus load. The analysis demonstrated that specimen stability was affected by sublaminates stability. Outward buckling in the +Z direction of the sublaminates forced overall coupon instability in this direction. The change in specimen stability resulting from sublaminates buckling exhibits trends similar to those observed in postbuckling analysis with increasing applied imperfections.

Out-of-plane specimen displacements were measured with a linear variable displacement transducer (LVDT). It can be seen that the amount of "imperfection" imparted to the specimen increases with damage size. The predicted displacements for 20.0 cm<sup>2</sup> damage area fall between experimental data curves for 13.2 and 26.1 cm<sup>2</sup> damage areas in the figure below. Note that the out-of-plane displacement corresponding to a surface stress of 478 MPa (undamaged compressive strength) in the model was 0.95 mm. This also compares well with the experimental data for 13.2 and 26.1 cm<sup>2</sup>.

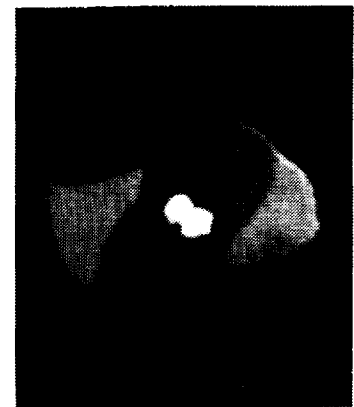
Pulse-Echo C-Scan  
Impact Energy = 40.7 Joules

The large delaminations visible in the ultrasonic c-scan occur in the back half of the  $[45_3, 90_3, -45_3, 0_3]_S$  laminate, effectively breaking it into two sublaminates. The sublaminates located toward the back side has octants containing 0, 3, 6 and 9 plies while the thicker, base sublaminates has octants containing 24, 21, 19, and 15 plies, respectively.

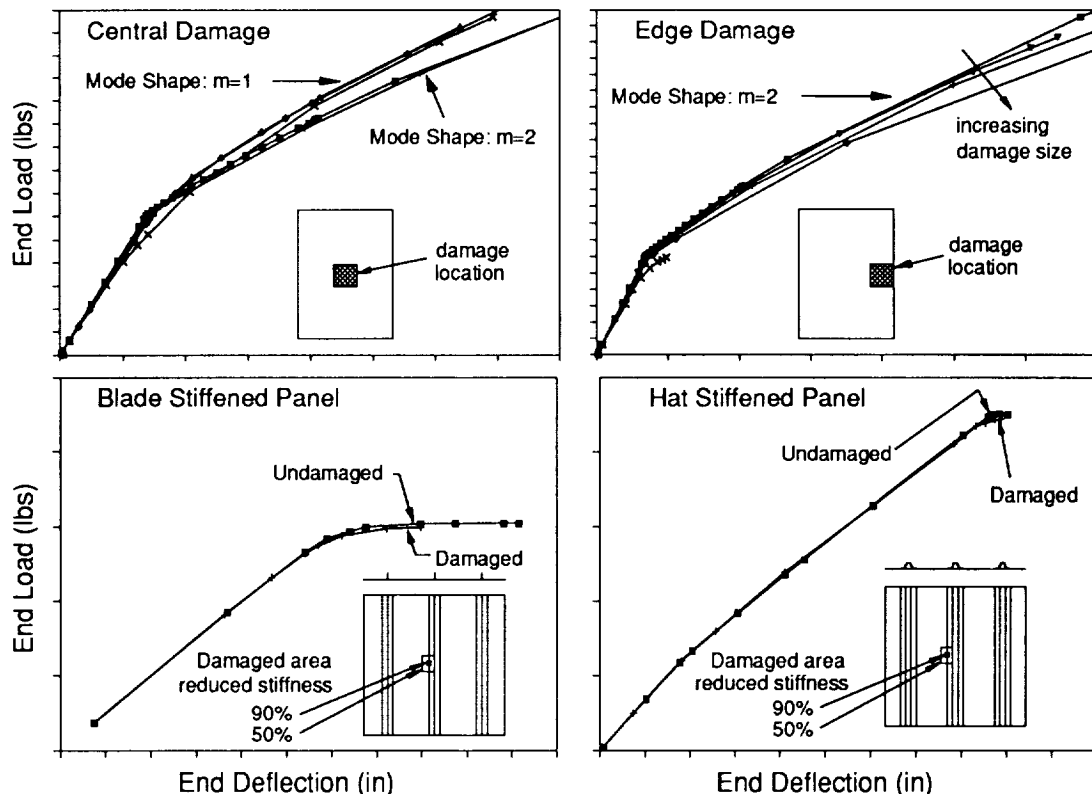
## Effect of Damage on Stiffness and Stability

The previous chart demonstrated that impact damage can significantly alter panel stability. Analytical studies on the effect of hypothetical damage on coupon stability were performed to examine this. Two types of simulated damage were used in these studies, both having an axial stiffness reduction of 50%. The symmetric damage was simulated with a 50% reduction in axial moduli, while unsymmetric damage was simulated with 1/2 the laminate stacking sequence and an offset. Analyses were run with damage simulations in the middle and on the edge of 24" by 12" rectangular plates. Damage size was varied from 2" x 2" to 5" x 5".

Center damage was found to lower initial buckling load for small damage sizes. As damage size increased the postbuckling mode shape changed from two halfwaves to a single halfwave. A stiffer postbuckling response was associated with this switch in mode shape. Plates with unsymmetric damage had a lower postbuckling stiffness than those with symmetric damage. Both symmetric and unsymmetric simulated damage on the edge of a plate were found not to change postbuckling mode shape. Postbuckling stiffness was found to decrease with increasing damage size. The difference in postbuckling stiffness between symmetric and unsymmetric damage tended to increase with increasing damage size, with unsymmetric damage having a lower stiffness.

The effect of hypothetical damage on stiffened panel stability was examined using analytical studies similar to those described previously. The simulated damage used in these studies was symmetric and had an axial stiffness reduction of 90% in a 1"x1" core region surrounded by 4"x2" 50% reduced stiffness zone. Analyses were run with the damage simulation at the edge of the stiffener attaching flange for both hat and blade stiffened panels. There was negligible change in postbuckling response of these panels for the described damage. Note: This was not necessarily the worst case scenario, but a demonstration of the concept. Other damage states and locations may have more effect on panel response.

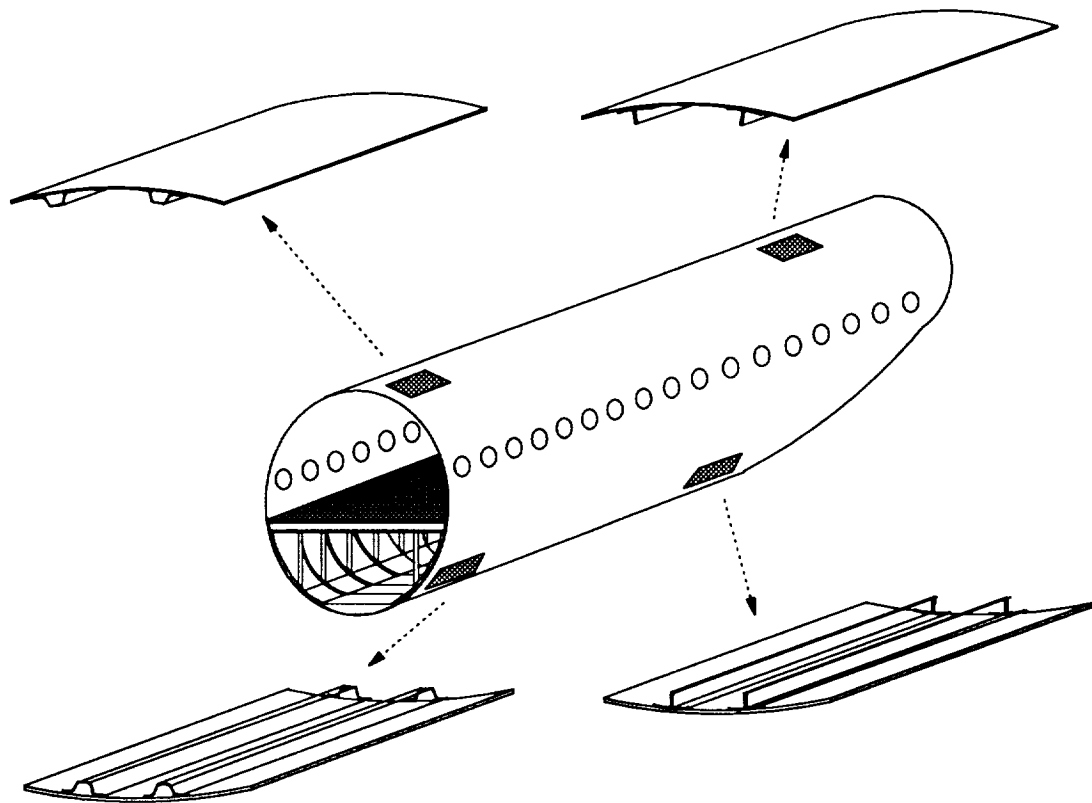
### *Fuselage Locations Represented by Test Panels*

The panel configurations and materials chosen for the impact damage resistance designed experiment are representative of a variety of locations around the fuselage. The fuselage crown is tension dominated structure and hence a stiffener spacing of 12.0 inches and thin skin gages can be used. The fuselage keel on the other hand is compression dominated and requires a closer stiffener spacing and thicker gages. Matrix material toughness may be required for the keel when considering high levels of impact energy resulting impact from runway debris. The crown, however has hail impact as a design criteria and may not require costly toughened materials to resist damage. The panels built for this experiment have combinations of the variables listed above covering a range of locations on the fuselage.

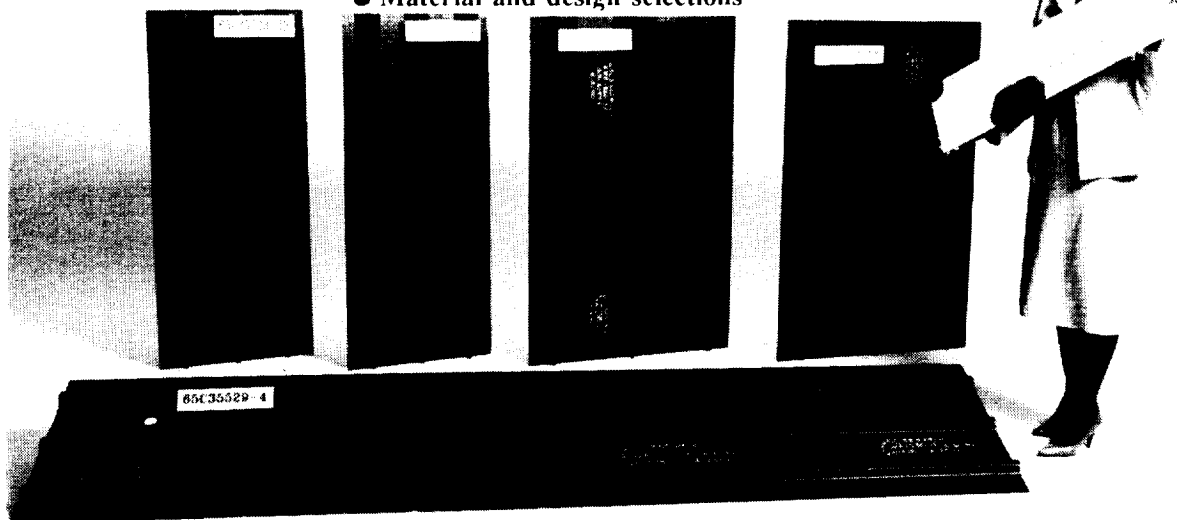
## *Integrated Approach to Manufacturing Demonstration and Structural Performance*

Design, manufacturing, and material selection for low-cost composite fuselage are made by the Boeing ATCAS Design Build Team. The selection criteria is based on a potential for low cost and weight in the fully assembled structure. The panels fabricated for ATCAS serve multi-functions devised to develop and validate composite manufacturing and structures technologies. Manufacturing trials and test articles for performance evaluation are coupled. This results in an efficient use of contract funds and allows test evaluation of process anomalies characteristic of panels fabricated with design details. To date, panel fabrication in ATCAS has evaluated (1) drape forming and tooling concepts for a low cost stiffener fabrication process, (2) advanced fiber placement for skin panels that include ply drop-offs characteristic of fuselage design, (3) process modifications for eight material types identified as candidates for fuselage structures. The 110 in. stiffened panels fabricated will be machined into specimens and test elements for assembly trials, impact damage resistance evaluation, damage tolerance tests, and stiffness/stability measurements.

Representative panels fabricated  
to support

- Low cost process development
- Tests of fuselage performance issues
- Material and design selections

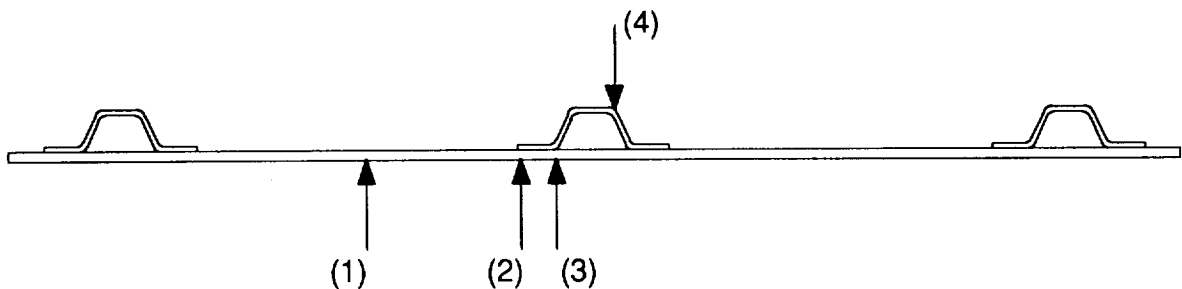
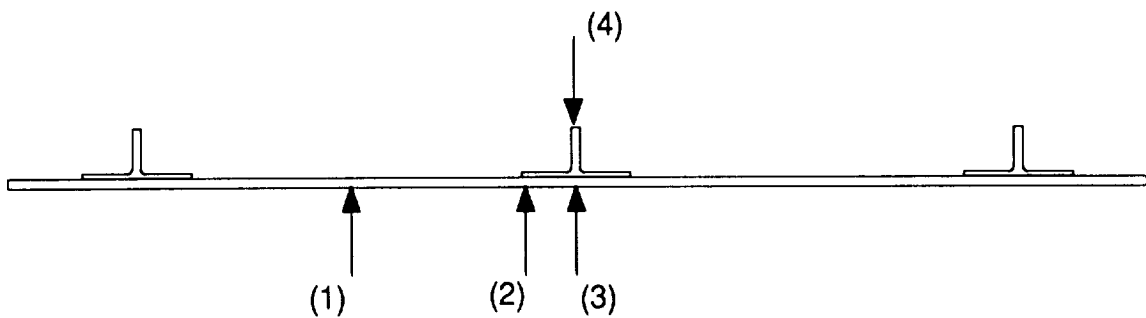
### CRITICAL IMPACT LOCATIONS

All 32 impact damage resistance panels will be impacted at the structural locations shown below. These are thought to represent those most critical for stiffened panels of this sort. All impacts will be instrumented to determine force/time relations. Each impact site will be nondestructively inspected to determine the maximum extent of damage created. Final impact locations will be based on extent and location of previous impact damage sites.

(1) Skin Midbay

(2) Edge of Stiffener Attachment Flange

(3) Base of Stiffener Web

(4) Top of Stiffener

The impact damage states will be characterized both in terms of lateral extent and through-the-thickness distribution of matrix and fiber damage. The impact sites will be inspected using time-of-flight pulse-echo ultrasonics to map out delamination depth and extent. Resin burnoff will be used to map out fiber failures which exist. Coupons will be machined and compressively tested to failure. The variables will then be ranked versus the different failure modes and residual strength to determine which variables and variable interactions are most significant to each failure mode.

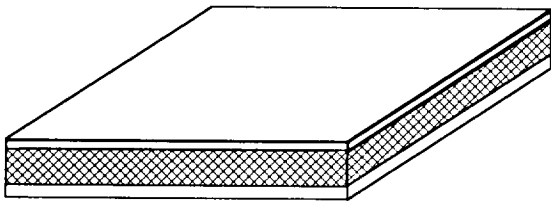
Constant Gauge

Core Type: Foam vs. Honeycomb

Core Density: 6 - 18 lbs/ft<sup>3</sup>

Core Thickness: 0.25 - 0.75 inches

Face Sheet Thickness: 0.1 - 0.3 in.

Impact damage resistance/residual strength of sandwich panels will be investigated experimentally to define impact damage related structural requirements for aircraft fuselage. Past investigations of low velocity impact on sandwich structure have been performed on panels with thin gauge face sheets and low density cores to support secondary structure applications. These typically have studied skin gauges less than 0.05 inch and core densities between 3 and 6 lb/ft<sup>3</sup> [9,10]. Impact damage resistance/residual strength studies will be performed on laminates with facesheets ranging from 0.15 to 0.3 inches and core densities from 6 to 18 lb/ft<sup>3</sup>.

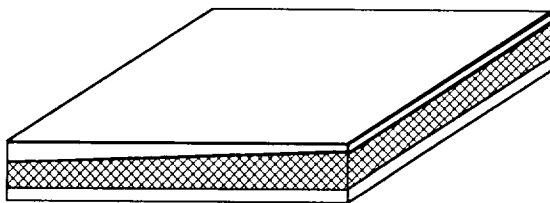
Tapered

Laminate Layup: Hard vs. Soft

The response of tapered structure to impact damage will be studied. The 10.0 inch long tapered region of the stiffened panel designed experiment will be fabricated into sandwich panels with a 3/4 inch core, representative of the aircraft keel. Facesheet delamination/transverse cracking, fiber damage, and core shear/crushing failures will be the measured responses.
