# ENVIRONMENTAL EFFECTS ON LUNAR ASTRONOMICAL OBSERVATORIES

Stewart W. Johnson<sup>1</sup>, G. Jeffrey Taylor<sup>2</sup>, and John P. Wetzel<sup>1</sup>

*The Moon offers a stable platform with excellent seeing conditions for astronomical observations. Some troublesome aspects of the lunar environment will need to be overcome to realize the full potential of the Moon as an observatory site. Mitigation of negative effects of vacuum, thermal radiation, dust, and micrometeorite impact is feasible with careful engineering and operational planning. Shields against impact, dust, and solar radiation need to be developed. Means of restoring degraded surfaces are probably essential for optical and thermal control surfaces deployed in long-lifetime lunar facilities. Precursor missions should be planned to validate and enhance the understanding of the lunar environment (e.g., dust behavior without and with human presence) and to determine environmental effects on surfaces and components. Precursor missions should generate data useful in establishing keepout zones around observatory facilities where rocket launches and landings, mining, and vehicular traffic could be detrimental to observato

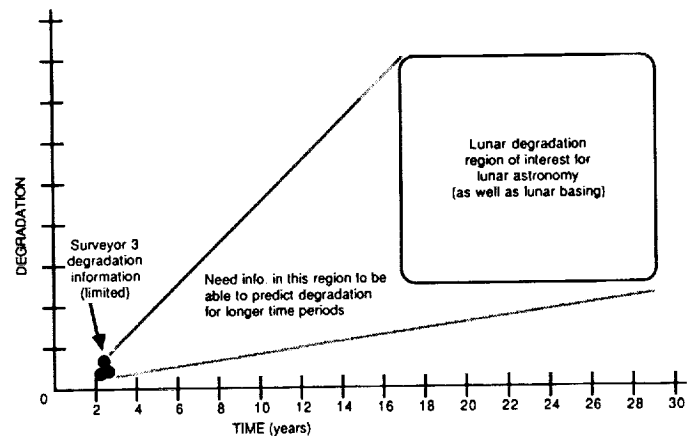
Fig. 2. Schematic representation of the information needed to investigate degradation on the lunar surface over a long period of time.

The goals of the visit and study will be to improve the technology for design, fabrication, and test of future lunar astronomical observatories (*Johnson*, 1988), enhance our understanding of processes that occur on the Moon and of the rates at which they operate, and to check the validity of accepted design approaches. Figure 2 demonstrates a generic representation of our need to better understand lunar environmental degradation (*Johnson and Wetzel*, 1988). As shown in this figure, we possess a very limited amount of experience with lunar surface degradation. We must gather additional information about degradation and its effects

over a long period of time. For example, revisiting and studying the materials and equipment from the Apollo sites will allow us to acquire information about lunar degradation in the 30-year time range.
