Inelastic Deformation of Metal Matrix Composites: Plasticity and Damage Mechanisms — Part II

B.S. Majumdar and G.M. Newaz
Battelle
Columbus, Ohio

December 1992

**INELASTIC DEFORMATION OF METAL MATRIX COMPOSITES: PART II,
PLASTICITY AND DAMAGE AT HIGH TEMPERATURES**

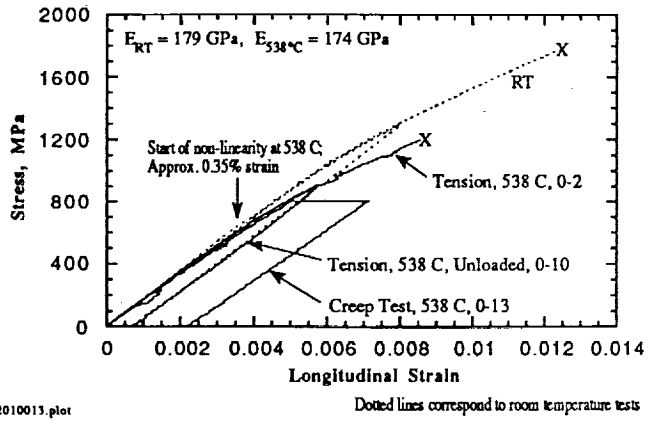
Figure 3a. Stress-strain behavior of 0° MMC specimens, tension tested at 538 C and room temperature. The results from a creep test are also included.

The elevated temperature deformation response differed from the RT response primarily in terms of the stresses and strains at which inelastic deformation initiated and fracture occurred. Whereas inelastic deformation at RT initiated at a "yield" strain of approximately 0.55%, it was approximately 0.35% at 538 C. Changes in the residual stress in the matrix cannot account for this temperature effect, since elevated temperatures would reduce, rather than increase, the residual *tensile* axial stress in the matrix. Rather, the lowering of the critical strain likely reflects the lowering of the flow stress of the matrix, which was approximately 800 MPa at RT, and which was only 400 MPa at 538 C (see Figure 8). The lowering of the *strain to failure* likely reflects the fact that fibers have less residual compression at 538 C compared with RT, so that the mechanical strain required to fracture the fibers would be less at 538 C compared with RT. These arguments are qualitative, and accurate predictions of the stress-strain response and the failure stress would require adequate incorporation of the inelastic deformation sequence into a constitutive model. Comparisons of mechanical data with theoretical predictions will be provided later.

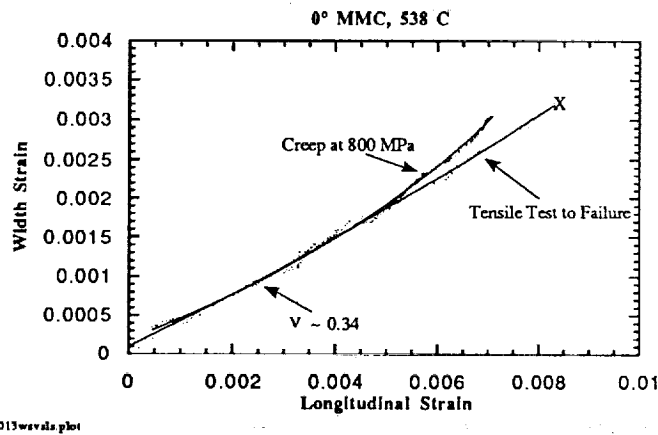
Figure 3b. Width strain plotted versus the longitudinal strain for 0° MMC specimens tested at 538 C. The data points are indicated by dots, and the solid lines correspond to best-fit polynomials.

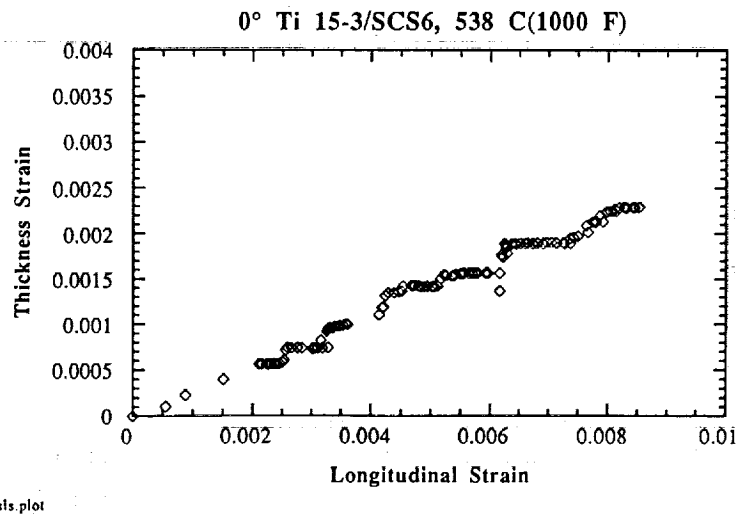
Figure 3c. Thickness strain plotted versus the longitudinal strain for a 0° MMC specimen, tension tested at 538 C (1000 F).

Figure 3c is a plot of the thickness strain versus the longitudinal strain for a specimen tested in monotonic tension at 538 C. This plot does not indicate any significant change in the thickness Poisson's ratio, which remained at approximately 0.28 throughout the experiment. The fact that the Poisson's ratio does *not decrease* again suggests that the deformation mechanism was not damage.

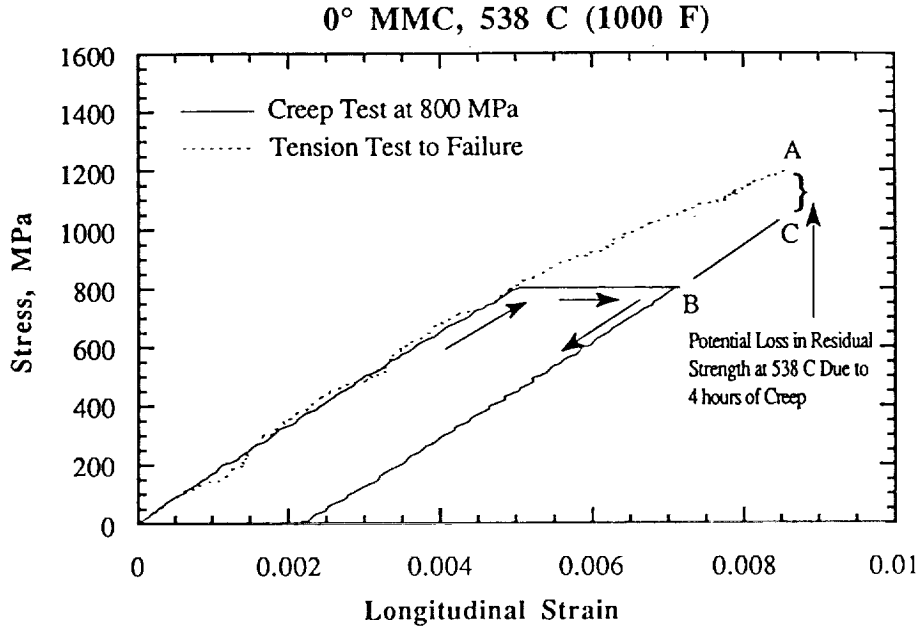
02013stvsis.plot

Figure 4a Stress versus longitudinal strain response from a short-term creep test; 0° MMC, 538 C (1000 F).

a simple tension test at 538 C at a strain rate of 10^{-4} /sec. The specimen was unloaded after approximately 210 minutes. Once again it may be observed that the unloading line was parallel to the loading line, indicating that inelasticity was likely by time-dependent plasticity. The dominance of matrix creep also is illustrated in Figure 3b, which shows that the Poisson's ratio increased in going from the elastic into the inelastic regime of deformation. It is notable that the MMC accumulated a strain of approximately 0.2 percent within the relatively short period of creep exposure.

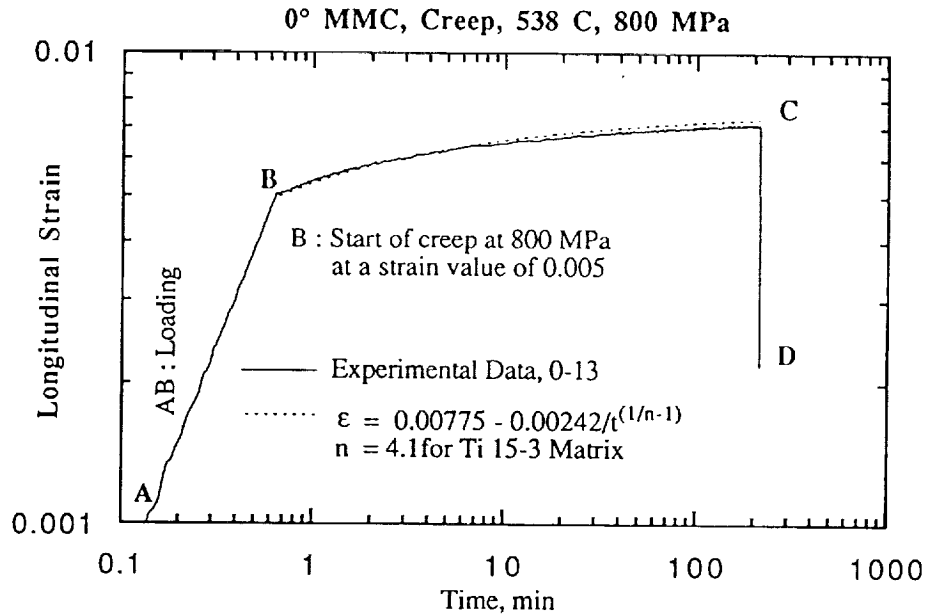
0131svstimepred.plot

Figure 4b. Strain versus time behavior for the [0°]₈ sample in Figure 4a.

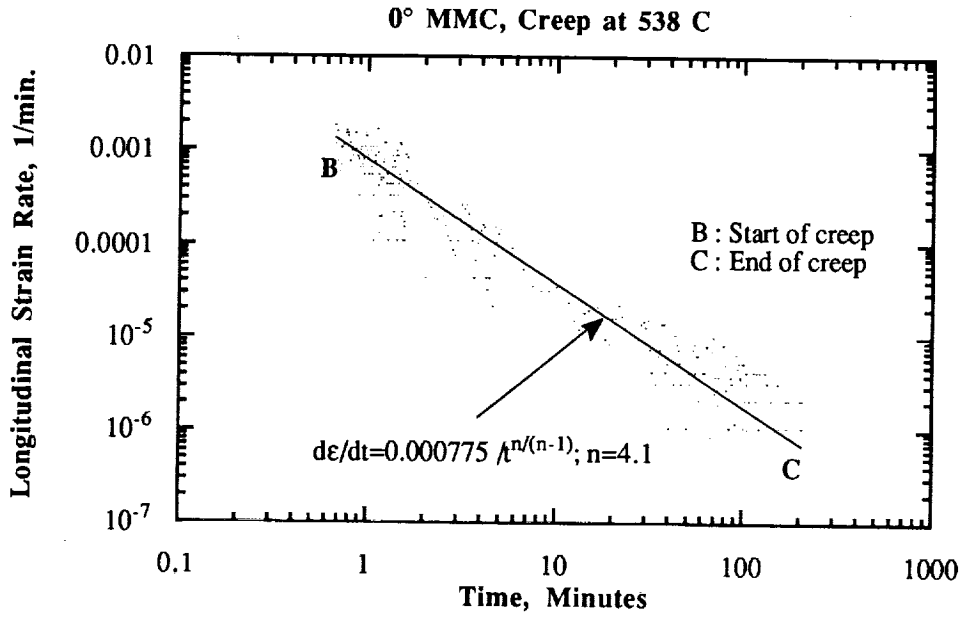
0131srtevstime.plot

Figure 5a. Strain-rate plotted versus time for the creep specimen in Figure 4a.

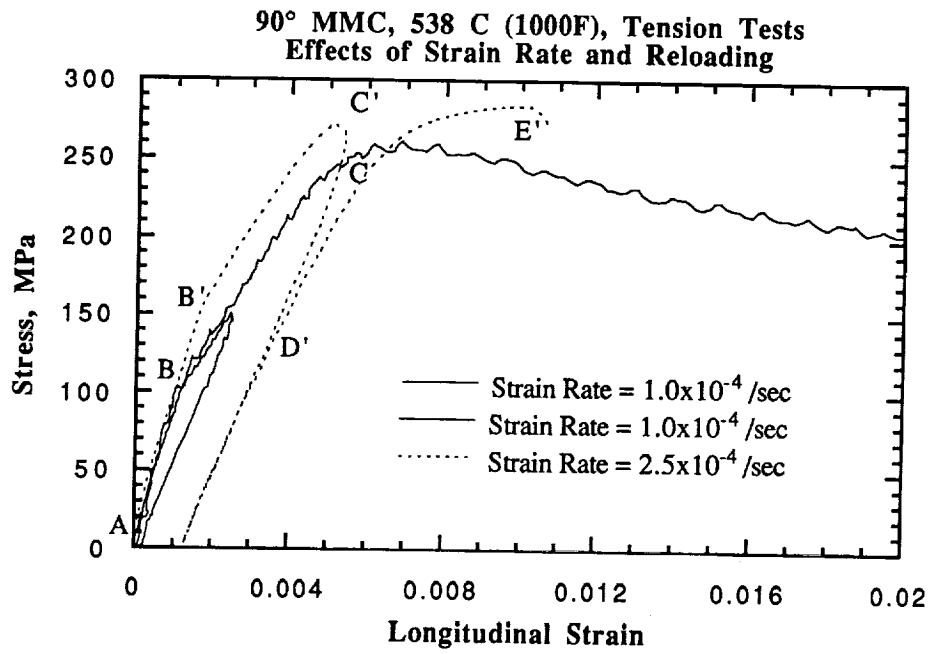
Figure 7. Effects of strain-rate on the stress-strain response of the $[90^\circ]_8$ system at 538 C (1000 F).

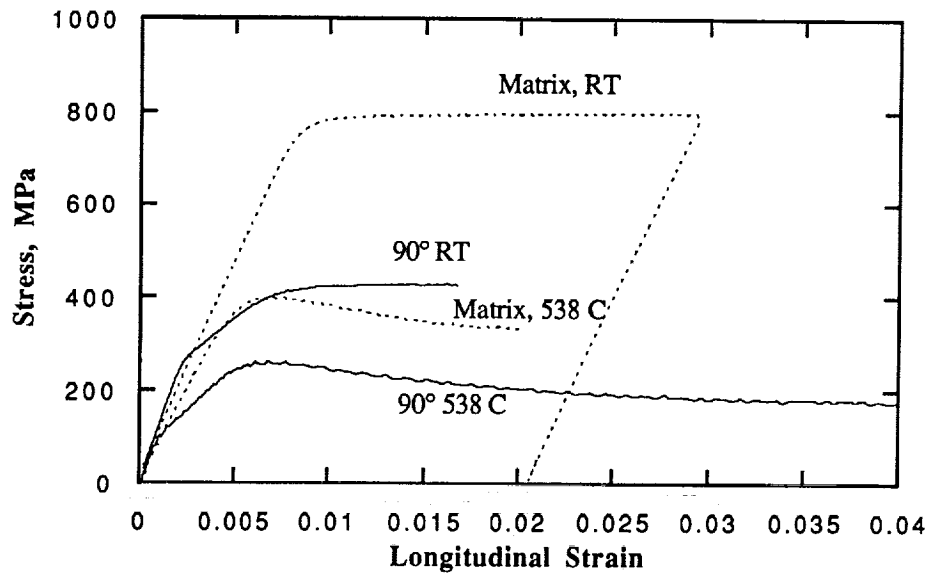
Figure 8. Comparisons of the stress-strain response of the $[90^\circ]_8$ MMC and the Ti 15-3 matrix at RT and 538 C.

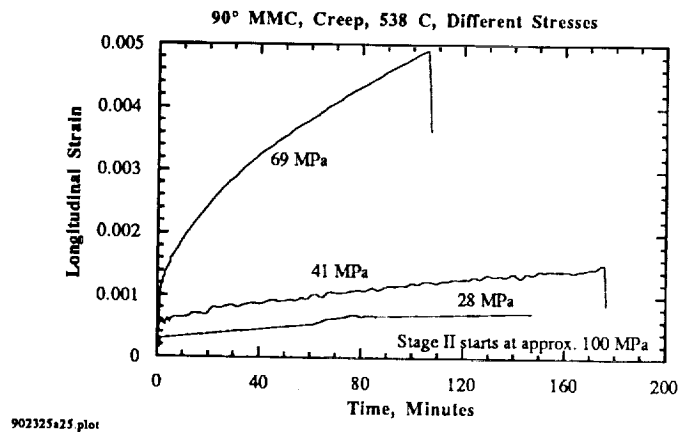
Figure 9a. Strain-versus-time behavior for three $[90^\circ]_8$ specimens, creep-tested at 538 C.

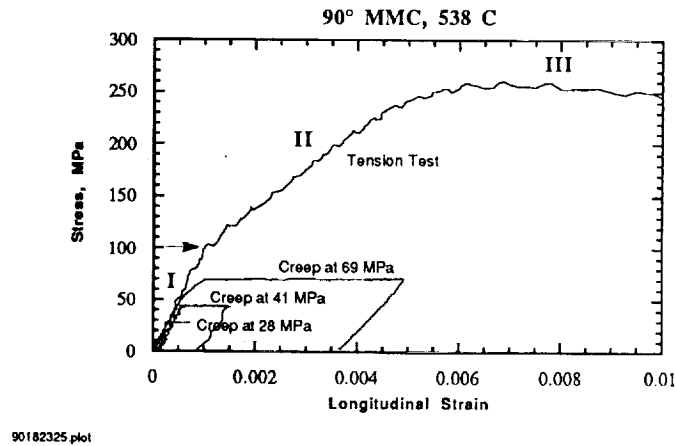
Figure 9b. Stress-strain behavior for three $[90^\circ]_8$ specimens, creep-tested at 538 C.

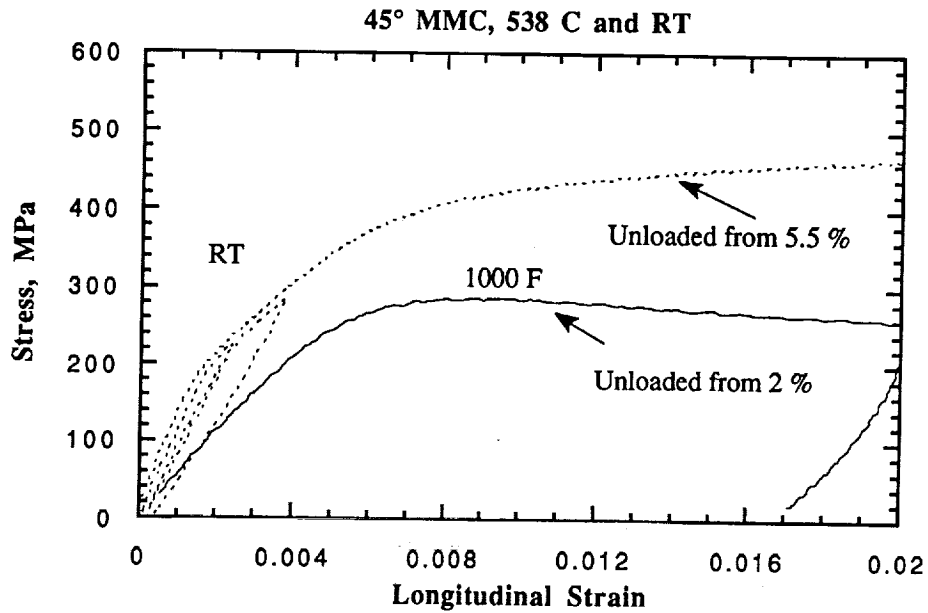
45456strsvsls.plot

Figure 10a. Stress-versus-longitudinal strain response for the $[\pm 45^\circ]_{2s}$ MMC at RT and 538 C.

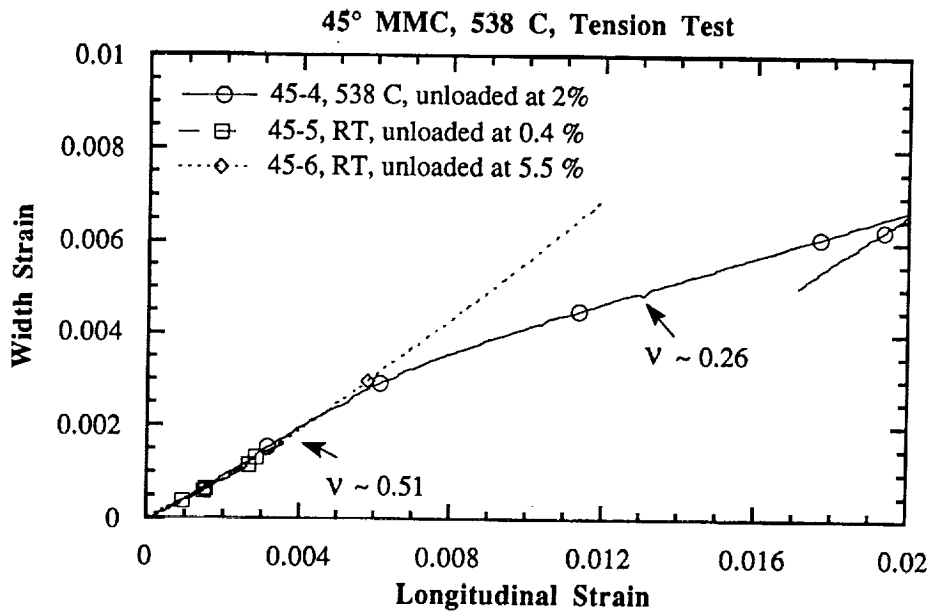
45456wsvsls.plot

Figure 10b. Width strain plotted versus the longitudinal strain for the $[\pm 45^\circ]_{2s}$ specimens.

Figure 10b illustrates the width strain versus longitudinal strain behavior for the $[\pm 45]_{2s}$ MMC. The Poisson's ratio was approximately 0.4 at strains less than 0.2 percent, then it increased to approximately 0.51. These values do appear to be quite high compared with elastic values around 0.30-0.35. At high strains, quite opposite behaviors were observed at RT and 538 C. At RT, the Poisson's ratio increased even further, whereas at 538 C it decreased to approximately 0.26. It is difficult to comment on these values pending adequate modeling of the $[\pm 45]_{2s}$ MMC.

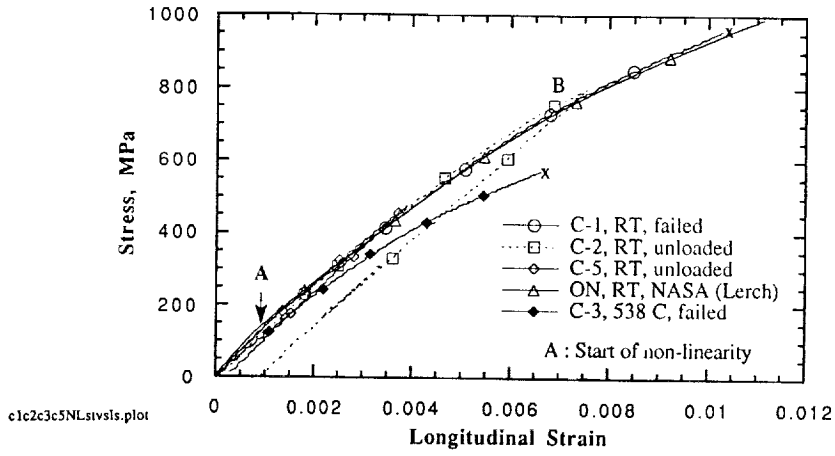
Figure 11a. Stress-versus-longitudinal strain response for the $[0/90^\circ]_{2s}$ MMC at RT and 538 C.

The stress-strain behaviors of the [0/90]_{2s} MMC at RT and 538 C are compared in Figure 11a. The points A and B in the figure signify the start of different regimes of deformation with different slopes, and the X's mark the failure of specimens. The slope of the unloading line (from a strain of approximately 0.6 percent) was less than the slope of the initial loading line, indicating the occurrence of damage beyond point A. We believe this was due to debonding type of damage for the 90-degree plies. However, it is interesting to note that the onset of inelastic deformation at RT occurred at a strain of approximately 0.1 percent, which was lower than the critical strain of approximately 0.2 percent for the [90]₈ system (see Figure 6a). We believe that this effect was likely due to less compressive residual stress in the 90-degree plies of the [0/90]_{2s} system compared with the unidirectional [90]₈ MMC.

At RT, the elastic modulus was approximately 141 GPa, and it decreased to approximately 111 GPa at 538 C. The failure strain also decreased from approximately 1 percent at RT to approximately 0.7 percent at 538 C. The decreases in the strain to failure were similar to the case of the [0]₈ specimens, where also decreases in strain to failure were of 0.3 to 0.4 percent were observed. The decrease in the failure strain with increasing temperatures are likely associated with lower residual axial compressive stresses in the 0-degree fibers at higher temperatures.

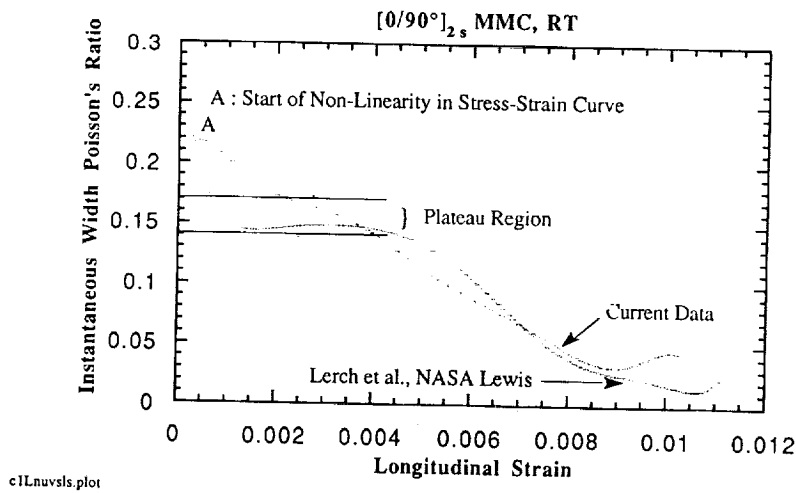
Figure 11c. Instantaneous width Poisson's ratio plotted versus the longitudinal strain for the $[0/90^\circ]_{2s}$ specimens tested at RT.

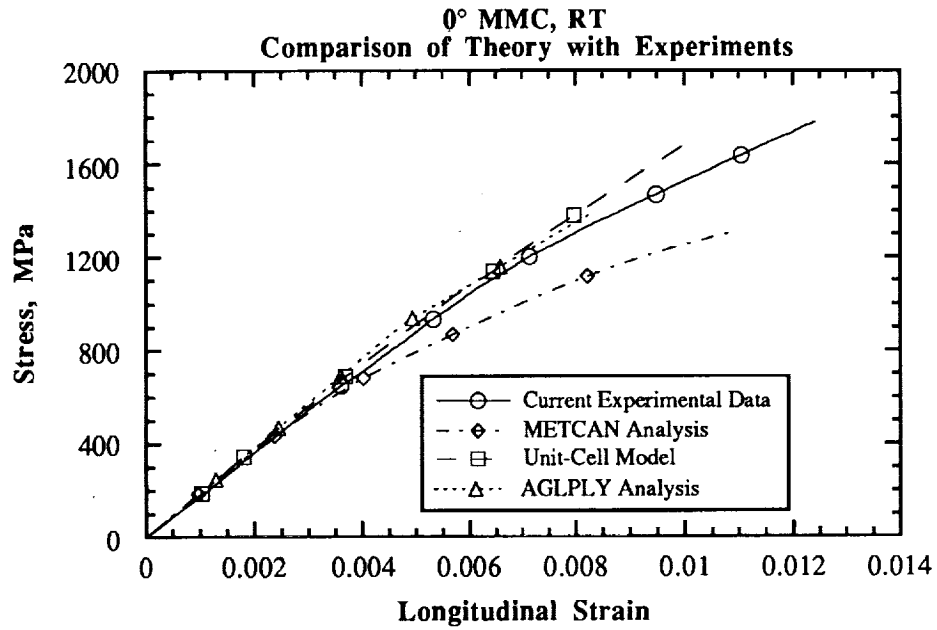
06FEMMETAGL.plot

Figure 17a. Comparison of model predictions with experimental data for the $[0^\circ]_8$ MMC at RT.

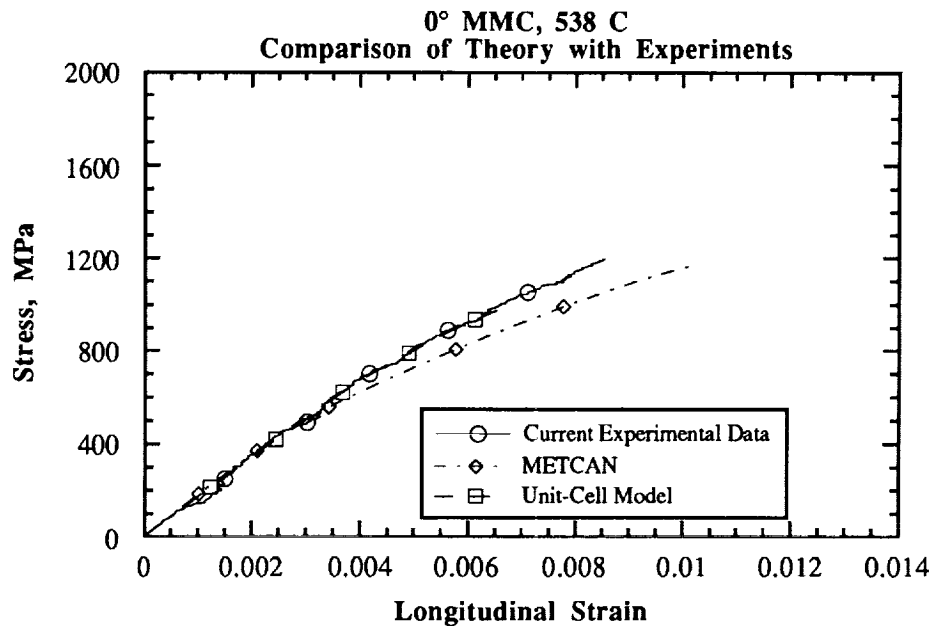
02FEMMET.plot

Figure 17b. Comparison of model predictions with experimental data for the $[0^\circ]_8$ MMC at 538 C.
