NASA Contractor Report 189595

Buffet Test in The National Transonic Facility

Cooperative Agreement NCC1-141
July 1992

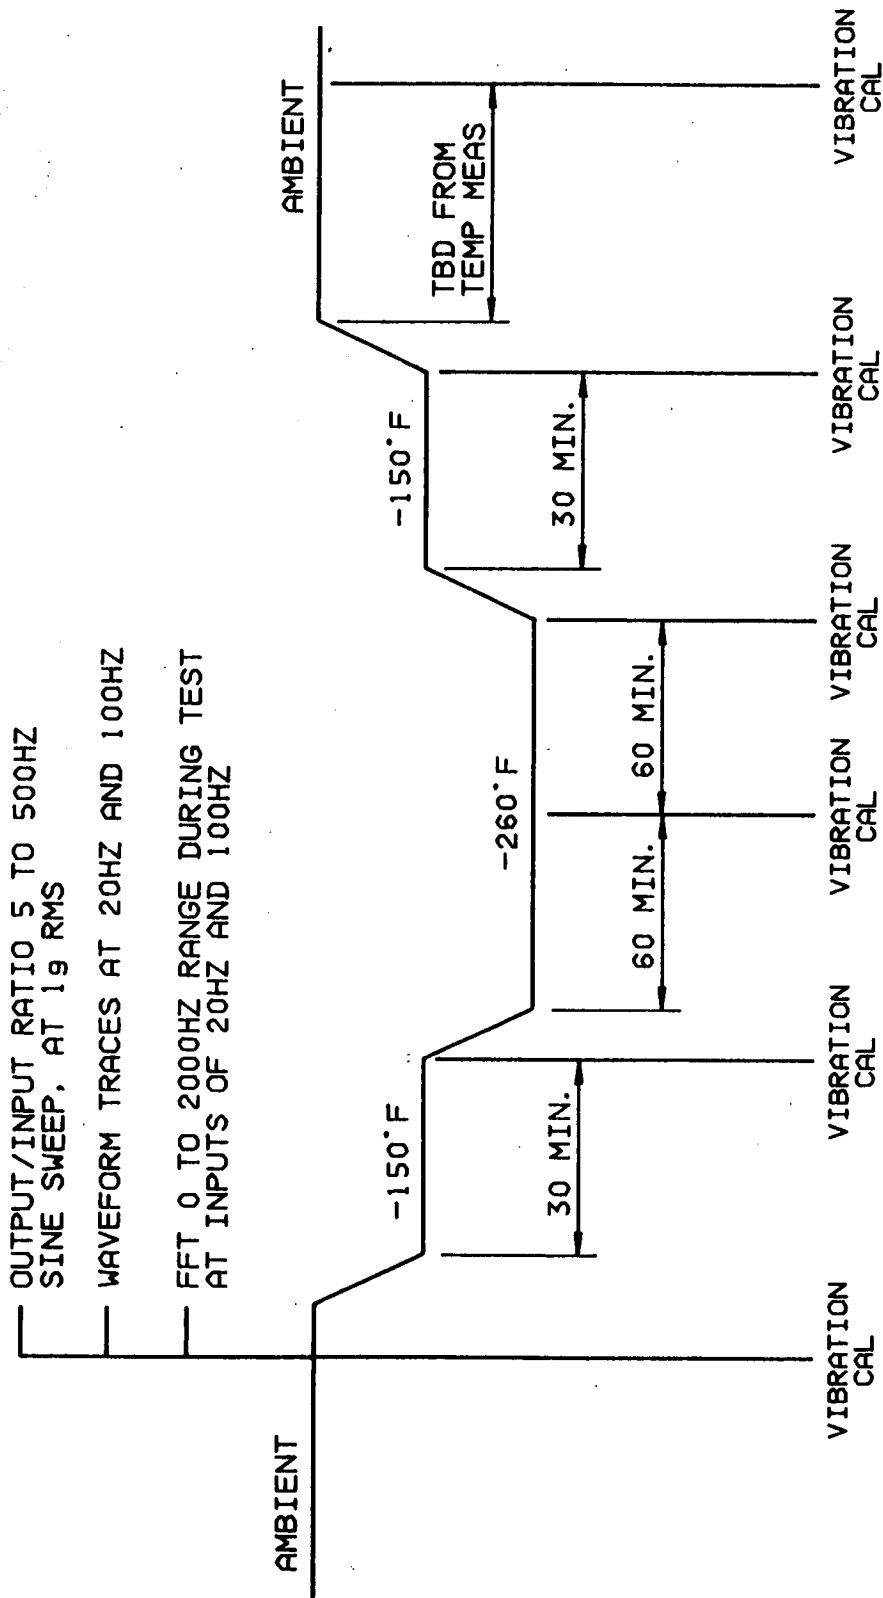
Figure A-1. VIBRATION CALIBRATION TEST SEQUENCE FOR PCB 309M15/309M42 ACCELEROMETERS

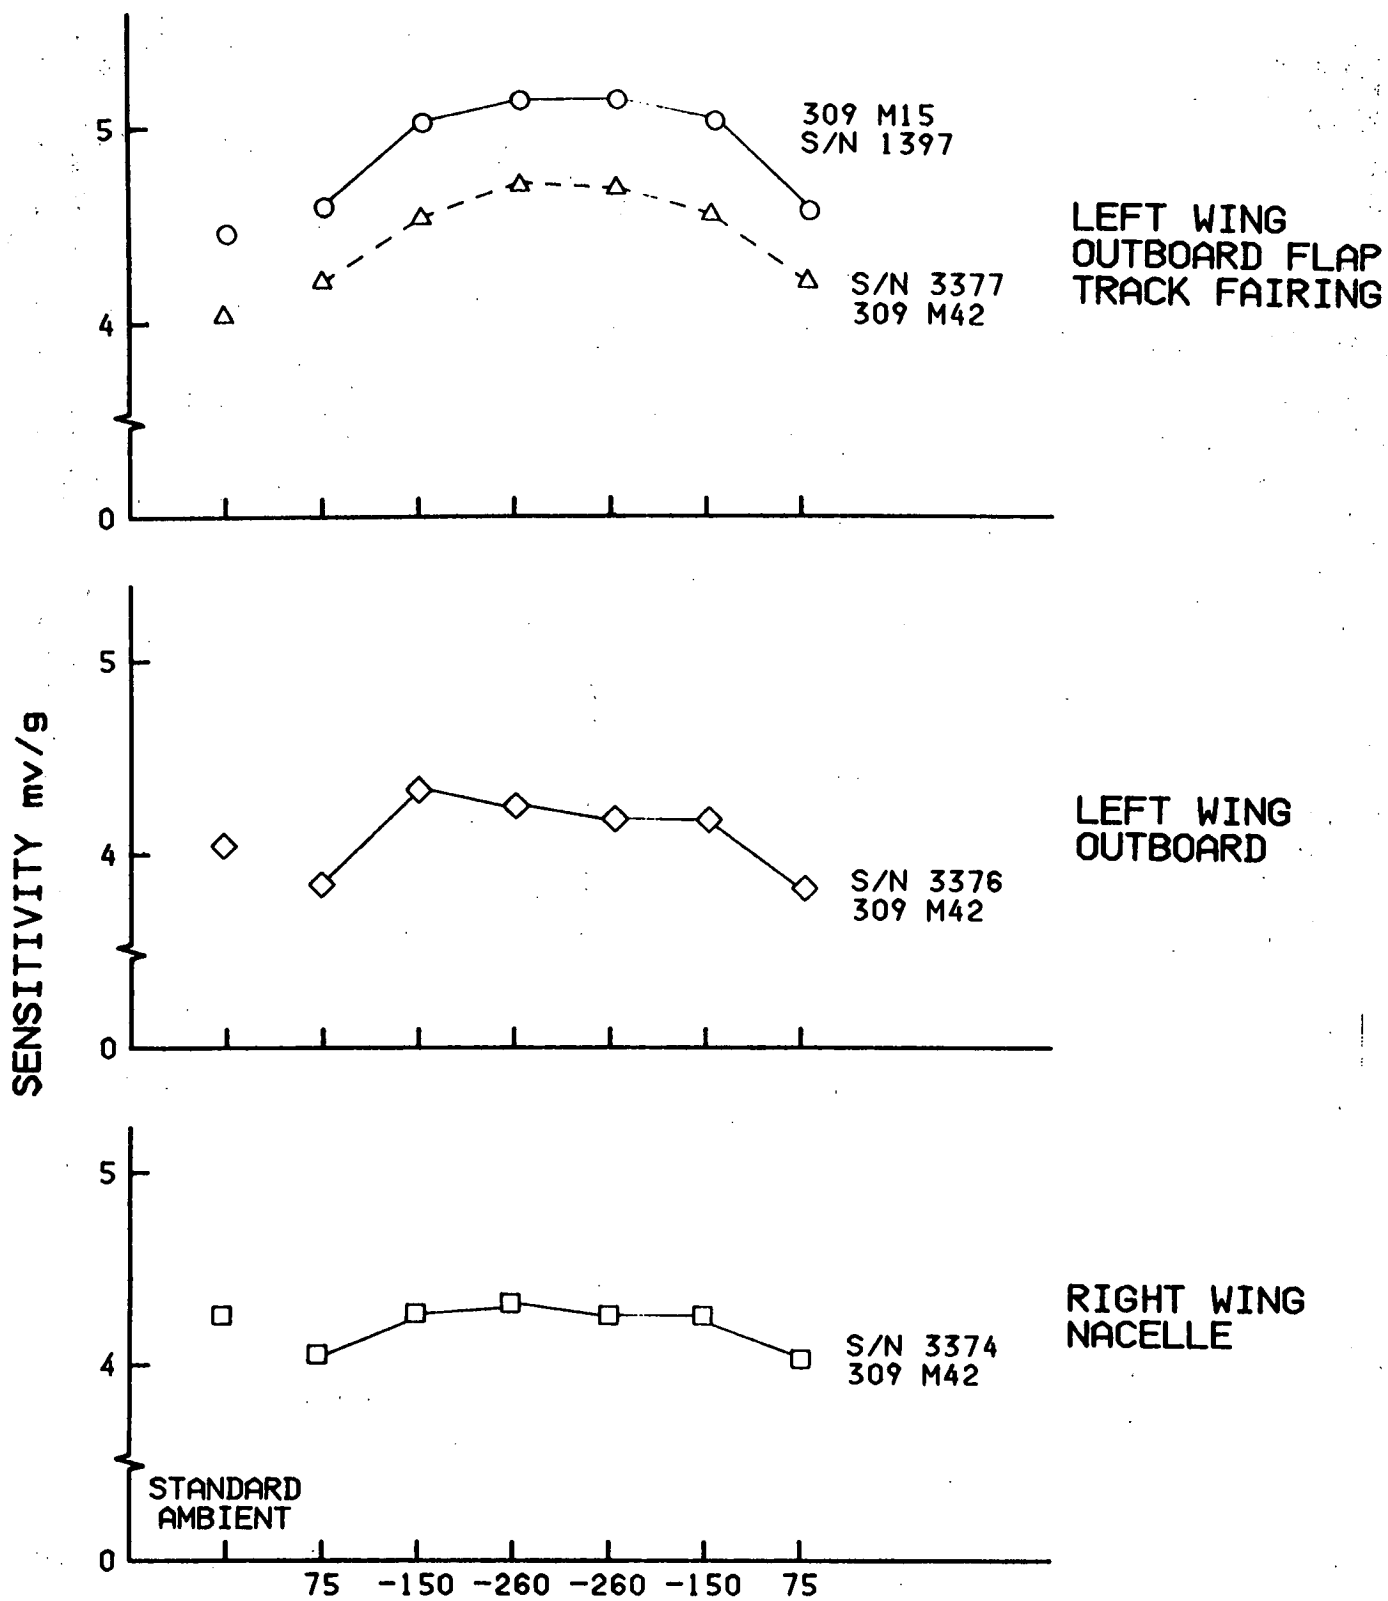
Figure A-2. **ACCELEROMETER SENSITIVITIES AT CRYO TEMPERATURES.**
PCB MODELS 309 M15 & 309 M42

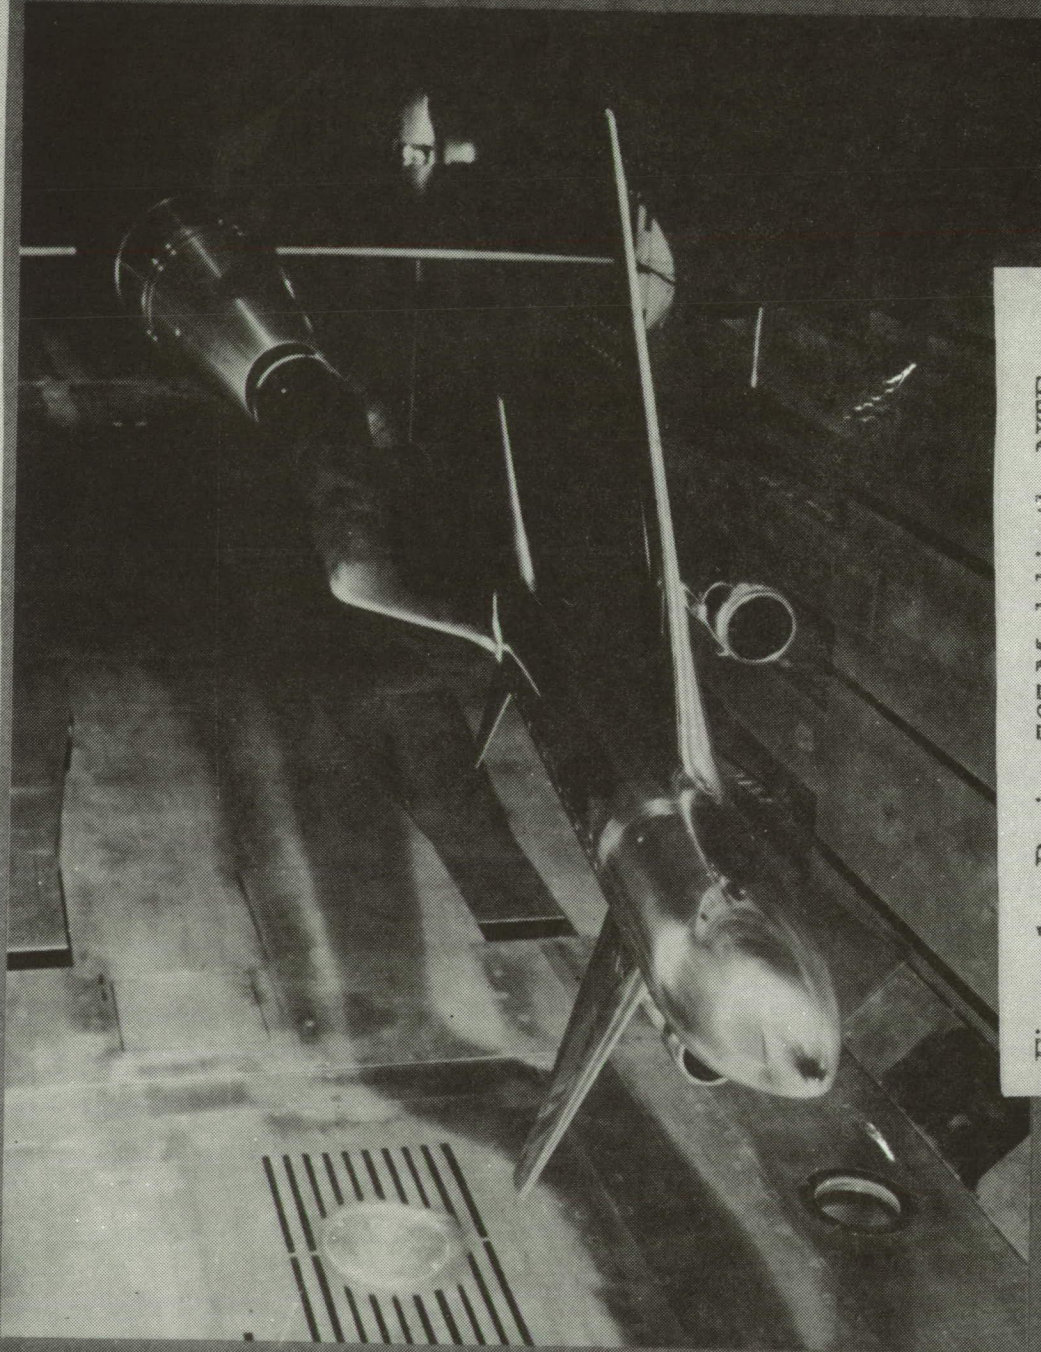
Figure 1. - Boeing 767 Model in the NTF

The Boeing 767 model installed in the NTF is shown in figure 1. The model is supported by a swept strut sting and uses an NTF 101B force balance. The model and support structure is constructed of 18 nickel Maraging Steel Grade 200. This material is used extensively for NTF models because of its high strength and acceptable fatigue and fracture properties when exposed to a cryogenic environment. Typical properties at -250°F include an ultimate strength of 252 kips/in². Young's modulus of 30 million lbs/in² and a fracture toughness K_{1c} of 85 ksi-in^{1/2}.

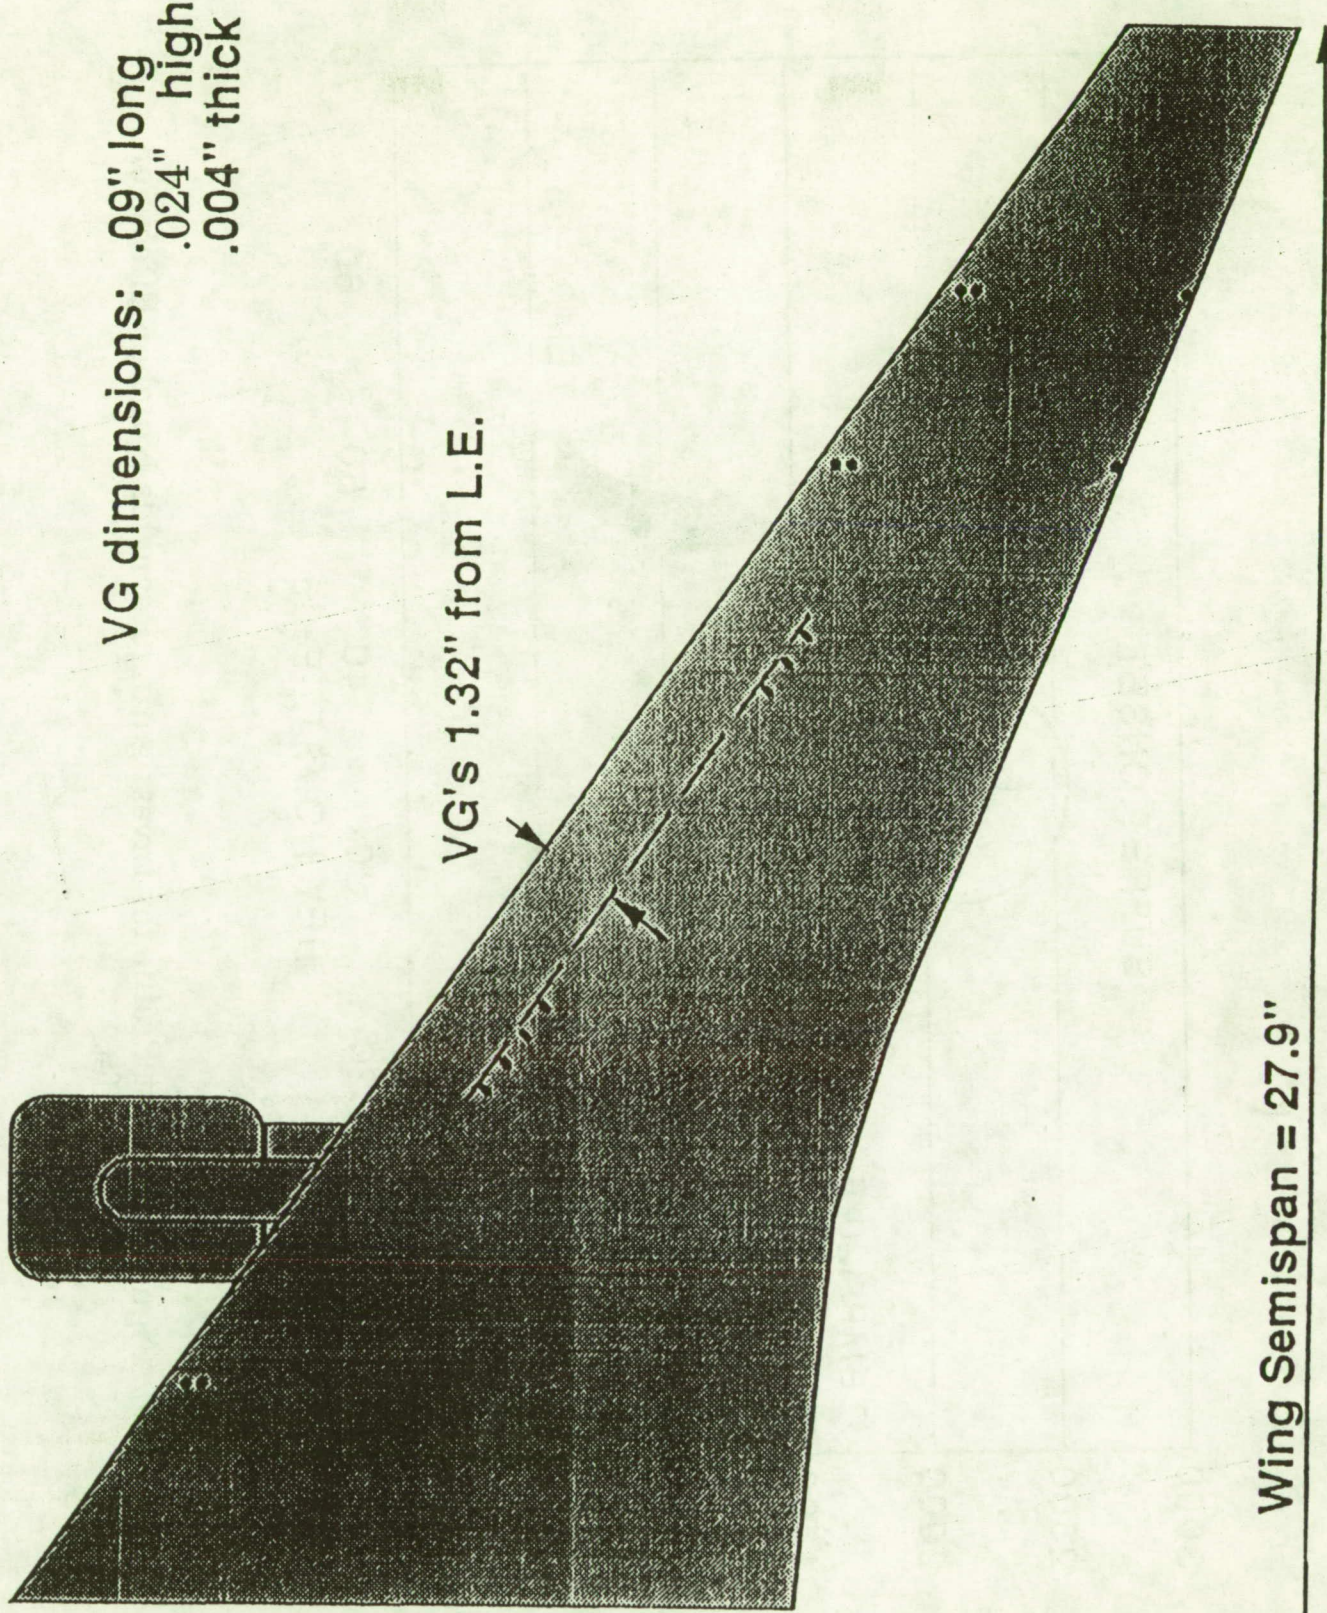
VG dimensions: .09" long
.024" high
.004" thick

VG's 1.32" from L.E.

Wing Semispan = 27.9"

Figure 2.- Vortex Generators Locations on Right Wing.

A planform view of the right wing is given in figure 2. In the figure, the locations of the vortex generators (VG's) on the wing are shown. The scaled VG's were bonded to the wings and are extremely small, i.e. .09 in. long, .024 in. high and .004 in. thick.

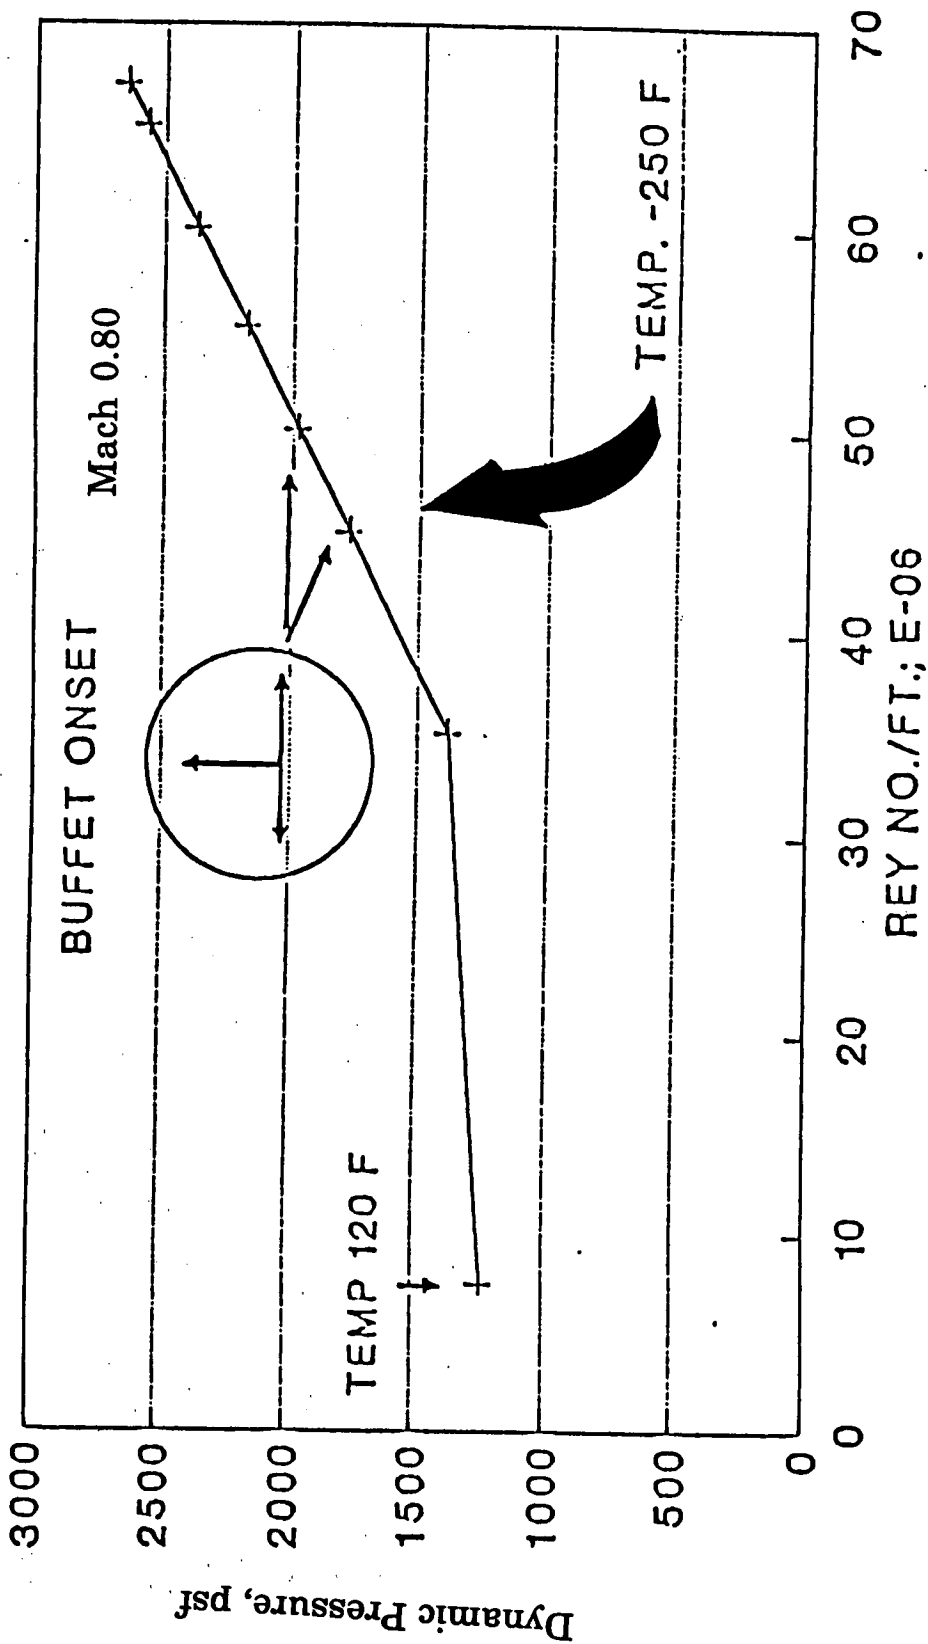
Figure 3. - Test Profile for Investigating Reynolds Number Effects on Buffet.

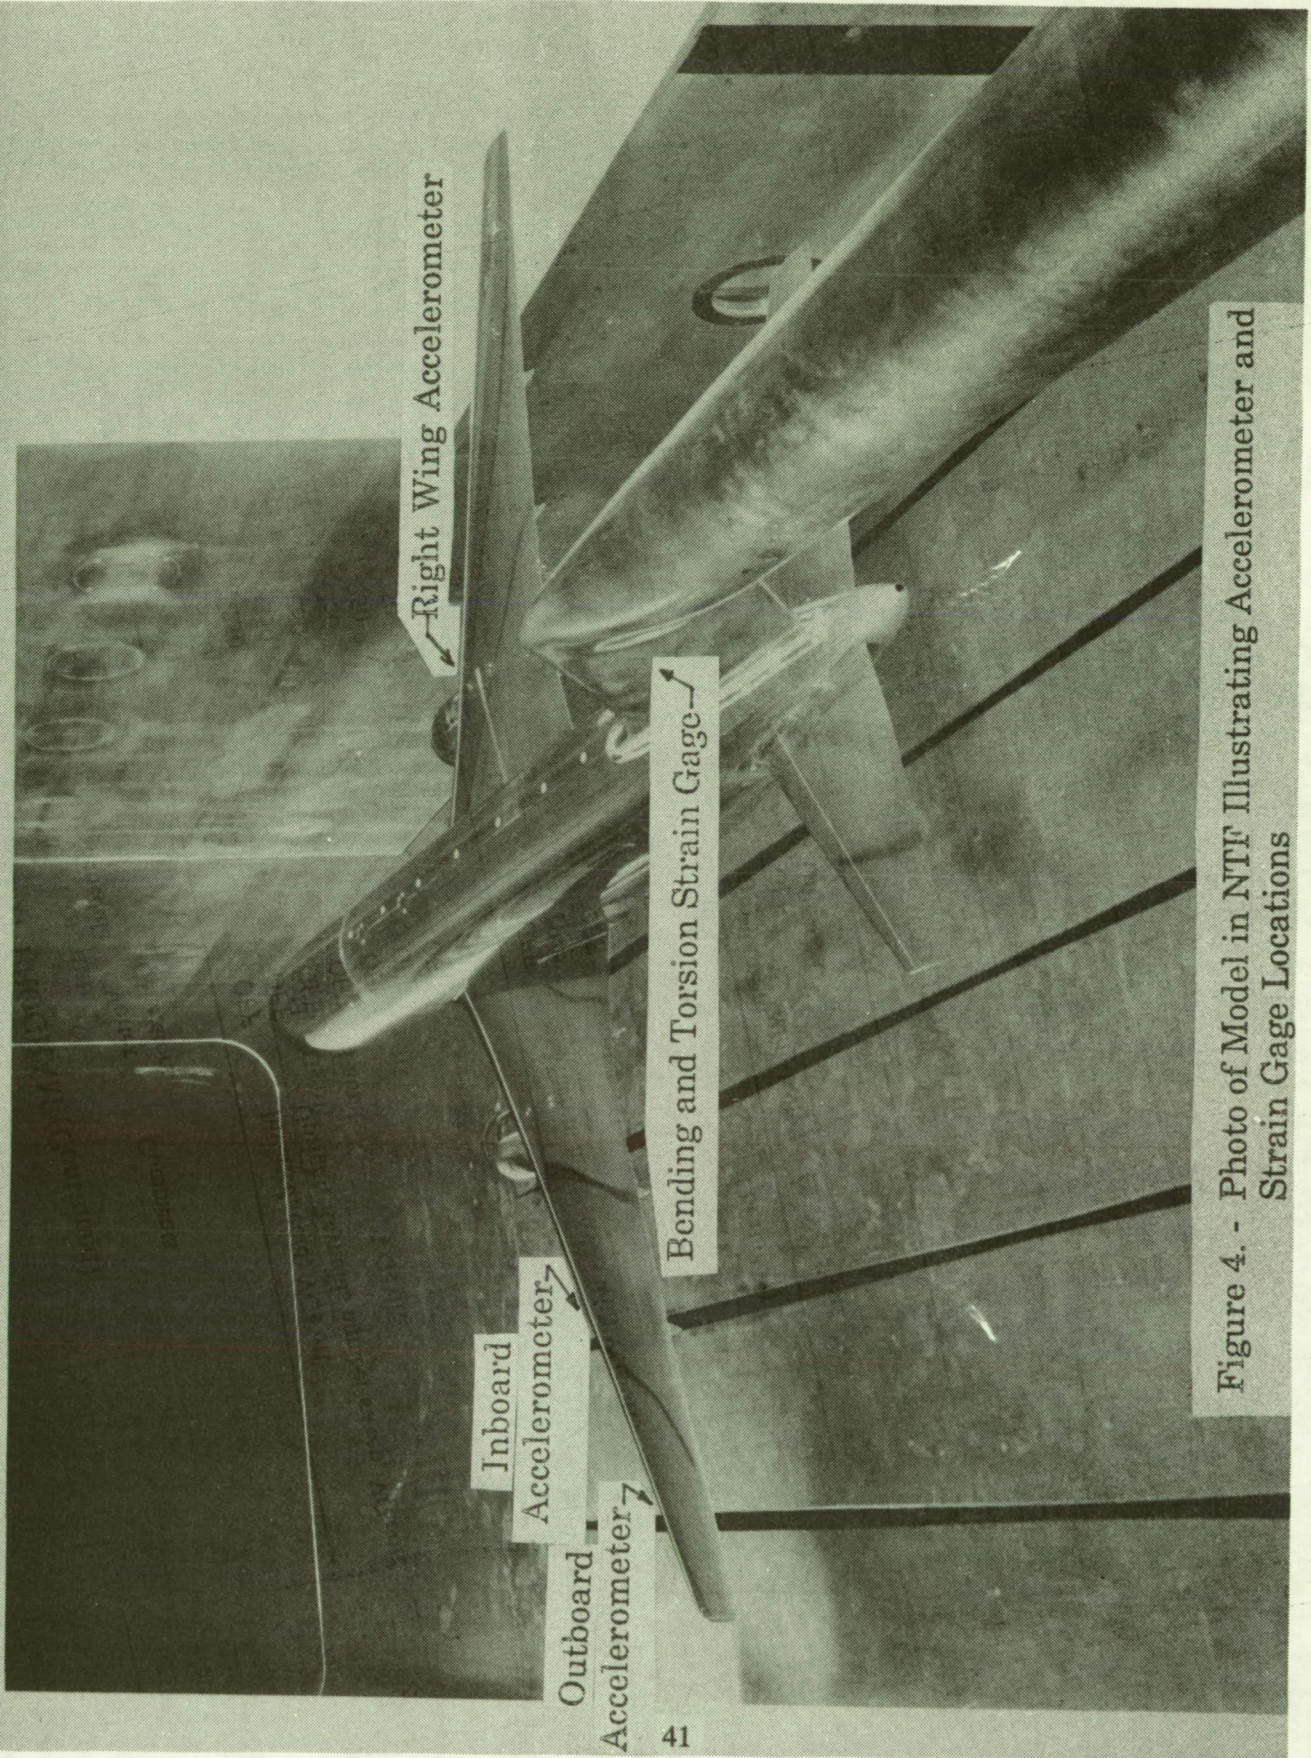
Figure 4. - Photo of Model in NTF Illustrating Accelerometer and Strain Gage Locations

The locations of the accelerometers are indicated in the photograph of figure 4. The most outboard accelerometer was located in the left wing about 5 inches from the tip. The other accelerometer placed in the left wing was located at the outboard flap track fairing approximately 10 inches from the wing tip. These two accelerometers were positioned to monitor the wing bending modes of principal interest as well as the model rigid body roll modes. The third accelerometer was located in the right wing at the intersection of the engine nacelle strut with the wing (18.5 inches inboard from the tip). This accelerometer was used to monitor the rigid body roll modes but was not used for wing elastic modes response due to its location at or near node points of the two wing modes of interest (see section on wind-off vibration tests). The two accelerometers in the left wing provided redundancy for monitoring the wing bending modes. Instrumentation redundancy is particularly important for testing in the NTF due to the likelihood that instrumentation will be lost in the harsh environment. Also, model access to troubleshoot or repair instrumentation requires tunnel warm-up which is very costly in time and resources.

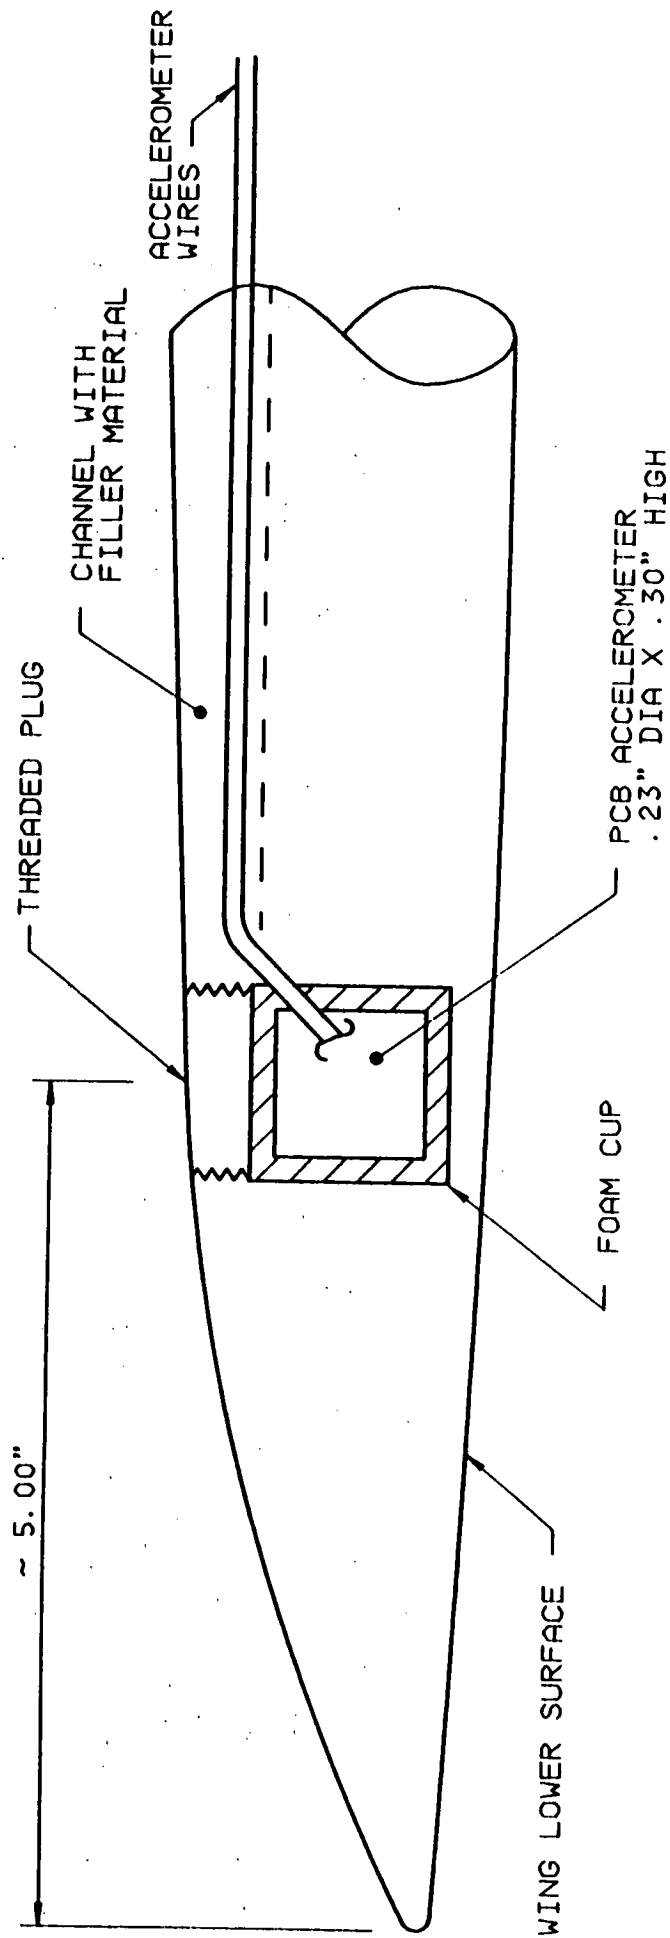
FIGURE 5. ILLUSTRATION OF PCB ACCELEROMETER INSTALLATION AT OUTBOARD LOCATION ON LEFT WING OF MODEL - VIEW LOOKING FORWARD - NOT TO SCALE

The accelerometers were installed in insulated foam cups (see figure 5 for typical installation), to prevent grounding problems. The accelerometer wires were routed in existing or special channels (grooves) machined into the wing. Planned installation of a pressure transducer near the trailing edge on the left wing could not be made due to lack of sufficient space in the channels for both accelerometers and the transducer wires. Problems were encountered with cracking in the channel filler material during the initial cryogenic cycling of the model in the NTF cryogenic test chamber. Subsequently, a filler material consisting of Hysol EA 9309 epoxy, mixed with 100 micron carbon spheres on a 1:1 ratio by volume, was used without problems (see ref. 1 for information on filler materials). During cryo cycling of the model system in the NTF model conditioning chamber, the accelerometers were functionally checked by vibrating the model at various times during the cooldown, cold soak, and warmup cycles.

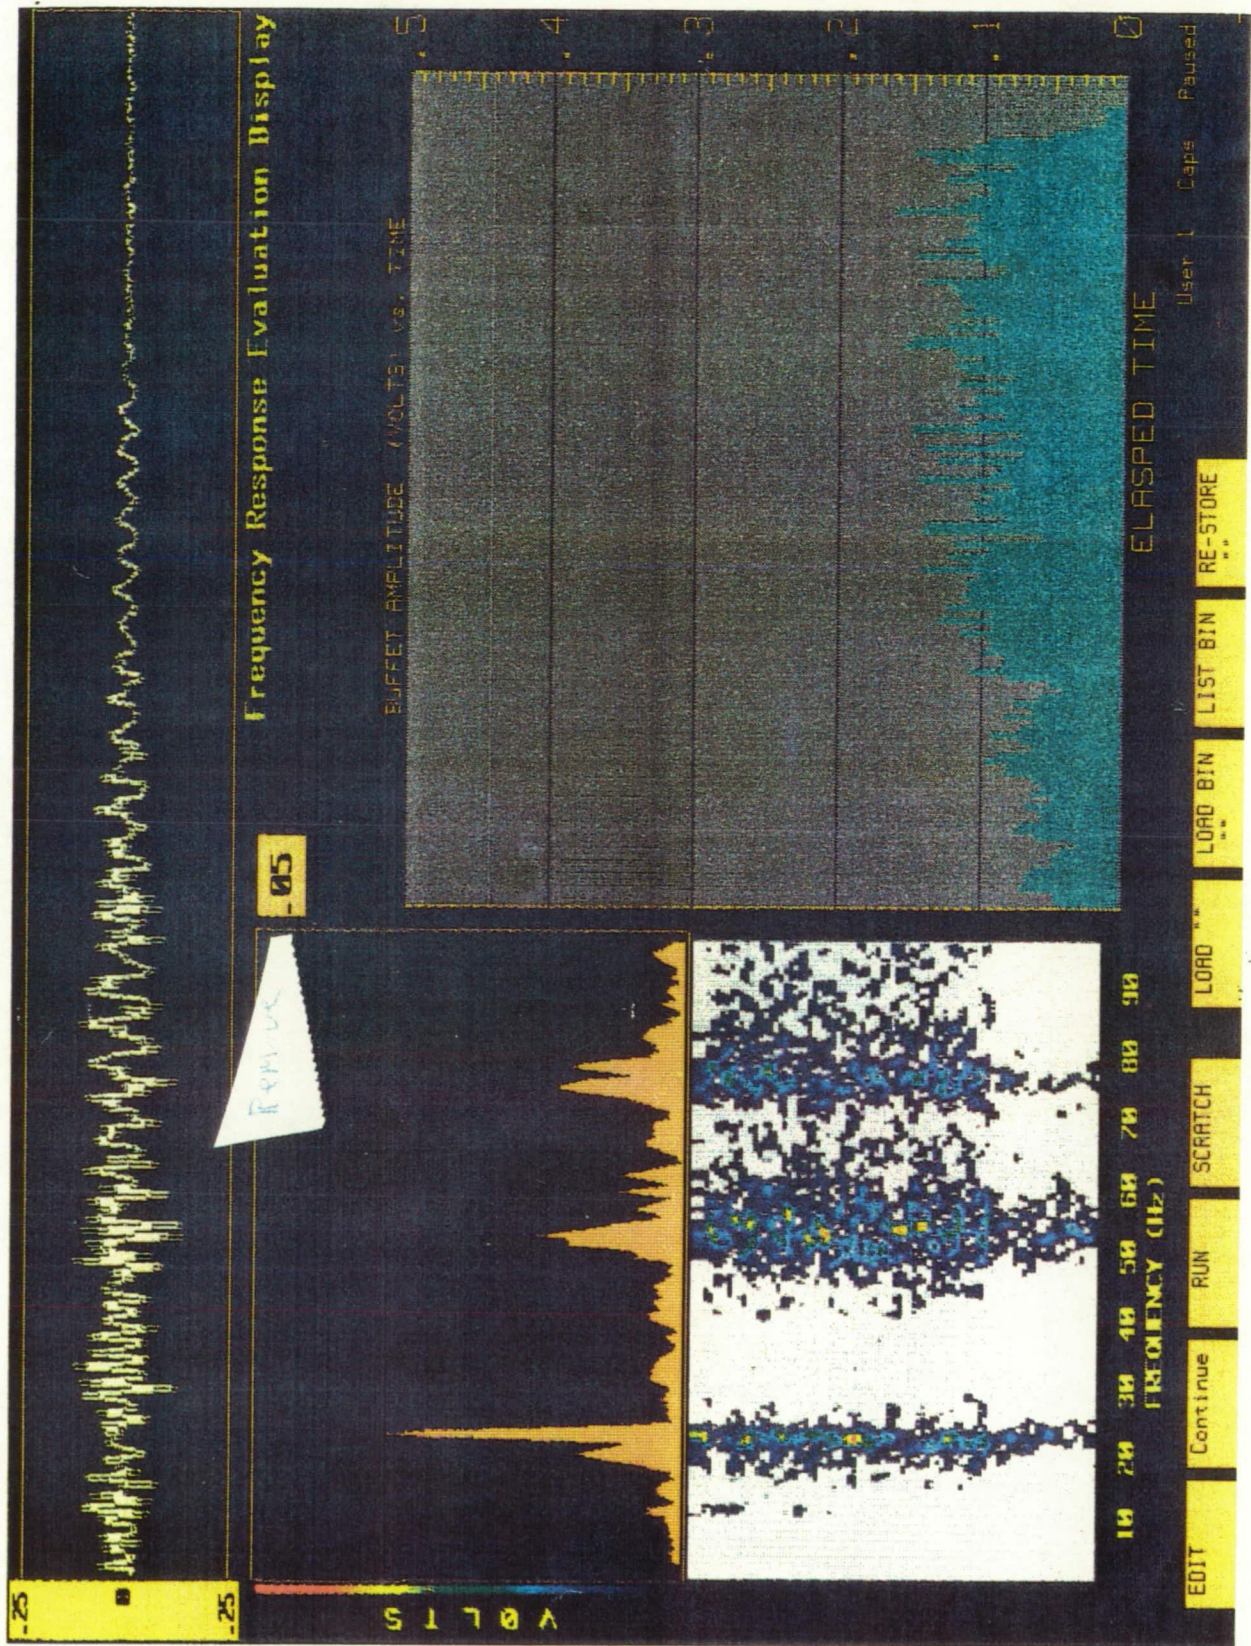
Figure 6. - Example of Colorgraphics Frequency and Time Domain Display for Roll Buffet Condition.

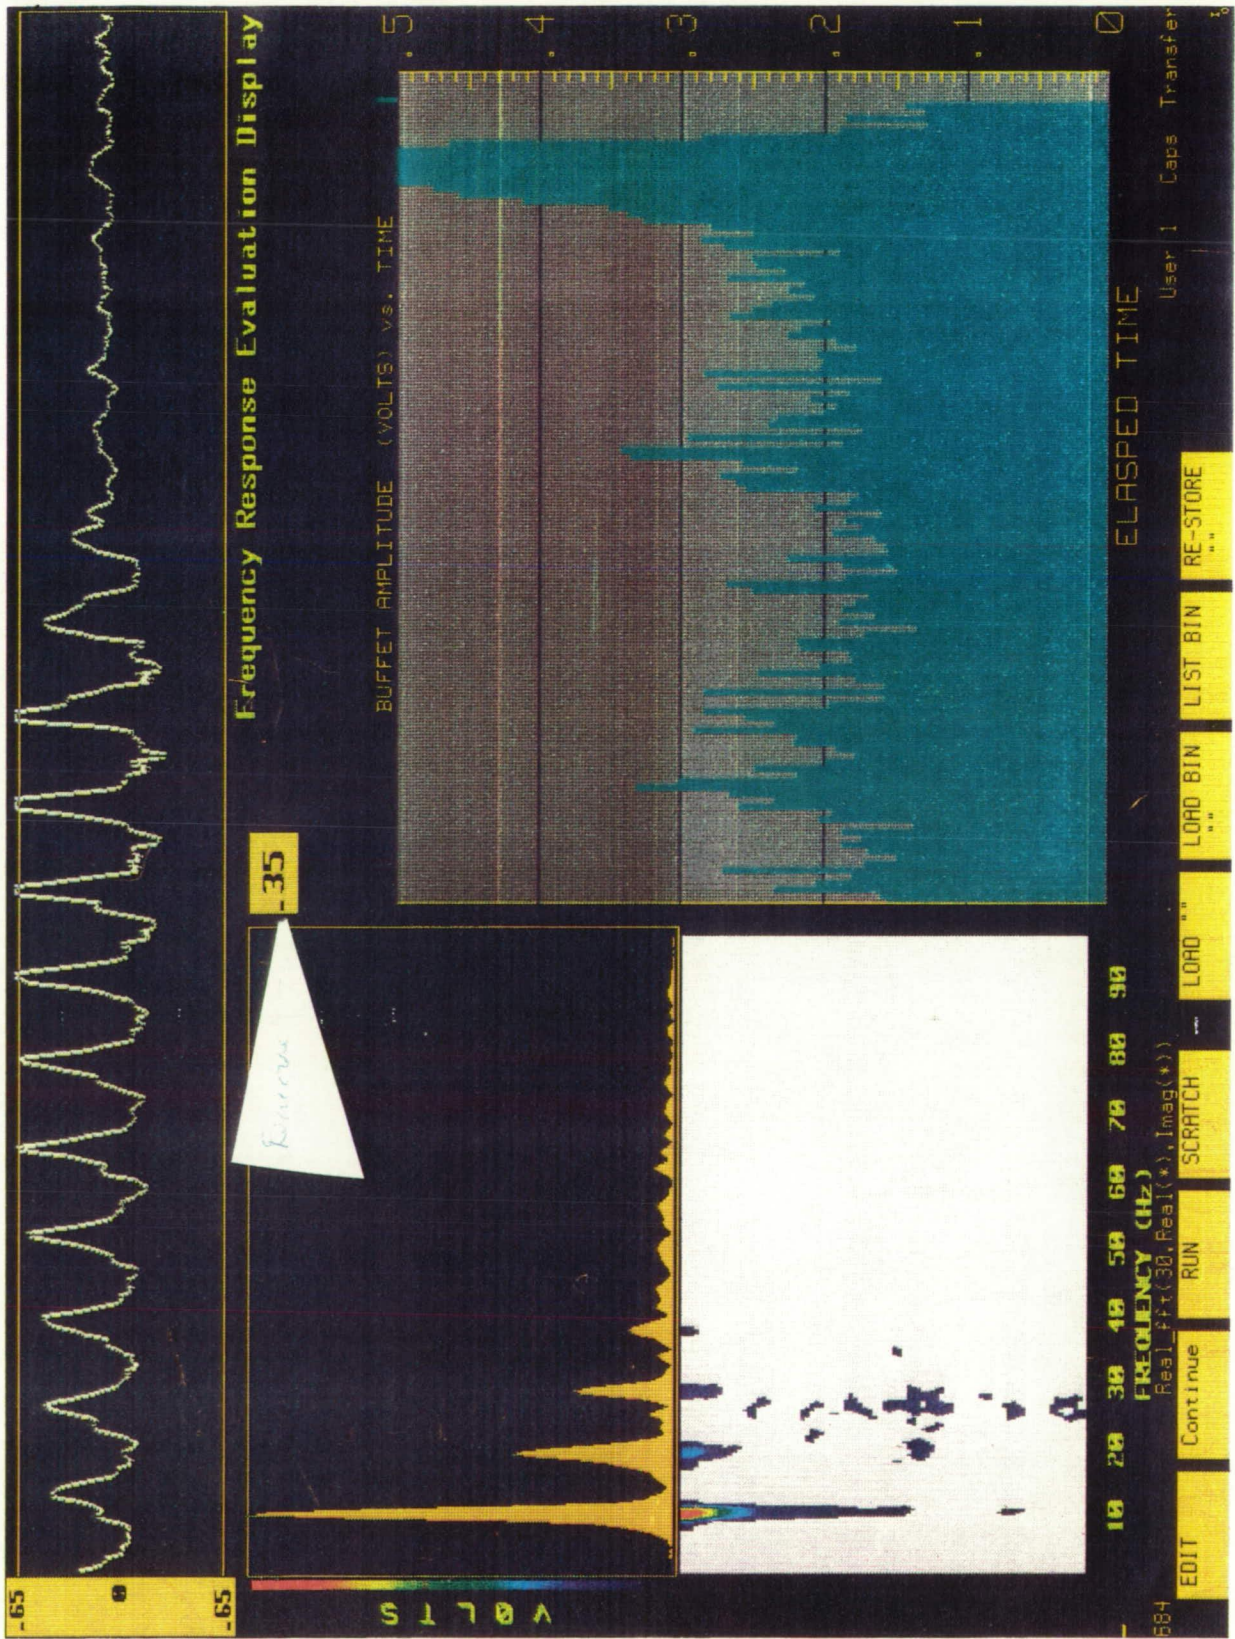
Figure 7. - Example of Colorgraphics Frequency and Time Domain Display for Pitch Buffet Condition.

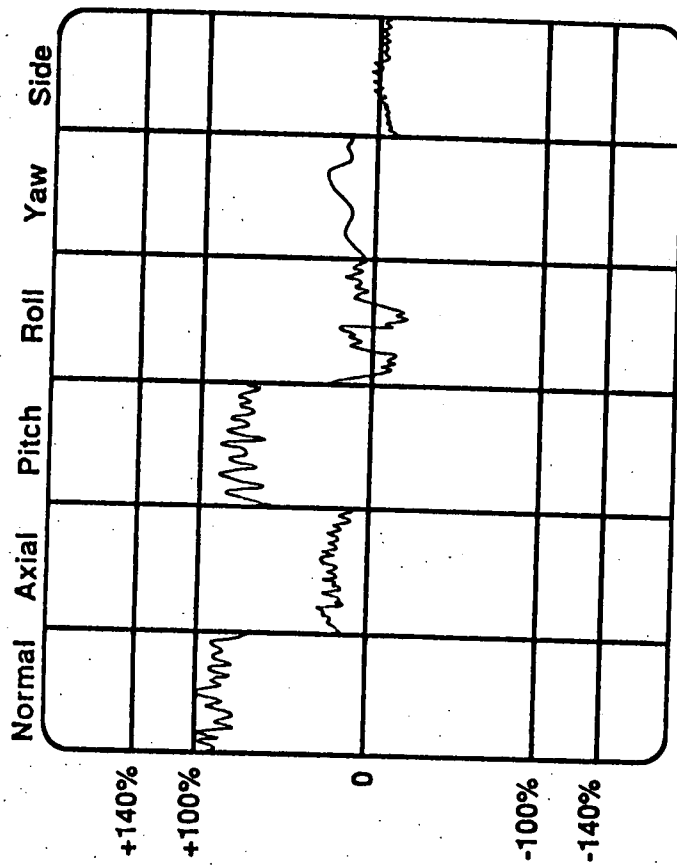
Figure 8. - Typical BDDU Display.

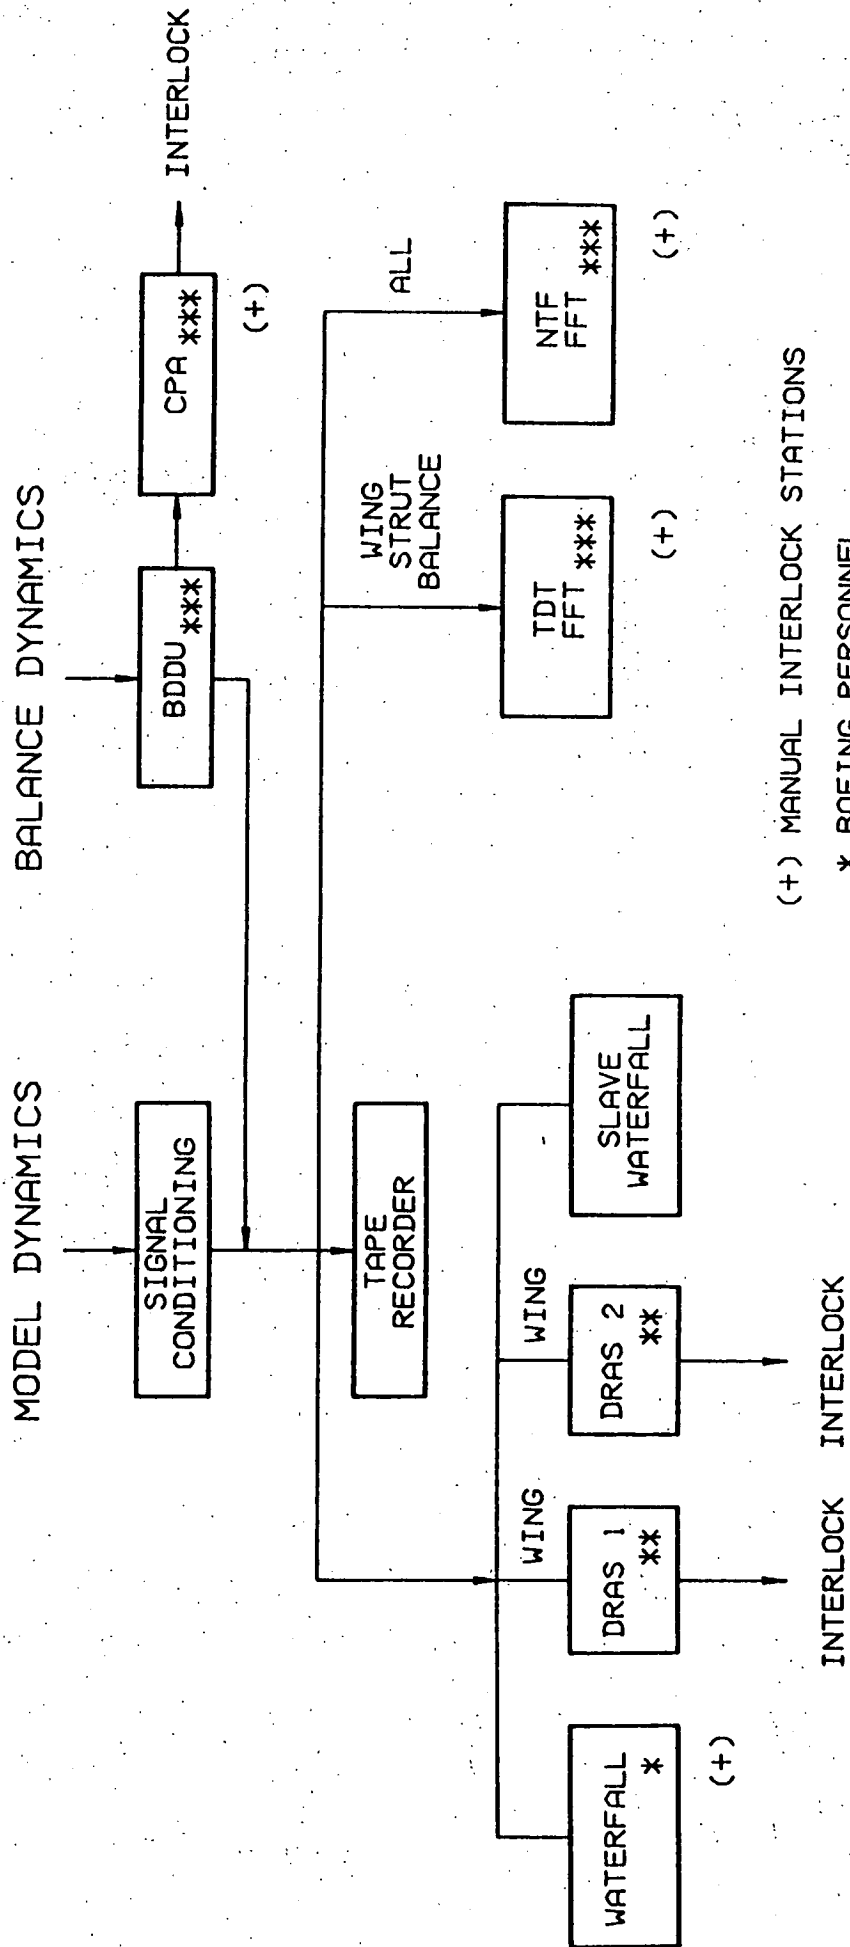
Figure 10. - Monitoring and Shutdown System Schematic.

As previously stated, the monitoring and shutdown system schematic is given in figure 10. As shown in figure 10, the DRAS 1, DRAS 2, and CPA units provided automatic interlock capability for protection of the model structure, force balance and swept strut. Manual interlock switches were provided to both Boeing and NASA personnel.

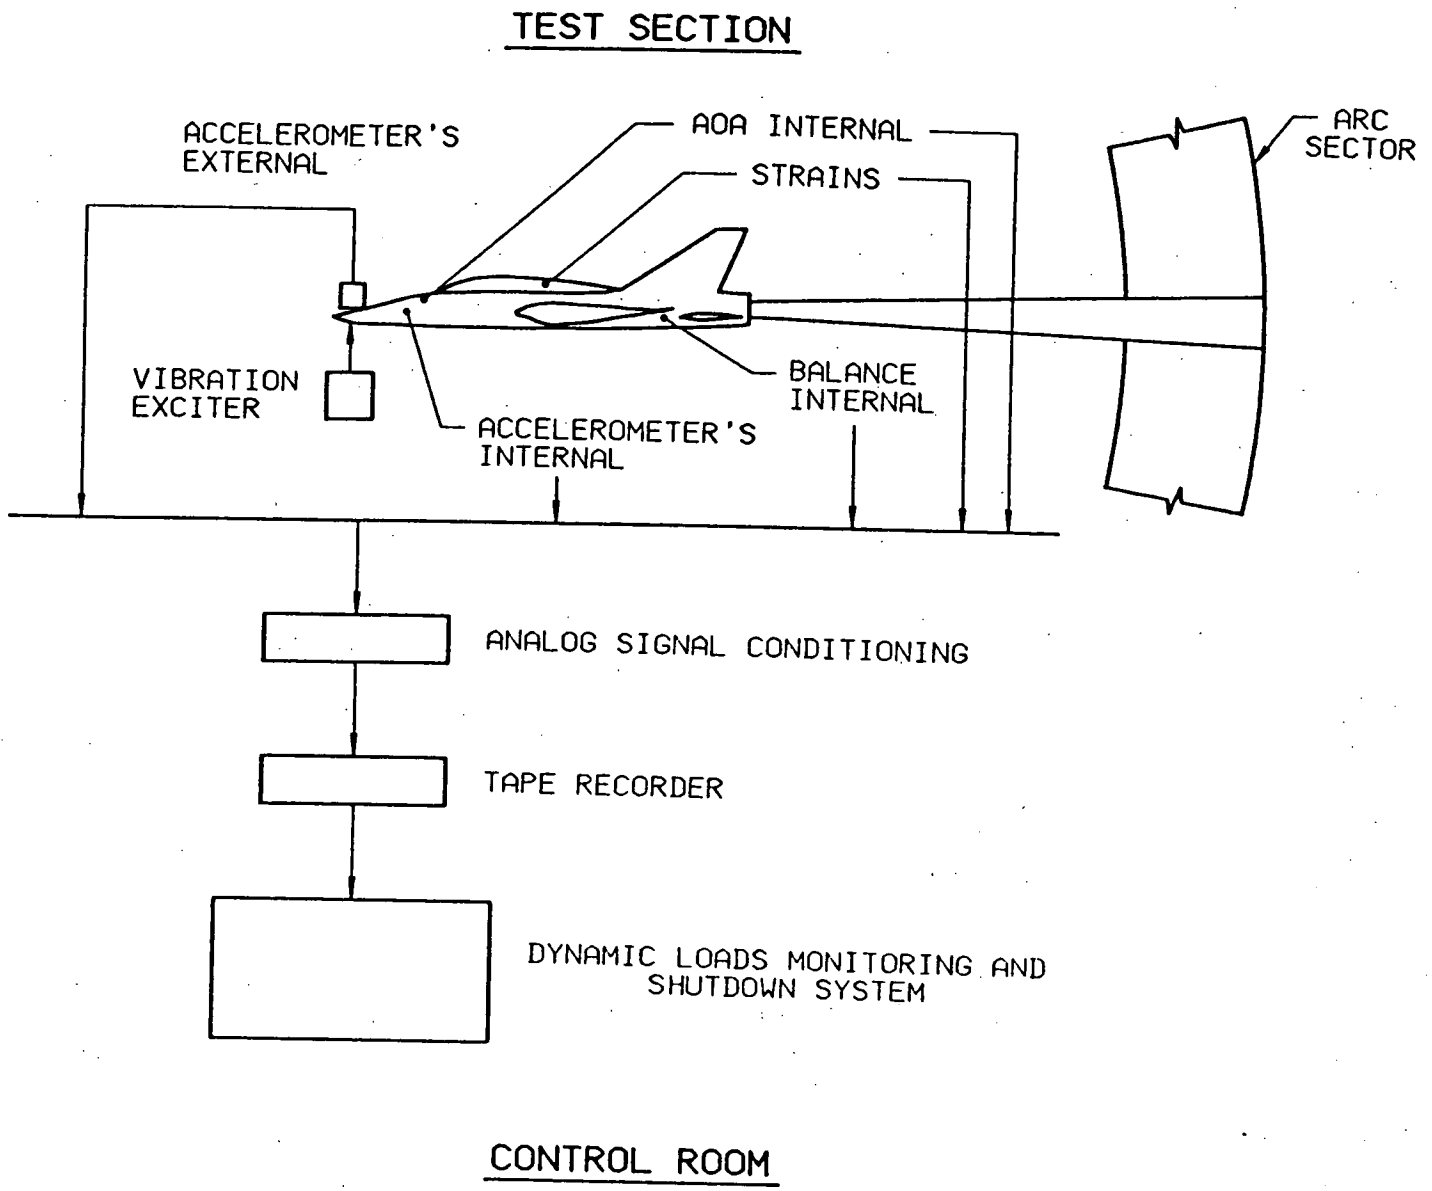
Figure 11. - Setup for Dynamic Loads Monitoring and Shutdown Systems Checkout.
