NASA Contractor Report 189595

Buffet Test in The National Transonic Facility

Cooperative Agreement NCC1-141
July 1992

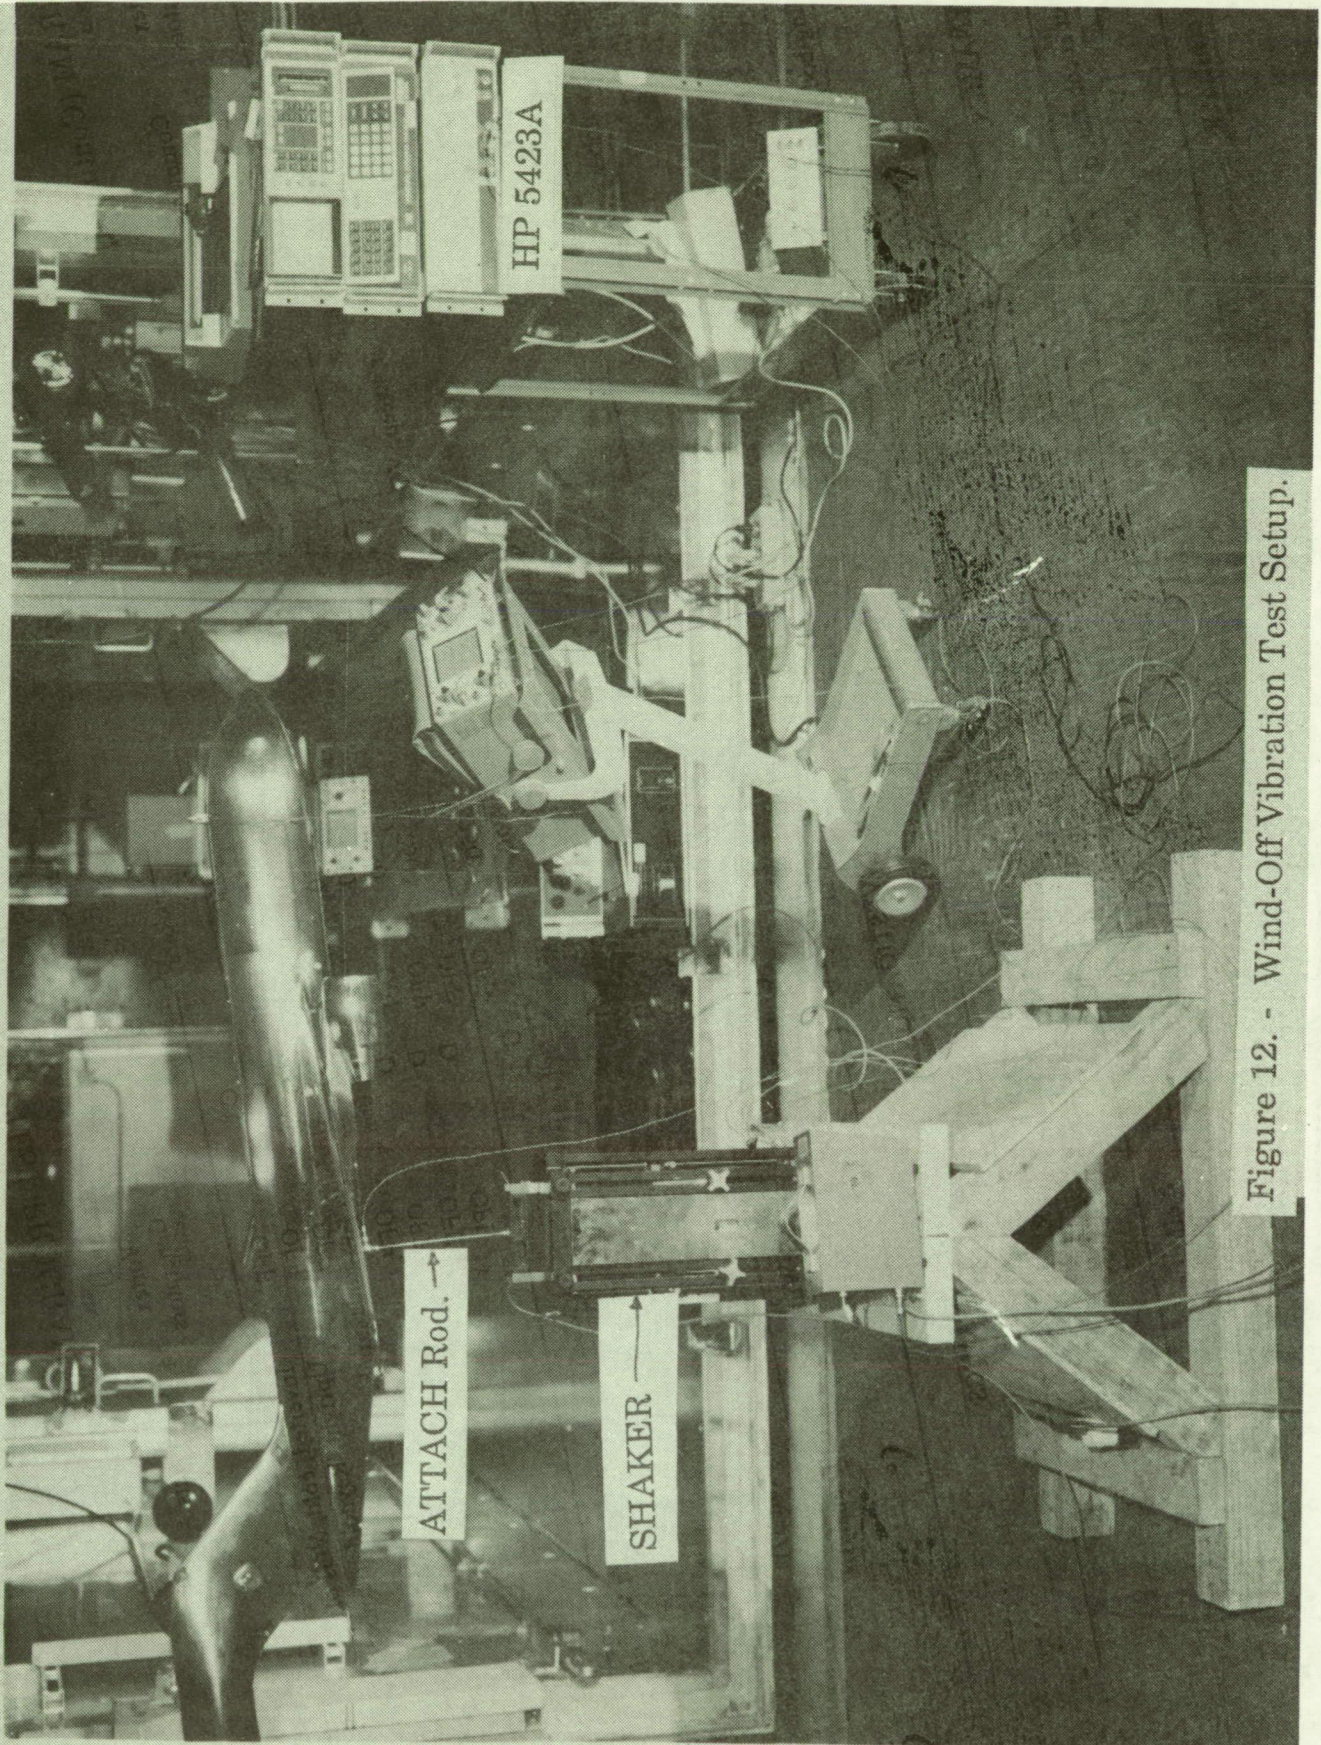
Figure 12. - Wind-Off Vibration Test Setup.

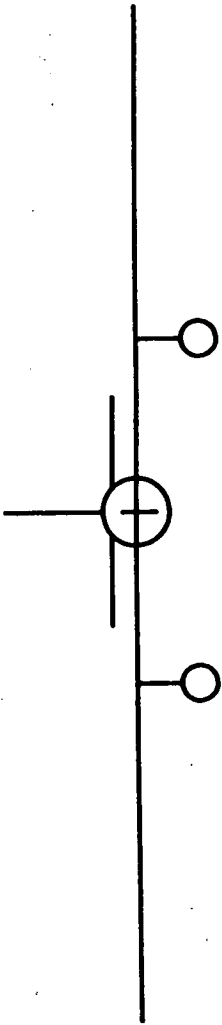
19 HZ ROLL-PITCH-YAW
23 HZ ROLL

Figure 13. - Vibration Modes of Primary Interest for Buffet Test.

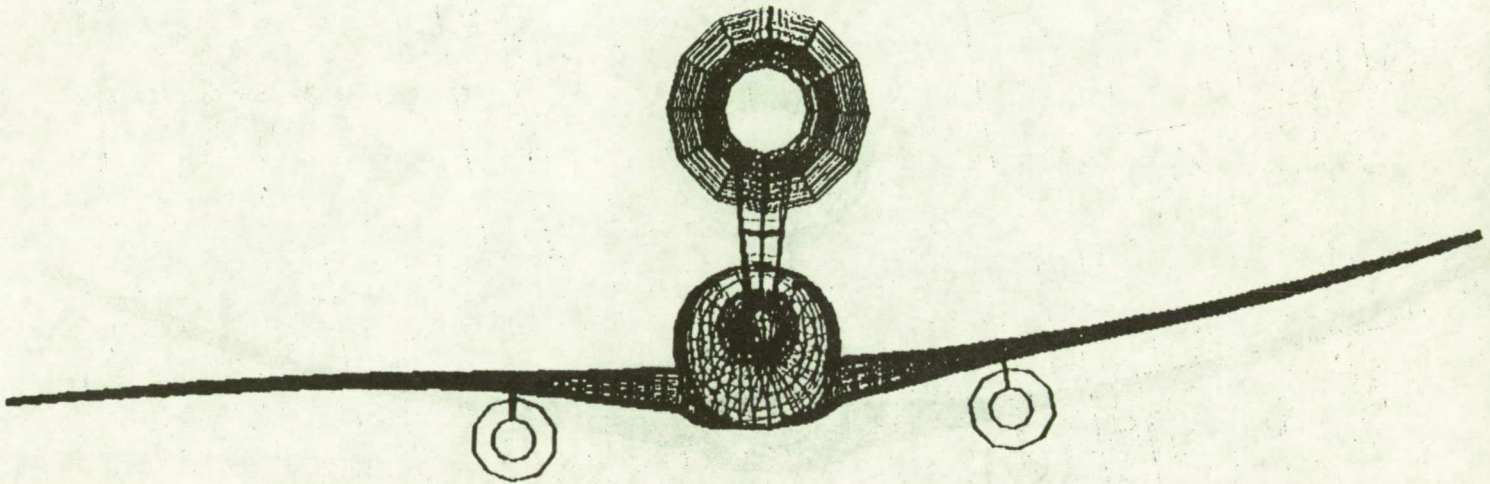
Figure 14. - Finite Element Model of Pure Roll Mode. (20 HZ)

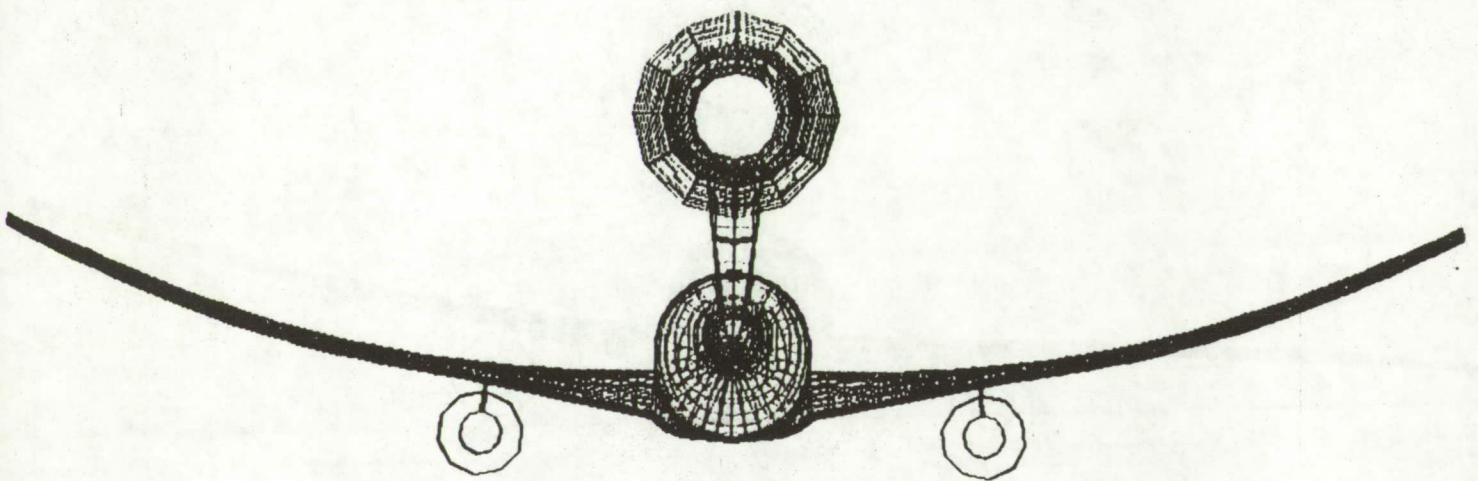
Figure 15.- Finite Element Model of First Wing Bending Symmetric Mode. (55 HZ)

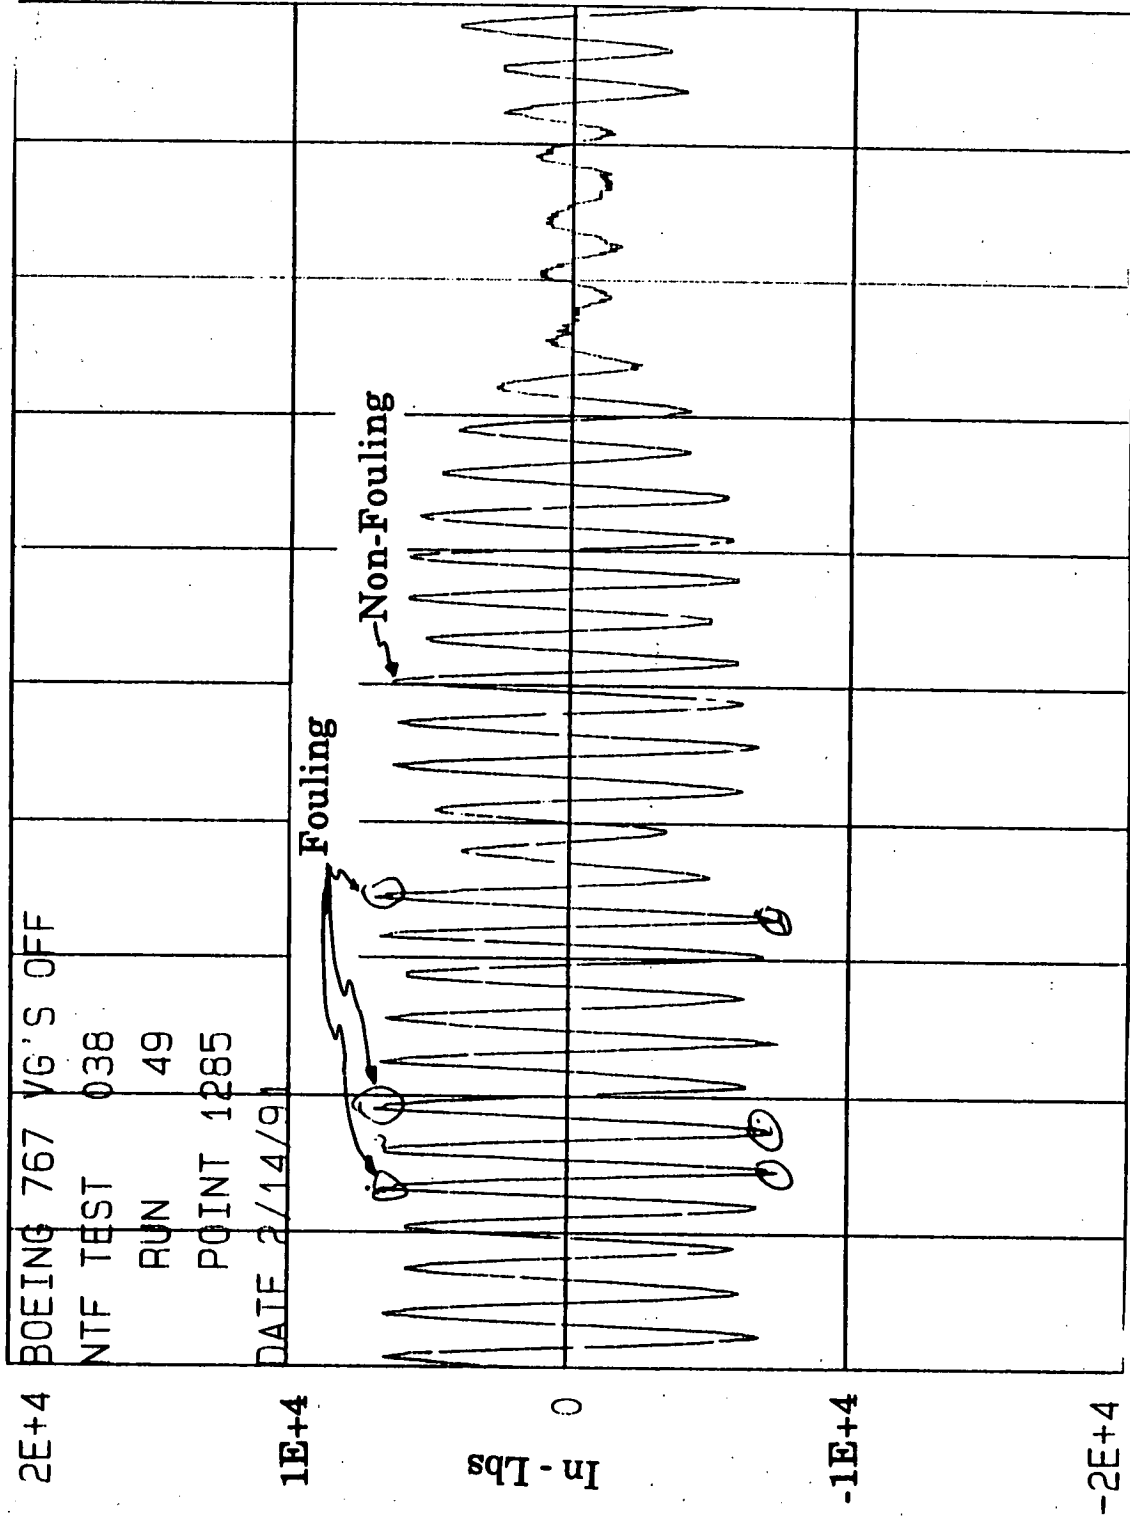
Figure 16.- Balance Yaw Moment Response Showing Evidence of
 Fouling Between Aft Fuselage and Swept Strut. (At
 Mach 0.80, Re No. 67 million/ft., $\alpha = 4.4^\circ$)

The second series of tests with the vortex generators removed began at a Reynolds number of 49 million per foot since the clean wing configuration (without VG's) was tested previously in 1988 at R_e number of 7 and 35 million per foot without buffet encounter. Roll buffet was first observed for this series of tests at R_e number of 59 million/ft at Mach .80. Subsequent testing at Mach .80 and 67.5 million/ft R_e number and dynamic pressure of 2670 lb/ft² resulted in a strong roll buffet response at $\alpha \simeq 4.5^\circ$. This test repeated the roll buffet encountered with the clean wing model at the same test conditions in 1988. The roll buffet (or buzz) amplitude was about 1 inch peak to peak at the wing tips and the frequency response was predominantly 20 Hz. These data clearly indicated that under roll buffet conditions the fuselage and swept strut were coming into contact (see figure 16) due to the yawing motion associated with the 20 Hz model response. The fouling occurred at about 80% of yawing moment full scale and is evident by signal clipping of the response peaks as shown in figure 16. The same type of signal clipping was observed during pre-test

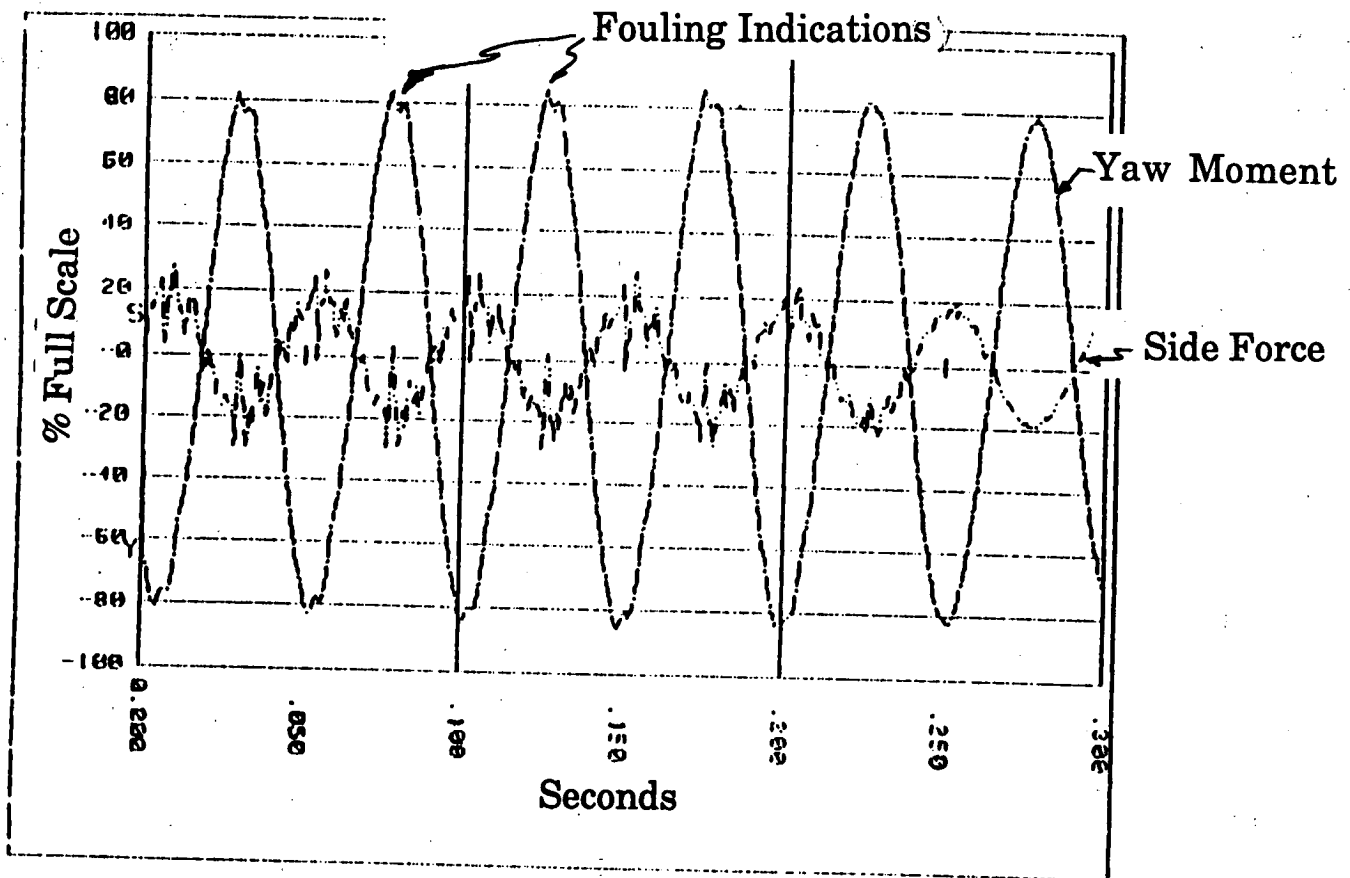
767 Test 101B Balance-Shaking Model 10 Jan 1991

Plot of Yaw & Side Balance Channels

Figure 17.- Balance Yaw Moment and Side Force Response from Forced Vibration Tests Illustrating Fouling Between Aft Fuselage and Swept Strut.

dynamic load simulation (Appendix B) when fouling was visually observed and recorded as shown in figure 17. This fouling indication during testing was verified by inspection during tunnel entry for model change, and was subsequently monitored closely throughout the test program.

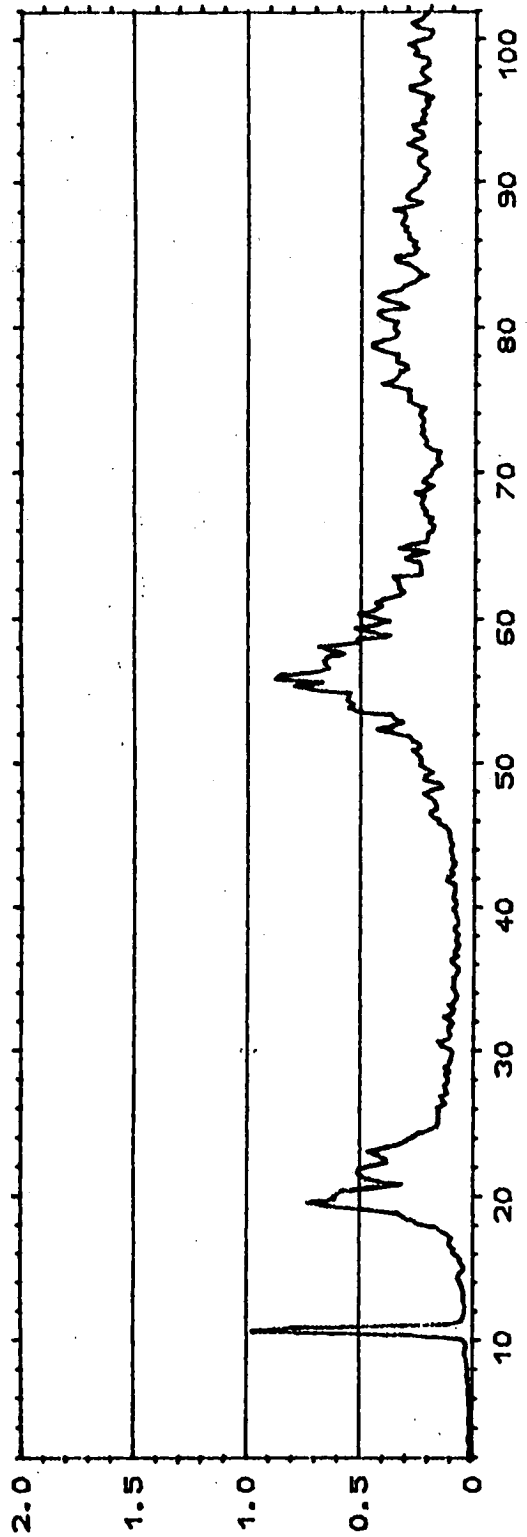
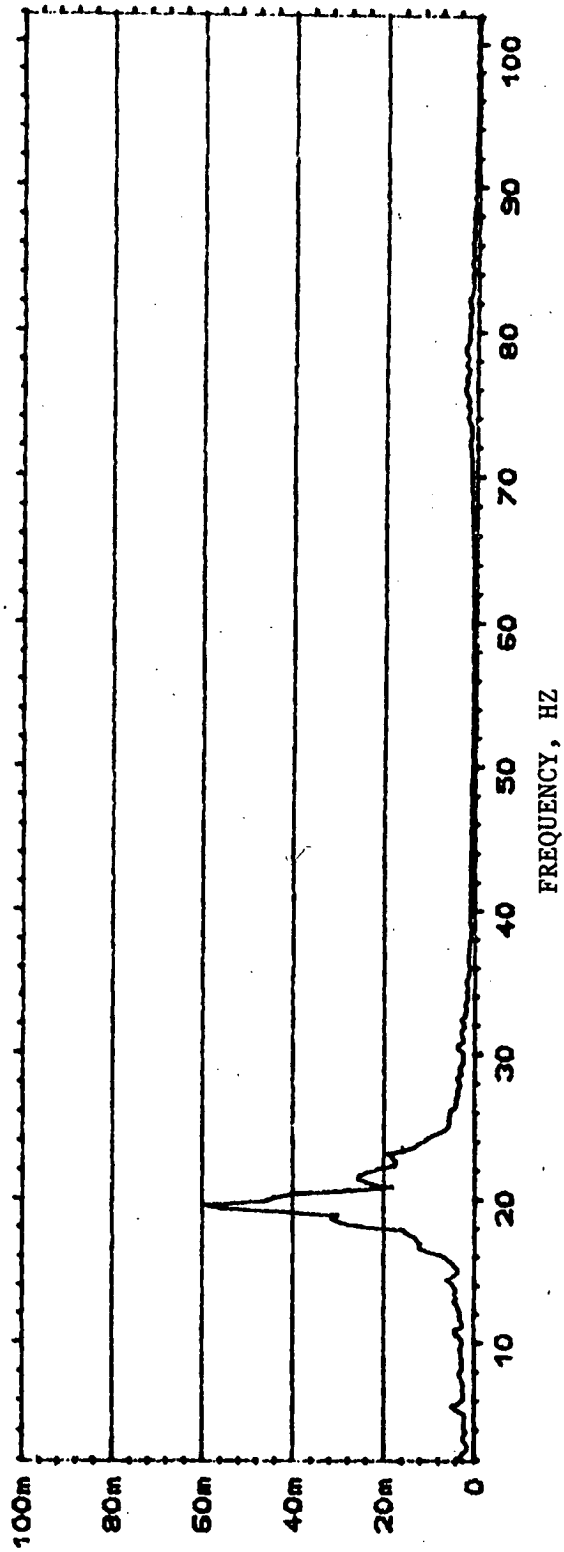
Wing Tip
Accelerometer,
Amplitude
g's

Balance
Roll Moment,
Millivolts

Figure 18.- Example Frequency Spectrum for Outboard Wing Accelerometer and Balance Roll Moment

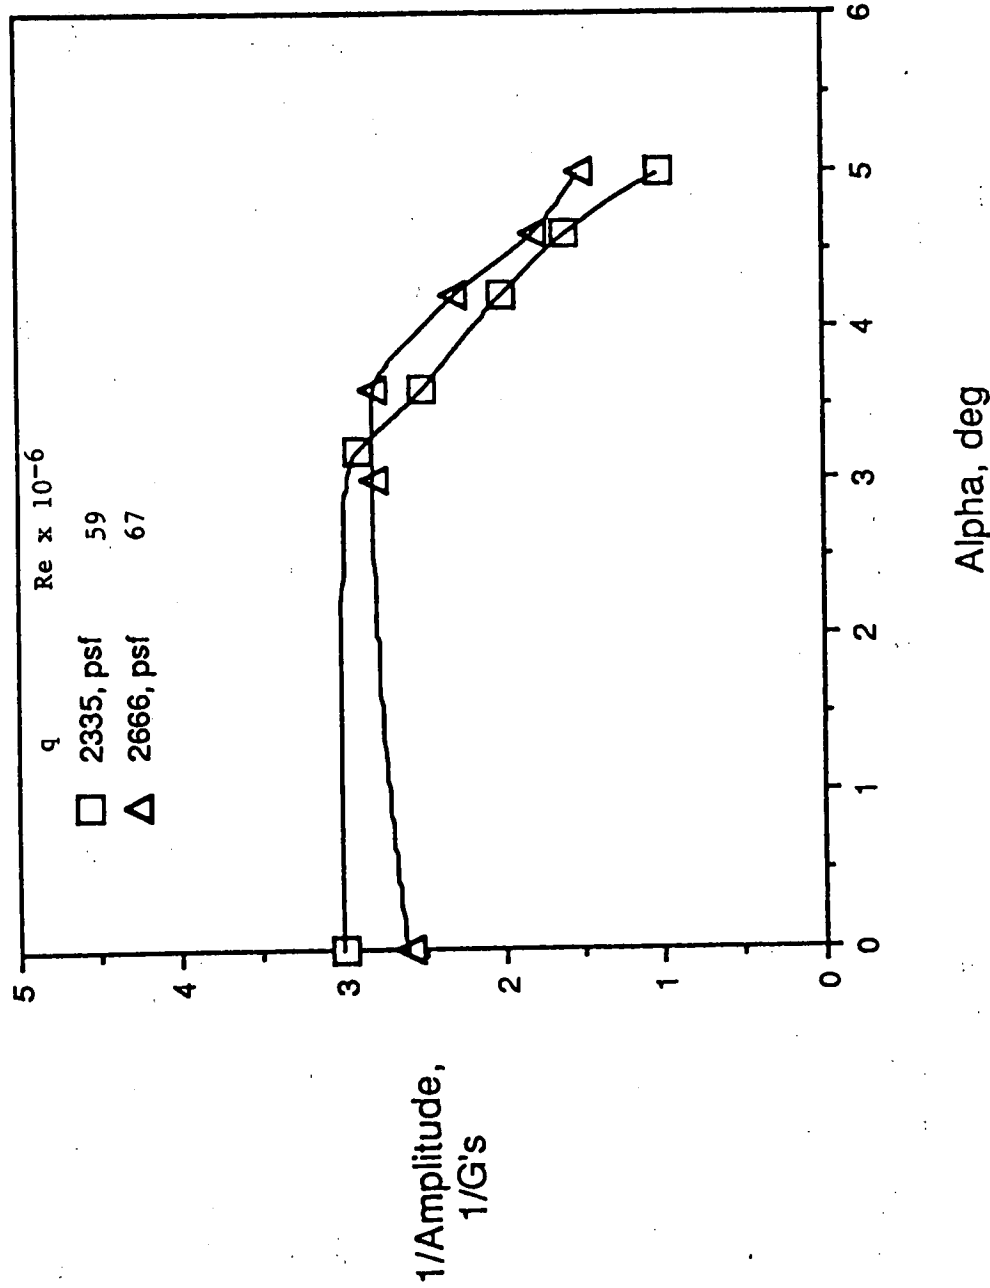
M=0.8, 20Hz Mode, VG's On

Figure 19. - Roll Buffet Stability Index Versus Angle of Attack for Variable Reynolds Number and With VG's Installed

The $1/\text{amplitude}$ plots for the 20 Hz mode response at Mach .8 and varying Reynolds number are illustrated in figures 19 and 20. Figure 19 gives the stability trends for the initial series of tests with the VG's installed on the model, while figure 20 gives similar results with VG's off the model. The condition for incipient instability is when $\frac{1}{A} \rightarrow 0$. As the slope of the curve tends to become steeper and $\frac{1}{A}$ shows a sharp trend toward zero, more data points must be taken at smaller angle-of-attack increments.

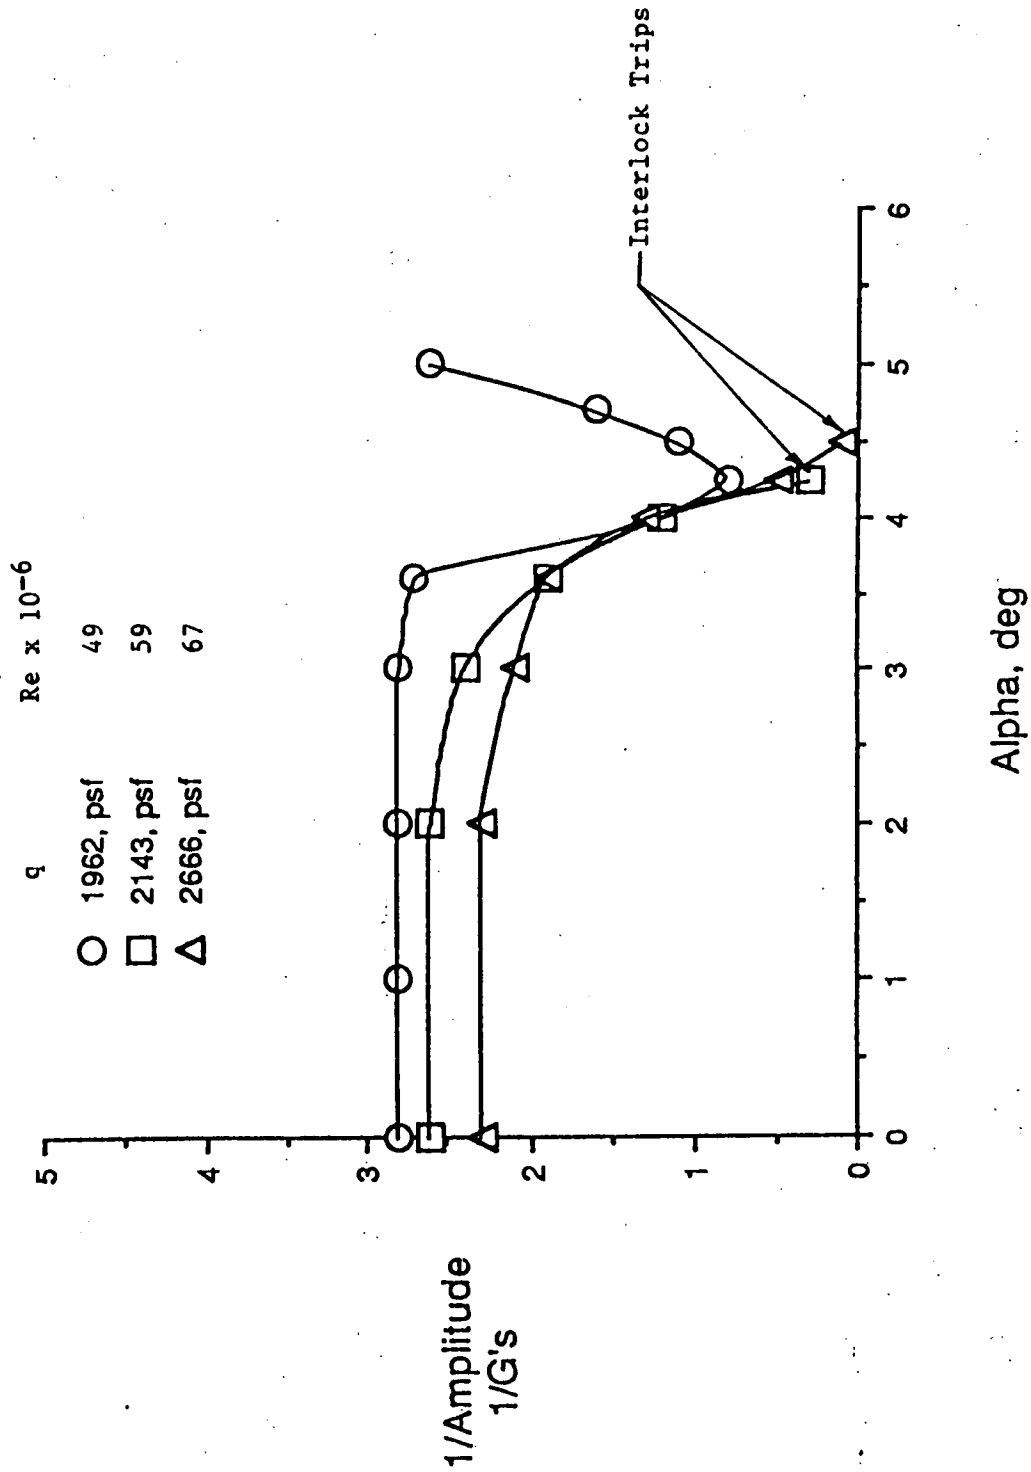
M=0.8, 20 Hz Mode, VG's Off

Figure 20. - Roll Buffet Stability Index Versus Angle of Attack for Variable Reynolds Number and With VG's Removed

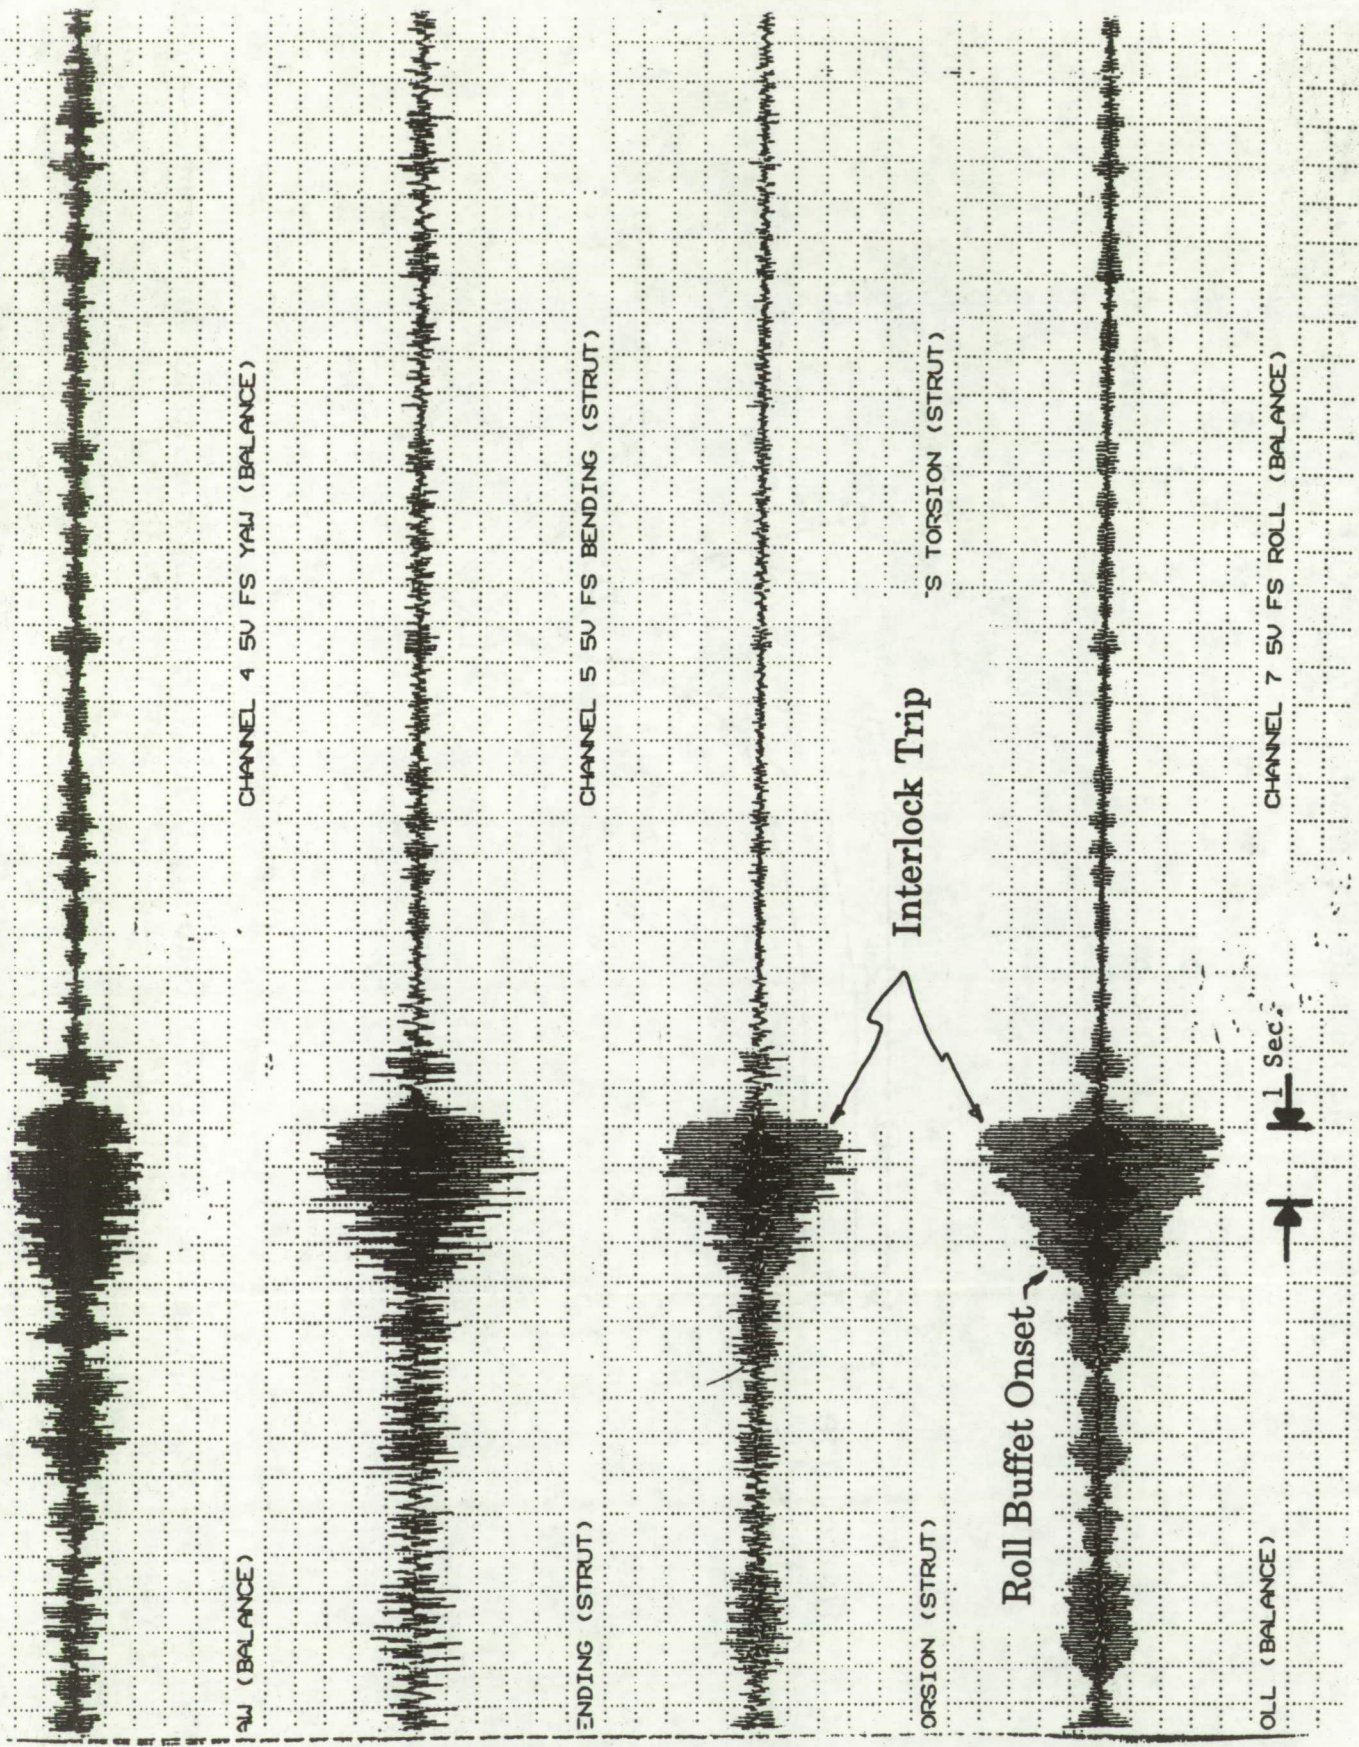
Figure 21.- Force Balance and Strain Gage Response Due to Roll Buffet.

An example of the roll buffet response, as seen from the time domain strip chart signal, is given in figure 21. The four channels of data shown in the figure include the yawing and rolling moment response as obtained from the balance and the swept strut bending and torsion strain gages response. When buffet onset and lock-in occurs, the frequency on all channels stabilizes in at 20 Hz with amplitude increasing rapidly. The buildup in amplitude to the interlock trip point for this case occurred in about 2 seconds. However, note the very rapid decay of the response from peak value to near zero in approximately 1/4 second. Since the tunnel Arc Sector pitch system moves about 3 degrees/second, the data suggests that only a very small change in α relieves the roll buffet lock-in oscillations. The interlock trip for the run shown in figure 21 was initiated manually by the engineer observing this strip chart data.

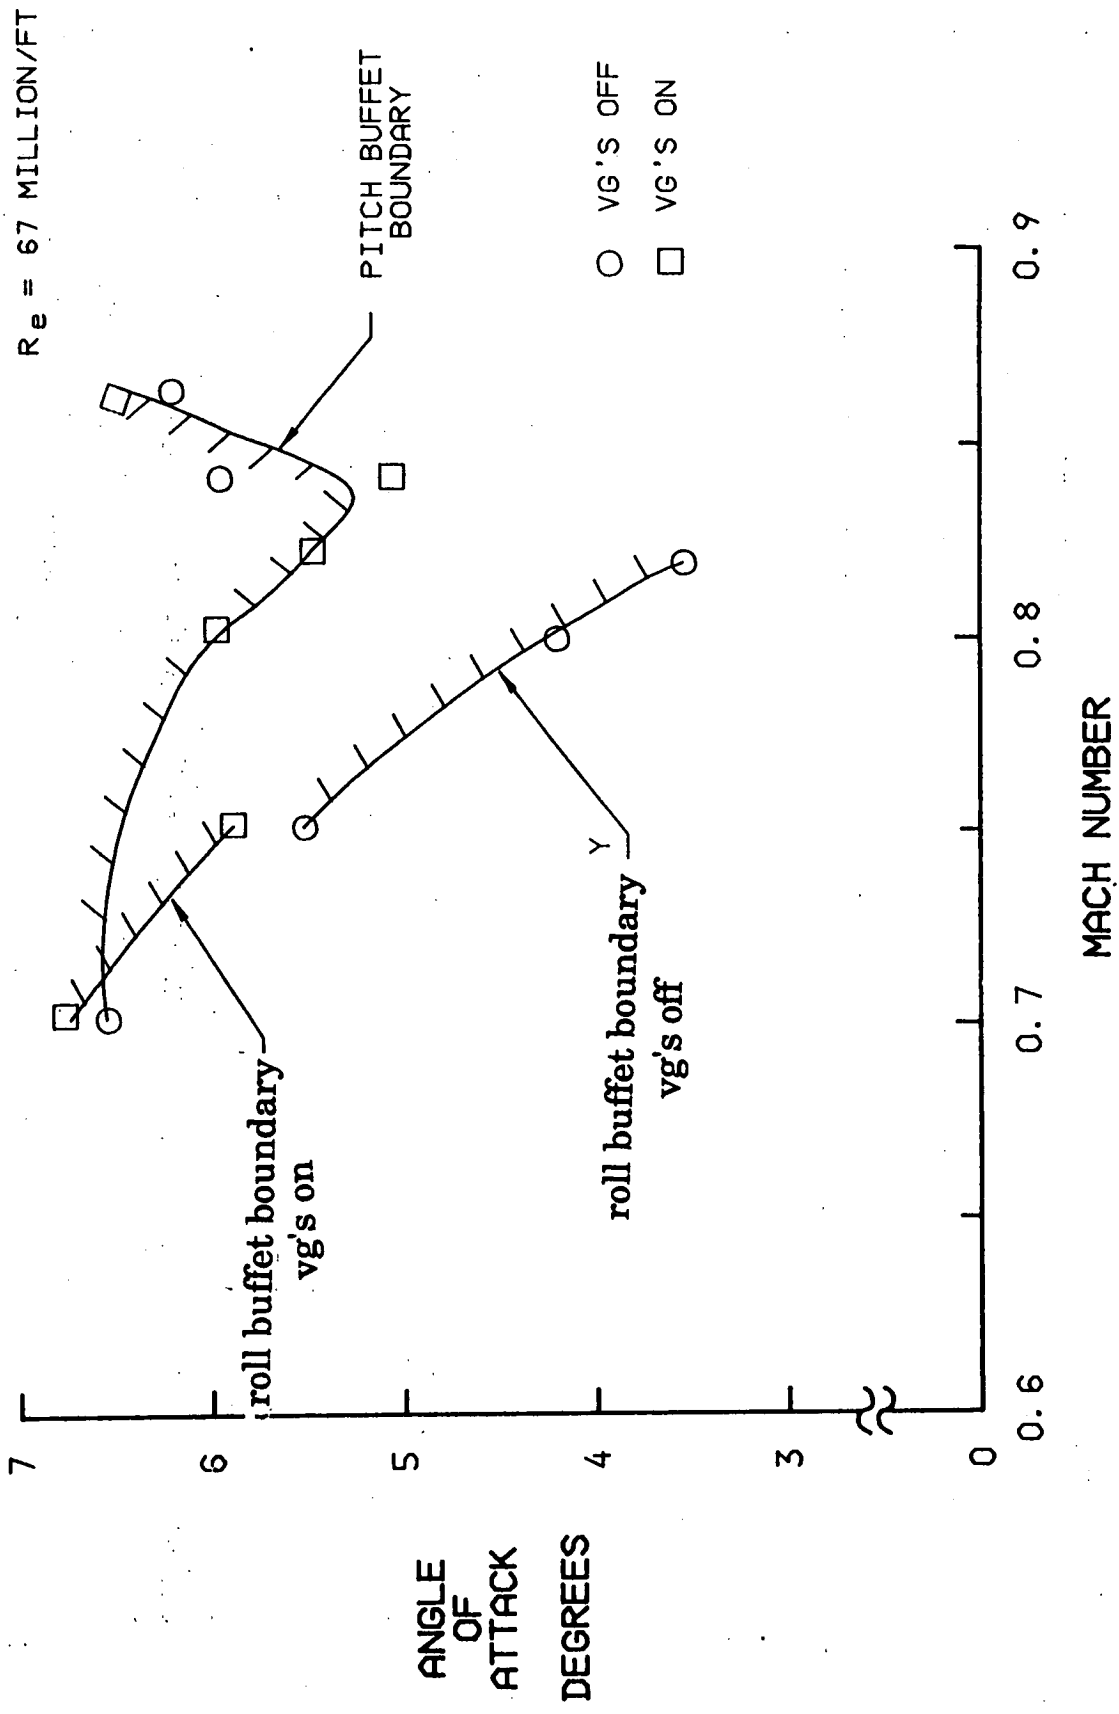
Figure 22. - Model Dynamic Response Boundaries at Reynolds Number of 67 Million/Ft.

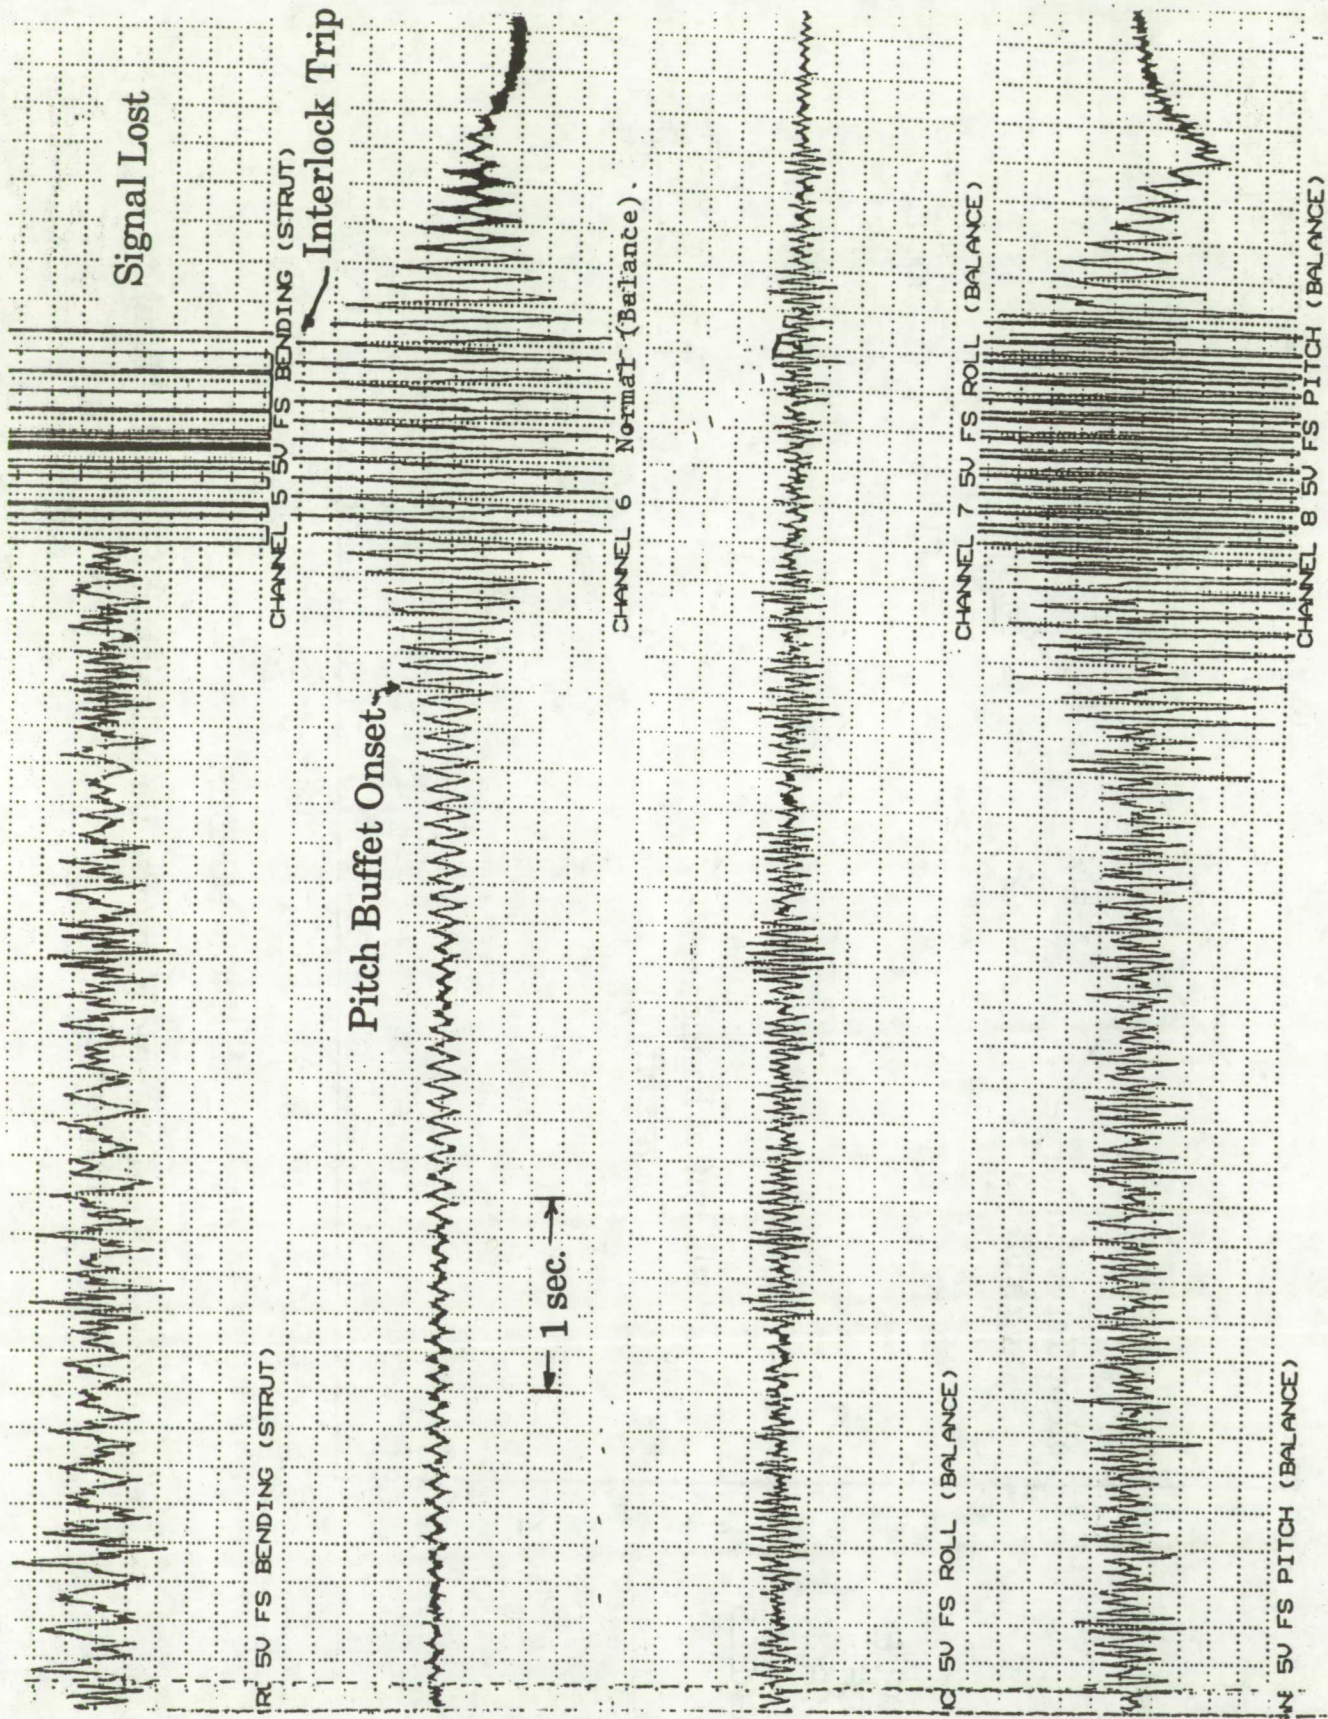
Figure 23. - Force Balance and Strain Gage Response Due to Pitch Buffet.
