# Flight Test of ARINC 741 Configuration Low Gain SATCOM System on Boeing 747-400 Aircraft

Timothy A. Murphy and Brian P. Stapleton  
Boeing Commercial Airplane Group  
PO Box 3707 - MS 47-31  
Seattle WA. 98124-2207  
(206) 655-6908  
FAX (206) 655-9252

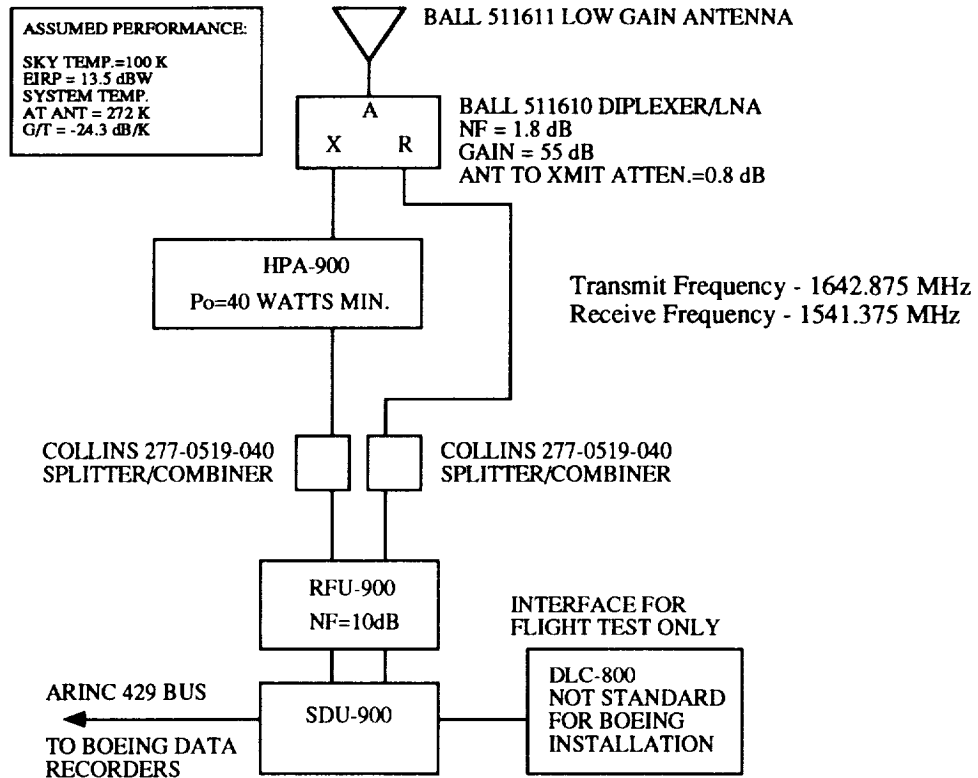
Fig. 1. Block Diagram of Low Gain Aeronautical Earth Station

Figure 1 shows a block diagram of the SATCOM avionics as configured on the Boeing 747-400 aircraft. This configuration represents the low gain portion of the standard installation offered by Boeing for the 747-400 at the time of this flight test. The low gain SATCOM system design parameters are (from the ARINC 741 characteristic) a receive  $G/T \geq -26$  dB/K and a minimum transmit EIRP of 13.5 dBW. The low gain antenna is a quadrifilar helix intended to provide omnidirectional azimuth coverage from zenith down to 5° elevation angles. The antenna is housed under an aerodynamically shaped radome which is less than 6 inches high. The design goal is to achieve a minimum of 0 dBic gain for 85% of the coverage volume defined from zenith to 5° elevation angles. The low gain SATCOM system installed on the 747-400 is believed to have had a receive  $G/T$  of -24.3 dB/K (assuming a 0 dBi aircraft antenna). The transmit EIRP is believed to have just met the minimum required, 13.5 dBW.

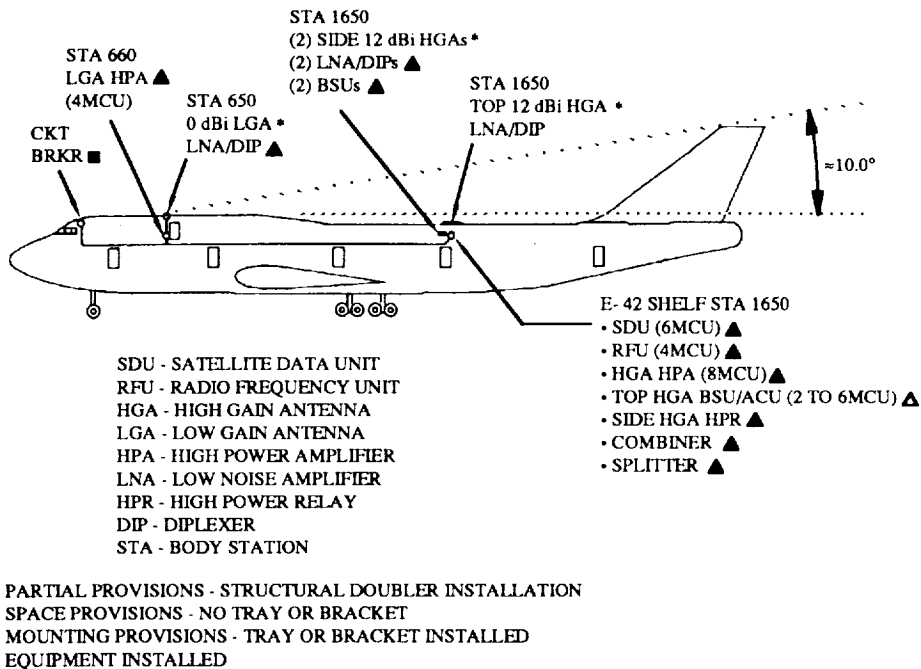
Fig. 2. Standard Boeing SATCOM Installation Provisions as of 9/89.

Figure 2 shows the SATCOM provisions as offered by Boeing at the time of this engineering test. The low gain antenna is located on top centerline at body station 650 (see figure 2). Since the low gain antenna is mounted on the top of the upper deck, only the tail fin extends above the horizon as seen by the antenna. Hence the tail fin may block the direct line of sight to the satellite for some aircraft attitudes, and bearings.

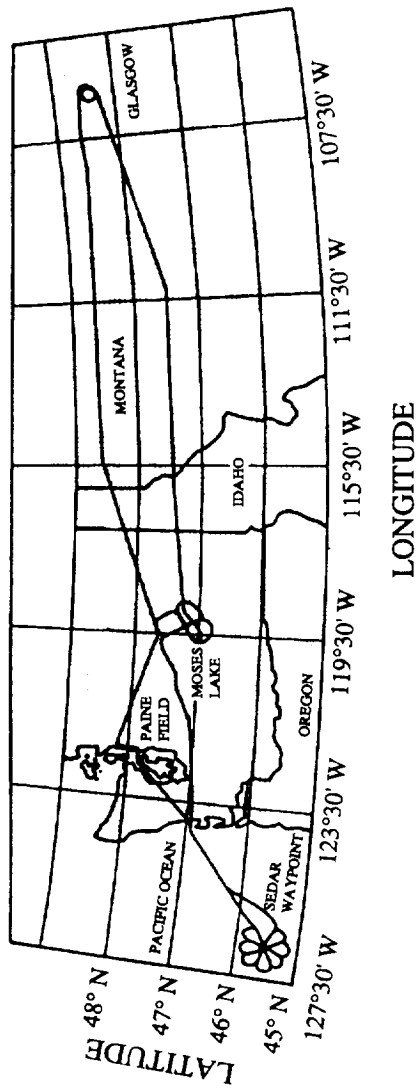
Fig. 4. SATCOM Test Flight Path

Figure 4 shows the flight path chosen for the test. The flight path was designed specifically to test the system over sea and a variety of land terrain. The Pacific Northwest is at the edge of coverage for the Pacific Ocean Region INMARSAT and therefore offers an excellent opportunity to evaluate the system at its performance limits and beyond. Special maneuvers were performed at three locations, Sedar Waypoint, Moses Lake, Washington and Glasgow, Montana in order to test the satellite link at a variety of satellite bearings and elevations in three different basic multipath environments.

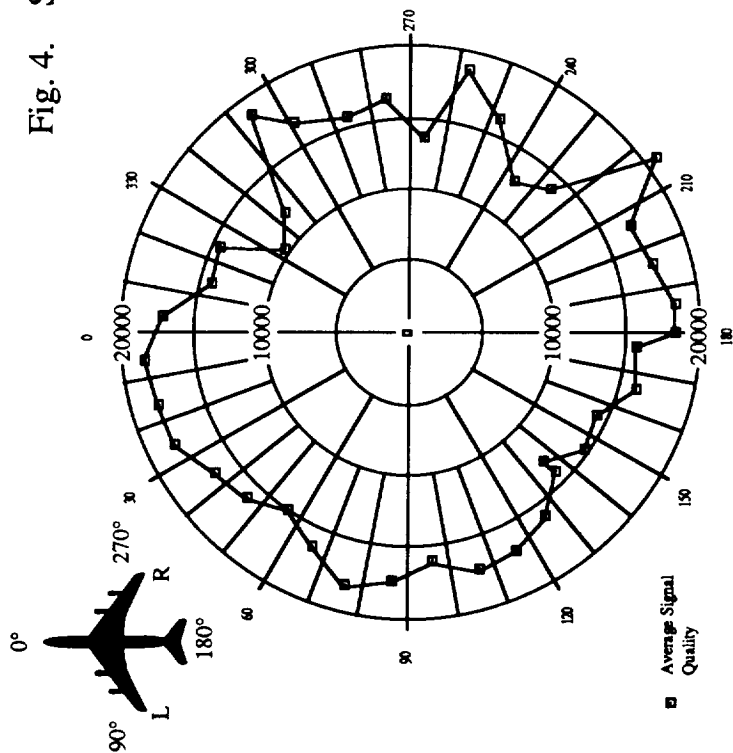
Fig. 3. Signal Quality Data From Compass Rose Test

Figure 3 shows the data collected during the compass rose test. The radial axis is in units of average signal quality. The angle reference is the bearing to the satellite in the aircraft reference frame. Care was taken to position the aircraft such that the tail was directly in line with the satellite. The nominal elevation was such that line of sight to the satellite was not actually

blocked and no airframe effects were evident in the data recorded.

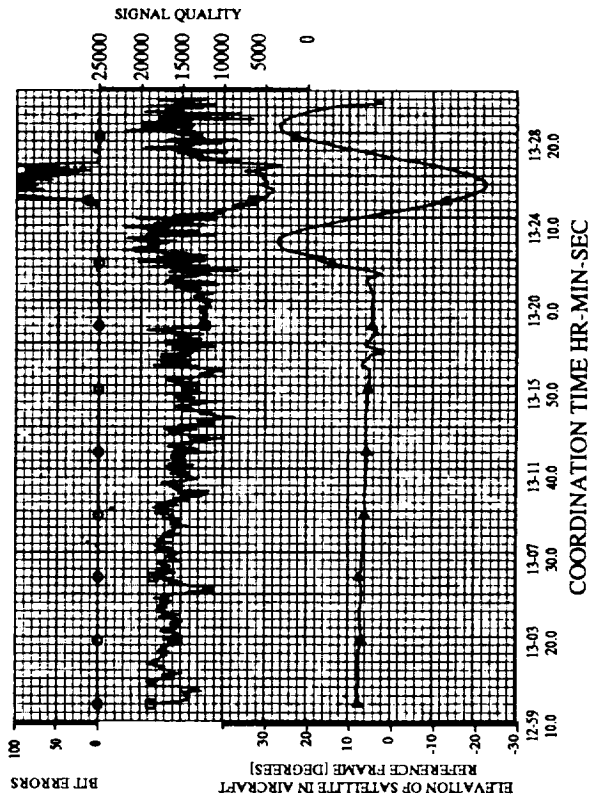
Fig. 5. Flight Test Data For Glasgow Maneuvers

Figure 5 shows the elevation of the satellite, the signal quality and the bit errors recorded over a period of time spanning about half an hour. This data represents the flight maneuvers conducted over Glasgow Montana (latitude N 48'13", longitude W 106'37"). Glasgow represents the most extreme nominal operating environment included in the test with a nominal elevation to the satellite of  $\approx 2.3^\circ$ . During the orbiting maneuver, from the aircraft reference frame the satellite dipped to more than  $22^\circ$  below the horizon. During this extreme condition, the receiver indicated a high number of channel bit errors, messages were not received by the aircraft and messages transmitted from the aircraft were not received at the GES. However, during level flight in the vicinity, with a nominal elevation to the satellite of  $\approx 4^\circ$  (in the aircraft reference frame) messages were transmitted and received successfully.

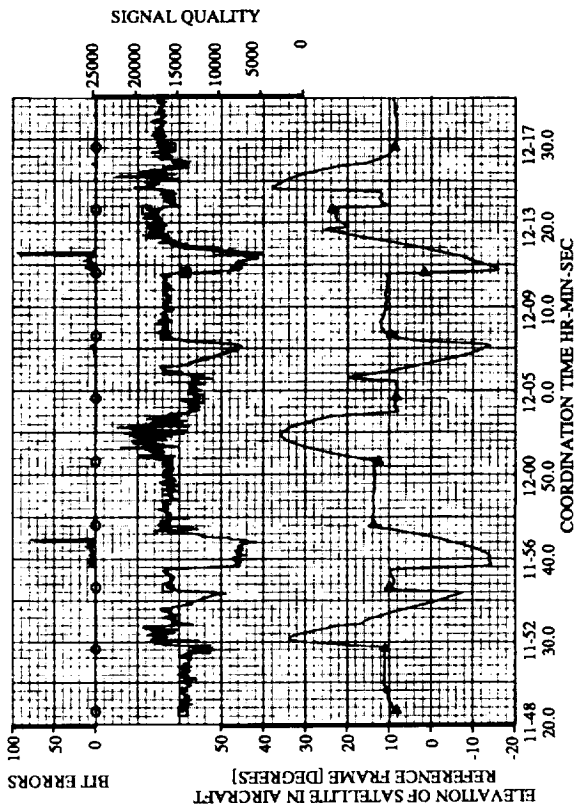
Fig. 8. Flight Test Data For Moses Lake Maneuvers

Figure 8 shows data taken during the maneuvers conducted over Moses Lake (latitude N 47°12.7', longitude W 119°18.9') approximately in the center of the state of Washington.. Again it can be seen that the system continued to operate when the satellite was several degrees below  $0^\circ$  elevation relative to the aircraft antenna reference frame.

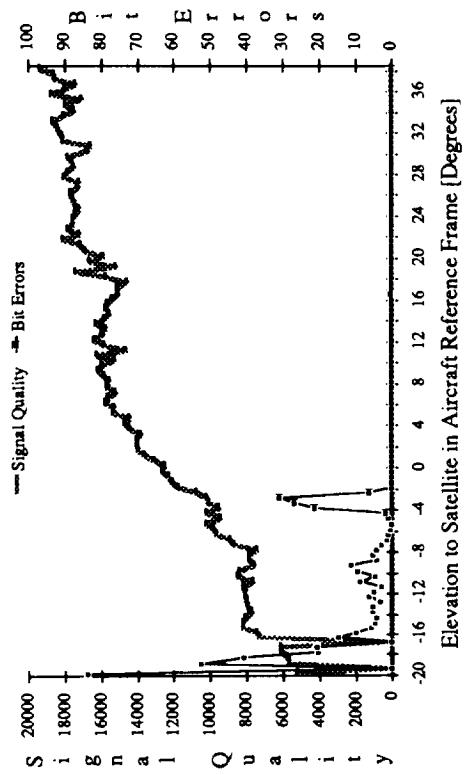
Fig. 9. Flight Test Data For Moses Lake Maneuvers

Figure 9 shows the average signal quality level and bit errors as a function of the elevation of the satellite relative to the aircraft antenna reference frame for the time period illustrated in figure 8.

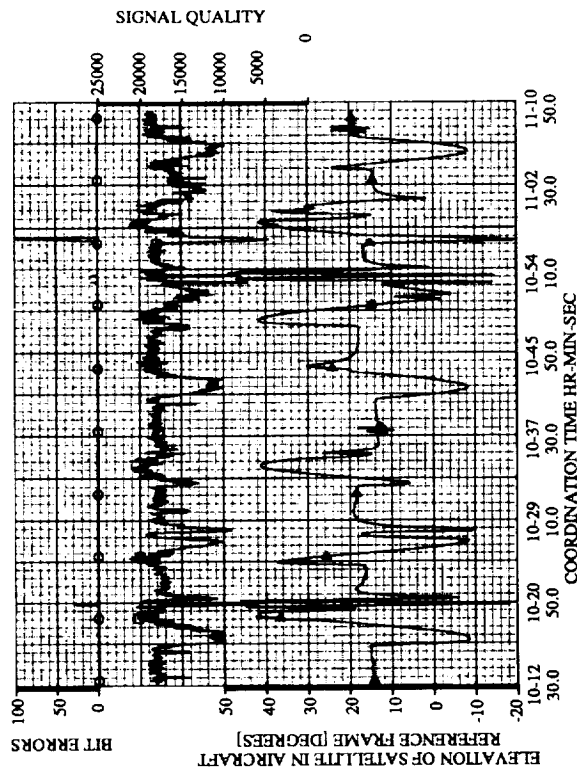
Fig. 6. Flight Test Data For Sedar Waypoint Maneuvers

Figure 6 shows the elevation of the satellite, the signal quality and the bit errors recorded over a period of time spanning the flight maneuvers conducted at the Sedar Waypoint (latitude N 45°30.5', longitude W 126°43.0') which is off the west coast of the state of Oregon. This geometry results in multipath from the sea for all azimuth directions. The

nominal elevation to the satellite in an 'earth normal' reference frame at this location is  $16.4^\circ$ . It can be seen from figure 6 that the system continued to operate with a low number of bit errors when the satellite was below the aircraft reference frame horizon (as much as  $10^\circ$ ). However, as would be expected, at some very low elevation angles, (greater than  $12^\circ$  below the horizon), the receiver lost lock and a high number of bit errors is indicated.

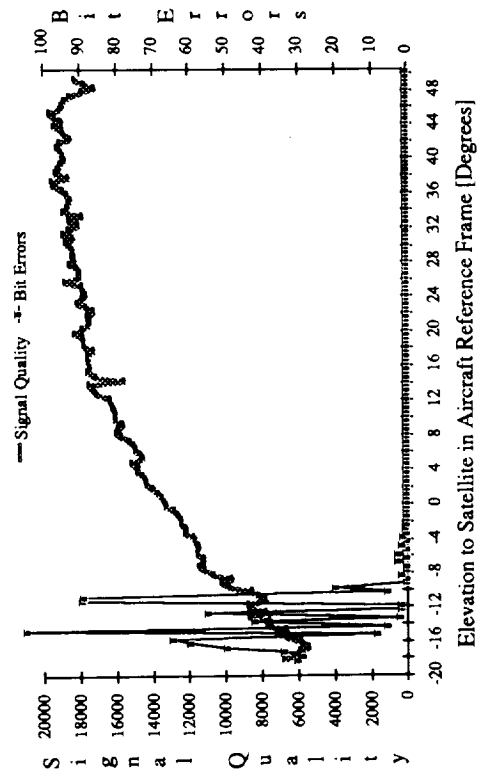
Fig. 7. Flight Test Data For Sedar Waypoint Maneuvers

Figure 7 shows the average signal quality level and bit errors as a function of the elevation of the satellite relative to the aircraft antenna reference frame. This function was produced by averaging the data taken over the time period illustrated in figure 6.
