FIELD TRIP GUIDEBOOK ON

ENVIRONMENTAL IMPACT OF CLAYS ALONG THE UPPER TEXAS COAST

Clay Minerals Society 28th Annual Meeting
Houston, Texas

October 5-10, 1991
Houston, Texas

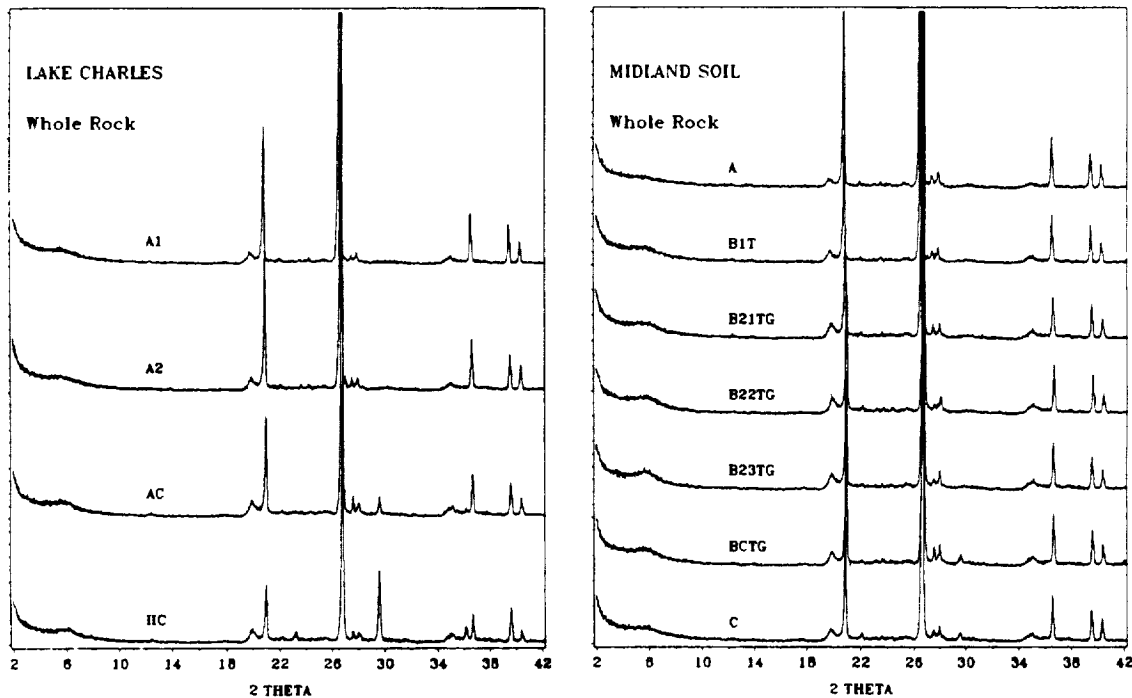
FIGURE 1-4. X-ray diffractograms of whole soils for the Lake Charles and Midland soils (Cu-K α radiation). The coarse fractions of these soils is predominantly quartz with minor amounts of feldspar. Carbonates are present in the lower horizons.

The mineralogy of the coarse fractions of the Lake Charles soil is predominantly quartz with minor amounts of feldspar. The lower horizons contain calcium carbonate which reflect the calcareous parent material in which these soils have formed (Fig. 1-4). The clay fraction of the Lake Charles soil is predominantly smectite with minor amounts of mica and kaolinite present (see Figs. 1-5 & 1-6). There is very little variation in clay mineralogy within the profile.

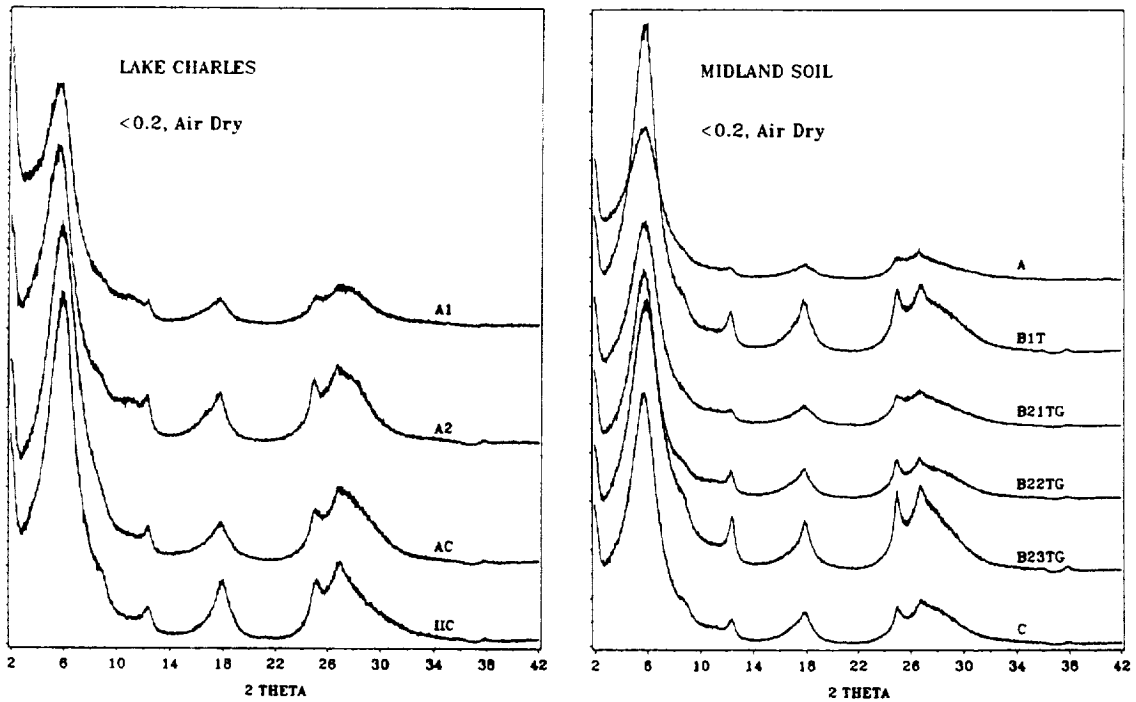
FIGURE 1-5. X-ray diffractograms for the $< 0.2 \mu\text{m}$ Mg-saturated clay fractions for the Lake Charles and Midland soils (Cu-K α radiation).

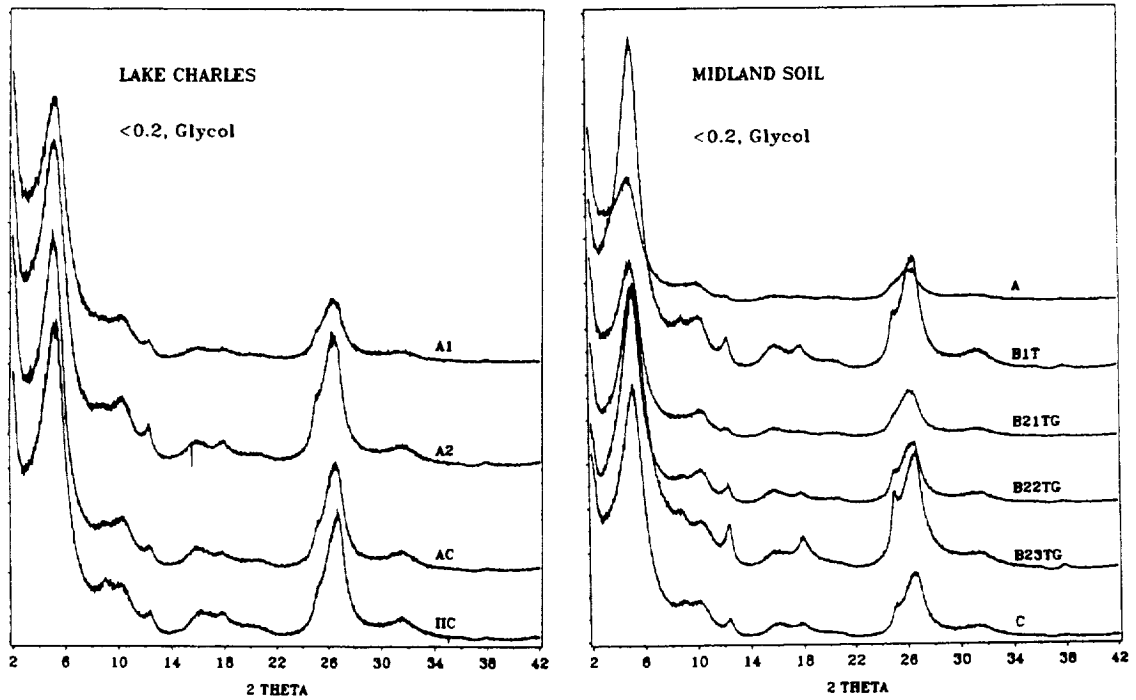
FIGURE 1-6. X-ray diffractograms for the $< 0.2 \mu\text{m}$ Mg-glycol clay fractions for the Lake Charles and Midland soils (Cu-K α radiation). The clay fraction is predominantly smectite with minor amounts of kaolinite and mica present.

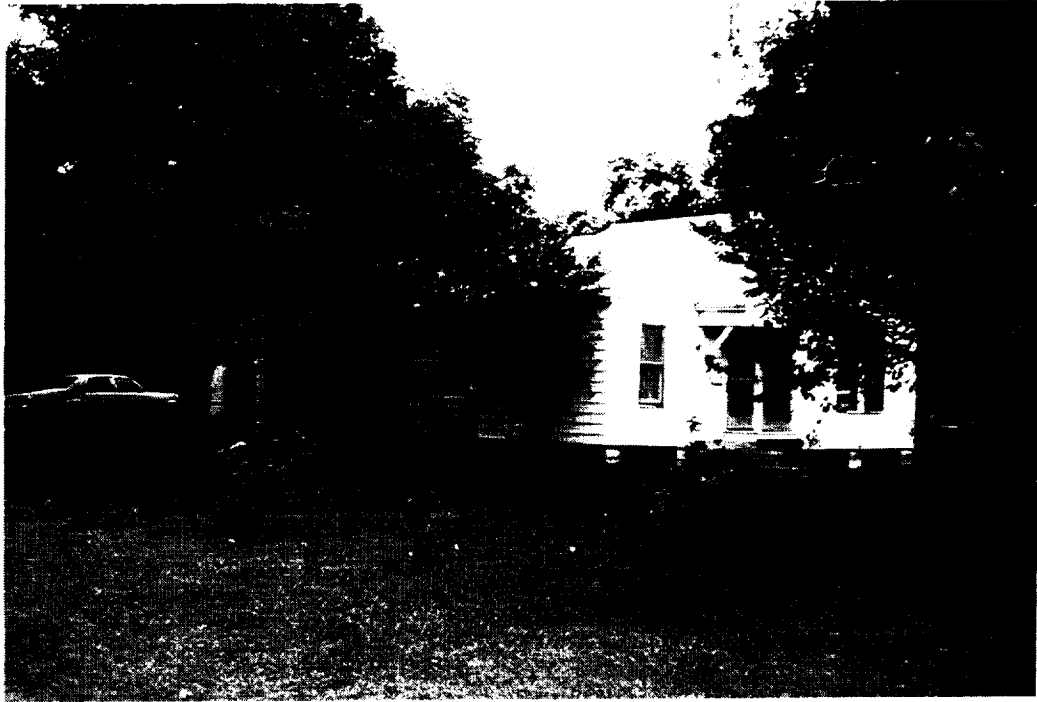
FIGURE 3-3. Residence that straddles the Wooster fault in Baytown.

Differential subsidence across a fault is to be expected and much of the environmental hazard associated with faults occurs on the downthrown side.

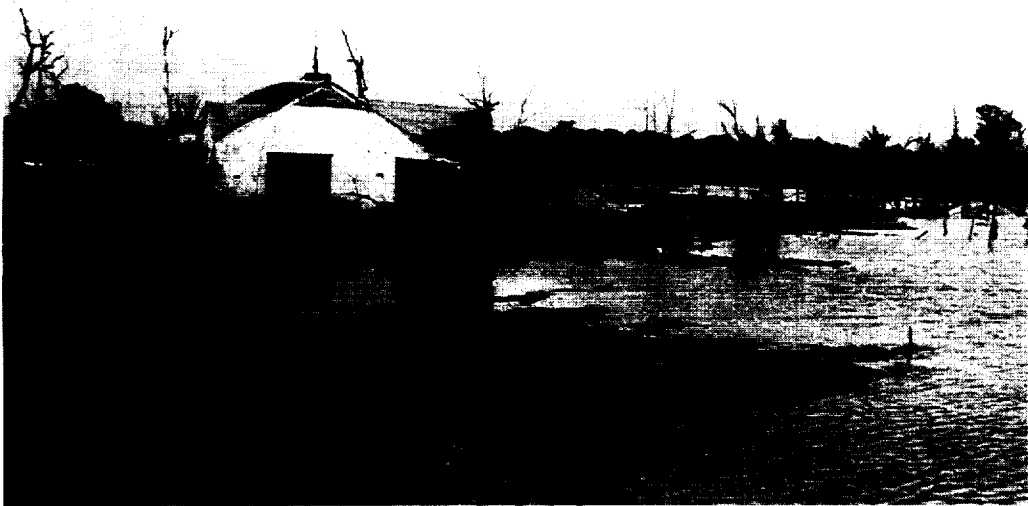
FIGURE 3-4. Submerged house in the Brownwood subdivision, Baytown, Texas.

A total of over 8 feet of subsidence has occurred since 1938 when building first began in the Brownwood Subdivision. Elevation at that time was about 10 feet (3.3 m) above sea level. At times in the past the rate of subsidence in this area was measured in inches per year. By 1961 when Hurricane Carla hit the Houston area the subdivision had lost 4 feet of elevation. Homeowners fought periodic flooding due to high tides, high winds, and storm surges until 1983 when

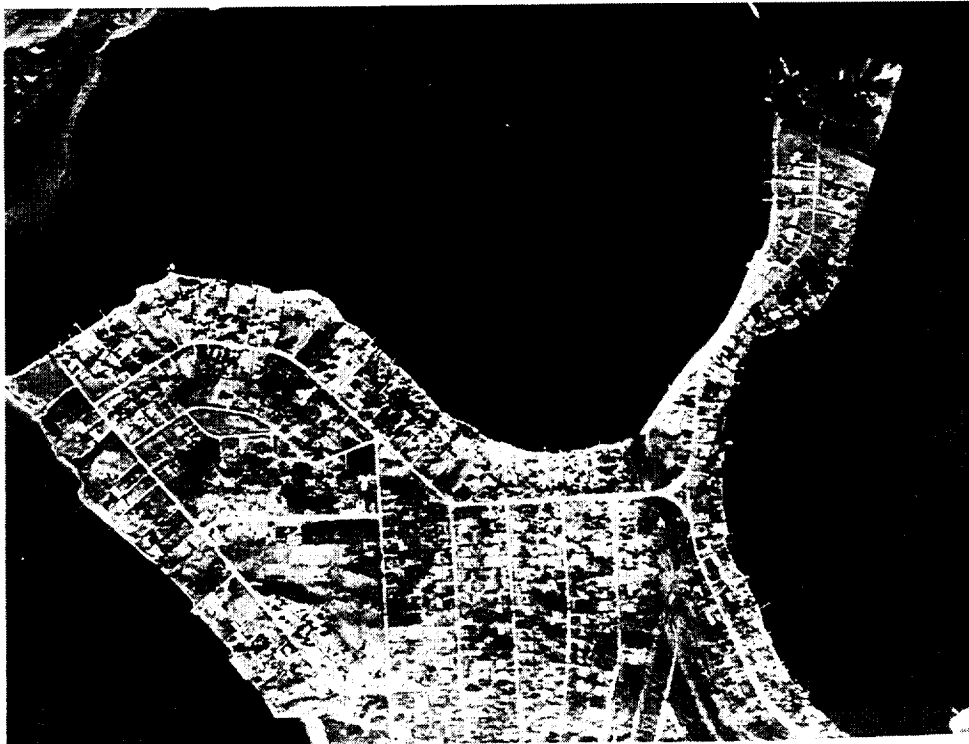
FIGURE 3-5. Aerial view of the Brownwood subdivision in 1964.

The progressive subsidence of Brownwood is clearly demonstrated by comparing the aerial photo in Figure 3-5 with the present view. In the 1940s, a

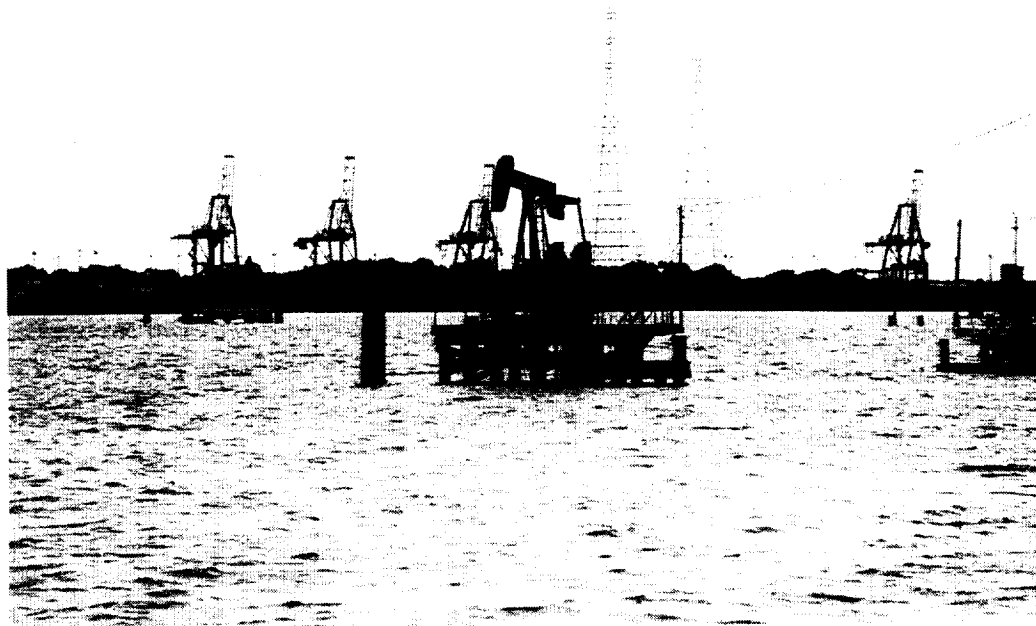
FIGURE 3-8. Submerged oil wells in the Goose Creek Oil Field near Baytown, Texas. These wells were once located on dry ground until subsidence in the oil field left them in their current, partially-submerged state.

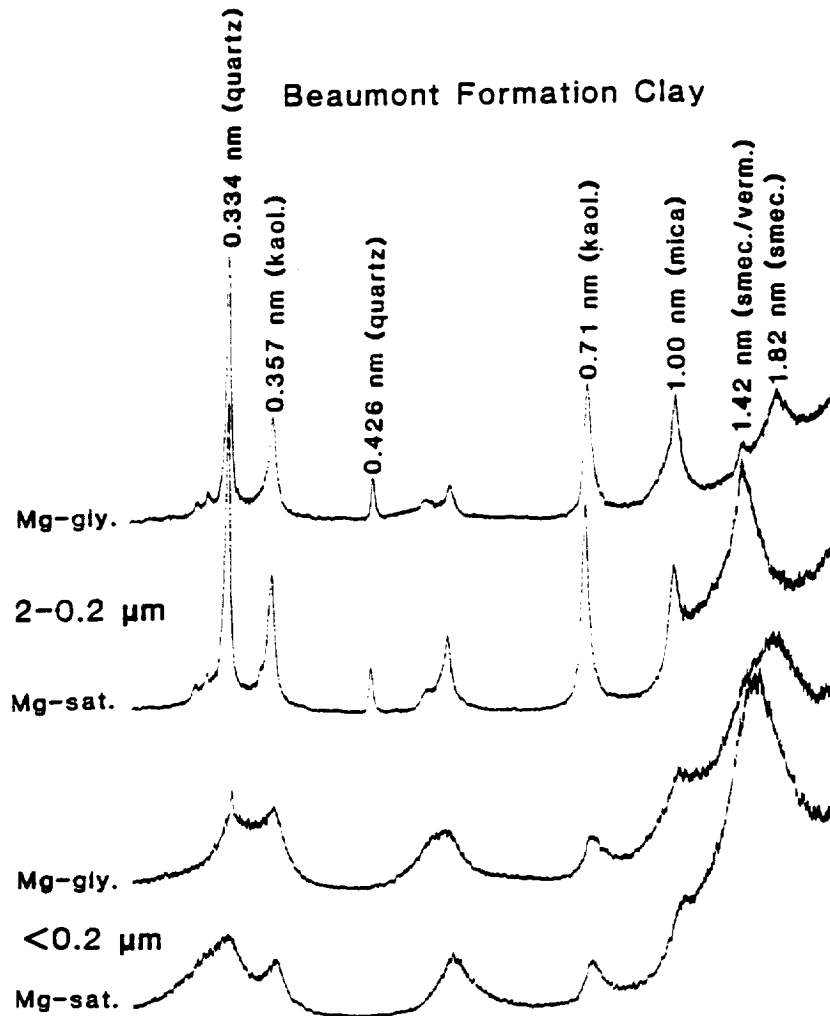
FIGURE 4-6. X-ray diffractograms of Mg-saturated clay-sized fractions of the Beaumont Formation clay from GCA's Campbell Bayou Facility. For the Mg-saturated and glycerated fractions, the 2.0 μm to 0.2 μm diffractogram revealed smectite, kaolinite, mica, and quartz peaks. The diffractogram of the < 0.2 μm fraction showed a large smectite peak, with lesser peaks for kaolinite, mica, and quartz. The peak located at 1.42 nm expanded in both clay fractions when glycerated to 1.82 nm, indicating smectite (Tuck, 1991).

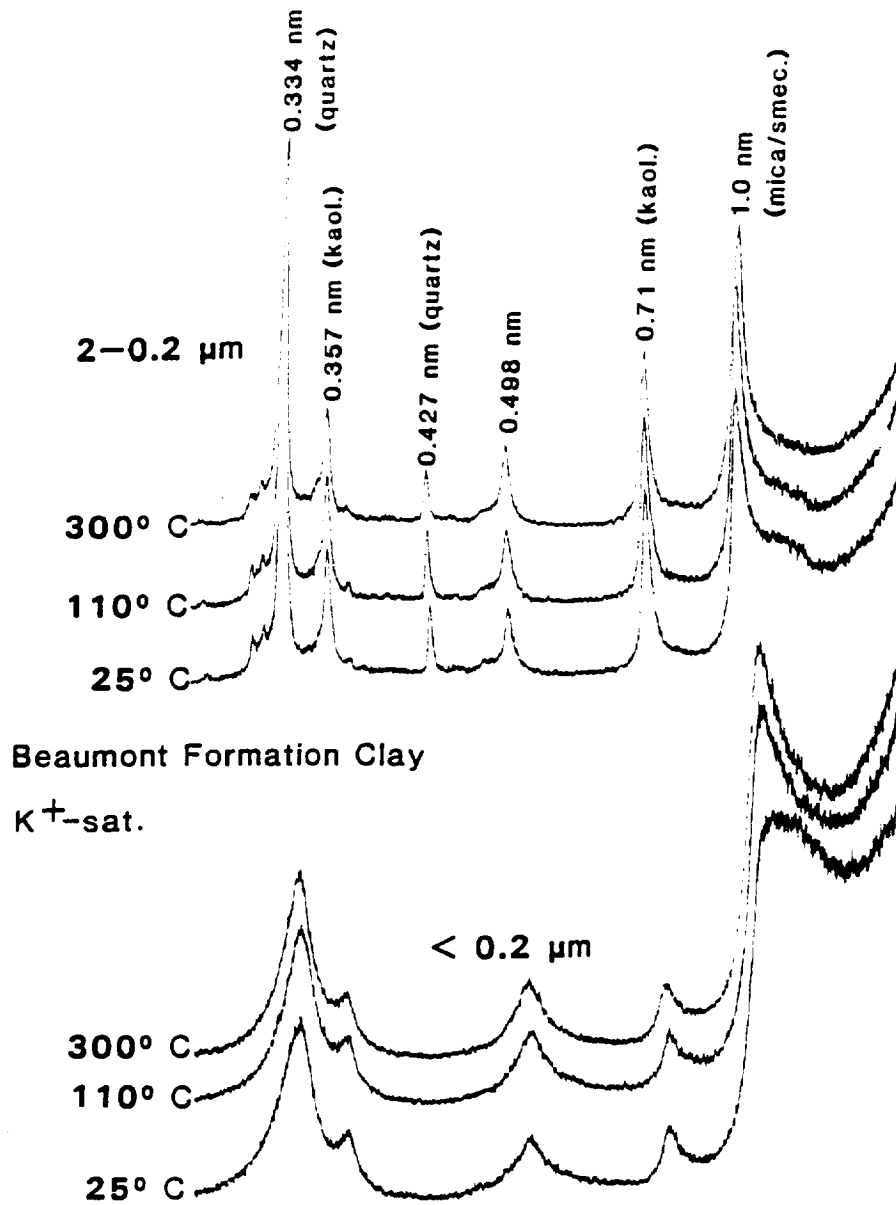
FIGURE 4-7. X-ray diffractograms of K-saturated clay-sized fractions of the Beaumont Formation clay from GCA's Campbell Bayou Facility. Heat treatments of K-saturated clays indicated the presence of smectite, kaolinite, mica, and quartz (Tuck, 1991).
