DESIGN AND DEVELOPMENT  
OF THE  
REDUNDANT LAUNCHER STABILIZATION SYSTEM  
FOR THE  
ATLAS II LAUNCH VEHICLE

M. Nakamura\*

The Launcher Stabilization System (LSS) is a pneumatic/hydraulic ground system used to support an Atlas launch vehicle prior to launch. This paper describes the redesign and development activity undertaken to achieve an LSS with increased load capability and a redundant hydraulic system for the Atlas II launch vehicle.

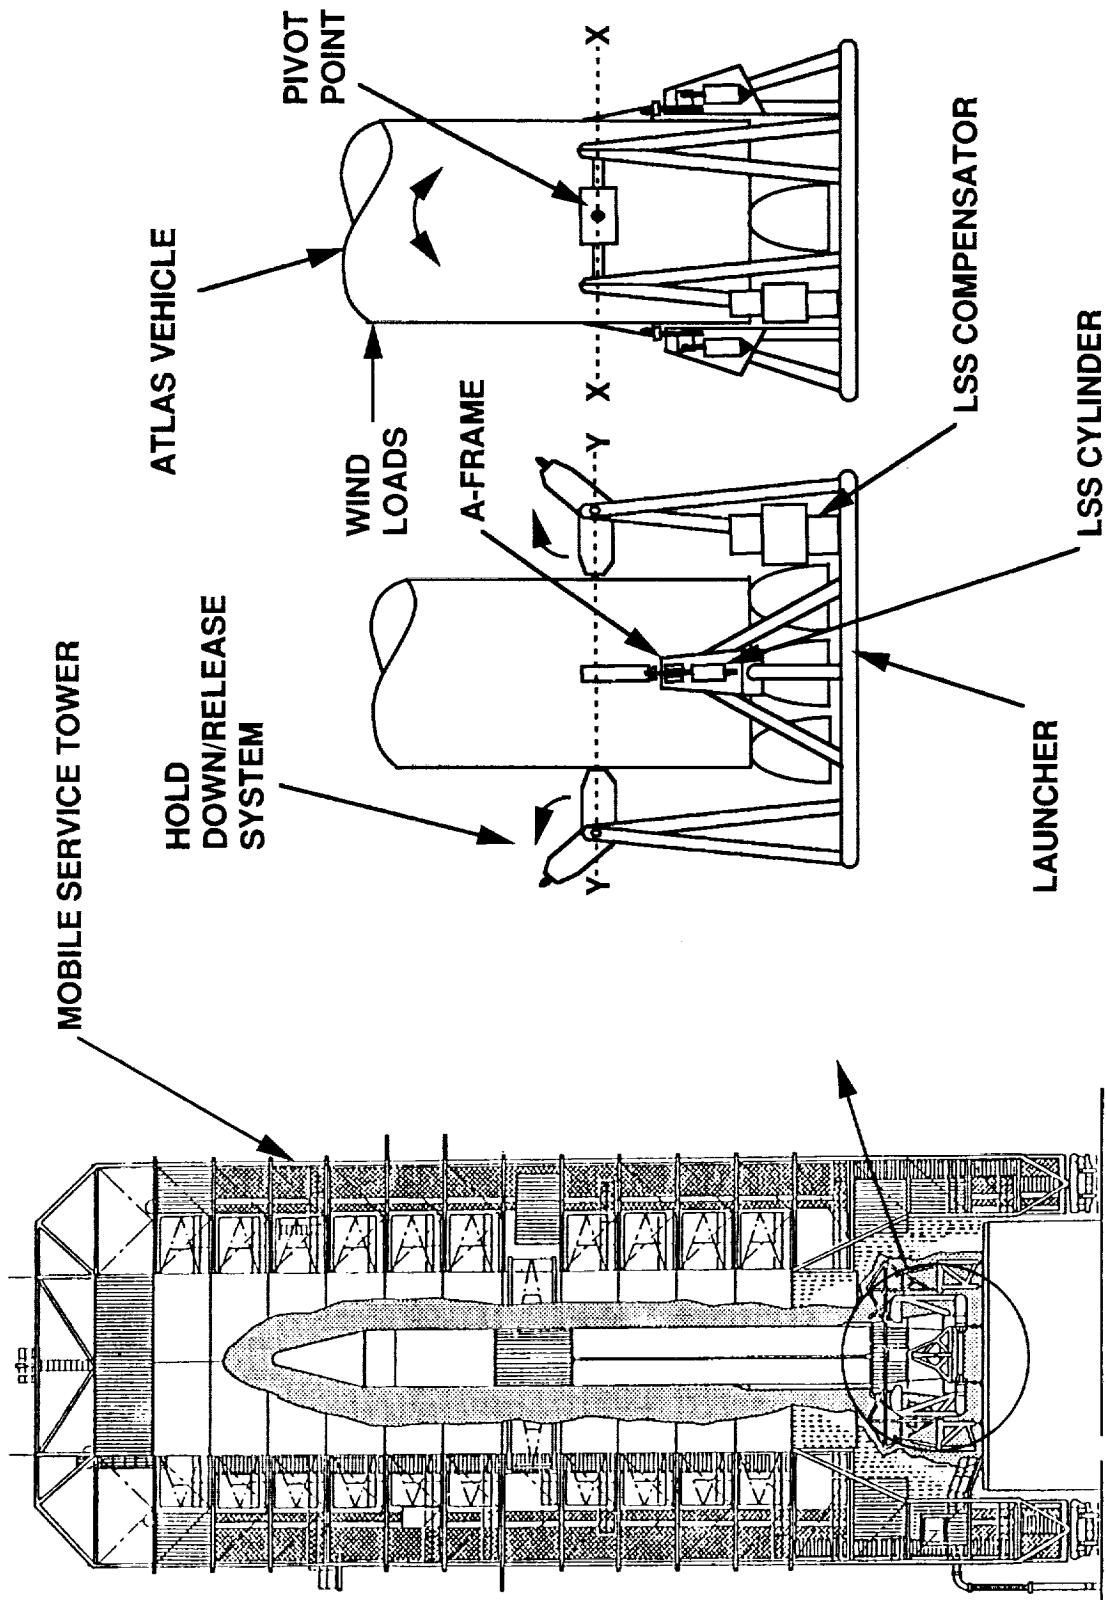
Figure 1. Atlas Ground Launcher System

The Atlas ground launcher system (see Figure 1) consists of a large, welded steel structure that is firmly anchored to the launchpad along with pneumatic and hydraulic systems. The holddown and release (HD/R) system serves the primary role of supporting the vehicle prior to launch and releasing the vehicle when commanded. The vehicle is restrained from flight by two holddown pins mounted on the launcher structure acting in the Y-Y plane. The vehicle can freely rotate about this axis. At liftoff, the HD/R system retracts these pins and rotates the

entire assembly away from the vehicle. The LSS is also part of the ground launcher system and provides an upward, balancing force called preload in the X-X plane to the outside structure of the vehicle to preclude it from toppling over. The LSS provides this force to the vehicle from the uppermost portion of the launcher structure called the A-frame.

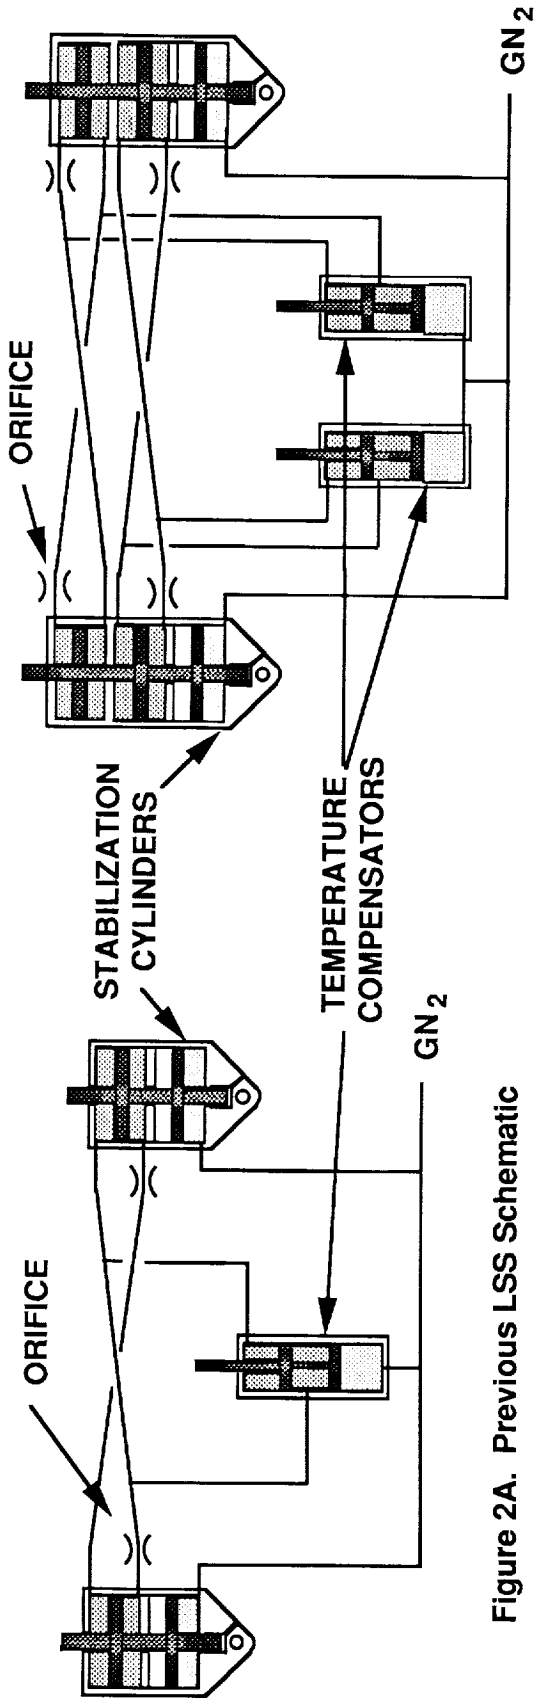
Figure 2A. Previous LSS Schematic

The previous design of the LSS used a passive hydraulic system that was pressurized with gaseous nitrogen (GN<sub>2</sub>) but did not have a redundancy feature (see Figure 2A). An increase of the component sizes in this configuration would only meet the primary goal of supporting the vehicle. Therefore, the first task was to determine a system configuration with a redundancy feature that would support the vehicle. A series of trade studies were performed to evaluate several system configurations (see Figures 2B, 2C, and 2D). Each system was evaluated for basic capability, redundancy, simplicity, and cost. After the configurations were analytically modeled through computer simulation and static analysis, the proposed schematic of Figure 2D was selected.

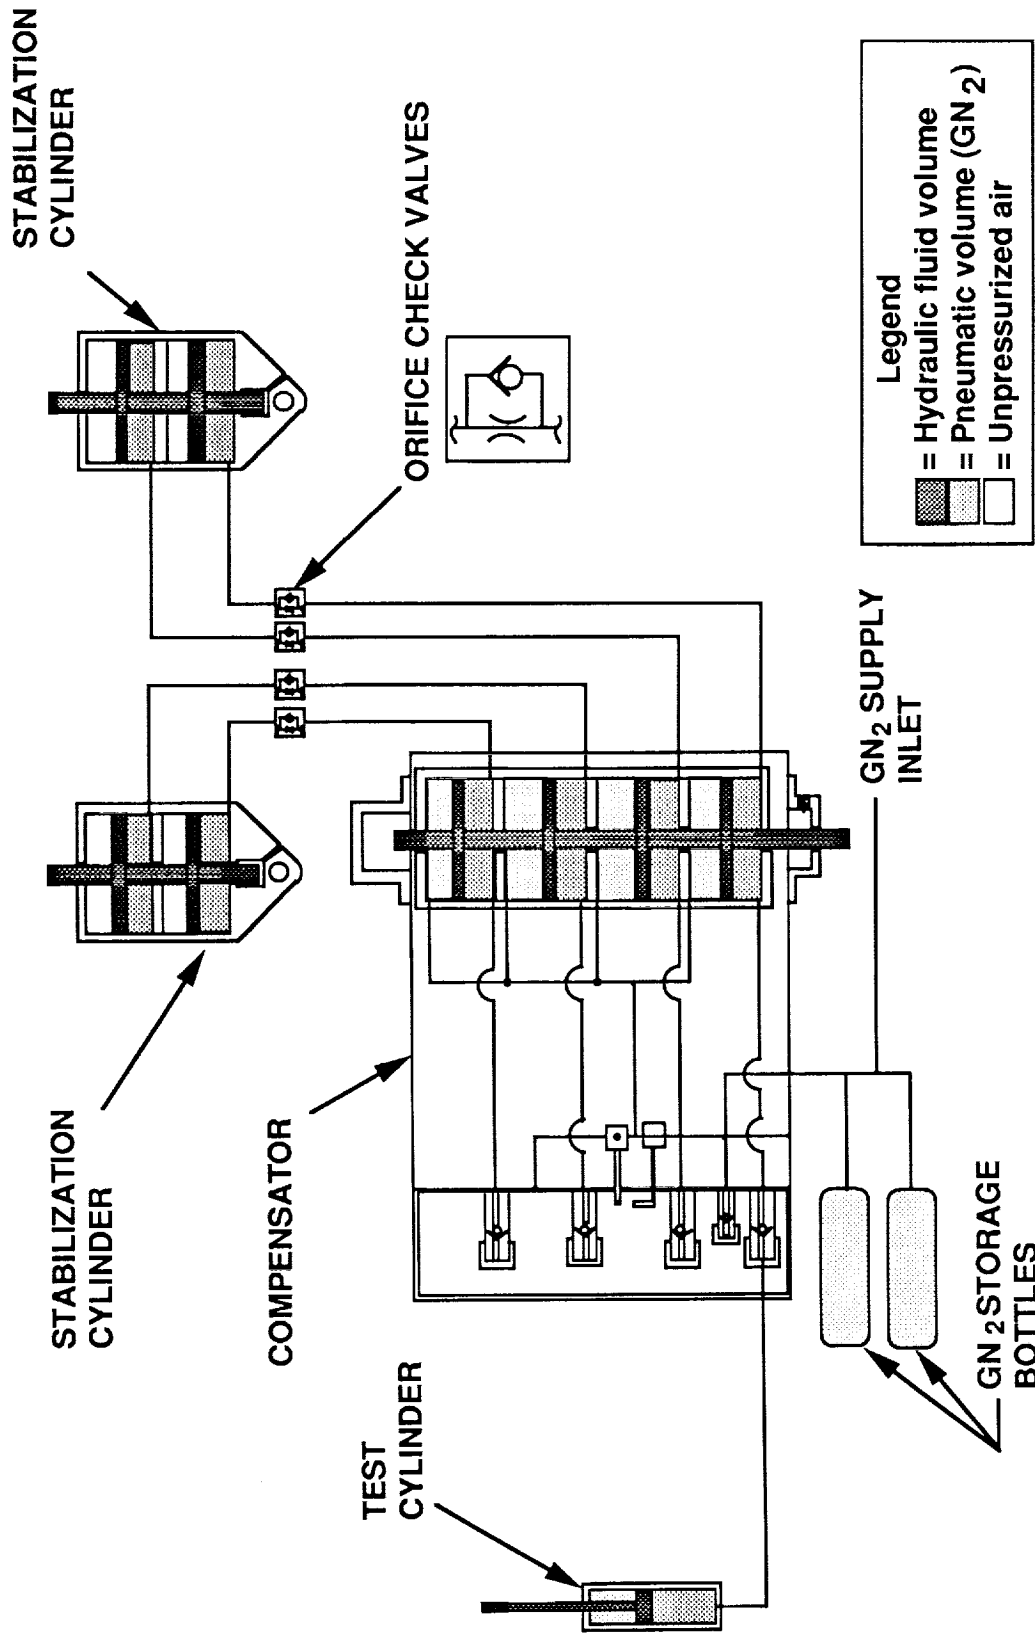
Figure 3. New LSS schematic

point where it could not properly respond to vehicle motions. In addition, the cylinders required many flexible hoses to connect the system together. These hoses would have expanded with pressure, which would also have reduced system performance as well as provide potential failure points. As a result, the configuration was refined to a tandem cylinder and four-piston, common shaft compensator design (see Figure 3).

The operation of this new system is simple but elegant. GN<sub>2</sub> is used to pressurize all four pistons of the compensator. This pneumatic force acts on these pistons, which are, in turn, hydraulically connected to the tandem cylinders. Two separate hydraulic circuits are routed to each cylinder and the resultant forces from each hydraulic circuit are then joined to apply the balancing force to the vehicle. When a wind gust acts on the vehicle structure, the LSS responds immediately by countering the vehicle force with an increase in the LSS hydraulic system pressure on that side. This pressure increase is possible as the compensator simply shifts the amount of "effective" pneumatic force to the piston/circuits that demand it. This transfer of force also results in a reduction in the preload on the opposite side—a subtle feature that aids the LSS balancing efforts by minimizing the preload on the side that is actually aiding the wind in trying to tip the vehicle.

The redundancy of the LSS is possible through the use of the two individual hydraulic circuits on each side of the vehicle. If one of the circuits develops a leak, the remaining circuit pressure will essentially double to maintain support of the vehicle. The increase in hydraulic pressure is possible as the compensator pneumatic force shifts to the remaining circuit.

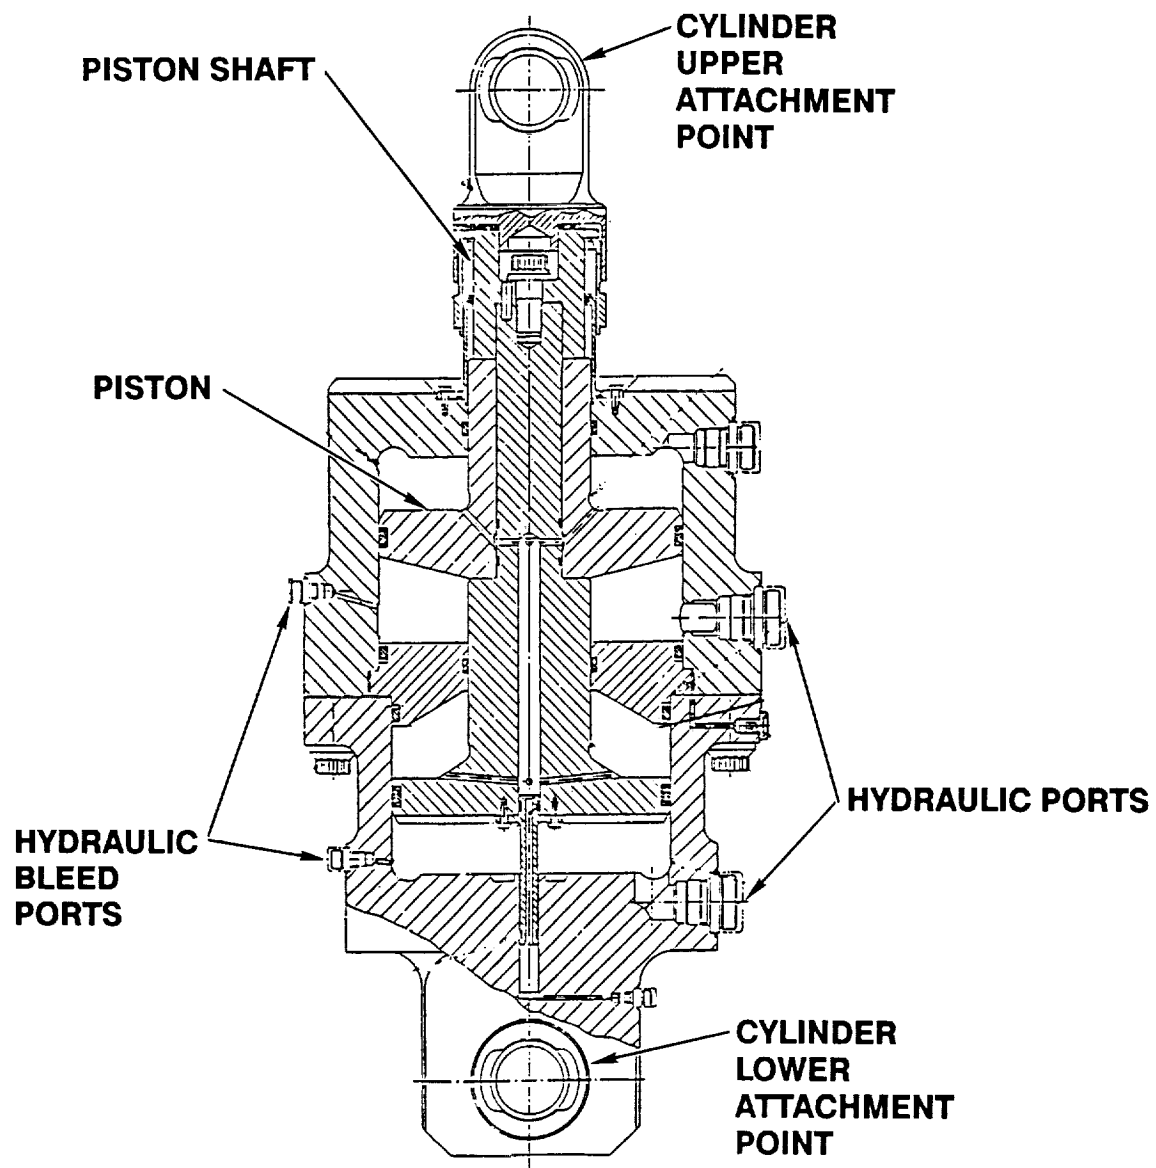
Figure 4. LSS cylinder assembly

During fabrication of the LSS components, the size and weight of the units made machining or even simply moving items very difficult. A fully assembled cylinder weighs about 2,225 N (500 lb) and a compensator weighs approximately 8,900 N (2,000 lb) (See Figures 4 and 5). Aside from the weight, the size and shape of the items also contributed to the difficulty. Specialized tooling was required to hold, lift, move, or even turn items. This was accomplished by using portable gantry-type cranes, special lifting adapters, and wheeled dollies.

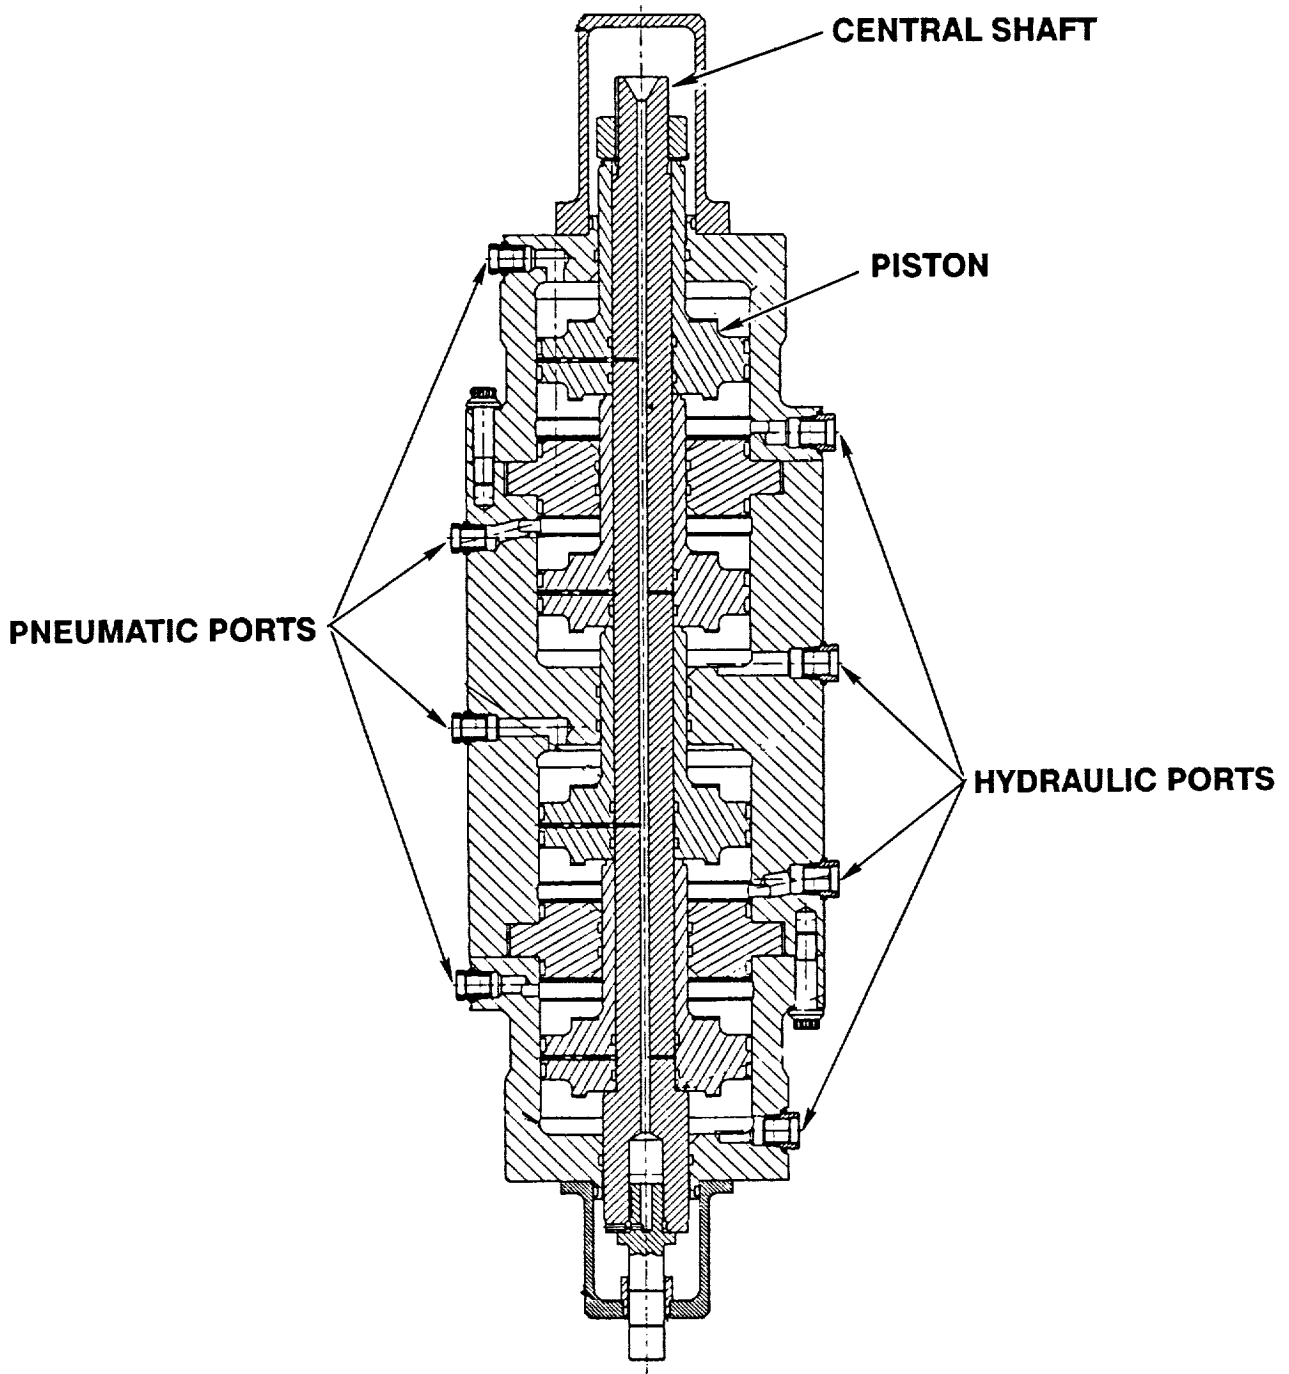
Figure 5. LSS compensator assembly

The LSS compensator piston assembly consists of four individual pistons stacked together (see Figure 5). They are held together by a nut and bolt assembly on a central shaft. The entire assembly had to be mechanically preloaded to ensure there was no free play that would degrade system performance. Unfortunately, there was no way to physically apply the load and still torque the nut. The problem was solved by initially assembling the pistons, then pneumatically pressurizing the entire assembly. The nut was tightened, and when the pneumatic pressure was removed, the assembly was automatically preloaded and the four individual pistons acted as a single unit.
