NASA Technical Memorandum 103708

# Thermal Barrier Coating Evaluation Needs

William J. Brindley and Robert A. Miller  
*Lewis Research Center*  
*Cleveland, Ohio*

Prepared for the  
Conference on Nondestructive Evaluation of Modern Ceramics  
cosponsored by the American Ceramic Society and the American  
Society of Nondestructive Testing  
Columbus, Ohio, July 9-12, 1990

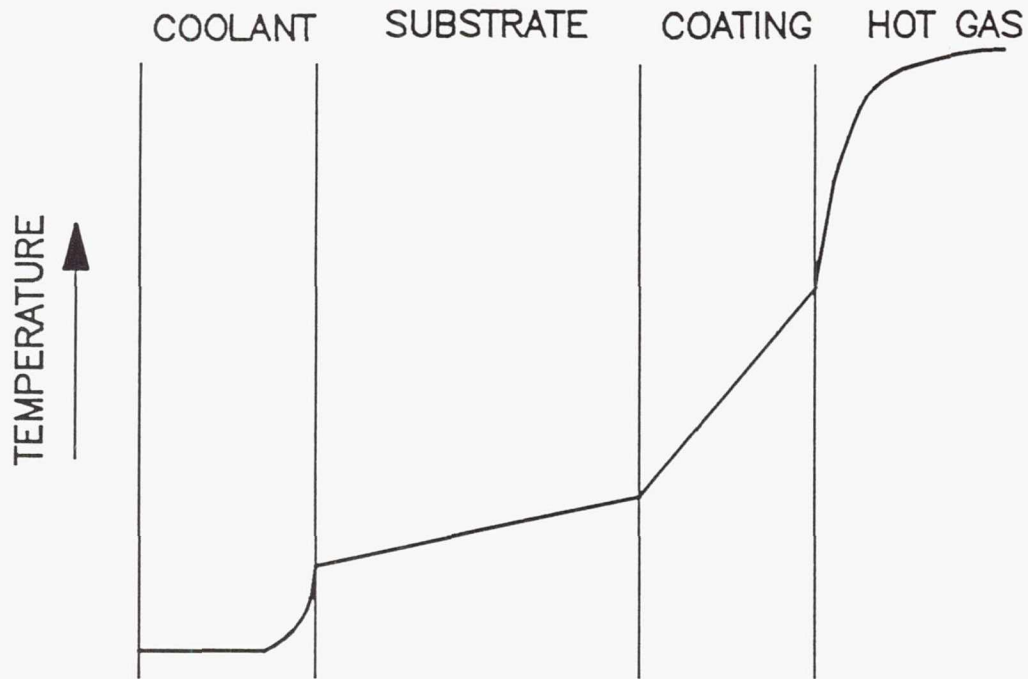
Figure 1. Schematic of the thermal barrier coating concept showing the hot gas heat source, the insulating layer, the component (substrate) and the component coolant.

The Thermal Barrier Coating (TBC) concept involves placing a thermally insulating layer between a cooled metallic component and the hot working gas to reduce heat transfer to the component (Fig. 1). Reduced heat transfer translates to a reduced component steady state temperature, less severe heating and cooling transients and a reduction in the severity of temperature gradients. The insulating material for the majority of applications consists of a ceramic layer. The actual design of a TBC, however, changes significantly with the specific application. TBCs designed for use in aircraft turbine engines and in low heat rejection (LHR) diesel engines will be reviewed here with a view to examining important aspects of TBCs that must be characterized for quality control, in-service inspection and continued research and development purposes.

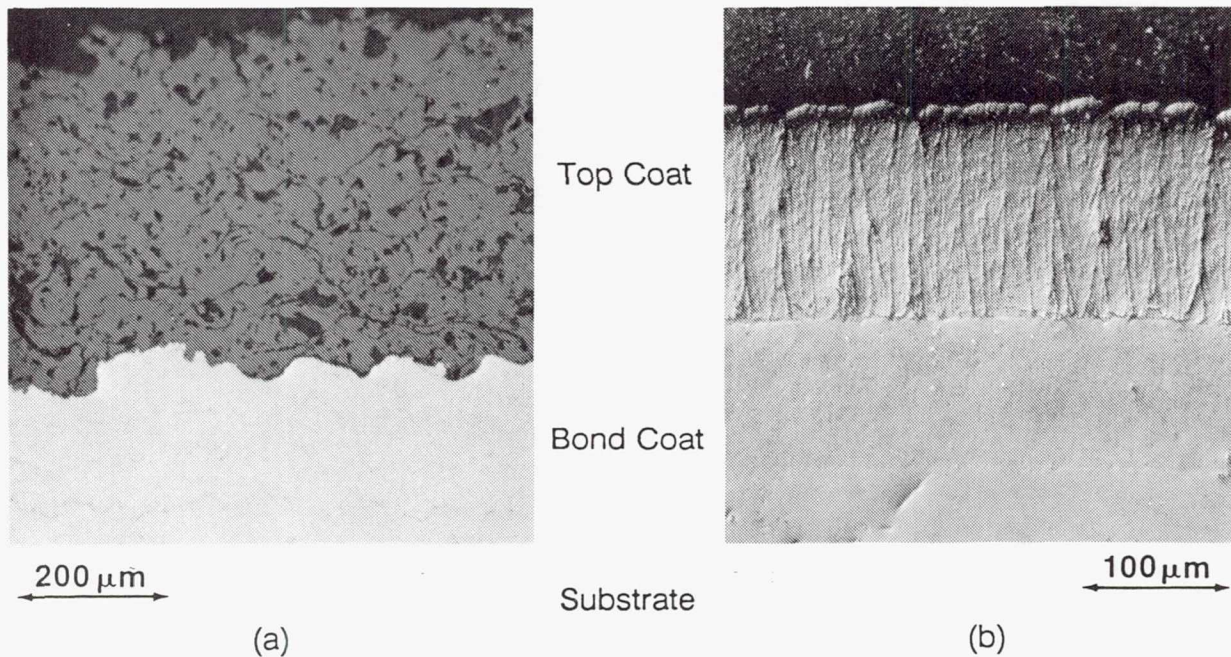
Figure 2. Optical micrographs of (a) a plasma sprayed two layer TBC showing porosity and cracks and (b) an EB-PVD two layer TBC showing a columnar structure. Micrograph (b) was taken using differential interference contrast.

TBCs for aircraft turbines and LHR diesel engines are quite different due to the differences in environment for the two applications. The state-of-the-art TBC developed for aircraft gas turbine engines incorporates an outer insulating layer (or top coat) of  $\text{ZrO}_2$ -(6-8)wt% $\text{Y}_2\text{O}_3$  (partially stabilized zirconia or "PSZ") 0.013 to 0.038 cm thick and a 0.013 cm thick oxidation resistant inner layer of MCrAlY (also called the bond coat), where the "M" is normally Ni, Co or Ni + Co. The common method of application for both layers is plasma spraying, but electron beam-physical vapor deposition (EB-PVD) of TBCs is gaining popularity, especially for deposition of the PSZ layer<sup>2</sup>. These two methods of deposition produce coatings with significantly different microstructures (Fig. 2).

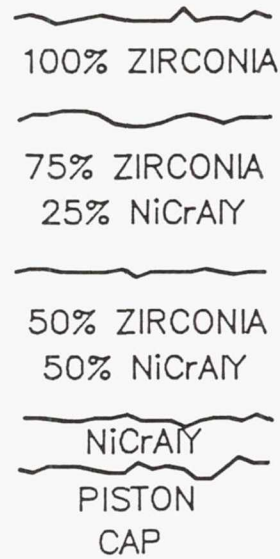
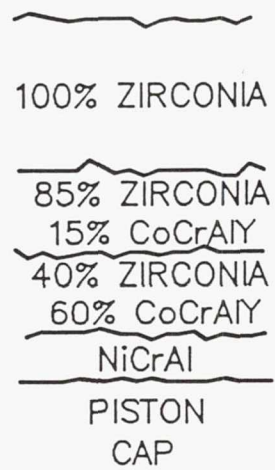
Figure 3. Schematics of the four layer graded coating approach to fabricating LHR diesel engine TBCs used by (a) Caterpillar and (b) Cummins/UTRC.

concentrate coefficient of thermal expansion (CTE) mismatch stresses at the top coat/component interface and therefore have poor durability. Improved durability for thick coatings is achieved by "grading" the CTE of the coating through the coating thickness. Grading is accomplished by applying a 100% metallic bond coat layer followed by successive layers of coating with decreasing fractions of bond coat material and increasing fractions of PSZ ceramic. This type of coating achieves a bulk CTE that changes gradually from the substrate to the outer surface. Current generation diesel TBCs achieve reasonable durability with up to four grading layers from the bond coat to the top coat and a total coating thickness of 0.25 cm or greater<sup>3,4</sup> (Fig. 3).

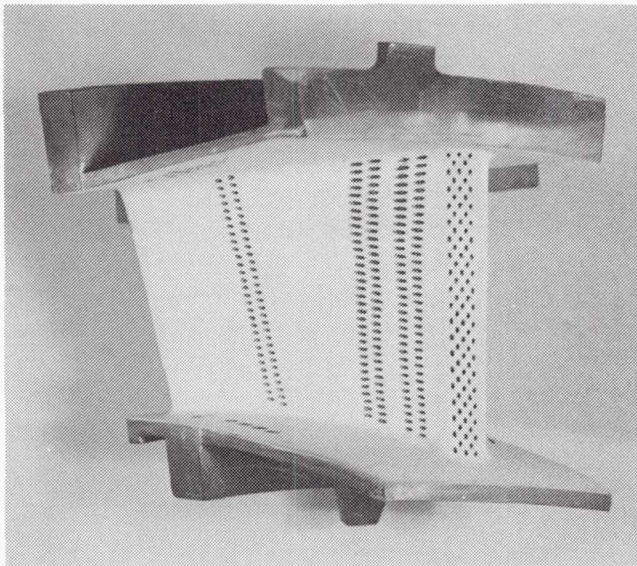
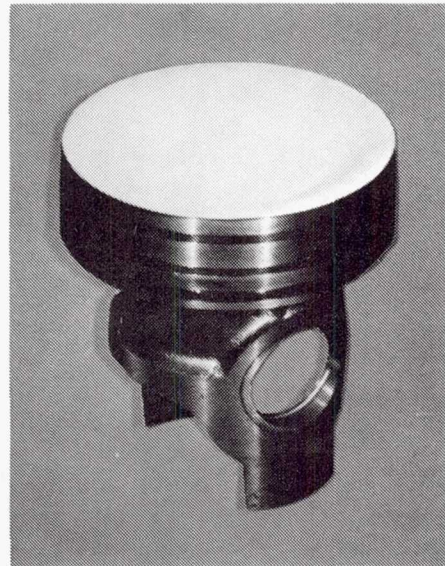
Figure 4. An aircraft gas turbine engine second stage stator vane (a) and a piston cap (b) are examples of components that can benefit from the use of TBCs.

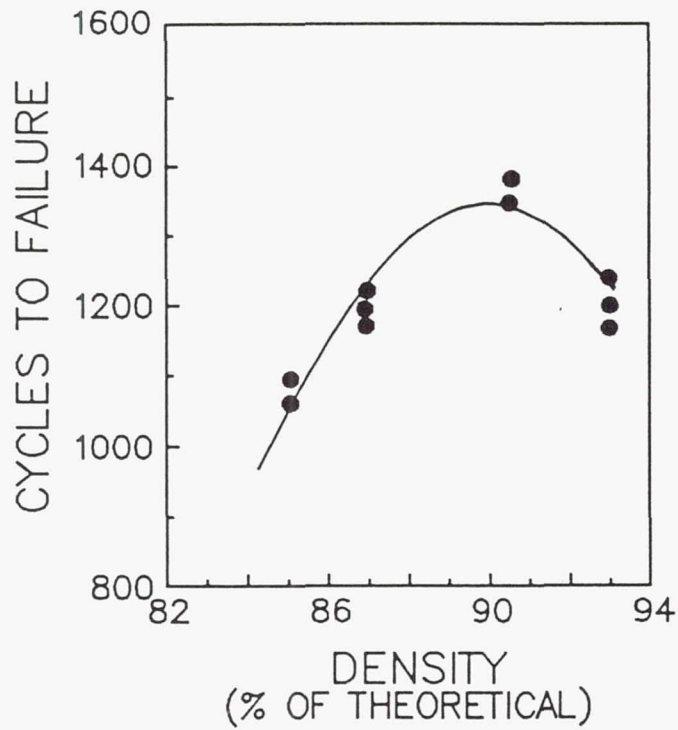
Figure 5. Cyclic life of an aircraft engine two layer TBC as a function of the density of the top coat<sup>7</sup>. The density is expressed as a percentage of the theoretical density.

The density of a plasma sprayed top coat (as a fraction of the theoretical density) is critical to the life of an aircraft engine TBC<sup>5,7,8</sup> as shown in Figure 5, is suspected to be important to the life of an EB-PVD aircraft TBC and may also be important to diesel engine TBCs<sup>3</sup>. Density variations may occur as a result of process variations or may result from the combination of part shape complexity and the line-of-sight deposition processes that are used. The effect of density on plasma sprayed TBC durability is a result of the strain tolerance gained through porosity and cracking in the top coat<sup>5,8</sup> (Fig. 2). The dependence of TBC life on the amount of porosity is complex in that the ratio of equiaxed pores to flat crack-like pores changes with density. Thus, it is not clear if top coat durability should be a strict function of density or a function of both density and the ratio of the different types of pores. These points have not been addressed due to the lack of adequate means of characterizing the pore content of a TBC. Recent advances in metallographic techniques<sup>9</sup> have made possible metallographic examination of the pore content of coatings and may lead to new information on pore effects on TBC life. Until pore-durability correlations can be made, it is only certain that pore content of a coating is critical to TBC durability. NDE methods that can characterize both density and the pore content of a coating are certain to be useful for both quality control and for research and development.

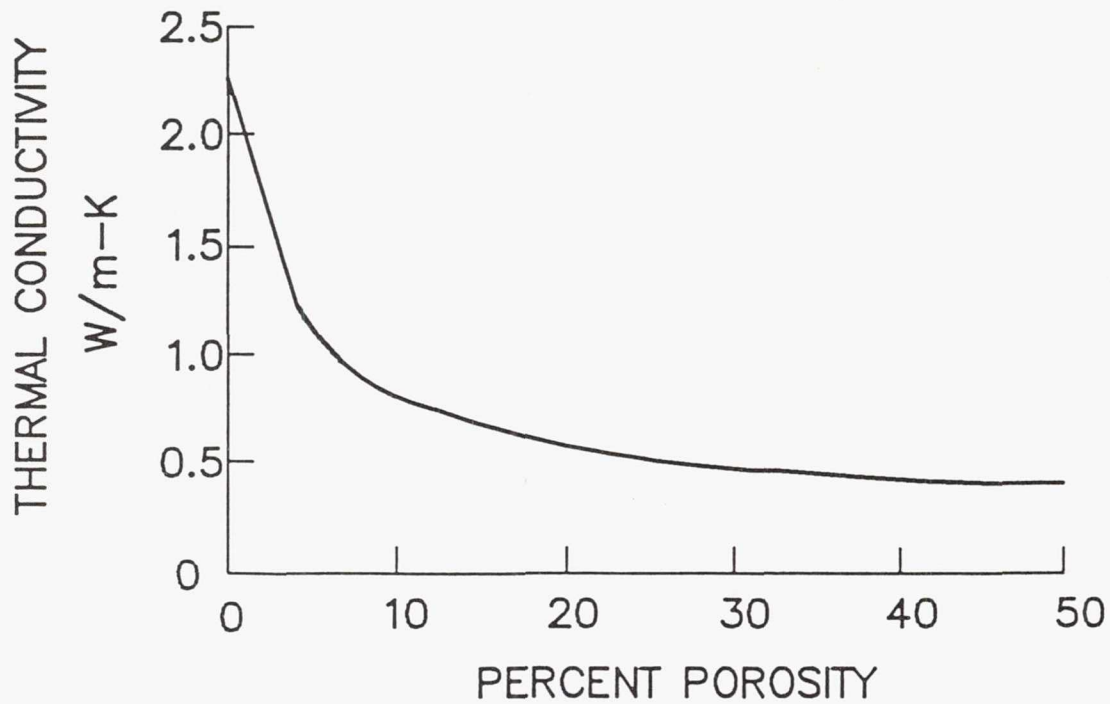
Figure 6. Variation in the conductivity (inverse of insulating ability) of a PSZ layer as a function of PSZ porosity content<sup>10</sup>.

Density also has an effect on the thermal conductivity of a plasma sprayed top coat material. Pores in the top coat act as air gaps that help to reduce the conductivity of the top coat material<sup>10</sup> (Fig. 6). As for durability, the type of pores that are present have a bearing on the conductivity. Flat pores with the major axis perpendicular to the direction of heat flow are more effective in reducing the conductivity of a PSZ layer than are an equal volume of equiaxed pores<sup>10</sup>. Thus, knowledge of pore types and amounts of pores present in a coating could make it possible to estimate the conductivity of a coating on a production part.
