AX-5 SPACE SUIT BEARING TORQUE INVESTIGATION

ABSTRACT

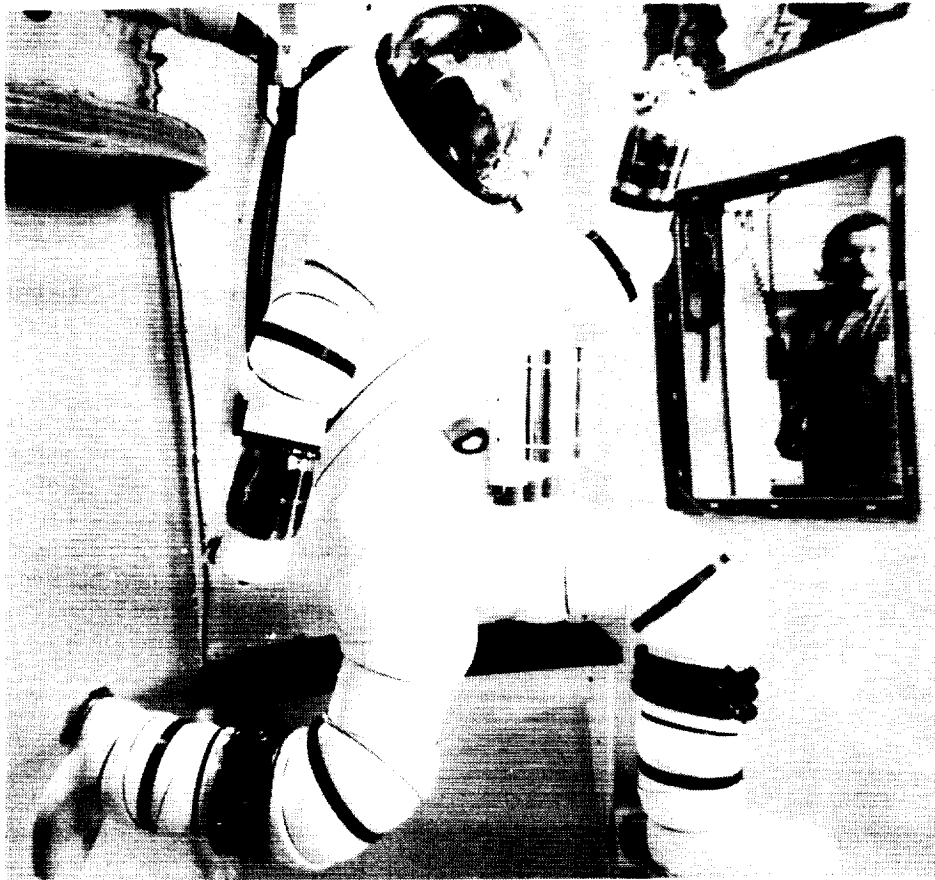
The AX-5 space suit (Fig. 1), developed by the NASA Ames Research Center, exemplifies the next generation of space suit considered for use aboard Space Station Freedom. Its "hard" (aluminum) construction and bearing joints allows for significantly higher internal air pressures [57 kPa (8.3 psig)] than current fabric suit designs [30 kPa (4.3 psig)] without increasing crew work load. The higher internal pressure eliminates the need for extensive crew prebreathing of 100% oxygen prior to an EVA as required by the current shuttle suit. Mobility is achieved through joint rotation, thus suit performance is directly dependent on bearing performance.

Fig. 1 AX-5 Space Suit

There were 34 ball bearings incorporated into the primary joints on the AX-5 suit. The joints included shoulder, elbow, hip, knee and ankle. Each joint contained an interconnected pair of bearings which were oriented at an angle to provide the required joint rotation (see Fig. 1). These bearings ranged in

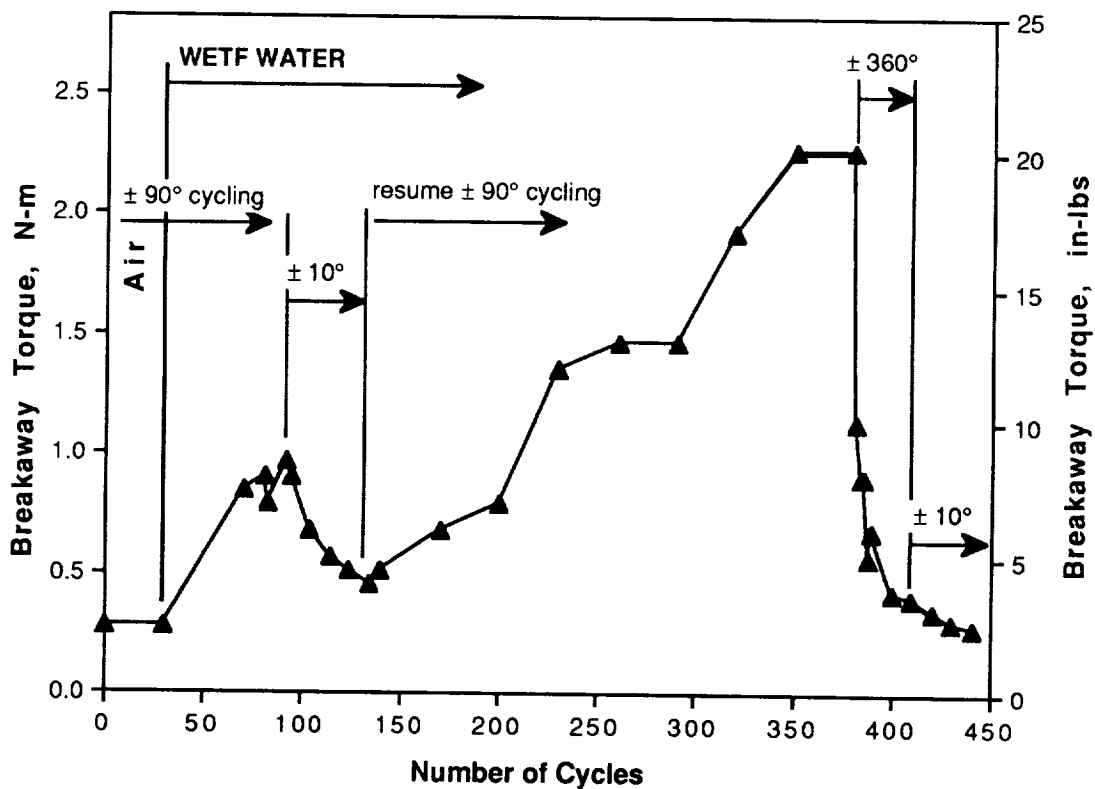
Large torque increases were observed during oscillatory bearing life tests in bench tests with WETF water. An example of a test run on a shoulder joint bearing appears in Fig. 4. Normal breakaway torques were on the order of 0.23 to 0.34 N-m (2 to 3 in-lbs) and grew to more than 2.3 N-m (20 in-lbs) in the wet tests. 360 degree rotations tended to release or reduce the torque build up, as did ± 10 degree cycles. In some cases cutoff torque limits occurred in only 40 cycles.

Fig. 4 Example of Bearing Torque Anomaly from Shoulder Joint Test

The adverse effects of BSV on cage loading for continuously rotating bearings have been known for some time, as discussed in detail by Barrish [4]. An estimate of the contact angle variation of balls as they orbit helps set minimum ball pocket clearances. However, the use of enlarged ball pockets or slots will not necessarily correct the potential torque problems associated with bearings which oscillate back and forth, as observed here. Furthermore unidirectional rotation usually releases or resets bearing torque close to original levels (as illustrated in Fig. 4) while constant stroke oscillations tend to aggravate blocking.

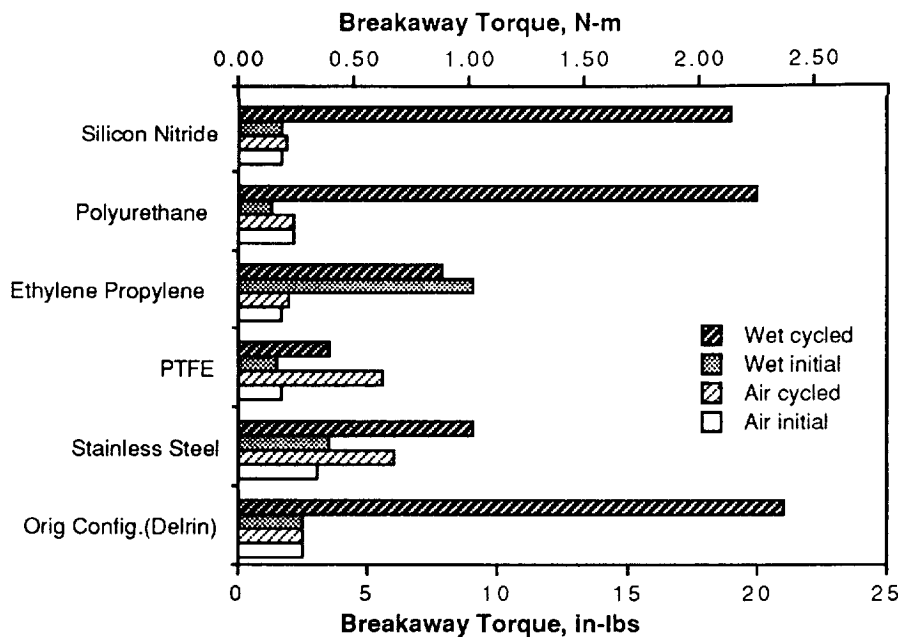
Idler Ball Materials - A series of tests were conducted to identify the right idler ball material and lubricant combination. Fig. 5 synthesizes the breakaway torques of many of the test candidates. This data covered the first 500 cycles or until blocking torque stabilized, whichever ever came first. Black oxide-coated, stainless steel idler balls were tested with both 814Z and Mobil 28 grease, in and out of water. Breakaway torques in water generally started at about 0.3 N-m (2.5 in-lbs) and would climb to 0.8 to 1 N-m (7 to 9 in-lbs) inside of 300 cycles by hand rotation, occasionally drifting down to 0.6 N-m (5 in-lbs) at the end of 500 cycles. Krytox grease (a grease with a PFPE oil similar to 814 Z or 815 Z oils) gave similar results with the baseline Delrin idler balls. A full

Fig. 5 Effect of Different Idler Ball Materials on Shoulder Joint Bearing Torque

complement of stainless steel bearing balls blocked almost immediately. Silicon nitride (Si_3N_4) idlers showed poor water performance, pointing out the importance of a compliant ball separator.

PTFE tube spacers, both large and small diameter, locked up in air in less than 200 cycles with 814 Z oil while PTFE idler balls gave relatively good results both in and out of water. Breakaway torques rose from 0.2 N-m (1.7 in-lbs) initially to 0.6 N-m (5.5 in-lbs) after 450 cycles out of water and 0.45 N-m (4.0 in-lbs) after 570 cycles in water. However, the PTFE balls showed some small dimples (1mm in diameter) under a microscope, indicating that the relatively soft PTFE was undergoing local brinelling.

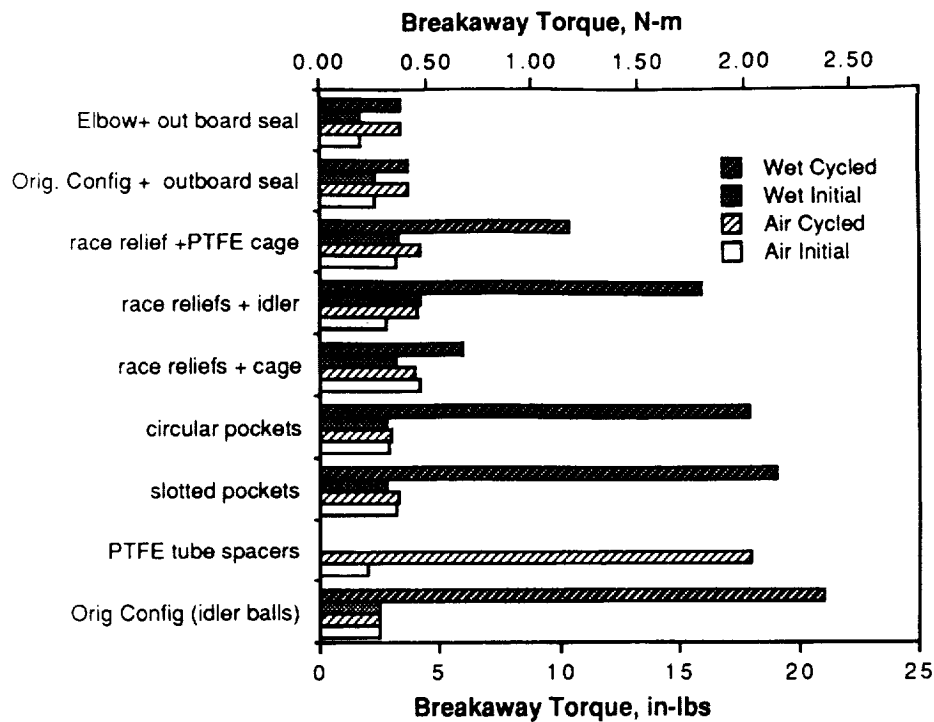
One Piece Cage - Kaydon manufactures a one piece, alternating slotted and circular pocket, snap over cage which it recommends for oscillatory bearings to inhibit torque anomalies. The theory is the slots will allow some free ball migration between back and forth oscillations. There was an interest in evaluating the effectiveness of such a retainer design in relation to other tests conducted, although an existing shoulder joint had to be reworked. The shoulder of the bearing was machined away to accept either a bronze, one piece slotted cage or an enlarged, circular ball pocket cage. Test results (see Fig. 6) showed that the slotted cage exhibited little torque buildup out of water but breakaway

Fig. 6 Effect of Different Geometries, Race Reliefs and Outboard Seals on Shoulder Joint Bearing Torque

torques ranged from about 1.1 to 2.2 N-m (10 to 19 in-lbs) in water. The enlarged circular pocket cage exhibited similar behavior with torques to 2 N-m (18 in-lbs). Spray coating the cages with PTFE kept torques under 0.7 N-m (6 in-lbs) for the first 500 cycles in water. However, there was a persisting risk of PTFE wear through with this approach.

Although remanufacturing all the joint sub assemblies to accept this seal modification was not inexpensive, this approach positively eliminates lubricant wash out as a failure mode. Breakaway torques inside and outside of water remained nearly constant. An elbow joint torque trace covering 1000 oscillatory cycles appears in Fig. 9. Comparison of torque levels from shoulder and elbow joints with other designs is given in Fig. 6.

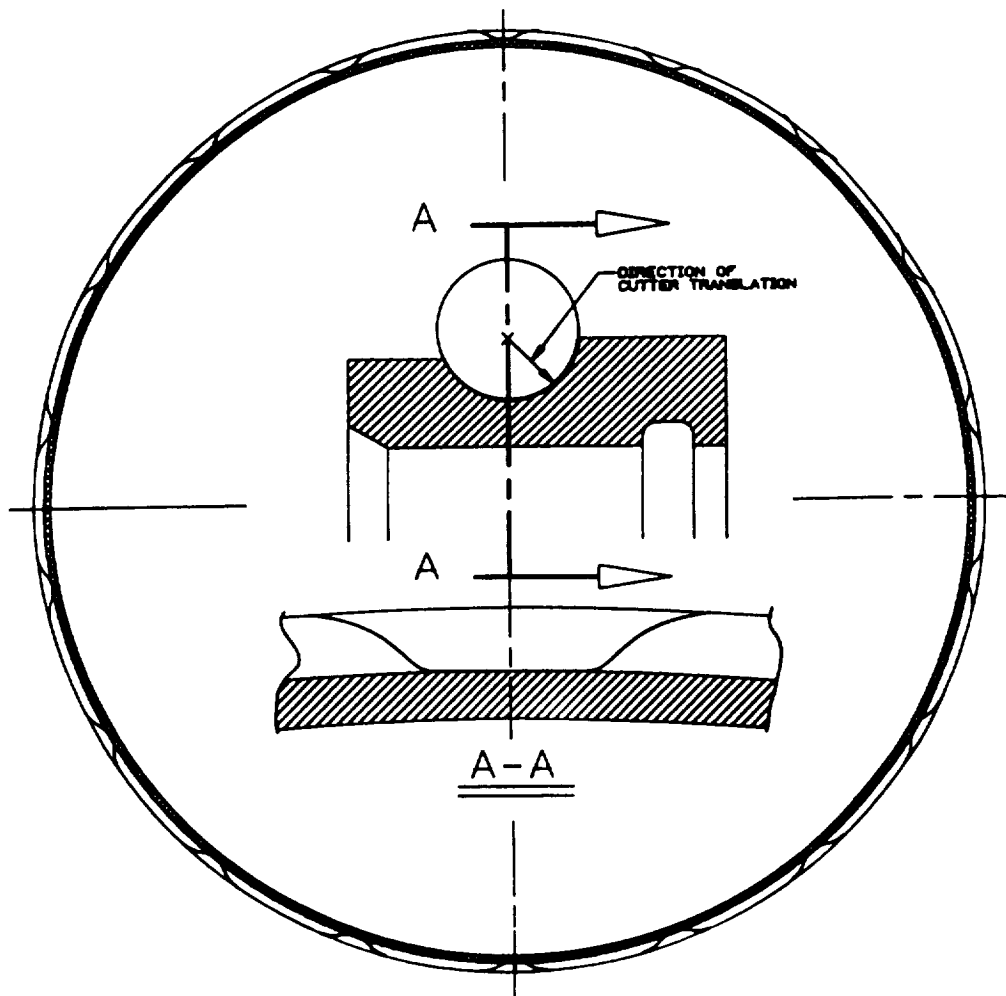
Race Reliefs - The balls are under an essentially constant load in a thrust loaded bearing, so if unequal ball spacing were to occur due to BSV, there is no opportunity to relieve the resulting wind-in torques. However, if a small region of the inner or outer race was recessed, then the ball passing over this relief would be momentarily unloaded and thereby given an opportunity to "release" its pinching load. (For this reason, radially loaded bearings are less apt to experience blocking since some balls can enter the unload zone opposite the radial load contact). Since the AX-5 joints can experience small angular motions, it was necessary to grind in multiple reliefs to be assured that each ball had an opportunity to pass over a relief during limited angular ball travel. Fig. 7 shows the geometry of the race reliefs cut a minimum of 0.002 inch along the nominal 45 degree contact at 18 locations. This depth was about 10 times the expected Hertzian deflection to guarantee ball unloading. Wet tests with a PTFE coated, one piece, circular pocketed, bronze cage exhibited some improvement but less so for a glass- reinforced PTFE cage (see Fig. 6). However, race relief tests with polyurethane idler balls show outstanding performance out of water, although torque once again rose dramatically in water.

Fig. 7 Details of Race Reliefs
