NASA Technical Memorandum 102540

Ultrasonic and Radiographic Evaluation of Advanced Aerospace Materials: Ceramic Composites

Edward R. Generazio
Lewis Research Center
Cleveland, Ohio

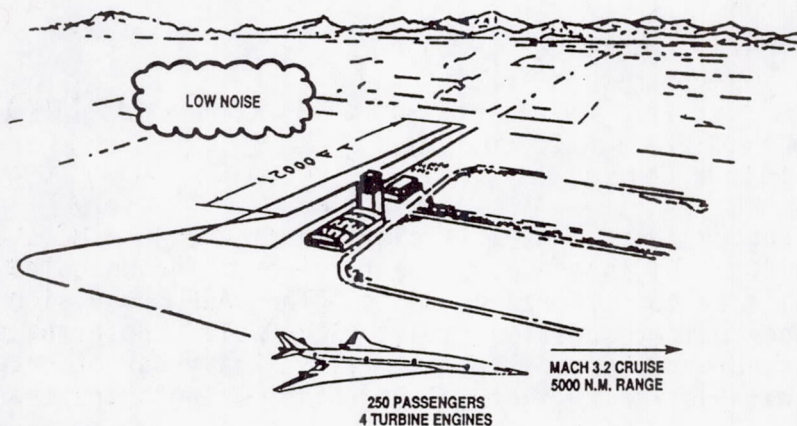
Figure 1. - High Speed Civil Transport (HSCT).

Advanced high-temperature, low-density composite materials are being developed for use in the next generation of aerospace systems. The High Speed Civil Transport (HSCT, fig. 1), an aircraft for transporting 250 passengers, at Mach 3.2 for 5000 n mi and the National Aerospace Plane (NASP, fig. 2) a transportation system that will take off, fly at Mach 25 directly into orbit and land like a conventional aircraft, will require advanced composite materials for both propulsion and structural components.

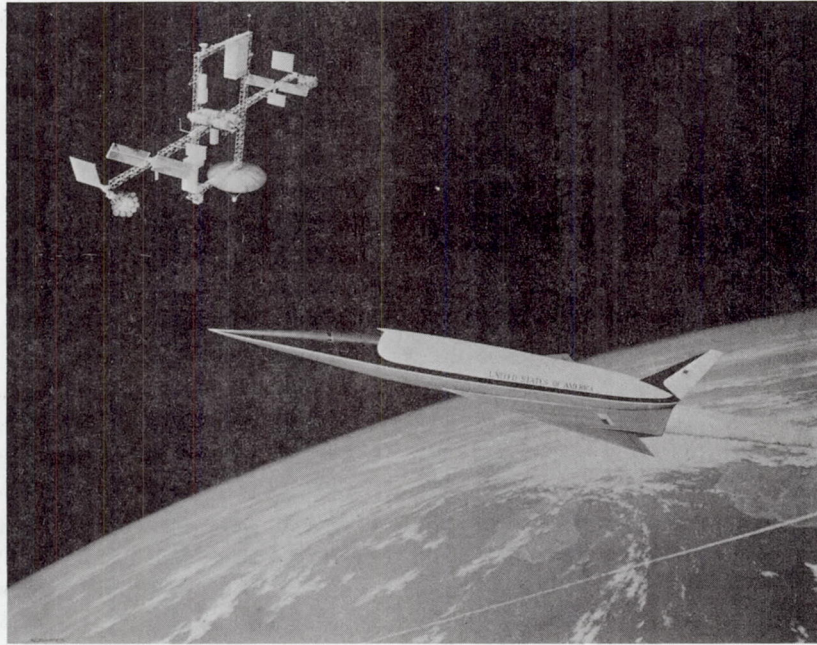
Figure 2. - National Aero-Space Plane (NASP).

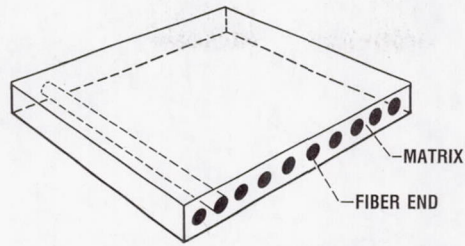
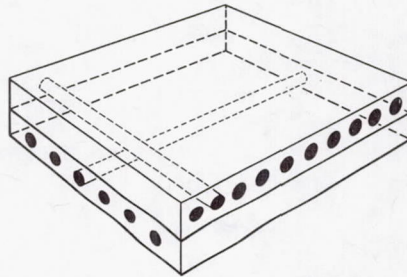
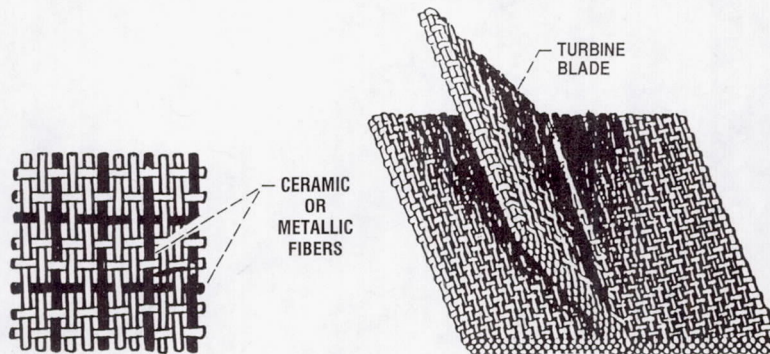
Figure 3. - Advanced composites.

(a) Monotape composite with fibers aligned along one direction.

(b) [0°/90°] cross-ply, laminated composite.

(c) 3-D woven fabric composite.

These composite materials consist of particles, whiskers, or fibers embedded in ceramic or metal matrices. The fibers may be parallel and lie in one plane (fig. 3(a)), layered to form crossplys (fig. 3(b)), woven into a three-dimensional pattern (fig. 3(c)), or wound to form cylinders. The composite matrix material may be polymeric, metallic, intermetallic, or ceramic. The wide range of composite materials under investigation for advanced aerospace systems is shown in table I. One advantage to using composites listed in table I is the increased ratio of ultimate strength-to-density (fig. 4) over conventional engine materials, e.g., superalloys like Inconel 100 (IN-100). The rapid progress in producing metal matrix composites has allowed actual test components to be manufactured. Here the NARloy-Z main combustion chamber (figs. 5 and 6) lining can be replaced by a metallic composite (fig. 7) that has a superior rupture strength.

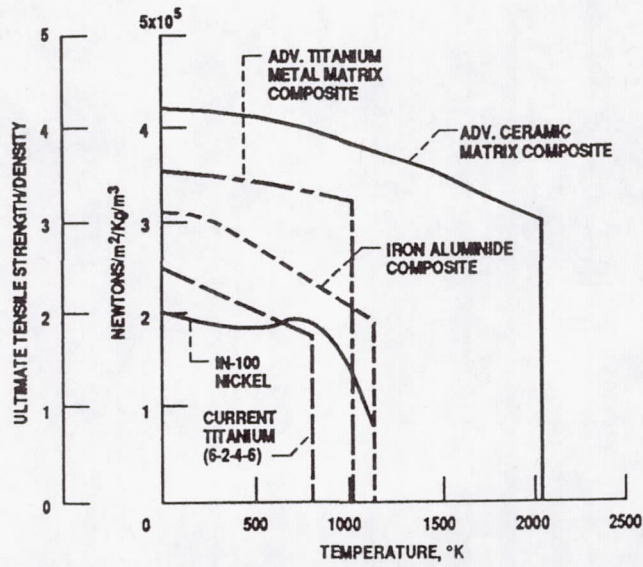
Figure 4. - Strength-to-density for advanced composites.

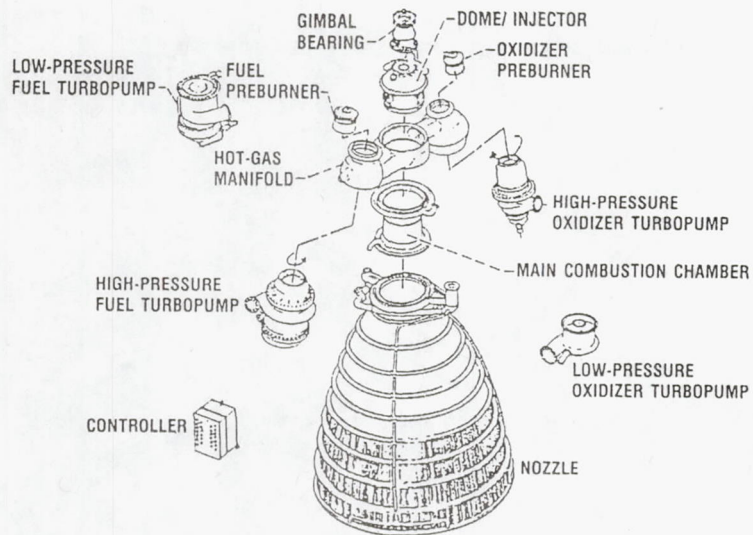
Figure 5. - Space Shuttle Main Engine (SSME).

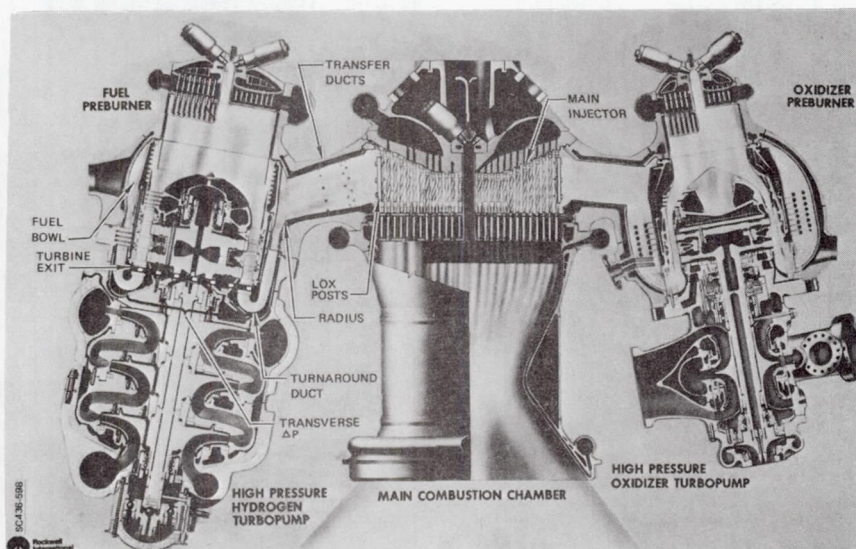
Figure 6. - SSME powerhead component arrangement.

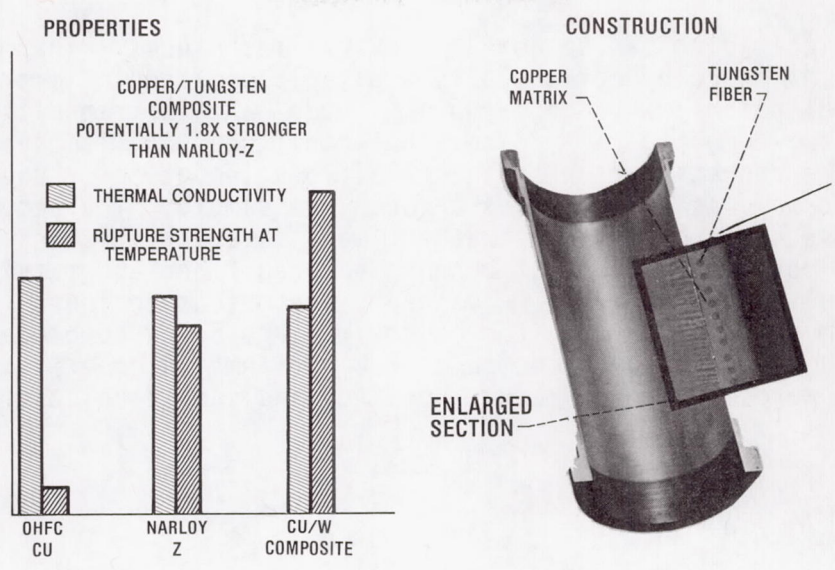
Figure 7. - Test MMC composite thrust (combustion) chamber.

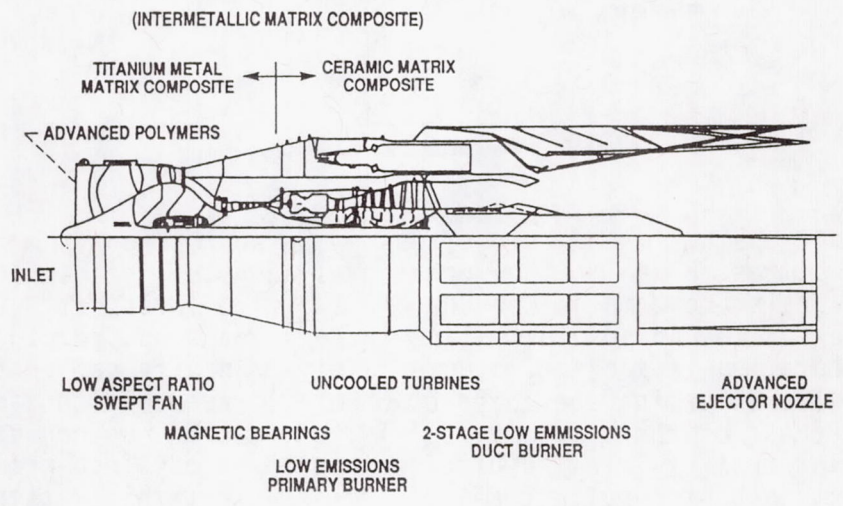
Figure 8. - HSCT engine materials.

The propulsion engine for the HSCT is shown in figure 8. IMC's and TiMMC's will be used from the inlet up to the turbines. The uncooled turbines and ejector nozzle will be constructed of CMC's. The NASP propulsion system is a hydrogen-fueled supersonic combustion ramjet (SCRAMJET). Both the engine and airframe will require advanced composite materials. Heavy use of ceramic composites is expected because their light weight, high strength and thermal shielding properties.

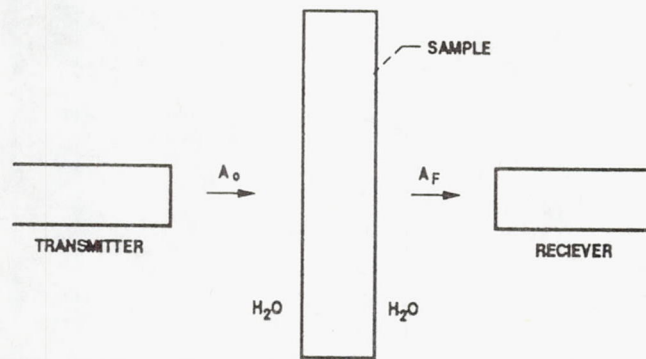
Figure 9. - Immersion ultrasonic C-scan arrangement.

Ultrasonic imaging can be done by several techniques. The most common technique is that used by commercially available ultrasonic immersion C-scan systems. An ultrasonic wave of known amplitude A_0 is transmitted through a sample as is shown in figure 9. The final amplitude A_f is used to form an image that is a representation of the relative attenuation or energy lost by the ultrasonic wave as it traverses through the sample. The amount of energy lost (high loss corresponds to decreased image intensity) is an indication of the amount of porosity, degree of bonding between fiber and matrix, and uniformity of the sample (ref. 3). Advanced ultrasonic techniques (e.g., angular power spectrum scanning (APSS)) for composites are being developed (ref. 3) that will make use of pattern recognition algorithms in order to characterize variations in porosity, fiber-matrix bonding, and sample uniformity.

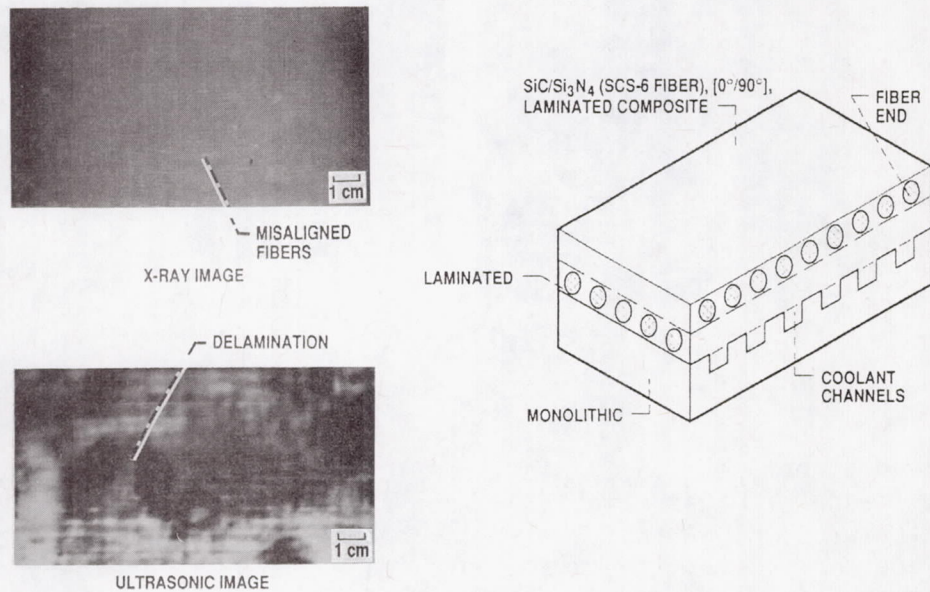
Figure 10. - X-ray and ultrasonic C-scan images of SiC/Si₃N₄ (SCS-6 fiber), [0°/90°], laminated composite NASP cooling panel.

The radiographic and ultrasonic C-scan of SiC/Si₃N₄ (SCS-6 fiber), [0°/90°], laminated composite NASP cooling panel is shown in figure 10. The x-ray image reveals misaligned or bowed fibers. The ultrasonic image indicates that there are regions (dark) between the laminae that did not bond (delaminations). The x-ray data indicates that the specimen is uniform in density, however, the ultrasonic data indicates that there are large variations in the amount of ultrasonic scattering throughout the sample area. It is believed that these variations are due to bond variations between the laminae.

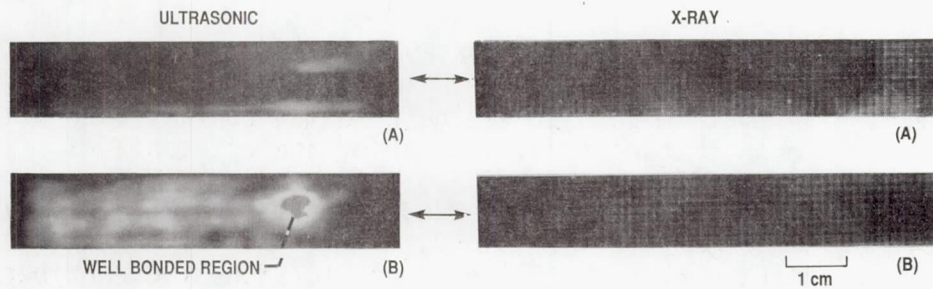
Figure 11. - X-ray and ultrasonic C-scan images of similarly produced SiC/Si₃N₄ (SCS-6 Fiber), [0°/90°], laminated composites.

Identically produced SiC/Si₃N₄ (SCS-6 fiber), [0°/90°], laminated composites can yield very different nondestructive evaluation results. Figure 11 shows the radiographic and ultrasonic data for two similarly produced samples. The x-ray data indicate that these two specimens have similar densities. In contrast, the low intensity of the ultrasonic image for specimen A indicates that there is relatively poor bonding between laminae. The highest intensity in the ultrasonic image for specimen B is a region having a good bond between laminae.

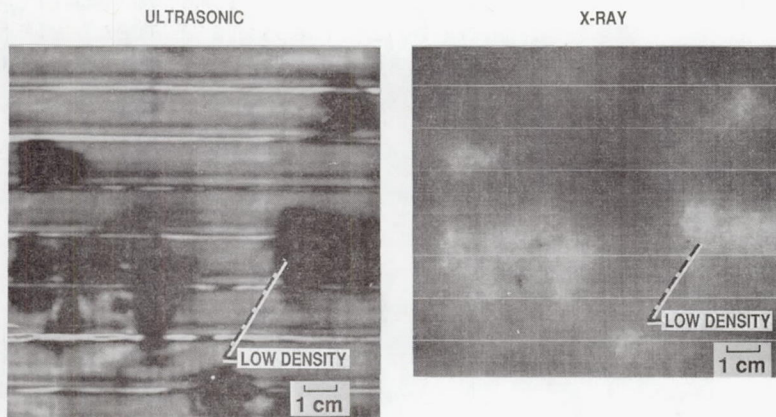
Figure 12. - X-ray and ultrasonic C-scan images of SiC(SCS-6)/Calcium Aluminosilicate (CAS), [0°/90°] composites.

When comparing the radiographic and ultrasonic images for the SiC (Nicalon)/Calcium Aluminosilicate (CAS), [0°/90°], laminated composites (fig. 12), it is observed that low ultrasonic intensity (dark) corresponds to low density (light regions) in the x-ray image. Therefore, these dark ultrasonic regions are areas having low densities and not poor interlaminar bonds.

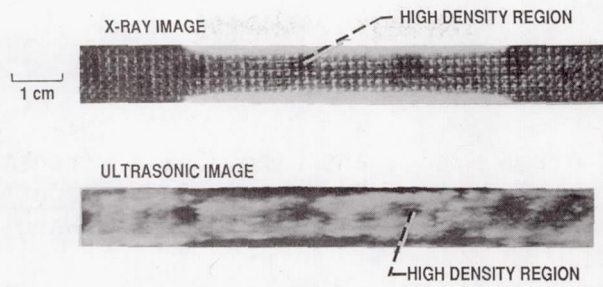
Figure 13. - X-ray and ultrasonic C-scan images of woven, SiC(Nicalon)/SiC laminated composite.

The woven structure of SiC (Nicalon)/SiC, laminated composites yield very distorted ultrasonic images (fig. 13). For example, compare figures 12 and 13. Processing features, high-density circular regions, can be found in both the ultrasonic and x-ray data. The ultrasonic image intensity is low where the density is high (dark in the radiograph). The cross hatch pattern in the radiograph reveals the degree of registration between lamina. Registration effects can result in an erroneous determination of porosity variations. This occurs when nearly identical plies, with uniform fiber spacing, are laid up so that the fibers are slightly off axis. This slight misalignment of fibers produces a Moire (ref. 7) pattern (fig. 14) in the x-ray image that may be misinterpreted as porosity variations. The large number of fibers in ceramic composites results in an overlap, of Moire patterns. These overlapping patterns are not as clearly visible as that shown in figure 14. As of this writing Moire patterns have not been explicitly observed for ceramic composites. However, researchers should be aware of their effect on determination of density.

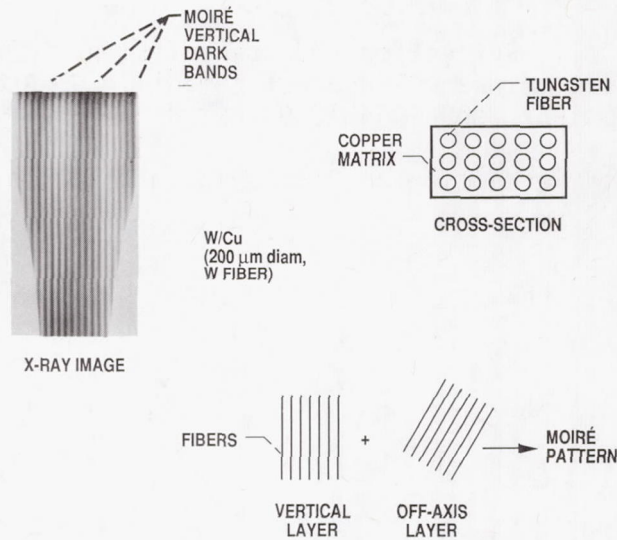
Figure 14. - X-ray image of W/Cu composite showing Moiré pattern.
