**NASA
Technical
Paper
2970**

Heat Treatment Study of the SiC/Ti-15-3 Composite System

Bradley A. Lerch,
Timothy P. Gabb,
and Rebecca A. MacKay

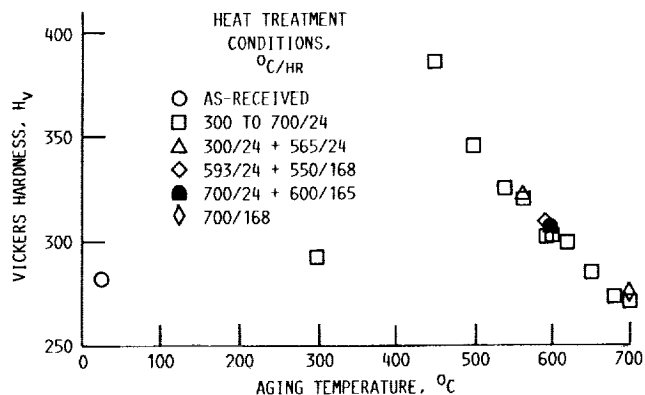
Figure 6.—Vickers hardness as function of aging condition for unreinforced matrix (Vickers hardness indentions made at 200-g load).

The effects of aging on the hardness of the unreinforced matrix can be observed in figure 6. Vickers hardness (H_v) was measured on all unreinforced matrix coupons, and each data point in figure 6 represents the average of at least six measurements for each specimen. The range of these hardness values per specimen was approximately $\pm 10 H_v$. Most of the specimens were aged 24 hr from 300 to 700 °C. These data show typical aging behavior with a peak hardness occurring somewhere between 400 and 450 °C for the 24-hr aging time. The heat treatment atmosphere had no apparent effect on hardness, indicating that additional precipitation due to oxygen diffusion into the matrix was minimal for these times and temperatures.

Heat treating at a temperature of 300 °C/24 hr caused a slight increase in hardness over the as-received material even though no apparent differences in the microstructure were observed. The aging kinetics below ~ 350 °C are very slow for the as-received and aged material. This was evident by the identical hardness for both the 24- and 100-hr aging times at 300 °C and by the low slope of the hardening curve over this temperature range.

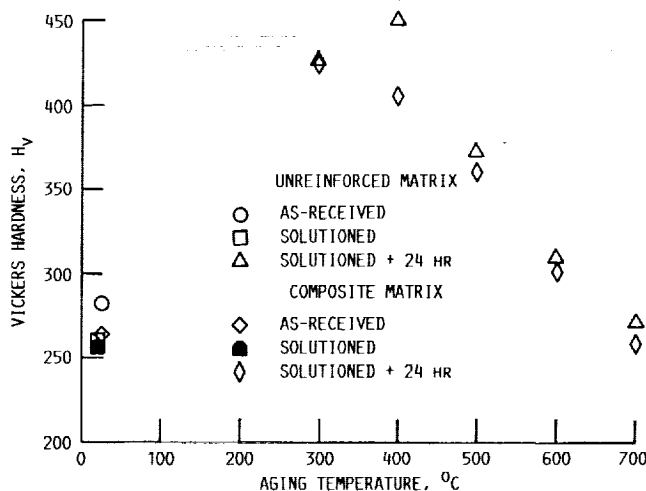
Figure 7.—Vickers hardness for unreinforced matrix and composite matrix in both solutioned and aged conditions (Vickers hardness indentions made at 200-g load).

Solutioning above the β transus had a marked effect on the aging characteristics of the material (fig. 7). The solutioned coupon had the lowest hardness, which suggests that the as-received material was not in the solutioned state. Fine, unresolvable α -precipitates were probably present in the grain interiors in the as-received material and increased the hardness over that of the solutioned material. The β' -phase may also have increased the hardness of the as-received material, and none of this phase was observed in the solutioned (or in the solutioned + aged) material. Comparison of the data in figures 6 and 7 shows that the unreinforced matrix which was solutioned and aged at 300 °C/24 hr had a hardness that was 70 percent higher than that of the as-received coupon after aging at 300 °C/24 hr. This difference was probably the result of very fine, unresolvable α -particles which precipitated uniformly in the solutioned + aged material. Okada et al. (ref. 6) have shown that aging at 300 °C can produce a strong age-hardening condition due to the formation of small α -particles; however, this microstructure also exhibited brittle behavior. In contrast to the strong age-hardening behavior of the specimen given the 300 °C/24 hr heat treatment, the

coupon which was solutioned and aged at 700 °C for 24 hr had a low hardness, identical to that of the as-received coupon given a 700 °C/24 hr age. Figure 7 also indicates that the composite matrix after solutioning and after subsequent aging was consistently softer than the unreinforced matrix in the same condition. However, because of the inherent scatter in the measurement technique, these hardness values are statistically equivalent.

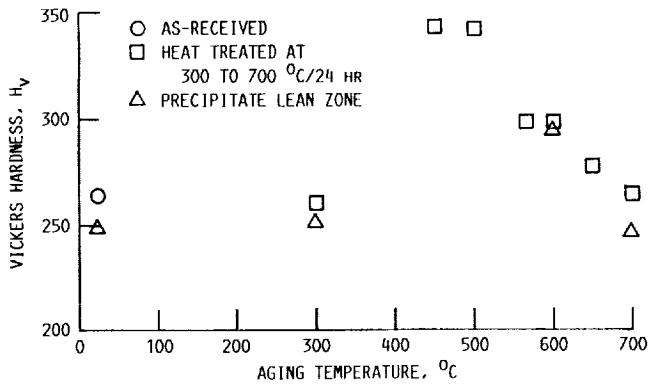
Figure 8.—Aging response of Vickers hardness for composite matrix (hardness of precipitate lean zone also included; Vickers hardness indentations made at 200-g load).

Hardness was similarly measured for the matrix in the heat-treated composite specimens, as depicted in figure 8. These values can be compared with those of the unreinforced matrix shown previously in figure 6. For hardness measurements of the precipitate lean zone surrounding the fibers, the indentation

was placed as remote from the fiber as possible, yet still within the precipitate lean zone. Figure 8 shows that the hardness of the precipitate lean zone was consistently lower than elsewhere in the composite, but was statistically equivalent to that of the composite matrix. Apparently, the fibers cause local chemical inhomogeneities in the matrix.

The hardness of the composite matrix was lower than that of the unreinforced matrix for both as-received and heat-treated materials. (Compare fig. 8 with fig. 6.) The peak aged condition occurs at ~450 °C for both materials, although the composite matrix had a peak hardness of 340 Hv, compared with 385 Hv for the unreinforced matrix. At aging temperatures at or above 500 °C, this difference in hardness diminished. The difference in hardness at lower aging

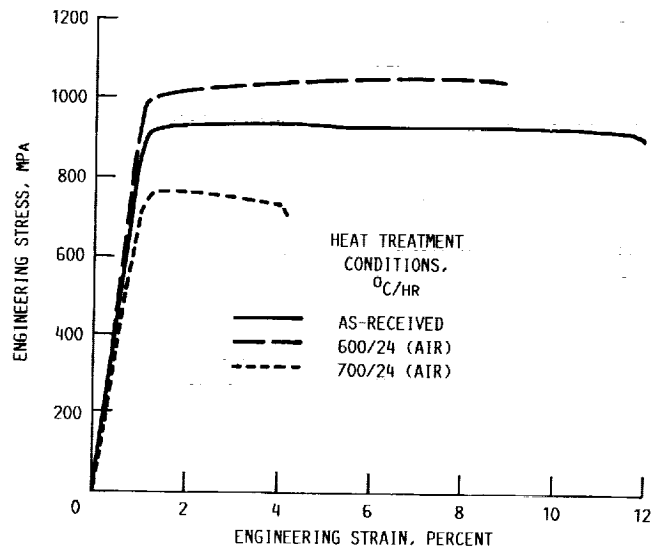
Figure 10.—Room-temperature stress-strain curves for unreinforced Ti-15-3 matrix.

Tensile specimens of the as-received, unreinforced matrix were aged and tested at room temperature to evaluate the effects of aging on the tensile properties. Because of a lack of material, similar tests were not performed on the composite. The stress-strain curves for the unreinforced matrix were similar in all cases in that little strain hardening was observed. (See fig. 10.) This is typical for many titanium alloys at room temperature (refs. 15 and 16). For micromechanics approaches, this material can be modeled as elastic, perfectly plastic. However, it should be cautioned that the in situ matrix may behave differently from the unreinforced matrix.

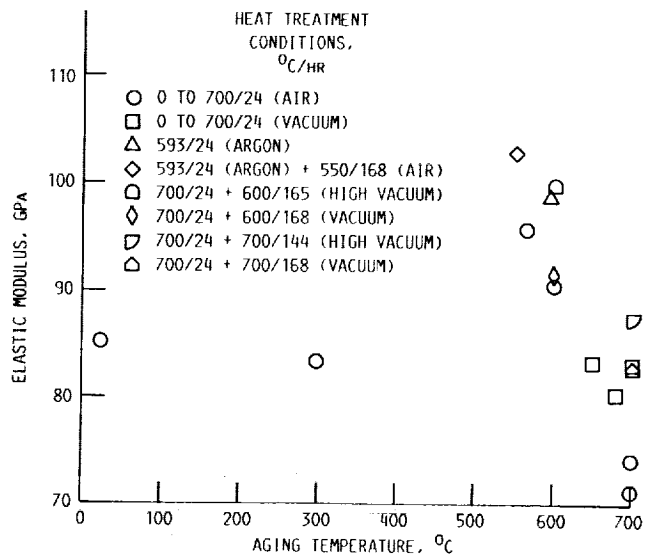
Figure 11.—Effect of aging on room-temperature elastic modulus of unreinforced matrix.

Figures 11 to 13 illustrate the tensile properties as a function of aging temperature. The values of elastic modulus were relatively constant at ~85 GPa after aging for 24 hr up to ~300 °C (fig. 11), whereas aging at 565 °C increased the elastic modulus to ~95 GPa. Aging at higher temperatures reduced the modulus considerably to a value of ~70 GPa after

aging for 24 hr at 700 °C. This change in modulus as a function of heat treatment is unusually large compared to other metals, although it has been suggested (ref. 3) that the modulus of β -Ti alloys may change with heat treatment. Reportedly, β -Ti has a 16 percent lower modulus than α (ref. 13), but even if all the β transformed upon aging to α , this difference in modulus would not be sufficient to explain the changes observed in this study.

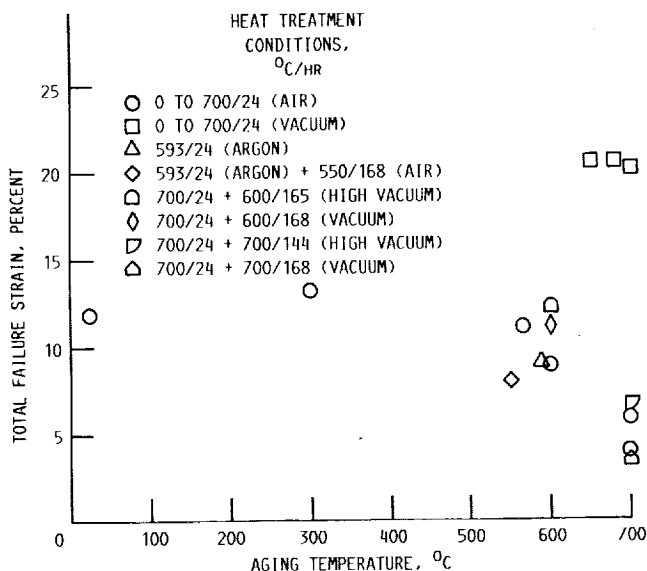
Figure 13.—Room-temperature failure strain as function of aging for unreinforced matrix.

The ductility of the material, as represented by the failure strain, is presented in figure 13. The failure strain increased slightly at the aging temperature of 300 °C, and it decreased

above 550 °C. However, specimens which were aged above ~550 °C in a vacuum exhibited extremely good ductility. Exceptions to this were the specimens given long-term exposures at 600 and 700 °C. Despite being heat treated in a vacuum, they had very low ductilities, probably a result of the large α -phase at laminae and grain boundaries. (See fig. 4.) Duerig and Williams (ref. 12) have found that the α -grain boundary phase is detrimental to ductility.
