TECHNIQUE FOR EVALUATING THE EROSIVE PROPERTIES OF ABLATIVE INTERNAL INSULATION MATERIALS*

J.C. McComb and J.M. Hitner
California Institute of Technology, Jet Propulsion Laboratory
Pasadena, CA 91109

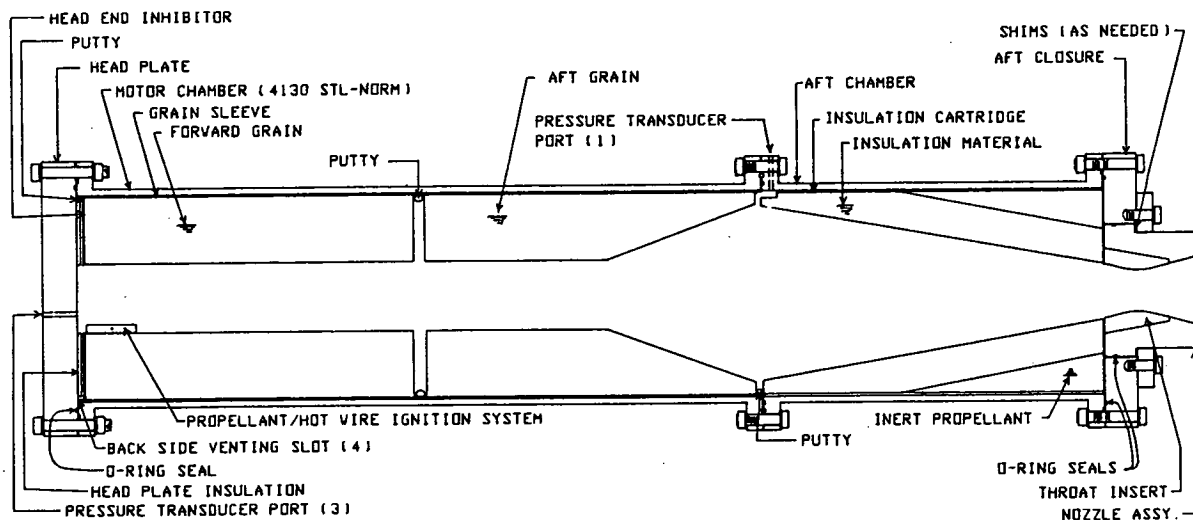
Fig. 1 Cross-sectional diagram illustrating the ballistics test evaluation system (BATES) motor hardware configuration.

TEST MOTOR DESCRIPTION - A cross-sectional diagram illustrating the ballistic test evaluation system (BATES) motor hardware used in this study is presented in figure 1. The primary test chamber has a 12 inch inside diameter and a length of 60.6 inches. Two cartridge loaded radial burning propellant grains are inserted into the forward end of the chamber. The grain web is

The key element of the insulation test motor consists of the insulation test cartridge located immediately downstream of the two propellant grains. The insulation test cartridge incorporates a truncated cone which constitutes the insulation test specimen. The entrance and exit diameters of the cone were sized relative to the nozzle throat to provide an initial Mach number range of approximately 0.035 to 0.40 at ignition. This cartridge configuration allows erosion data to be obtained over a wide range of Mach numbers during each test firing. The aft end of the aft grain was flared to insure even flow into the entrance of the test cartridge throughout its burn time.

The nozzle assembly was mounted immediately aft of the insulation test cartridge. The throat insert entrance butts up against, and is faired smoothly with, the exit diameter of the insulation test cone to ensure smooth gas flow. The main body of the nozzle assembly was made of a compression molded half-inch long chopped glass fiber/phenolic material. The throat insert was fabricated from HLM-85 graphite. Precision throat sizing was required to achieve consistent chamber pressure control from test to test.

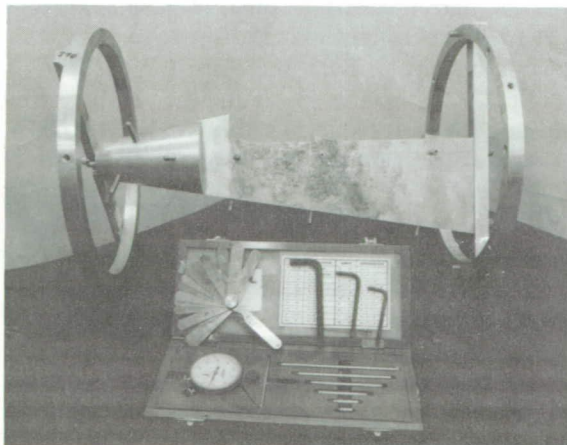
Fig. 2 Erosion rate measuring tool and accessories.

The mechanical tool developed in this study to measure the erosive properties of candidate insulation materials consists of two main components: an insertable tool probe equipped with measuring pins and a pair of ring plates which attach to the forward and aft ends of the insulation cartridge and suspend the tool within the cartridge interior. A photograph of the tool probe and the ring plates is shown in figure 2. A diagram illustrating a cut-away view as well as top view, front view, and rear view perspectives of the measuring tool is presented in figure 3. The tool probe was all-aluminum in construction, except for the measuring pins which were manufactured from steel drill rod material. The tool has an overall length of 20.200 inches, with the triangular-shaped rear unit (which houses 5 of the probe's nine pins) having a width of 0.765 inches and length of 14.700 inches. The steel pins are the active elements used to measure the internal surface of the test cartridge. The front unit of the tool is a solid aluminum truncated cone 5.500 inches long which houses four measuring pins. Because of difficulties in accessing retaining screws for the pins located in the front unit, it was necessary to design this segment of the tool so that retaining screws for the front four pins could be accessed from the front of the tool. Thus, the angular positions of 3 of these four pins had to be offset 45° from the position of the remaining pin. All nine of the pins were placed at an angle of 100° from the center axis of the cartridge (10° from axis normal) in order that the extended pins measure the surface at an angle normal to the internal insulation surface.

The tool retention bar positions the Tool inside the Test Cartridge at the desired angle. The bar has a notch at one end to indicate the angle being measured. The retention bar attaches to the tool snugly to the aft ring plate, and, at the opposite end, an attachment set screw secures the tool to the forward ring plate centering/retention bar.

The aluminum ring plates, which secure the measuring tool within the test cartridge, have an outside diameter of 15.000 inches and an inside diameter of 11.995 inches - an I.D. which is identical to the I.D. of the steel motor hardware casing. Eight set screws placed at 45° increments around the ring circumference secure each ring plate to the test cartridge external surface. Centering is achieved by adjusting the set screws until the desired target micrometer settings are achieved at four micrometer measuring seats located on each of the two ring plates. The aft ring plate is equipped with eight $3/8$ " diameter pins extending from the plate at 45° circumferential increments. These pins ensure proper alignment of the tool at the desired azimuths.

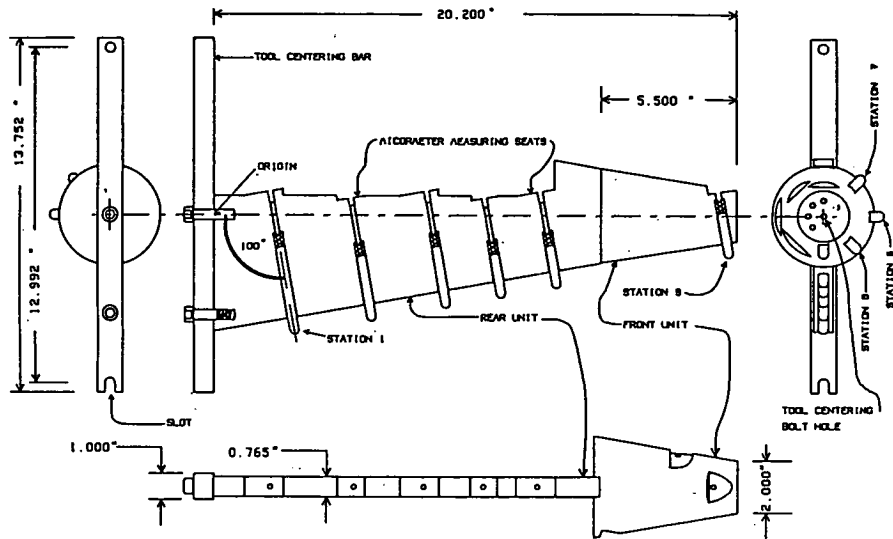
Fig. 3 Top view, front view, back view, and cut-away view of the measuring tool.

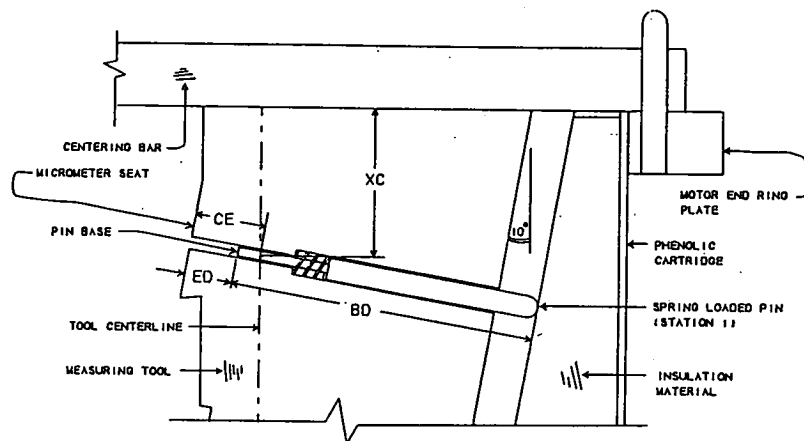
- BD - PIN LENGTH
- CE - MICROMETER SEAT TO TOOL CENTERLINE DIMENSION
- ED - MICROMETER SEAT TO PIN BASE EROSION MEASUREMENT
- XC - TOOL MOTOR END TO PIN STATION CENTERLINE DIMENSION

Fig. 4 Cut-away detail of a single measuring pin station defining the parameters used in the calculation of erosion rate.

DATA REDUCTION AND ANALYSIS - A cut-away drawing illustrating the measuring tool positioned inside an insulation cone and defining the parameters which were used to calculate the degree of material erosion is given in figure 4. Figure 4 specifies these parameters for pin

station one, but these definitions can be extended to all nine stations on the measuring tool. A spring-loaded pin of known length (BD) is released and allowed to extend to the material surface. The distance between the micrometer seat and the pin base (ED) is measured with a depth gauge. Once data has been collected at all of the eight azimuthal increments, the average distance, $ED_{ave(i)}$, as defined by:

where $R(i)$ is the perpendicular radius from the centerline at station i , and the other parameters are as defined in figure 4. Axial positions along the length of the cartridge are calculated from:

where $L(i)$ is the axial length at station i , and again the other parameters are as in figure 4. The total number of inches eroded at any station i is calculated from:

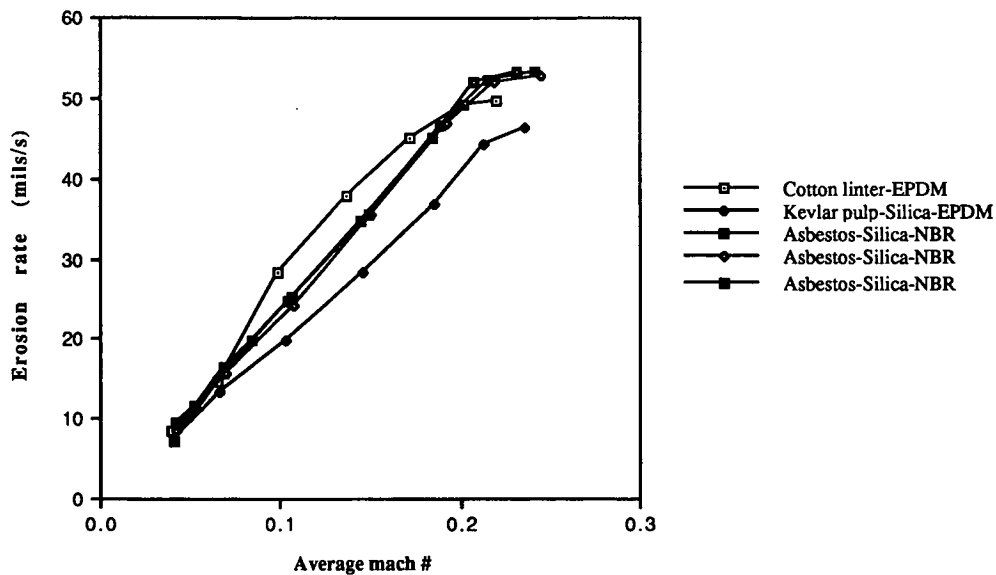
Fig. 5 Erosion rate vs. Mach# plot for baseline material (Asbestos-Silica-NBR) and for two candidate internal insulation materials (see legend for individual material identities). Chamber pressure ranged from 613 to 626 psia, all firings used PBAN propellant except the third baseline firing; HTPB propellant was used for this firing.

EROSION RATES FOR IN-HOUSE DEVELOPED AND BASELINE MATERIALS - Plots of erosion rate vs. Mach number for several test firings of baseline material and a few candidate materials are given in figure 5. The baseline material (Asbestos-Silica-NBR) was fired using both PBAN and HTPB propellant. Averages of the erosion rate calculated at a Mach numbers of 0.10 and 0.15 were found to be 21.0 ± 1.9 and 32.5 ± 3.1 , respectively, for baseline material fired using PBAN propellant and 22.8 ± 1.0 and 36.0 ± 2.3 for baseline material fired using HTPB propellant.

Of the three material types tested other than Asbestos-Si-NBR, only Kevlar pulp-Si-EPDM was found to have erosion characteristics as good or better than the baseline material. Materials derived from cotton linters, oxidized polyacrylonitrile fiber (PAN), and Kevlar pulp suspended in butadiene-nitrile rubber (NBR) all failed to match or exceed the erosion resistance of the Asbestos-Si-NBR insulation.
