DOE/NASA/50162-3  
NASA TM-102476

# The Experimental Evaluation and Application of High-Temperature Solid Lubricants

January 1990

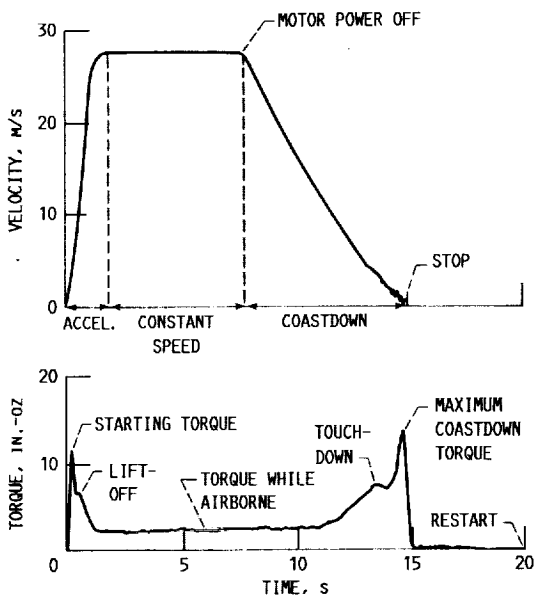
FIGURE 7. - TYPICAL TORQUE PROFILE OF A FOIL BEARING DURING A SINGLE START/STOP CYCLE.

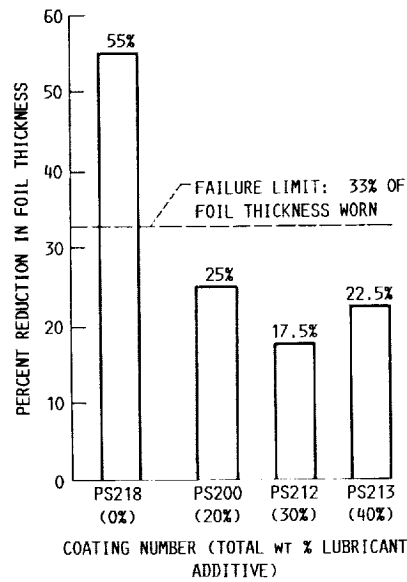
FIGURE 10. - FOIL WEAR VERSUS JOURNAL COATING COMPOSITION: TEST CONDITIONS: 9000 START/STOP CYCLES, 14 KPA LOAD.

Markedly lower wear occurred for foils sliding against the modified coatings PS200, PS212 and PS213 than for foils sliding against the unmodified coating, PS218. The use of PS212 (70 wt % metal bonded  $\text{Cr}_3\text{C}_2$ , 15 wt % each of silver and eutectic) resulted in the lowest foil wear, with a loss of only 17.5 percent in foil thickness after the 9000 start/stops. The use of PS200 and PS213 resulted in slightly higher foil wear which was 25 percent and 22.5 percent of the foil thickness respectively. Therefore, the PS212 coating is optimum for this coating system, in terms of minimum foil wear.

Among the three modified coatings, PS212 displayed the lowest coating wear and the lowest foil wear (See figs. 9 and 10). One plausible reason for this behavior can be seen by comparing the transfer films from the coating which accumulate on the foil surface during testing. Figure 11 shows the EDS x-ray (Energy Dispersive x-ray Spectroscopy) level spectra of the foil surfaces after sliding against the modified coatings. The foil slid against PS212 had the highest levels of silver and eutectic (indicated by Ca and Ag peaks on fig. 17(b)) at the sliding surface.

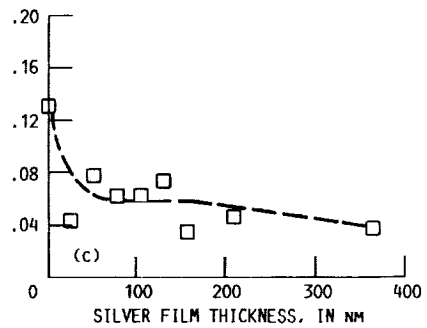
FIGURE 15. - WEAR FACTOR RATIO VERSUS SILVER FILM OVERLAY THICKNESS.

Table IX contains the wear factor ratio tabulated with the silver film thickness and test temperature. Figures 15(a), (b) and (c) are plots of the wear factor ratio versus film thickness for the three test temperatures. When these plots are inspected, several trends become apparent.

At 25 °C the ratio is about 0.10 for the control case (with no silver overlay). As the silver film thickness is increased from 25 to 100 nm, the ratio is decreased from about 0.11 to 0.02. That is, the silver film reduced the abrasivity of the coating to the pin up to a film thickness of 100 nm. Films thicker than about 150 nm did not result in a further wear factor ratio reduction.

At 760 °C there was no relationship between the film thickness and the ratio, but the silver films did reduce the ratio by approximately a factor of two compared to the control case. One plausible reason for this behavior is that the tests at 760 °C were the initial tests for each specimen. In these cases, the silver film merely served to smooth out and fill in the imperfections in the plasma-sprayed surface leading to reduced pin wear. But since the silver has low compressive strength at 760 °C the benefit was not a function of silver film thickness.

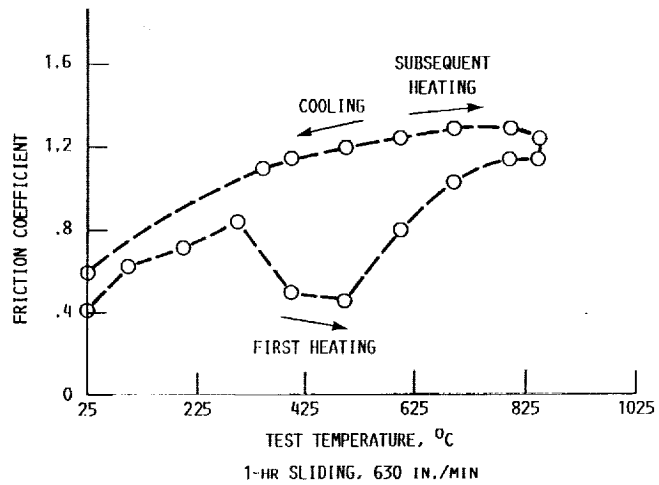
FIGURE 22. - FRICTION COEFFICIENT FOR FABRIC SLIDING AGAINST INCONEL WITH NO LUBRICANT COATINGS.

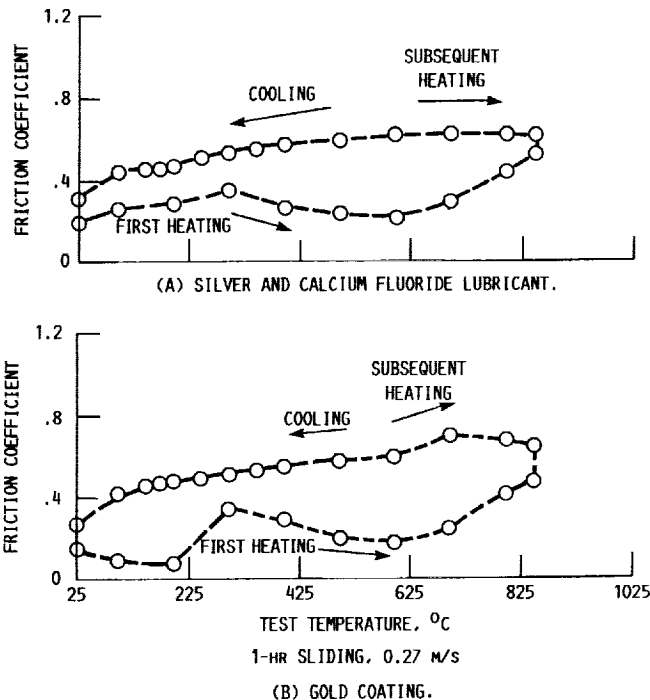
FIGURE 23. - FRICTION COEFFICIENT FOR FABRIC SLIDING AGAINST INCONEL TEST DISK.

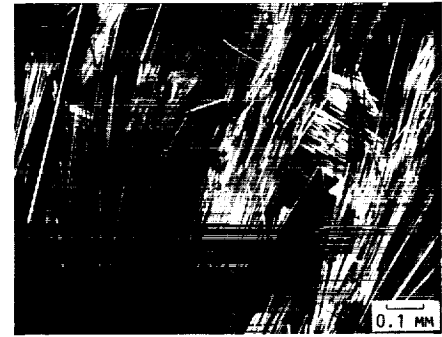
FIGURE 25. - FRACTURED CERAMIC FIBERS.

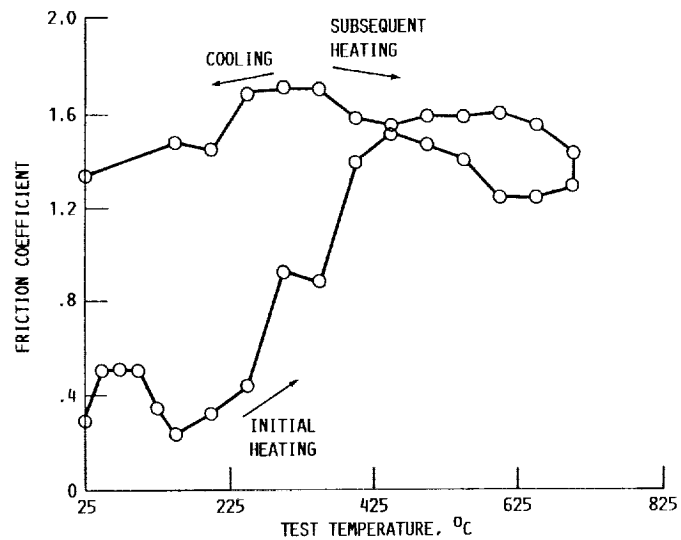
FIGURE 26. - FRICTION COEFFICIENT FOR FABRIC SLIDING AGAINST  $Ti_3Al-Nb$  INTERMETALLIC DISK. AIR ATMOSPHERE, 0.27 kg LOAD, 0.27 m/s SLIDING VELOCITY.

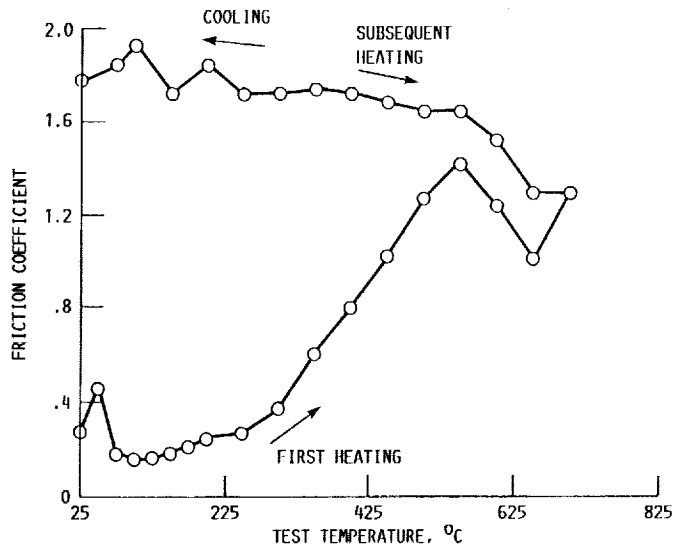
FIGURE 27. - FRICTION COEFFICIENT FOR THE FABRIC COATED WITH 150 nm GOLD WHEN SLIDING AGAINST THE  $Ti_3Al-Nb$  INTERMETALLIC DISK. AIR ATMOSPHERE, 0.27 kg LOAD, 0.27 m/s SLIDING VELOCITY.

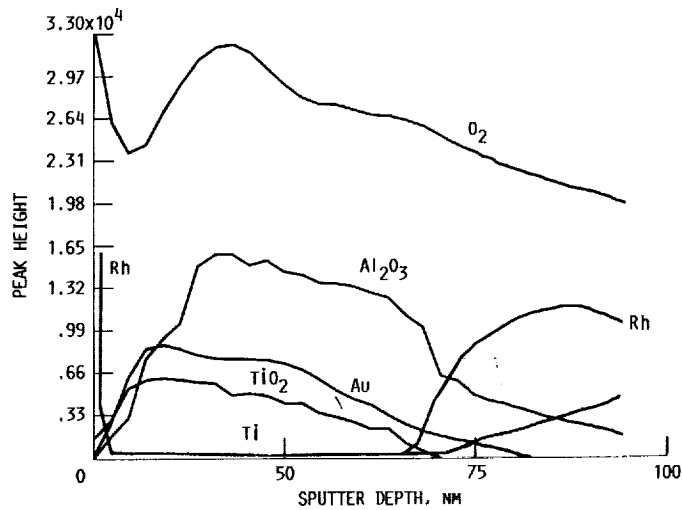
FIGURE 30. - XPS DEPTH PROFILE OF HEAT TREATED INTERMETALLIC SPECIMEN COATED WITH 50 NM RHODIUM AND 100 NM OF GOLD.
