NASA Technical Memorandum 100459

**Atomic Oxygen Effects
Measurements for Shuttle Missions
STS-8 and 41-G**

Volume II

Compiled by James T. Visentine

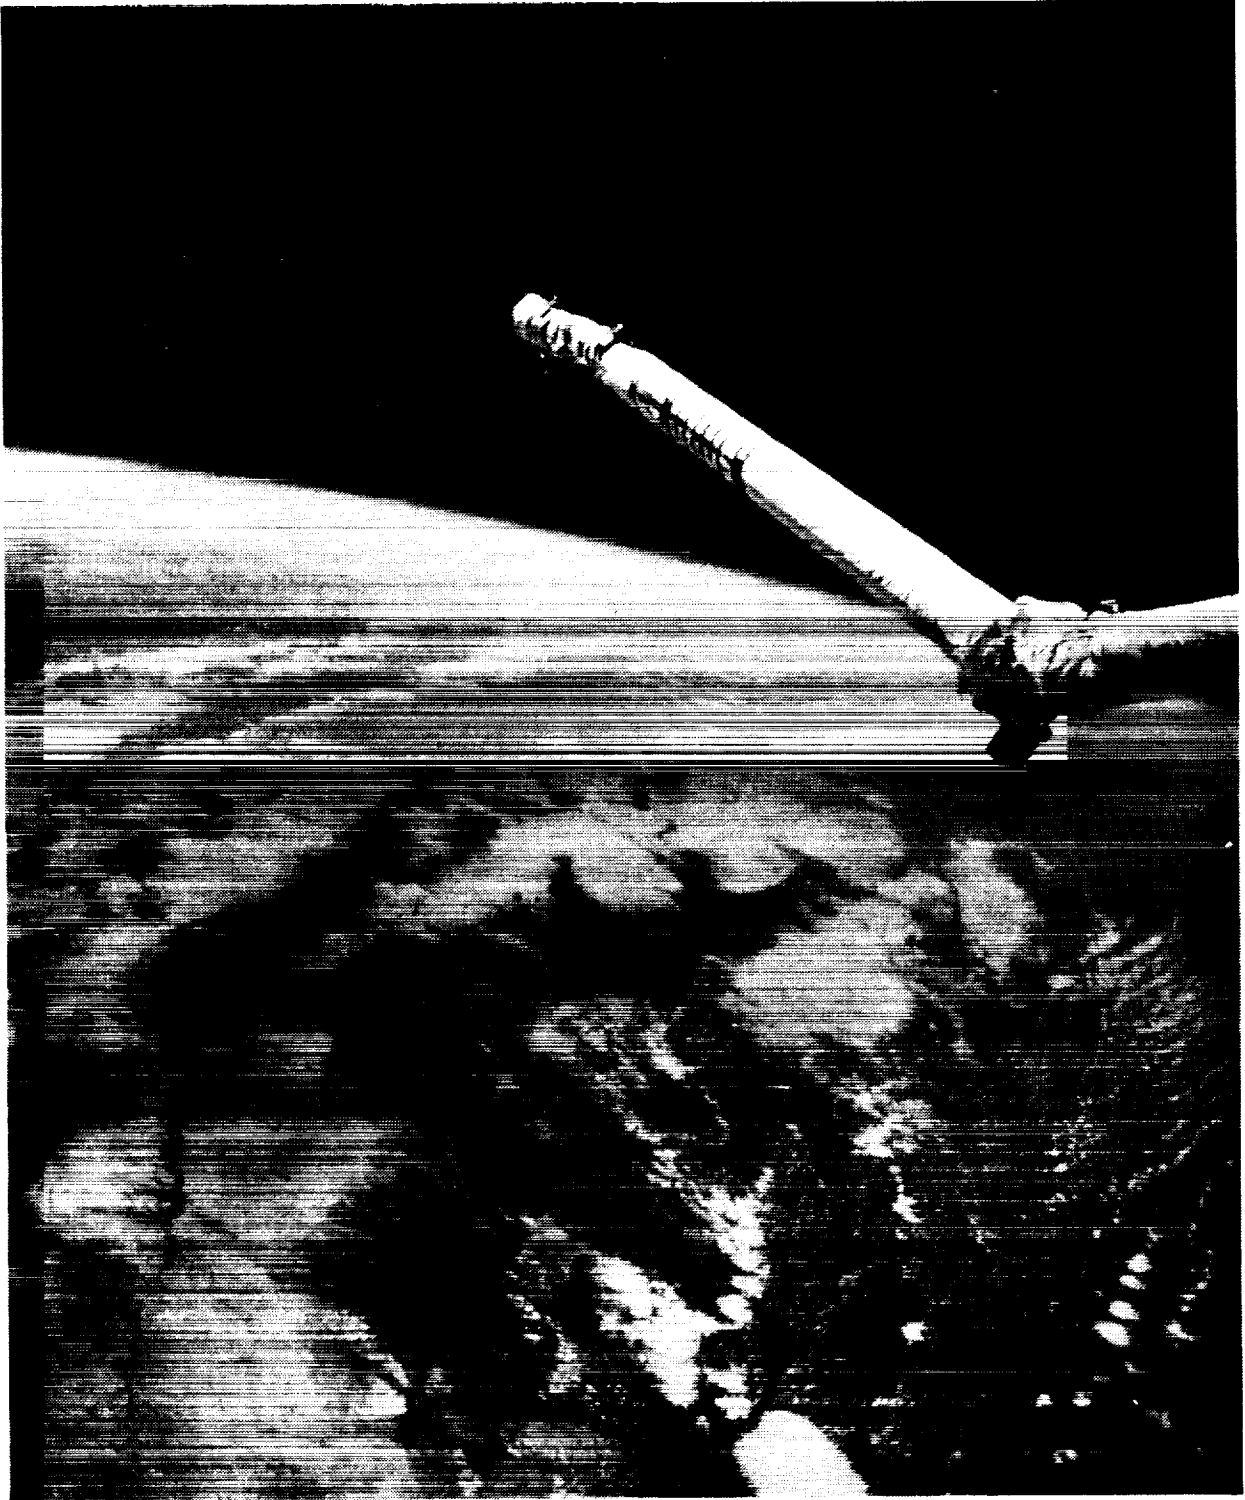
Exposure of material samples on the Shuttle RMS, during the STS 41-G flight.

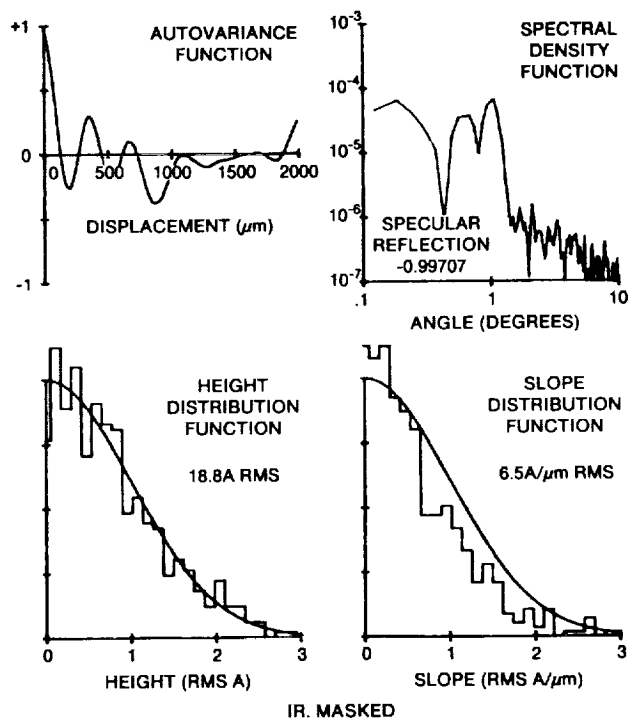
Fig. 4. Optical Heterodyne measurements of unexposed Ir sample.

iridium, is much less efficient than that for osmium. Gold showed no permanent effects except for more particulates in the exposed area. Al, Ni, and W showed minor decreases in optical density and increased film thickness ascribed to growth of the oxide layer. Calculated thicknesses from optical properties given in Table II suggested protective oxide layers initially existed on the unexposed films and were only slightly increased by the exposure. Increases in oxide thickness were observed on two Nb films except the thinner film indicated a larger change, perhaps as a result of being at a higher temperature due to greater absorption of solar radiation. Optical heterodyne measurements of the rms surface roughnesses listed in Table II showed slight smoothing of all surfaces except those of tungsten and 6-nm Pt/Os. This is opposite to the rough textures produced on heavily etched materials. Optical heterodyne measurements of unexposed and exposed iridium are shown in Figs. 4 and 5, respectively.

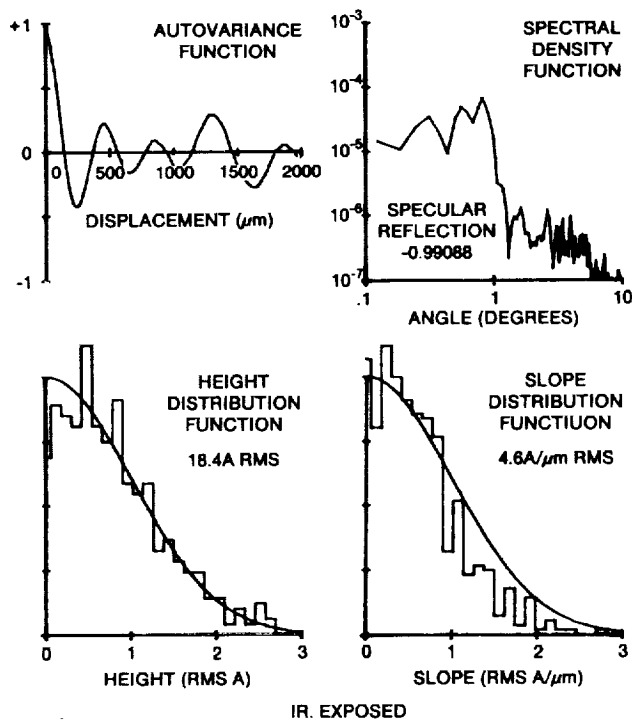
Fig. 5. Optical heterodyne measurements of exposed Ir sample.
 Note: profile scale is twice that of Fig. 4.

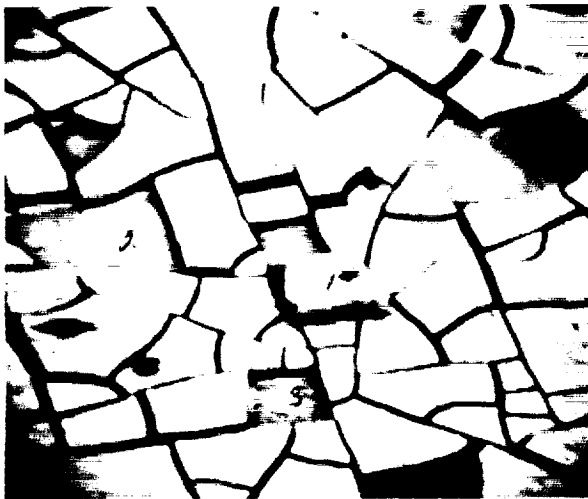
Figure 38.- Photomicrograph of Mo/Cr/Black Cr Sample, Showing Debonding of Surface Layer and Exposed Cr Undercoating

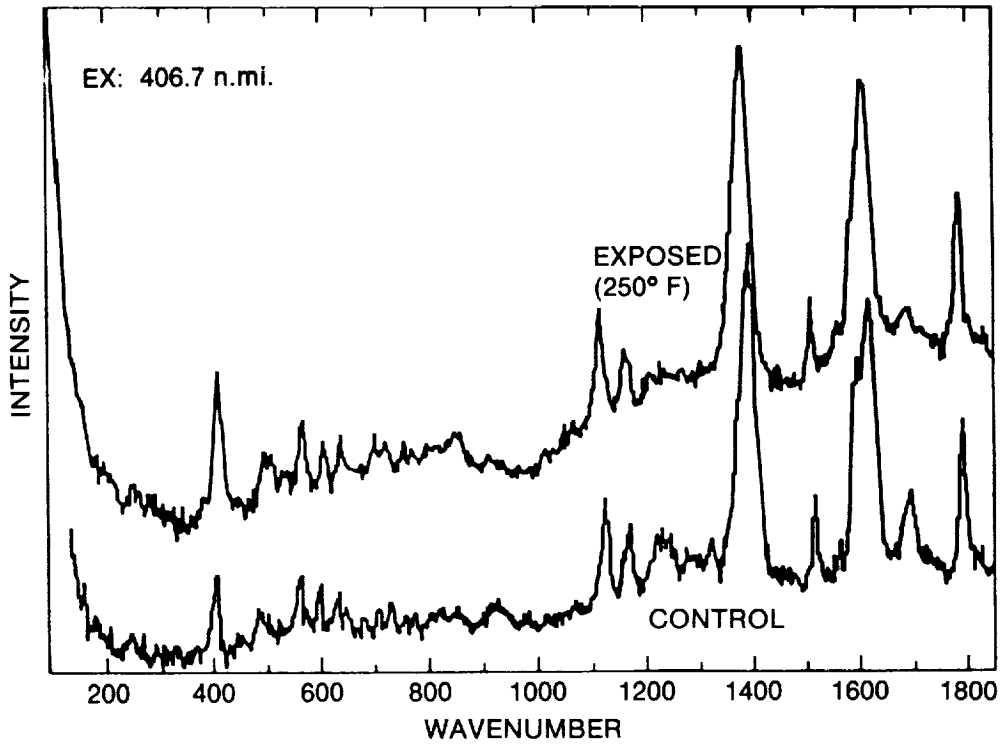
Figure 8.- Resonance Raman Spectra of Kapton Before and After Exposure.
