NASA Technical Memorandum 100834
AIAA-88-0027

Chemical Vapor Deposited Silica Coatings for Solar Mirror Protection

Prepared for the
26th Aerospace Sciences Meeting
sponsored by the American Institute of Aeronautics and Astronautics
Reno, Nevada, January 11-14, 1988

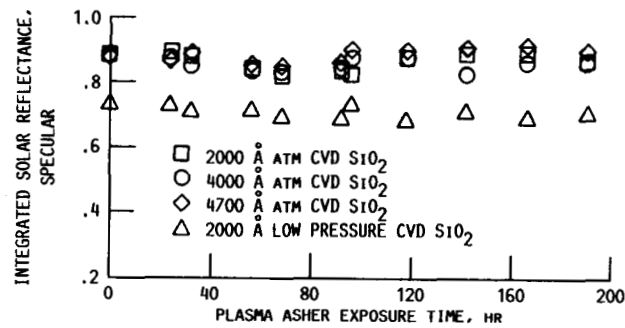
FIGURE 1. - SOLAR SPECULAR REFLECTANCE VERSUS OXYGEN PLASMA EXPOSURE TIME FOR THE REFLECTOR SAMPLES (VARIOUS THICKNESSES OF SiO₂ ON 1800 Å OF SILVER ON NICKEL SUBSTRATES) PREPARED IN THIS STUDY.

Figure 1 presents the effect of the RF plasma environment on the various samples prepared for this study. Overall, no significant effects of the plasma environment on reflectance durability were noted for any of the samples. Each appeared adequate to protect a silver surface from oxidation. Differences were noted, however, in terms of absolute reflectance, visual appearance, and appearance under SEM.

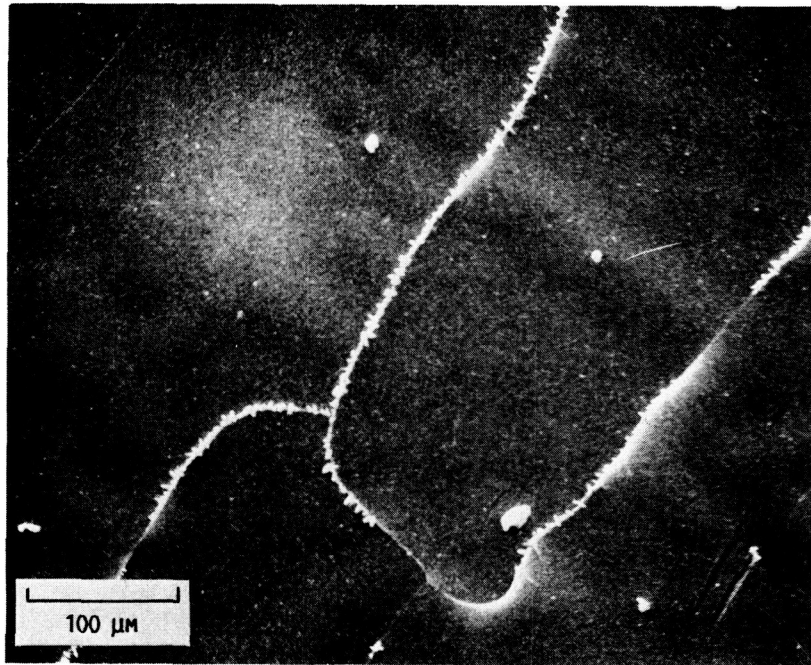
FIGURE 2. - EXAMPLE OF CRACKING OBSERVED ON SAMPLES WITH THICKER (4700 Å) SiO_2 COATINGS. PROTRUSION OF SILVER OXIDE THROUGH CRACKS IS EVIDENT. RF PLASMA EXPOSURE TIME WAS 190 HR.

Examination of the two thicker samples under scanning electron microscopy revealed that, in most instances, the cracks extended down to the silver layer. Figure 2 shows a typical region of the surface of the sample with the 4700 Å thick SiO₂ coating. At most locations along the cracks, silver oxide can be seen protruding through the coating. Figure 3 is an enlargement of a portion of figure 2, and clearly shows the protruding oxide. The growth of this oxide, however, did not have an effect on specular reflectance, which indicates that the surface area of the cracks was small compared to the total sample surface area. Also visible is evidence of multiple fractures along a crack line. These fractures suggest that the cracks are a result of compressive stresses in the film which arise from the greater degree of contraction of the nickel substrate relative to the coating after the heating occurring during deposition. This can also explain the slightly increased degree of cracking observed during plasma exposure mentioned above. As a side effect, the samples are heated to approximately 60 °C during oxygen plasma exposure, and the continual heating and cooling from repeated exposures continues to stress cycle the film and results in additional cracks. No evidence is seen, however, of any undercutting of the protective coating by the oxygen plasma. This would have been expected to appear as a front of discoloration surrounding the crack edges, which is behavior seen previously (ref. 6) on protected silver layers on non-oxidizable substrates. The previous work suggested that the oxidation process would eventually cease, due to the inability of the oxygen atoms to diffuse through the silver oxide to reach fresh, unoxidized silver. This appears to be the case here.

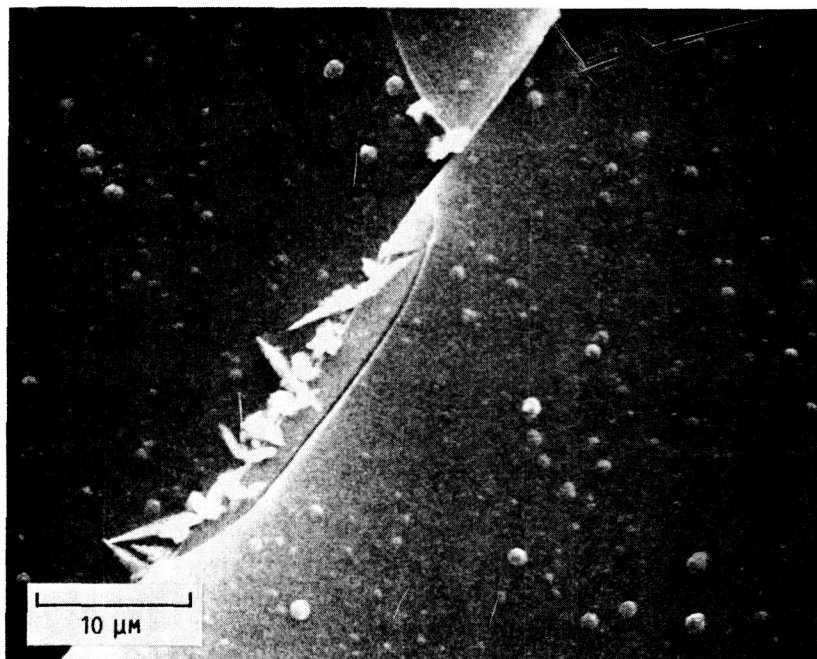
FIGURE 3. - DIFFERENT REGION OF SAME SAMPLE SHOWN IN FIG. 2, BUT AT HIGHER MAGNIFICATION. MULTIPLE FRACTURES ALONG THE CRACK INDICATE STRESS DUE TO DIFFERENT COEFFICIENTS OF THERMAL EXPANSION BETWEEN THE SUBSTRATE AND COATING.

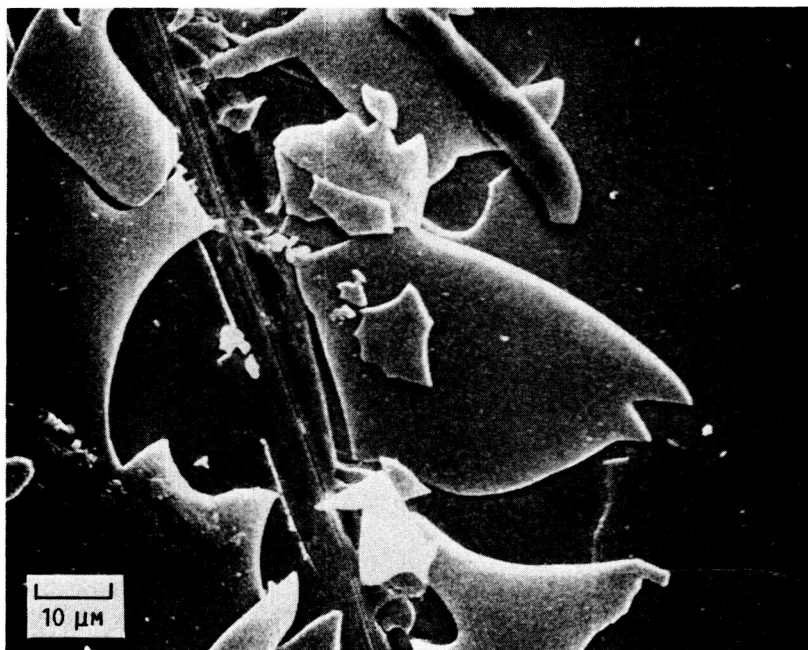
FIGURE 4. - AN EXAMPLE OF A CRACK WHICH DID NOT PENETRATE THROUGH TO THE SILVER LAYER, AS EVIDENCED BY ABSENCE OF SILVER OXIDE. SiO_2 COATING WAS 4000 Å THICK. RF PLASMA EXPOSURE TIME WAS 190 HR.

As with the 4700 Å coating, the 4000 Å SiO₂ coating showed a significant degree of stress cracking. Figure 4 is an SEM photo of one of these fissures and, similar to figure 3, shows a high degree of local "shattering" of the coating. At the location of figure 4, however, no oxidation of silver is evident, indicating that the crack did not extend to the silver layer. This is not true in figure 5, which is an SEM photo of a different location on the surface of the sample in figure 4. Here a significant degree of oxidation along a crack can be seen.

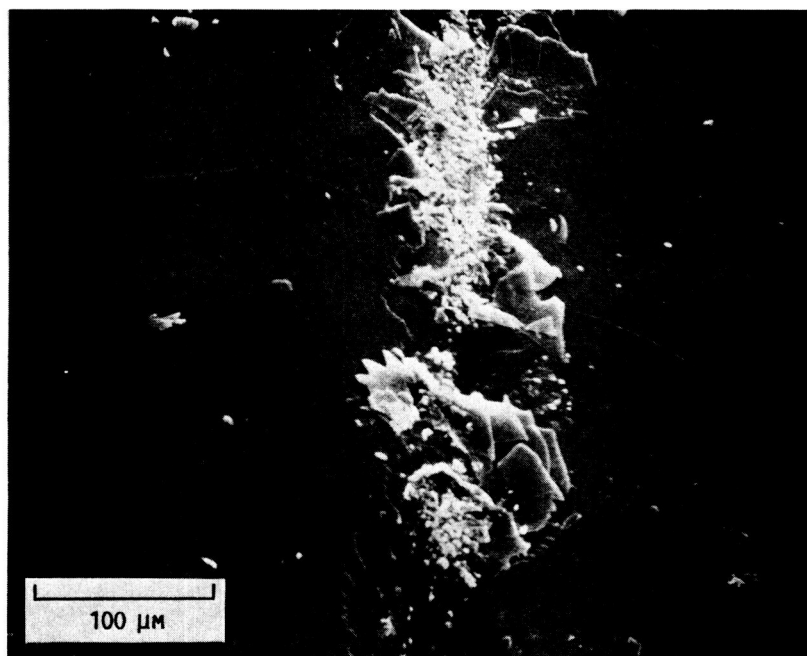
FIGURE 5. - DIFFERENT REGION OF SAME SAMPLE SHOWN IN FIG. 4 SHOWING A CRACK WHICH DID PENETRATE THROUGH TO SILVER LAYER.
