DOE/NASA/50162-2
NASA TM-100806

Tribological Properties of Alumina- Boria-Silicate Fabric from 25 to 850 °C

March 1988

Work performed for
U.S. DEPARTMENT OF ENERGY
Conservation and Renewable Energy
Office of Vehicle and Engine R&D
Washington, D.C. 20545
Under Interagency Agreement DE-AI01-86CE50162

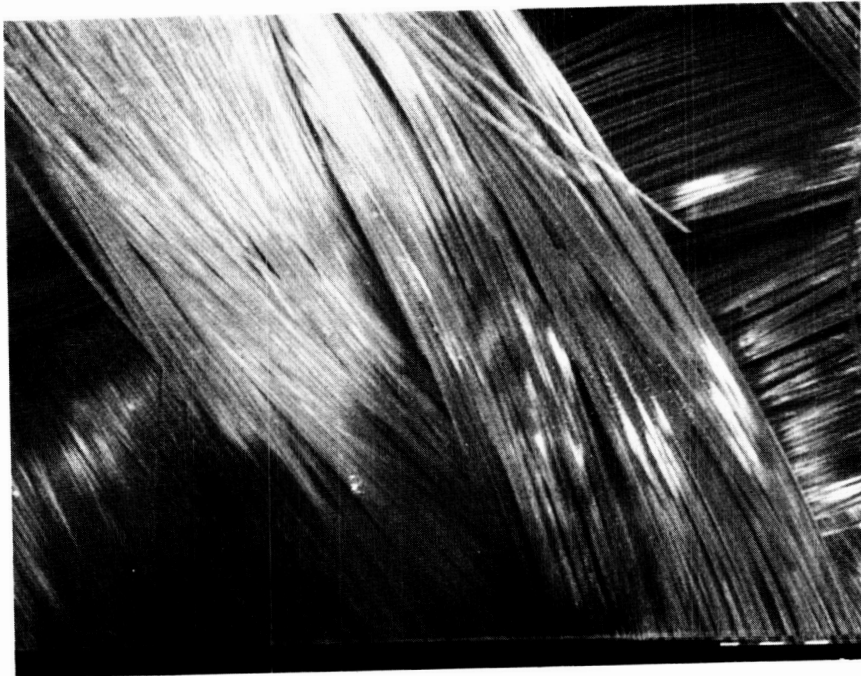
FIGURE 2. - VIRGIN FABRIC BUNDLE 50x.

A fabric woven from Alumina-Boria-Silicate fiber was tested in this program. The composition of the fibers, designated AF-40, by weight is, 62 percent Al_2O_3 , 14 percent B_2O_3 , and 24 percent SiO_2 . This fabric has excellent strength and flexibility to temperatures over 1000 °C. The fabric is made from fibers 10 μm in diameter. The weave is a cross weave type. Each weave bundle contains 390 fibers. The fabric is tightly woven and has the general consistency of heavy burlap. Figure 2 is a photograph of the test fabric.

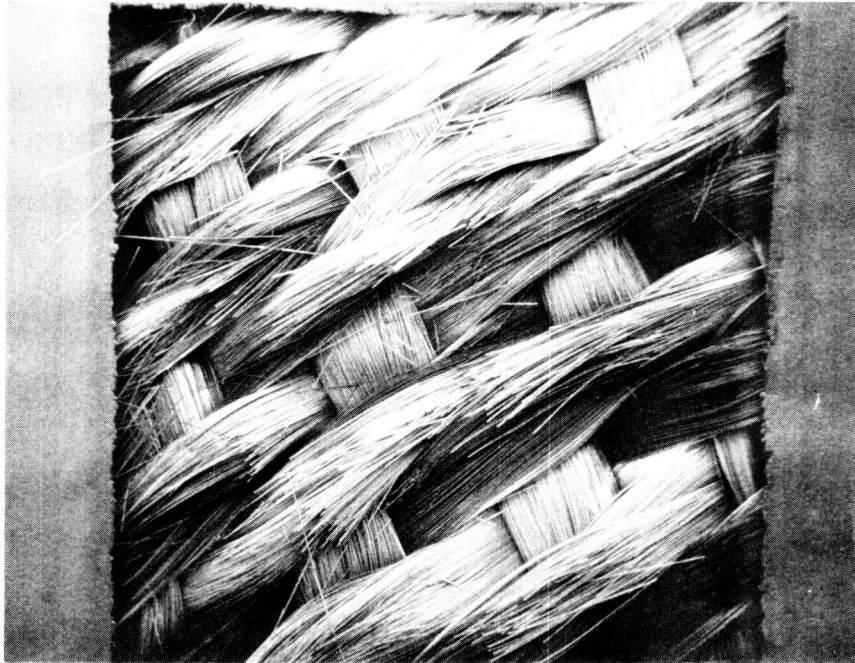
FIGURE 8. - FABRIC FRACTURE AFTER SLIDING AGAINST INCONEL X750. NO LUBRICANT COATINGS APPLIED. (TOP PHOTO 10X, LOWER PHOTO 50X.)

The friction coefficient for the bare AF-40 fabric sliding against the polished Inconel disk was 0.42 ± 0.02 during initial testing at room temperature. Upon heating, the disk began to oxidize and the friction increased. At 850°C the friction coefficient was very high, 1.25 ± 0.06 . As the specimens were cooled, the friction coefficient decreased gradually to about 0.60 ± 0.03 at room temperature. Subsequent heating and cooling cycles produced friction coefficients of 0.60 ± 0.03 at room temperature, which increased, once again, to 1.3 ± 0.1 at 850°C . Moderate fiber breakage occurred during these tests (fig. 8).

An SEM analysis of the fabric and the disks after testing indicated that the mode of failure for the fabric is fiber fracture. No fiber abrasion was detected. EDS elemental analysis shows that no lubricants or fibers transferred to the disk surface but there was a transfer of nickel and chromium, or copper depending upon the test, to the fabric surface probably in the form of oxides. These materials may have provided a limited lubricating effect by separating the fabric from the metal counterface (ref. 5).
