SURFACE SCATTERING CHARACTERISTICS
AND
THE MEASUREMENT OF PARTICULATE CONTAMINATION

Paolo A. Carosso
TS Infosystems, Inc.

Nancy J. P. Carosso
NASA Goddard Space Flight Center

ABSTRACT

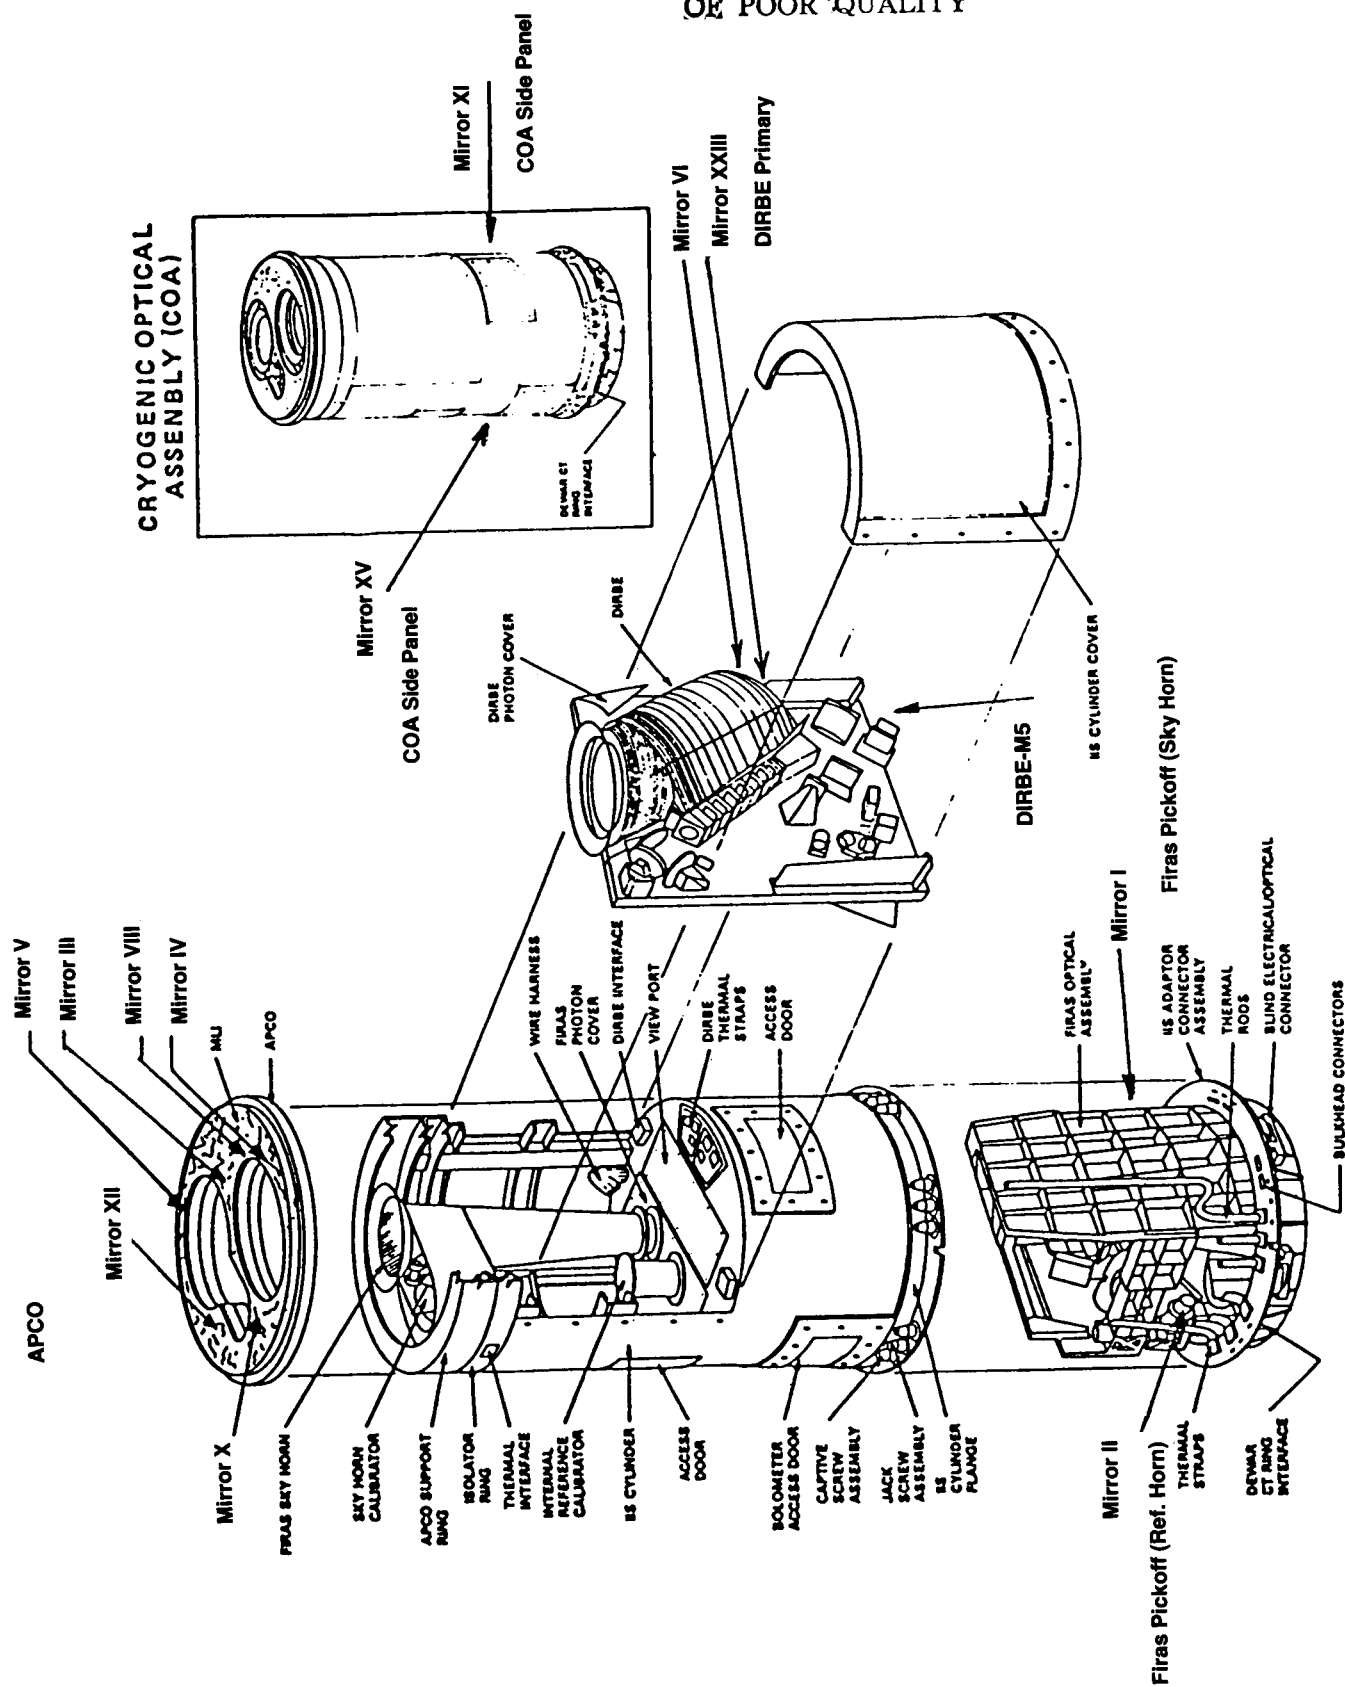
Figure 1. Witness mirrors location

The integrated flight-like TSU COA was originally instrumented with 15 contamination witness mirrors. Due to concerns about overstressing two of the DIRBE mirror mounts, two witness mirrors were taken off the TSU prior to the vibration test. The location of the witness mirrors are illustrated in Figure 1.

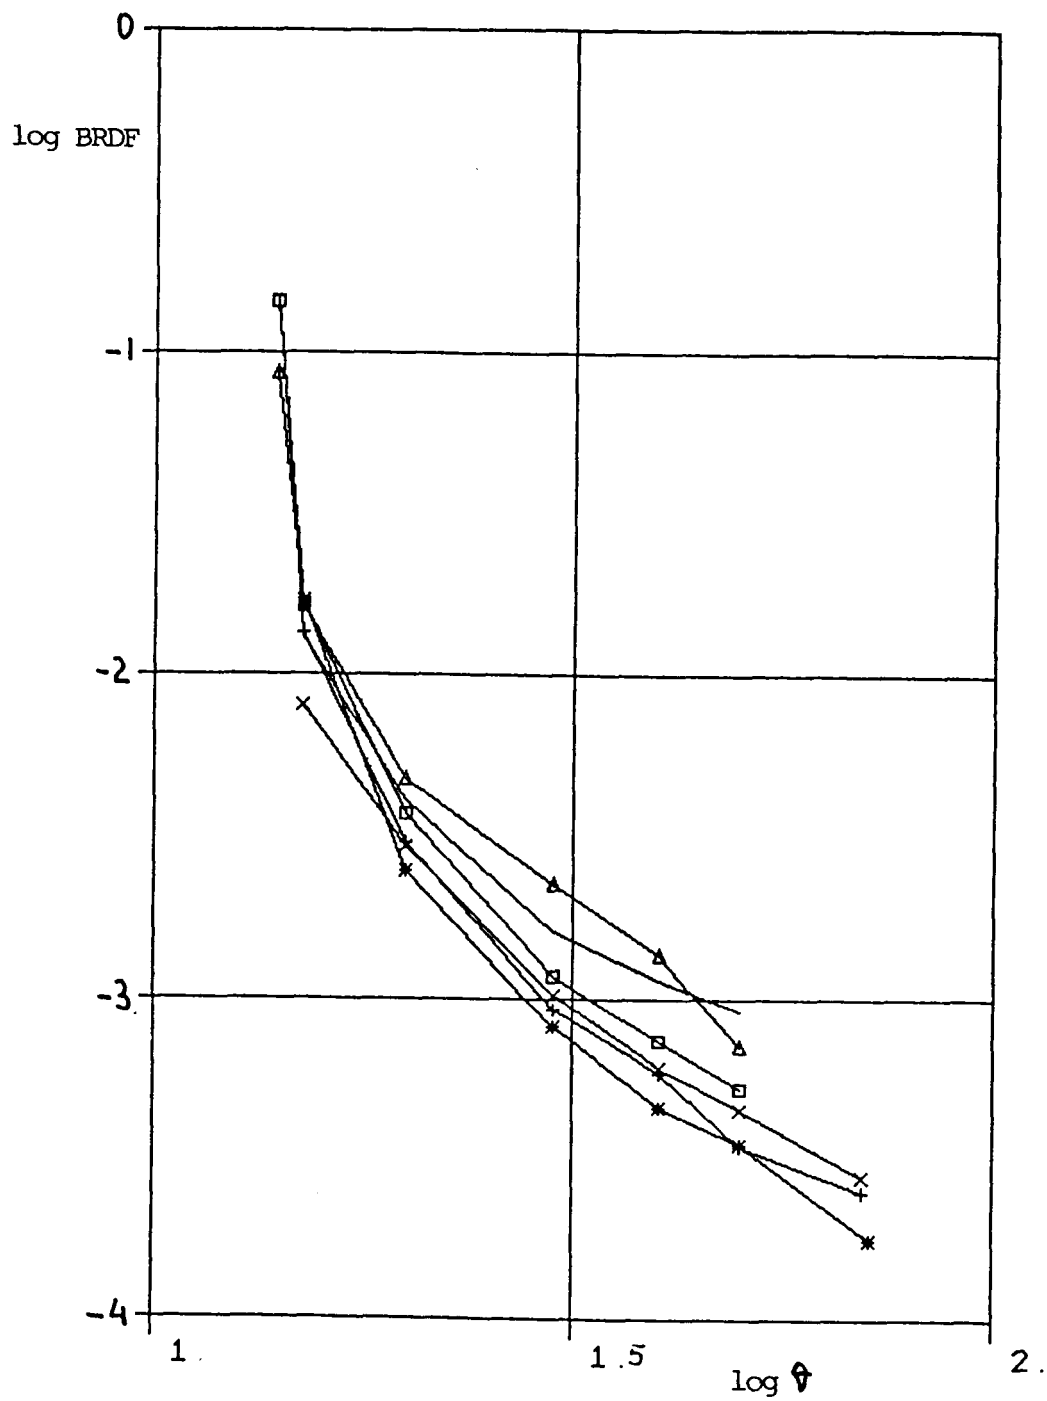
Figure 2. Mirror I

Each witness mirror was measured before and after the vibration test. In order to obtain a complete description of the mirror characteristics, three areas were measured on each mirror. The BRDF curves obtained for mirrors II, VI, are reported in Figures 2 to 13. In these figures, the curves labeled B1, B2 and B3 are relative to the mirror areas as measured before the vibration test. Analogously, curves A1, A2 and A3 refer to the after vibration test BRDF measurements. As it can be seen from the figures, the after test BRDF values are generally higher than the before test ones. The differences are certainly above the experimental error, and represent, therefore, an effect of the contamination accumulated on the mirrors during the vibration test. In some cases, the contamination effect is strong enough to cause dramatic changes in the BRDF values, up to two orders of magnitude

In general, as already mentioned, the BRDF values obtained in the after test measurements are higher in modulus. Also, the curves tend to level off at high scattering angles, which represents a diffuse scatter component due to the presence of contaminants. In other words, the specular behaviour typical of the clean mirror (straight BRDF line with negative slope), is poisoned by a component typical of a diffuse scatterer, in this case the contaminant particulates.
