THE CALIBRATION OF PHOTOGRAPHIC AND SPECTROSCOPIC FILMS

A Densitometric Analysis of IIAO Film Flown Aboard the Space Shuttle Transportation System STS 3, STS 8, & STS 7

SEMI-ANNUAL REPORT

MORGAN STATE UNIVERSITY

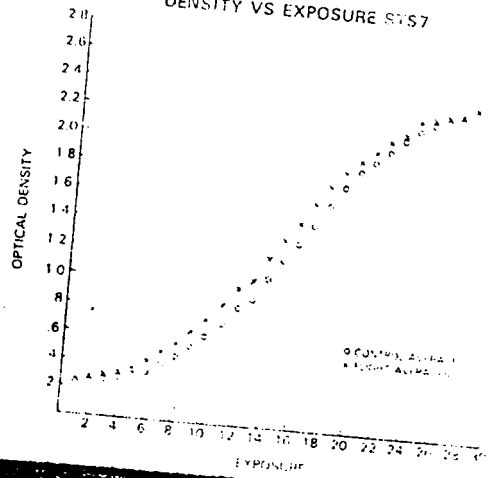
Slide #8

DENSITY VS EXPOSURE STS7

Slide (8) During the loading pre-flight launch, post-flight analysis indicates that the IlaO film had been exposed to some type of thermal aging effects. The exact nature of these effects are not apparent as we examine the temperature profiles for STS-7. But, there is a concern that the rapid increase in temperature from approximately -15°C to a temperature of $+22^{\circ}\text{C}$ in an hour and a half after touchdown of the shuttle could explain the exaggerated thermal and aging effects. There is another real concern which is associated with the fact that the shuttle landed on the West Coast, and the automatic temperature cut-off control was turned off approximately three days before the shuttle arrived at Cape Kennedy for the unloading of the getaway special canister containing the above mentioned film.

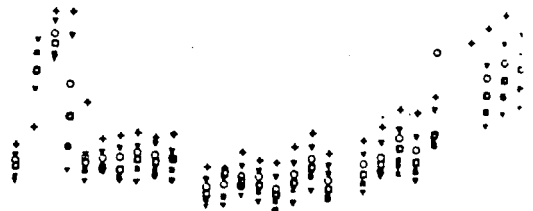
Slide 41

Seconds

An examination of the reciprocity failure for the 1 to 30 second exposure periods (i.e., a separate wedge pattern was exposed to an amount of light from 1 to 30 seconds sequentially) reveals that for two separate batches of film whose history of use was different, there is some Reciprocity Failure occurring at the darker wedge patterns. Slides (39,40,41,42,
