NASA Contractor Report 178323

Breakdown Characteristics of an Isolated Conducting Object in a Uniform Electric Field

Report on
N.A.S.A. Grant NAG-1-28

December 1986

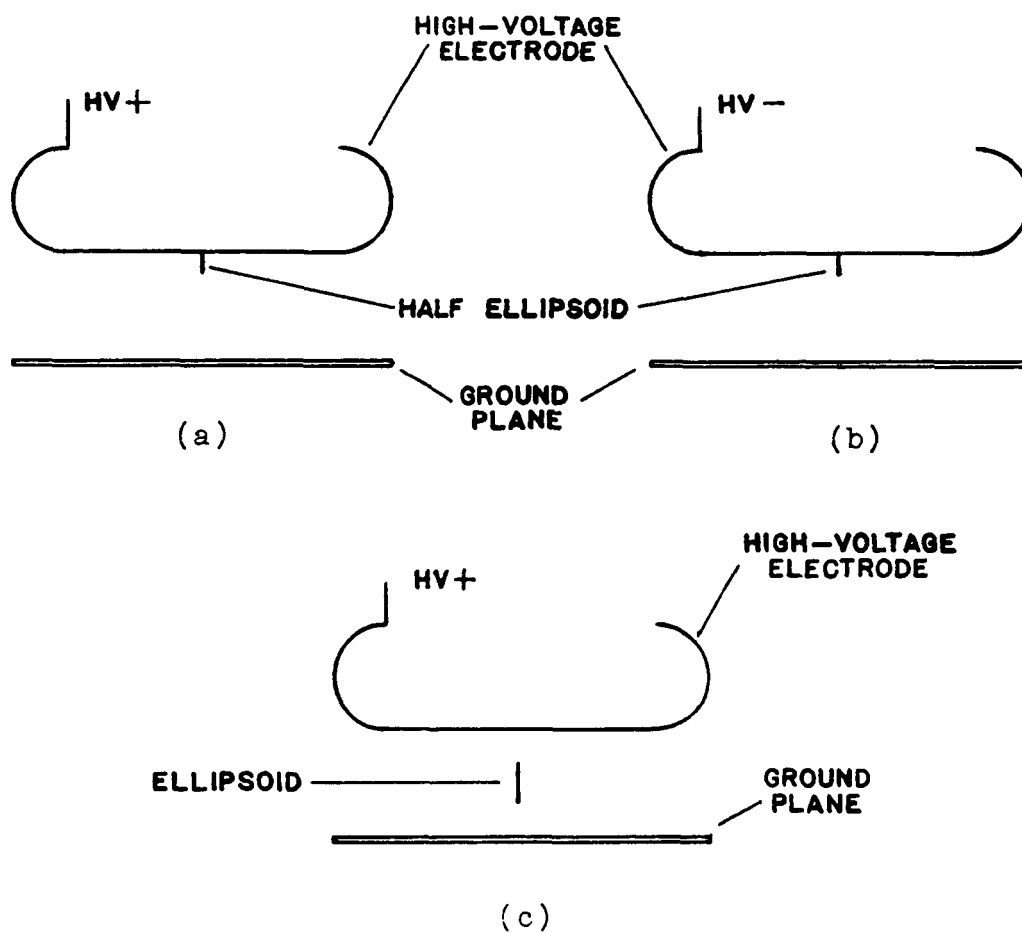
Figure 1: Spark Gap Configurations: (a) Configuration 1: half-ellipsoid attached to positive high-voltage electrode. (b) Configuration 2: half-ellipsoid attached to negative high-voltage electrode. (c) Configuration 3: full ellipsoid centered between positive high-voltage electrode and the ground plane.

configurations of Figure 1 (5). These configurations include not only the isolated-object arrangement, which is similar to the aircraft-triggering case, but also the simpler cases of positive and negative point-plane gaps. Data was gathered from a D-dot sensor and an fast framing camera, with the D-dot waveforms being integrated by a 10 μ s analog integrator.

Configuration 3 was set up by suspending the ellipsoid such that it was oriented vertically in the center of the gap (Figure 1c). The plate separation was 25.4 cm (10 in), and power supply voltage was 152 kV. Note that in this case there were actually two gaps in series, each 7.7 cm in length. The framing photo for the event is shown in Figure 4, with three frames from right to left. The ellipsoid itself is not visible, but it lies in the center between the ionized channels. The

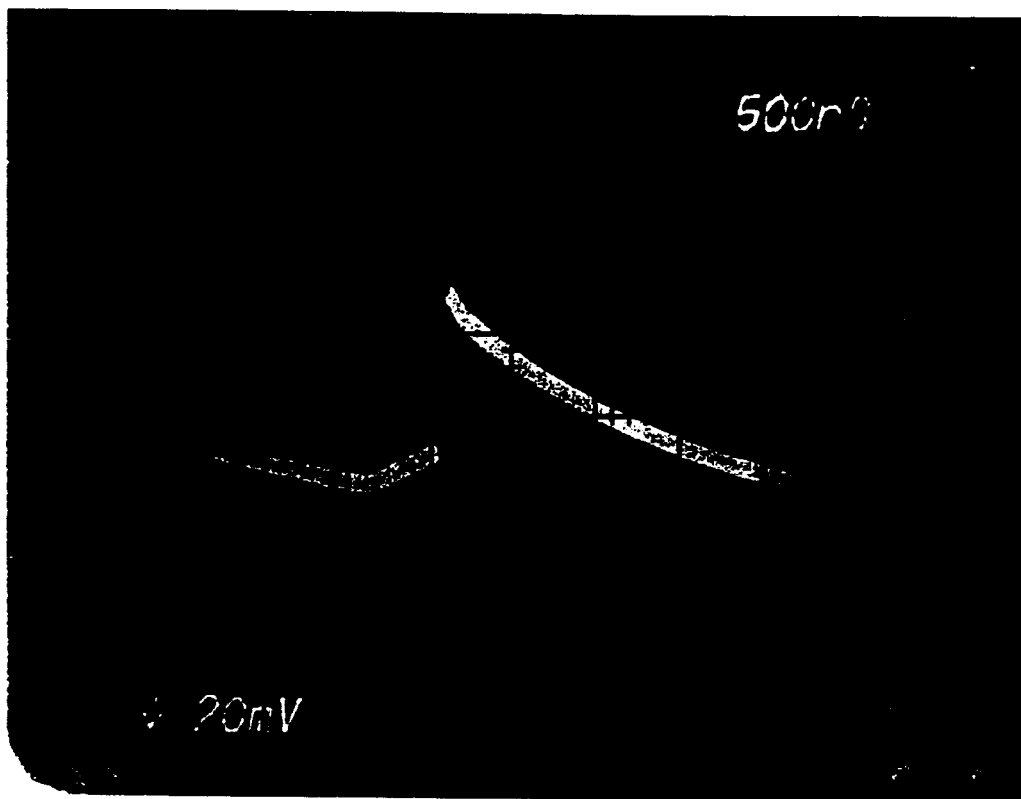
Figure 25: (Continued) (b) Transition to arc with leader propagation.

For the event of Figure 23, arc transition occurs without being preceded by leader propagation from the positive point of the lower gap. In some instances, however, there is evidence that indicates that positive leader propagation does precede arc transition. Figure 25 consists of two integrated D-dot waveforms of separate events. Aside from the decays due to the time constants of the analog integrators used, the waveforms provide a picture of the collapse of the electric field in the gap. Comparing the two waveforms, we see that the upper is a relatively short event while the lower is quite a bit longer. The region of interest is that section just preceding the second peak. Any evidence of positive leader propagation will show up as a slow linear rise in the electric field record. Figure 25a gives no indication of a leader. Figure 25b, though, has the characteristic ramp indicating leader propagation. Measurement of the time involved produces an approximate leader velocity of 1.7×10^7 cm/s, which is fairly consistent with the results stated previously.
