NASA Technical Memorandum 87353

Friction and Wear of Sintered Alpha SiC Sliding Against IN-718 Alloy at 25 to 800 °C in Atmospheric Air at Ambient Pressure

Deniel L. Deadmore and Harold E. Sliney
Lewis Research Center
Cleveland, Ohio

July 1986

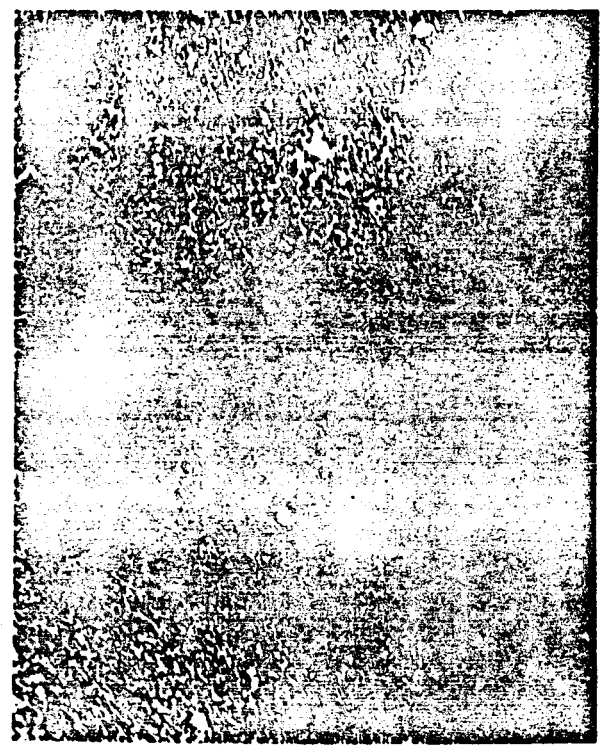
(b) EDX analog dot scan for Si.

(a) SEM photograph.

(c) EDX analog dot scan for Ni and Cr.

Figure 11. - SEM photograph and analog dot maps at edge of SiC wear scar after sliding against IN-718 at 550 °C.
