NASA Technical Memorandum 89025

**VERTICAL DROP TEST OF A TRANSPORT FUSELAGE SECTION
LOCATED AFT OF THE WING**

EDWIN L. FASANELLA AND EMILIO ALFARO-BOU

SEPTEMBER 1986

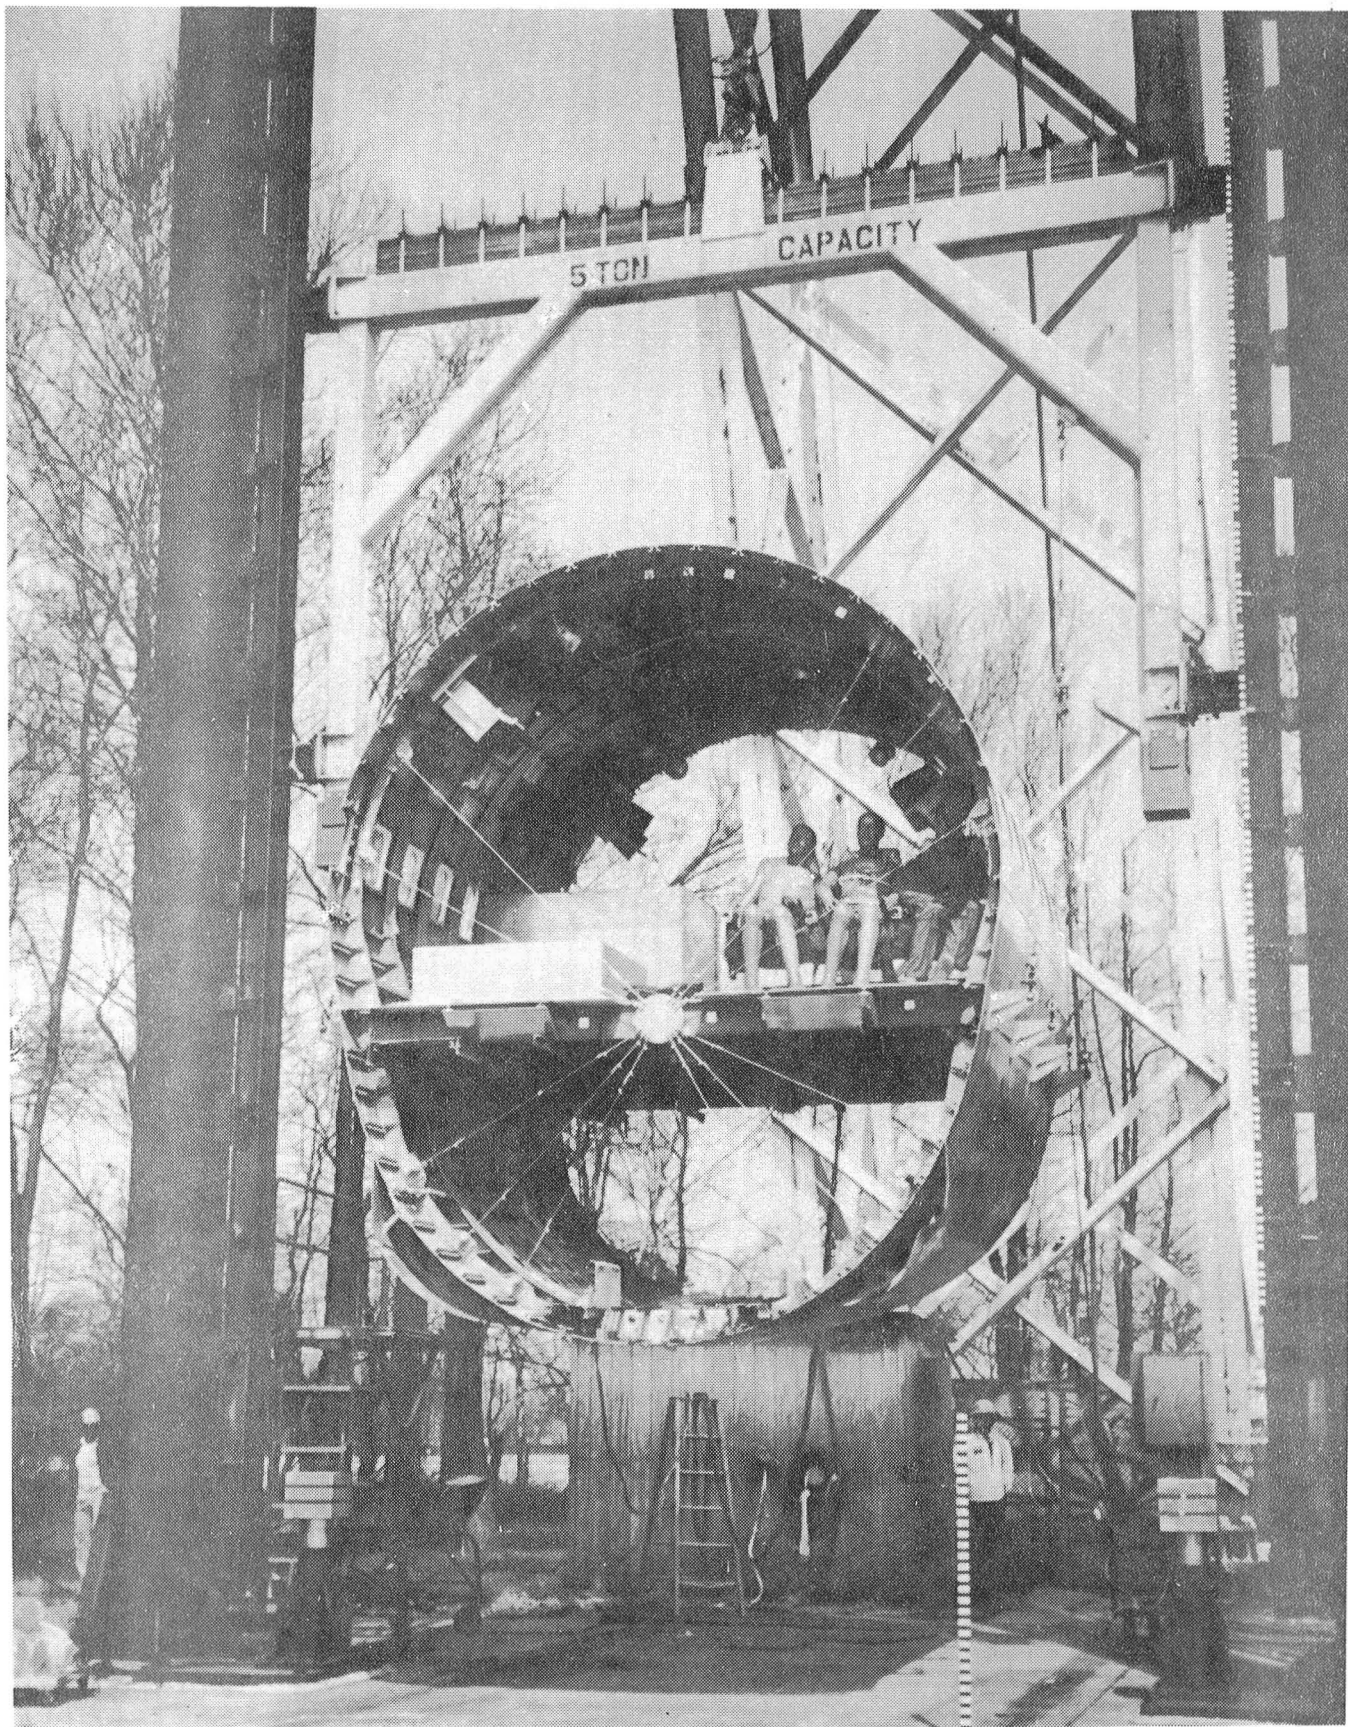
Figure 1.- Aft Transport section suspended in Vertical Test Apparatus.

The fuselage section is shown in figure 1 suspended in the Vertical Test Apparatus at the Impact Dynamics Research Facility. The 12-foot long section was cut from a Boeing 707 approximately 10 inches forward of Body Station (BS) 1020 to 10 inches aft of BS 1140. Nonstructural items such as interior paneling, insulation, ducting, etc. were removed from the section. The section weighed 6395 pounds when loaded with a seat and three anthropomorphic dummies, data acquisition system (DAS) pallet, DAS power pallet, DAS recorder pallet, cameras, lights, instrumentation and ballast used to balance the section.

The NASA Vertical Test Apparatus (VTA) (Figure 1) was used to drop test the transport section and to provide a stable guide mechanism for the vertical impact test. The VTA was designed with the following maximum conditions:

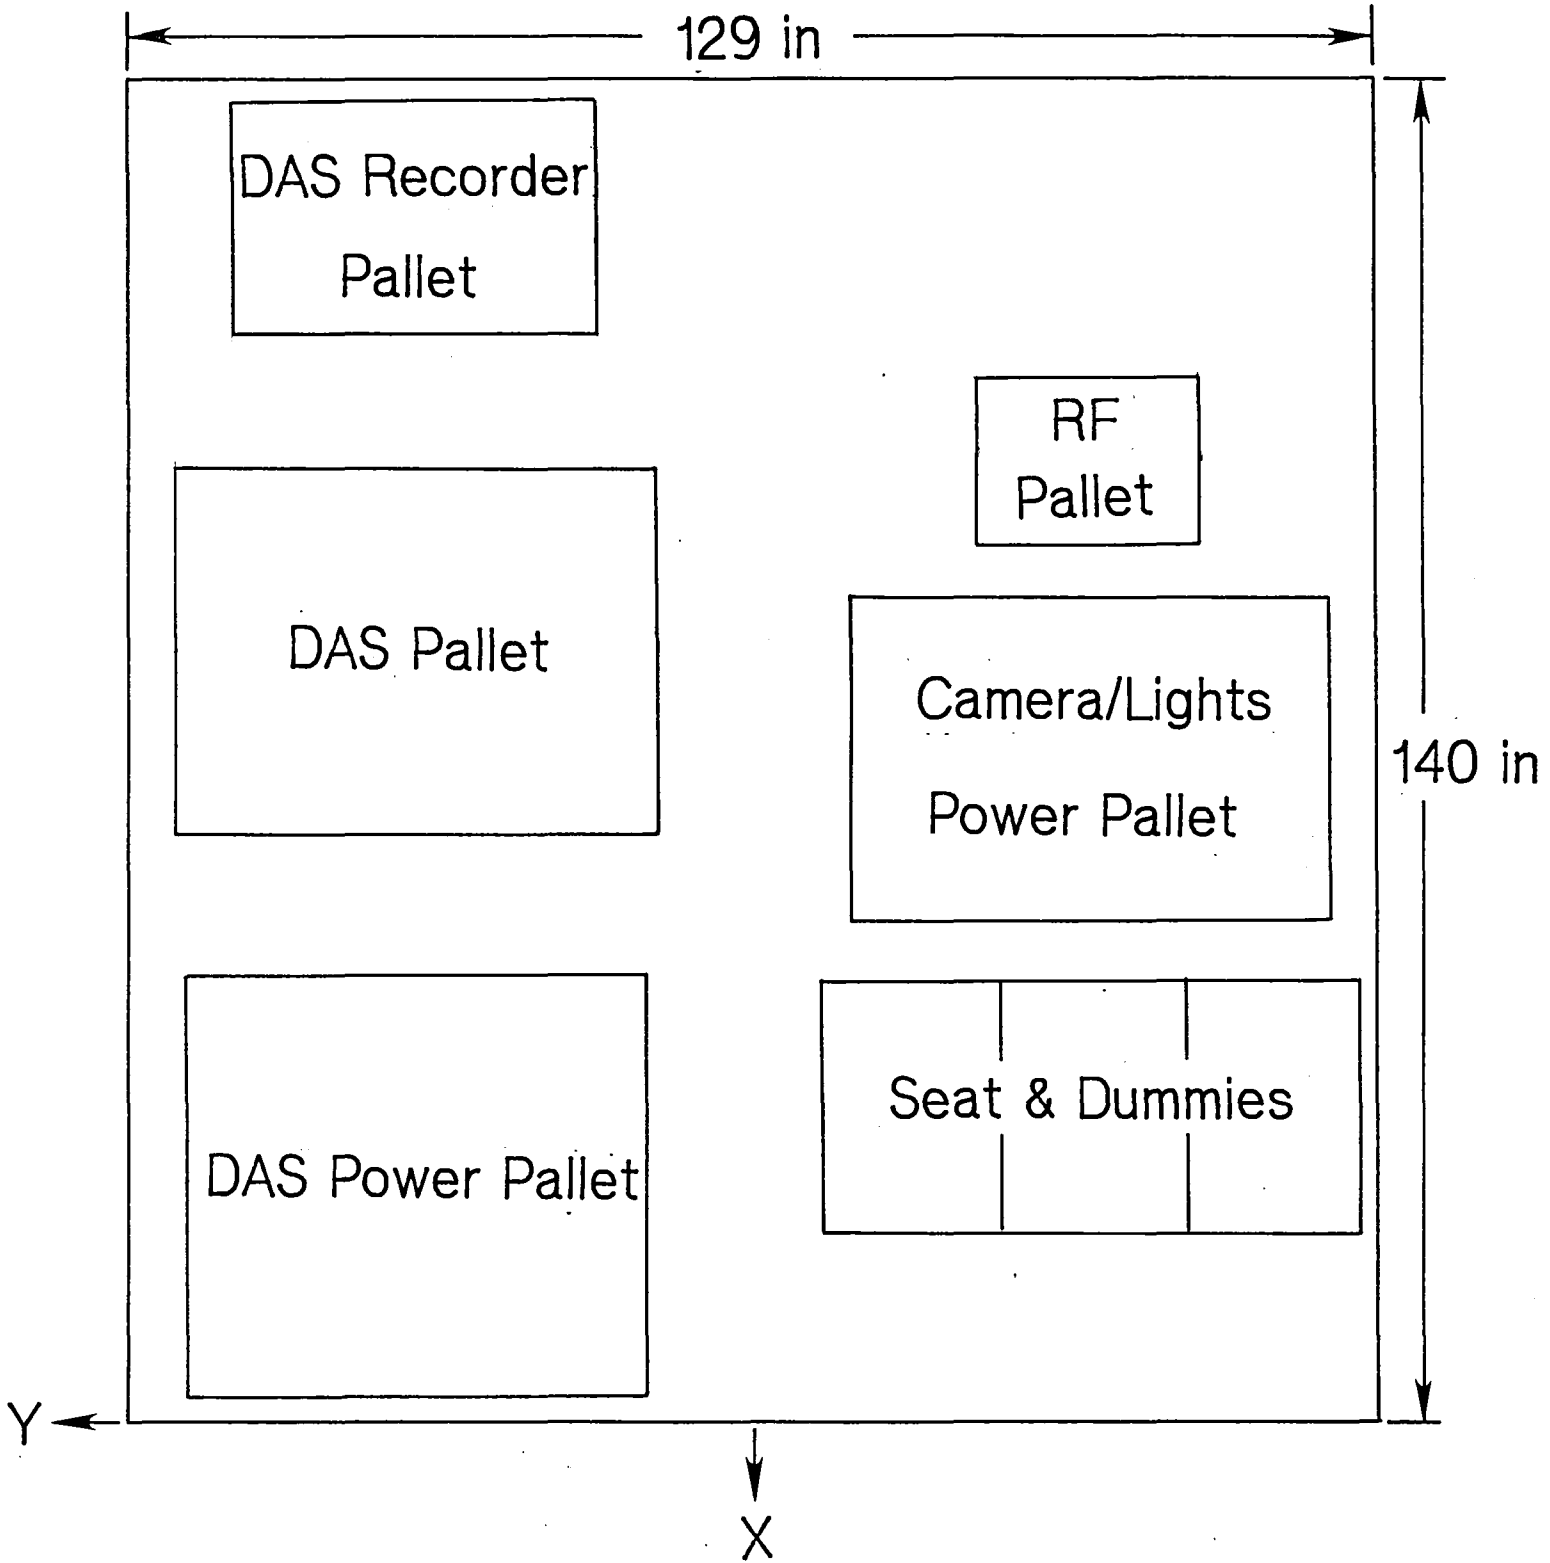
Figure 2.- Floor plan of section showing coordinate axes.

Figure 2 is a floor layout of the section showing the seat, DAS system pallets, etc. The seat was a standard triple transport seat that was acquired along with the transport sections. Only the center dummy of the three anthropomorphic 50th percentile, 165 lb dummies was instrumented.

Table I gives the weight and coordinates of all articles onboard the test section. The X-axis was chosen to be the longitudinal axis with positive x running forward toward the nose of the airplane. The positive Y-axis is transverse to the right, and the positive Z-axis is downward. The origin (0,0,0) was chosen to be at floor level at the center of the front edge (see figure 2). Accelerations along the Z-axis direction will be called normal accelerations; along the Y-axis, transverse; and along the X-axis, longitudinal.

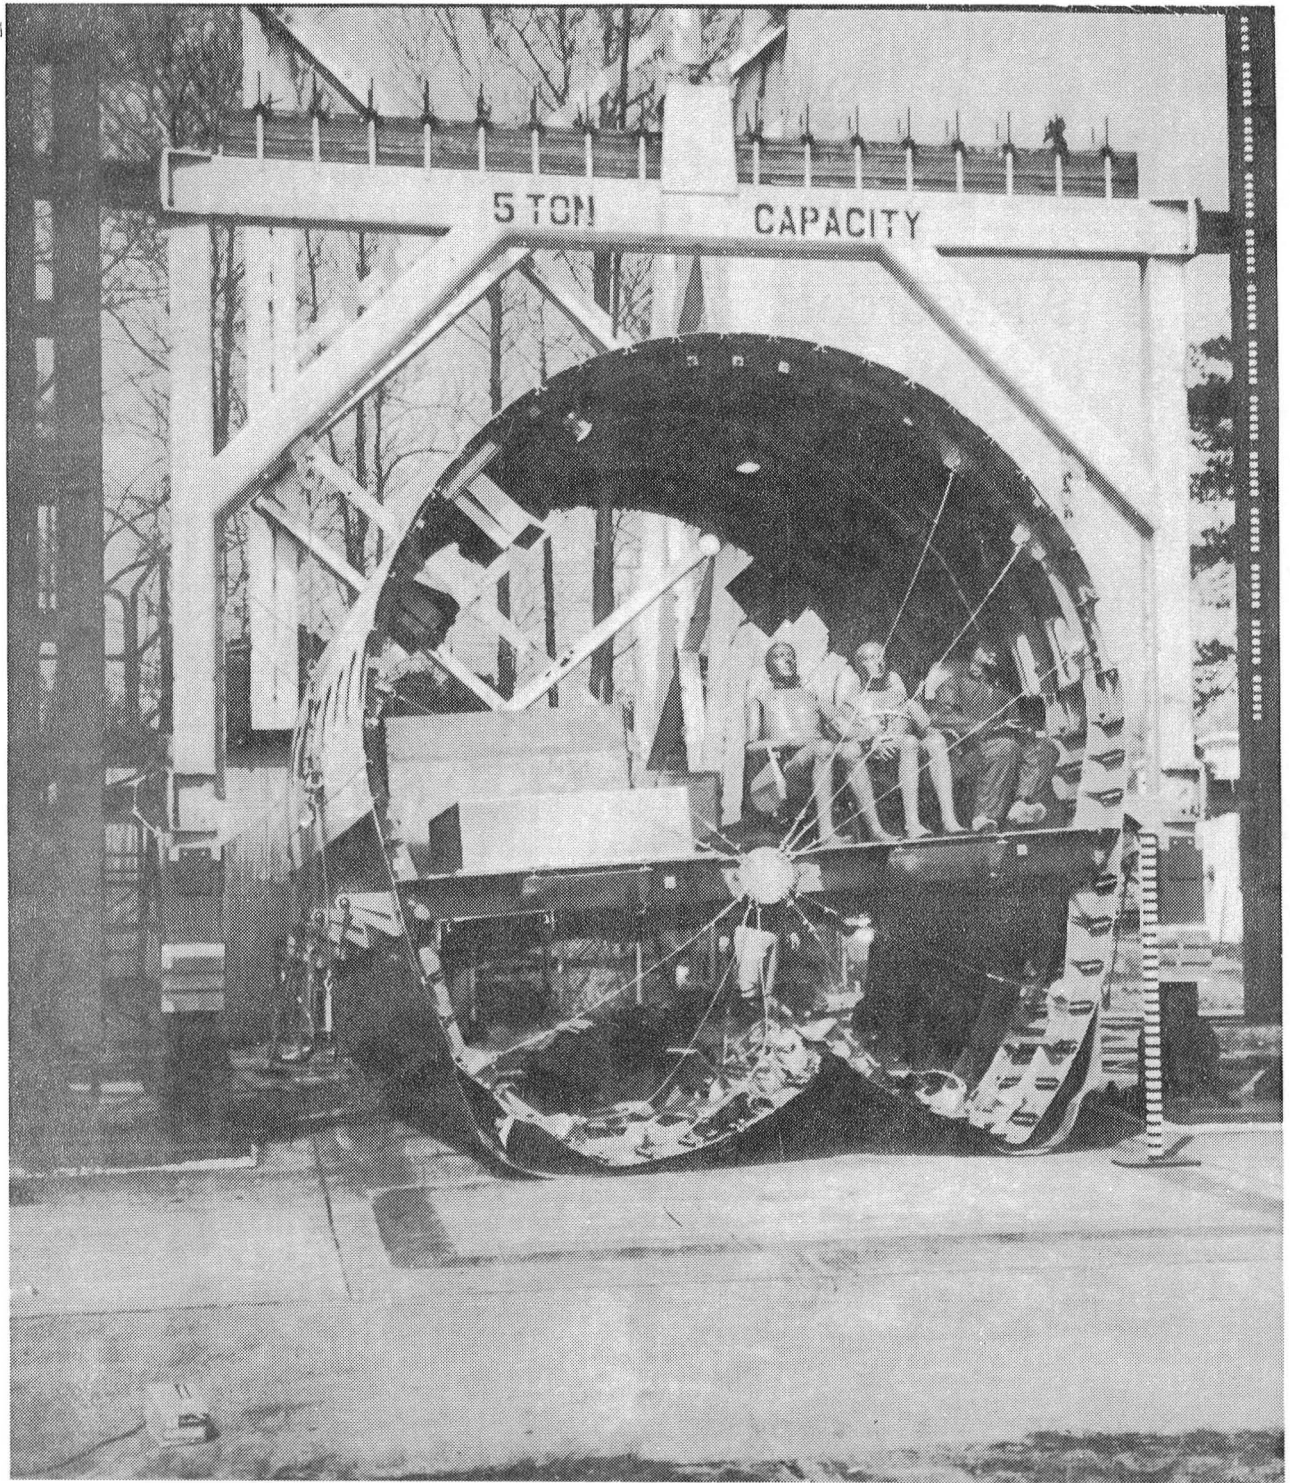
Figure 3.- Front view of section post-test.

Figures 3-4 show post-test damage to the transport section. The frontal view of the section in figure 3 shows that the fuselage beneath the floor collapsed approximately 14 inches. Except for slight deformation of the floor near the DAS pallet and seat, no other structural damage was apparent at floor level or above. Figure 4 shows the rear view of the section. Since the rear of the section had farther to fall because of the sloping bottom contour, a pitch rate developed and the rear frame impacted with both a longitudinal and vertical component of velocity and deformed approximately 18 inches.

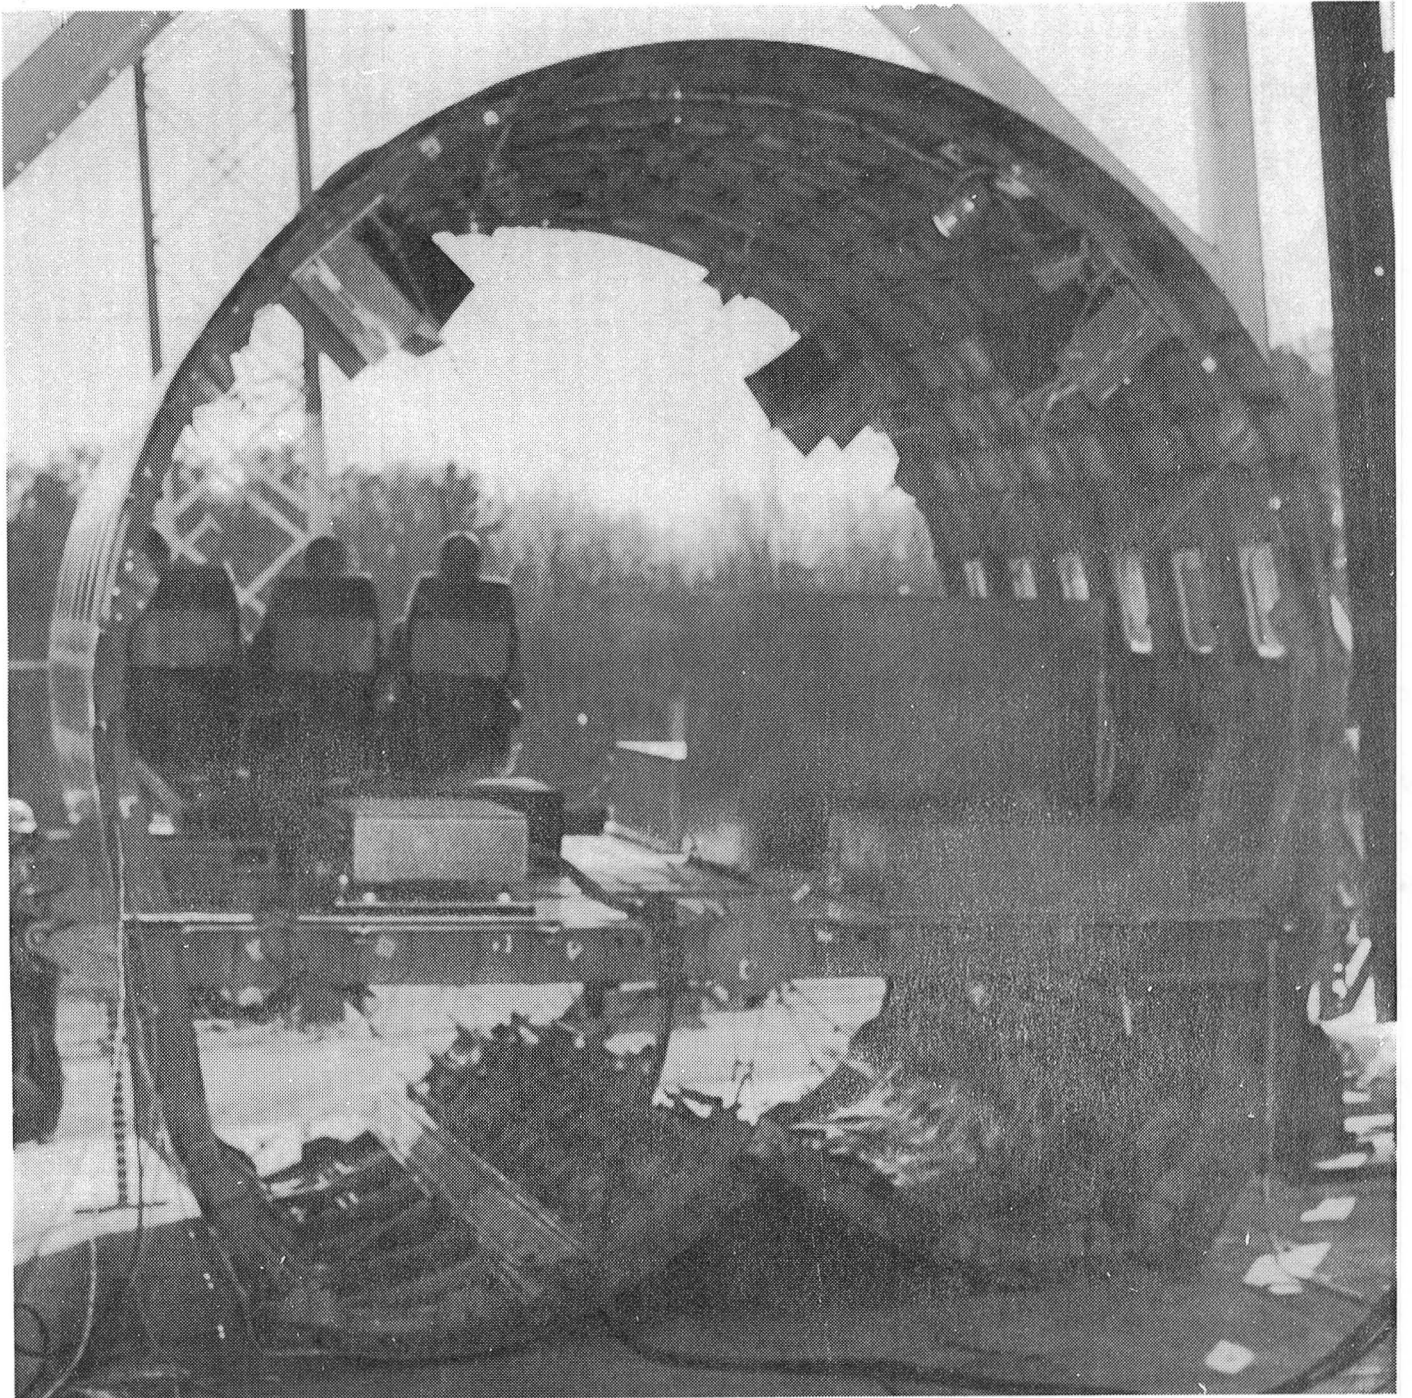
Figure 4.- Rear view of section post-test.

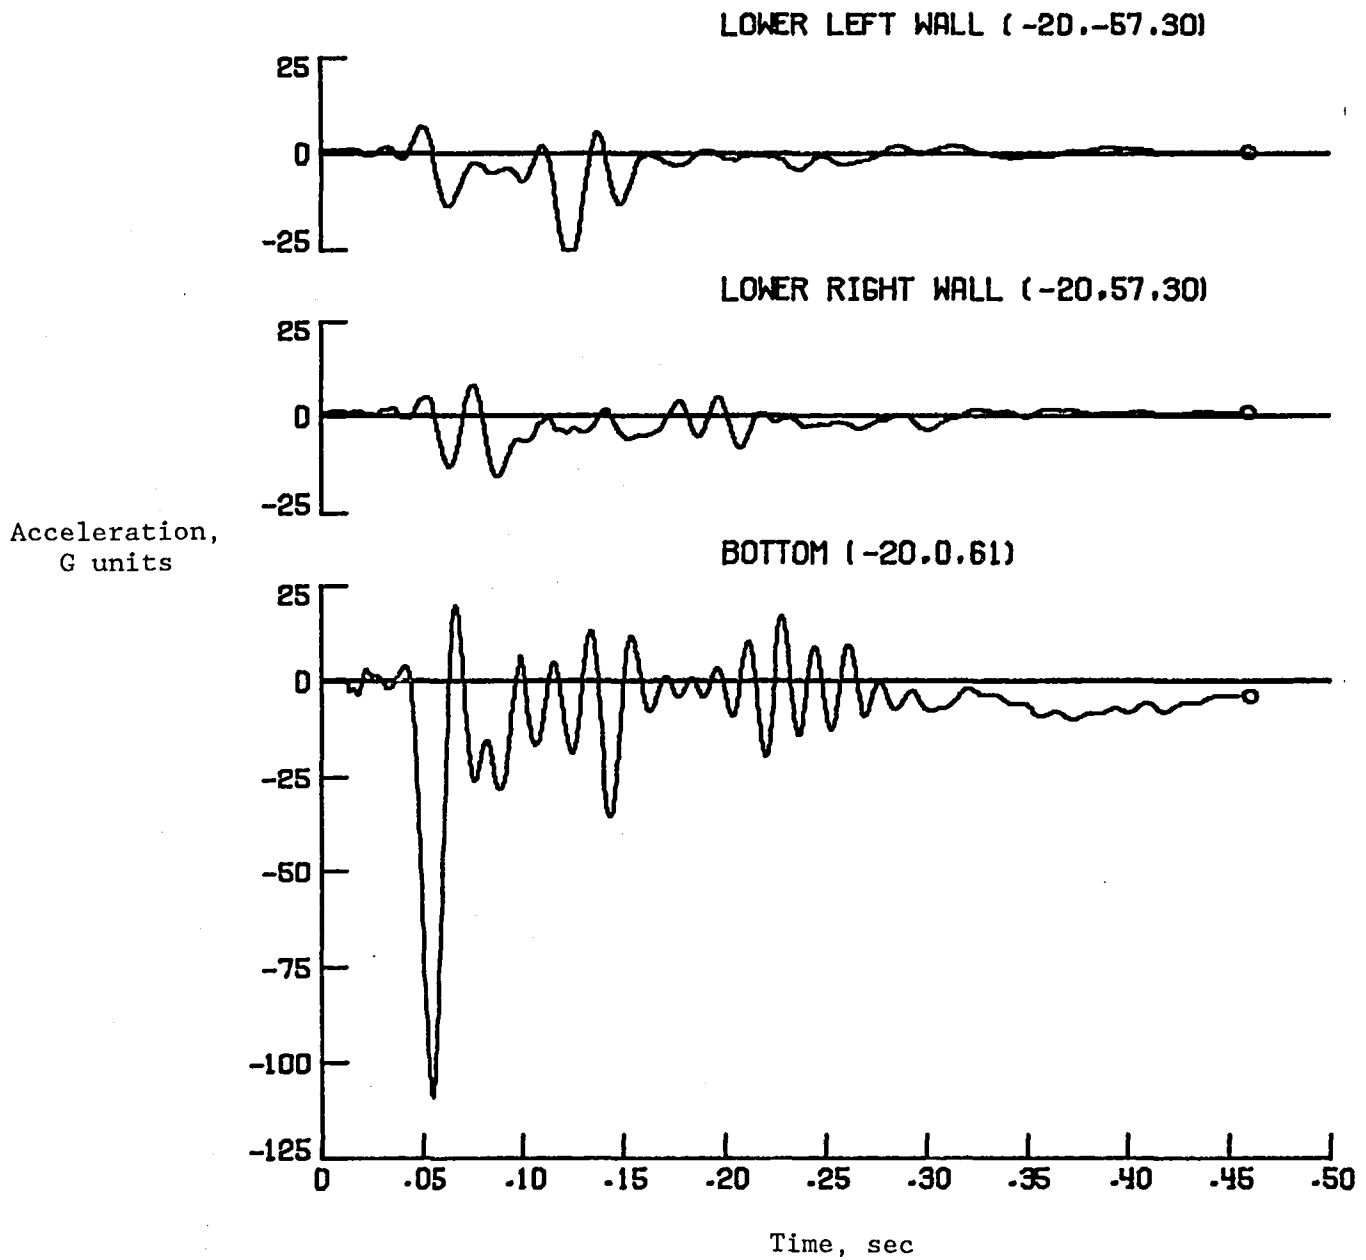
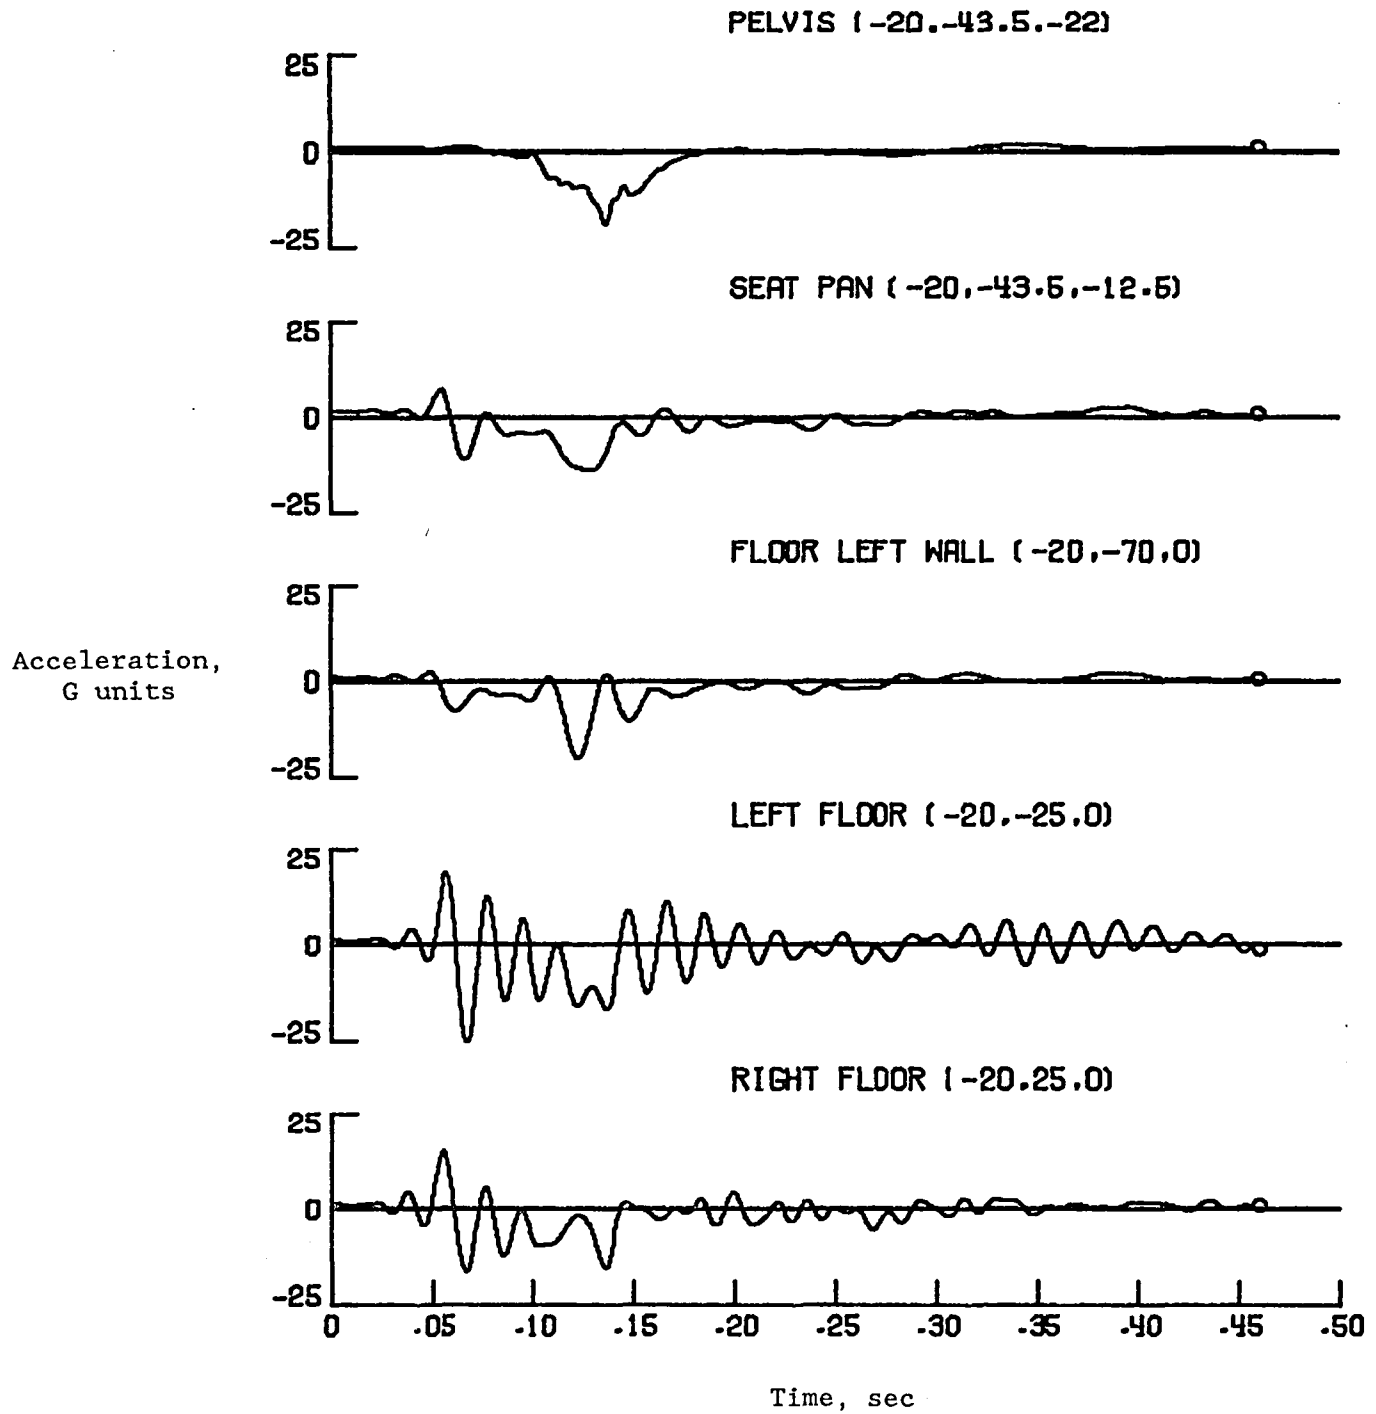
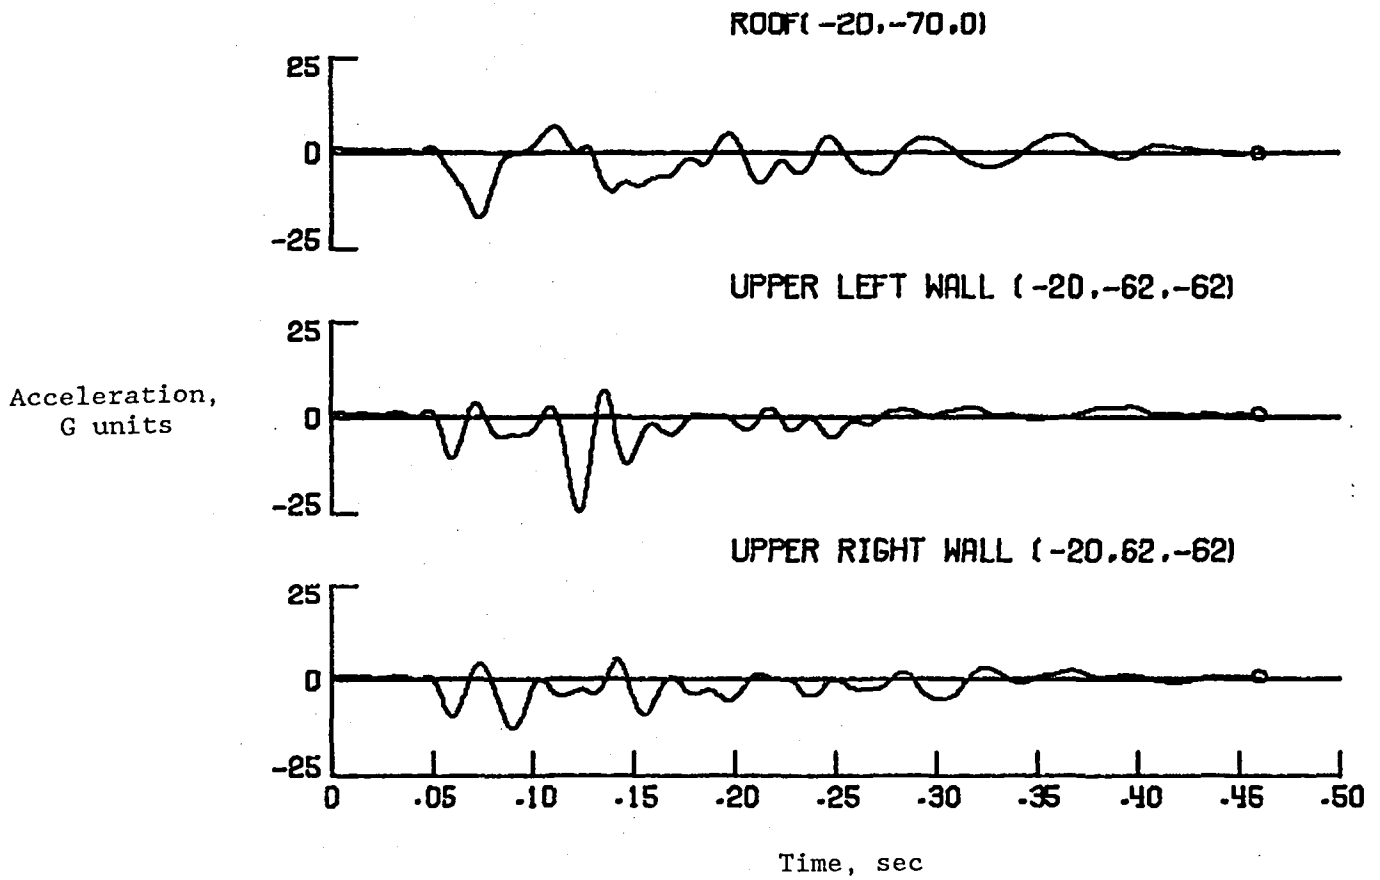
(a) BS 1040

Figure 5.- Normal acceleration time histories.

The normal accelerations for locations on frames at BS 1040 and 1120 are shown in figure 5a-5c and 5d-5e, respectively. The normal acceleration varies from a maximum of about 110 G's at the bottom of frame 1040 (which impacted first) to 65 G's on the bottom of frame 1120. The accelerations at the bottom of the frame are difficult to obtain and must be used with caution. More relevant are the floor accelerations. The maximum vertical floor acceleration on frame 1040 varies from approximately 20 G's on the right to about 25 G's on the left side. The primary deceleration pulse lasts for less than 0.1 seconds total. On frame 1140, the maximum normal acceleration on the floor is somewhat less, and does not exceed 20 G's. Only the center dummy was instrumented. The seat pan maximum acceleration (Figure 5 b) was 14 G's. The pelvis acceleration did show a normal spike of 19 G's; however, the plateau was in the same 14 G range as the seat pan. The pelvis acceleration pulse duration was approximately 0.10 seconds.

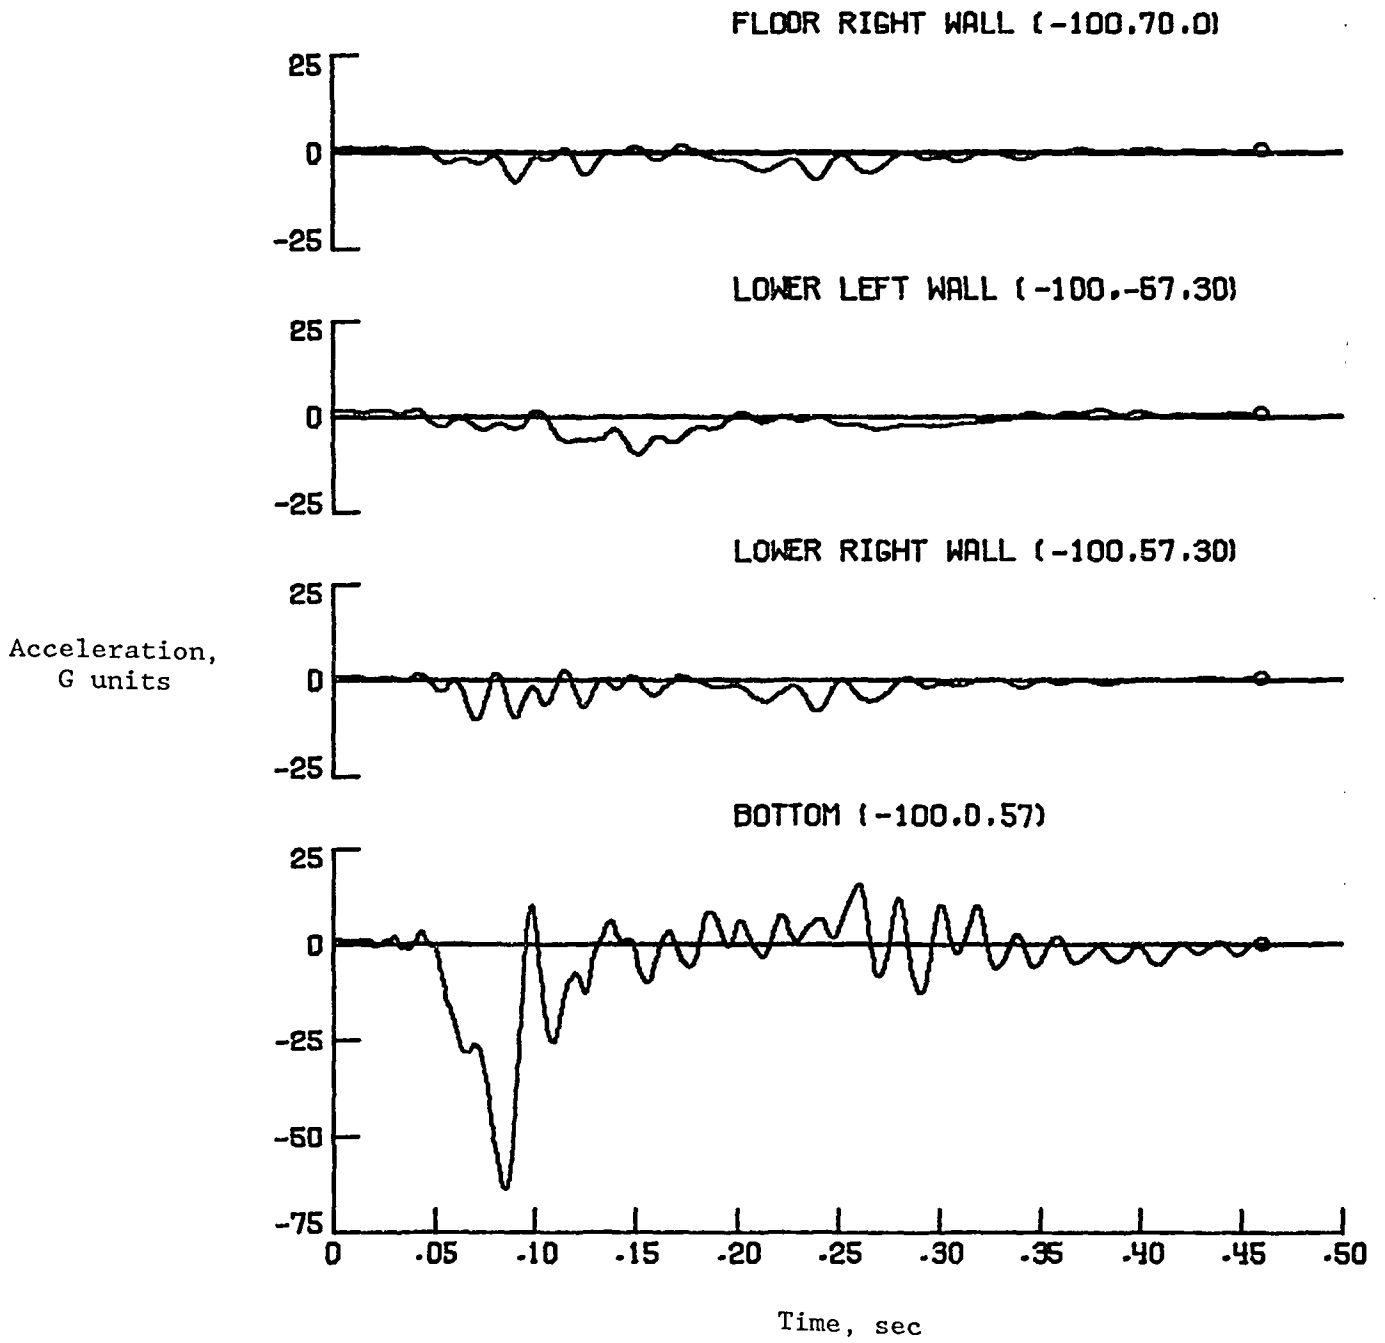
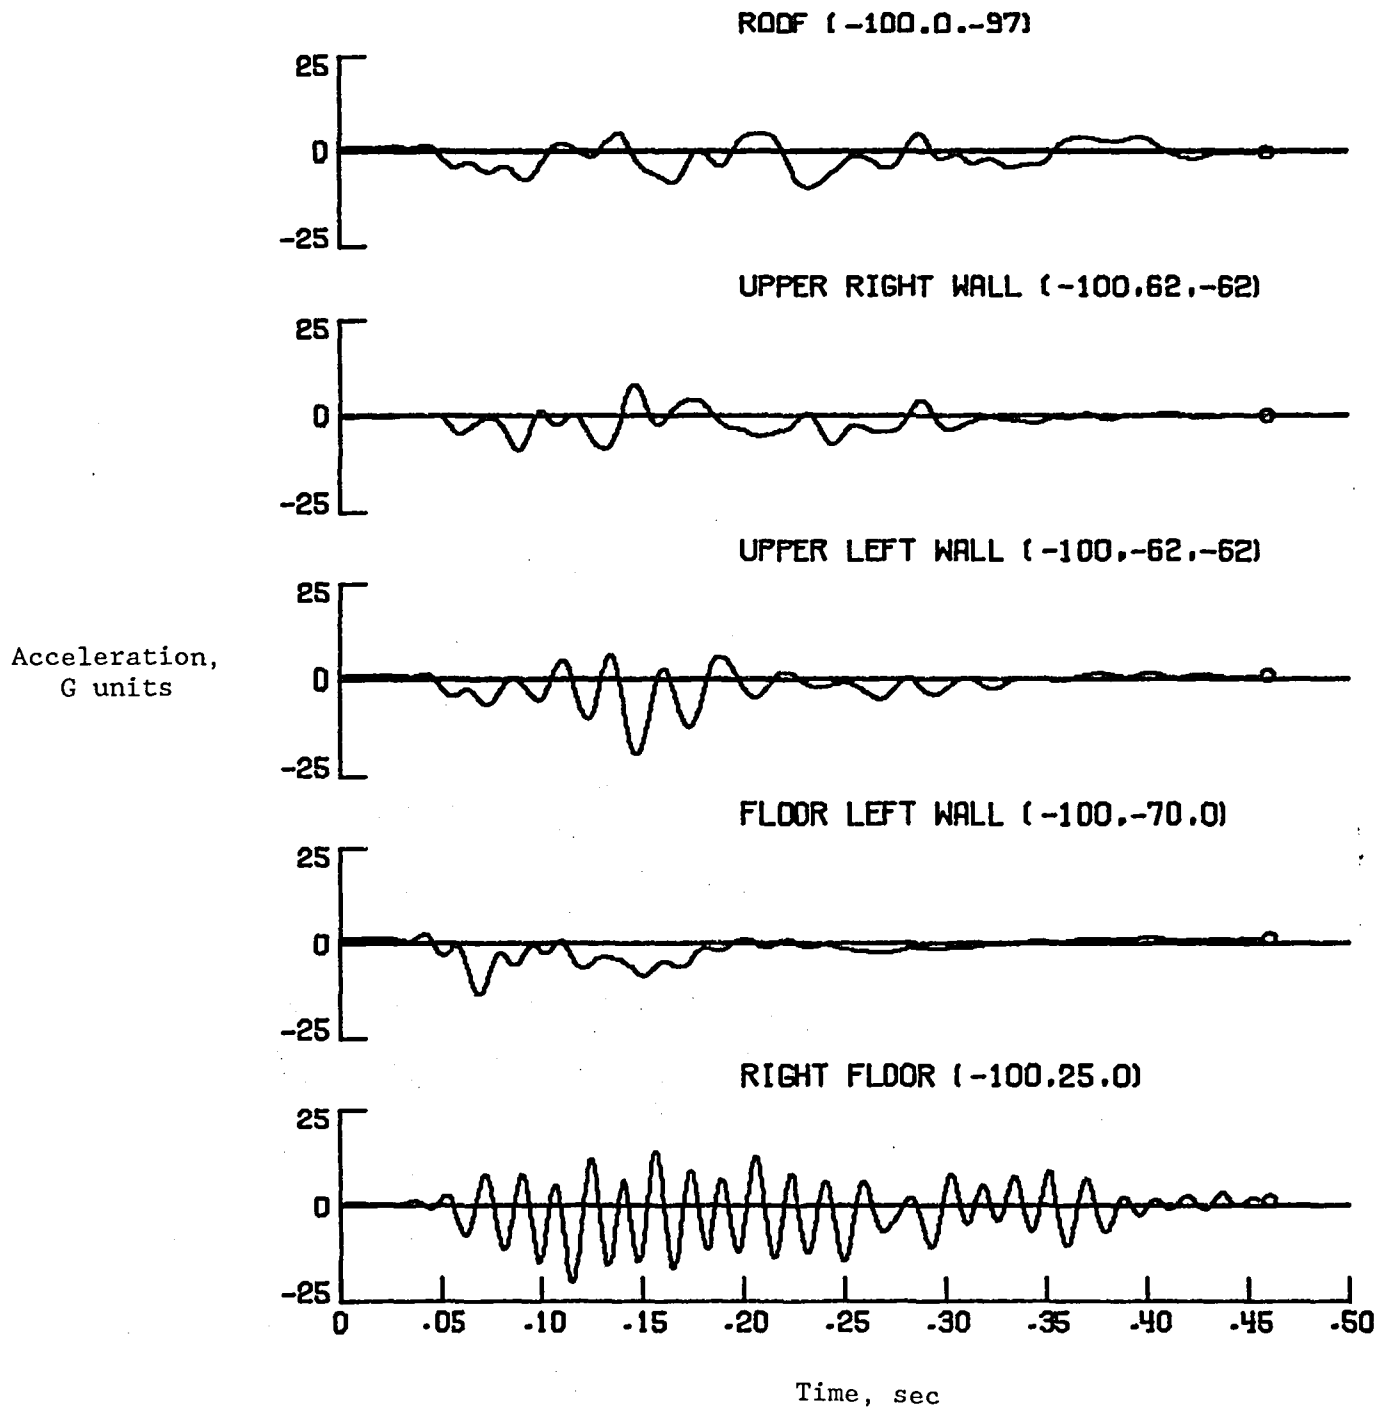
(d) BS 1120

Figure 5.- Continued.

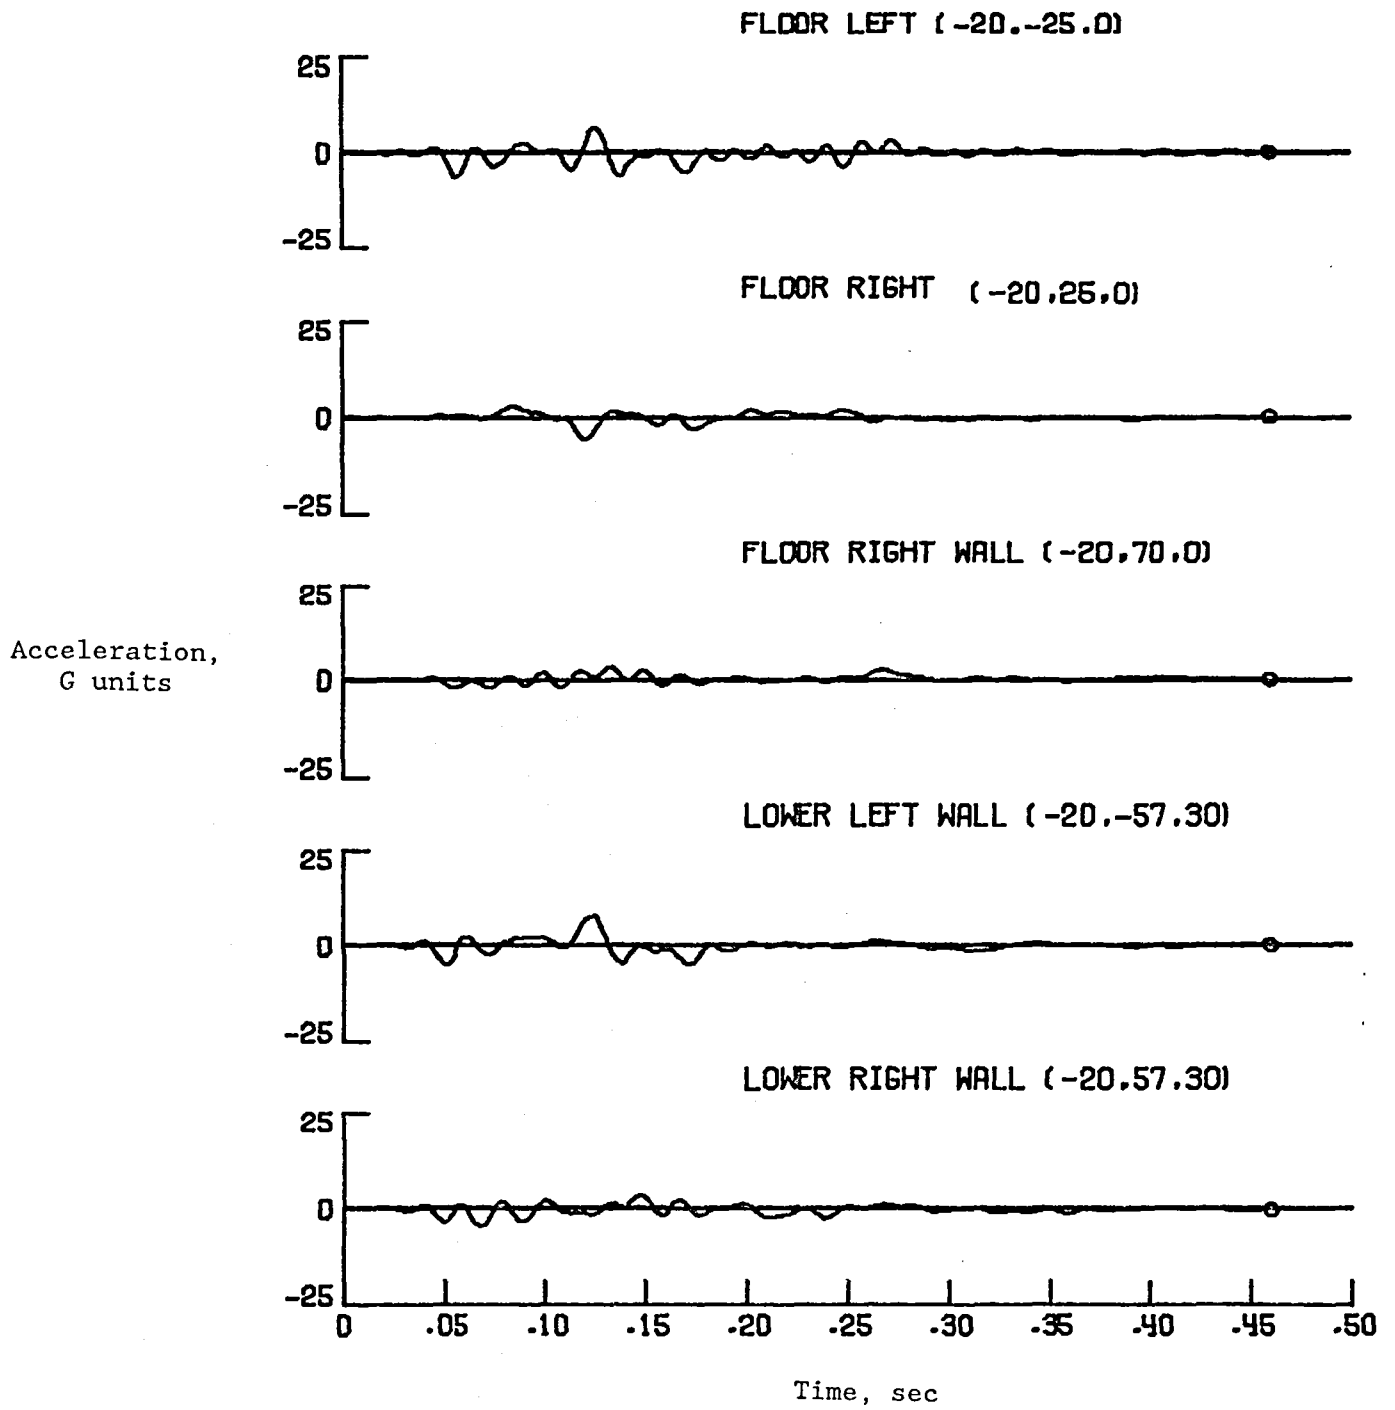
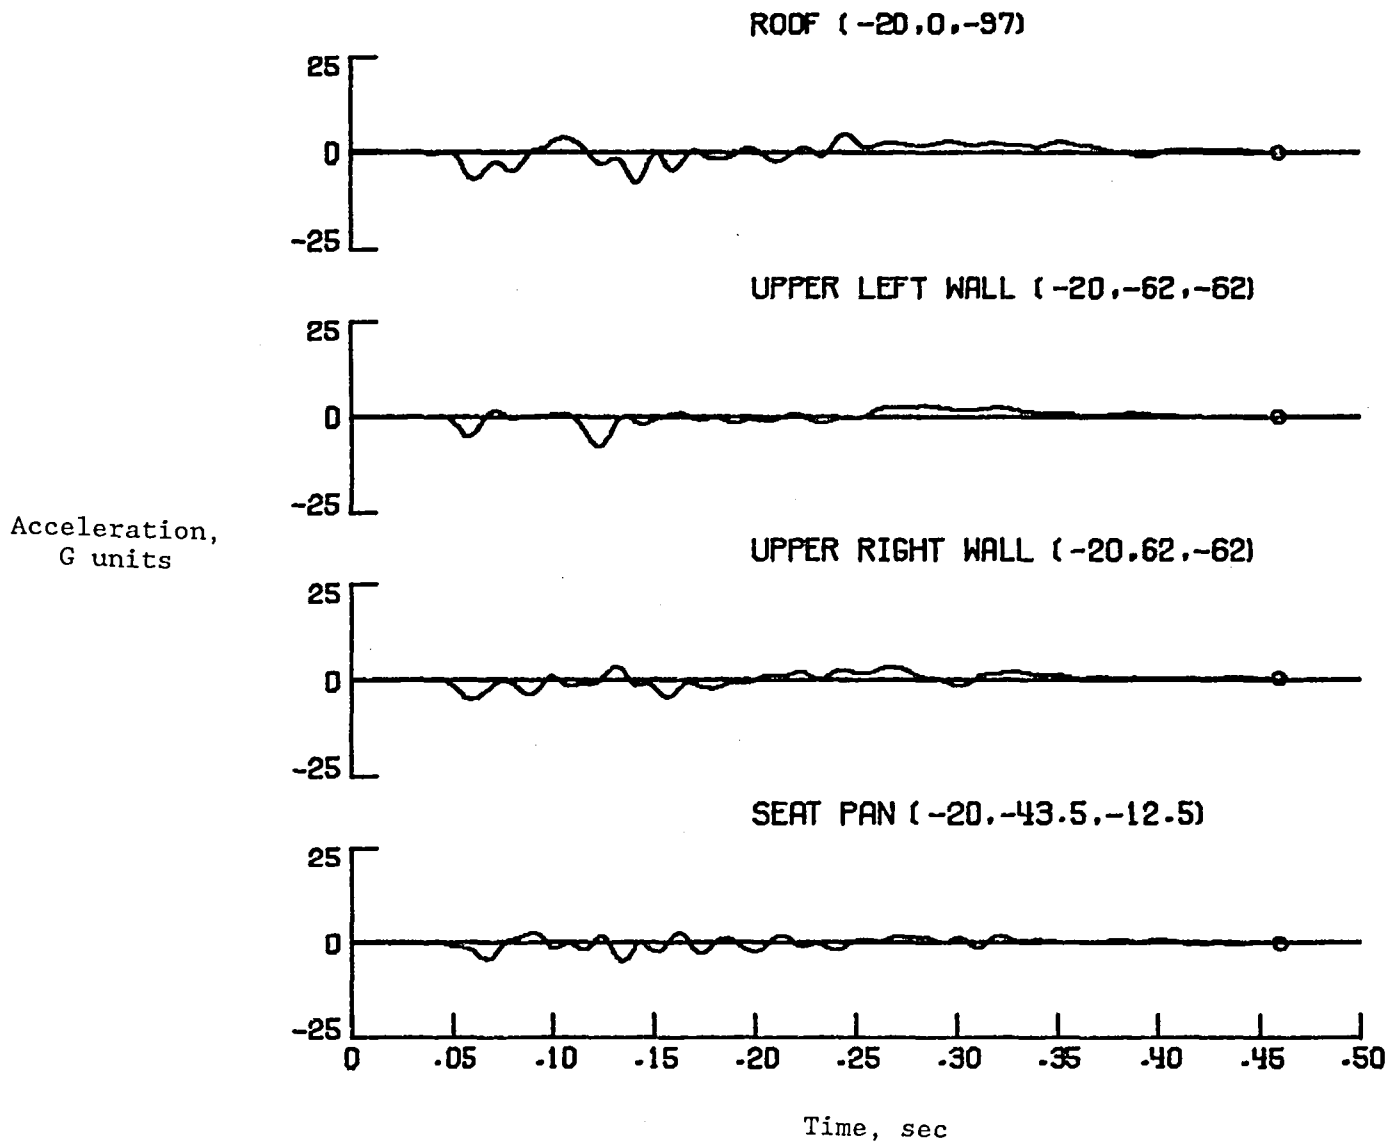
(a) BS 1040

Figure 6.- Longitudinal acceleration time histories.

Longitudinal accelerations for locations on frames 1040 and 1120 are shown in figure 6. The longitudinal accelerations on frame 1040 (figure 6a-b) are primarily oscillatory and are of low magnitude. However, the longitudinal accelerations at the floor level for frame 1120 (figure 6c-d)
