NASA Technical Memorandum 89025

**VERTICAL DROP TEST OF A TRANSPORT FUSELAGE SECTION
LOCATED AFT OF THE WING**

EDWIN L. FASANELLA AND EMILIO ALFARO-BOU

SEPTEMBER 1986

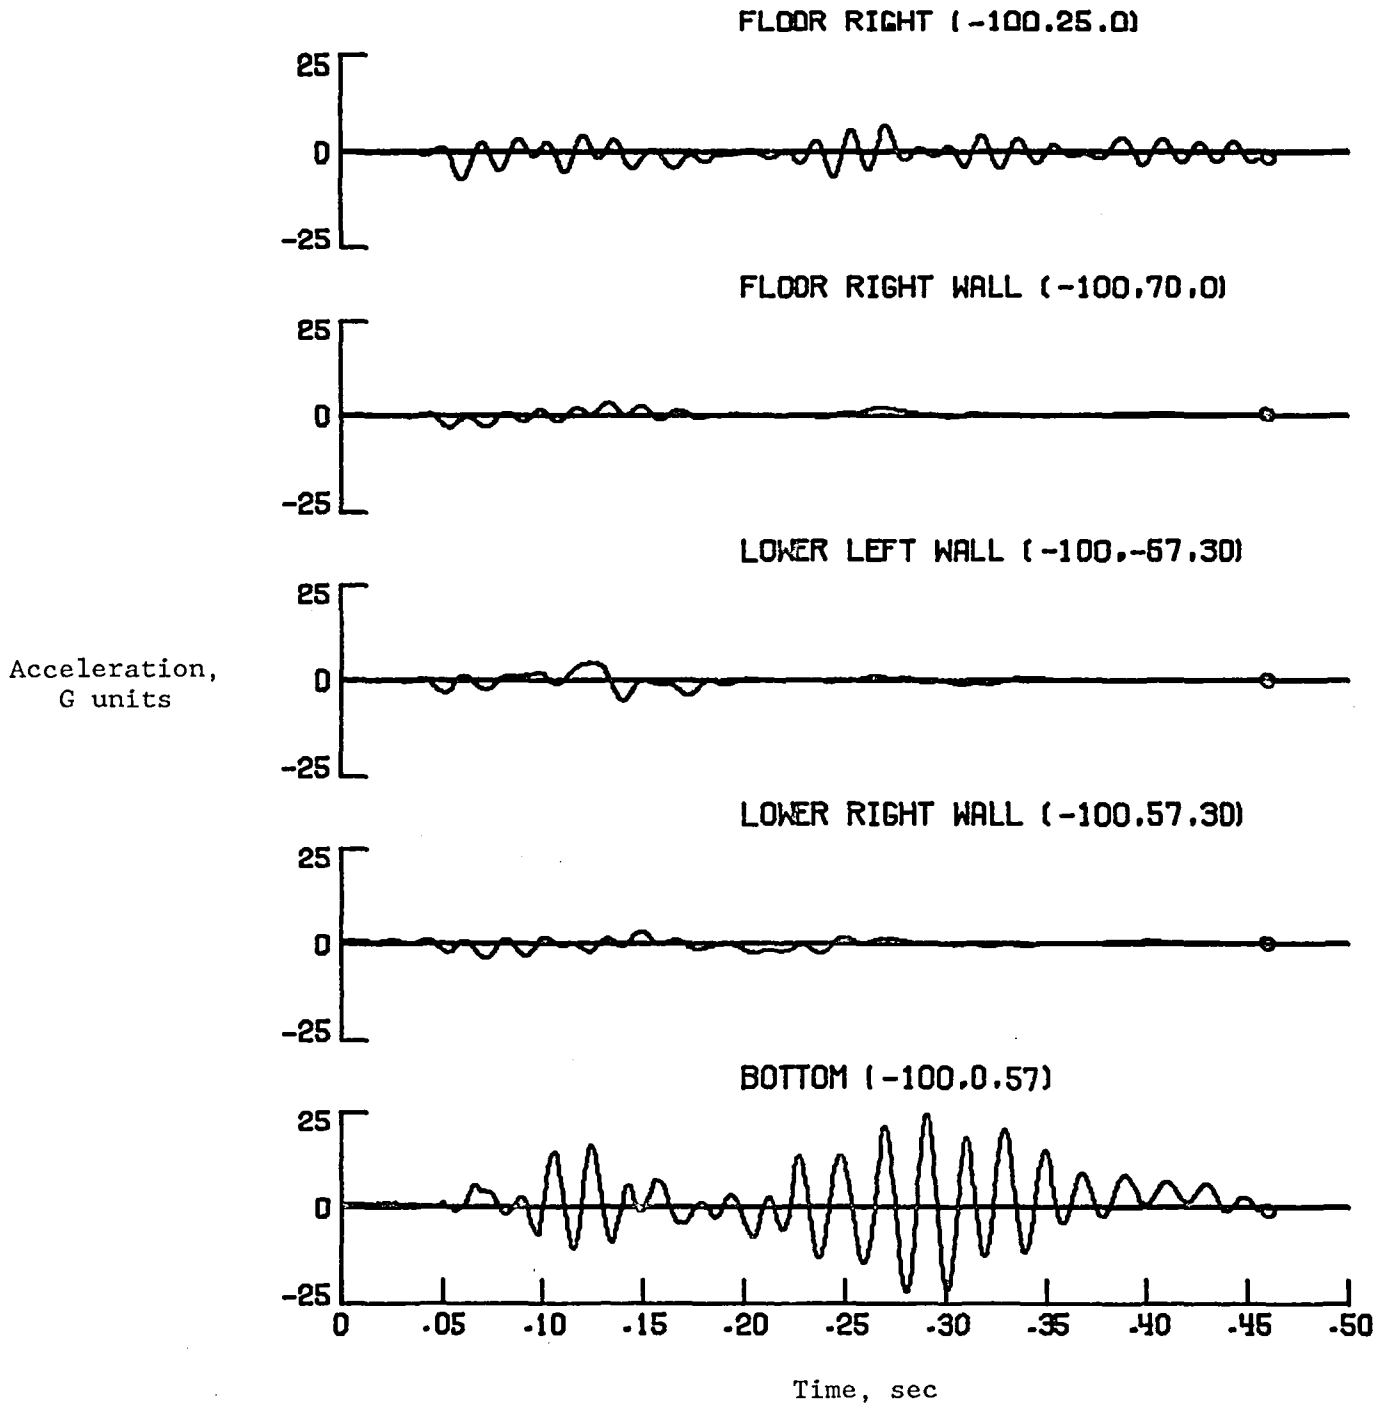
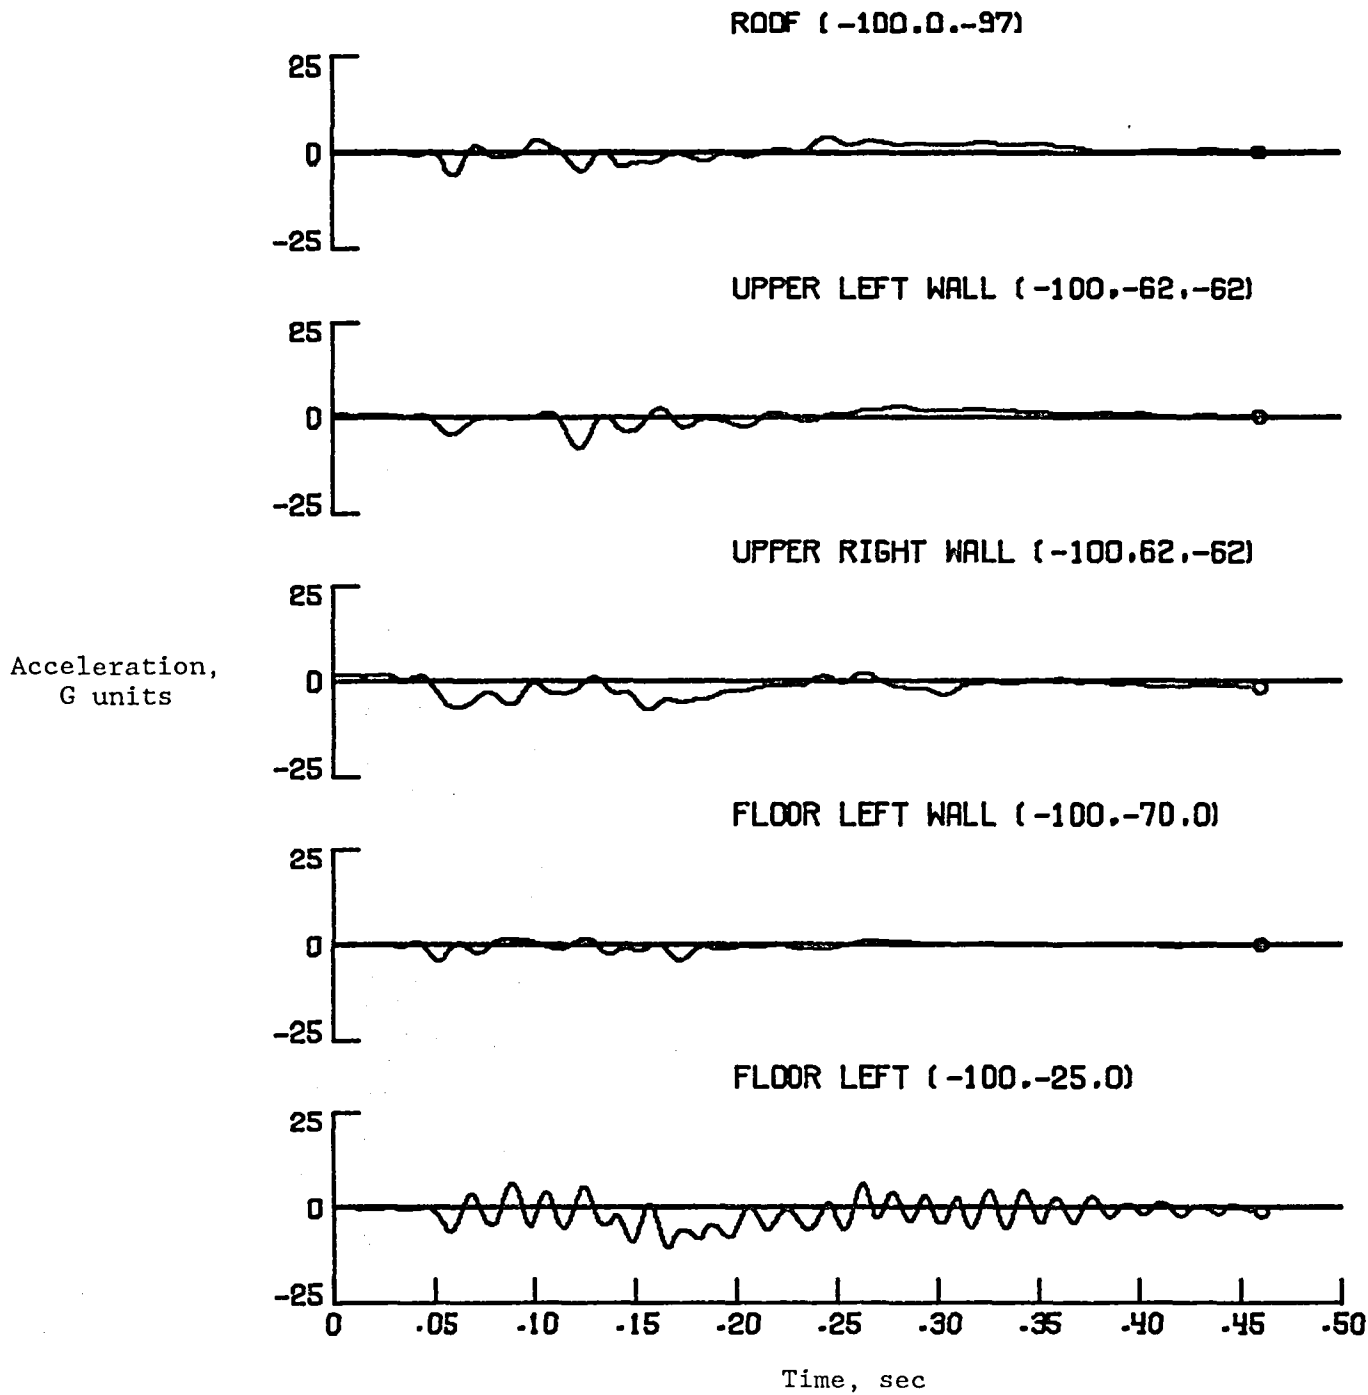
(c) BS 1120

Figure 6.- Continued.

Longitudinal accelerations for locations on frames 1040 and 1120 are shown in figure 6. The longitudinal accelerations on frame 1040 (figure 6a-b) are primarily oscillatory and are of low magnitude. However, the longitudinal accelerations at the floor level for frame 1120 (figure 6c-d)

are of higher magnitude because the sloping bottom allowed some longitudinal velocity to develop due to rotation about the contact point on frame 1040.

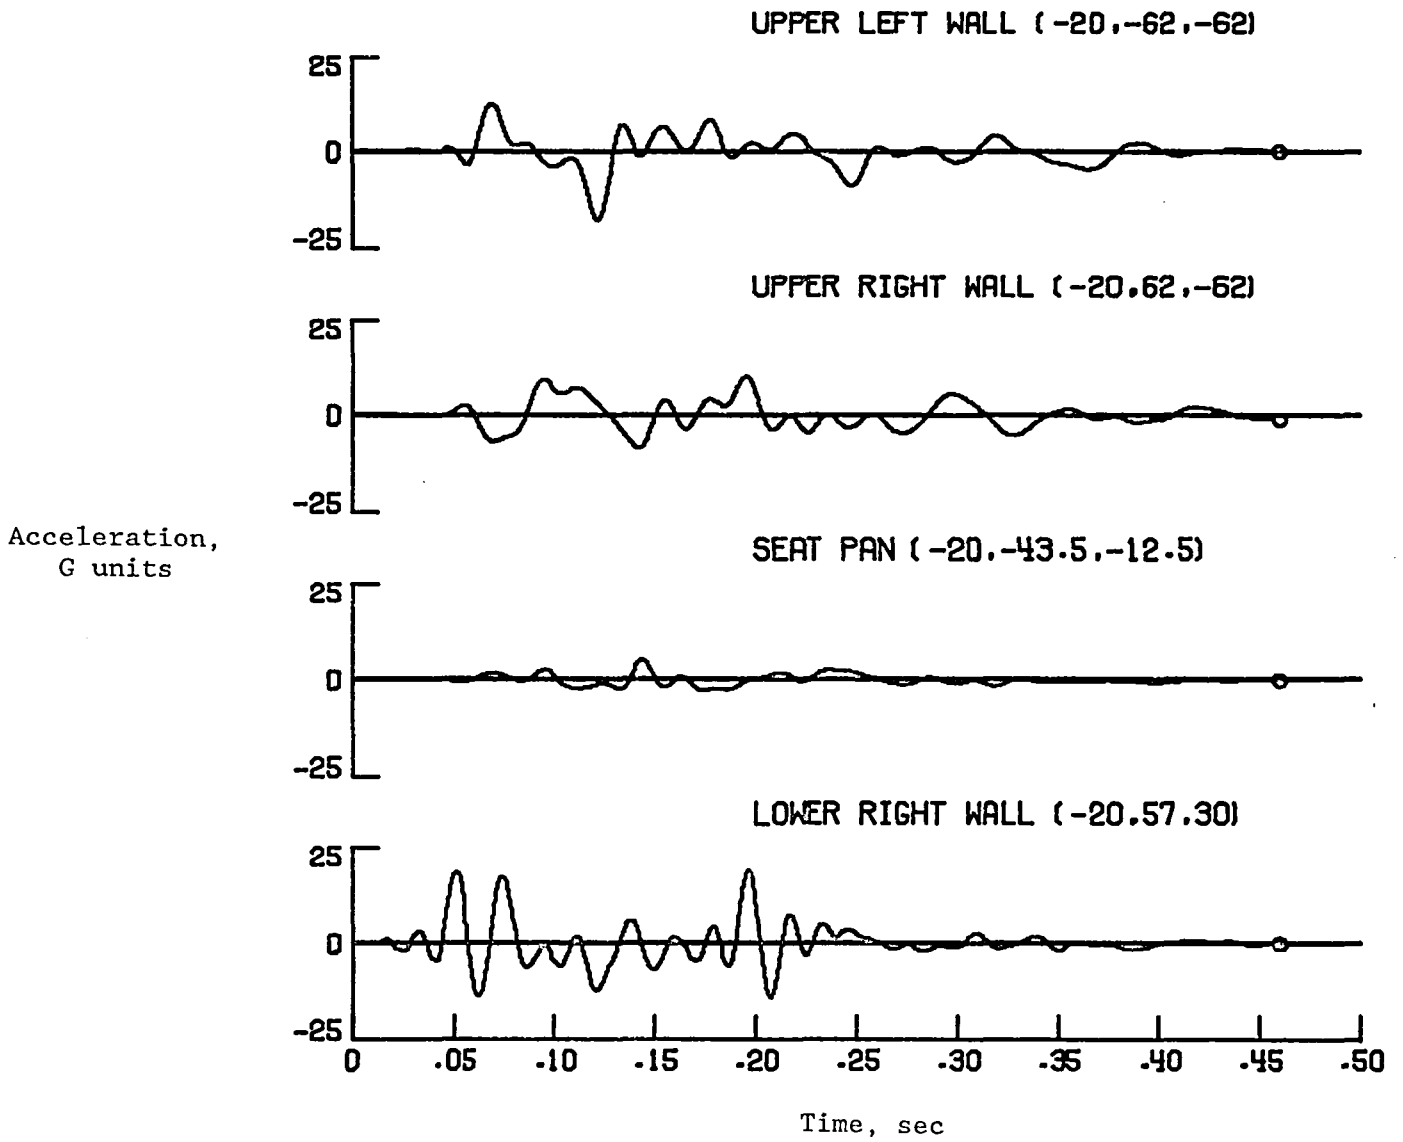
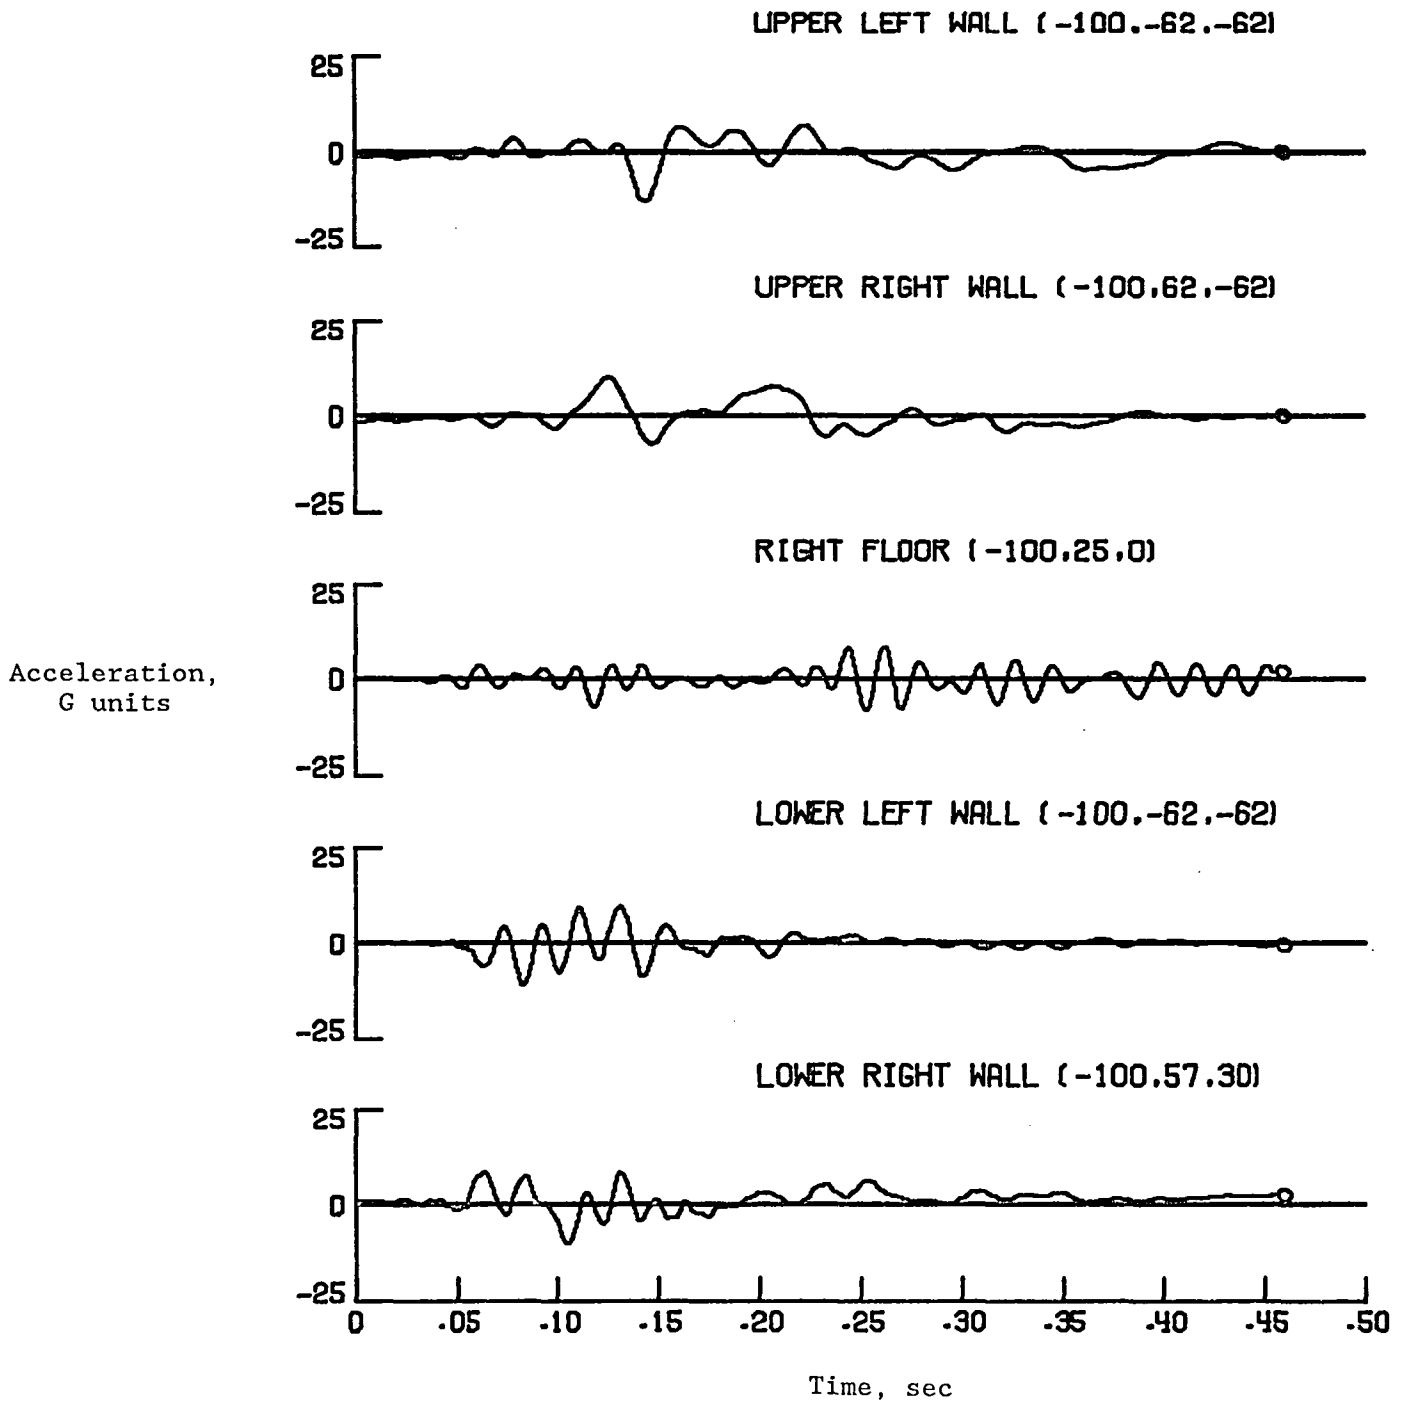
Figure 7.- Transverse acceleration time histories.

Transverse accelerations are given in figure 7. The highest peak recorded was at the lower right wall and measured 19 G's. At the floor level, the transverse acceleration was low and oscillatory as would be expected.
