NASA CR-174990
R86AEB104

IMPROVED FRACTURE TOUGHNESS CORROSION-RESISTANT BEARING MATERIAL

FINAL REPORT

GENERAL ELECTRIC COMPANY
AIRCRAFT ENGINE BUSINESS GROUP

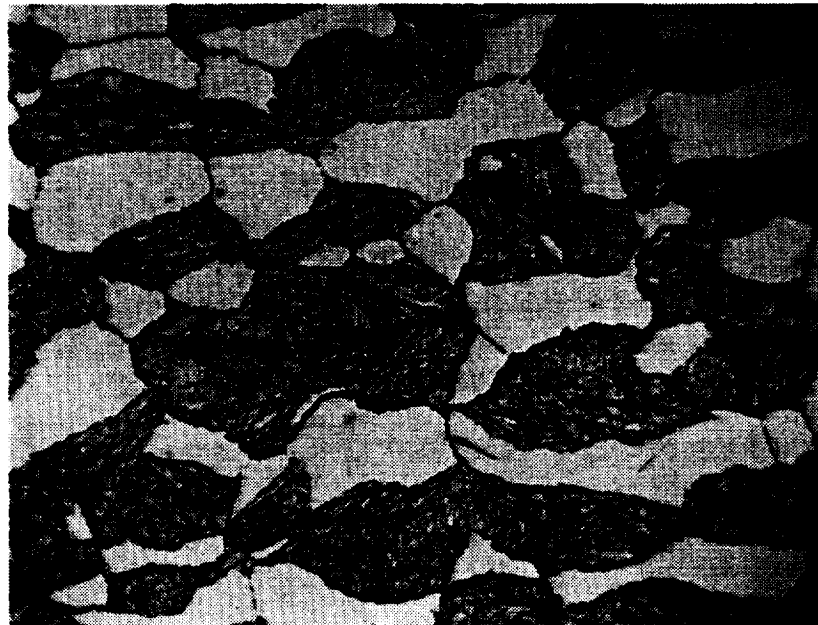
Figure 20. Microstructure of Nickel Modified, Low Carbon (0.13%) AMS 5749: Austenitized at 1366K (2000° F); Temper 811 K (1000° F) 2+2 Hours; Hardness R_c 35; Etchant Mod. Picral.

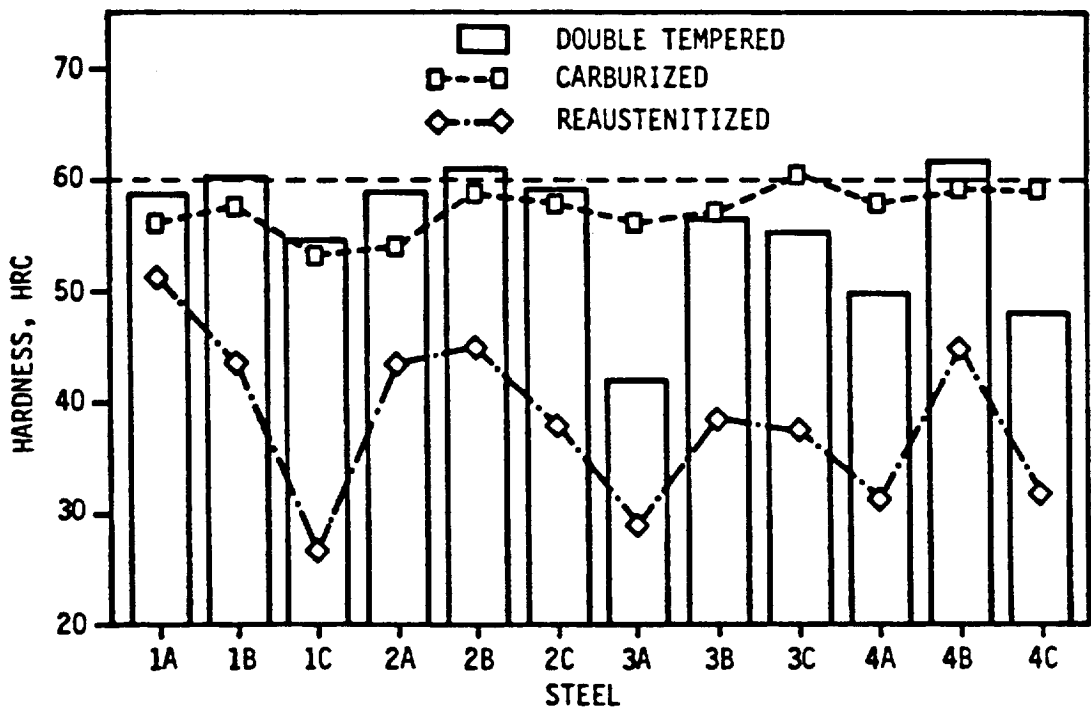
Figure 35. Surface Hardness Following Various Heat Treating Stages.

(a) Carbon Potential 0.5% for 7 hours

(b) Carbon Potential 0.8% for 2 hours, then 0.5% for 5 hours

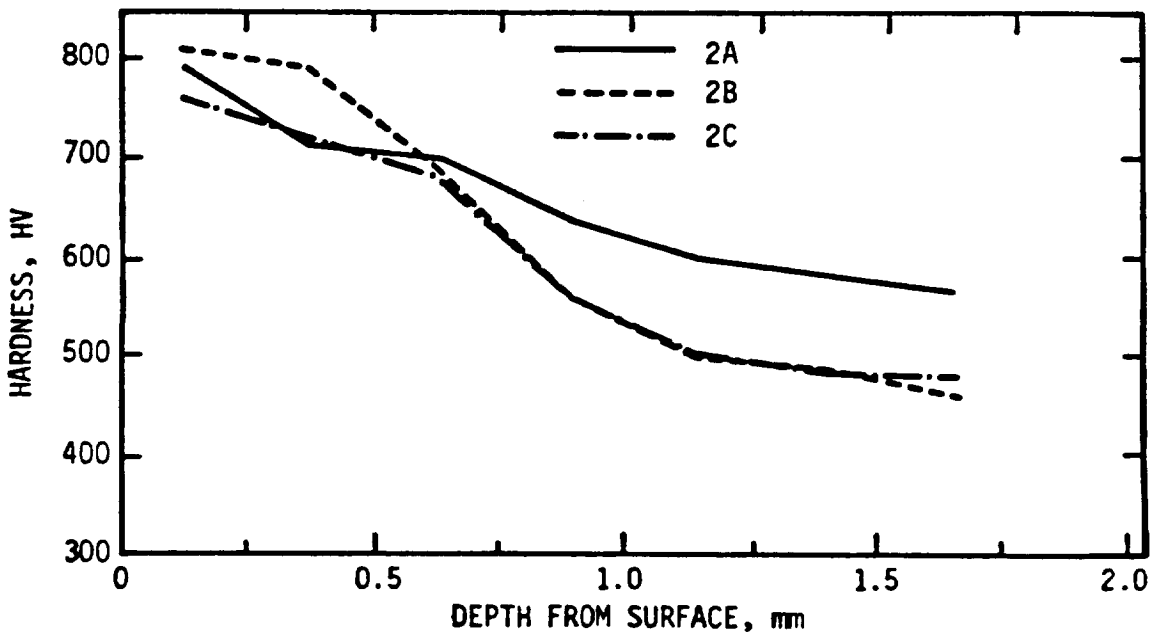
Figure 37. Microhardness Profiles of Steels Carburized at 0.8% Carbon for 2 Hours, 0.5% Carbon for 5 Hours.
