NASA Technical Memorandum 86994

Fabrication of Ceramic Substrate- Reinforced and Free Forms

Prepared for the
12th International Conference on Metallurgical Coatings
sponsored by the **American Vacuum Society**
Los Angeles, California, April 15-19, 1985

FABRICATION OF CERAMIC SUBSTRATE-REINFORCED AND FREE FORMS

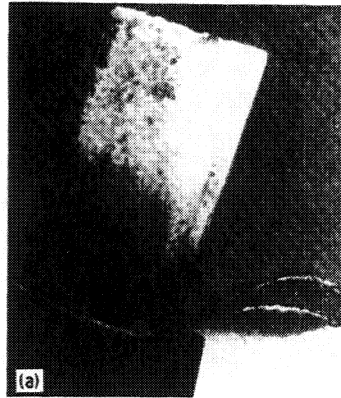
Figure 1. - Prof. Schmidt's experimental ceramic vanes and blades.

- (a) Structure of porcelain enamel compliant core.
- (b) Closeup of shell and compliant core structure.
- (c) Turbine blade configuration and experimental ceramic blades.

In the early 1940's, Ernst Schmidt¹ was fabricating ceramic turbine blades of two basic types: a hollow core with coolant passages, and a membrane over a compliant porous substrate (Fig. 1). Apparently Schmidt recognized four basic needs: low thermal conductivity, a smooth exterior surface, blade cooling, and a strain relief mechanism.

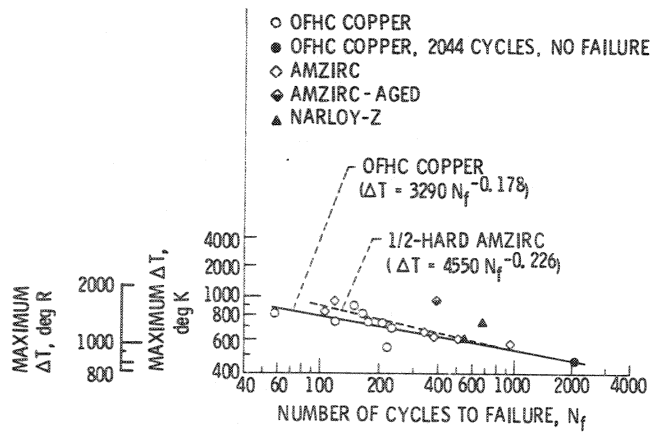
Figure 9. - Strainrange partitioning using maximum wall temperature difference between hot-gas side and back side as a function of cycles to failure for OFHC, Amzirc, and NARloy-Z cylinders.
