Advanced Thin Film Thermocouples

(U.S.) National Bureau of Standards
Gaithersburg, MD

NBSIR 84-2949

ADVANCED THIN FILM THERMOCOUPLES

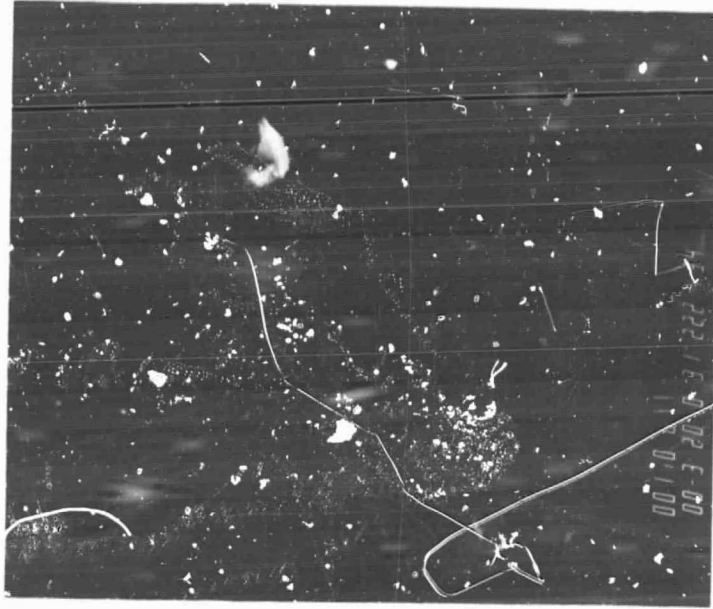
Figure 10. Scanning electron photograph of D14
Al₂O₃ is dark 1 μm line 580x

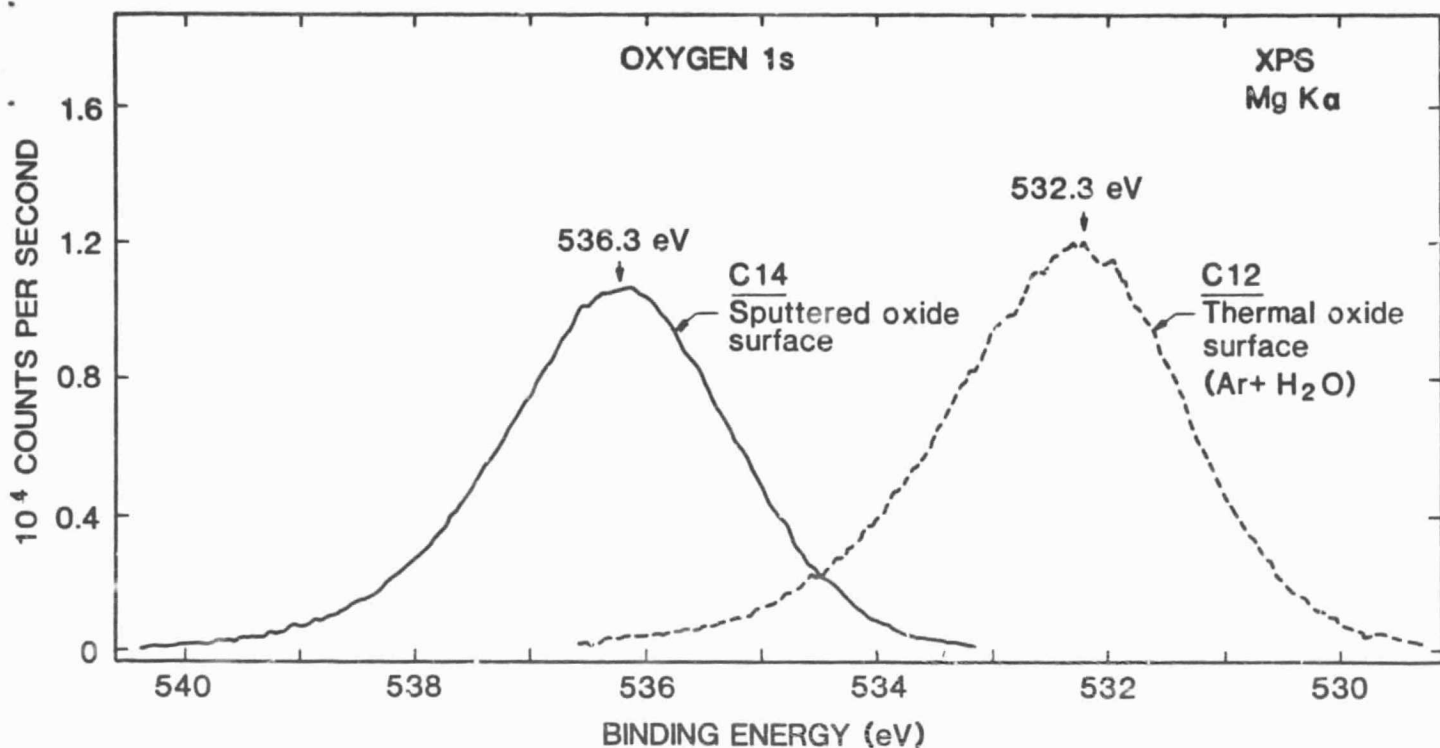
Figure 26. Oxygen 1s XPS core levels from samples C12 and C14. The better insulating properties of the C14 sputtered oxide surface lead to an upward shift in binding energy which positions the O1s level 4eV higher than O1s level from the Ar+H₂O thermal oxide at the surface of C12. Similar shifts were observed in comparisons of other features (e.g., C1s) derived from these samples.

Charging shifts for thermally oxidized samples were always smaller than those observed from sputtered layers of aluminum oxide over a thermal oxide. For example, Figure 26 illustrates an approximately 6 eV shift (mainly from charging since both surfaces are predominantly aluminum oxide) between the oxygen 1s electrons emitted from the sputtered oxide on C14 (2.8 μm sputtered over 2.7 μm thermal) and the Ar+H₂O-grown oxide on C12 (1.1 μm). In this case, the difference in the thicknesses may explain at least part of the larger shift for C14. Charging shifts for air-oxidized samples like A42 [1075°C], B23 [1077°C] and D2 [1025°C] were usually intermediate between the sputtered and Ar+H₂O grown oxides (1.5 eV or more above the Ar+H₂O oxides, and about 1.5 eV below the sputtered overlayer). The charging shift in Figure 27 shows that the air-oxidized D2 (2.7 μm) has a better insulating layer than D1 (Ar+H₂O, 2.6 μm) even though these layers have essentially the same thickness. Notice that there is some difference in the O1s position for the Ar+H₂O oxidized samples C12 [1090°C] and D1 [1050°C] in Figures 26 and 27. This difference, as well as the generally poorer insulating quality of the thermally grown oxides may be connected, not only to differences in oxide thickness, but also to the presence of pores and pits that have been optically observed in such layers. It is possible that the sputtered layers fill these pores, thereby leading to the larger charging shifts that are indicative of better insulating layers.

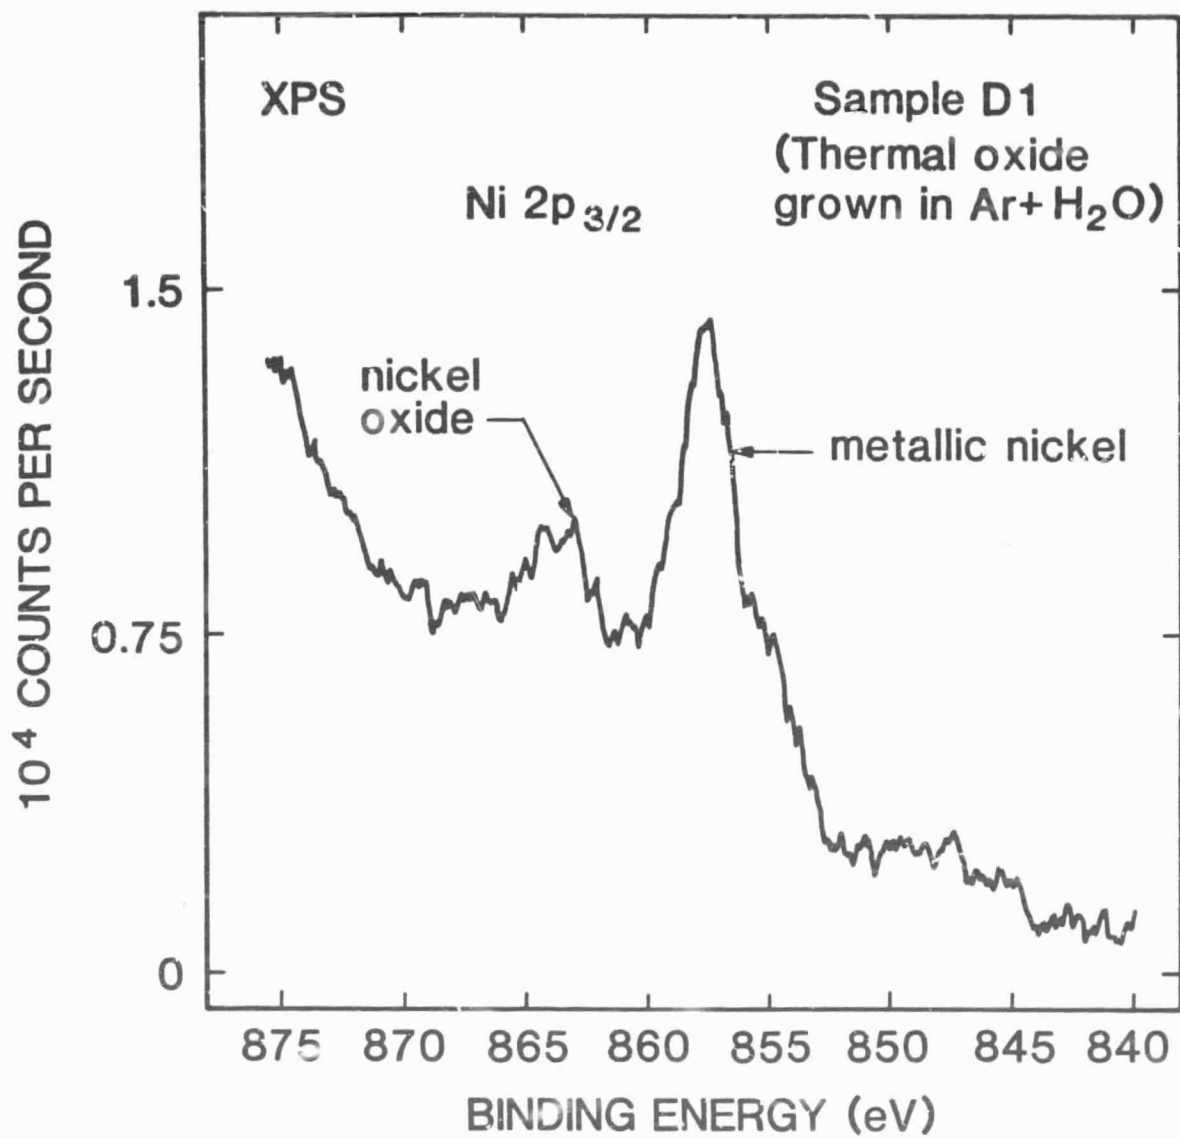
Figure 28. XPS nickel 2p_{3/2} core level region indicating the presence of metallic and oxidized nickel in the surface aluminum oxide of sample D1.

It is interesting to note also that the Ar+H₂O grown oxides may have a somewhat higher Ni and Cr content than their air-grown analogues. Figure 28 shows what is probably the strongest Ni core level signals observed during this study from an aluminum oxide, in this case a Ar+H₂O-grown layer on sample D1. A feature attributable to nickel oxide is also observed several electron volts higher in binding energy. The metallic Ni peak would indicate that the Ni oxidation reaction did not go to completion in the Ar+H₂O atmosphere.

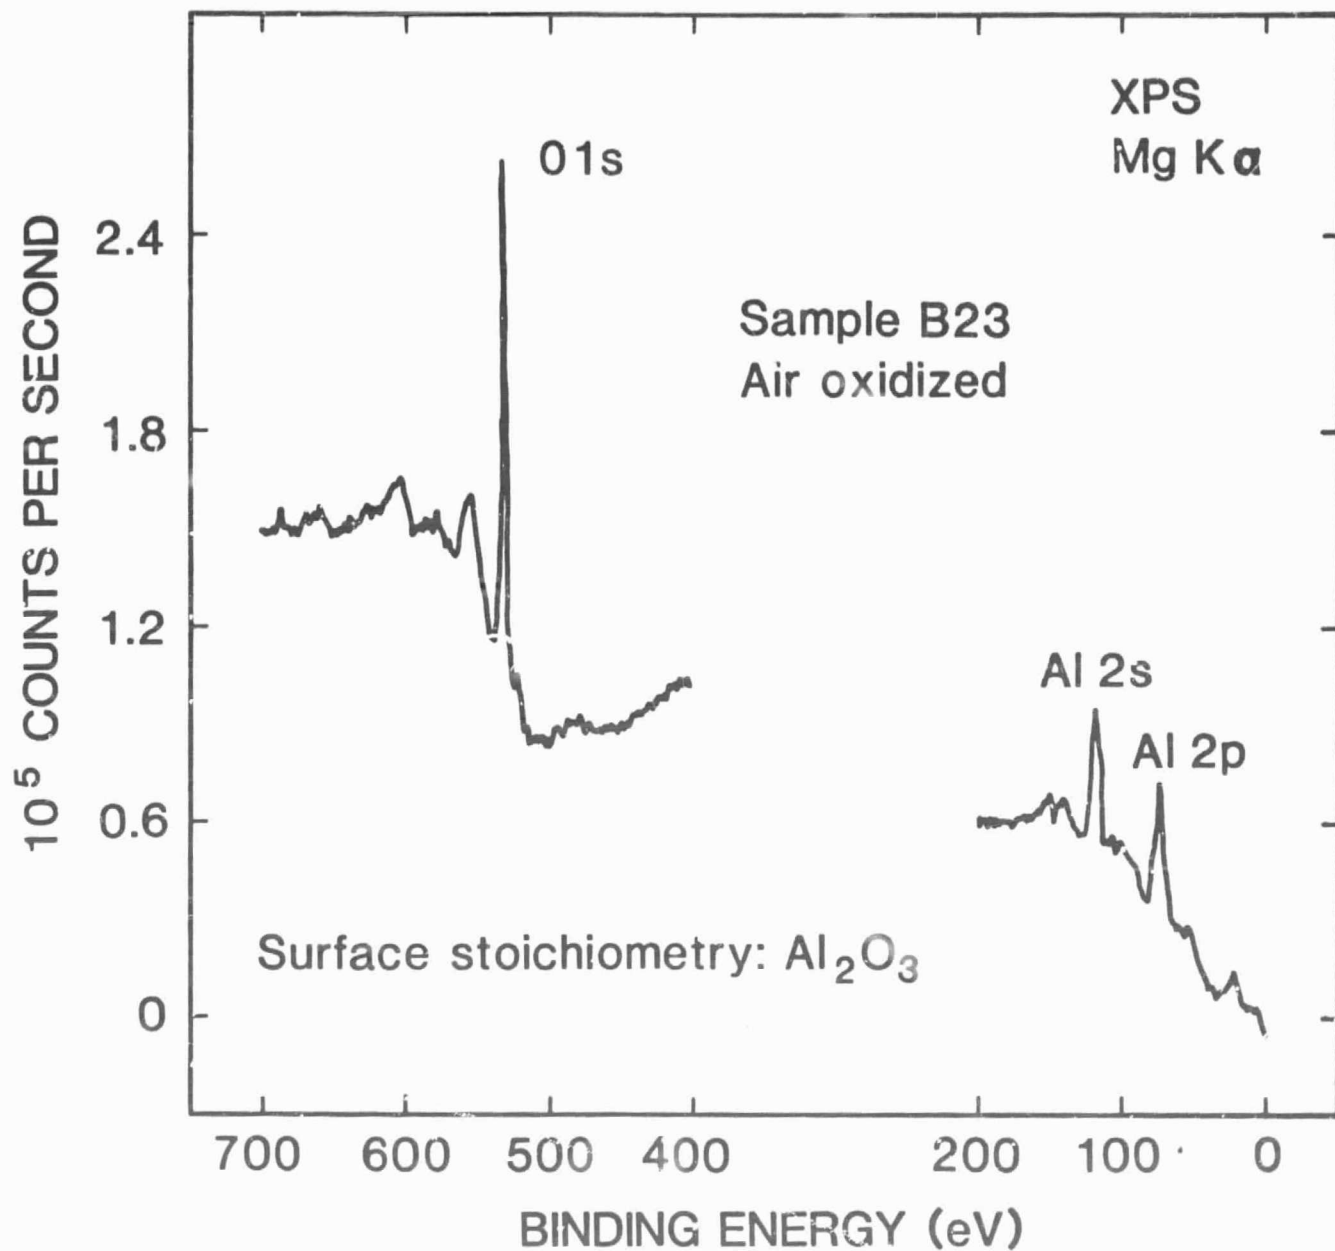
Figure 29. Wide energy range XPS spectrum obtained from the air-oxidized surface of sample B23. The O1s and Al features indicate an Al₂O₃ stoichiometry at the surface.

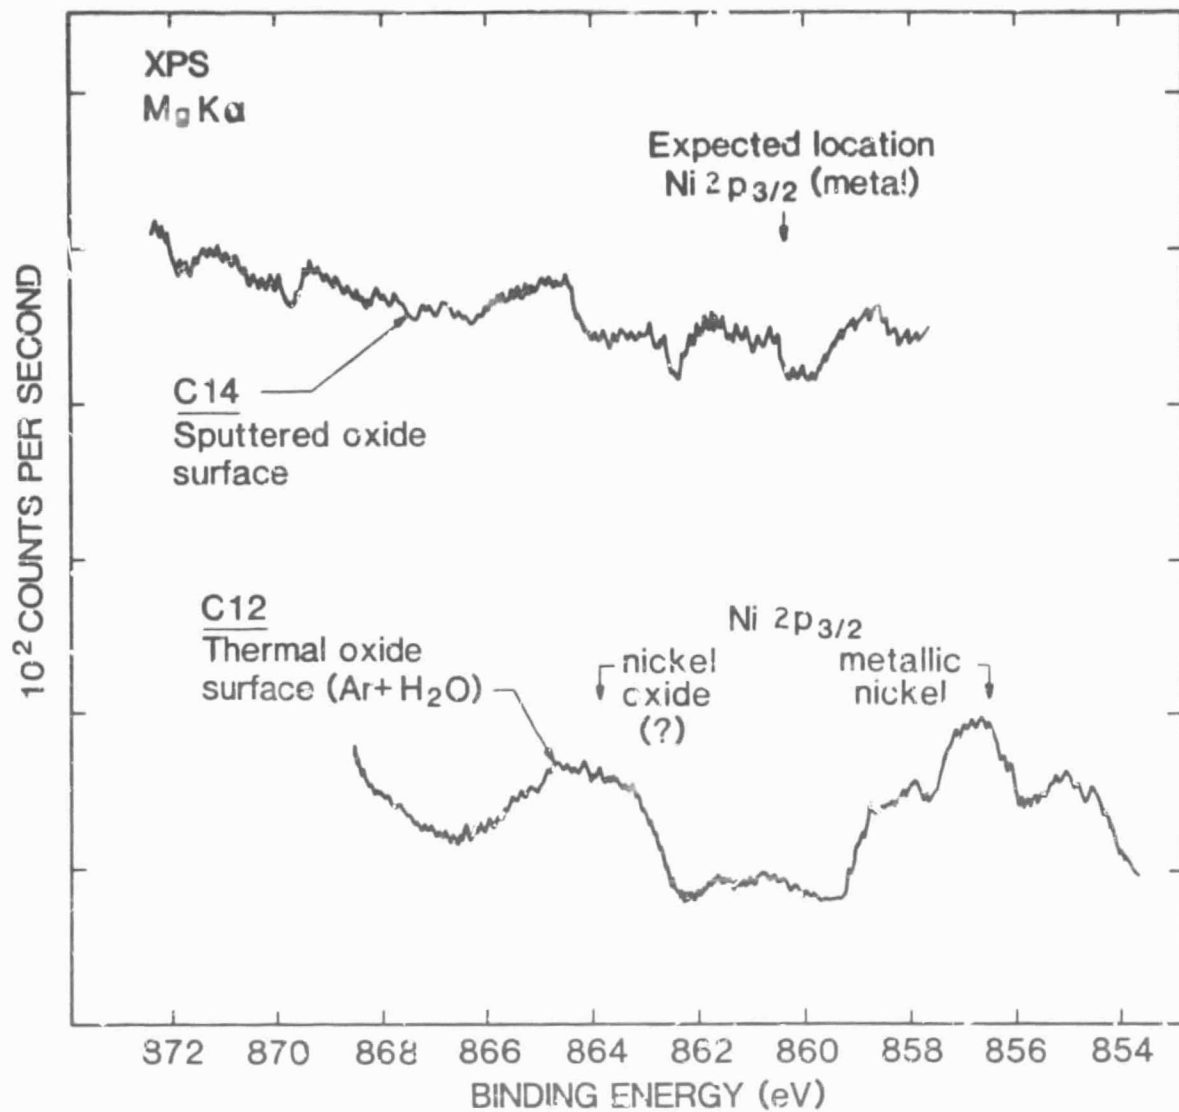
Figure 33. XPS spectra for samples C12 and C14 in the binding energy region near the Ni2p $_{3/2}$ level. The thermally oxidized C12 surface has Ni present at an estimated level near 0.5%, while essentially no Ni is observed in the sputtered aluminum oxide on C14.

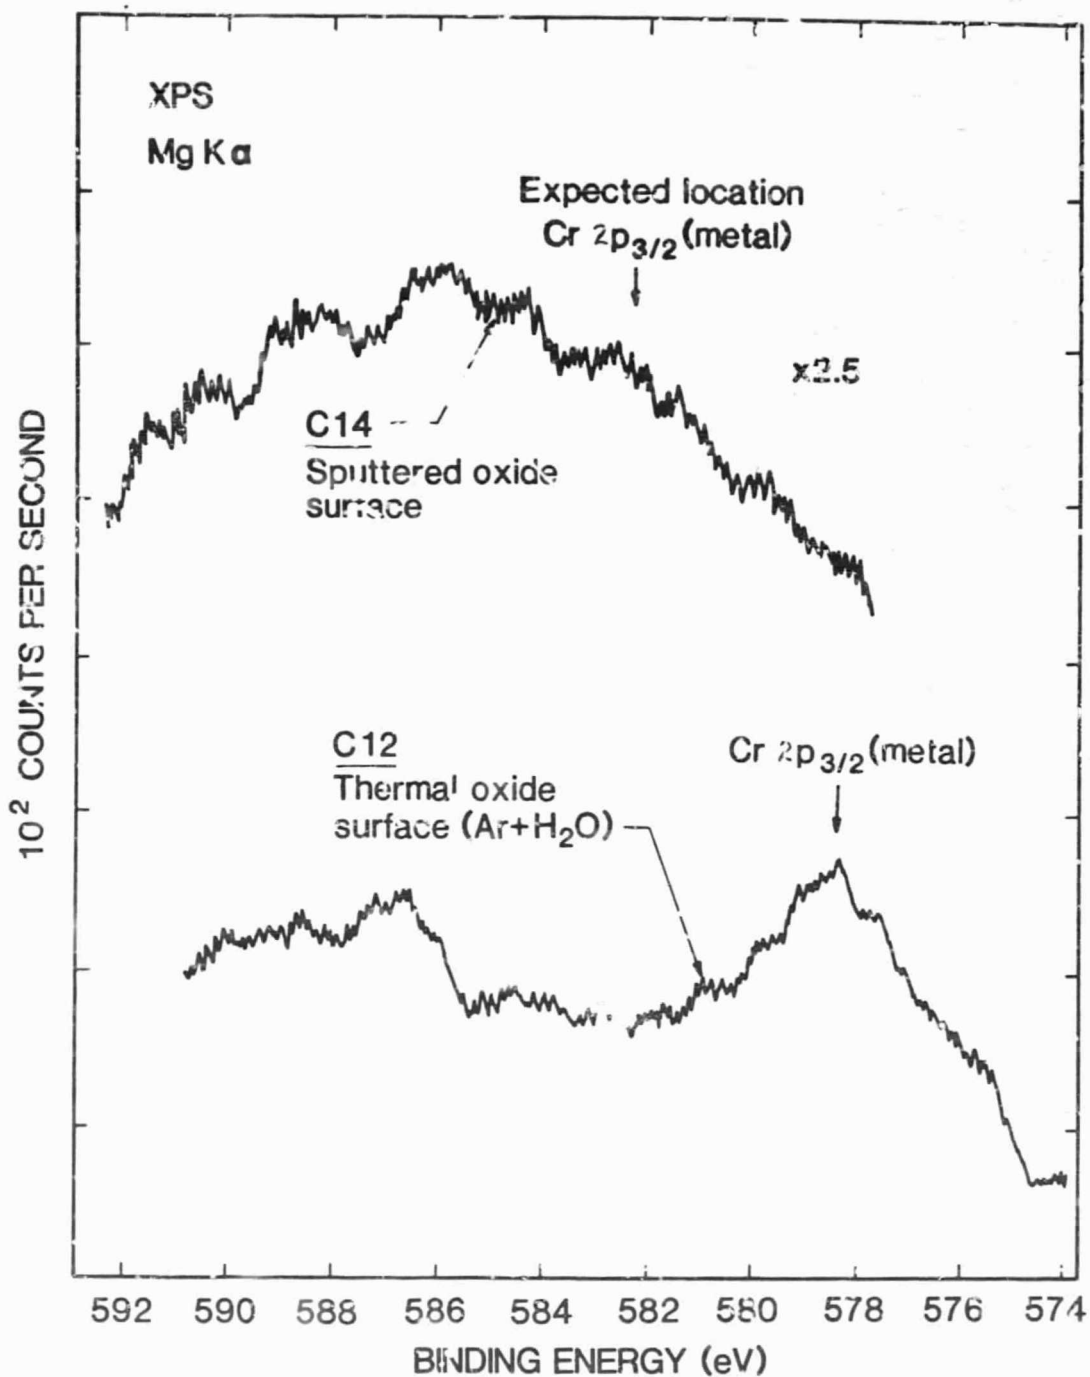
Figure 34. XPS spectra for samples C12 and C14 in the binding energy region near the Cr $2p_{3/2}$ level. The feature in the C12 spectrum indicates a Cr concentration in the thermal oxide near 0.5%, while Cr appears to be completely absent from the sputtered oxide surface of C14.
