(NASA-CR-171201) LARGE-DIAMETER ASTRONAUT
DEVELOPMENT Final Report (Astro Research
Corp.) 43 p HC A03/MF A01 CSCI 13B

**LARGE-DIAMETER ASTROMAST
DEVELOPMENT, PHASE II
FINAL REPORT**

ARC-TN-1132

Prepared for
NASA Marshall Space Flight Center
under Contract No. **NAS8-34547**

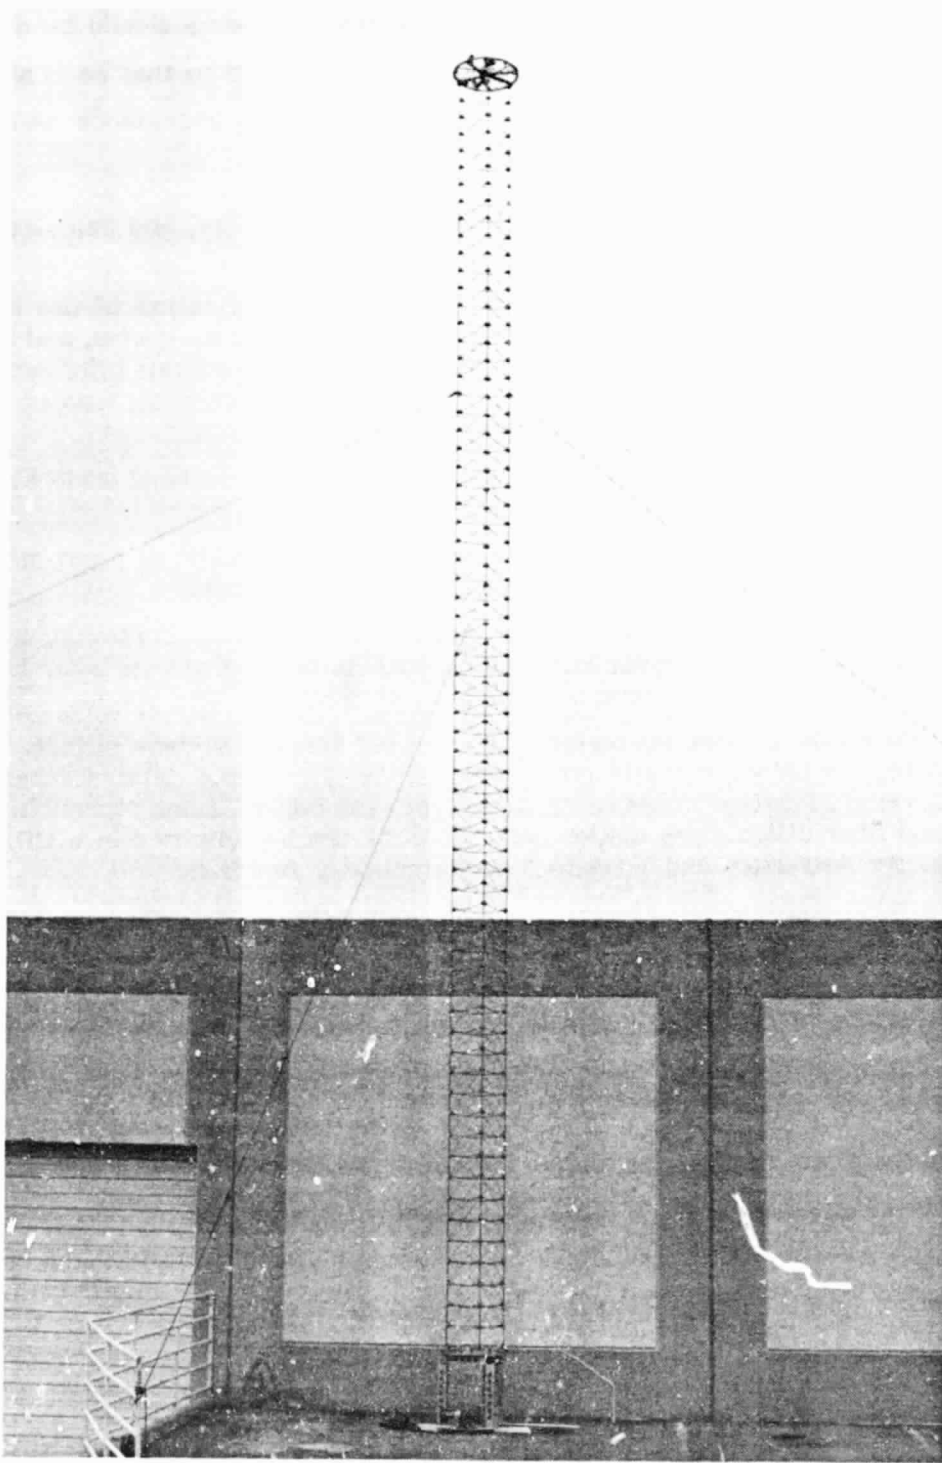
Figure 1. Double-laced Astromast (0.75-m diameter, 15-m long).

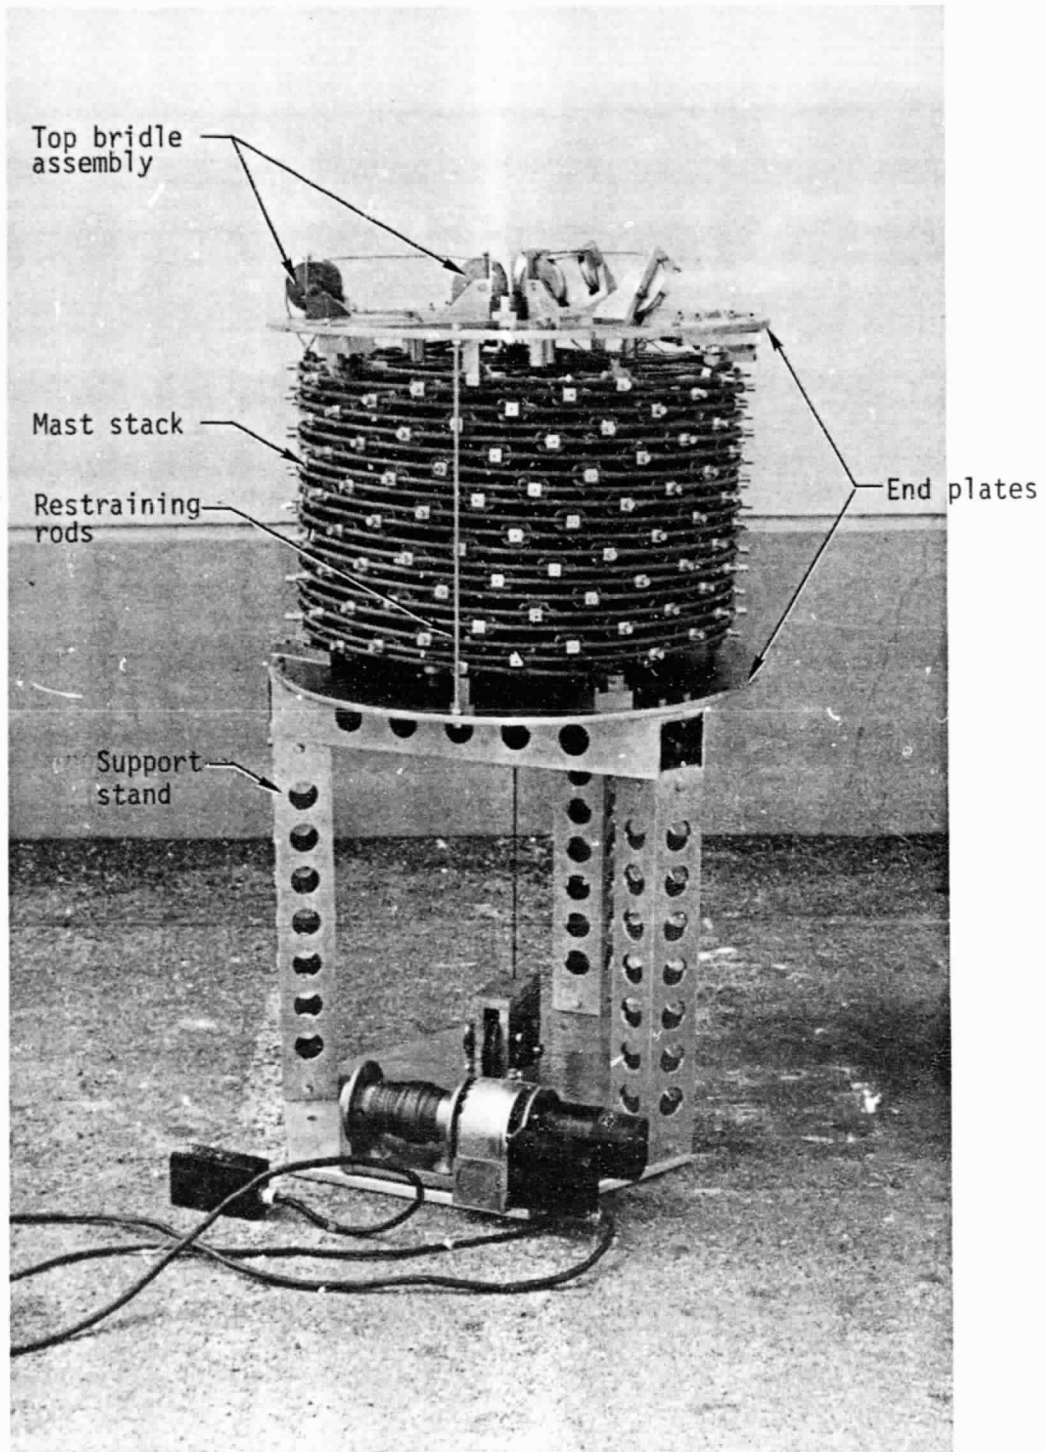
Figure 2. Double-laced Astromast in stowed configuration (0.75-m diameter, 15-m long).

The hardware delivered consists of two main components: a 15-m-long section of Supermast which is approximately 0.6-m long when stowed and a base support/winch stand which is used for 1-g testing.

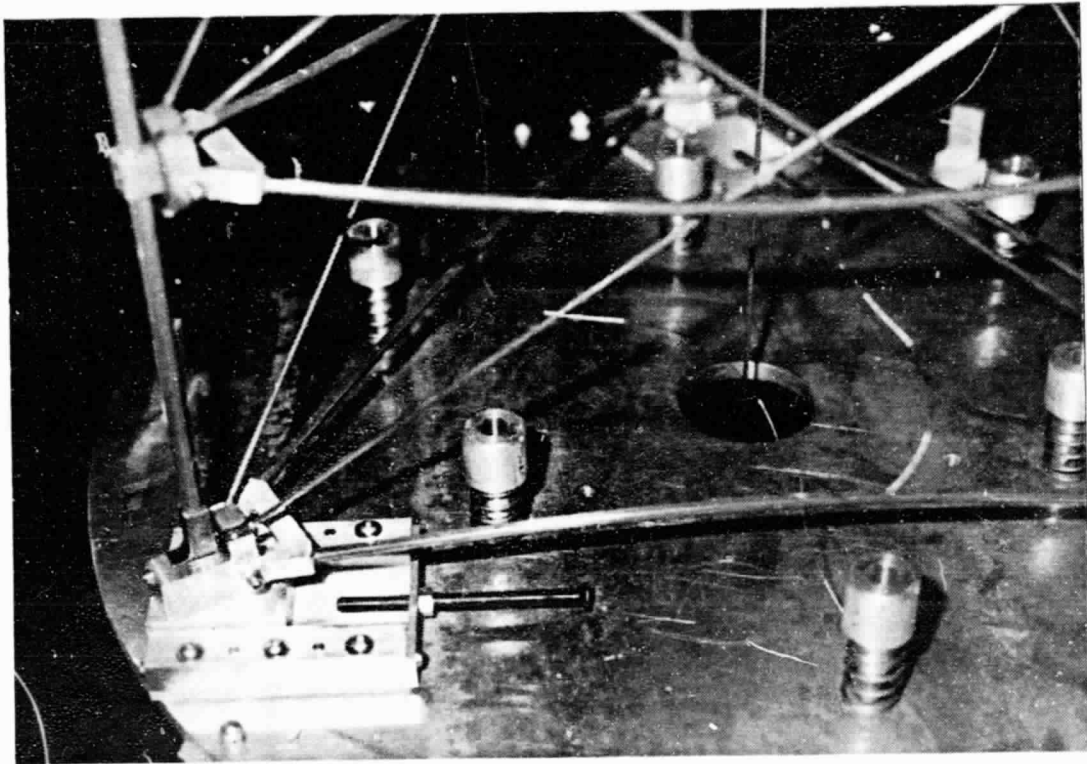
Figure 3a. Base plate slider detail (travel is limited to approximately 1 inch).

Repeated difficulties with the 12- and 20-foot masts in the end regions of the mast prompted development of a device to reduce the end effects. Although the 20-foot model could be retracted and extended without damaging the mast, it was felt that the deployment characteristics were marginal and that the high loads induced by the diagonals rubbing against each other impeded the deployment and reduced the excess lanyard tension (e.g., deployment force) to nearly zero. With sliding end terminals installed, the diagonals still make contact with each other, but the tensions in the diagonals are dramatically reduced by allowing the mast to contract at the end bay. The drawing for the sliders was made in March 1983, and they were first implemented in the rebuilt 12-foot mast during July 1983. The design was refined with the addition of stops to limit excursion in the sliders in October 1983 (see Figure 3).

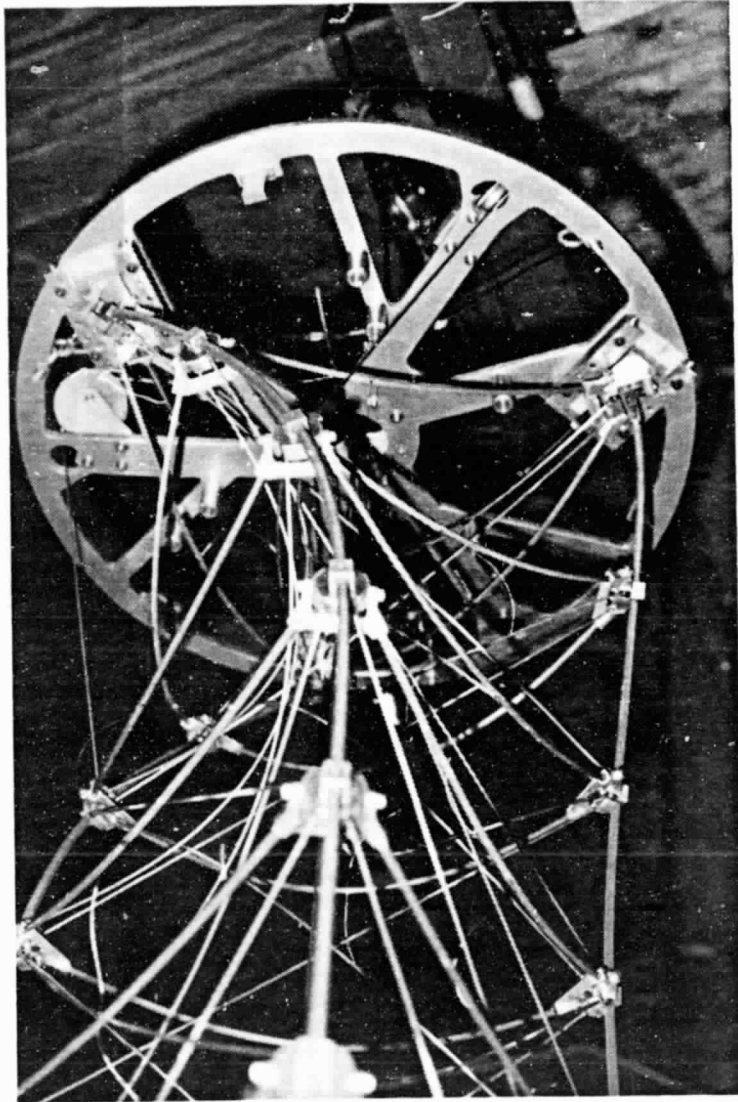
Figure 3b. Inboard position of sliders as transition region reaches the tip.

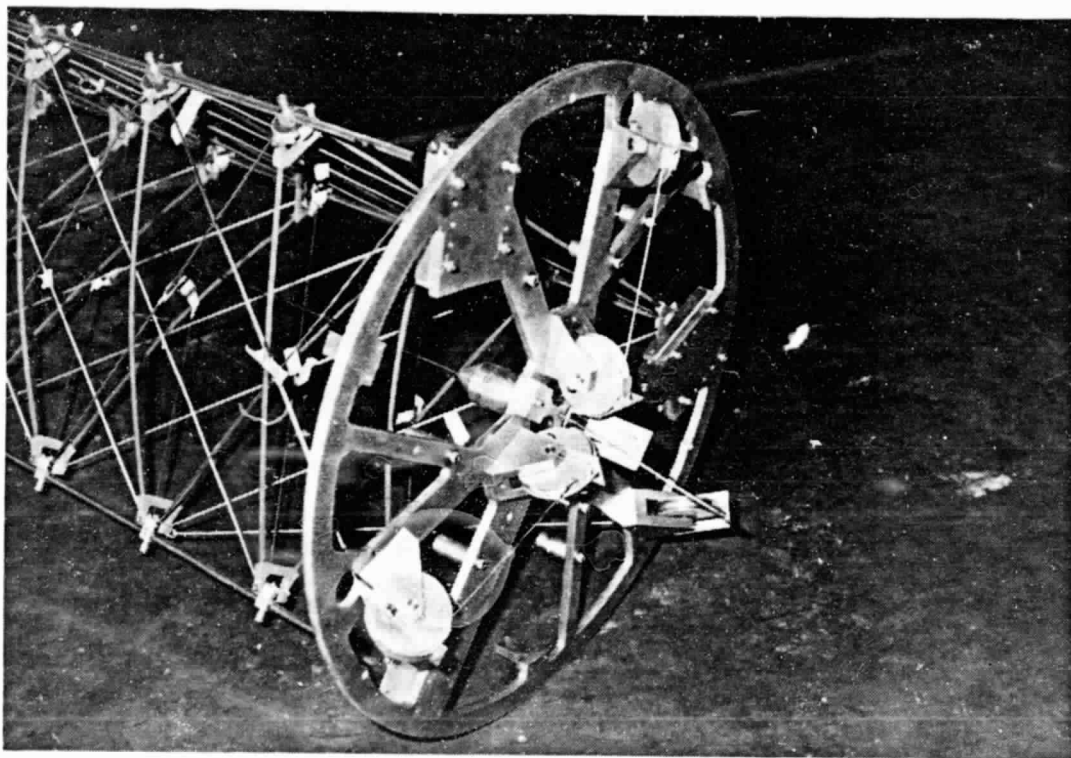
Figure 4. Details of tip plate bridle assembly.

When the 12-foot mast was assembled with the original bridle arrangement, it was observed that retraction stopped at the beginning of the retraction of the third bay and lanyard tension increased without a corresponding movement of the tip plate. It was felt that further application of tension would result in serious damage to the mast. Consequently, the trifilar bridle is used just to initiate the helix into the longerons. Once this has been accomplished (after retracting approximately 18 inches), an override on the lanyard engages the tip plate and applies a compressive load. This removes the high shear load from the longeron at the point of attachment of the bridle and reintroduces the load into the end terminal where it is carried for the remainder of the retraction (or until the first bay is fully retracted and the load is then carried through the battens in the stack as well). This device was first installed on the 12-foot mast in October 1983. The 12-foot

mast was tested with the override and the results are presented in Figure 4. Lanyard tension necessary to operate the bridle to initiate the helix into the mast is shown in Figure 5.

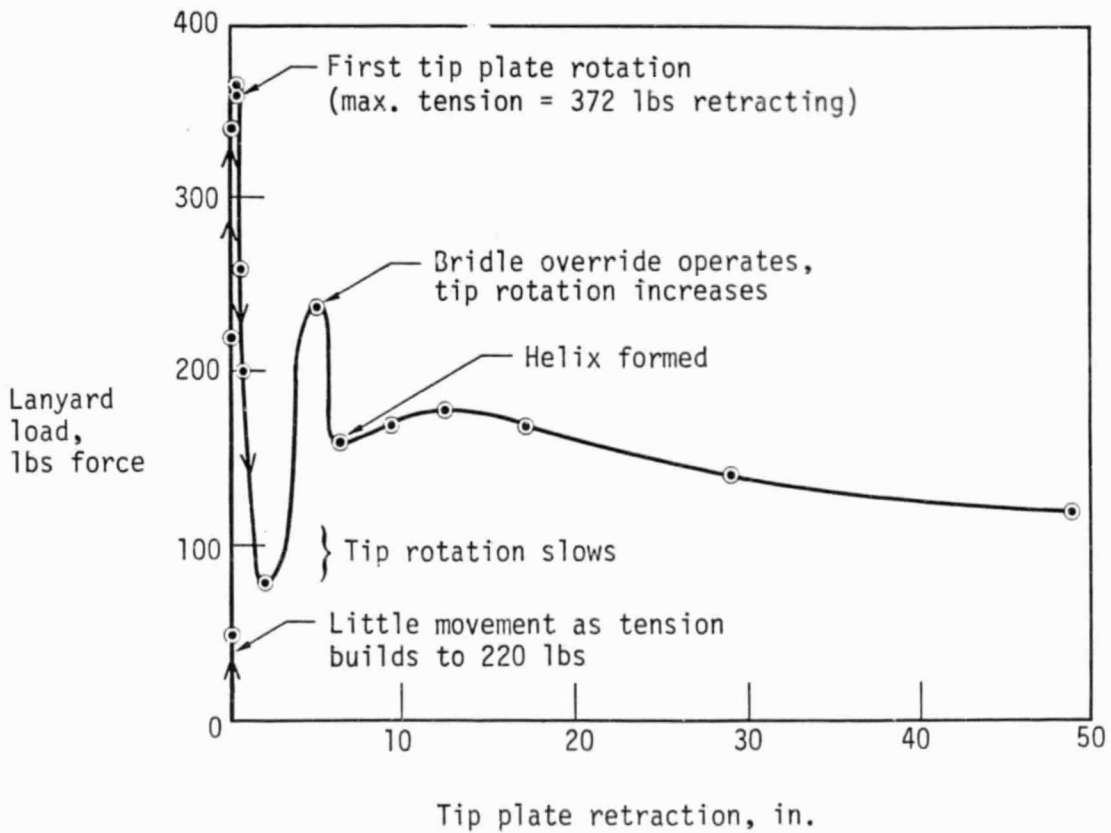
(12-foot mast, vertical retraction, tip plate counter balanced)

Figure 5. Lanyard tension vs. tip plate retraction.

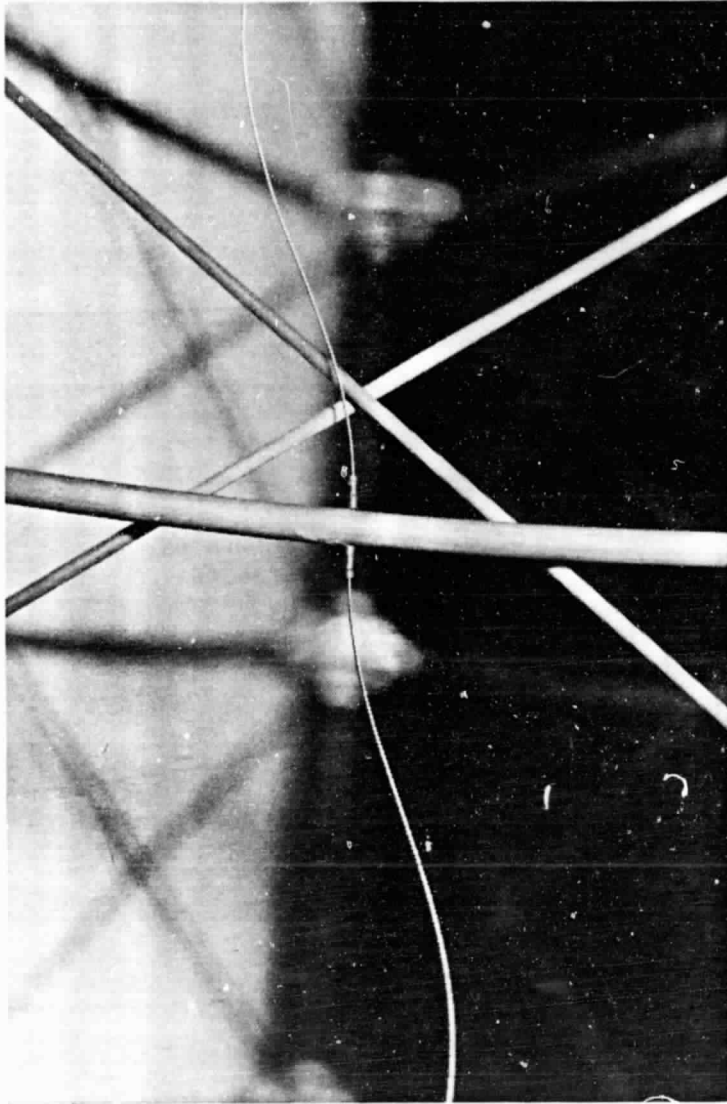
Figure 6. Detail of batten interconnecting system.

A device to prevent this was implemented which relies on interconnecting the batten members so that as one reaches its maximum deflection it influences the adjacent batten which is still in a low deflection state. This system does presuppose, however, that the initial batten in the sequence is correctly formed, which at this point must be done manually. (See Appendix A, Section 4, Phase 1.) This system was developed on 21 October 1983 (Ref. Astro Logbook 1023, Pg. 33) and first implemented on the 12-foot mast (see Figure 6).

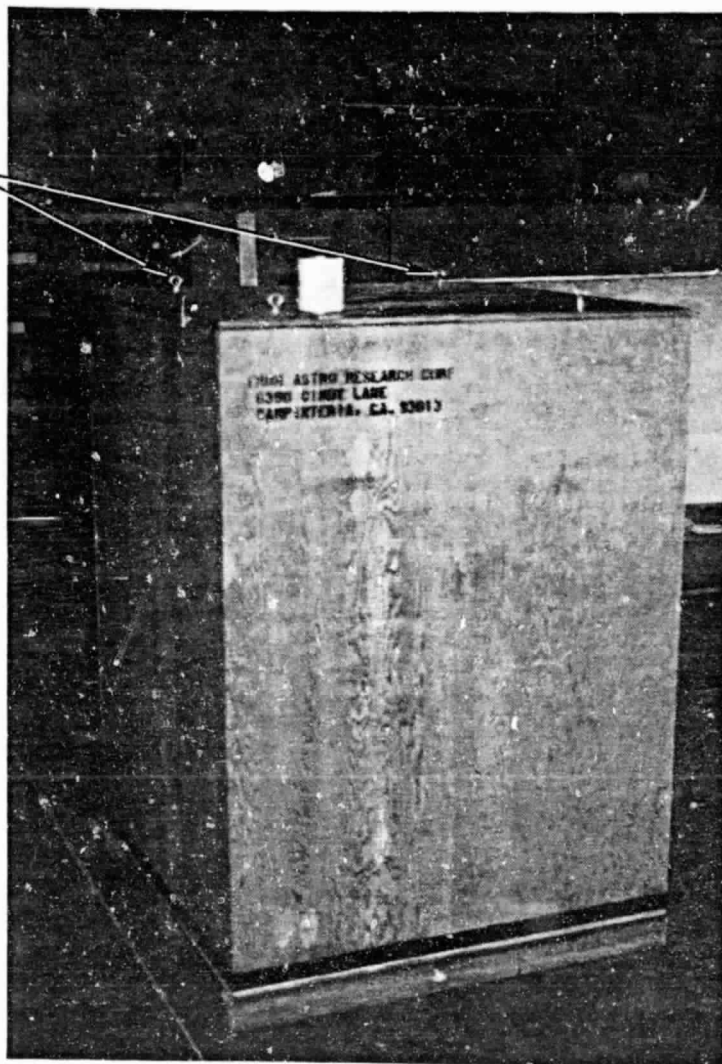
Lifting eyes
(4) for lid

Figure 1. Shipping container.

The packing container is reusable and designed for use with an overhead lifting apparatus. The lid surrounds the mast assembly and is attached around its lower edge to a forklift pallet. Once the screws holding the lid are removed, the four lifting eyes on the top are used for lifting the lid (see Figure 1).

NOTE: The eyes on the top of the crate are for lifting the lid only. **DO NOT ATTEMPT TO LIFT THE ENTIRE UNIT WITH THESE EYES.** Once exposed, the unit may be removed from the pallet by removing the bolts holding the baseplate to the wooden pallet. Forks may then be inserted under the top surface of the support stand to lift the unit off the pallet. Once free of the shipping container, the unit can be operated in any orientation; however, as with the 20-foot mast previously delivered, each orientation requires a different setup.

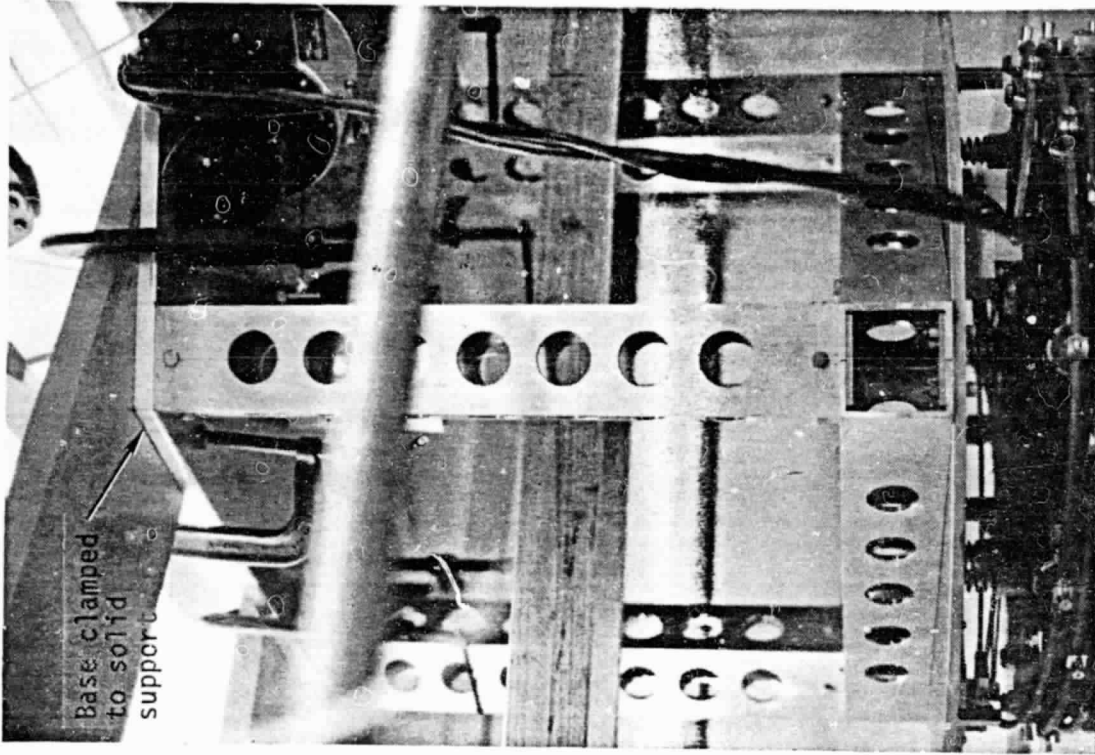
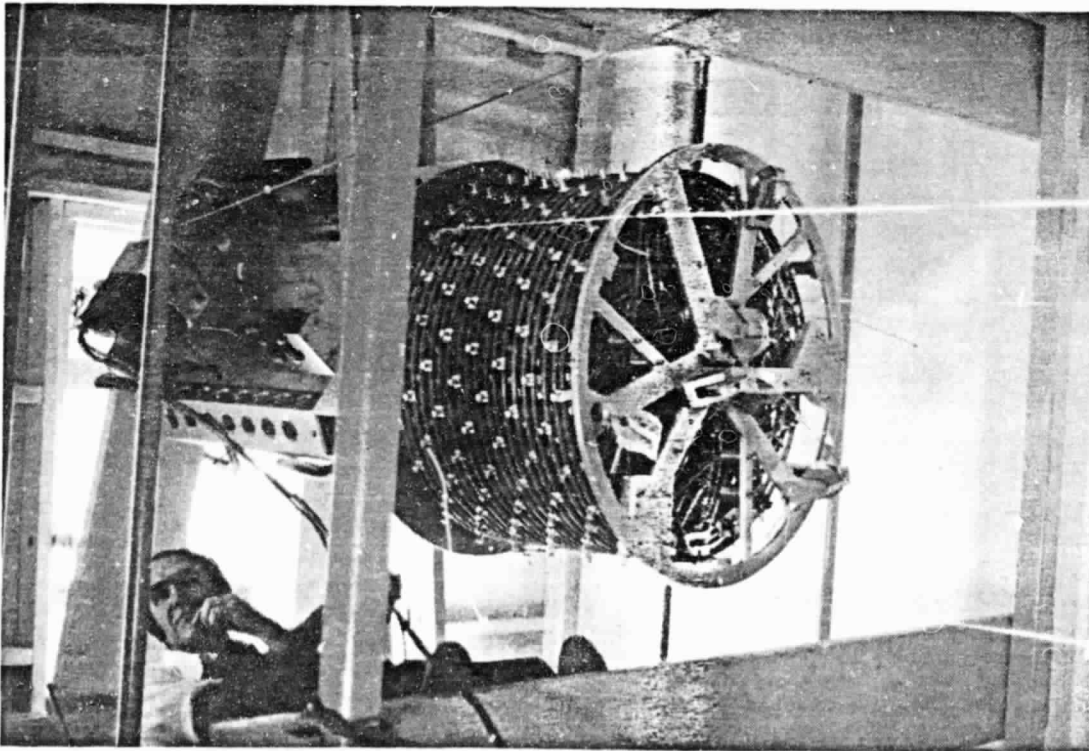
Figure 2. Unit shown mounted for vertical downward operation.

Once inverted, the unit may now be raised to a platform at least 55 feet above the nearest obstruction. The base of the winch stand should be firmly attached to a solid support and be horizontal to within at least 1/16 inch across its width (see Figure 2).

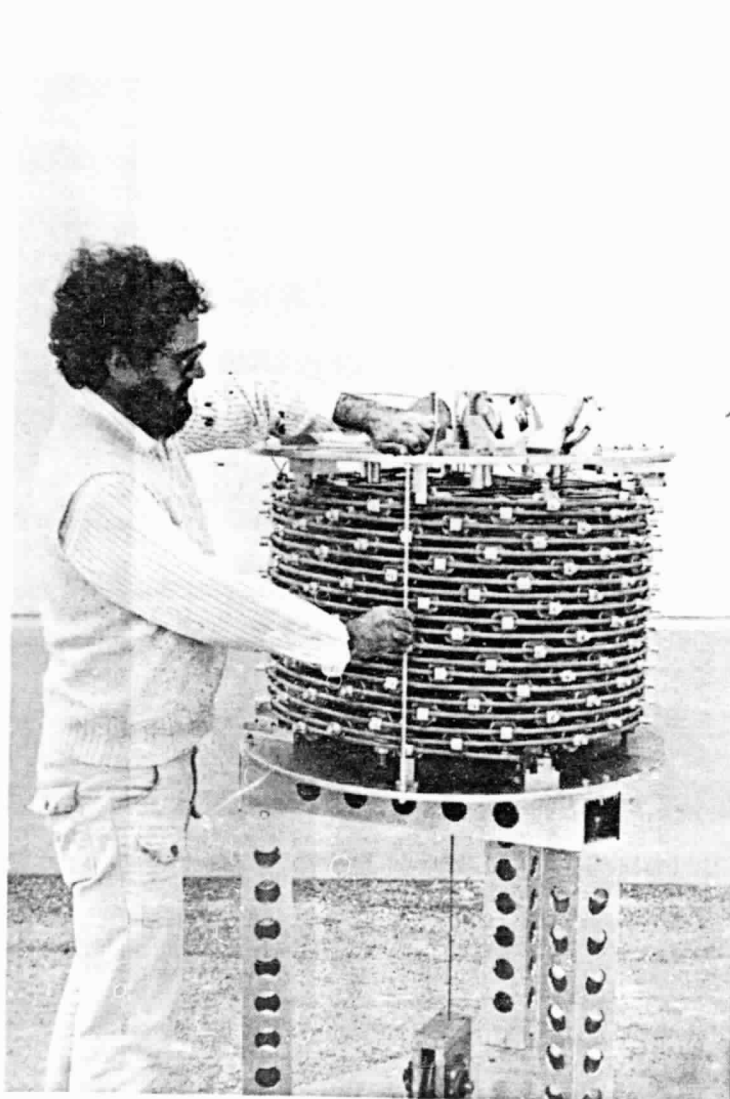
Figure 3. The threaded retaining rods are an indication of the nominal stack height.

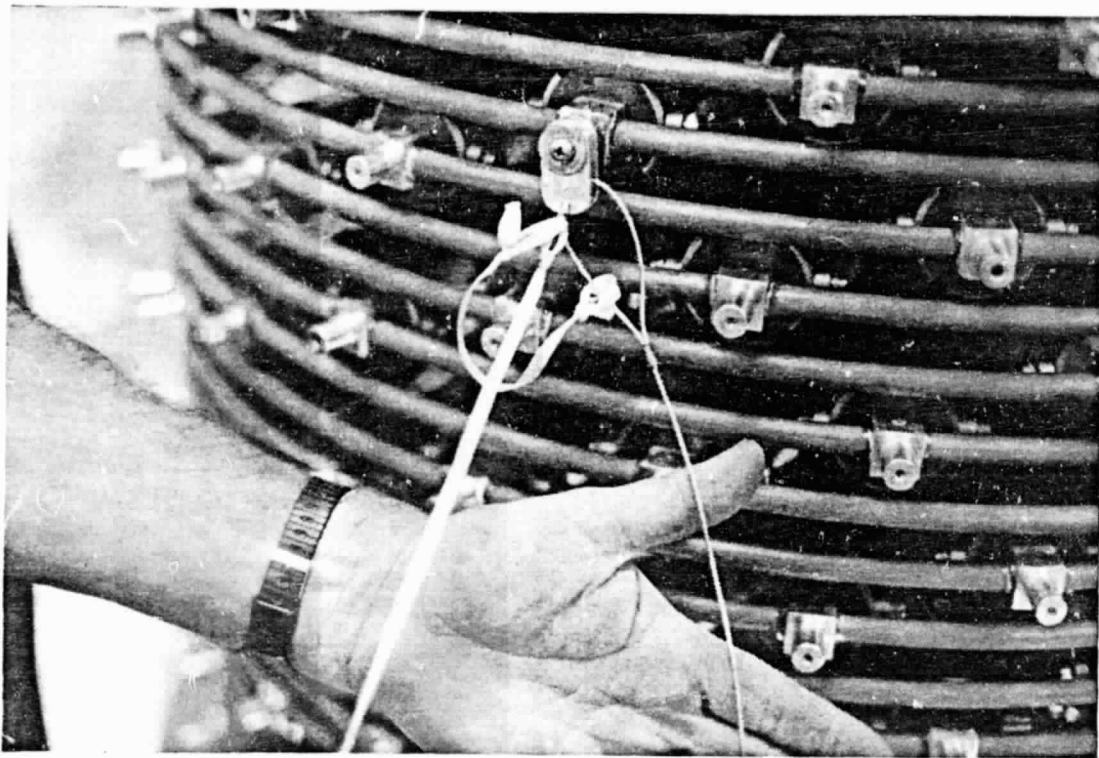
Figure 4. Stack restraint bridle installed.

In order to facilitate a quasi hands-off deployment and reduce the dynamics caused by the one-g environment, a stack restraint system has been provided. It consists of three wire harnesses which connect the pivots on the eighth batten, from the base on each longeron, to the tiplate. They are released by pulling towards the tip (outward at an approximately 30-degree angle) on each of the three white release cords. They are NOT to be released until the mast has extended approximately 6 feet and erected the first bays in the base (see Section 4, Deployment). Although they were shipped engaged, they should be checked to make sure that the wire ends are inserted in the release and the cotter pins are in place. The three white cords should be hanging downward and may be extended, if necessary to be activated, by someone at ground level. Care should be taken that the weight of cord necessary should not exceed the disengagement force of the cotter keys. It may be necessary to further spread the keys to ensure that they stay engaged (see Figure 4).

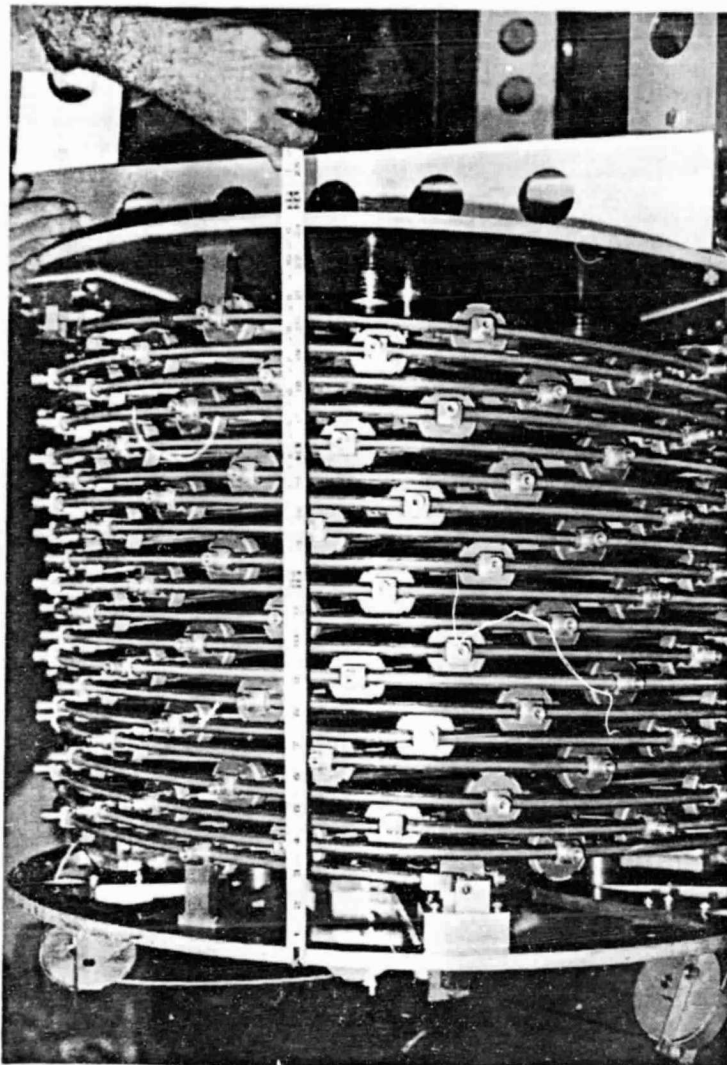
Figure 5. Restraining rods have been removed.

The final step in preparation to operate is the removal of the three threaded rods holding the tiplate and baseplate rigidly apart. The outer nuts on all three rods should be backed out evenly. If there is still considerable tension just as they are ready to release, the lanyard should very carefully be taken in approximately 1/4 inch to remove the load from the rods. This is done by switching the control box to "BRAKE" and "IN." The Variac may then be set to zero voltage and plugged in. Set the switchbox to "RUN." Advance the Variac very slowly just until the winch begins to turn. After only 1/4 inch of retraction return voltage to 0 Vac. The mast is now being supported by the lanyard and the threaded rods may be removed (see Figure 5). To continue deployment, switch to "BRAKE" and "OUT" and then back to "RUN."

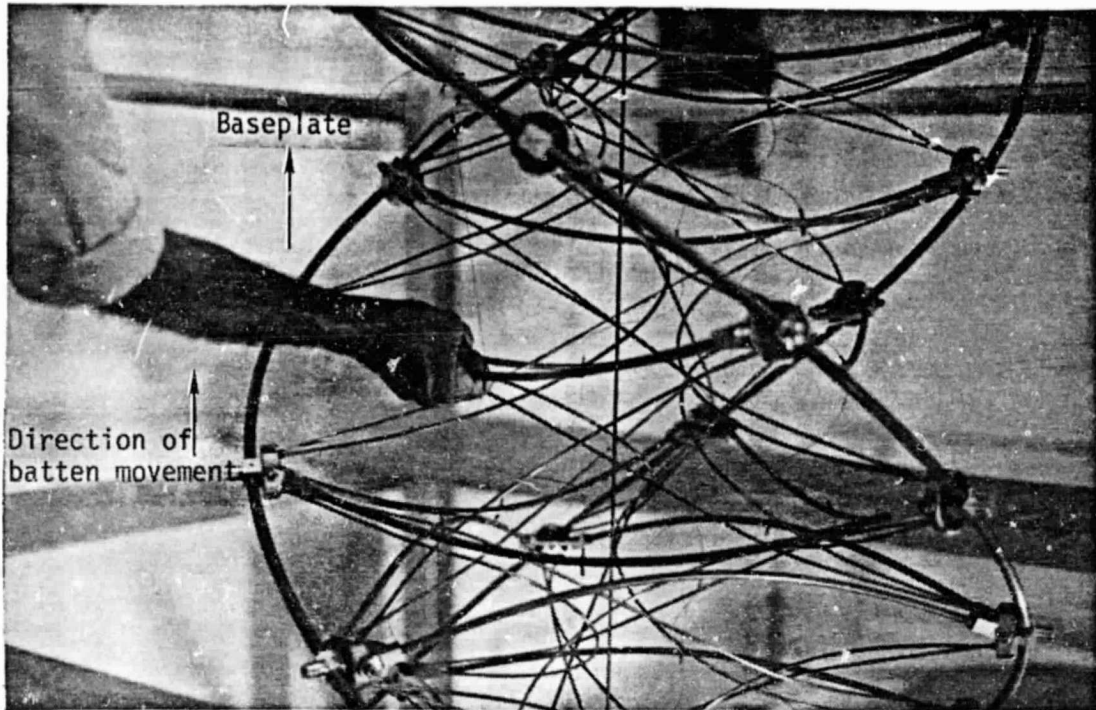
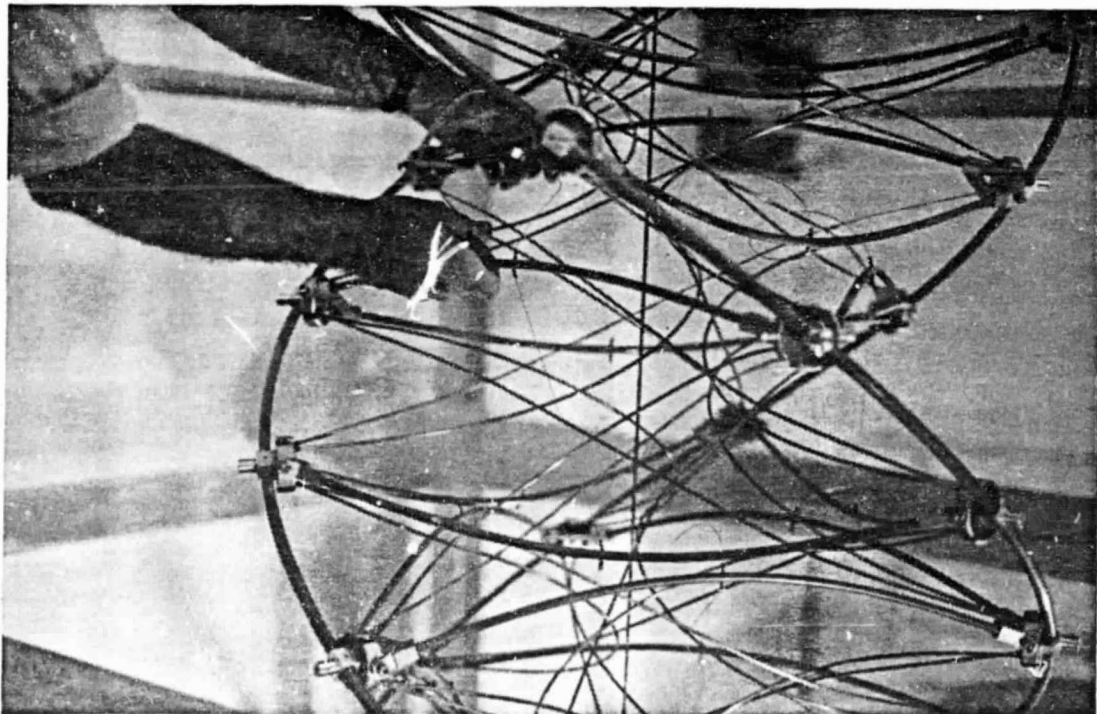
Before repositioning

After repositioning

Figure 6. Deployment stopped at 5-foot extension to reposition the batten frames for uniform direction of curvature (mast shown prior to "snapdown").

1. Phase 1: Initial Extension and Batten Adjustment (L = 0 to 5 feet) - Using a voltage of 40 Vac, the mast should extend easily. Extend the tiplate approximately 5 feet and/or until the first several battens at the base begin to curve. At this point stop the deployment and manually adjust the battens by "flipping" each section so that all the battens are curved with their convex side towards the baseplate. (Once started properly, this pattern will continue indefinitely until the unit is again fully retracted.) (See Figure 6.)

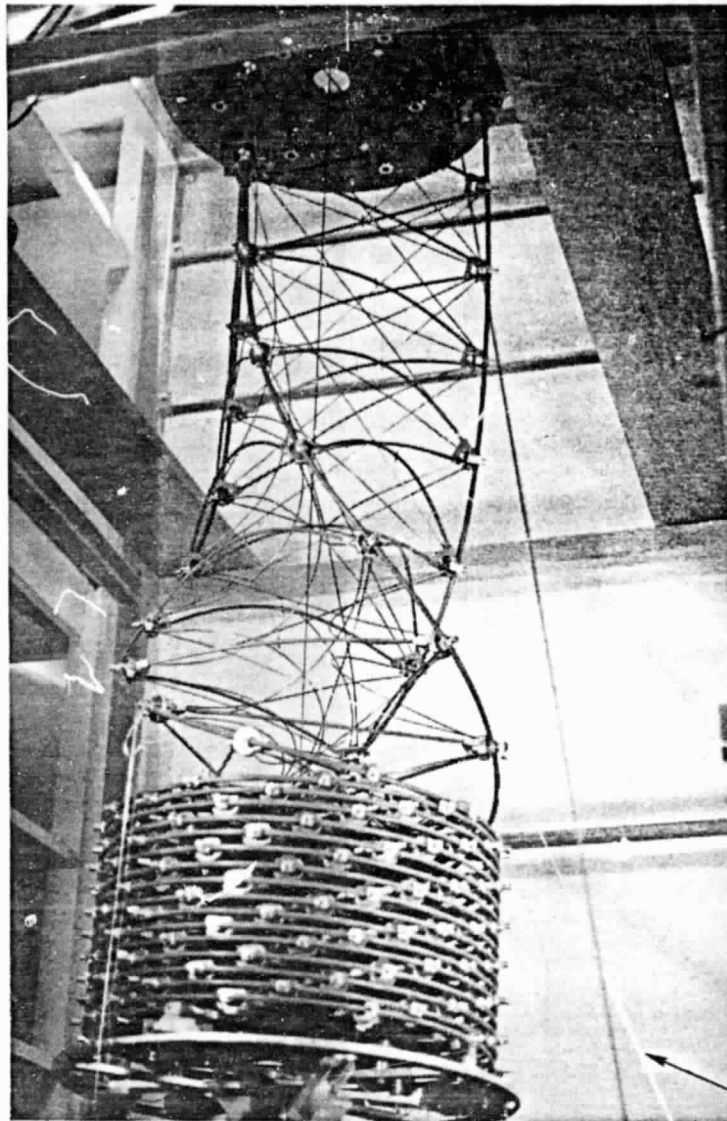
Tether line
being tensioned

Figure 7. Just after "snapover." Note correct orientation of all batten frames (convex side to baseplate).

At this point, approximately 7.5 feet of deployment, manually pull the white tethers downward (see Figure 7) and outward at approximately a 15-degree angle. They will pull out of the mast and drop. Continue pulling until all three wire bridles are free and clear from the mast and have dropped about 2 feet below the tiplite (see Figure 8).

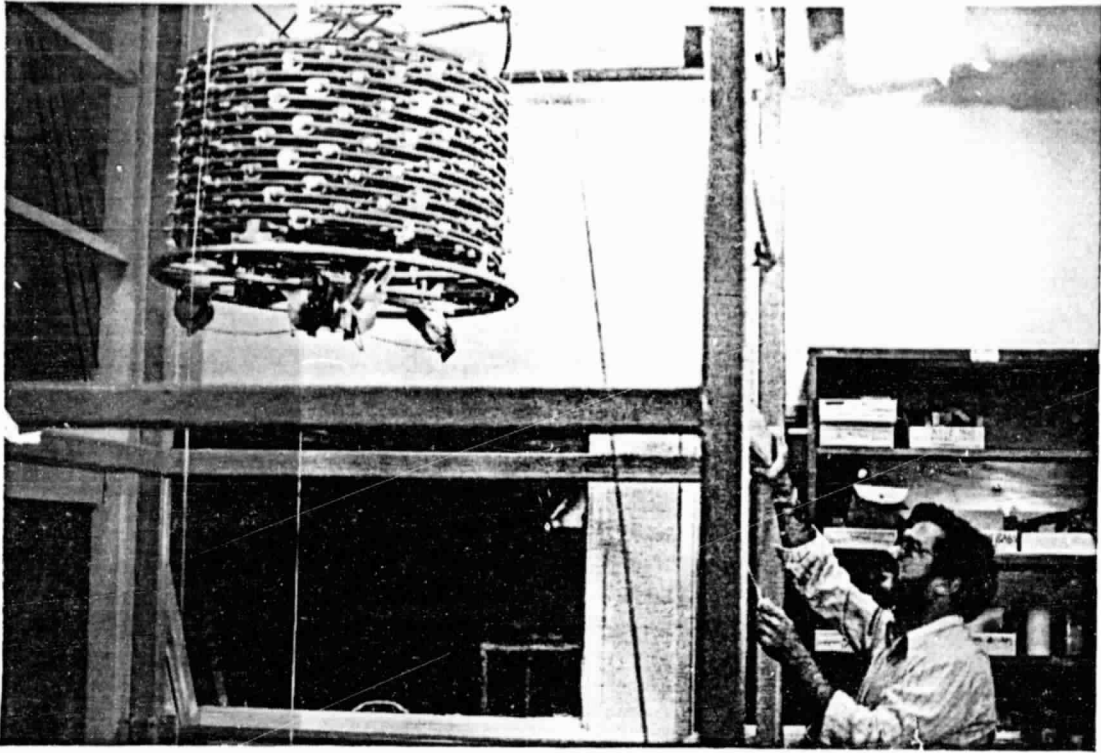
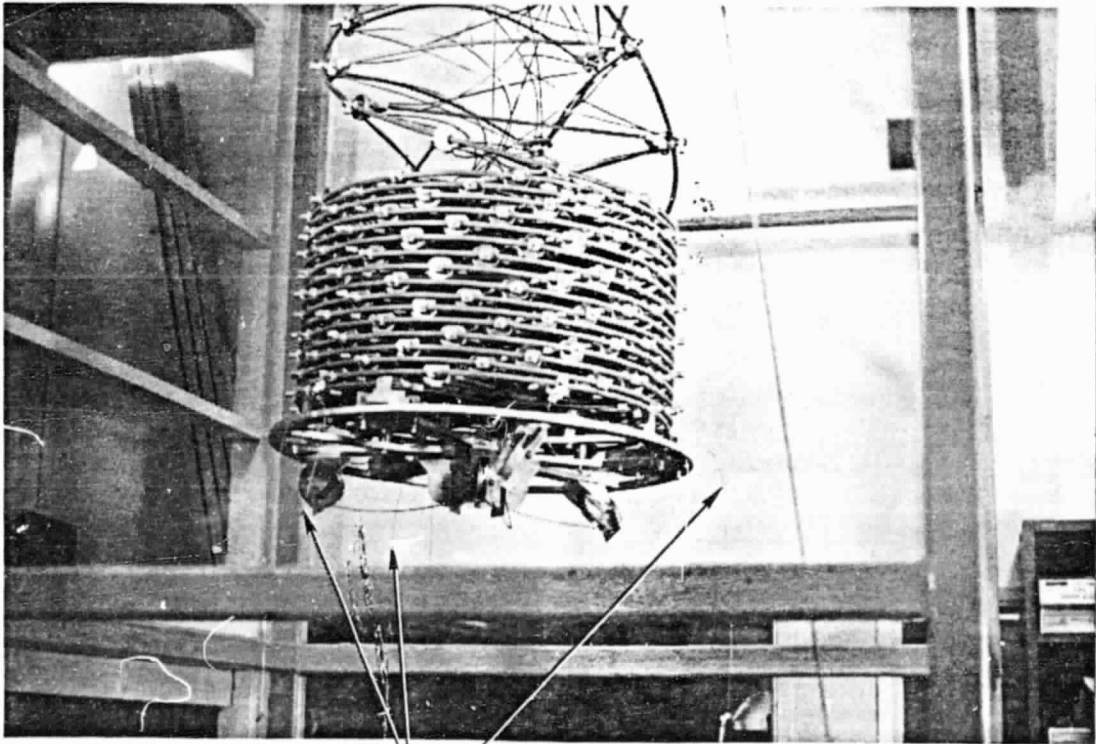
Pulling on tether to release pin

Bridles hang
free after release

Figure 8. Release of stack restraints. Unit may now be fully extended and/or retracted without further assistance.
