NASA Technical Memorandum 83764

An Experimental Investigation of the Effect of Boundary Layer Refraction on the Noise From a High-Speed Propeller

James H. Dittmar, Robert J. Burns, and Dennis J. Leciejewski
Lewis Research Center
Cleveland, Ohio

September 1984

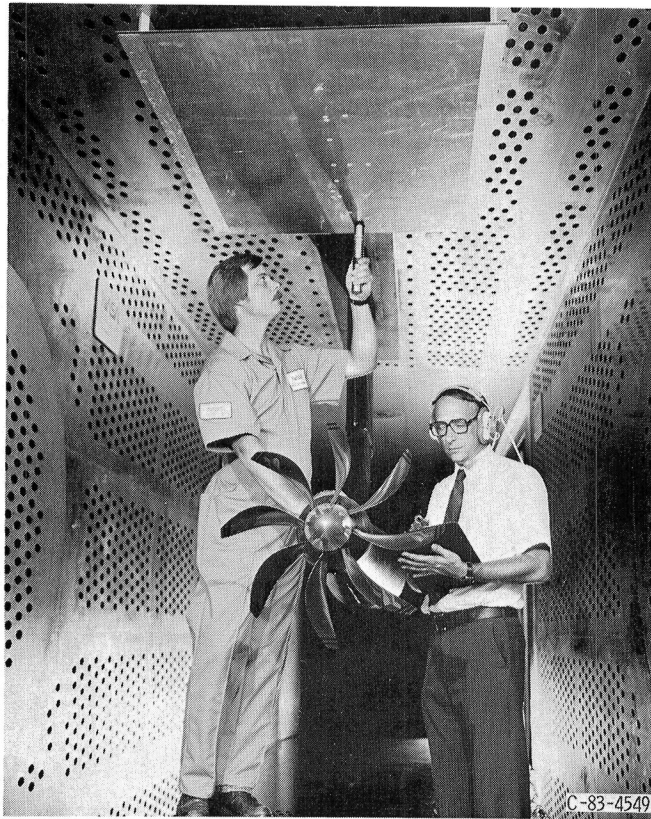
Figure 3. - Plate installed at close to ceiling position.

was believed to be around 10.2 cm (4 in) thick at a tunnel Mach number of 0.8. The plate was installed on 12.7 cm (5 in) standoff supports so that a 12.7 cm (5 in) space existed under the plate and the surface of the plate was 15.24 cm (6 in) from the tunnel ceiling. Figure 3 shows the plate installed in the wind tunnel in this "close to ceiling" position.
