NASA  
Technical Memorandum 83769

USAAVSCOM  
Technical Report 84-C-16

# Low Cycle Fatigue Behavior of Conventionally Cast MAR-M 200 at 1000° C

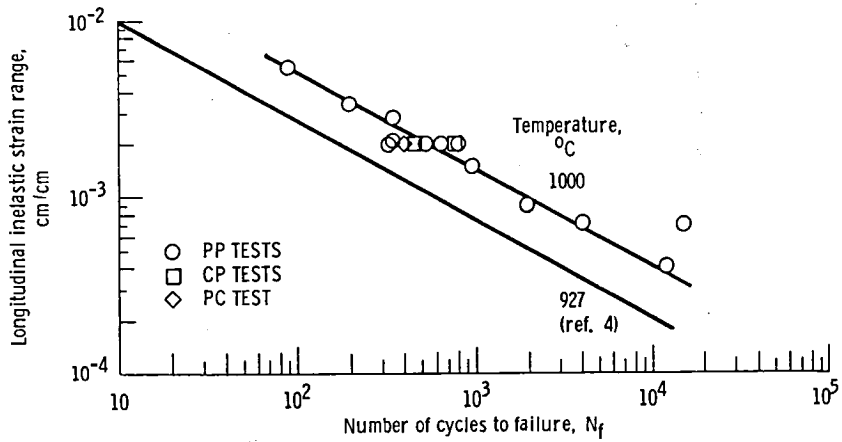
Figure 2. - Inelastic strain range versus  $N_f$  for polycrystalline MAR-M 200 at 1000°C.

As seen from figure 2, the strain-controlled fatigue data are fairly consistent, and the alloy follows the Coffin-Manson Law in the range of inelastic strainrange ( $\Delta\epsilon$  in) studied. Also, for the conditions studied ( $\Delta\epsilon_p = 0.2$  percent,  $T = 1000^\circ$  C), the fatigue life is not affected by changing the frequency or imposing a hold time. Results from SRP tests of hollow tubular MARM-200 specimens reported by Manson, Halford and Oldrieve (ref. 4) at 927° C are also shown for comparison. An approximately fourfold increase in life is seen for the 1000° C data compared to the 927° C results from reference 4. This is believed to be due to two effects. First, consider the mechanical properties. For a given inelastic strain range, peak stresses at 1000° C are about 25 percent lower than those at 927° C, thereby reducing the dynamic crack growth driving force. Also, ductility of MAR-M 200 at 1000° C is 10 to 20 percent higher than at 927° C, thereby increasing the low cycle fatigue life one would predict on the basis of cyclic inelastic strain. Second, all other

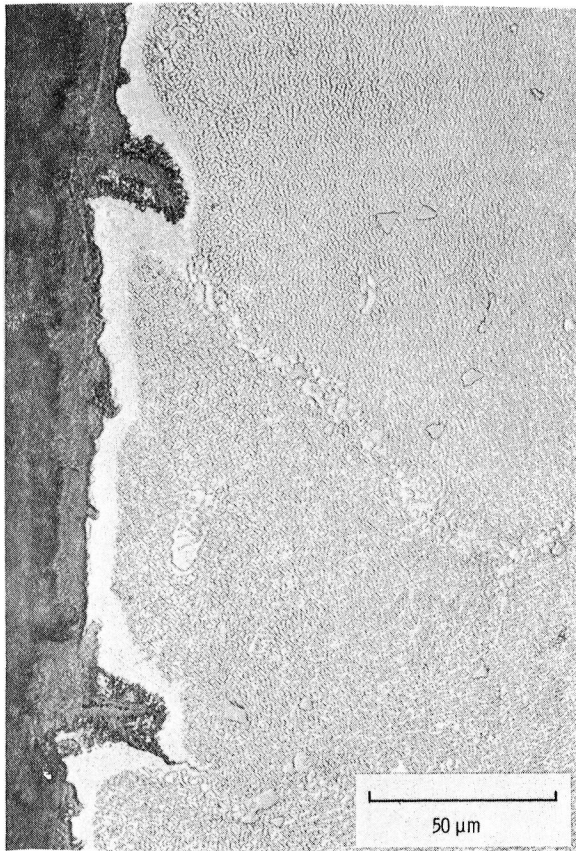
Figure 6. - Preferential oxidation and diffusion at grain boundaries.

(a) Specimen G27 (compressive strain hold,  $t_f = 17$  hr). Note the crack initiated at the lower grain boundary.

(b) Sample oxidized under no load for 16 hours.

At 1000° C, crack initiation always occurred in grain boundaries on the specimen surface, as shown in figures 3 to 6. It was also observed that crack initiation was always accompanied by preferential oxidation and alloy depletion at the grain boundary.

The primary damage mechanism for this material at 1000° C consists of environmentally assisted intergranular crack initiation and propagation, as illustrated in figures 5 and 6. Gell and Leverant (ref. 1), McMahon and Coffin (ref. 7), Coffin (ref. 8), and Antolovich, Liu and Baur (ref. 9) have documented this type of behavior for similar alloys at high temperature. Several specific mechanisms have been proposed. Gell and Leverant describe an oxidation affected zone ahead of the intergranular crack. The oxidation affected zone is structurally and chemically changed, specifically undergoing depletion of oxide forming elements. Under some circumstances intergranular crack growth may be accelerated by the formation of this oxidation affected zone ahead of the crack. An intergranular crack initiation mechanism was observed by McMahon and Coffin in cast Udimet 500 wherein surface oxide ridges that formed at highly stressed grain boundary sites led to crack initiation. McMahon and Coffin also observed extensive oxide penetration, independent of cracking, along surface connected grain boundaries as well as alloy depletion adjacent to
