Double Arch Mirror Study
Part 3, Fabrication and Test Report

Daniel Vukobratovich
Don Hillman
University of Arizona

CONTRACT NAG2- 220
November 1983

Prepared for
Ames Research Center
under Grant NAG2-220

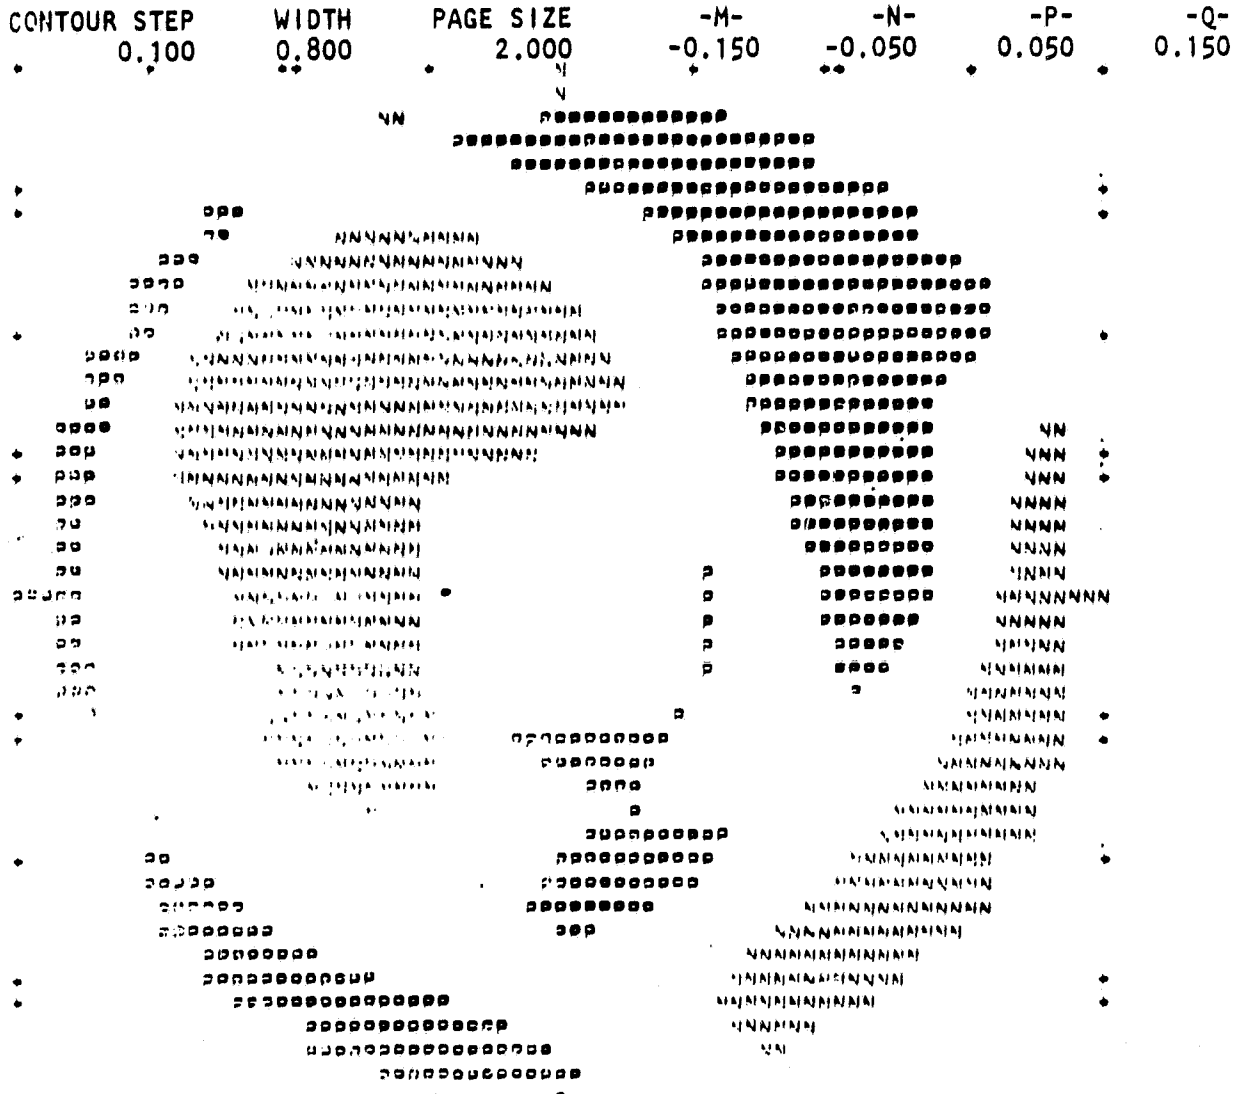
| RTS | RMS | MAX | MIN | SPAN | VOLUME |
|---|---|---|---|---|---|
| 664. | 0.117 | 0.649 | -0.052 | 0.121 | 0.153 |

Fig. 8. Mirror figure after modification. Mirror on its back, back continuously supported.

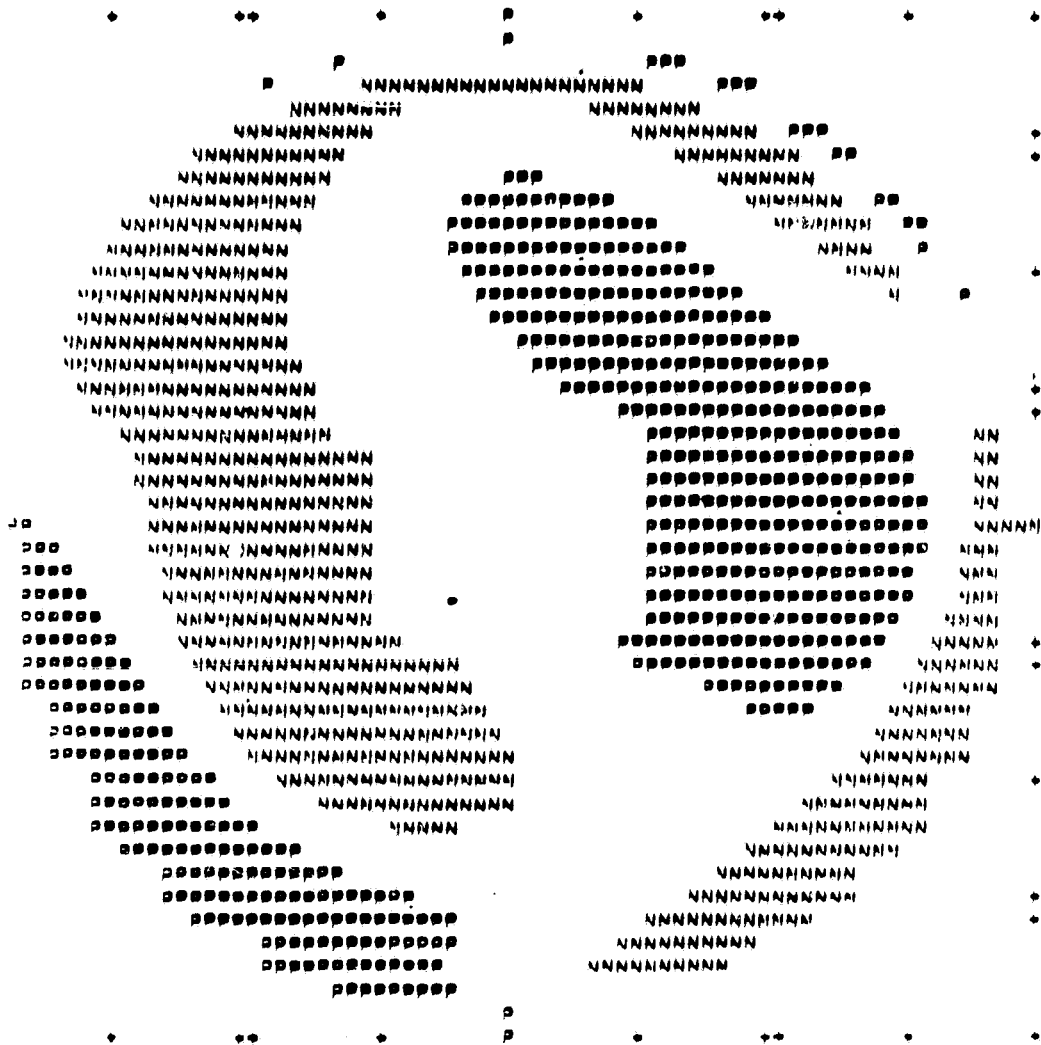
| <u>PTS</u> | <u>RMS</u> | <u>Max.</u> | <u>Min.</u> | <u>Span</u> | <u>Volume</u> |
|---|---|---|---|---|---|
| 664.0 | 0.017 | 0.061 | -0.048 | 0.109 | 0.142 |

Fig. 11. Mirror under test upside down, stressed.

The translation stages were then driven 0.029 in. to simulate a cryogenic contraction of the aluminum baseplate. This corresponded to a 10°K final temperature. The results of this test are seen in Fig. 11. The RMS surface error is 0.017 waves and the peak-to-valley error is 0.109 waves. Again, there is no apparent print-through of the three support points.
