## Development of an Advanced Composite Aileron for the L-1011 Transport Aircraft

C. F. Griffin and E. G. Dunning

CONTRACT NAS1-15069  
FEBRUARY 1982

Prepared for  
Langley Research Center  
under Contract NAS1-15069

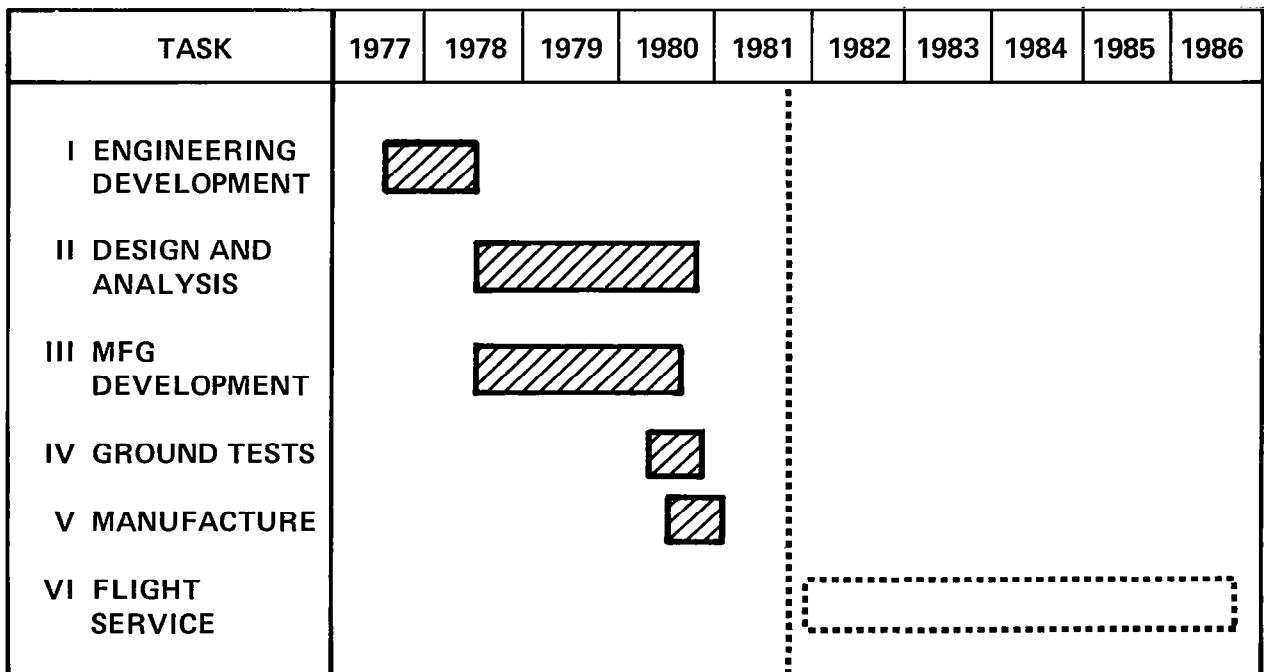
Figure 1. - Master schedule.

As shown on the master schedule, figure 1, the program was conducted in six nonsequential tasks. Task I, Engineering Development, and Task II, Design and Analysis, are the portions of the program wherein the composite aileron design was formulated and subcomponents fabricated and tested to verify design concepts and fabrication procedures. During Task III, Manufacturing Development, and Task IV, Ground Test and Flight Checkout, production quality manufacturing tools were constructed, and two full-scale ailerons were fabricated and tested. A production run of five shipsets were fabricated during Task V, Aileron Manufacture, to provide manufacturing and cost information. In Task VI, Flight Service, inspection and maintenance data

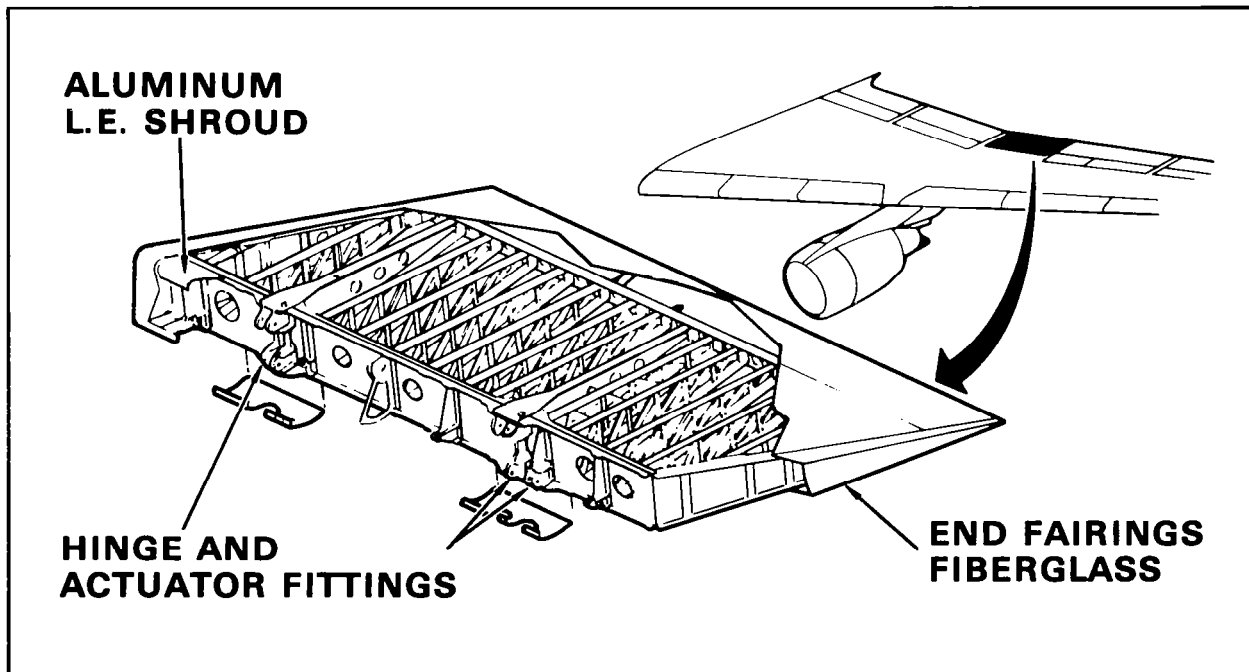
Figure 2. - Inboard aileron - existing metal design.

The inboard aileron is located on the wing trailing edge between the outboard and inboard trailing edge flaps, as indicated in figure 2. It is

The current aluminum aileron, shown in figure 2, consists of a front spar, a rear spar, and upper and lower skins, joined by three hinge ribs and fifteen intermediate and end ribs. A trailing edge wedge, leading edge shroud, and end fairings complete the assembly.

supported from the wing at two hinge points and is actuated by three hydraulic actuators. It is a wedge-shaped, one-cell box, thinning slightly from root to tip. At the front spar the aileron is 2337 mm (92 in.) in length and approximately 254 mm (10 in.) deep. The width of the aileron is 1270 mm (50 in.).

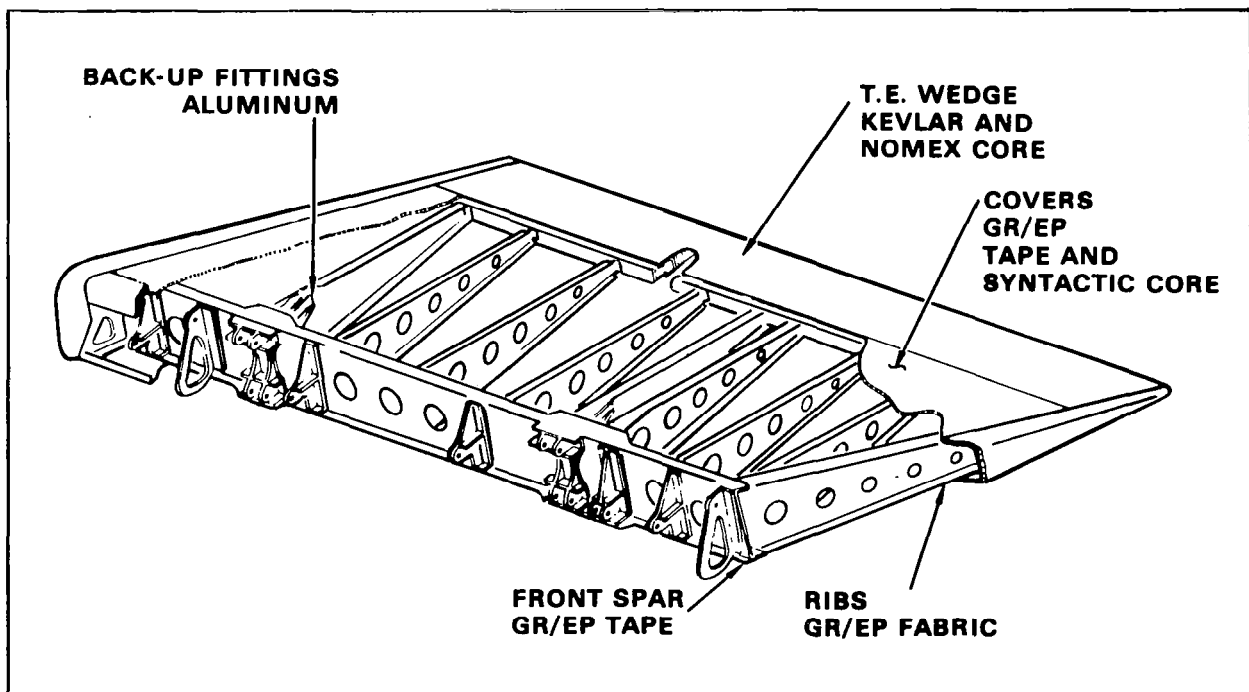
Figure 3. - Advanced composite aileron assembly.

Design trade-off studies and materials evaluation tests were conducted to determine component designs and materials which best meet the program goals. The selected composite aileron design, illustrated in figure 3, is a multirib configuration with single piece upper and lower covers mechanically fastened to the substructure. Three composite materials are utilized in the aileron design: Thornel 300/Narmco 5208 graphite/epoxy unidirectional tape [0.19 mm/ply (0.0075 in./ply)]; Thornel 300/Narmco 5208 graphite/epoxy bidirectional fabric; and Hysol ADX-819 syntactic epoxy. The selected resins have a cure temperature of 450 K (350°F) for excellent environmental resistance. The [0.19 mm/ply (0.0075 in./ply)] tape thickness was selected for the aileron for optimum weight savings and minimum lay-up time. The bidirectional fabric offered lower production costs through reduced number of plies required and improved drapability. Syntactic epoxy, which is a film adhesive filled with hollow glass microballoons, is used as a core to create a lightweight sandwich structure.

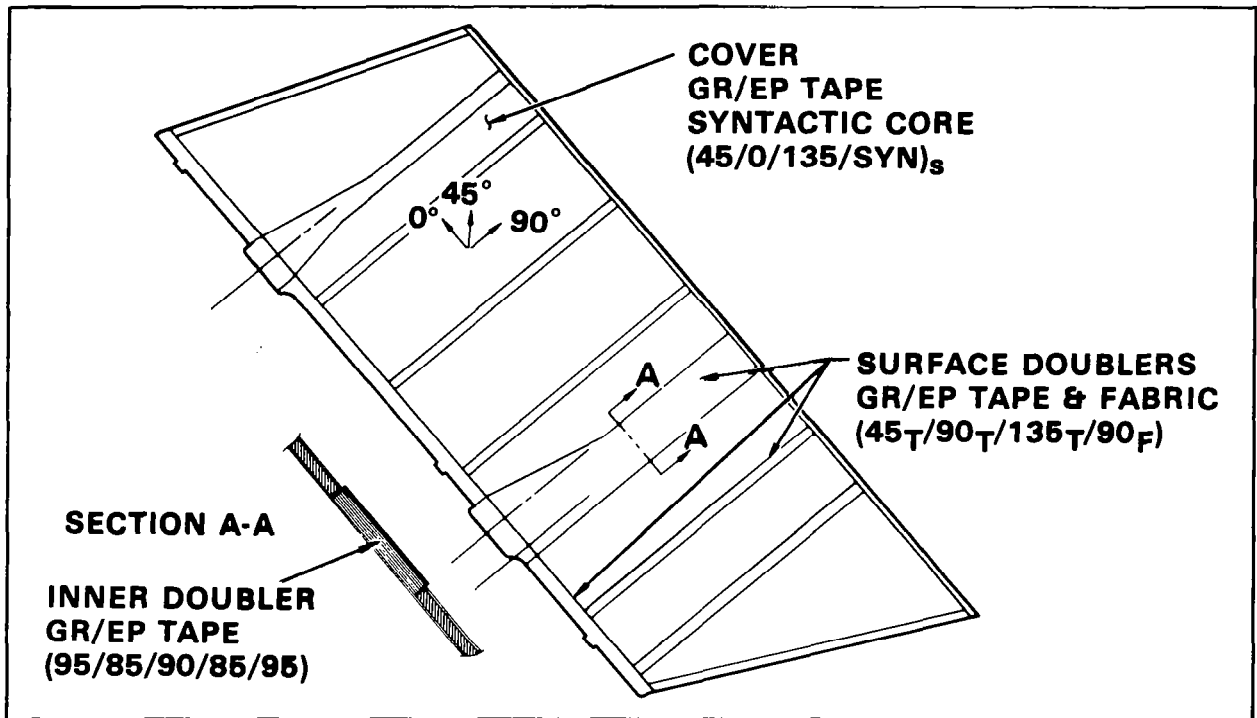
Figure 4. - Aileron cover design.

The aileron covers are approximately 2438 mm (96 in.) by 914 mm (36 in.). The structure, shown in figure 4, is a syntactic core sandwich consisting of three plies of 0.19 mm (0.0075 in.) thick graphite/epoxy tape on each side of a 0.953 mm (0.0375 in.) syntactic/epoxy core. The orientation is 45°/0°/135° with the 0° ply in the spanwise direction. The syntactic core over the three main ribs is replaced by five-ply unidirectional tape doublers. Additional doublers are cocured to the inner surface at the ribs and spars to assist in

load transfer between covers and substructure and provide thickness buildup required for countersunk fasteners. Forward of the front spar datum, the syntactic core is omitted and inner surface doublers are added to help carry the spar bending loads near the main ribs.

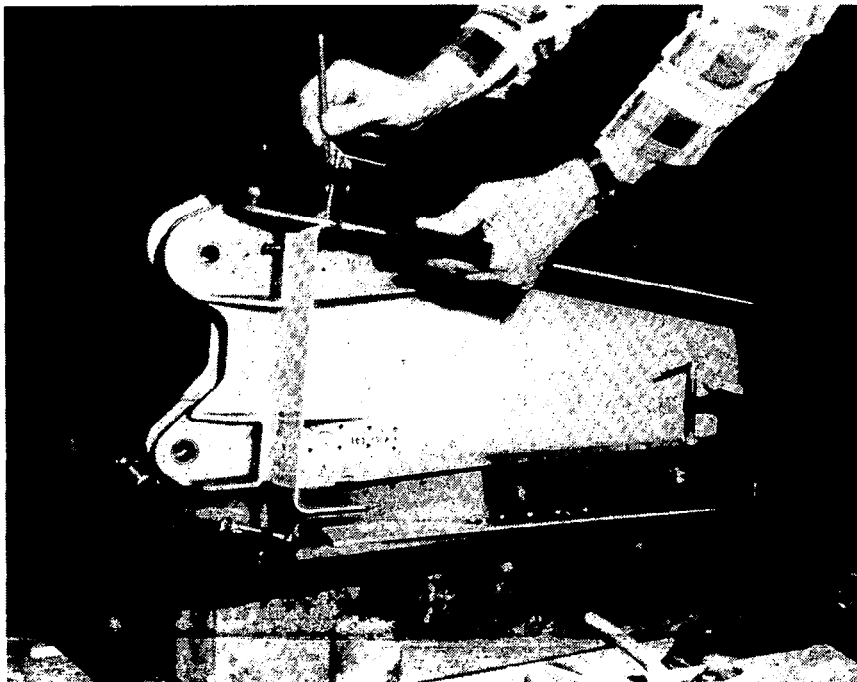
Figure 5. - Hinge/actuator fitting installation.

Front spar bending moments are shared by both the spar cap and the leading edge of the cover which has local doublers at the main rib-front spar intersections. This design approach yields a very efficient fail-safe design. The ribs, hinge/actuator fittings, and leading edge shroud supports act as stiffeners on the spar shear web; thus, no additional stiffening elements are necessary.

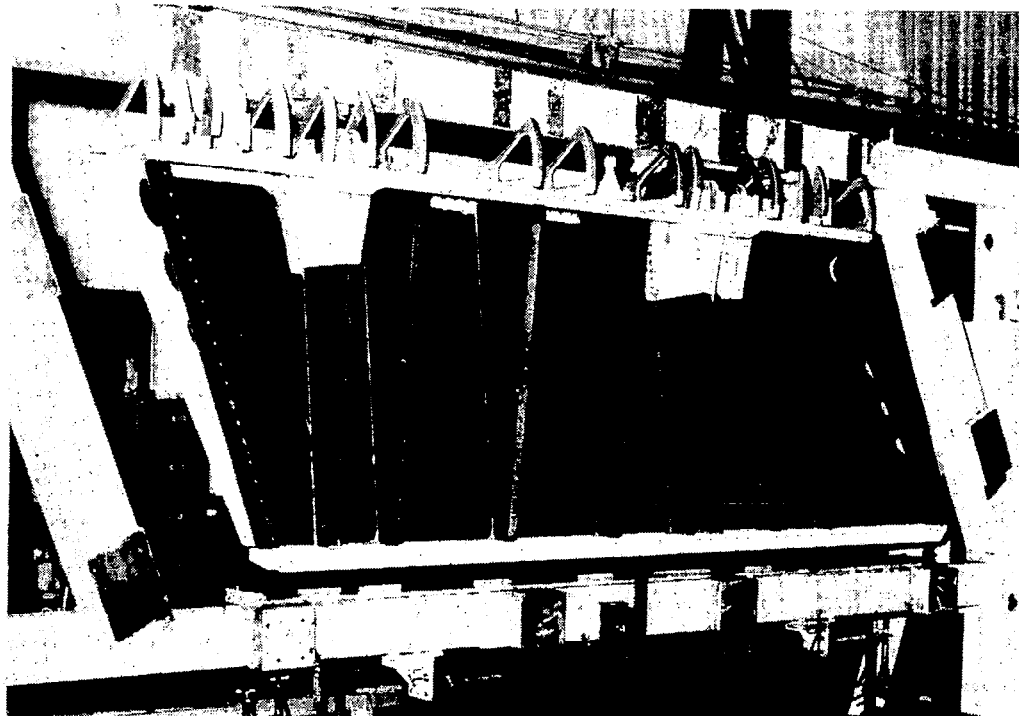
Figure 6. - Aileron assembly.

A photograph of the aileron assembly is shown in figure 6. The upper surface, ribs, and spars are permanently fastened with titanium Triwing screws and stainless steel Hi-Lok collars. The removable lower surface, trailing edge wedge, leading edge shroud, and end fairings are attached with the same type of screws but with stainless steel nut plates attached to the substructure with stainless steel Cherry rivets. The trailing edge wedge, front shroud and fairings are identical to those used on the current metal aileron. To preclude galvanic corrosion, aluminum parts within the aileron are anodized, primed with epoxy and then given a urethane topcoat. Graphite/epoxy parts in contact with aluminum parts are also painted with a urethane topcoat. Faying surface sealant is used at the interface of all aluminum and composite parts. After assembly the aileron is primed and painted. Lightning strike tests indicated that no lightning protection was required for the aileron assembly.

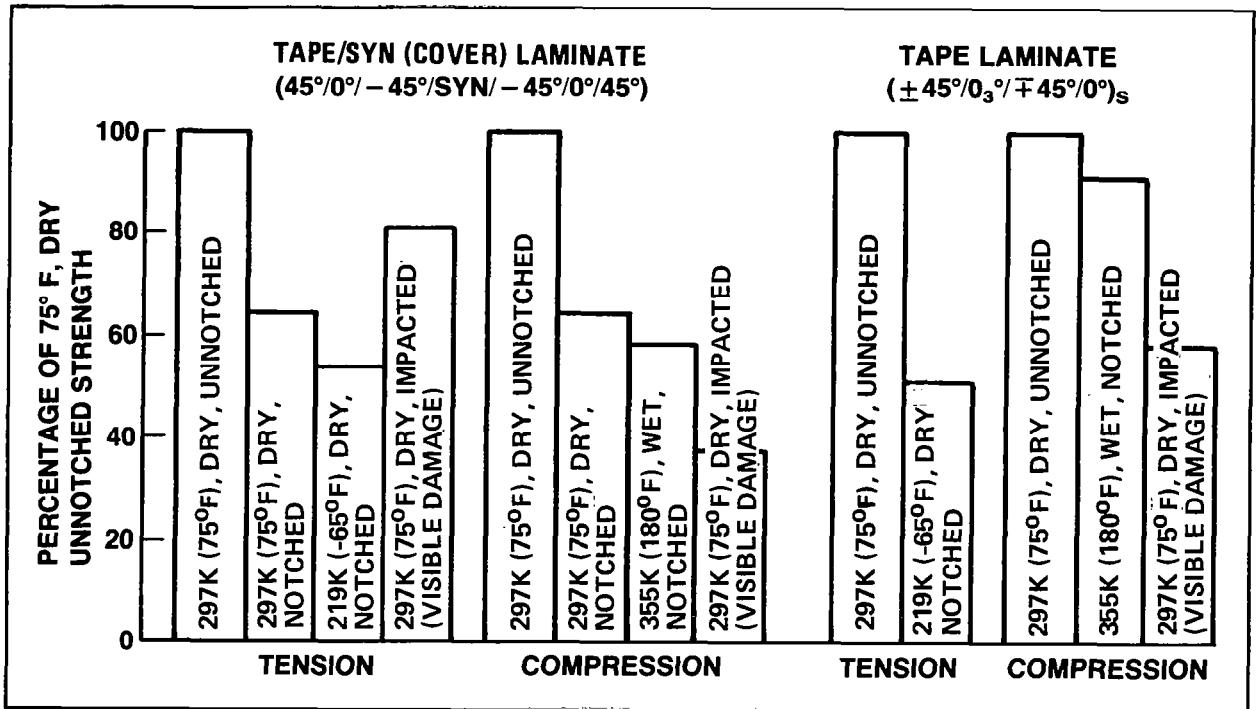
Figure 7. - Typical defect and damage tolerance data.

Defect and damage tolerance of the aileron was determined by conducting tests on representative laminates. Defects and damages investigated included voids, notches, and impact damage. Information from these tests was used to establish the manufacturing accept/reject criteria and laminate design allowables. Typical defect and damage tolerance data for the ACA cover laminate and a graphite/epoxy tape laminate are presented in figure 7. Results of all of the tests indicated that for tensile loads an open hole degraded the strength much more than a void or impact damage. For compression loads, impact damage caused the greatest reduction in strength.

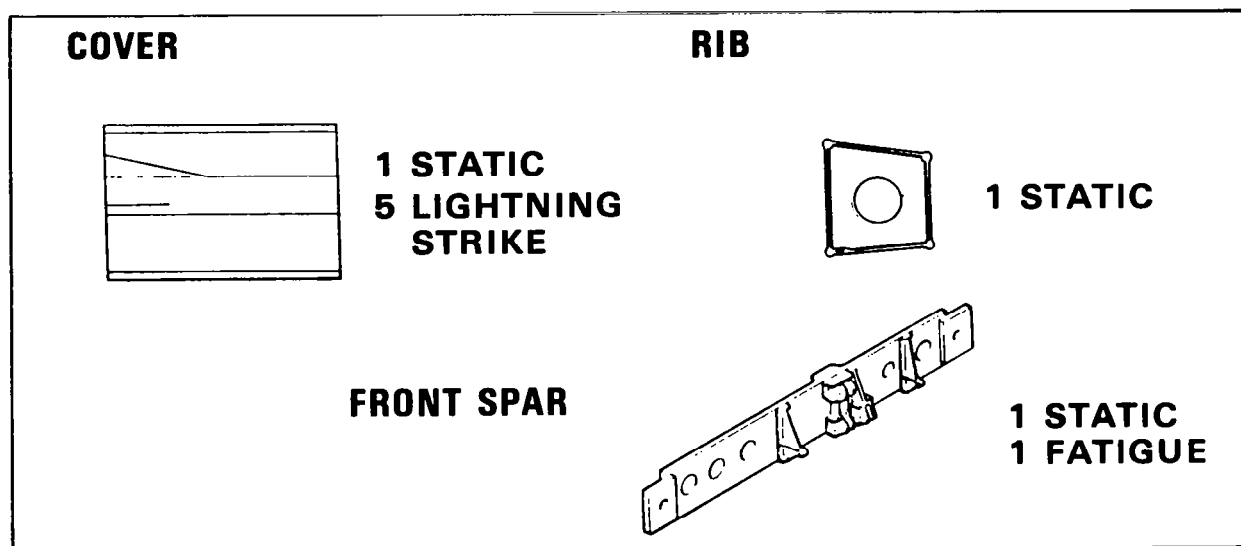
Figure 8. - Summary of subcomponent structural tests.

Structural tests were conducted on ACA subcomponents and assemblies, as summarized in figures 8 and 9, to investigate the various design details and to verify that strength is adequate. These tests included static tests, and spectrum fatigue tests for two lifetimes followed by residual strength tests.

The cover specimen which was tested included local regions where the syntactic core is replaced by strips of graphite tape doublers which form part of the rib cap and spar cap structure. After confirming the predicted shear stiffness of the cover, these doublers were investigated by loading the cover in combined shear and compression (and later, tension) to 112 percent of design ultimate load without failure. Subsequently, the fail-safe capability was demonstrated by cutting a 305 mm (12 in.) long slot in the most highly loaded region of the cover (adjacent to the rib/spar intersection). Limit load (shear and spanwise tension) was applied, but no damage growth occurred. The load was increased to 169 percent of limit load with no damage growth or failure. This confirmed the damage tolerance/fail-safe characteristics of the cover design.

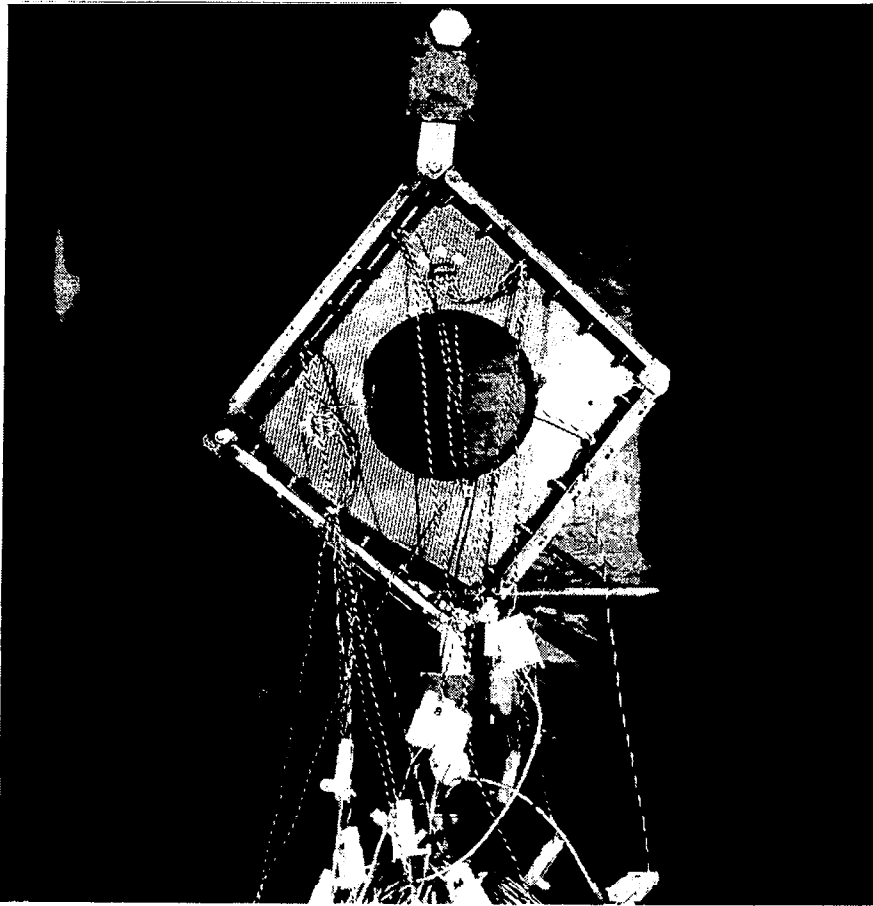
Figure 10. - Setup for rib static test.

Intermediate and closure rib webs contain flanged lightning holes which result in a 13 percent weight savings compared to a solid web rib. Analytical investigations indicated that the loss of shear strength in the web due to a cutout could be recovered by adding a flange to the periphery of the hole. Experimental verification of the shear strength of a web containing a flanged lightning hole was obtained by statically testing a segment of an intermediate rib. The specimen, shown installed in the picture frame test fixture on figure 10, failed at a load of 2168 kg (4780 lb), which is approximately three times greater than design ultimate load (D.U.L.). Initial buckling of

the specimen occurred at 771 kg (1700 lb). Both the initial buckling load and failure load of the specimen were analytically predicted to within six percent of the measured loads.

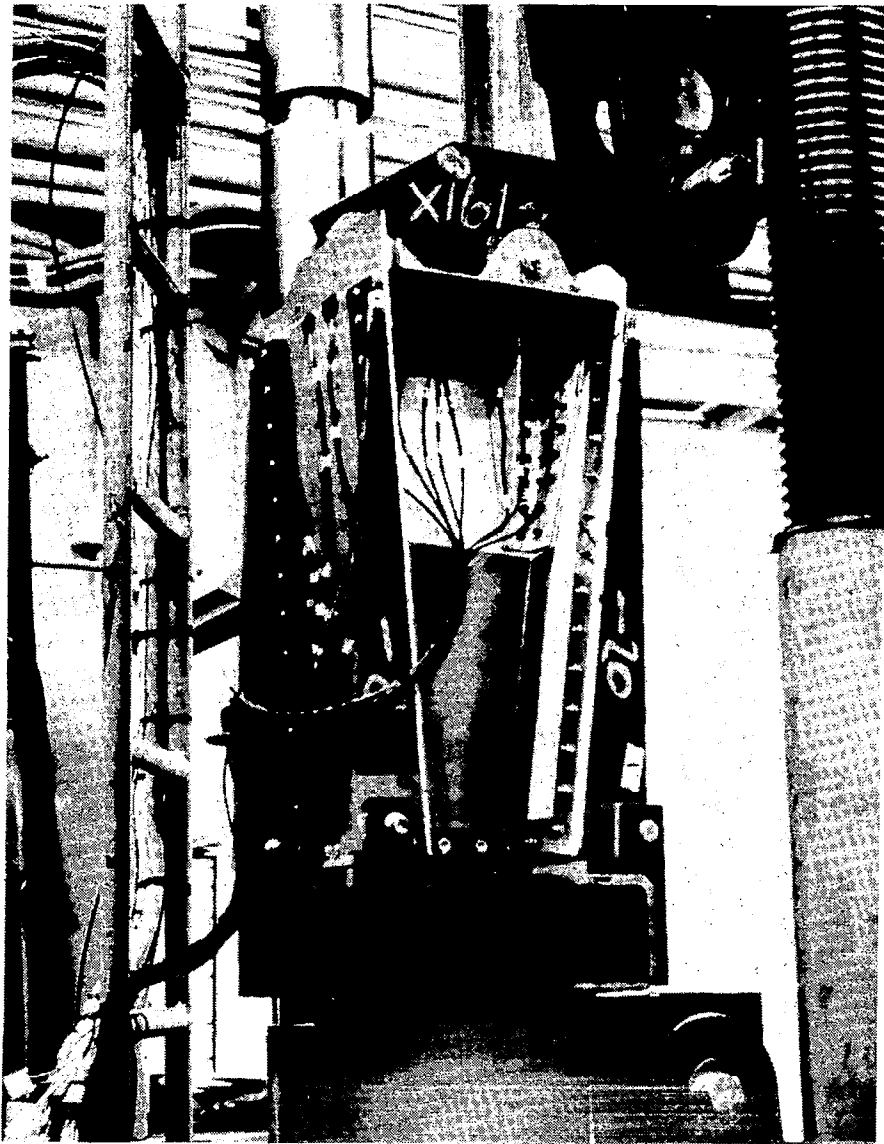
Figure 11. - Rib/spar/fitting specimen installed in test machine.

The hinge/actuator fitting at the main rib introduces a concentrated load of over 12 250 kg (27 000 lb) into the rib and covers. The rib/spar/fitting specimen was tested statically and in fatigue to verify the design concept. As shown in figure 11, a fixture introduced the loads into the

hinge/actuator fitting, and the loads were reacted through the covers and the rib web. The specimen was loaded in compression to 110 percent D.U.L. without visible damage. Two lifetimes of fatigue loading were applied to a second specimen without visible damage. Then it was loaded statically in tension, and a bolt attaching the fitting to the aileron failed at 140 percent D.U.L. which substantiated the analysis which had predicted failure at 139 percent D.U.L. These tests verified the structural integrity of the fitting load transfer design concept.

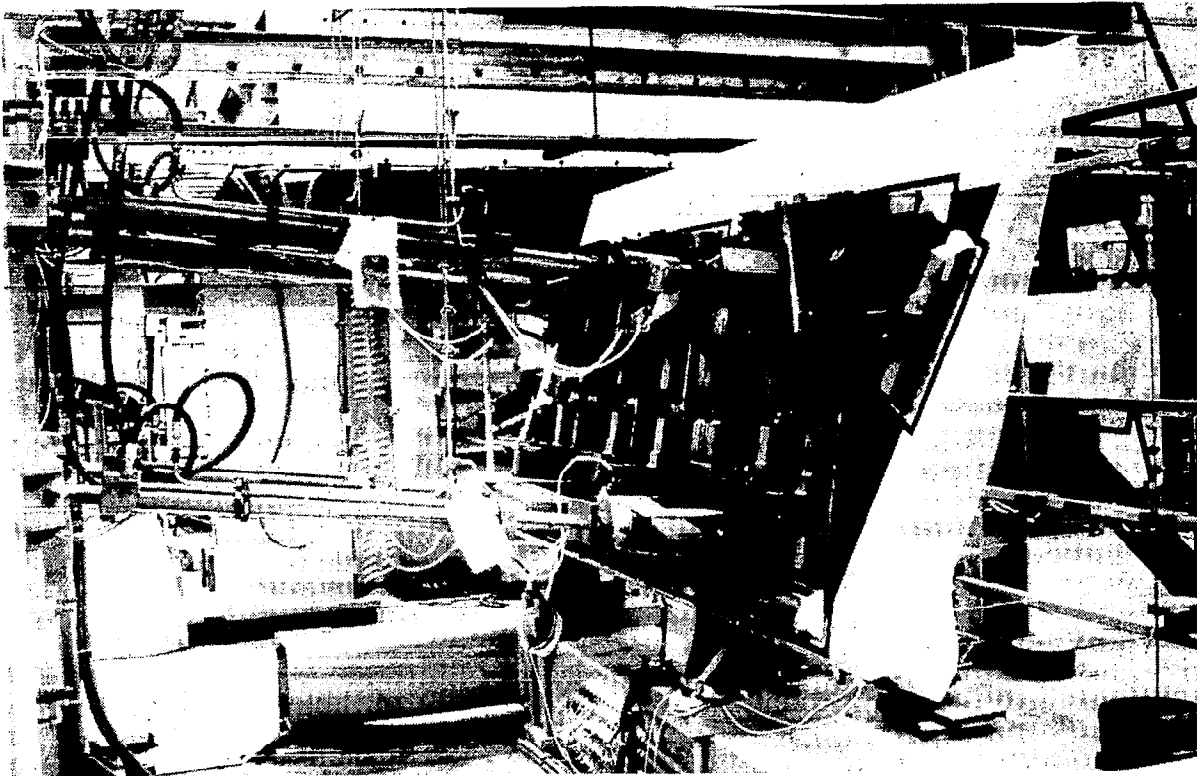
Figure 12. - Aileron ground test set-up.

Two loading conditions were tested. Condition 4 loads, representing the 12° down aileron position, were applied to 124 percent D.U.L. without failure. The 24 percent factor on condition 4 loads resulted in loads on the hinge/actuator fitting fasteners equal to the design ultimate load for another loading condition that was not tested. There was no visible damage from this test.

The condition 1 loads, representing the 20° up aileron position, were applied to 117 percent D.U.L. without failure. The 17 percent factor accounted for the strength differences between the environmental extremes and the ambient testing conditions. The condition 1 loads were increased to failure which occurred at 139 percent D.U.L. Failure was a result of postbuckling of the webs of the hinge and actuator backup ribs at stations 102.7 and 107.1.

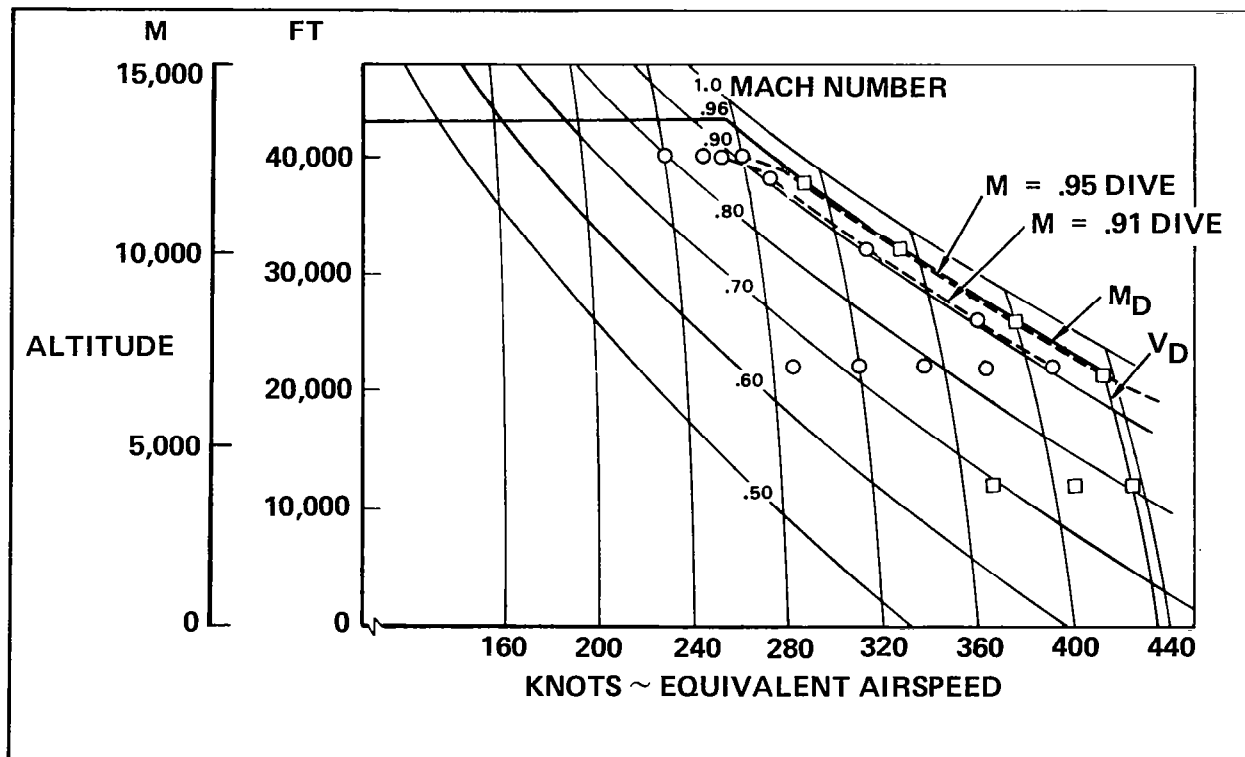
Figure 13. - Flight conditions investigated.

The flight test of the advanced composite inboard ailerons was successfully completed in June 1980. The first shipset (left and right) of inboard composite ailerons was installed on the Lockheed L-1011 flight test aircraft. The aircraft takeoff gross weight (TOGW) was 160 121 kg (353,000 lb). The ailerons were ballasted with lead tape to achieve a worst-case hinge unbalance of 23 043 mm-kg (2000 in-lb). Ground servo stability during engine run up, level flight, and high-speed descent tests were performed (figure 13). During these tests one or two of the three hydraulic servos were shut off to simulate fail-safe conditions. Pulses were applied to the control column to give a momentary longitudinal pitch or lateral right or left roll impulses.

The advanced composite aileron response was somewhat better than the metal aileron during ground engine run up, and the damping characteristics of the composite aileron were comparable to the metal aileron during all tests. The composite aileron was flutter-free throughout the flight envelope.

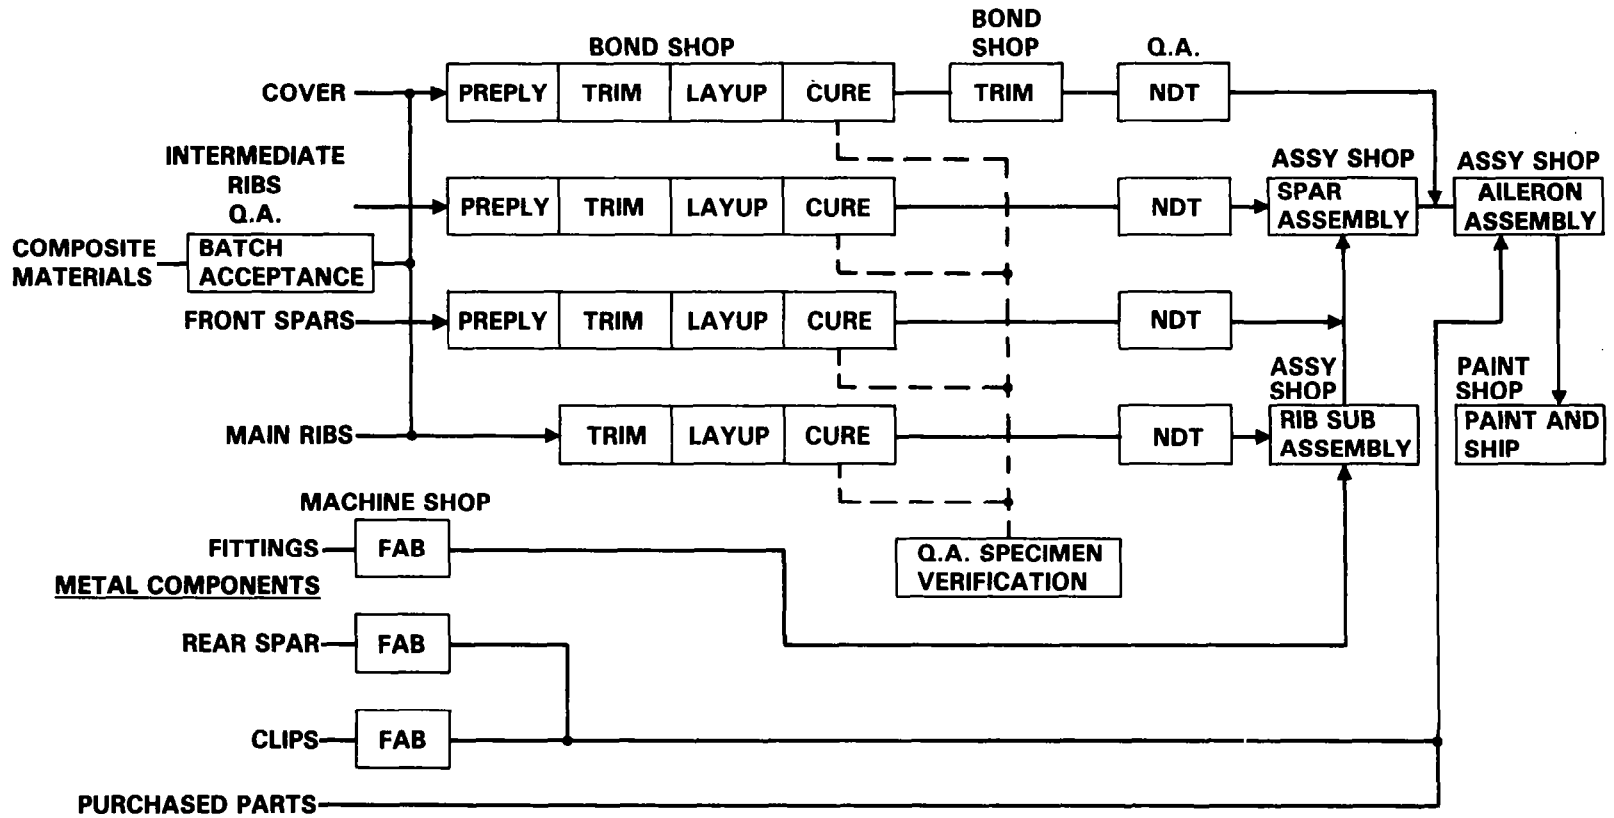
Figure 14. - Manufacturing flow diagram.

The 13 graphite composite parts required for each composite aileron were fabricated in production environment using the developed tools and processes.

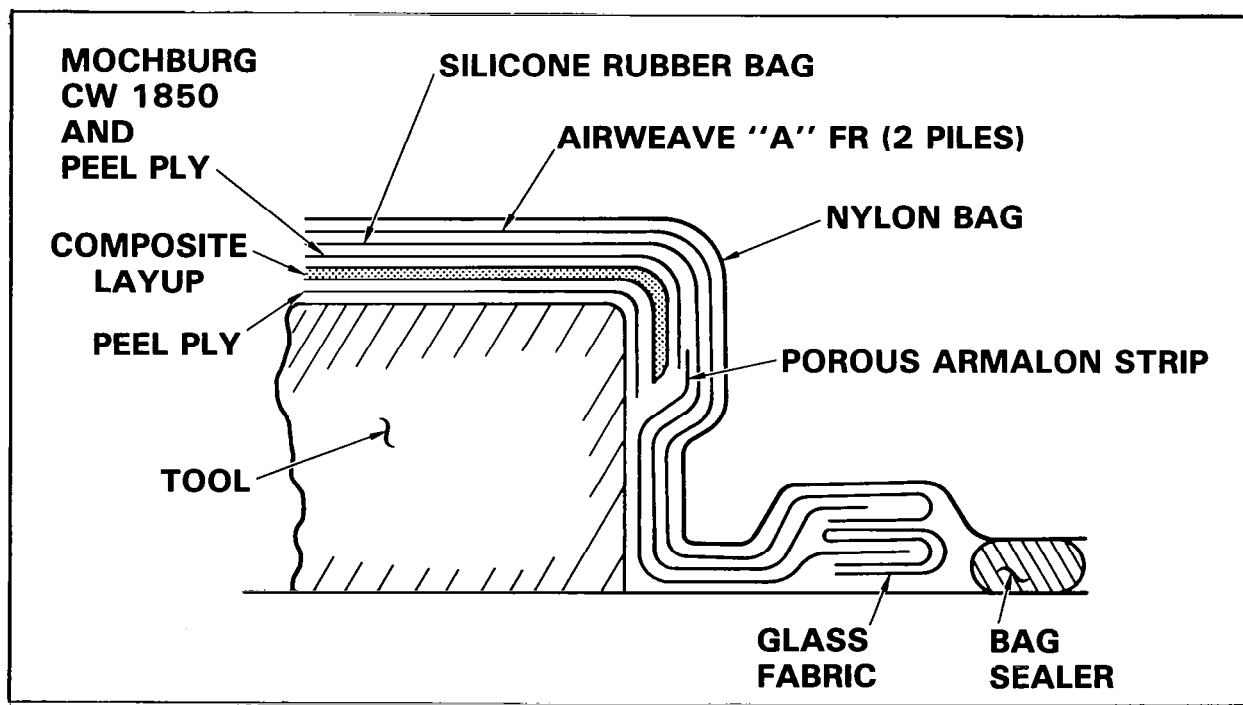
Figure 15. - Rib layup

The three types of ribs were fabricated in a like manner. The required quantity of graphite/epoxy fabric plies were preplied and then hand trimmed to net size using a template and shop knife. This preplied material was laid up onto the male cure tool. Bleeder/breather materials were then applied to the layup. Bleeder/breather arrangement for the ribs was as follows: one peel ply, one ply Mochburg CW 1850 paper, and Armalon strips to provide a vacuum path to the vacuum source. A silicone rubber bag was applied, which acts as a dam at the part edge for control of resin flow and allows a more even distribution of pressure on the laminate. This entire layup with a product control panel was sealed under a nylon vacuum bag. This arrangement is shown in figure 15. The ribs were cured to a net configuration, eliminating subsequent trimming operations. Resin flash was manually removed using 200 grit abrasive paper.

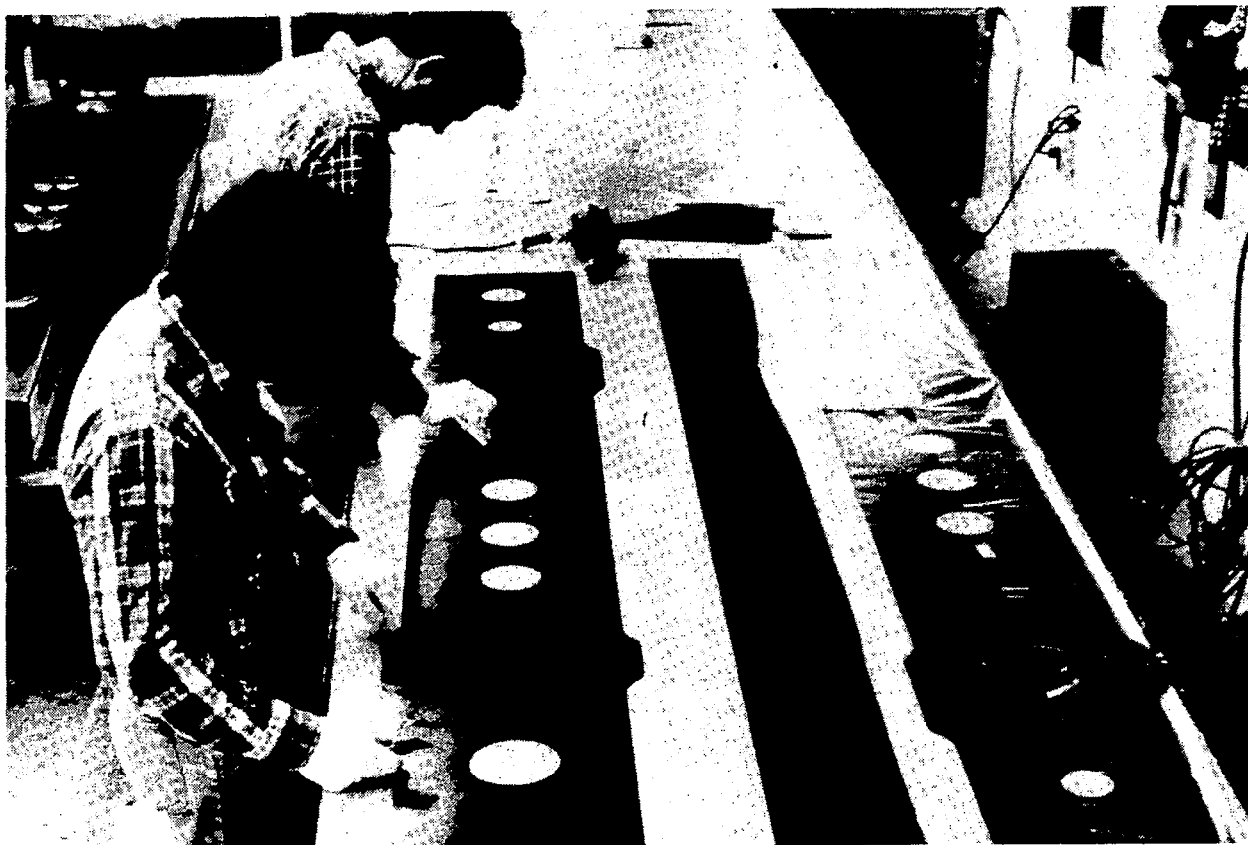
Figure 16. - Spar preplying operation.

The ten-ply graphite/epoxy tape spar laminate was preplied in four sets as follows: three plies/two plies/two plies/three plies. Each set of preplied material was hand trimmed to net size using a template and shop knife as shown in figure 16. The spar cure tool (see figure 17) was heated to 325 K (125°F) to enhance drapability of the graphite tape. The four sets of preplied material were oriented on the cure tool by aligning the prepreg index holes on the tool targets during layup. Bleeder/breather materials, a silicone rubber bag and nylon vacuum bag were then applied. A process control panel was included and laid up on the same tool. The spar was also cured to a net configuration eliminating any trimming operations.

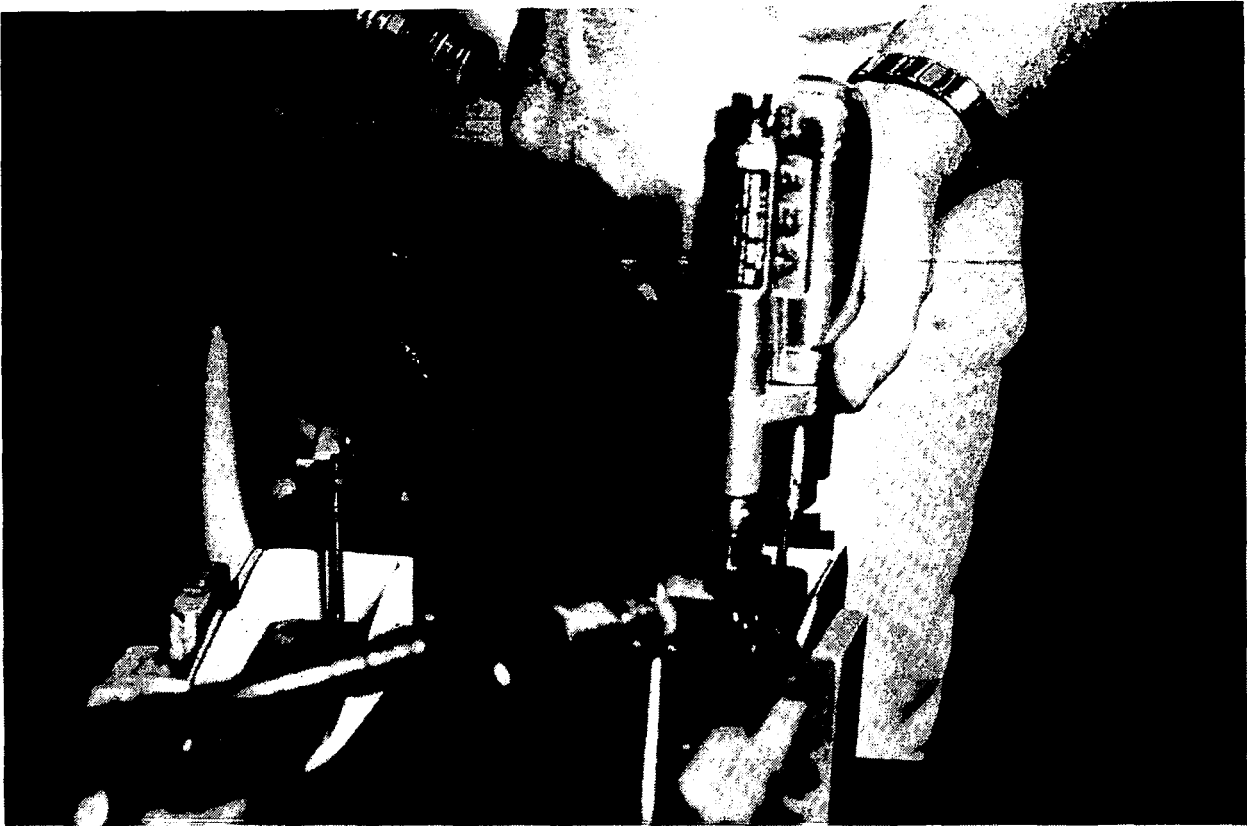
Figure 18. - Drill motion with hydraulic check attachment.

1. Load front spar assembly, rear spar and closeout ribs
2. Drill attach holes through rear spar and ribs
3. Load upper cover and drill attach holes
4. Remove upper cover, load lower cover and drill attach holes
5. Remove lower cover and permanently fasten upper cover
