Wear Particle Analysis Using the Ferrograph

William R. Jones, Jr.
*Lewis Research Center
Cleveland, Ohio*

Prepared for the
Joint Meeting of the Fluid Power Society and the
American Society of Lubrication Engineers
Detroit, Michigan, April 26, 1983

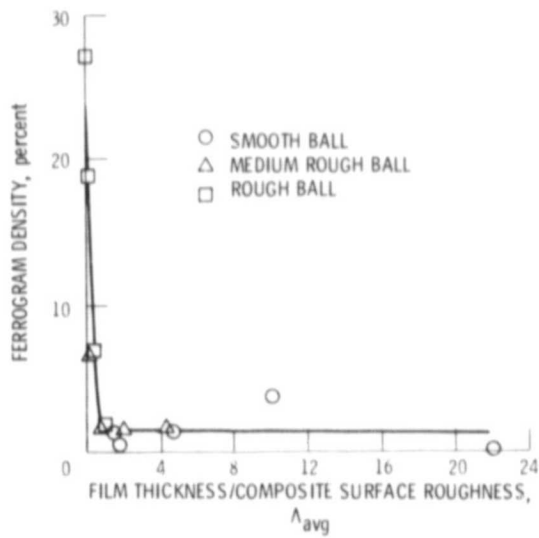
Figure 8. - Ferrogram density versus average Λ ratio (ref. 11).

The transition from the EHD regime into the mixed and boundary regimes is dramatically illustrated by Ferrographic analysis (fig. 8) (ref. 11). In this figure, the Ferrogram density is plotted as a function of λ which is the ratio of the film thickness to the composite surface roughness. This data was generated by sliding steel balls of three different roughnesses against a sapphire plate. As can be seen, the amount of wear debris increases sharply at λ values of one and below where surface interactions begin taking place.

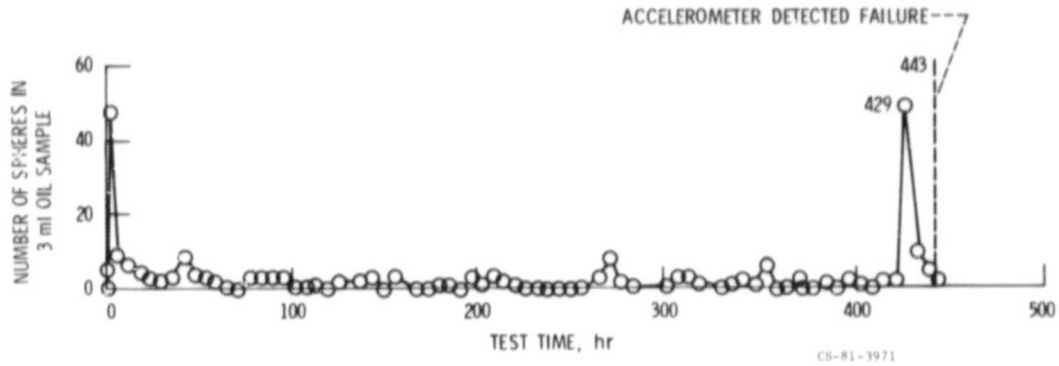
Particles thought to be related to rolling element fatigue are metallic microspheres. They resemble miniature ball bearings and are of the order of 1 to 5 μm in diameter. Presumably, they are generated in propagating fatigue cracks. When these cracks reach the surface, spheres are released into the oil. Our work (fig. 13) has shown an increase in sphere count just prior to failure as detected by accelerometers (ref. 12). Earlier work (ref. 13) involving accelerated rolling element fatigue tests yielded mixed results. Some tests yielded increases in sphere counts while in others few spheres were detected. An example of a sphere from a rolling element fatigue test appears in figure 14.

Figure 13 - Number of spheres in 3 ml of oil for full scale bearing fatigue test (from ref. 12).

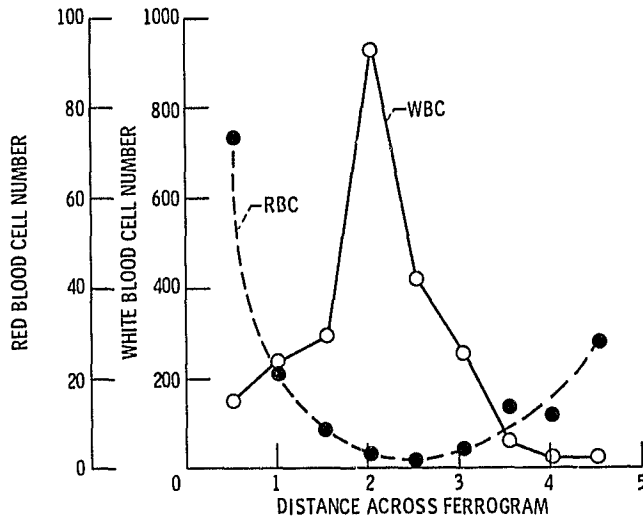
Another example of the differential bonding of the erbium chloride magnetizing solution is shown in figure 22. Here, a solution of human blood cells have been passed over the Ferrogram. Figure represents a cross section of this Ferrogram at the 40 mm position. The magnetizing solution is preferentially absorbed by the white blood cells (WBC). In contrast, the red blood cells (RBC) absorb little or none of the solution. In fact, the RBC have a magnetic susceptibility less than the solution and are repelled by the magnet. Most of the RBC simply run off the Ferrogram to waste, although a few are pushed to the outside of the Ferrogram track.

Figure 22 - Concentration of human red and white blood cells across a ferrogram at the 40 mm position (Ref. 16).
