ADVANCED GAS TURBINE (AGT) POWERTRAIN SYSTEM DEVELOPMENT

Second Semi-annual Report
For work performed from July 1, 1980-December 31, 1980

Detroit Diesel Allison
Division of General Motors Corporation
Indianapolis, Indiana 46206

July 1981

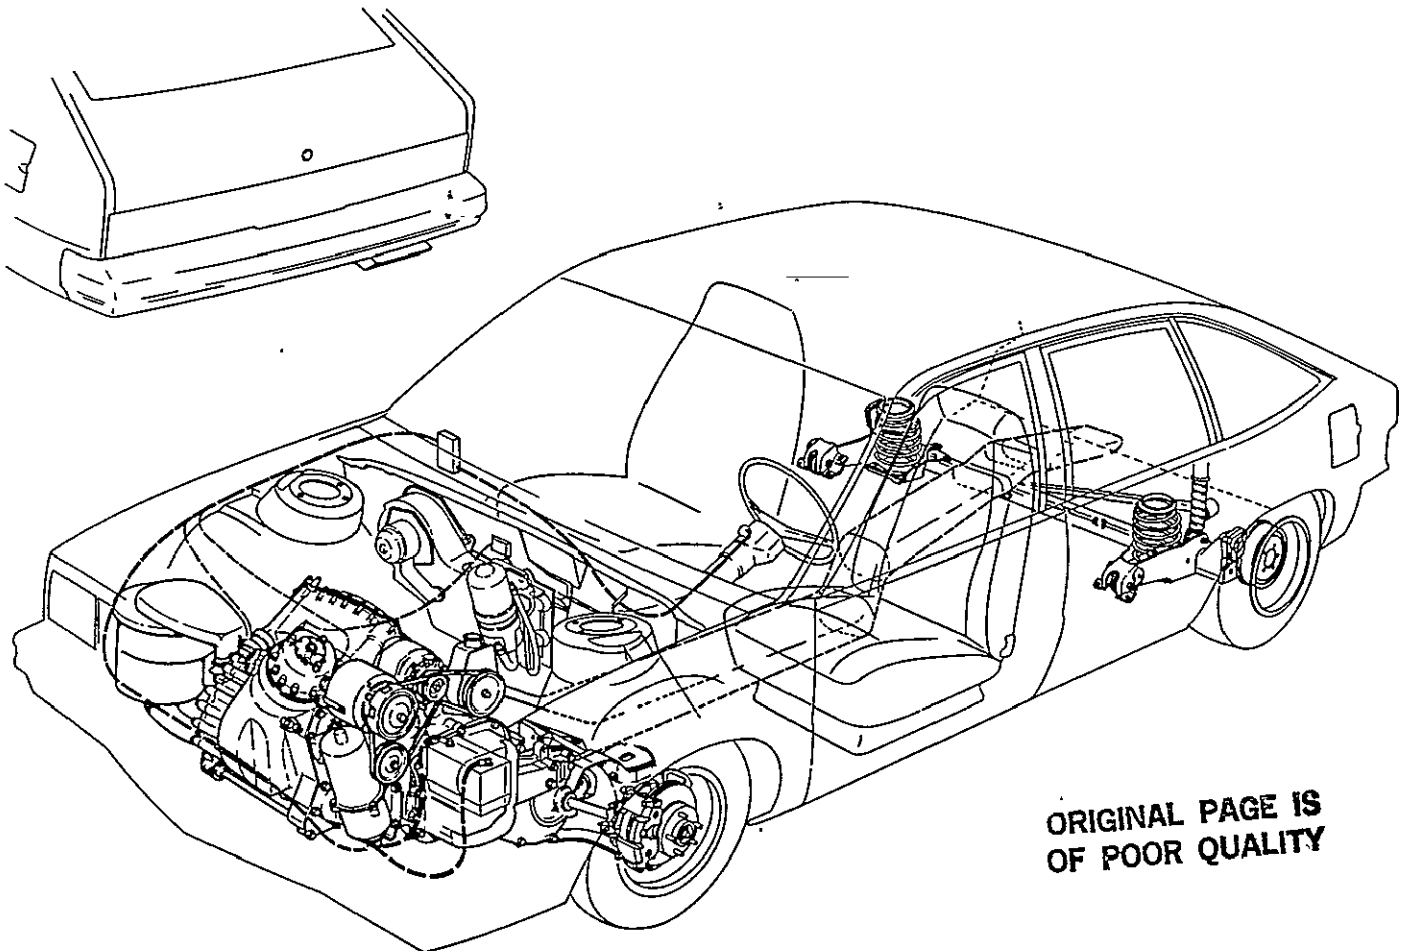
Figure 2 — AGT 100 Gas Turbine Powered Pontiac Phoenix

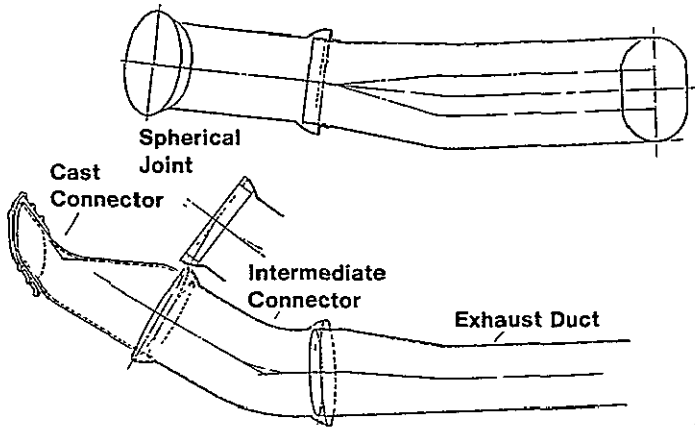
Figure 3 – Engine Exhaust Flange to Exhaust Duct

The design of the exhaust system remains as reported in the first semi-annual report, but with additional detail of the engine to exhaust duct connection as shown in Figure 3. A cast connector has been designed to attach to the engine exhaust outlet with a spherical jointed intermediate connector between the connector and the exhaust duct. This system provides flexibility for installation with normal body to engine variations, and also provides a flexible joint to accommodate relative engine-to-body movement under operating conditions.

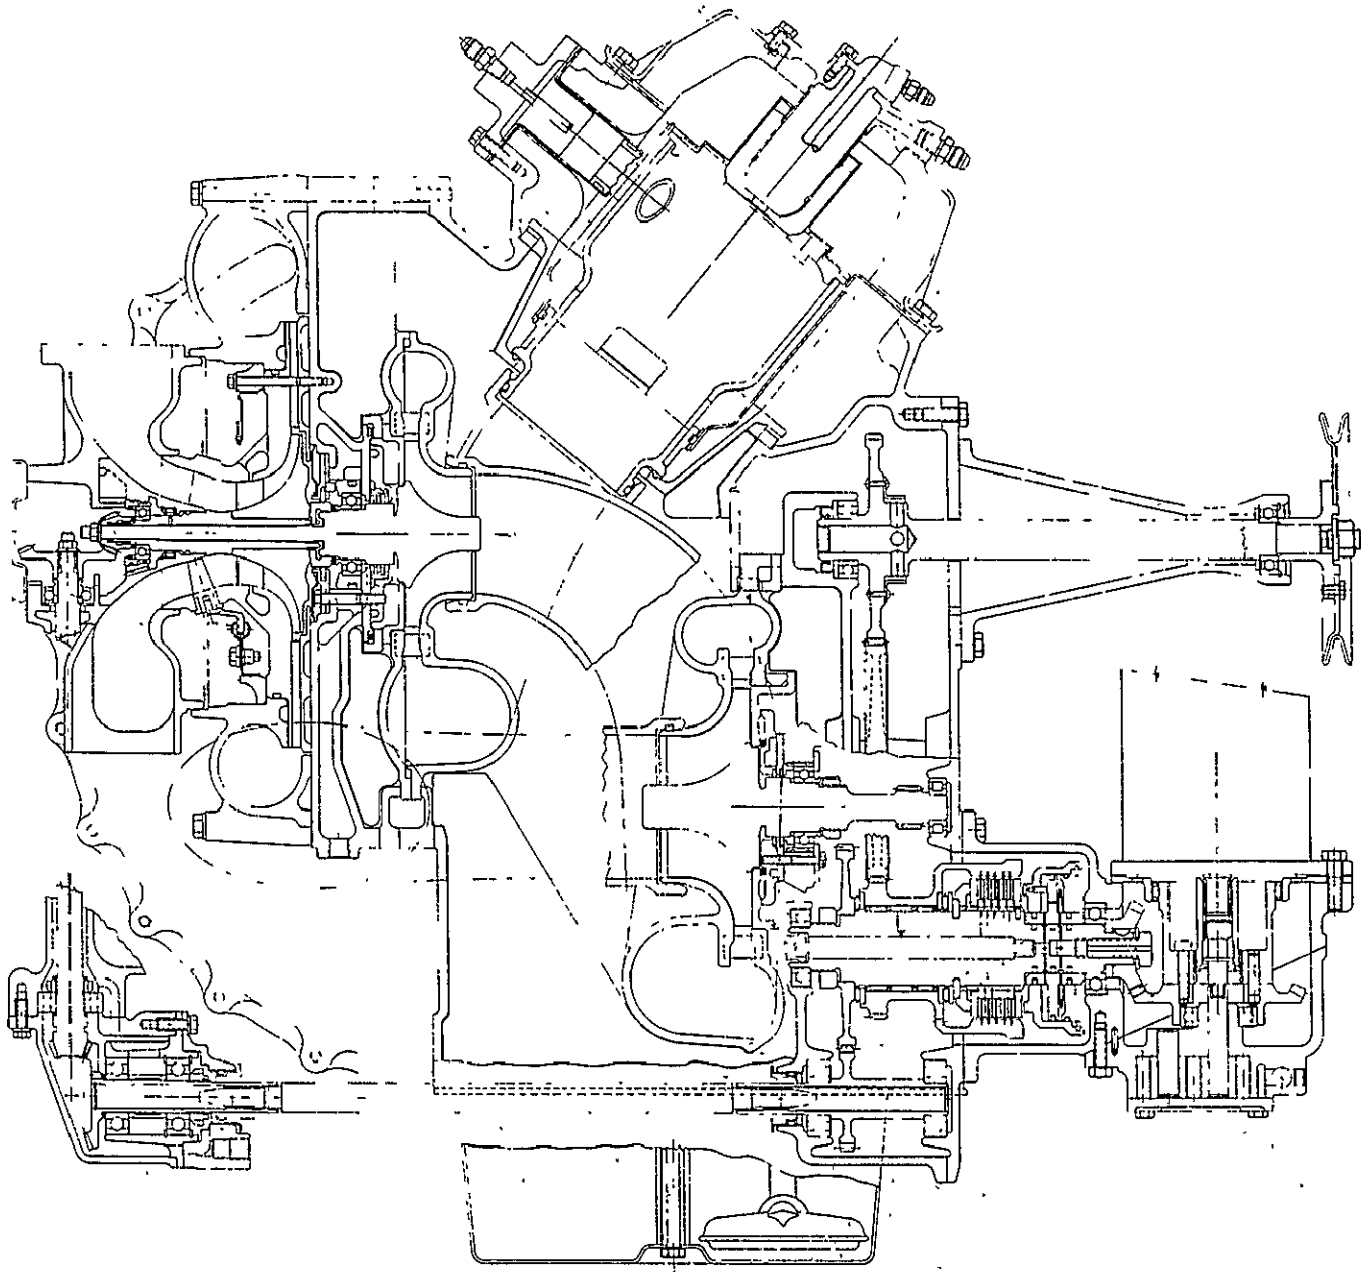
Figure 5 – Initial RPD Engine Arrangement

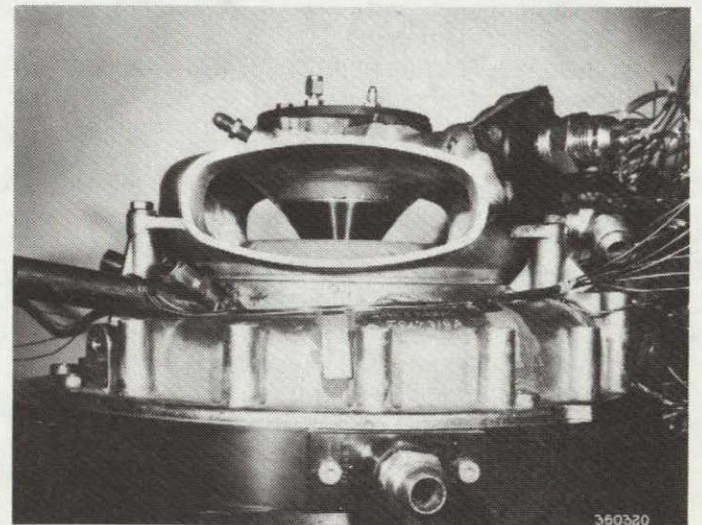
Figure 10 – AGT 100 BU 1 Compressor Rig

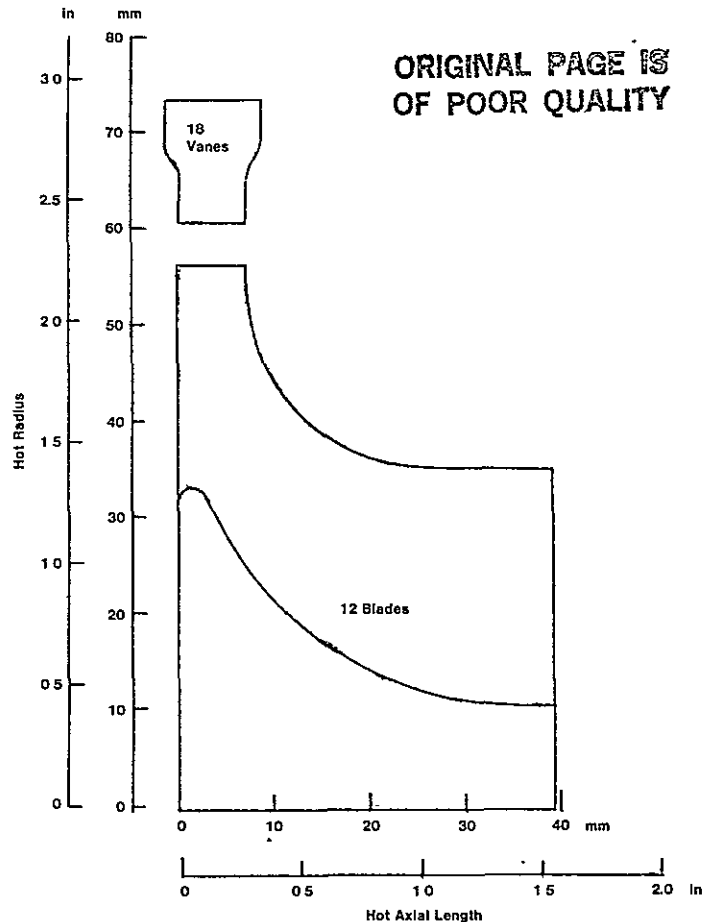
Figure 21 — Mod I Gasifier Turbine Flow Path

Operating at the sea level static (SLS) maximum power condition, the turbine exhibits a tip speed of 508 m/sec (1667 ft/sec), an aerodynamic loading parameter (U/C-Tip Speed/Isentropic Spouting Velocity) of 0.67 and a specific speed of 70.

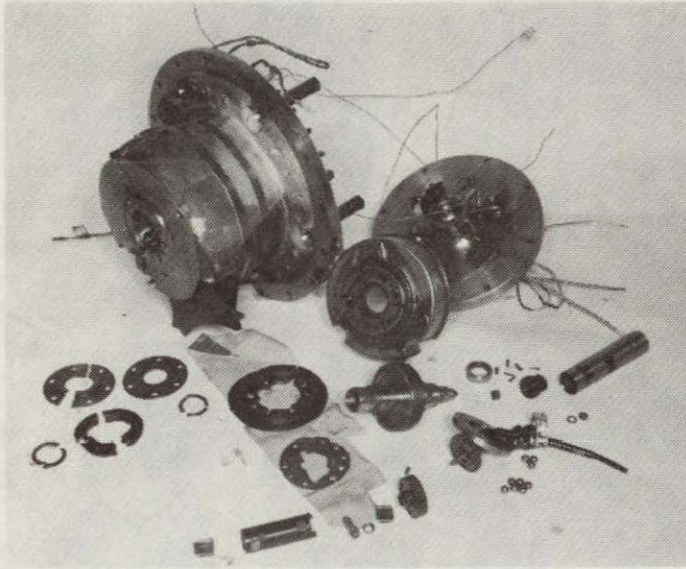
Figure 29 – Damaged Turbine Rig Module Hardware

Rig fabrication and checkout continued this period up to the point where a bearing failure in a water brake dynamometer caused damage to the rig. The rig has been rebuilt. A calibration of the torque meter has been accomplished in preparation for turbine testing early in January 1981.

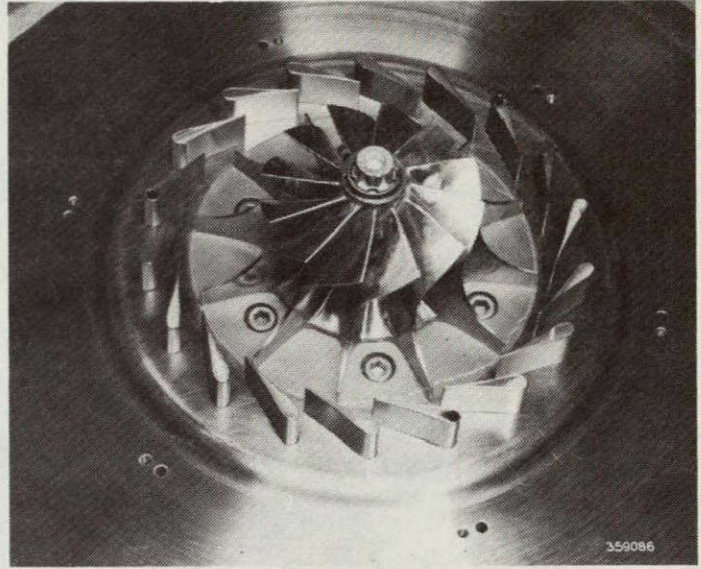
Figure 30 – Test Rig Vane and Rotor Assembly

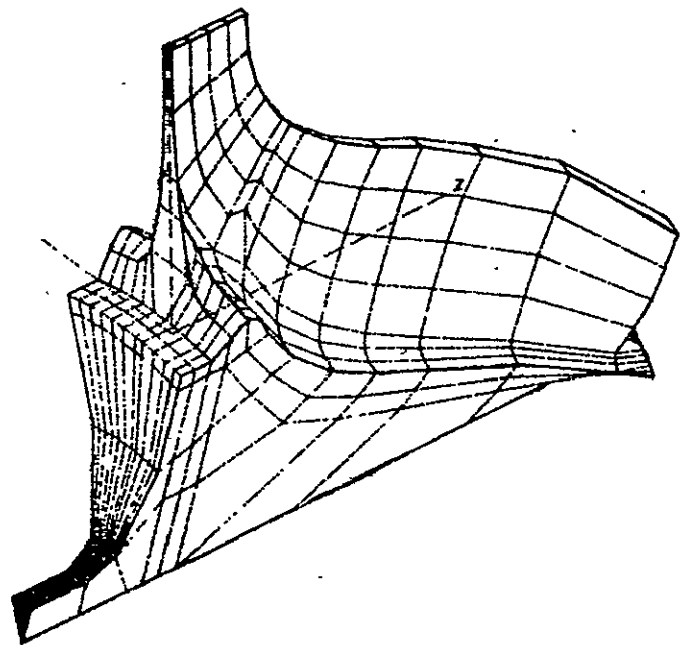
Figure 39 — 3-D Finite Element Model of Gasifier Turbine

The minimum survival probability point occurs at an elapsed time that is in close agreement with 2-D analysis results reported previously. However, the peak stress and location differ markedly. Transient stresses at the blade root are much less in the 3-D model, probably because of

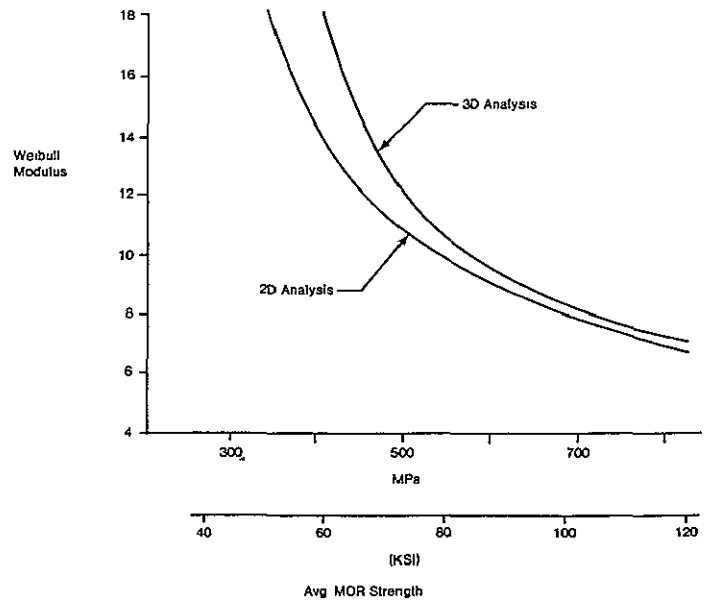
Figure 42 – Required Material Strength for Sintered Silicon Carbide Gasifier Turbine at Maximum Transient Operating Condition

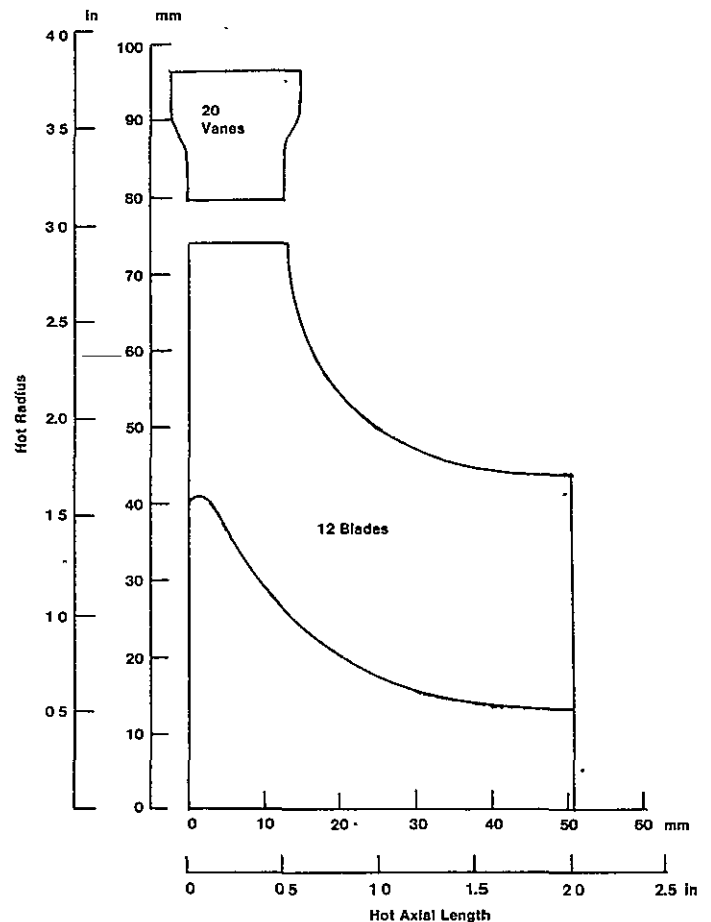
Figure 43 — Mod I Power Turbine Flow Path

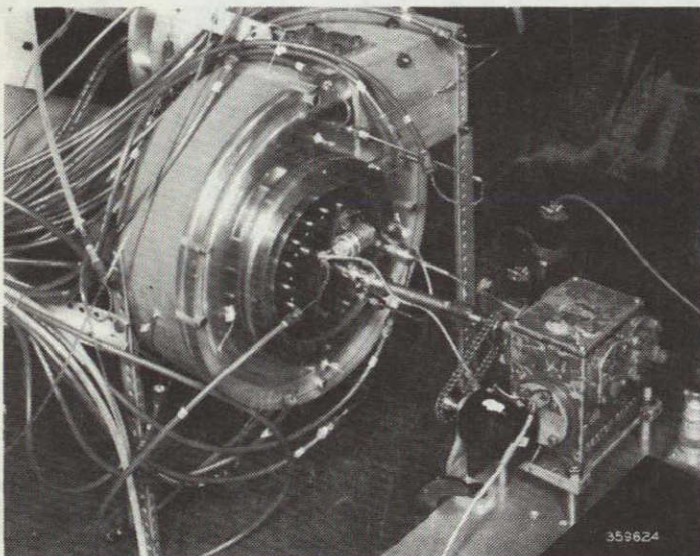
Figure 53 - Traverse Mechanism and Plexiglass Backplate

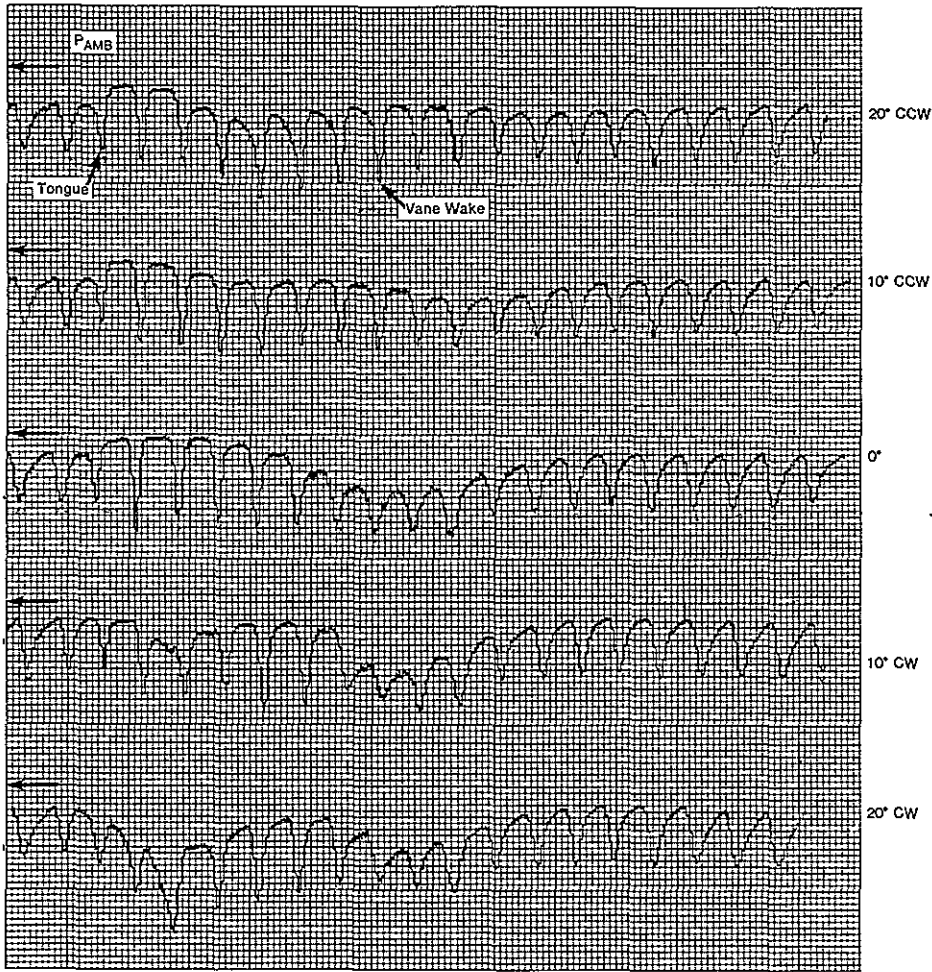
Figure 59 — Variation in Circumferential Traverse with Swirl at Vane Mid Span

Testing with varying amounts of interturbine duct inlet swirl was accomplished and typical results in mid channel traverse data are shown in Figure 59. Some variation in circumferential traverse was observed due to direction of swirl. As shown in Figure 59, clockwise swirl produced more of a notable depression in total pressure at 90 to 180 degrees than counter clockwise swirl. The explanation for this is that CW swirl produces a natural "peeling" of the flow into the vanes where CCW swirl requires a backflow to feed the vanes (See Figure 60). Although circumferential variation with swirl is noted, average total pressure loss variation was only slight for the range of swirl expected in the engine, (10 degrees CW to 20 degrees CCW). Average total pressure was calculated for each tra-

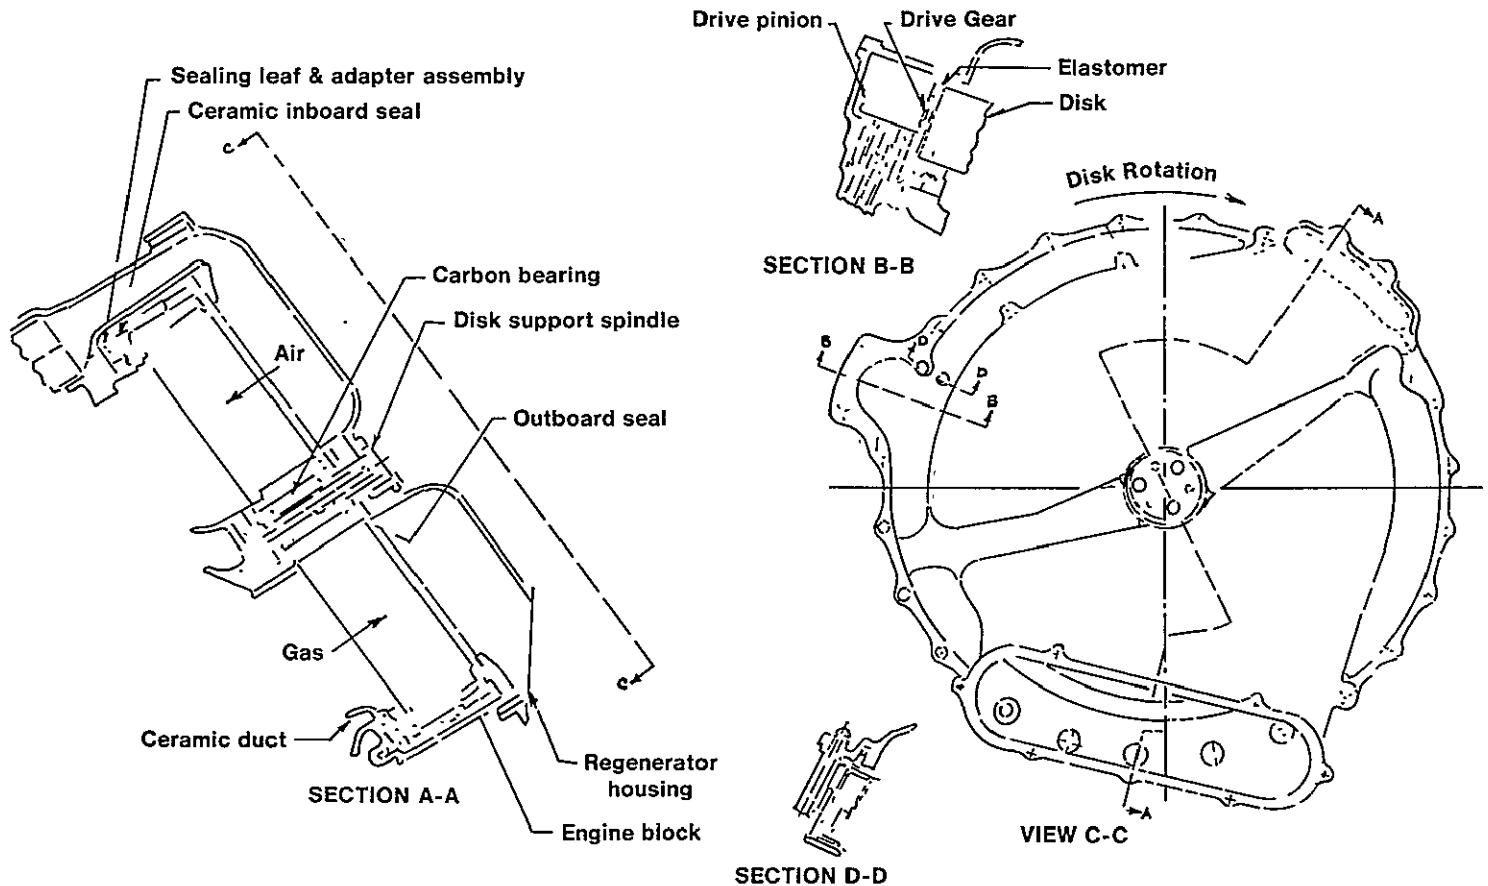
Figure 69 - AGT-100 RPD Initial Regenerator General Arrangement

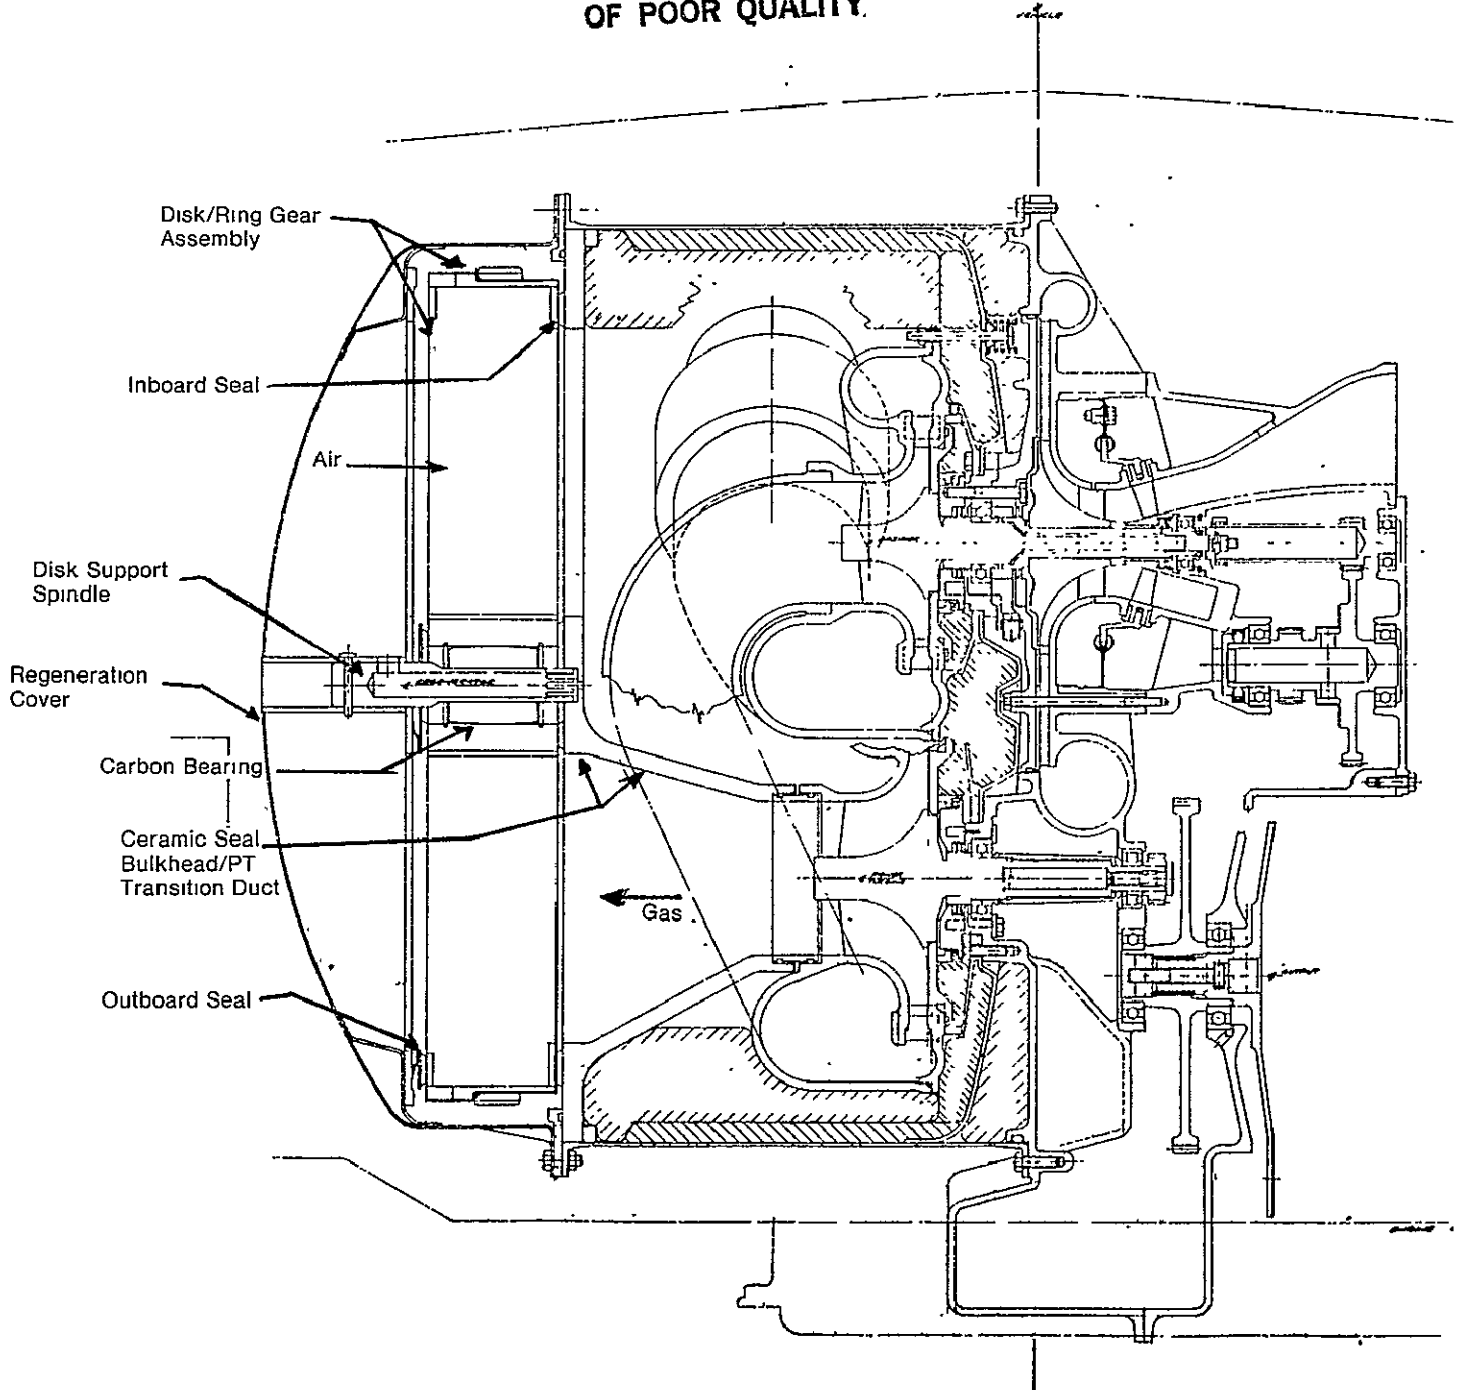
Figure 70 – Revised RPD Regenerator Preliminary Design

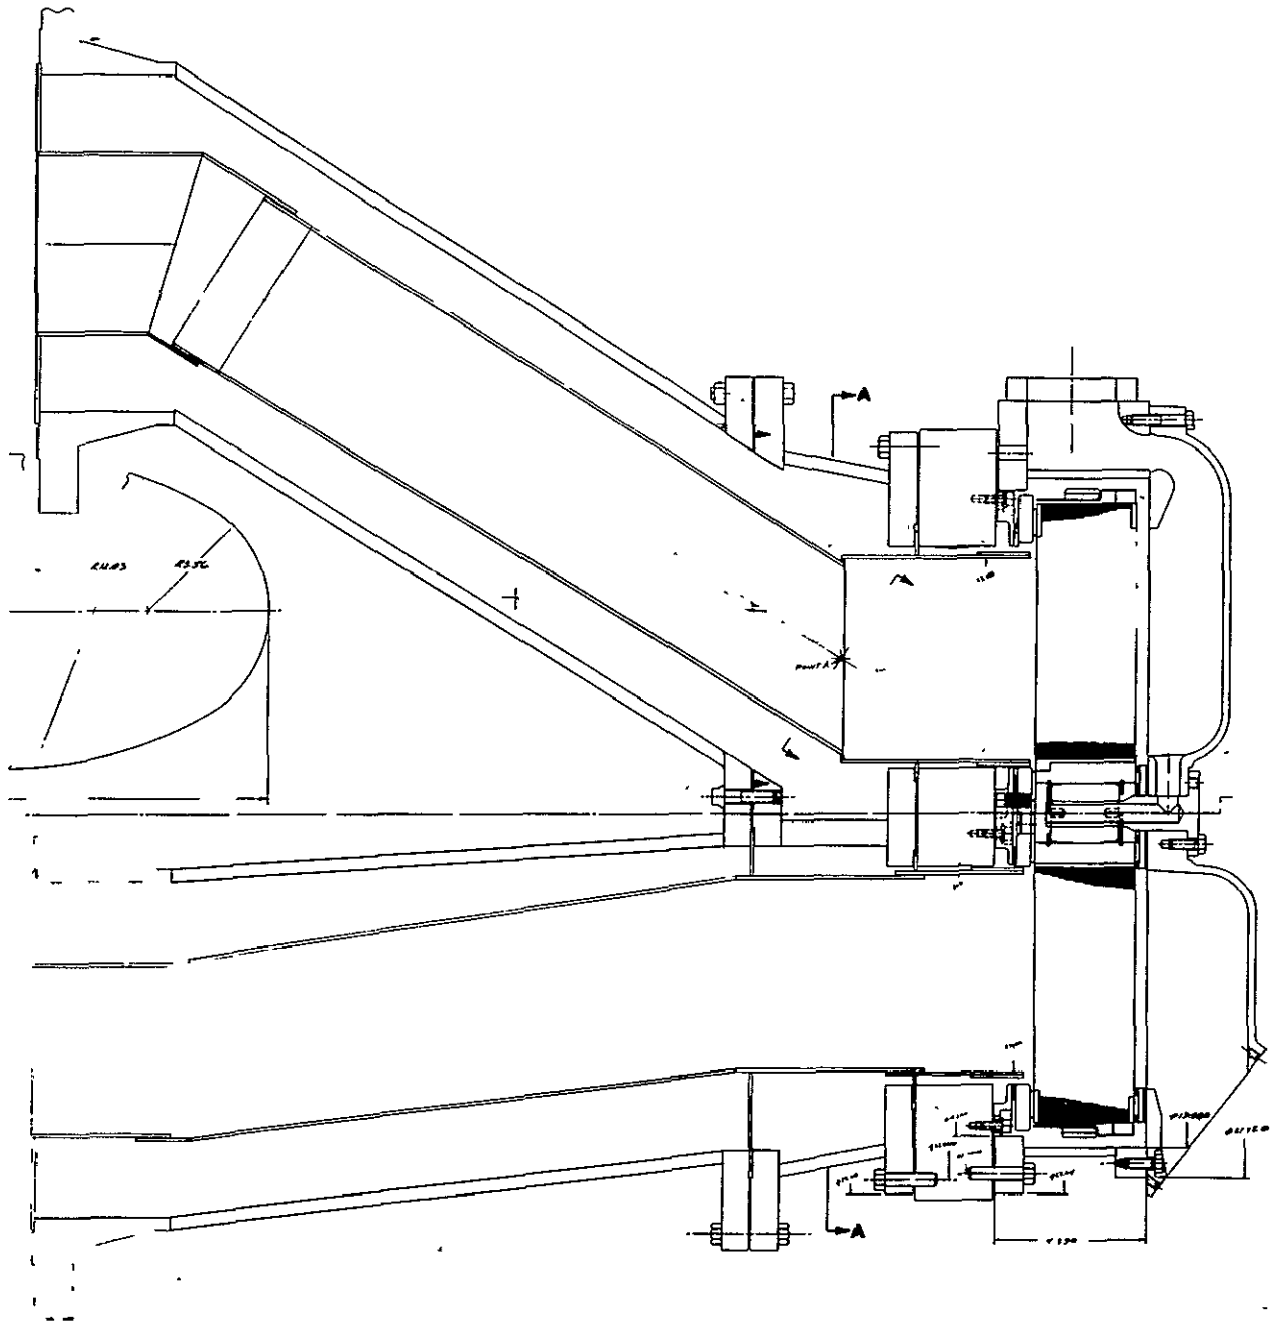
Figure 80 — Regenerator Hot Test Rig—Working Section

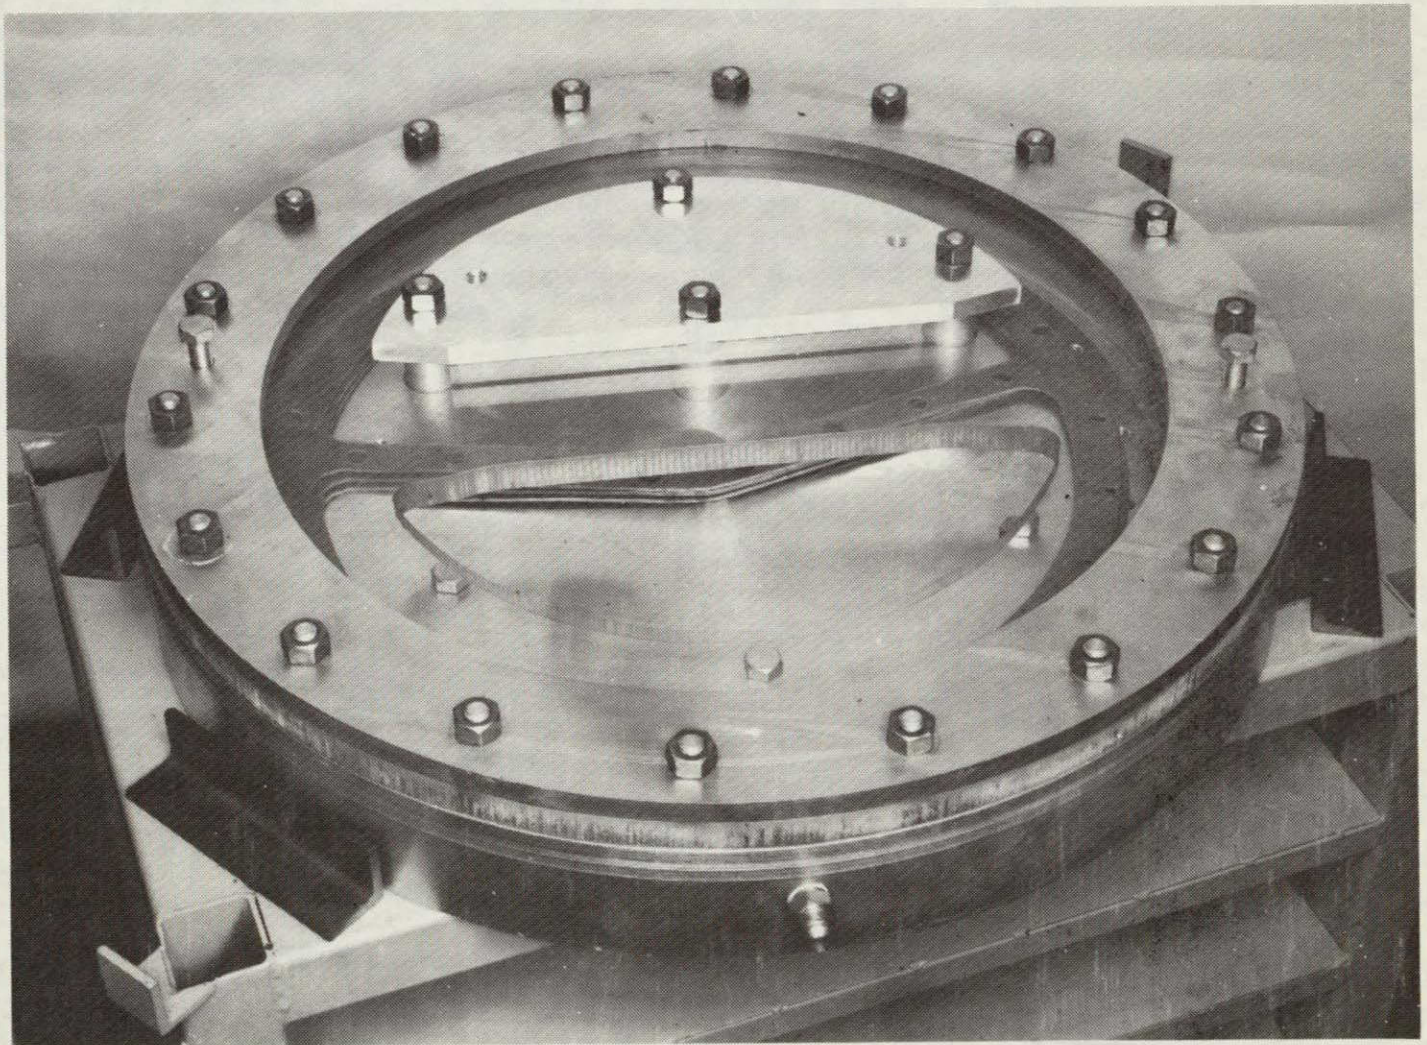
Figure 81 — Seal Leaf Leakage Test Rig

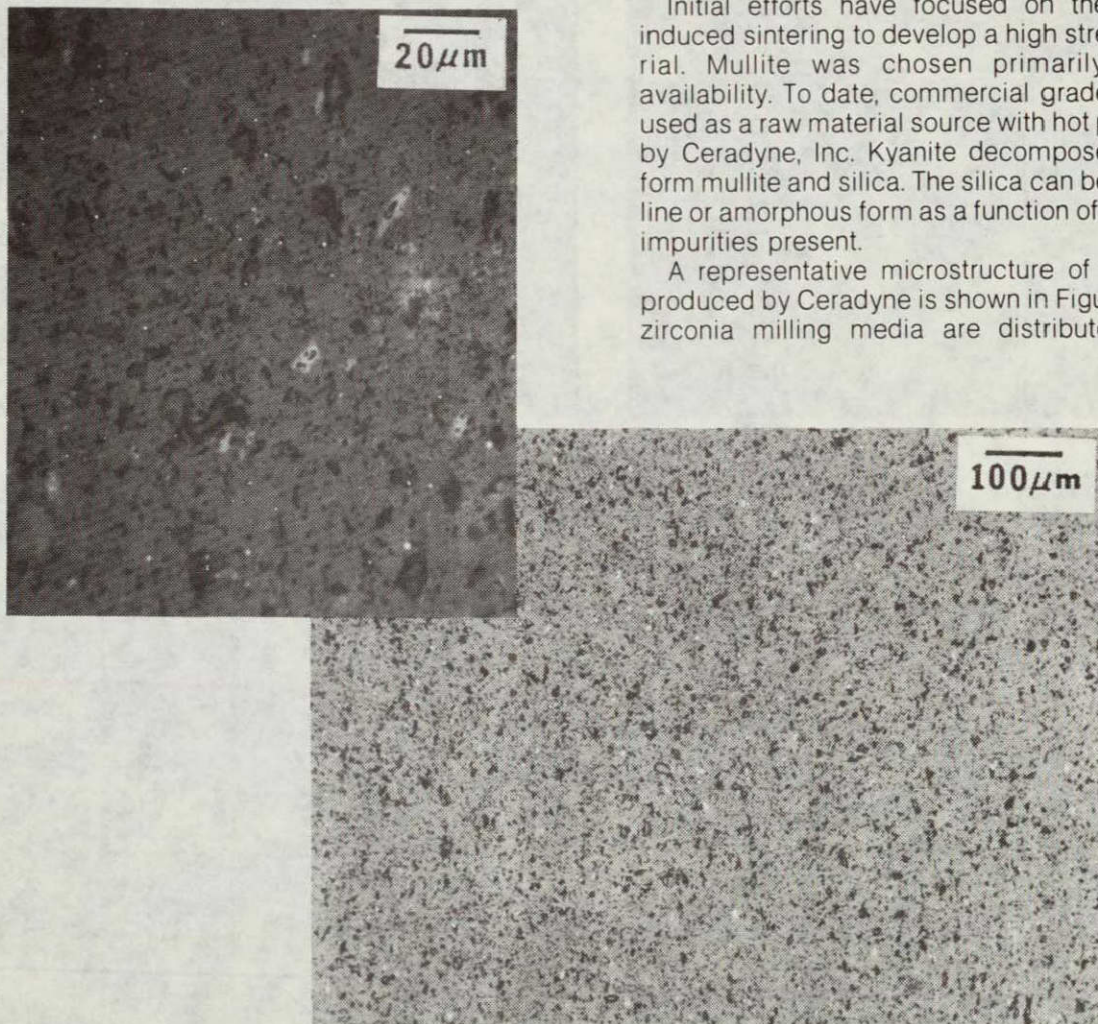
Figure 83 — Etched Polished Surface of Hot Pressed Mullite

A representative microstructure of the initial material produced by Ceradyne is shown in Figure 83. Inclusions of zirconia milling media are distributed throughout the

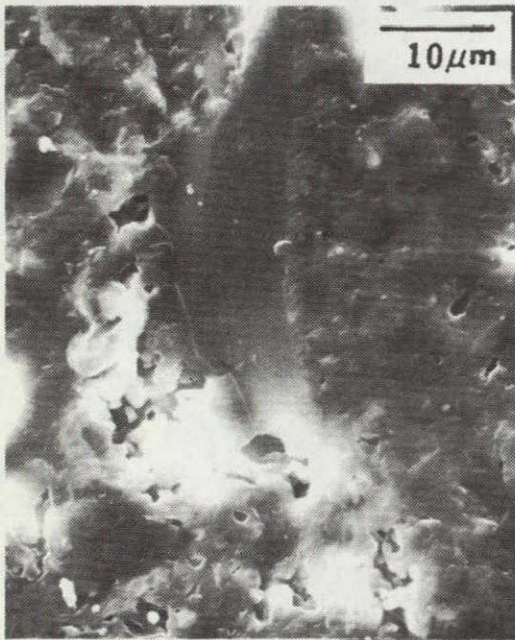
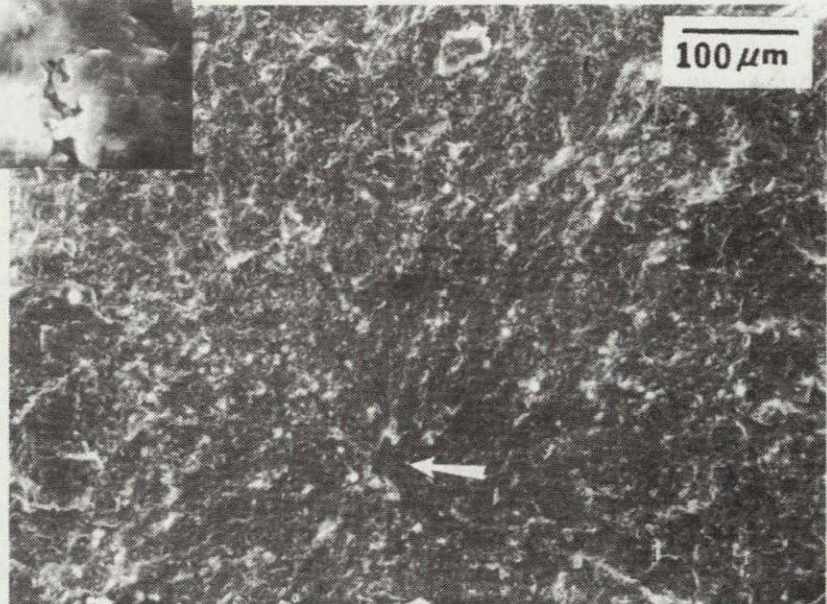
Figure 86 — Fracture Surface Showing SiO_2 Inclusion Failure Source

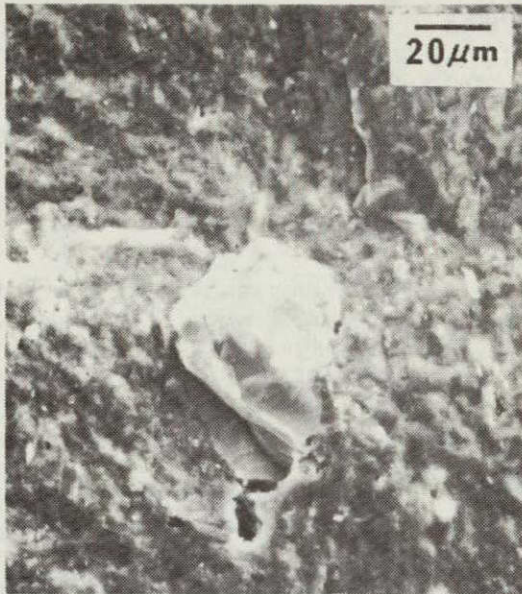
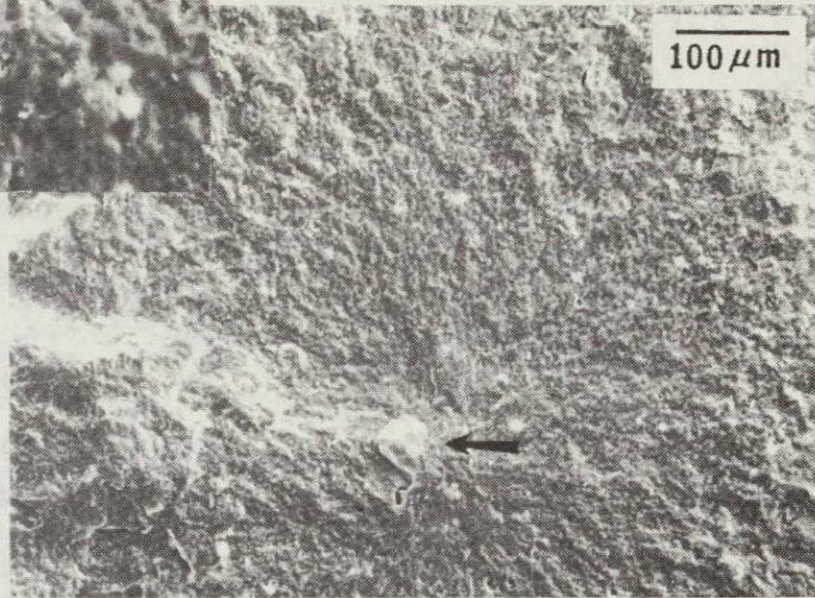
Figure 87 — Fracture Surface Showing TiO₂ Inclusion Failure Source

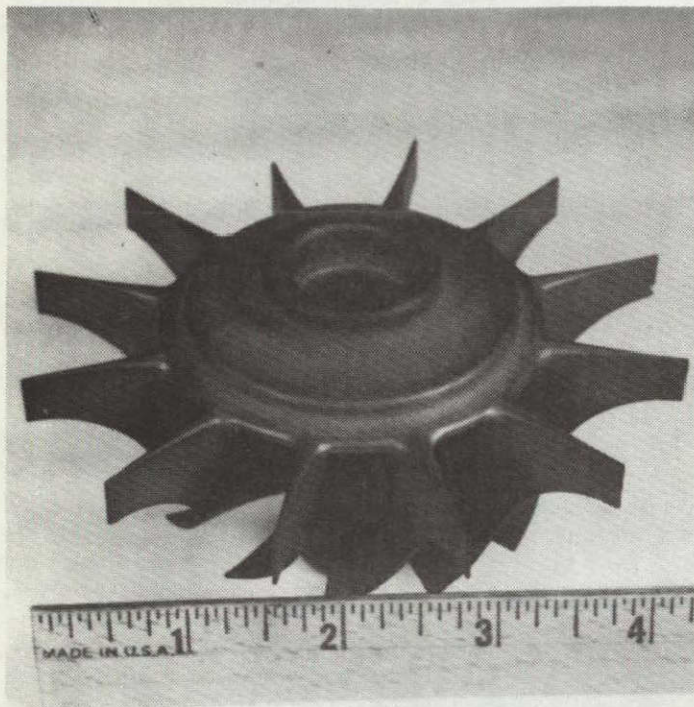
Figure 91 — Solid One-Piece Injection Molded Sintered Alpha SiC Gasifier Rotor

Progress has been made in reducing molding, baking, and sintering defects. The alternate mix composition bakes out more readily and two out of the three rotors fully processed were crack free (No. N4, and No. M11) and passed dye penetrant testing. Their densities were 3.10 g/cc and 3.09 g/cc respectively but both showed porosity in X-ray examination which indicates a need for optimizing the molding conditions for this mix. These preliminary results with the new composition are very encouraging for making solid one-piece rotors and additional rotors will be molded with this new mix. Figure 91 shows a typical rotor.

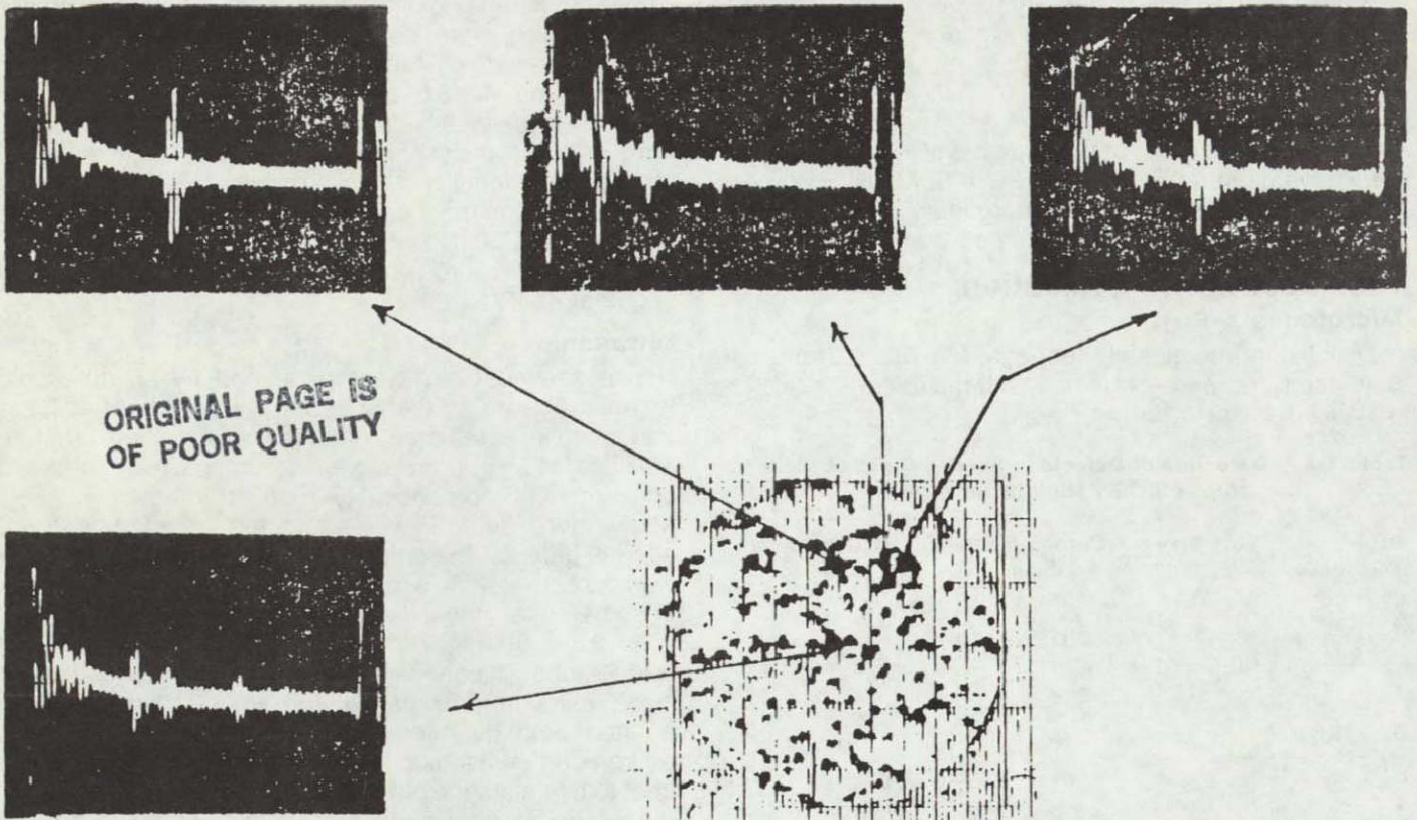
Figure 121 — Ultrasonic A- and C-Scans for 12.7mm (0.50 in.) Thick Disk of Alpha SiC Containing Seeded 125-250 μm Voids. Longitudinal Wave Velocity, $v_e = 11.80 \times 10^3 \text{ m/s}$.

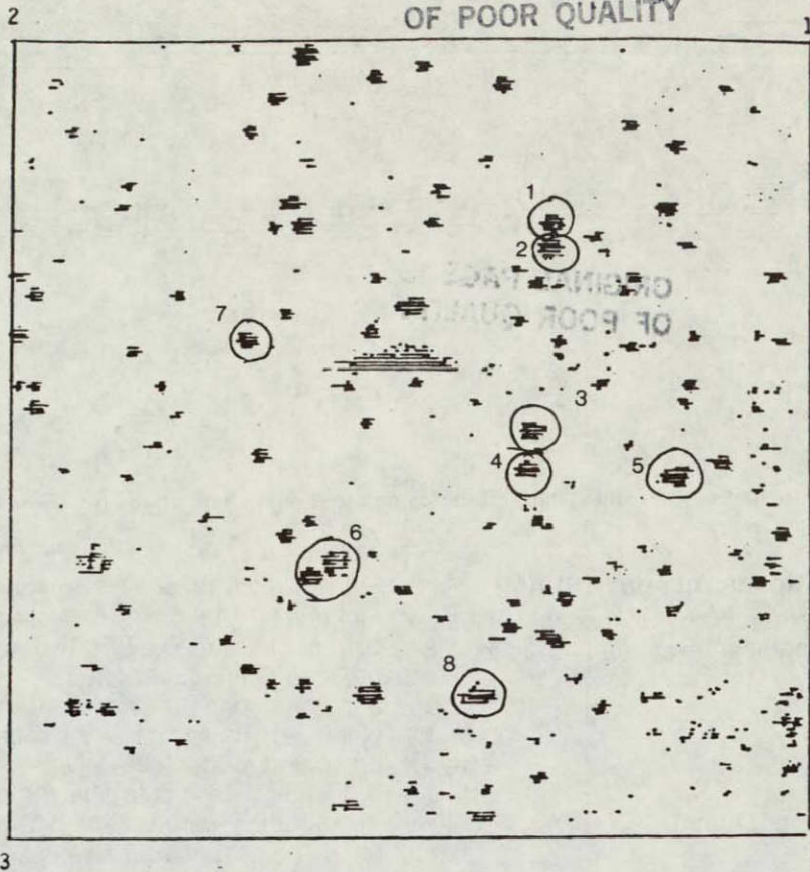
Figure 123 — Ultrasonic C-Scan of Seeded Void Plate at 36 MHz. The Scan Was Performed Twice and Good Consistency in Defect Detection Was Seen.

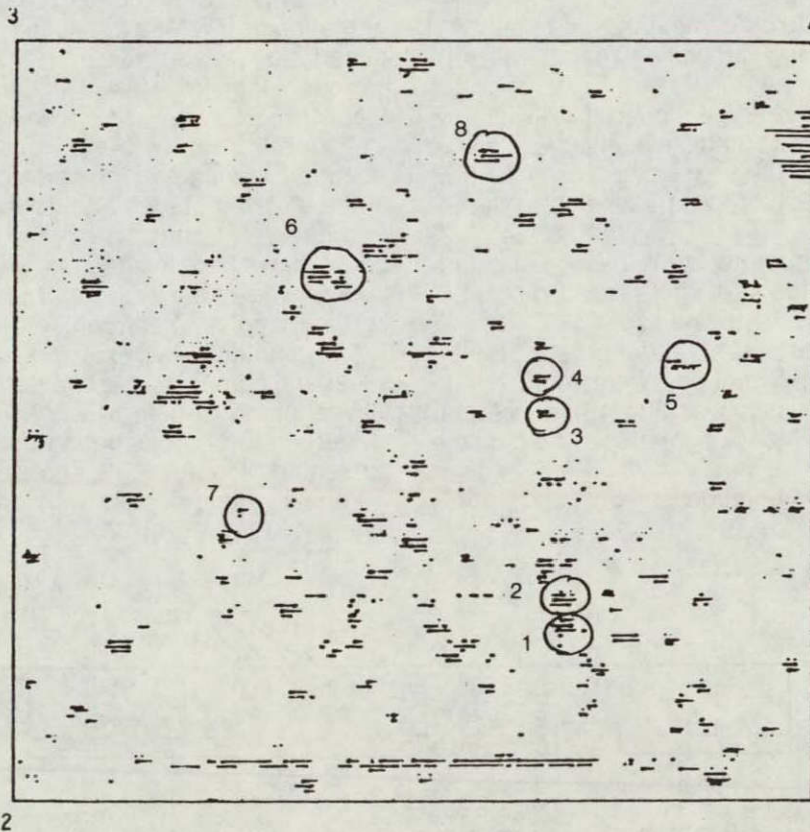
Figure 124 — Ultrasonic C-Scan of Seeded Void Plate at 36 MHz Corresponding to Figure 10 With Transducer on The Opposite Face of The Plate.

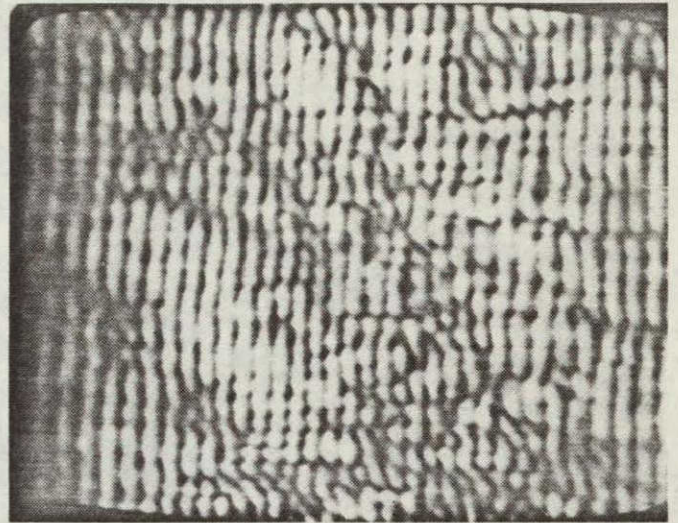
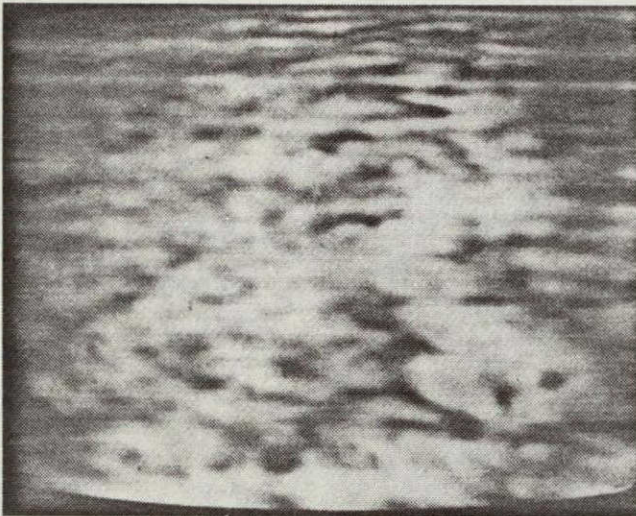
Figure 128 shows a zone of transmission variation found in the central zone of Bar 175. This zone contains little acoustic speckle and is interpreted as a zone of increased porosity.

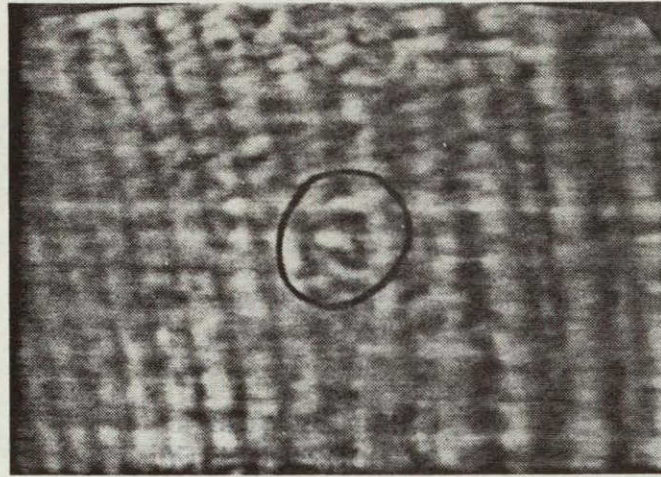
Figure 134 shows an amplitude micrograph from the airfoil region of Vane 142. The micrograph shows an isolated pore (circled) and its location was marked on the sample. Similar features were found throughout the vane. (The vertical lines are sound reverberation artifacts.)
