ADVANCED GAS TURBINE (AGT) POWERTRAIN SYSTEM DEVELOPMENT

Second Semi-annual Report
For work performed from July 1, 1980-December 31, 1980

Detroit Diesel Allison
Division of General Motors Corporation
Indianapolis, Indiana 46206

July 1981

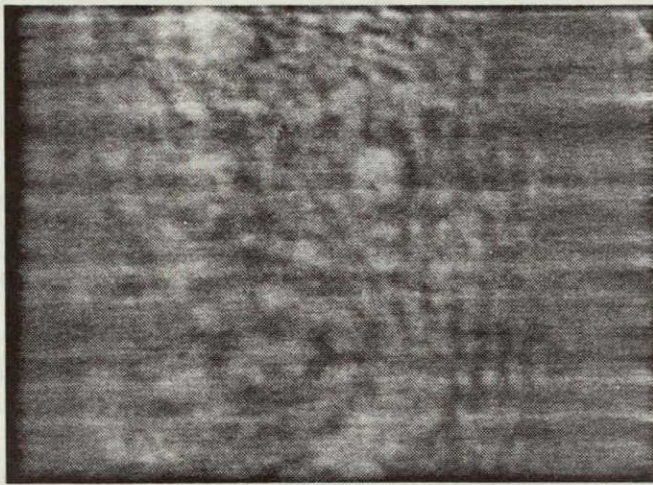
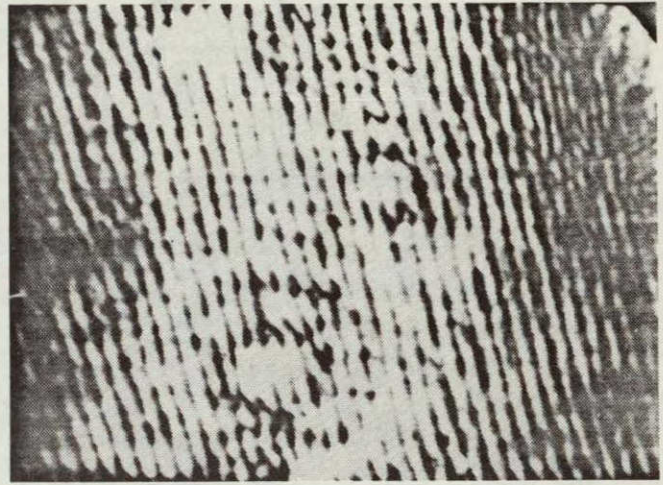
Figure 135 shows two circular structures found near the tip of the airfoil in Blade 17. Similar structures were found in Blade 94.

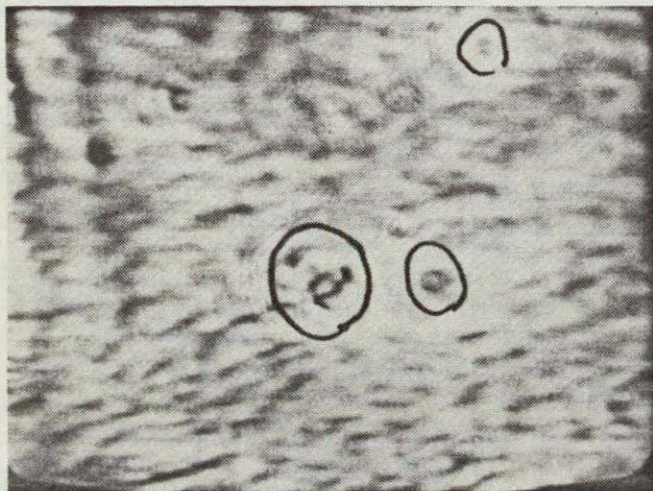
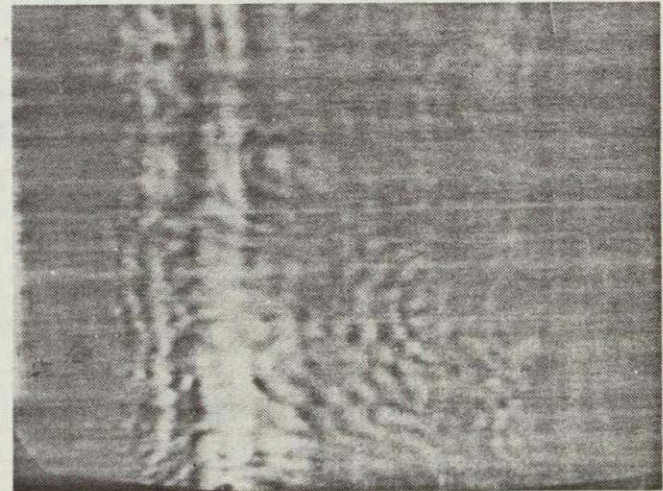
Figure 136

Figure 136(a) was taken in an area of the airfoil of Vane 321 with many surface pits (circled), while (b) was taken near the leading edge. Several large, isolated pores lead to the ring patterns observed in this micrograph.

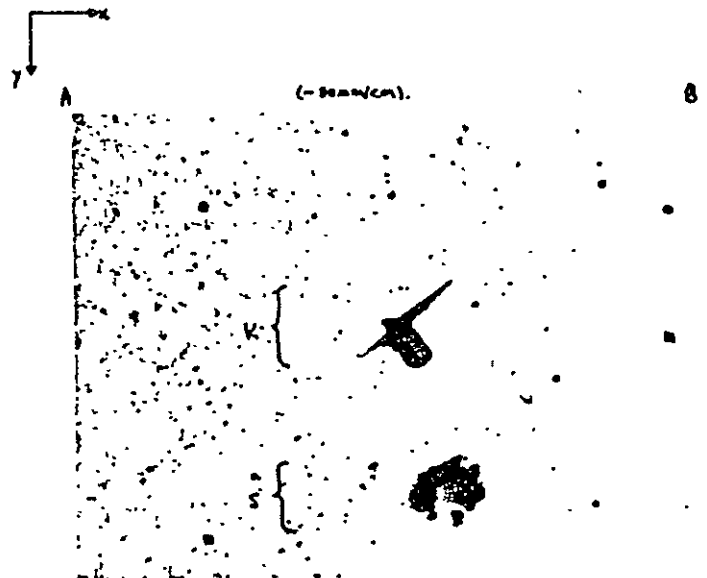
Length = 154 μm (0061 in) Relative depth = 4.2
Width = 12 μm (0005 in) Cracks: (3)
Load = 3.5 kg 2 Side chips

Figure 139 — Polished SiC Knoop Flaw #18

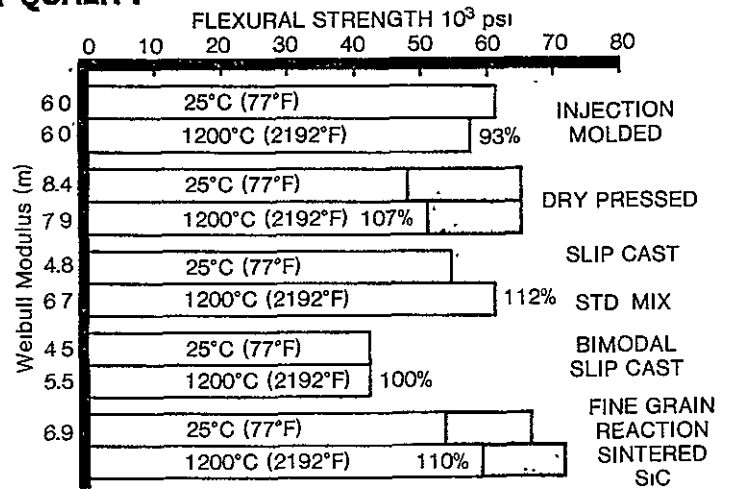
Figure 142 – High Temperature Strength Retention of Silicon Carbide Materials

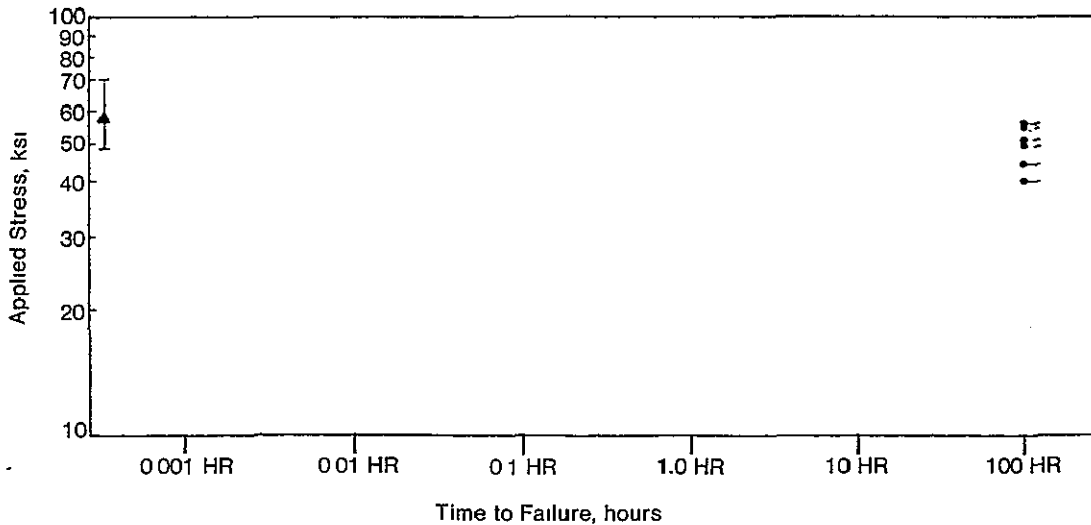
Figure 143 – Static Stress Rupture Plots for Compression Molded Reaction Bonded SiC (a) at 1000°C (1832°F) and (b) at 1200°C (2192°F) in Air in 4-Point Bend.

Static creep stress rupture tests were conducted with compression molded fine grain reaction sintered silicon carbide in air at 1000°C (1832°F) and 1200°C (2192°F) in 4-point bend. In 100 hours of testing, failure occurred at and above 379.2 MPa (55 ksi) of applied stress at 1200°C (2192°F). No failure occurred for stresses up to 386.1 MPa (56 ksi) at 1000°C (1832°F) (Figure 143). Creep deflections were seen during the stress rupture test, especially at 1200°C (2192°F). Based on the static fatigue data, the slow crack growth deformation aspect for these materials seems to be insignificant at these temperatures at the very high applied stress levels.

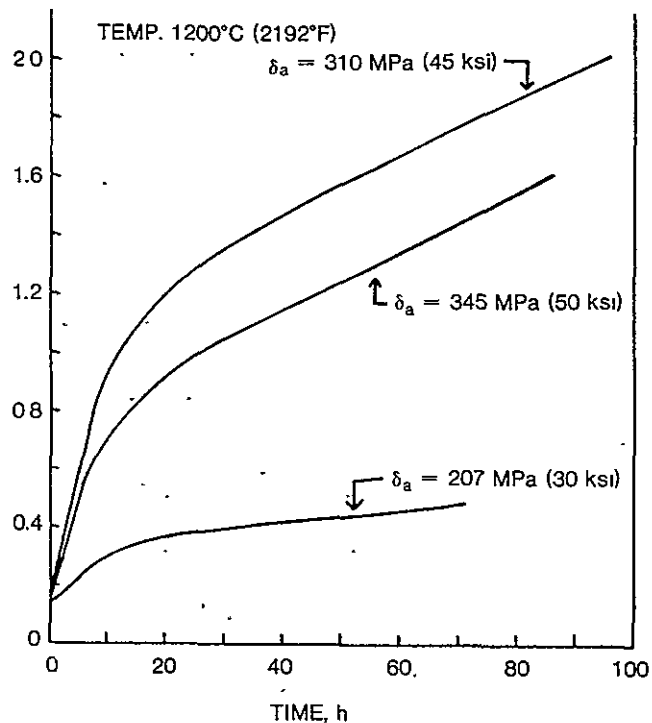
Figure 144 — Creep Curves at 1200°C (2192°F) for Fine Grain Reaction Sintered SiC in Air in 4-Point Bend
