ESCALATOR DESIGN FEATURES EVALUATION

JPL PUBLICATION 81-78

May 1982
Final Report

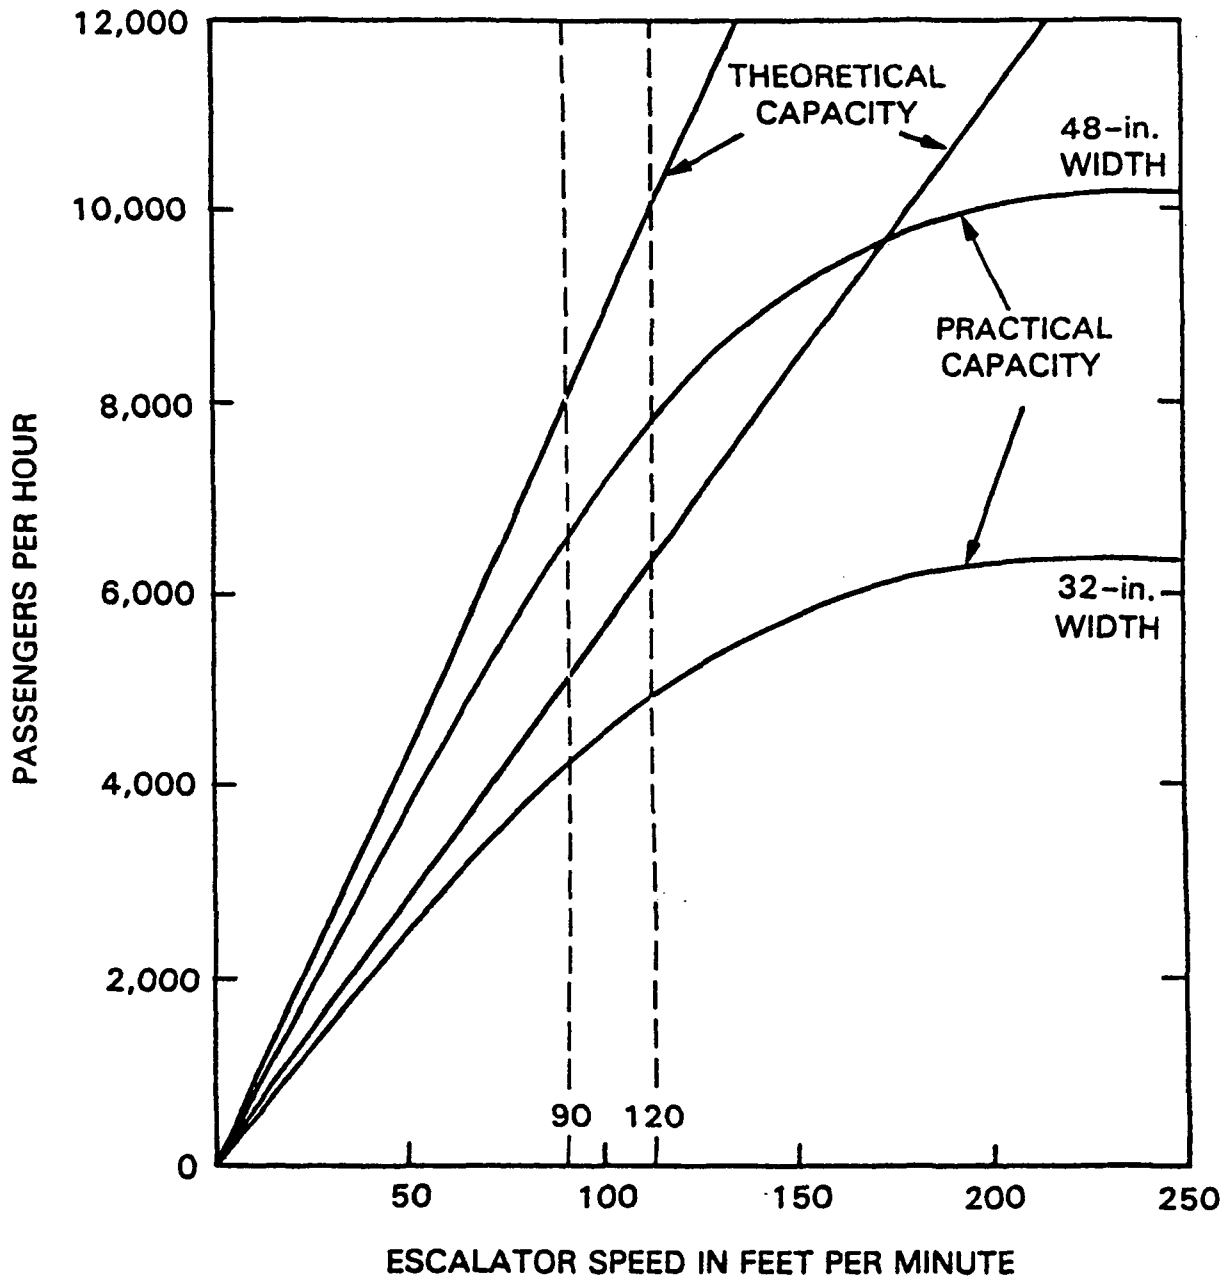
FIGURE 2-1. ESCALATOR CAPACITY AT VARIOUS SPEEDS

Generally, an increase in speed results in an increase in capacity. However, this relationship is not linear as shown in Figure 2-1. The theoretical values in Figure 2-1 are based on the assumption of 1.25 passengers per step on the 32 inch and 2.0 passengers per step on the 48 inch wide escalator. The practical capacities are based on field measurements of traffic flows. Studies (Refs. 11, 12, 14) indicate that an actual increase in passenger capacity from 90 fpm to 120 fpm escalator speed is around 12%. This

increase in capacity is of marginal value at low or moderately loaded stations. However, at stations experiencing high passenger flow rates during the peak hours, a 12% increase in carrying capacity could help clear the station platforms more quickly.

The escalator capacity in practice is lower than the theoretical at higher speeds due to hesitation of passengers at higher speeds to get on an escalator (Refs. 12, 14). This hesitation delays a patron's first step onto an escalator and results in several steps being empty to cause the capacity reduction.

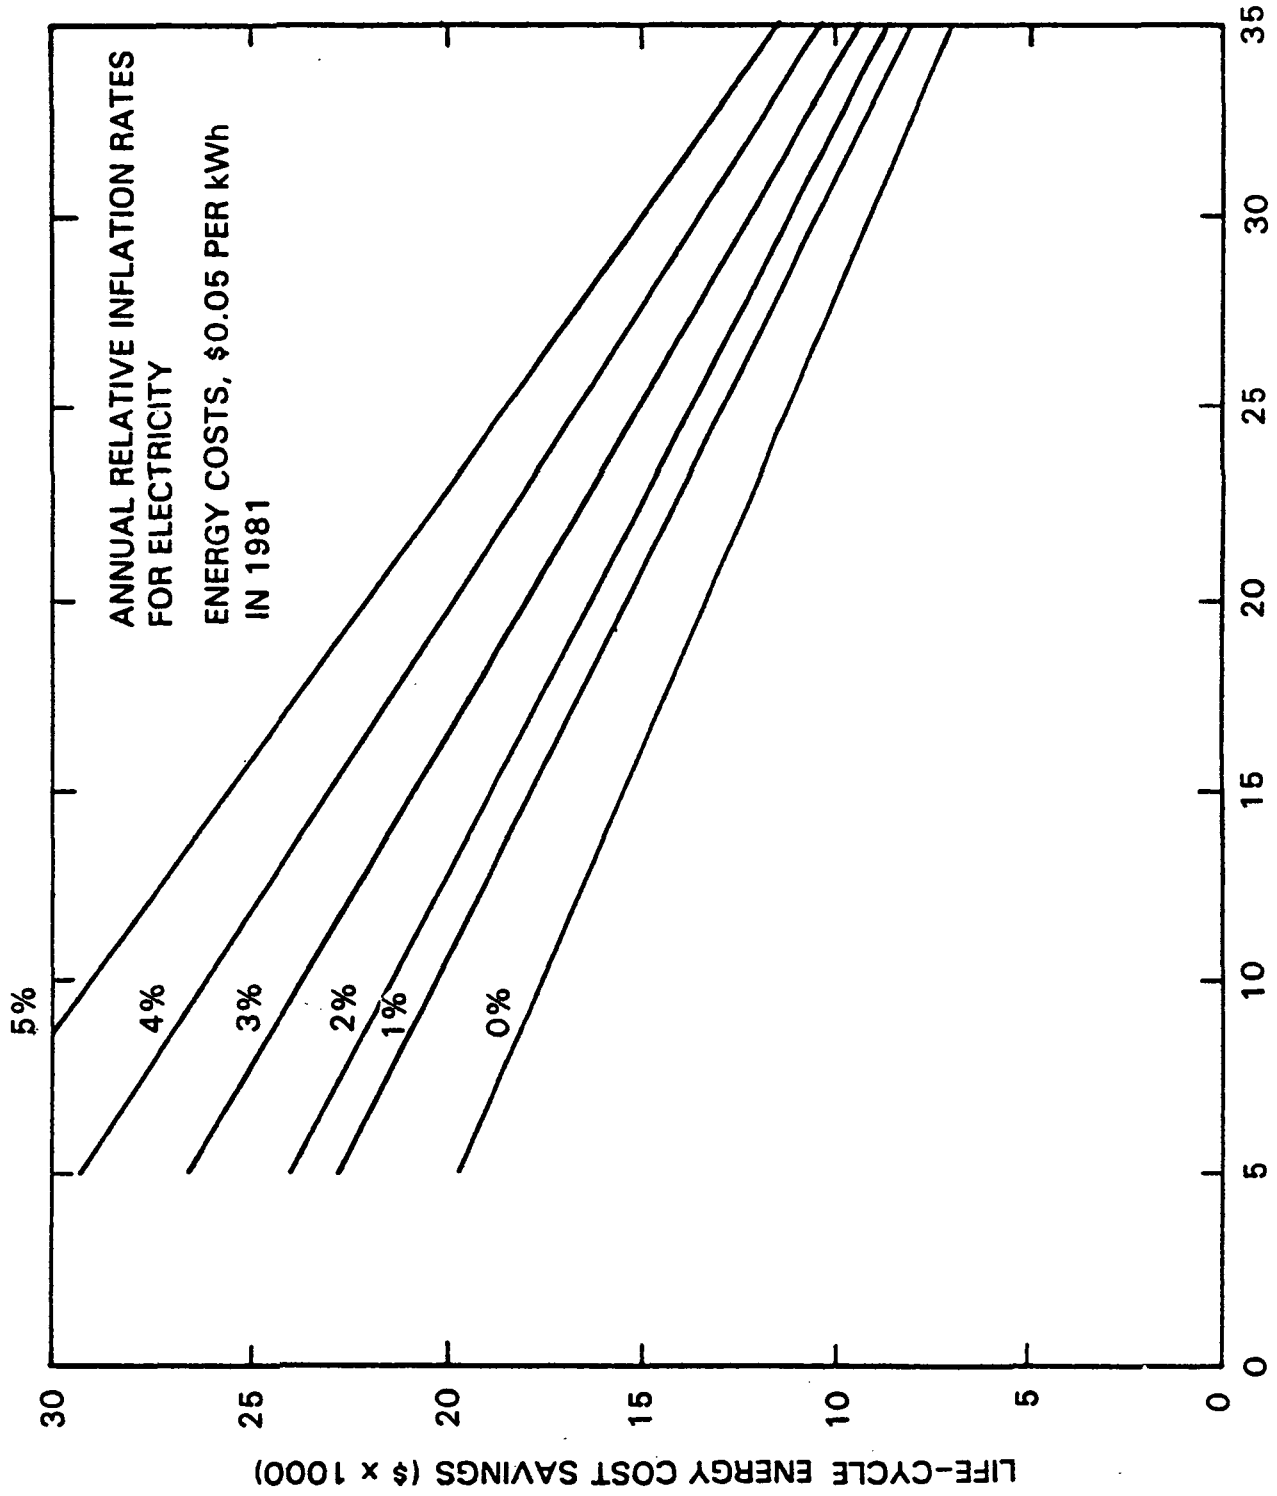
FIGURE 3-1. LIFE CYCLE ENERGY SAVINGS USING MAT OPERATION

If escalators are operated continuously under no load conditions, there is little difference in the energy consumption between that of an escalator going up or down. Under load, however, the escalator going down consumes less energy than that going up. Westinghouse test data (Ref. 16) indicate under a load of five passengers, the consumption in the up direction is 2.8 kW, but drops to 0.764 kW in the down direction. As the load increases, the down direction escalator starts consuming less energy. Westinghouse test

ESCALATOR DEMAND IN STOPS PER HOUR

Thus, under all cases, a total present mat operation cost penalty of \$10,000 + \$2,550 = \$12,550 is easily offset by energy savings utilizing the mat operation for escalators. Figure 3-1 shows the life cycle energy cost savings at various escalator demand levels during the off-peak hour and at relative inflation rates of 1, 2, 3, 4, and 5% for electricity cost.
