NASA Contractor Report 165549

HOT ISOSTATICALLY PRESSED MANUFACTURE OF HIGH STRENGTH MERL 76 DISK AND SEAL SHAPES

R. D. Eng and D. J. Evans United Technologies Corporation East Hartford, Connecticut 06108

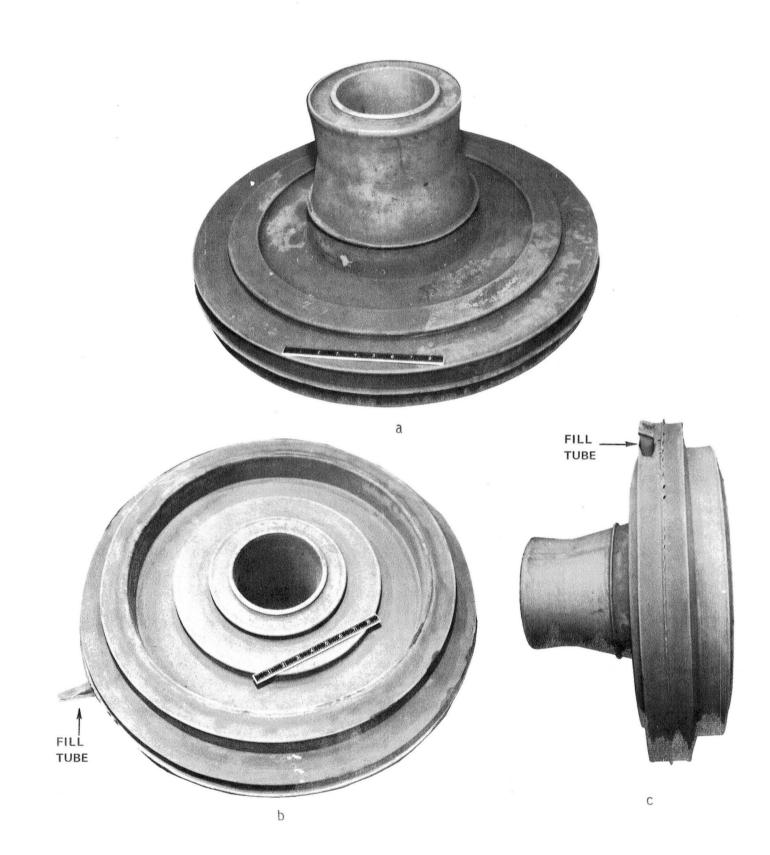
Figure 17 HIP Consolidation of Disk 34D-1 (a) Front view (b) Rear view (c) Side view

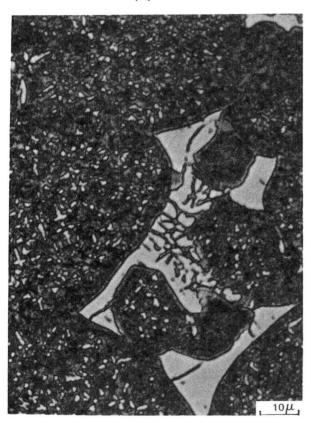
Figure 22 As-HIP Microstructures of MERL 76 Disk 35D-3

Since the MERL 76 composition had been modified to permit HIP consolidation to a slightly coarser grain size for improved notch stress-rupture properties, disk 35D-3 was re-consolidated at 1196°C (2185°F)/103 MPa (15KSI)/3 hrs. to obtain coarser grain (ASTM 6-8) material. Testing of this disk was to provide data on coarse grained material earlier than scheduled. However, the grain size of the re-HIP consolidation was too large as shown in Figure 22. A close examination of this coarse grain microstructure revealed irregularly shaped eutectic gamma prime phases, indicating incipient melting had occurred (Figure 22(c). As a result of this brief study, the HIP consolidation temperature range was restricted to between 1169°C (2135°F) 1191°C (2175°F) to limit the maximum grain size (ASTM 6) for all subsequent consolidations, as well as to avoid further occurrence of incipient melting.

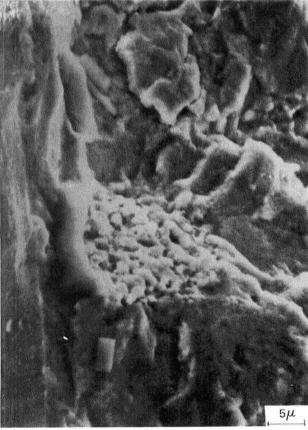
Figure 70 Typical Crack Initiation Site of a Bolt-Hole Specimen. While the primary origin contained a pore, a secondary origin displayed an aluminum-hafnium rich inclusion.
