101
NASA Technical Memorandum 82793

Metal Honeycomb to Porous Wireform Substrate Diffusion Bond Evaluation

Prepared for the
Spring Conference of the American Society
for Nondestructive Testing
Boston, Massachusetts, March 22-25, 1982

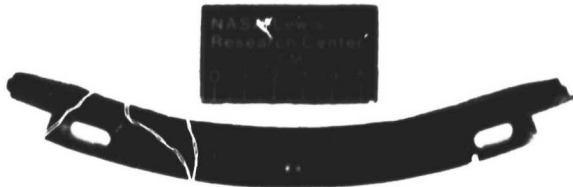
(a) FRONT VIEW.

(b) END VIEW.

(c) BACK VIEW.

Figure 1. - Views of shroud segment. Layer of honeycomb formed from metal foil is diffusion bonded to wireform porous metal layer, details in figures 2 and 4.

One of the shroud segments evaluated for diffusion bond integrity is shown in Fig. 1. Eight shroud segments identical to the one shown comprise a complete circular assembly in an experimental, high pressure aircraft turbine test facility at NASA's Lewis Research Center. The shroud surrounds a high pressure turbine stage in which only small clearances are allowed between the blade tips and shroud.
