NASA TECHNICAL MEMORANDUM

NASA TM-82446

PASSIVE OPTICAL SAMPLE ASSEMBLY (POSA): FINAL REPORT

August 1981

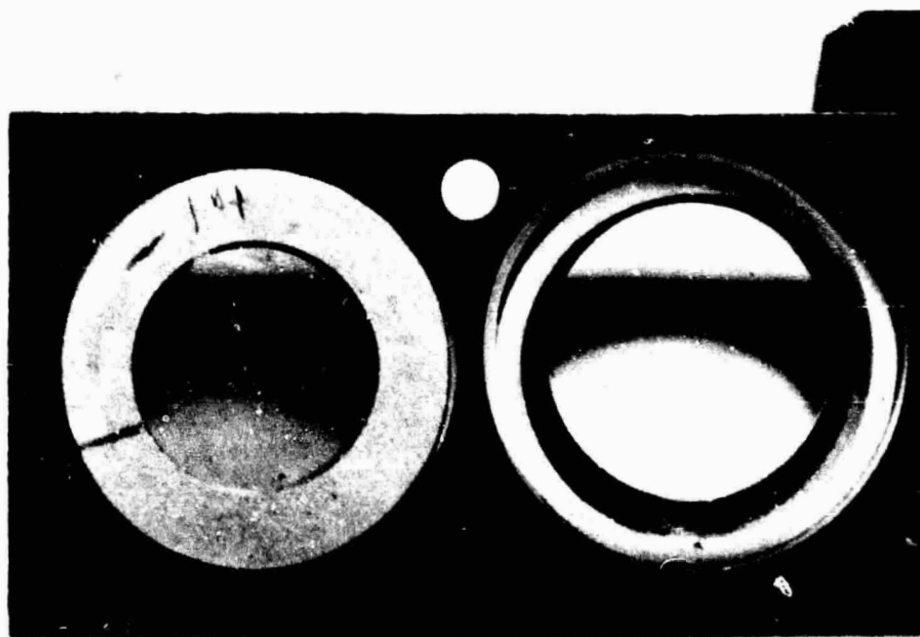
The flight units were returned to MSFC on May 7, 1981. They were photographed, as received on May 8 (Figs. 2 through 9) in the environment of a class 10,000 laminar flow bench. The larger particulates (and/or fibers) can be readily observed in the photographs on the samples of both units; considerably greater amounts of particulates of smaller size can be seen on closer inspection under magnification (see Particulate Analysis, later in this report). Visual inspection of the samples from both POSA units reveals no direct evidence of a contaminant film, with the single exception of the magnesium fluoride overcoated aluminum (MgF_2/Al) mirror of the POSA/DFI unit (Figs. 2 and 3). The smudge and the droplet on this sample were examined with the magnification of a phase-contrast microscope (Figs. 10 through 12). From examination of these photographs, the "dendritic" pattern in the smudge lacks the regularity and pattern of true crystalline dendritic growth. Since the smudge and the droplet were later determined to have the same composition (see Chemical Analysis, later in this report), and the droplet has no such pattern, the conclusion of human involvement with, perhaps, a fine-haired brush is more likely as a source for the smudge pattern.

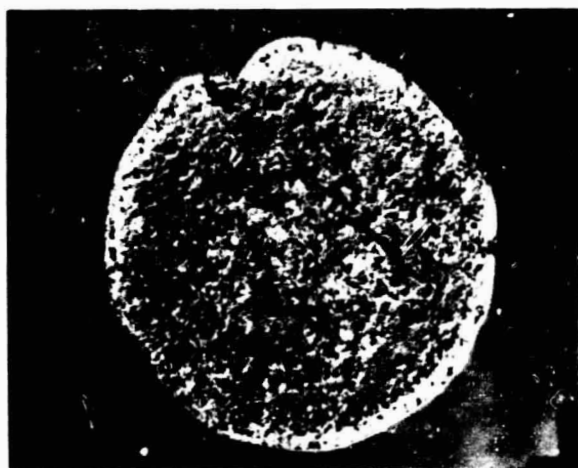
Figure 11. Phase-contrast microphotographs of droplet (residue) on sample A (MgF_2/Al) of POSA/DFI.

1 mm
VIEW OF DROPLET

1 mm
(ENHANCED MAGNIFICATION)
EDGE OF DROPLET

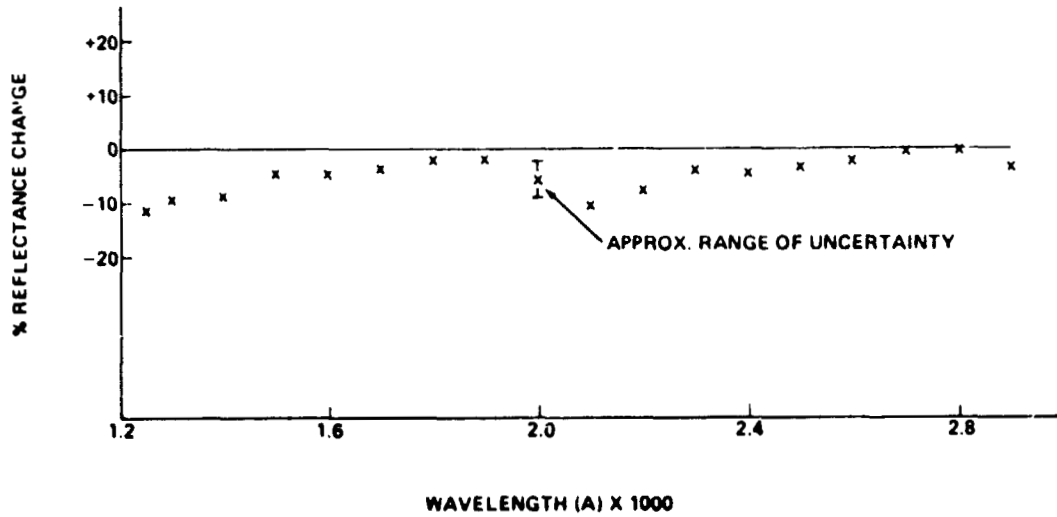
Figure 16. POSA/FF sample MgF_2/Al , position A.

a. Reflectance measurements.

$$x = \left(\frac{R_0 - R}{R_0} \right) \times 100$$

b. Calculated percent change in reflectance.

The reflectance and the percent change in reflectance of the MgF_2/Al mirror of POSA/DFI indicate a uniform 10 percent relative decrease from preflight levels, in general agreement with the diffuse reflectance results. For the ferry flight MgF_2/Al mirror, the indicated degradation is less over most of the wavelength range, with evidence of some spectral effects (Fig. 16). The absence of spectral effects in the POSA/DFI MgF_2/Al mirror may be attributed to light scattering from the smudge and droplet, masking any interference effects that may be present. A significant increase in backscatter on the smudged mirror was detected by the Gier Dunkle/Beckman facility at longer wavelengths.

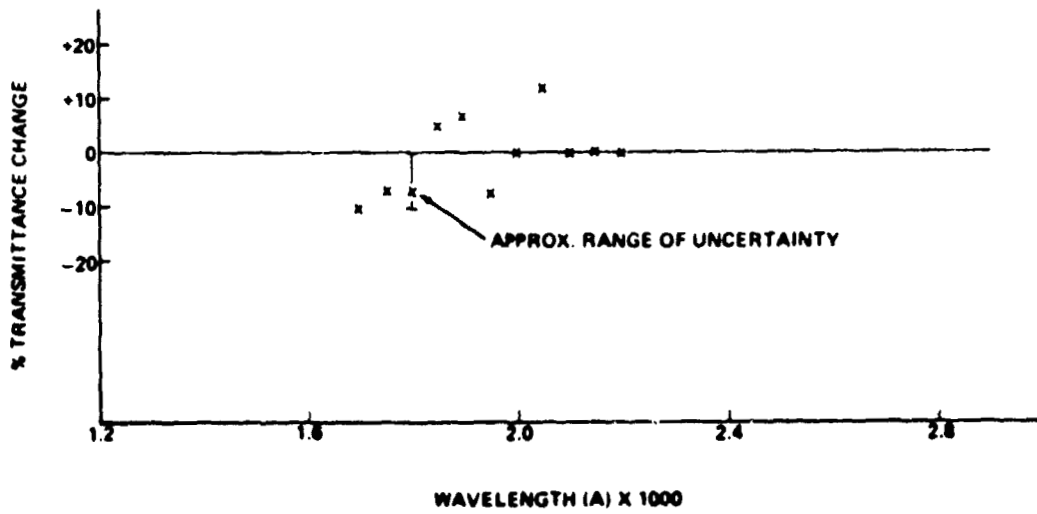
Figure 20. POSA/DFI sample: 1810 Å filter, position C.

The results for the vacuum ultraviolet filters (~200 Å bandwidth) indicate no significant change in the transmittance for the filter of either POSA unit, considering the uncertainty (Figs. 20 and 22). The front surface reflectance of these filters indicates measureable degradation, although the greater change occurred in the region of lower front-surface reflectance (transmissive bandwidth) and is subject to greater uncertainty due to the lower initial magnitude of reflectance.

$$X = \left(\frac{T_0 - T}{T_0} \right) \times 100$$

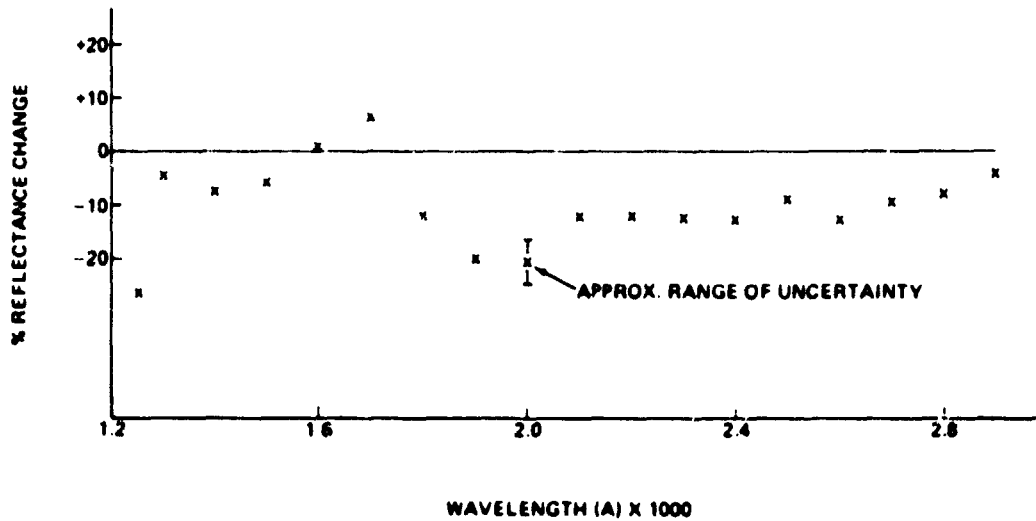
Figure 21. POSA/DFI sample: 1810 Å filter, position C.

The results of the vacuum ultraviolet measurements of specular, spectral reflectance and transmittance are shown in Figures 15 through 28. A tabulated summary of these results is listed in Table 3. For each Optical sample of each POSA unit, the curves show the postflight changes in the measured optical properties, and additionally, on separate graphs, show the computed percent changes for assessing the significance of indicated degradation. The reflectance, and percent changes in reflectance, of the narrow band ultraviolet filters (Samples C of both POSA units) were included simply to extend the spectral range of investigation (Figs. 21 and 23).

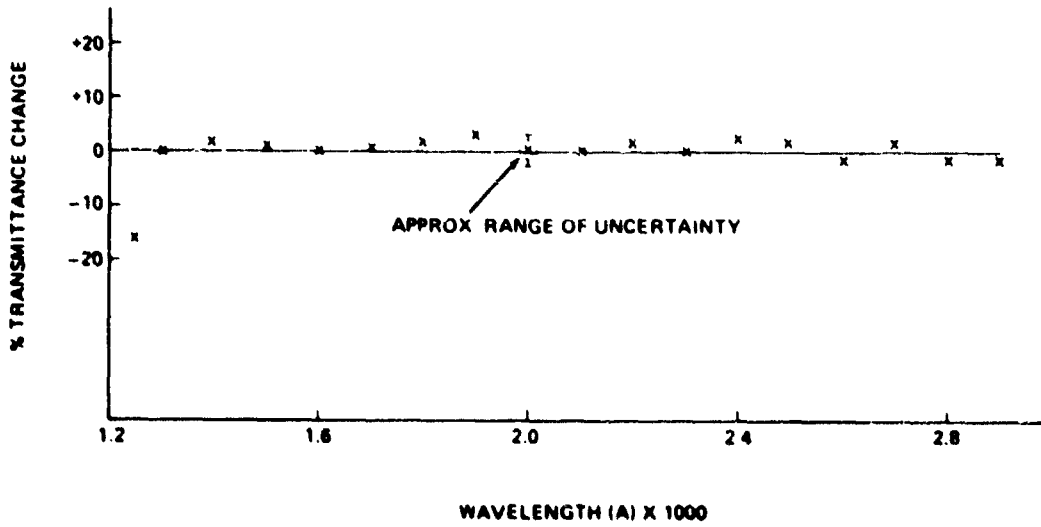
Figure 24. POSA/DFI sample: CaF₂ No. 2, position D.

There is generally no significant change in the optical properties of any of the transparent samples (CaF₂, fused silica) of either POSA unit, with the exception of the reflectance of the reverse side of the CaF₂ sample in position D of POSA/DFI; there was no apparent change in the reverse-side reflectance of the comparable sample in POSA/FF.

T₀ - PRE-FLIGHT TRANS.
T - POST-FLIGHT TRANS.
