FINAL REPORT

A STUDY OF POULTRY PROCESSING PLANT NOISE CONTROL TECHNIQUES

Research Grant No. NSG 3228

GEORGIA INSTITUTE OF TECHNOLOGY

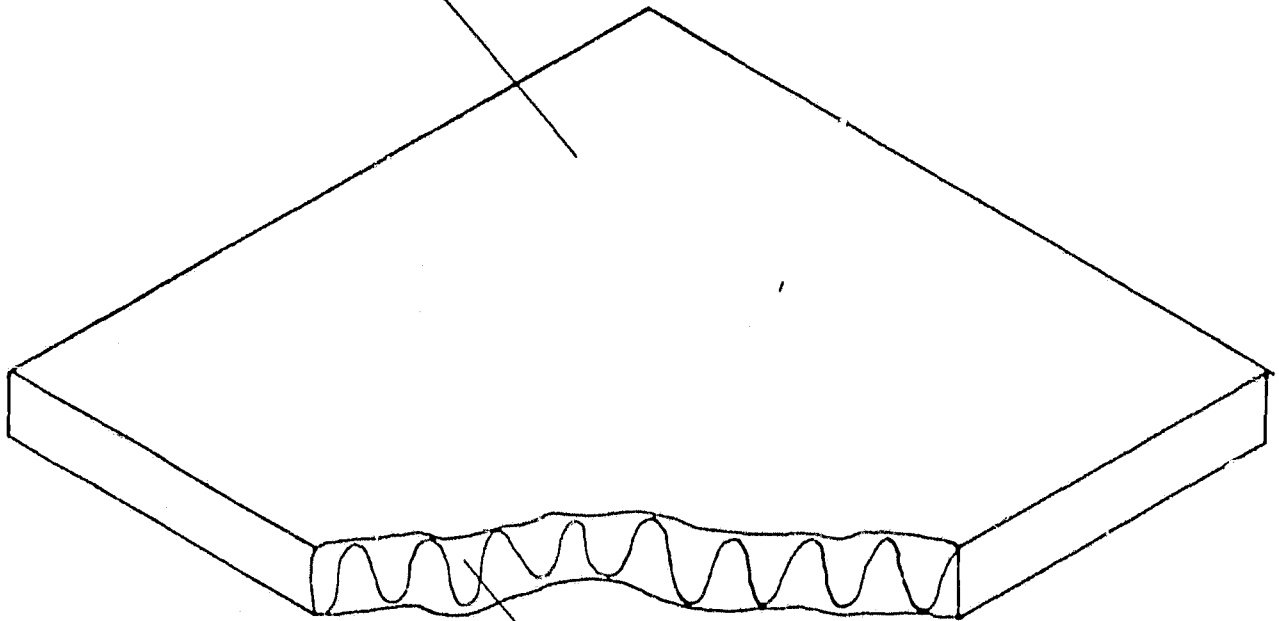
Figure 1 - Typical Design of Current Acoustical Panels

The absorbing media typically are fiberglass, mineral wool, or foam. The plastic covers, all of which are thin (between 0.5 mil and 2 mil in thickness), are either polyolefin or polyvinyl fluoride (PVF). This latter film (typically Tedlar®) has grown in popularity among panel builders.

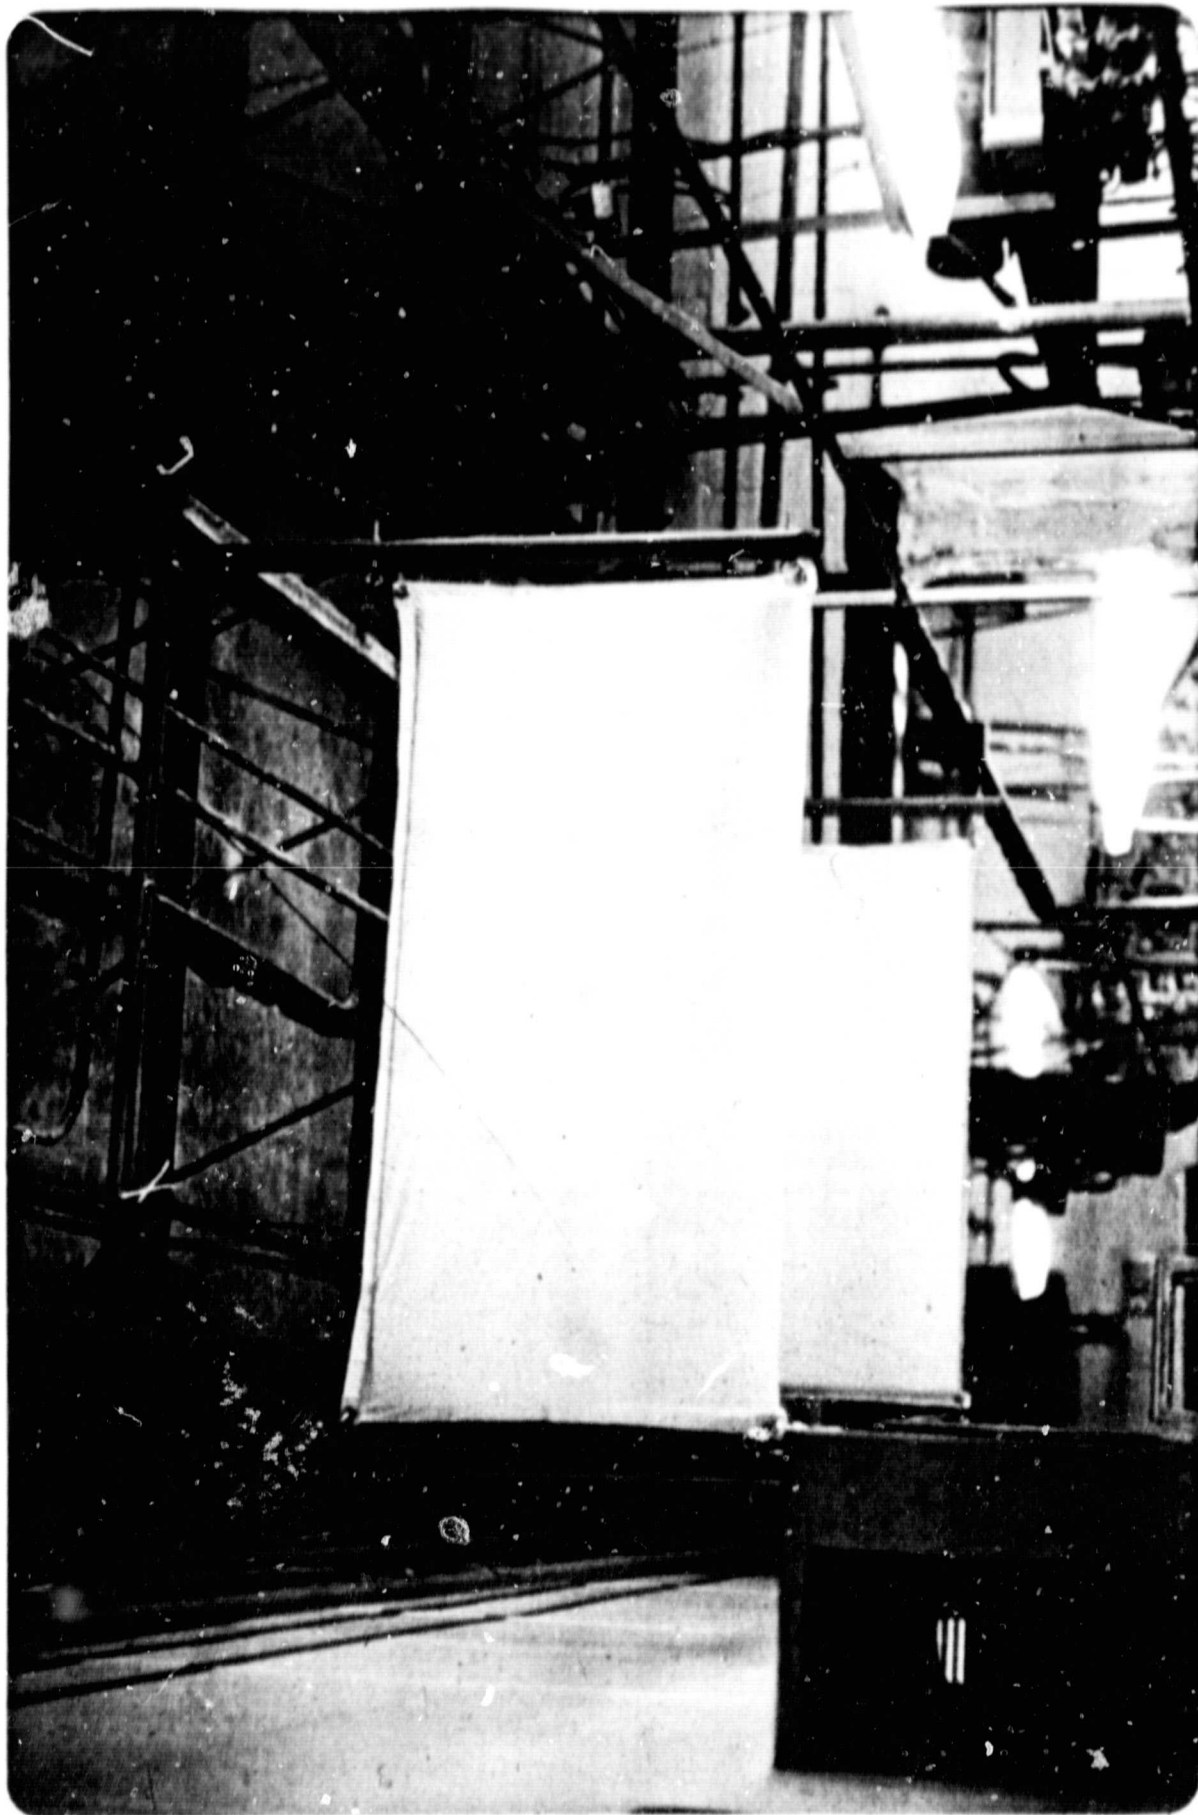
Figure 4 - Test Panels in Plant

The samples (eight in all) were made using a fiberglass core material, and the panels were hung at Tip Top Poultry in Marietta, Georgia. The mounting arrangement placed the panels low enough to the floor (approximately 10 feet) to insure their being washed daily (see Figures 4 and 5). The test lasted six months. Test results are presented in Table 4.

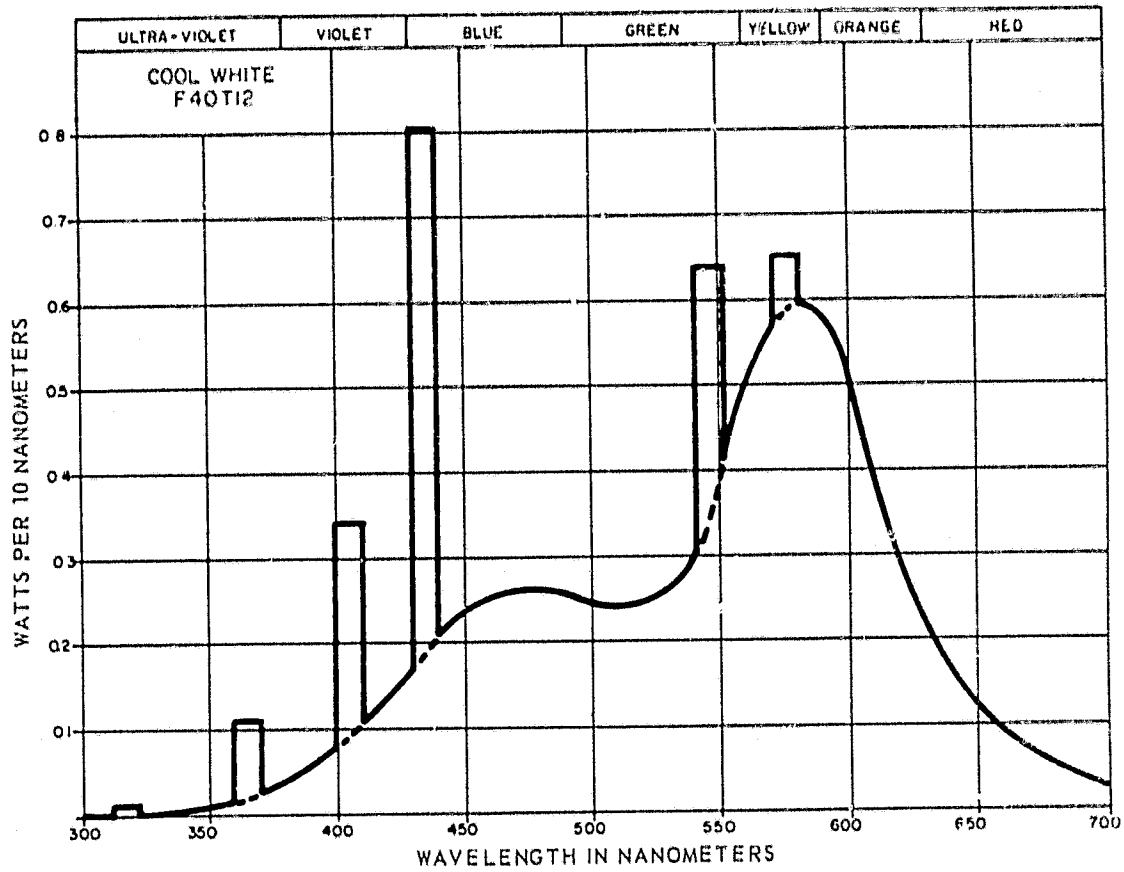
Figure 6 - Energy Spectrum for a 40-watt Fluorescent Light Fixture

to sunlight. However, when the light spectra of typical industrial fluorescent lighting are viewed, there is a noticeable absence of ultraviolet energy (see Figure 6), which is absorbed by both Mylar® and nylon (see Figure 7) and eventually leads to their degradation.³ While considerable debate was found regarding the possible life of the composite under continuous lighting exposure, nearly every expert contacted agreed the product should last several years at worst.

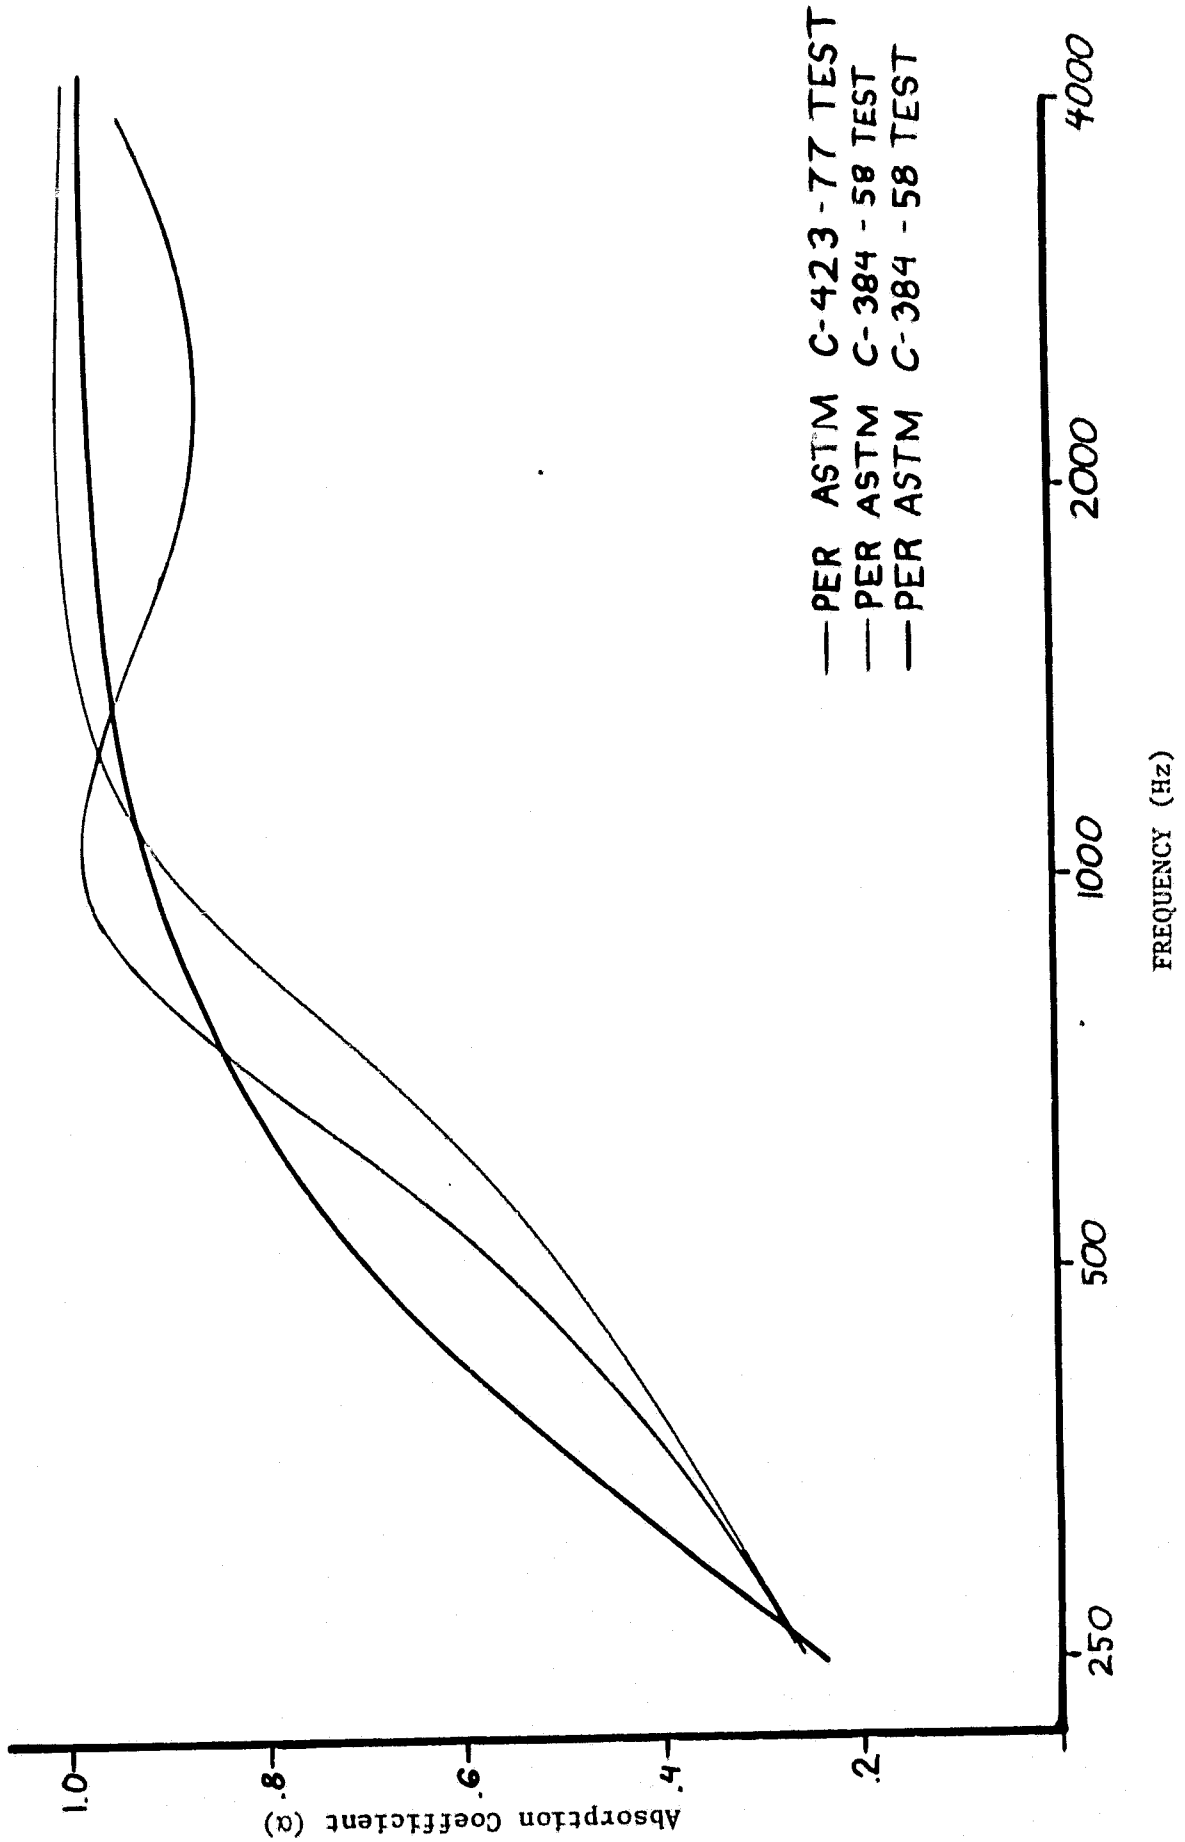
Figure 8 - Absorption Characteristics of Potential Panel Cores (1" Thickness)

Red - Scottfelt (felt)
 Blue - Noiseguard (foam)
 Black - Fiberglass (fiberglass)

based on published data. In order to utilize published data and still make an equal comparison, we had to look at a 1" thick product. The data are shown in Figure 8. It must be pointed out that this information was developed by the manufacturer. Two of the manufacturers used the impedance tube method, which measures normal incidence performance. They then corrected the data for random incidence performance. The third manufacturer used the reverberant room test method, which measures random incidence performance.

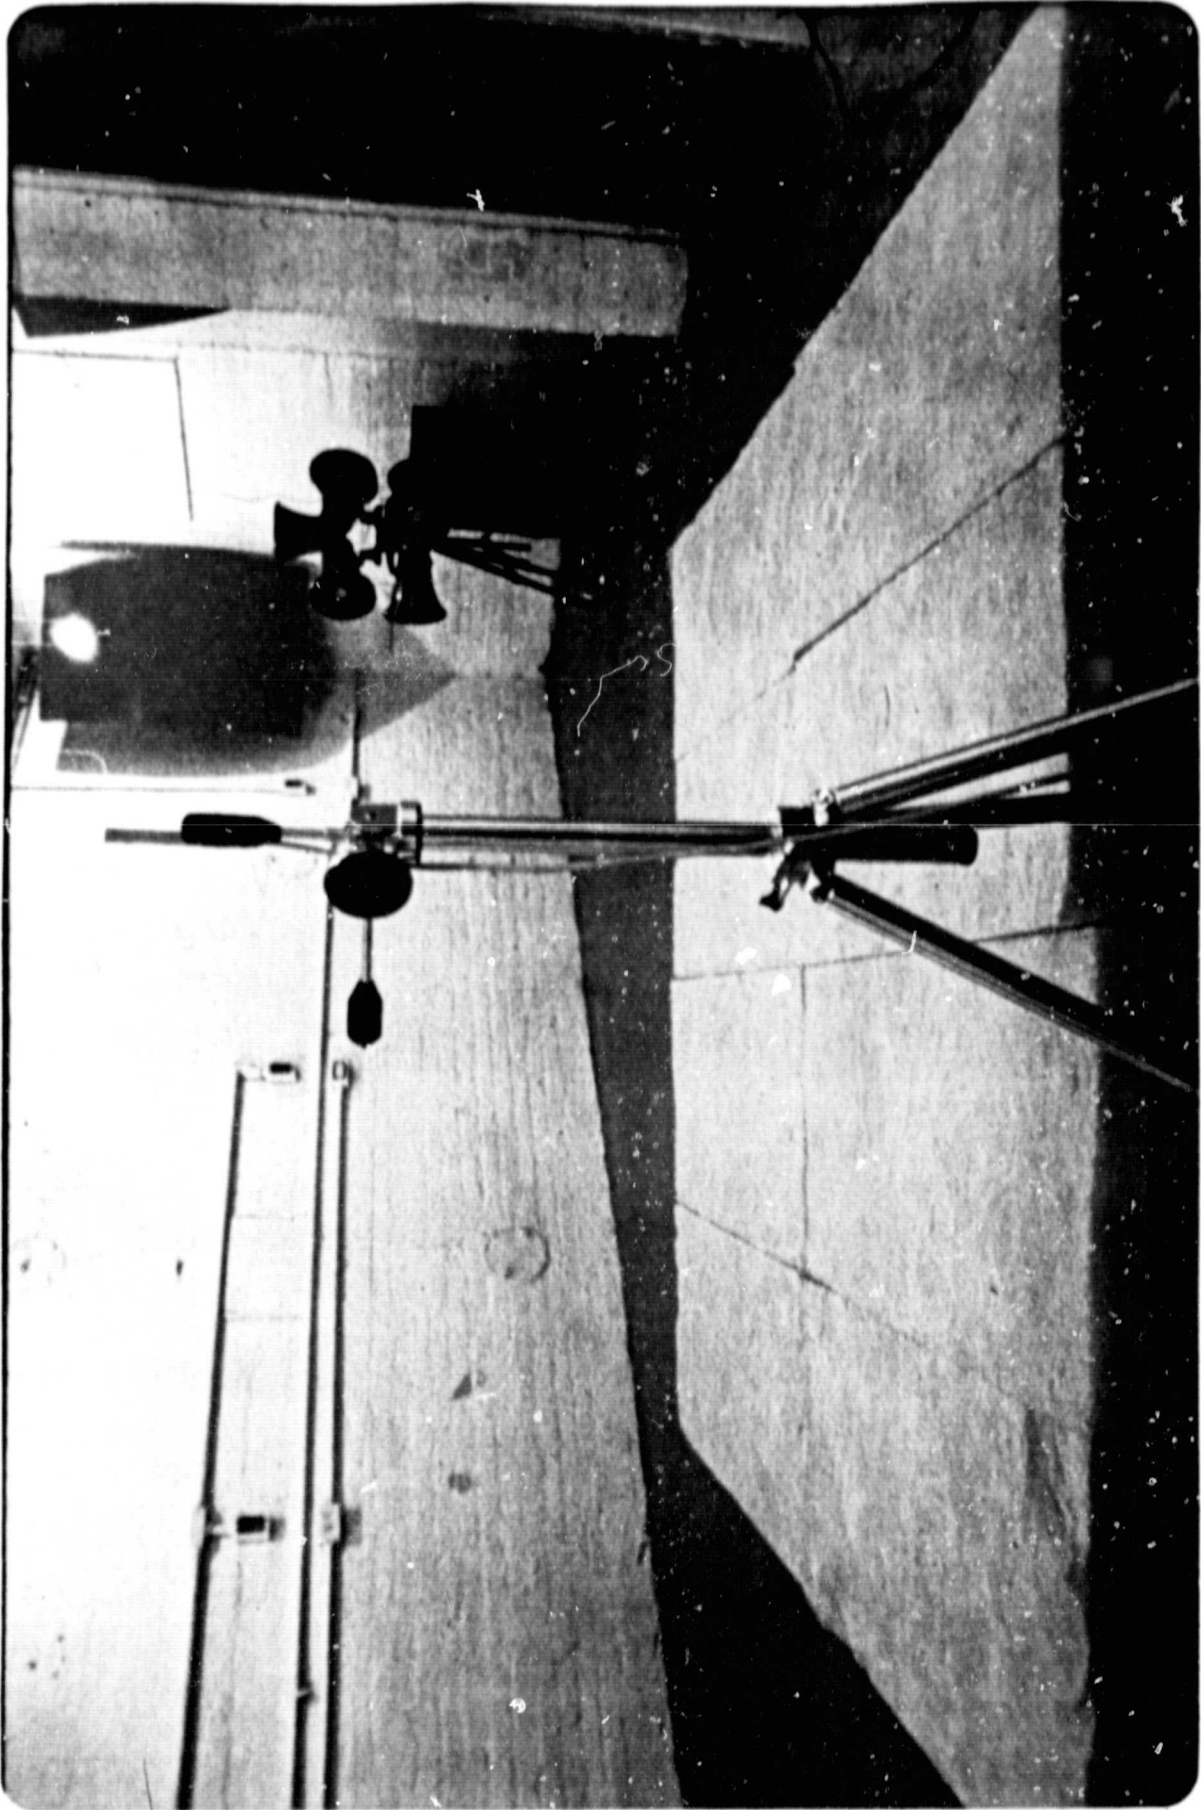
Figure 9 - Uncovered Panels Being Tested in Reverberant Chamber

test procedure involved using eight 2' x 4' x 2" series 703 semi-rigid Fiberglas® insulation boards from Owens-Corning. The panels were placed on the floor of a reverberant test chamber (see Figure 9). The sound absorption coefficients for the uncovered panels were determined, and a comparison was made of the change in the sound absorption coefficient when the panels were covered with different films.

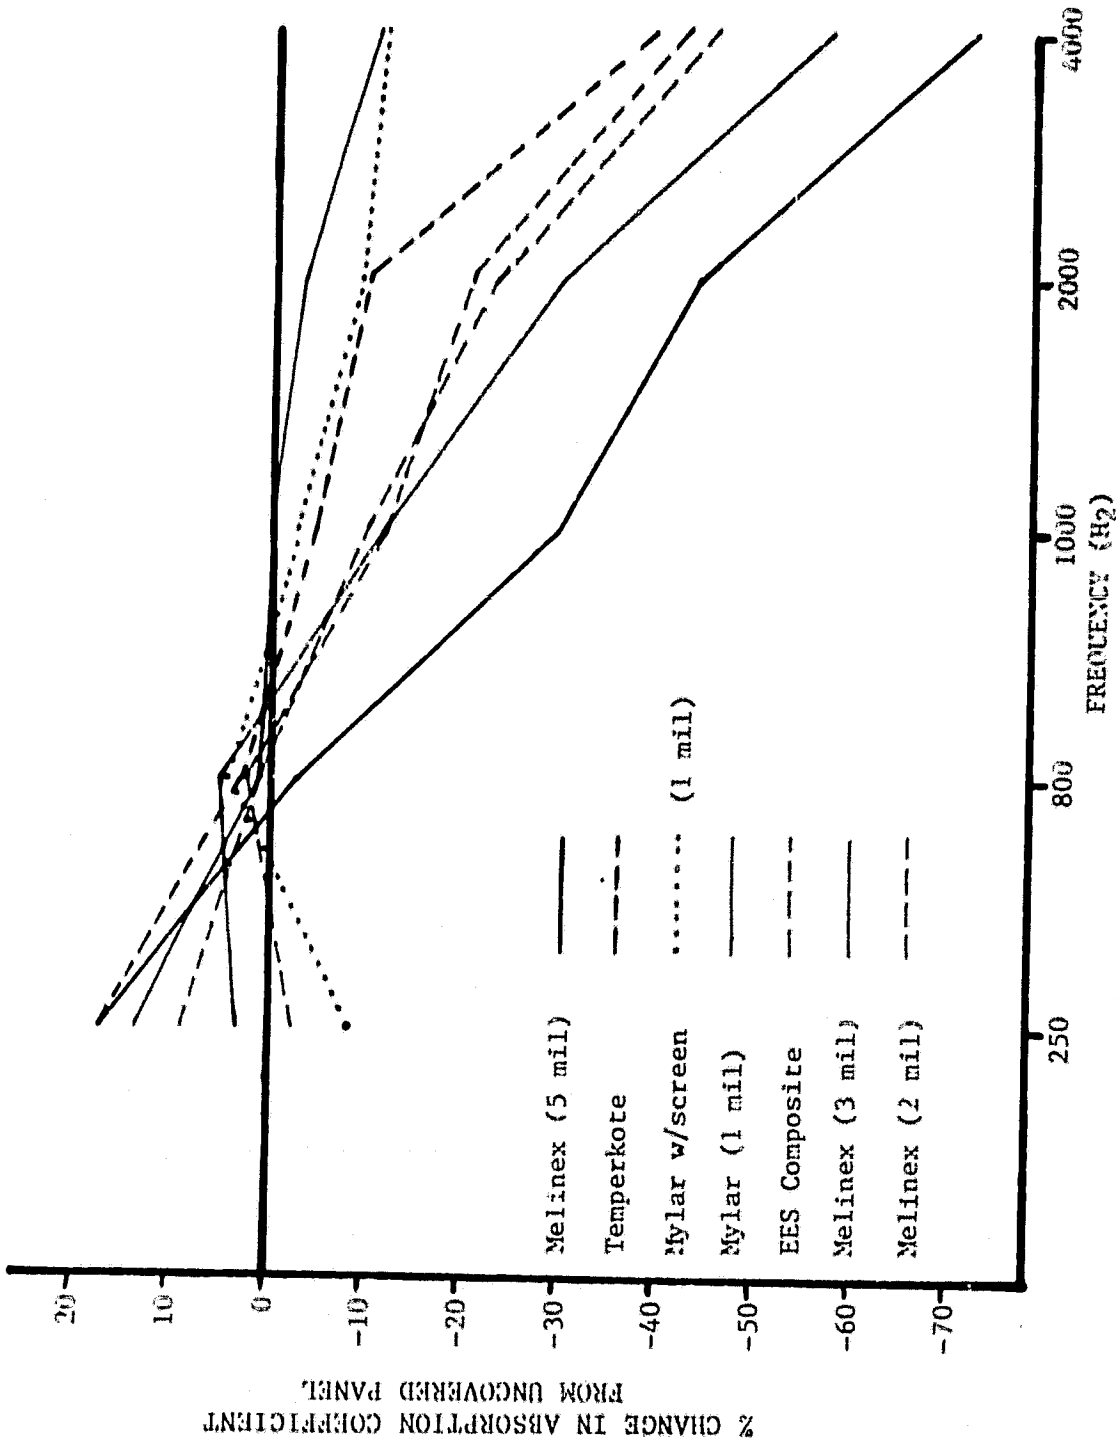
Figure 10 - Percentage Change in Panel Absorption Coefficient Caused by Covering the Panel

Listed in Table 9 are the percentage changes in absorption coefficient observed for the fiberglass panels using different covering materials.

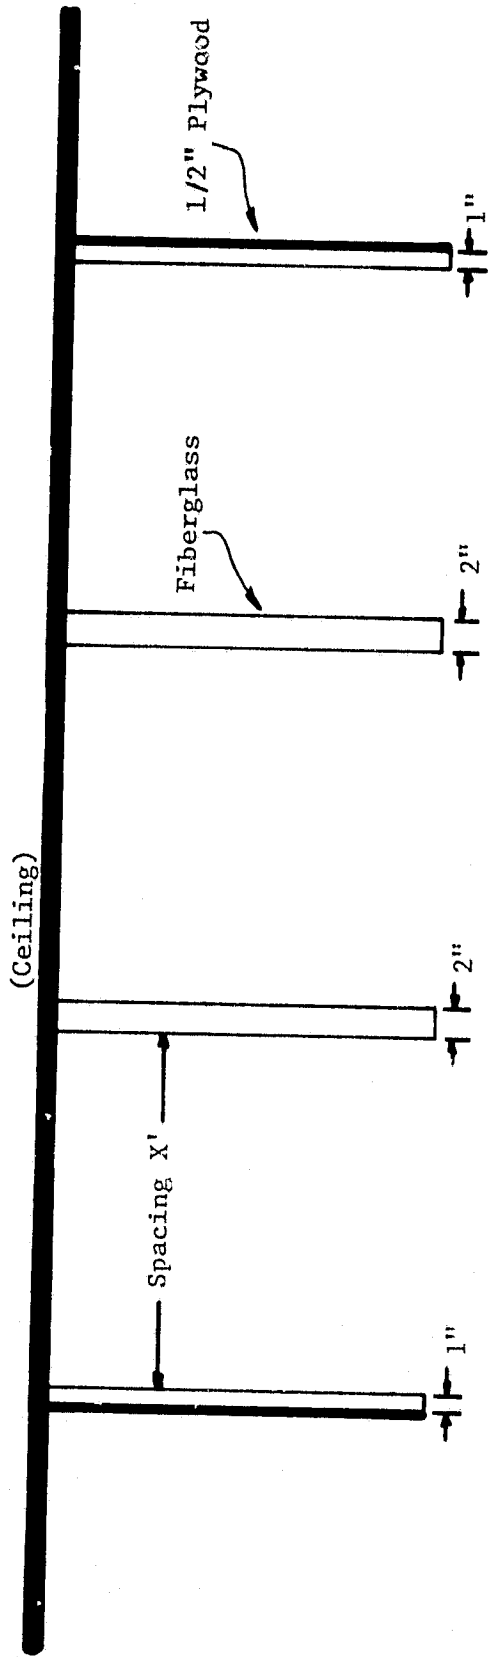
Figure 12 - Schematic of Panel Spacing Test

NOTE: Spacing Values X = 1/2, 1, 2, 3, 4

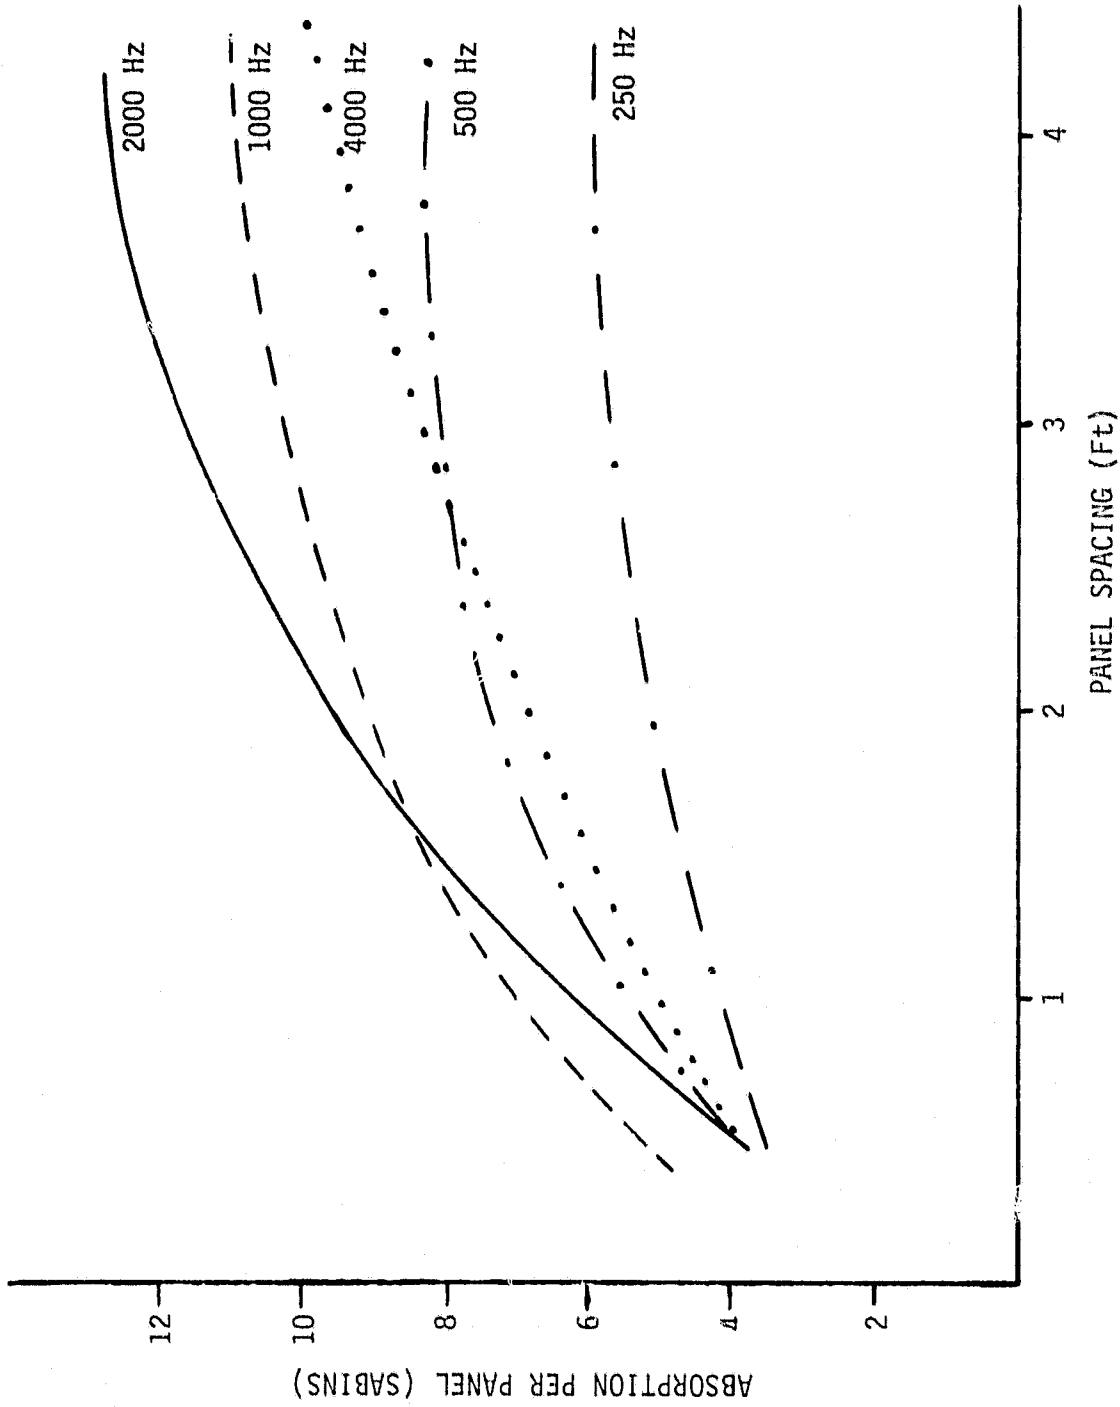
Figure 13 - Panel Absorption as a Function of Spacing (Uncovered Fiberglass)

The test results were evaluated from two angles. First, the total change in absorption (sabins) noted during the tests was divided by the area of ceiling displaced by the hanging panels. This evaluation provided a measure of the improvement in the reflecting surface absorption when it was covered with the hanging panel arrangement. These values are presented in Table 11. Next, the total change in absorption (sabins) was divided by the number of panels used in the hanging pattern. This evaluation provided a measure of the effectiveness of each panel in contributing to the total absorption observed. These values are presented in Figures 13 and 14.

The test results observed from Figures 13 and 14 demonstrate that as the spacing between panels is increased, the unit absorption per panel increases. The values in Figure 13 for the uncovered panels resemble results reported by Owens-Corning.¹⁰ As they noted, there is an optimal panel spacing beyond which no additional increase in unit panel performance will be achieved. This spacing, however, is frequency dependent. Figure 14 shows that the relationship between panel spacing and unit panel absorption is changed by the addition of a cover, particularly in the lower frequency octaves, where the increase in unit panel absorption bears an exponentially increasing rather than decreasing relationship with larger spacing. This suggests a possible shift in the optimal panel spacing point if covering materials are used.

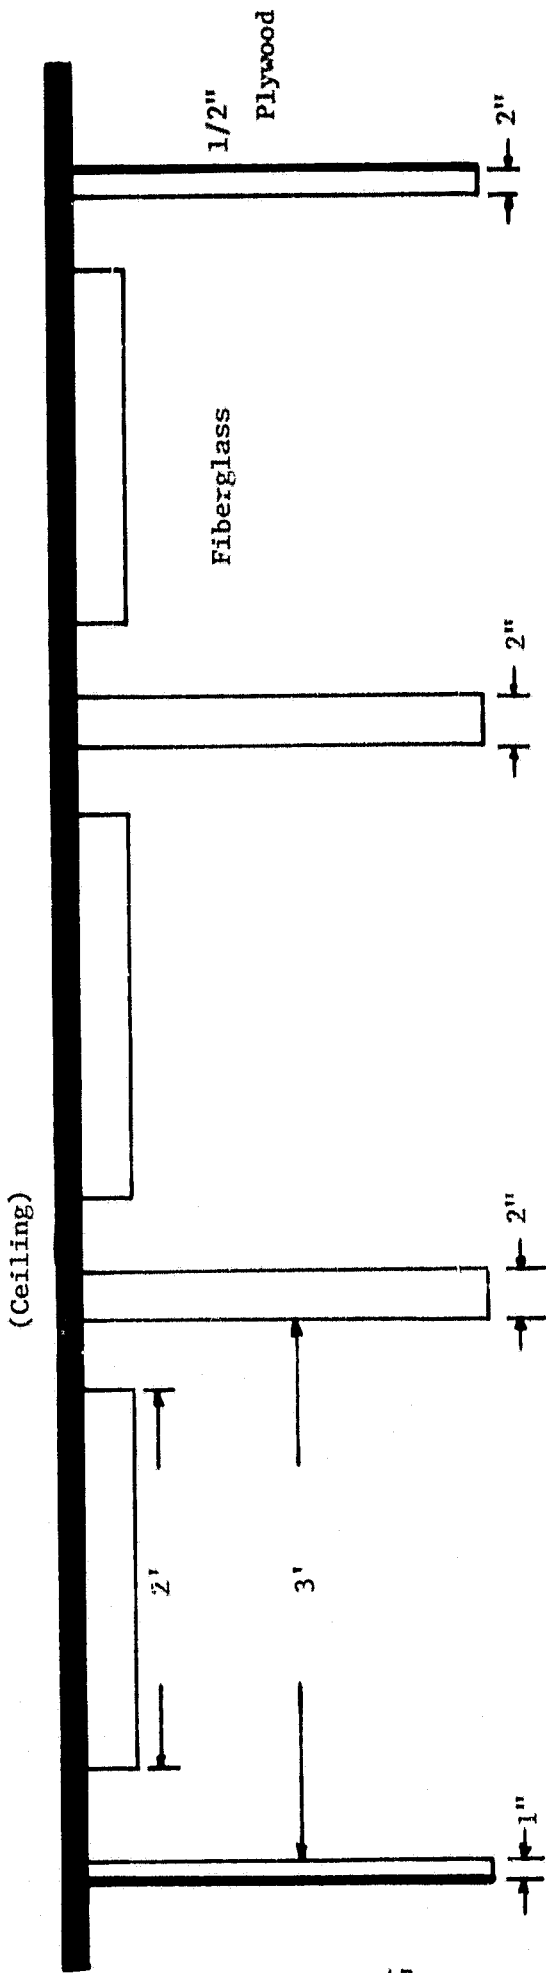
Figure 16 - Schematic of Panel Spacing Test with Ceiling Panels Added

One additional study we performed involved placing panels flat against the ceiling between hanging panels spaced 3' apart (see Figure 16). Reviewing this orientation by absorption per square foot of ceiling area covered, we developed the values in Table 12. While the absorption values exceed those for the 3'

spacing with no inserts, the additional panels result in the following unit panel absorption rates: 250 Hz (5.9 sabins/panel), 500 Hz (7.1 sabins/panel), 1000 Hz (6.2 sabins/panel), 2000 Hz (5.2 sabins/panel), 4000 Hz (3.5 sabins/panel). If the eight panels had all been hung in a 12' x 4' area, the resulting equidistant spacing between panels would have been 1 1/2'. Using Figure 13, the absorption characteristics of such an arrangement per panel would have been: 250 Hz (4.6 sabins/panel), 500 Hz (7.6 sabins/panel), 1000 Hz (6.8 sabins/panel), 2000 Hz (5.5 sabins/panel), 4000 Hz (3.3 sabins/panel). When the two orientations are compared, there does appear to be some benefit in the 250 Hz octave to placing a panel flat between the hanging orientation. However, the remaining octaves show no appreciable difference in unit panel absorption.

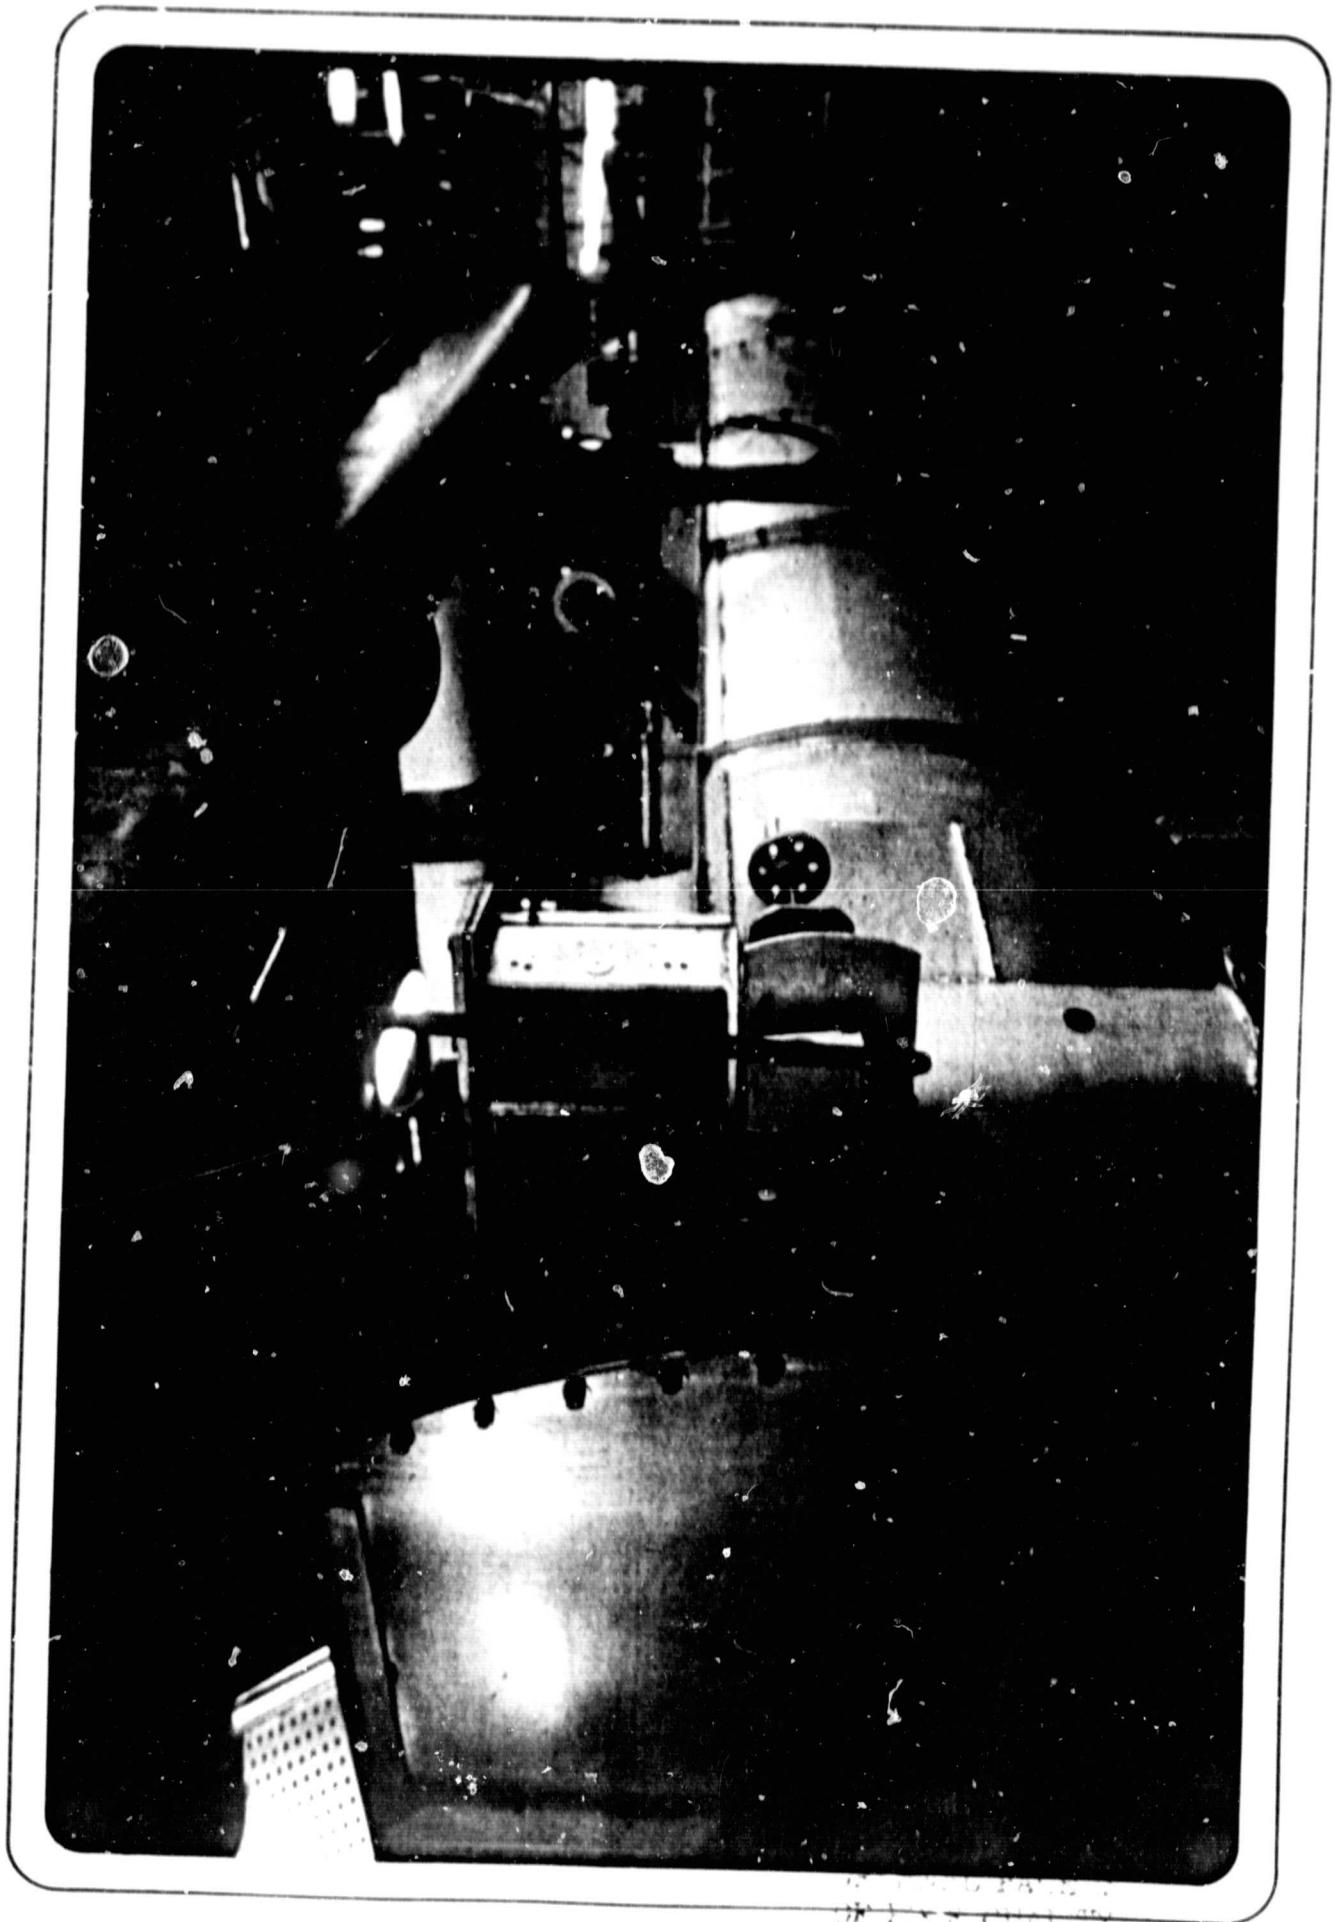
Figure 17 - Paddle Chiller

The first unit was a paddle-type chiller common throughout the industry (see Figure 17). We began the study by filling the chiller with water and

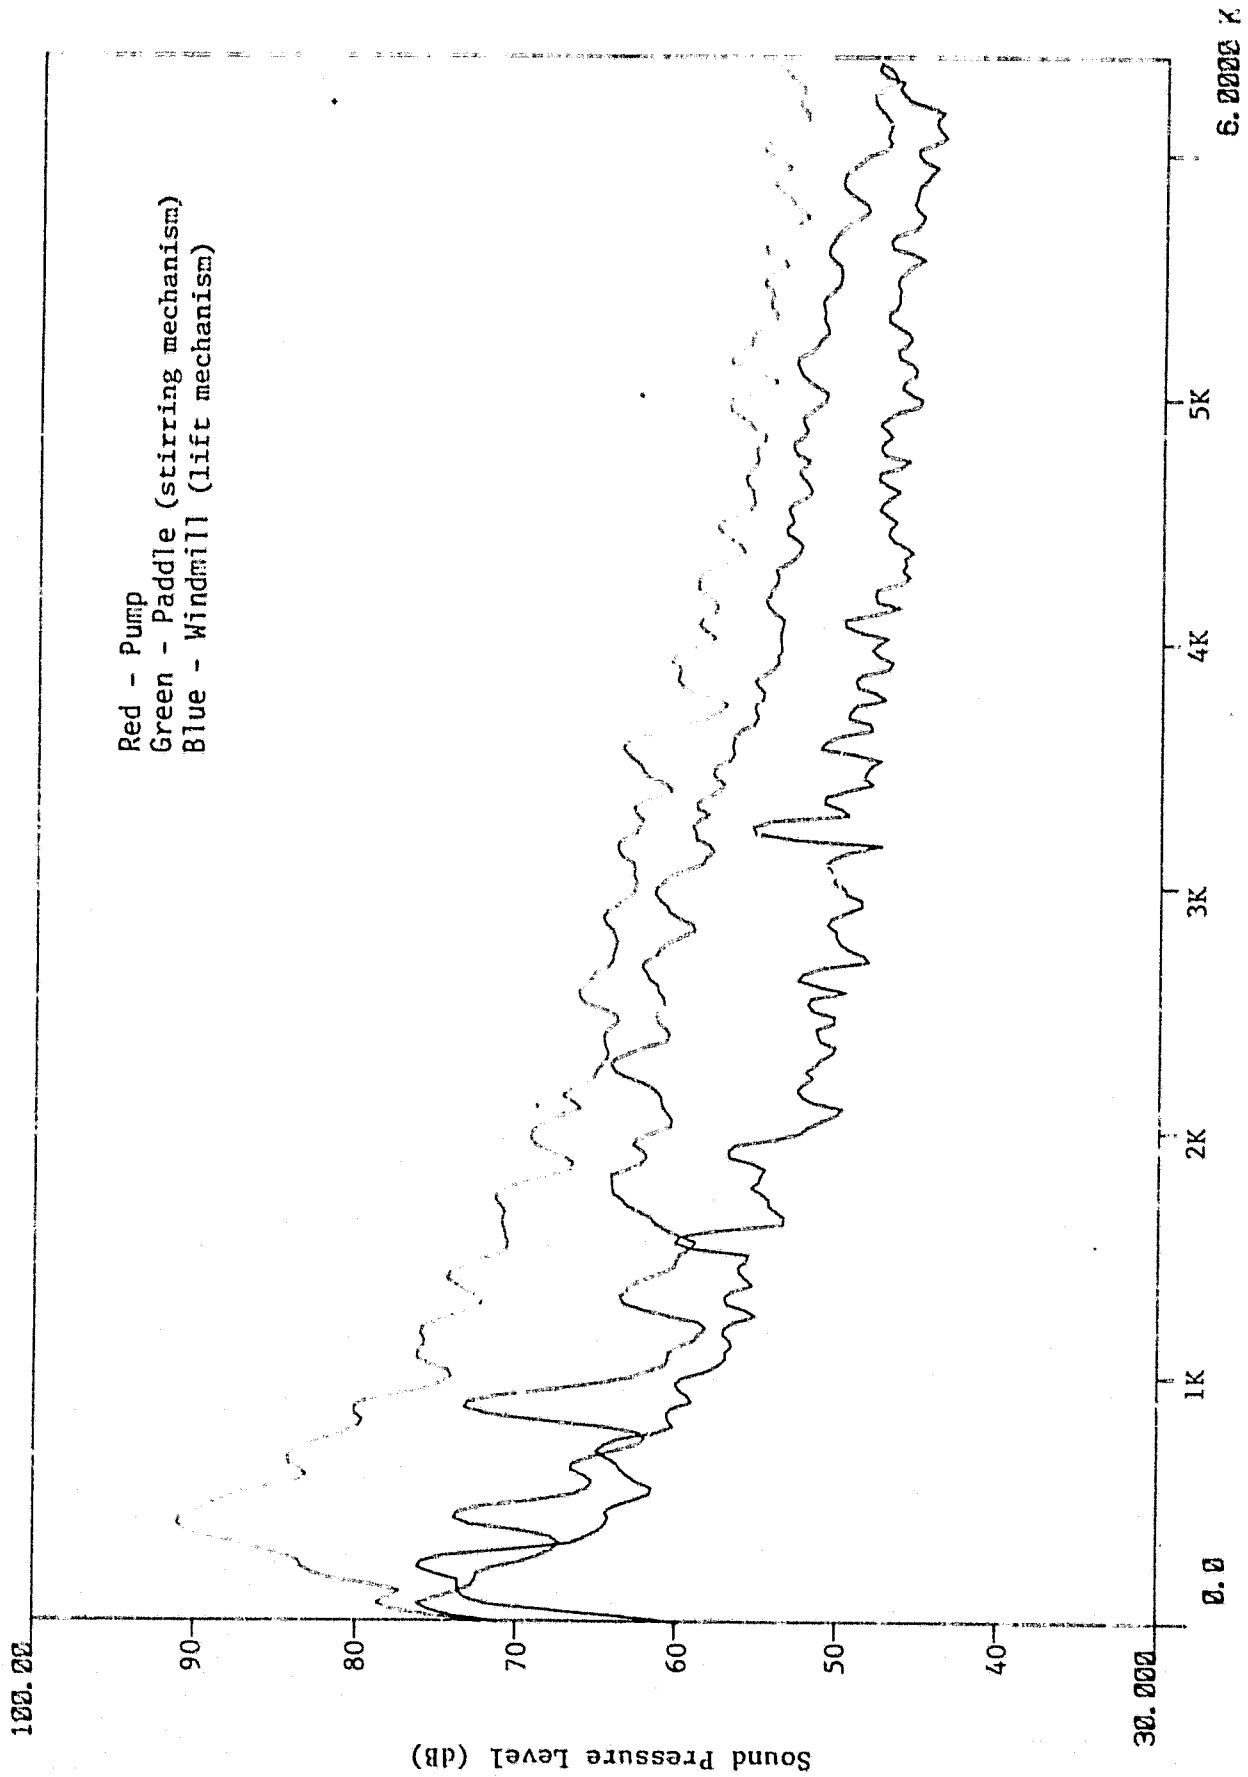
Figure 18 - Spectrum for Individual Components on a Paddle Chiller

turning individual components on and off one at a time. The result was a characterization of the noise signature of each component (see Figure 18). When it became obvious that the pumps were the primary noise-generating mechanism for this chiller, we immediately began a detailed study of it.

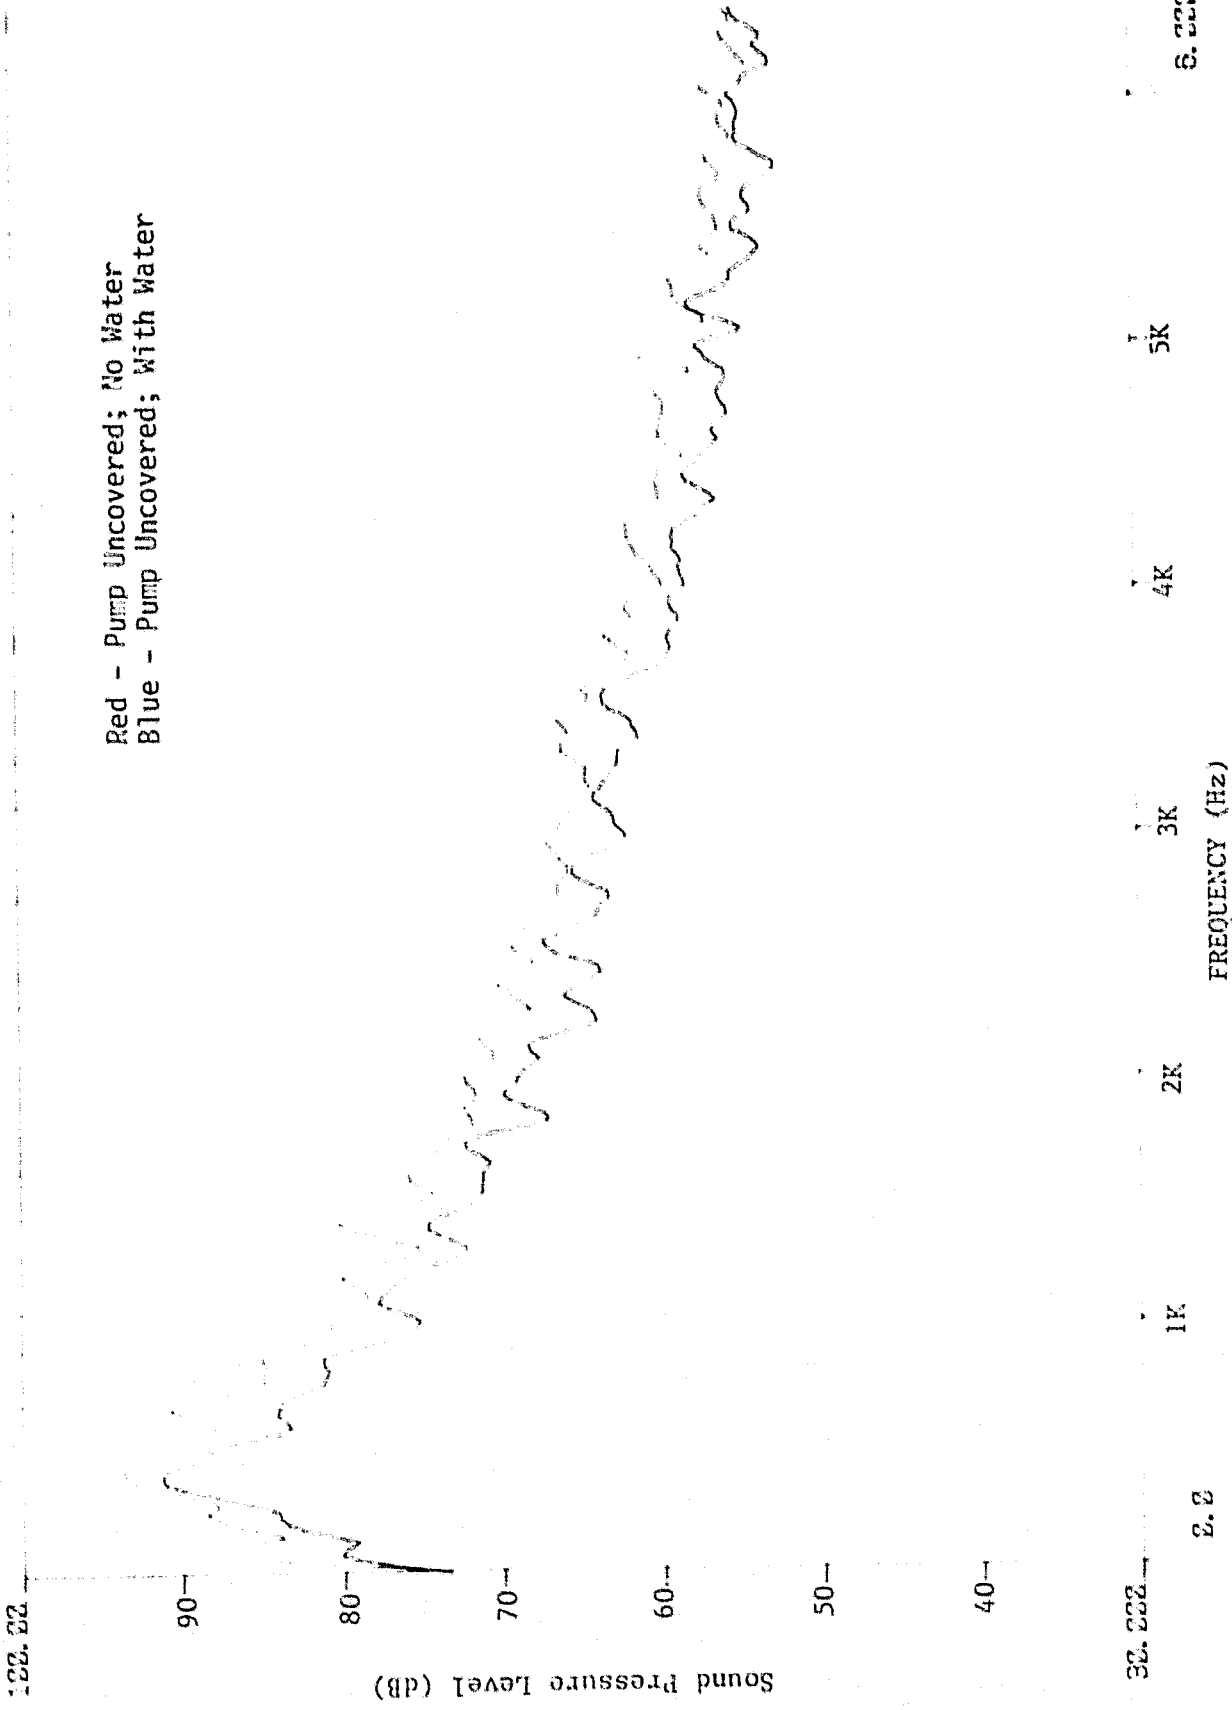
Figure 20 - Sound Energy Spectrum Changes in the Paddle Chiller

We first took a series of noise readings on the chiller while varying general conditions. Our test scenario involved operating a single circulating pump on the chiller, first without any water in the chiller and then with water in the chiller. This helped to identify the role water plays in quieting chiller noise. Next, a hood filled with 3" fiberglass padding was placed over the top of the pump housing and drive motor (see Figure 19). This later feature allowed us to reduce noise emanating directly from the pump top and drive motor. Figure 20 shows the impact on the chiller's noise spectra when water was added. The overall level dropped 3.7 dB. Figure 21 shows the impact on the spectra when the hood was then added. The overall level dropped an additional 3.3 dB.

The information in Figures 20 and 21 point out that a tremendous amount of sound energy emanating from the chiller is low frequency (250-2000 Hz). When the drive motor and pump housing top are covered, a full 3.3 dBA reduction in sound pressure level is observed, yet the primary reduction brought about by the hood is centered in the 2000-6000 Hz range. A possible explanation for this occurrence is that the pump and drive motor are unquestionably the noise-generating mechanisms (nothing else mechanical is operating), yet the pump housing and main chiller body are amplifiers of the noise generated. Due to their size, they are more efficient in acoustically transmitting the low-frequency portion of the generated spectrum. Another possible explanation

is that the acoustic hood was not effective in reducing low-frequency noise and that the pump was the only major noise-generating mechanism.
