FINAL REPORT

A STUDY OF POULTRY PROCESSING PLANT NOISE CONTROL TECHNIQUES

Research Grant No. NSG 3228

GEORGIA INSTITUTE OF TECHNOLOGY

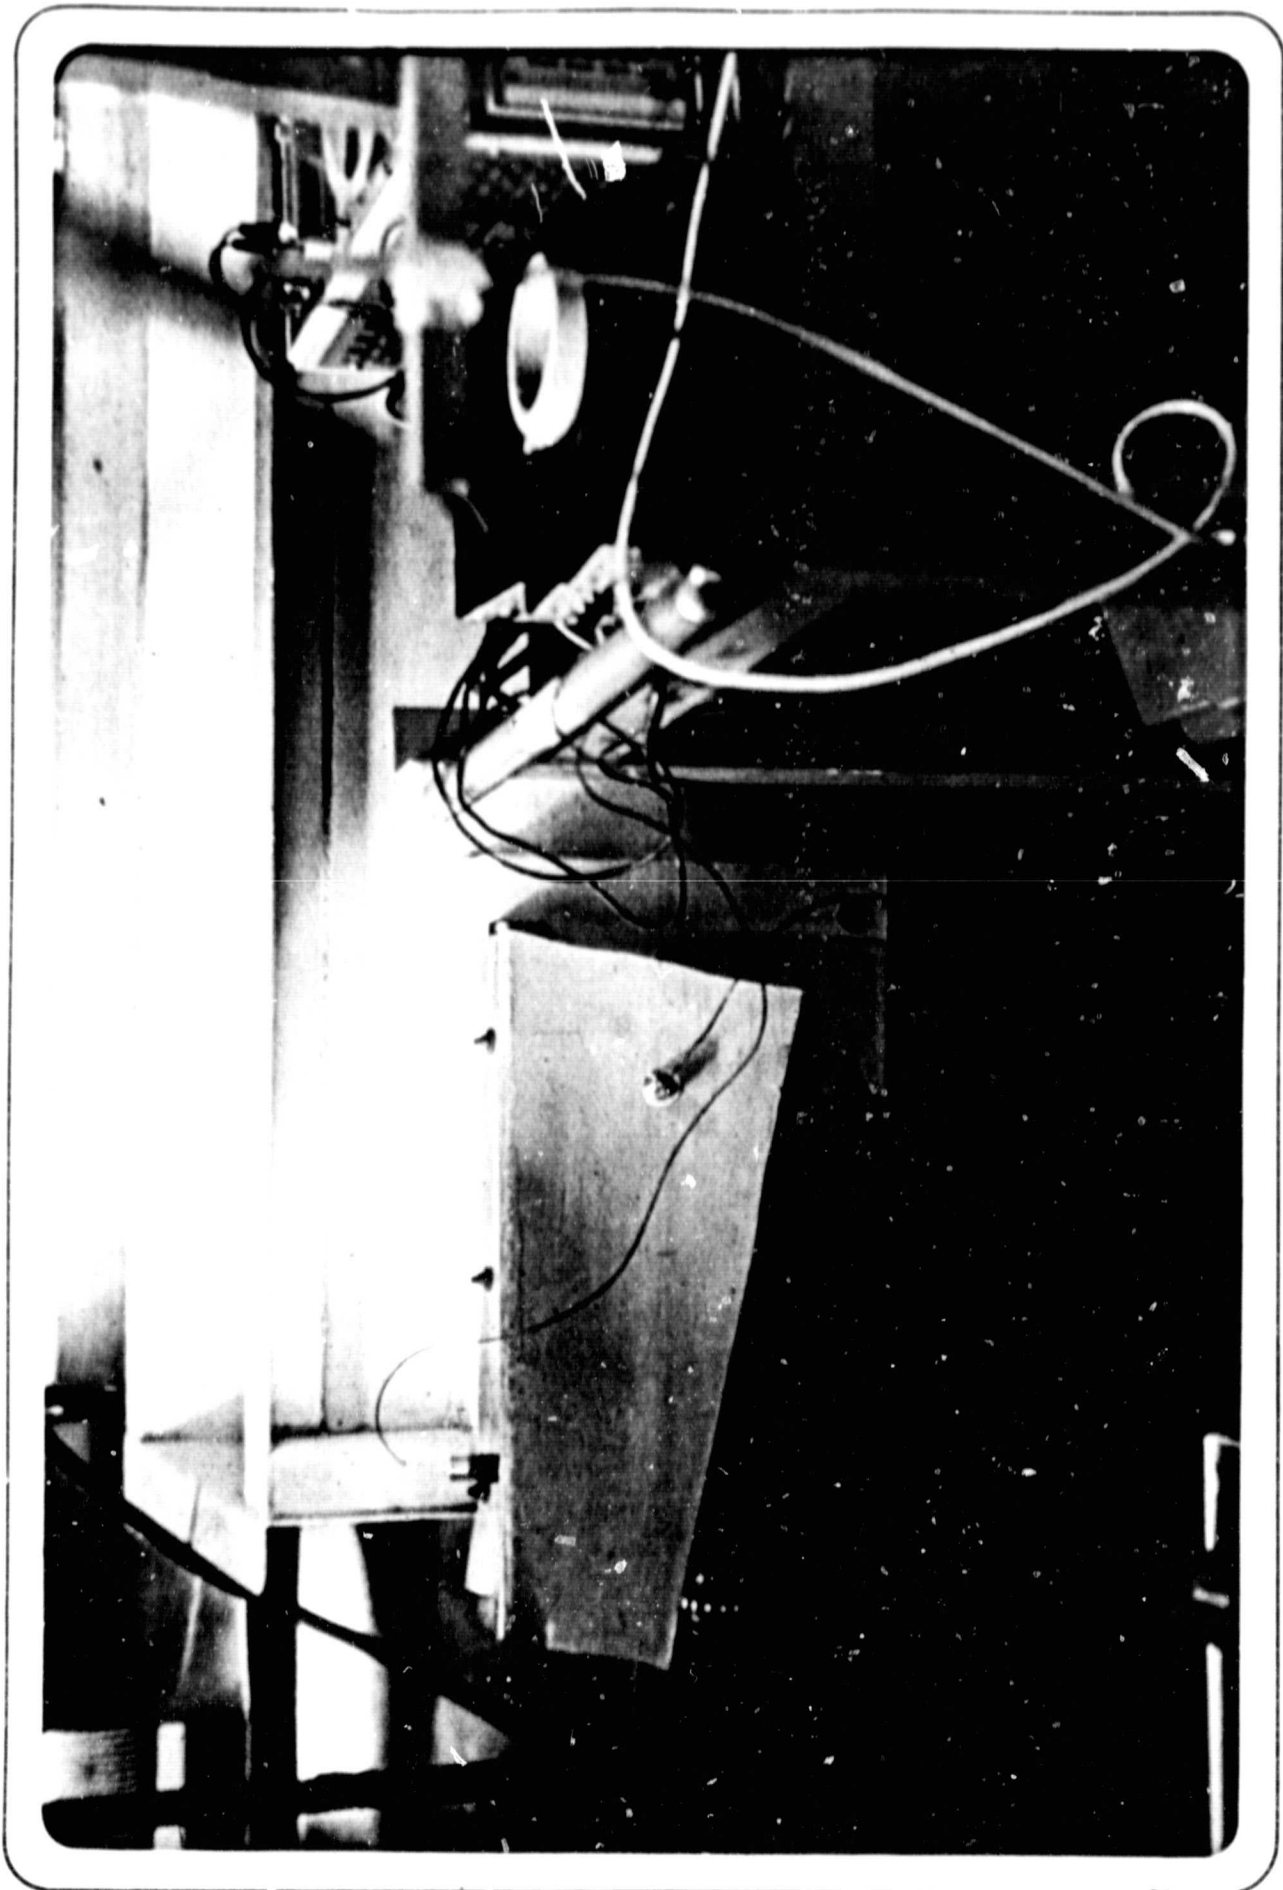
Figure 23 - Giblet Chiller Undergoing Tests

As mentioned earlier, we studied two chillers. The second chiller was a gilet chiller (see Figure 23). During the course of our study, we discovered a problem in the gear box, and the gear box and drive motor were subsequently replaced. Figure 24 shows the change in sound energy transmitted by the chiller when the replacement was made. Overall, a 16 dB drop in sound pressure level was observed. Clearly this dramatizes the need to isolate and enclose the drive mechanisms. It also points out the need for good maintenance programs.

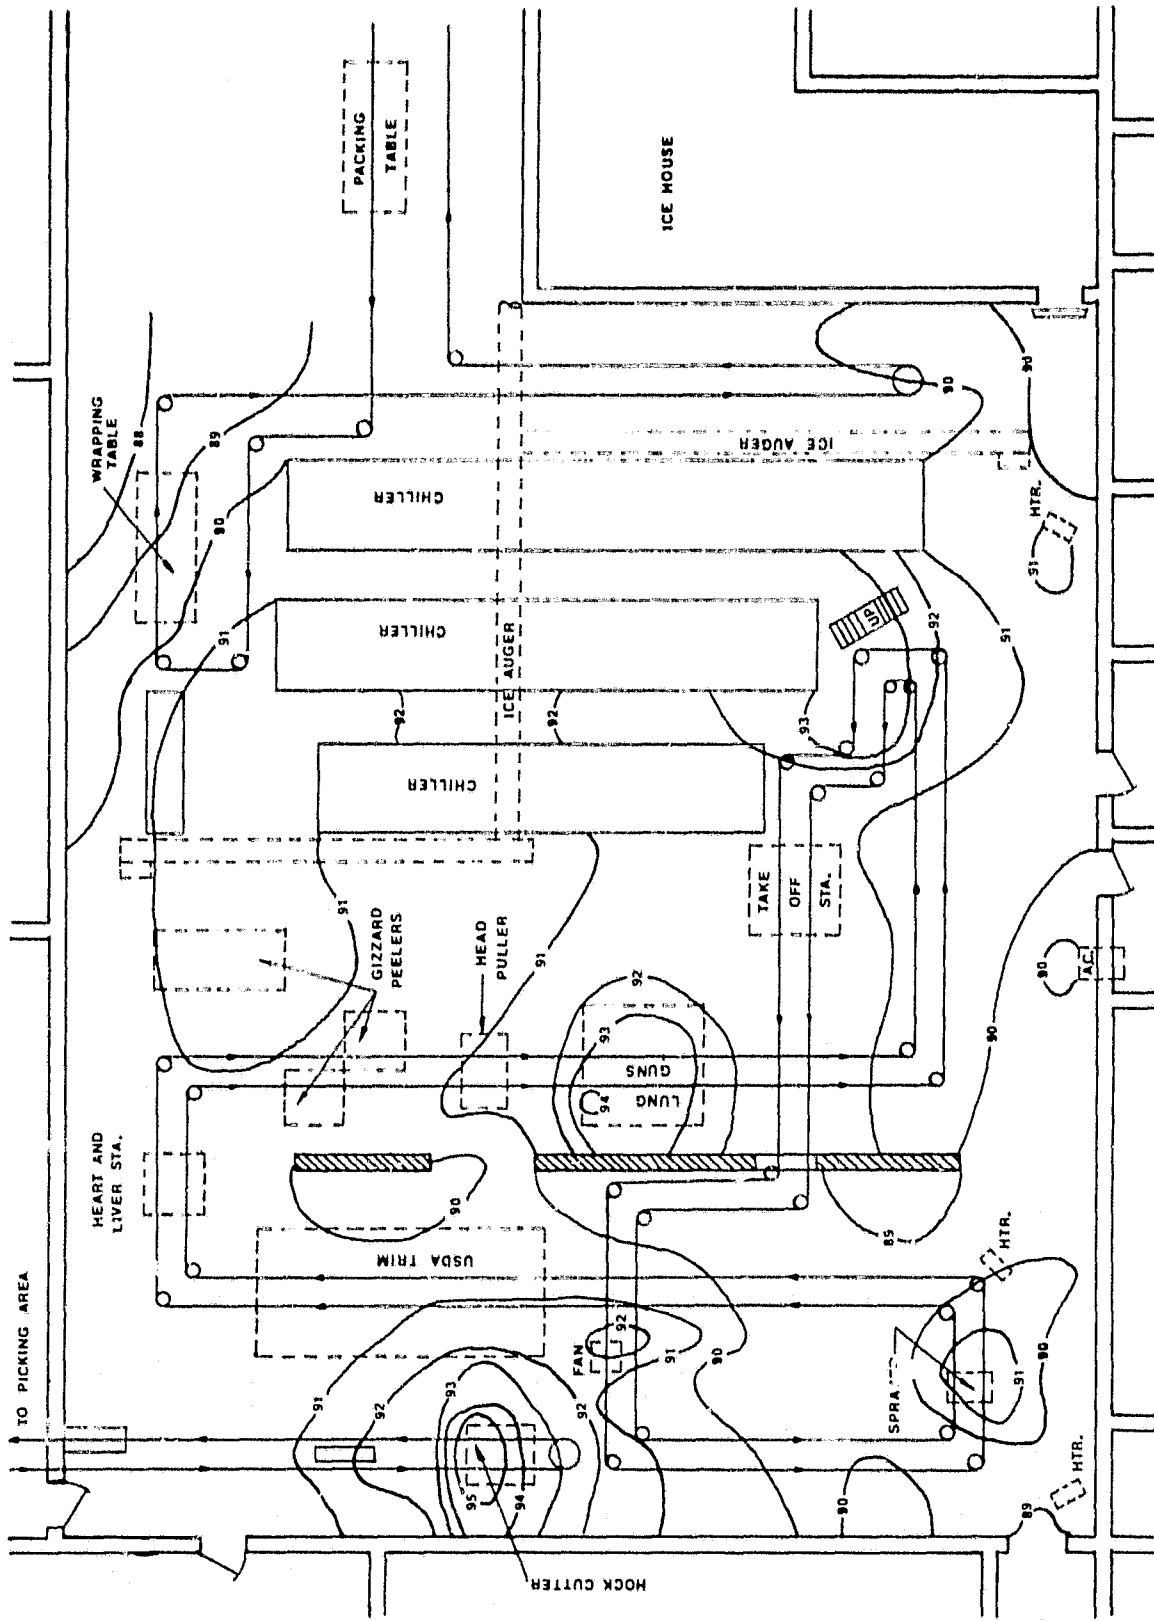
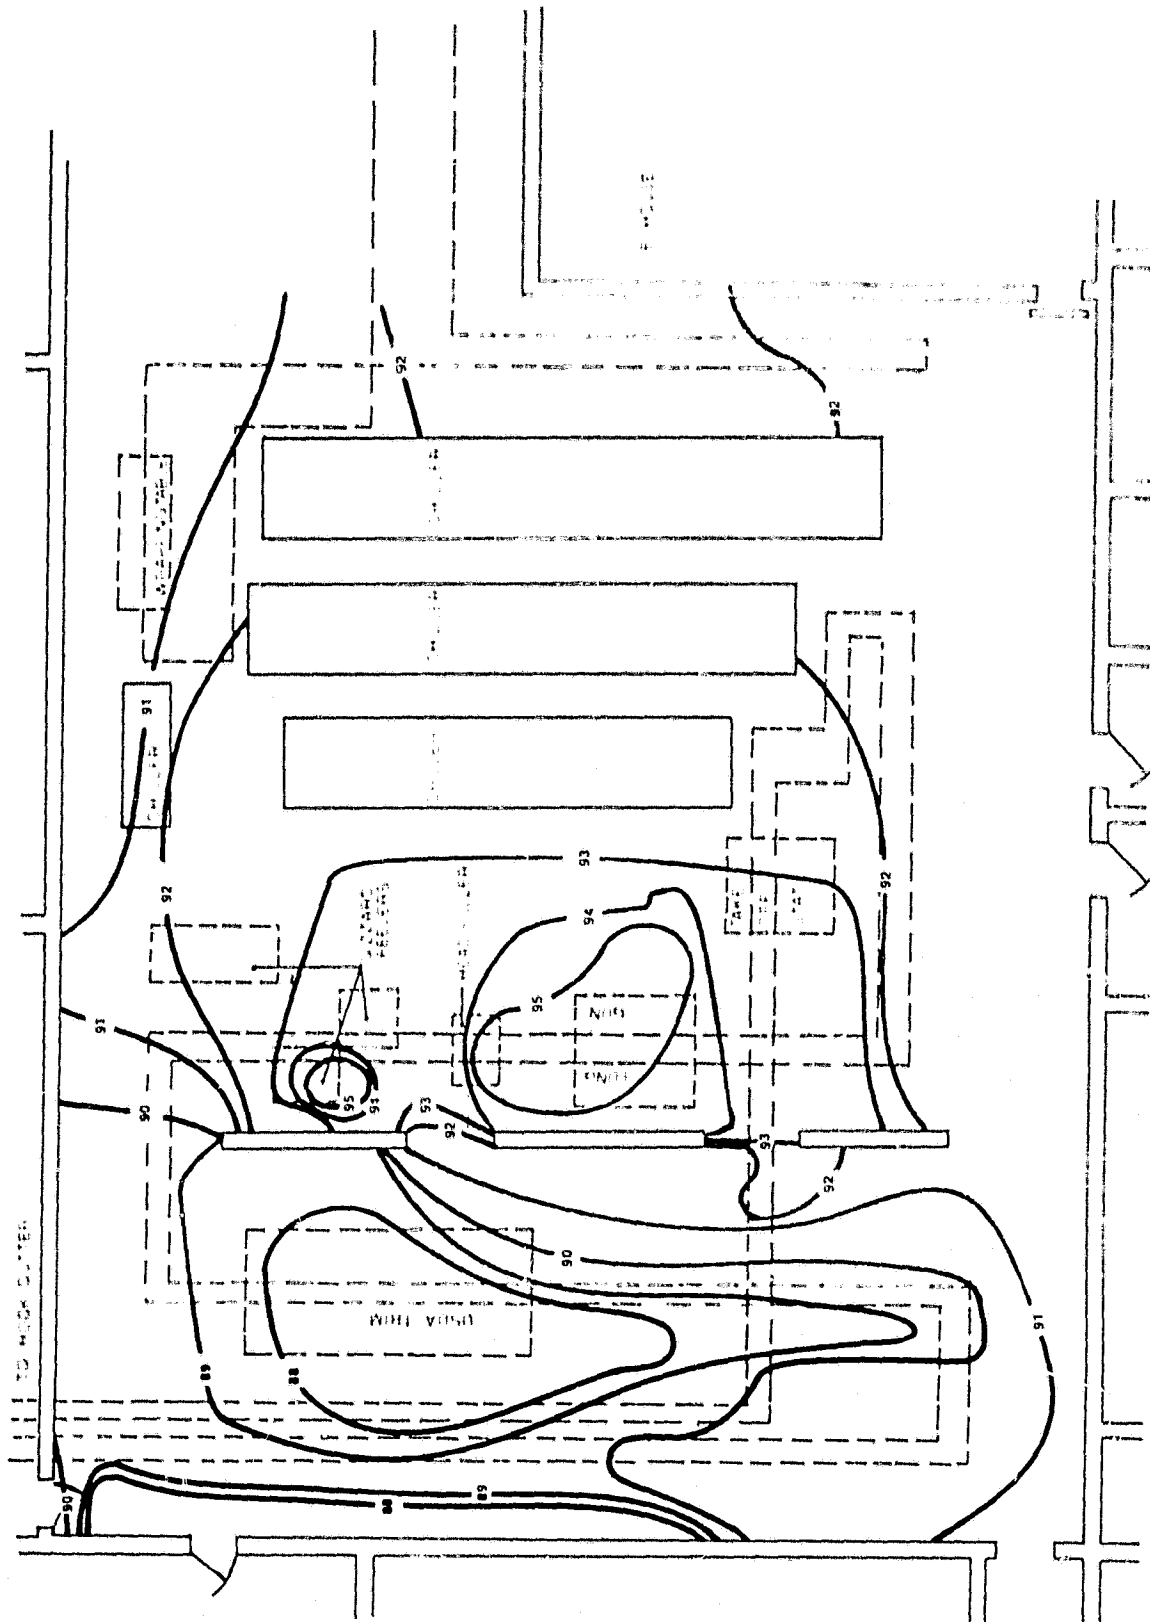
Figure 29 - Noise Contour in Plant with Hock Cutter

Hock cutter noise reduction has been accomplished largely by isolating the machine from personnel. Figures 29 and 30 display the observed noise reduction brought about by relocating the hock cutter to another area of the plant. However, isolation techniques are not always successful, either because a large opening is used to convey the birds back into the evisceration room or because many plants still require personnel to work near the machine after isolating it.

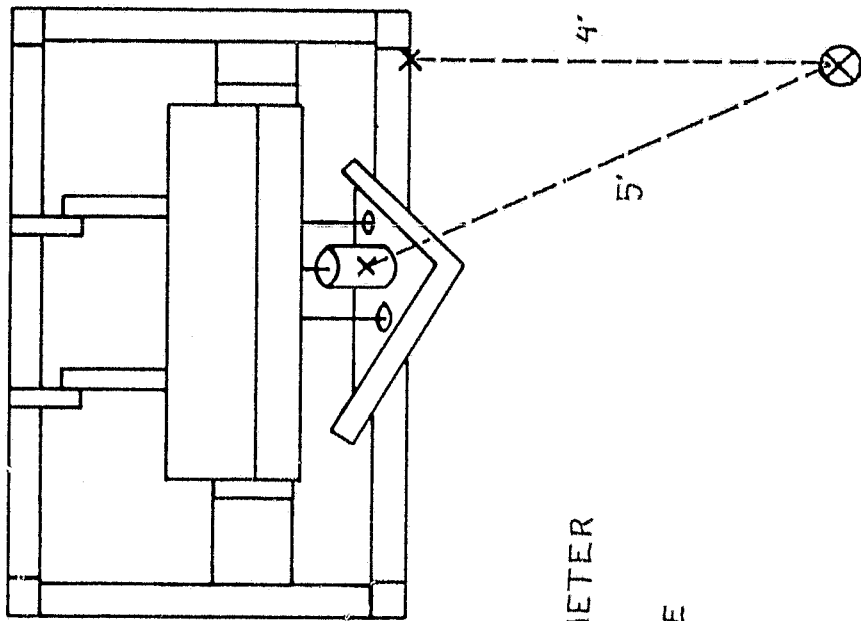
Figure 31 - Accelerometer and Microphone Locations
For Hock Cutter Analysis

X ACCELEROMETER

⊗ MICROPHONE

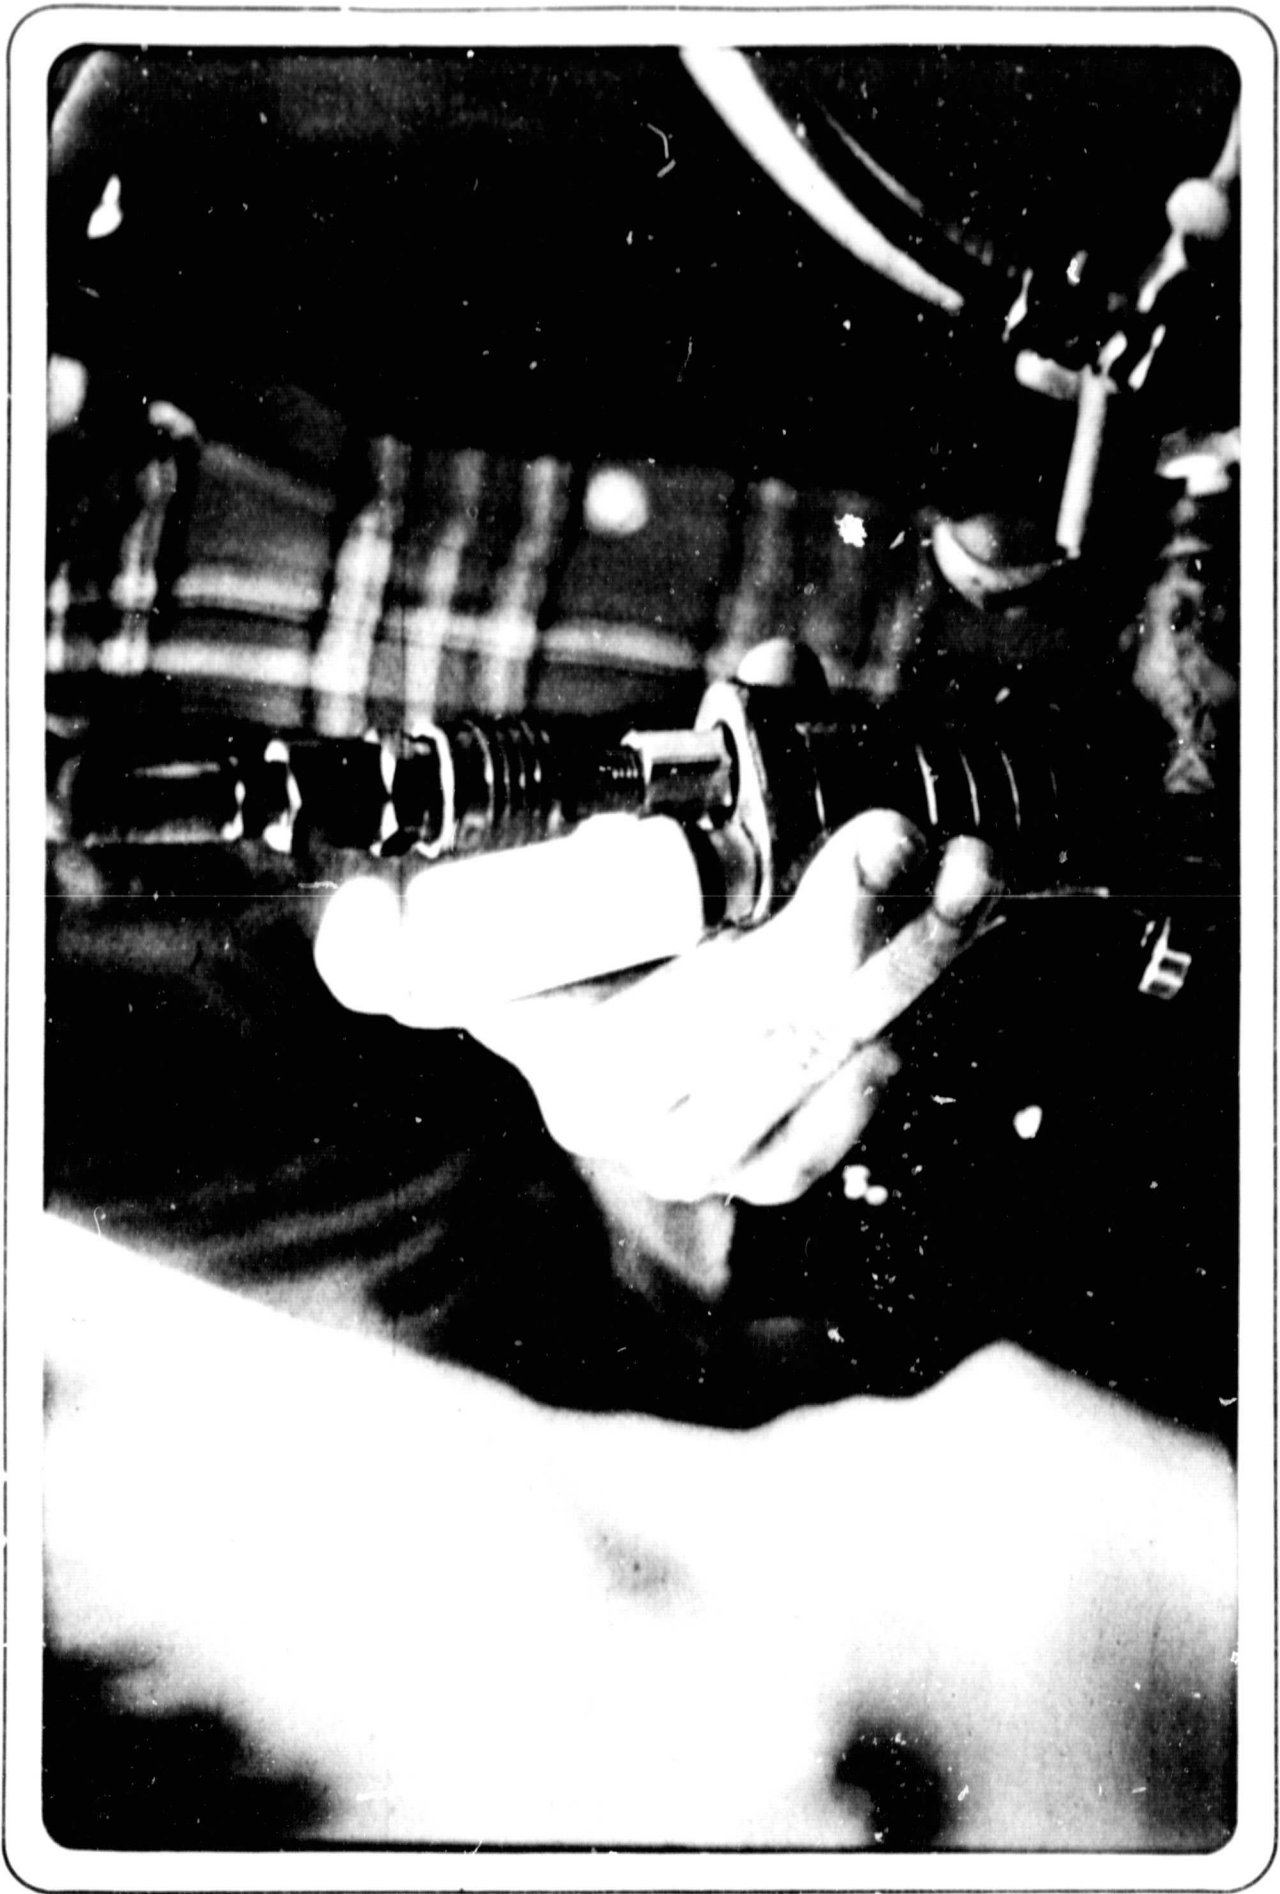
Figure 34 - Pneumatic Muffler Tested

Vent cutter noise can contribute significantly to local noise levels in a plant. A vent cutter in many cases is merely a pneumatic drill used to open the bird for subsequent evisceration. While newer machine designs exist whereby the drilling is performed automatically by mechanical drive mechanisms, for the pneumatic tools that continue to be used, we evaluated the potential effectiveness of exhaust mufflers. The muffler we selected was a polyethylene design (see Figure 34) which was washable and rugged.

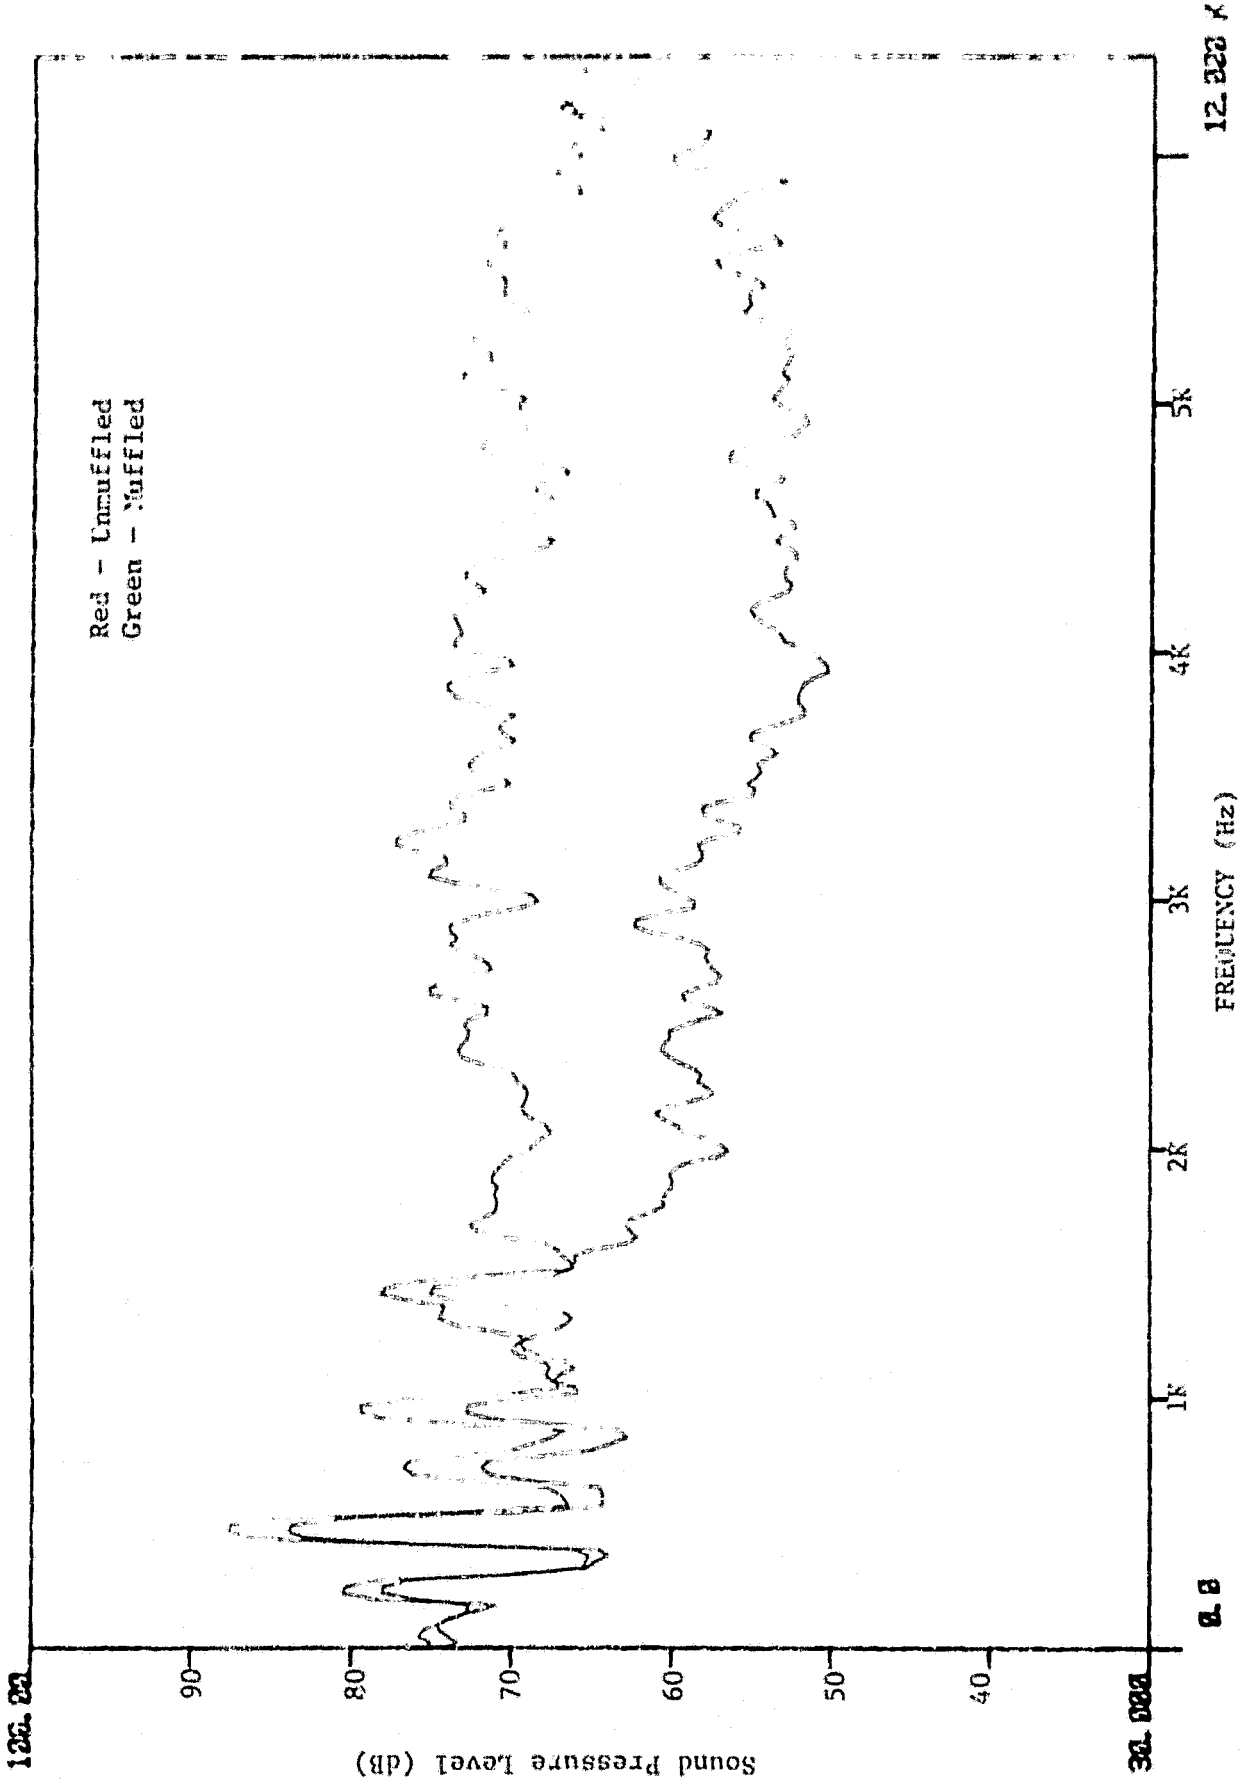
Figure 35 - Sound Energy Spectrum Changes in the Vent Cutter

Figure 35 shows the change in sound spectra, measured one foot away from the exhaust part, both before and after muffler attachment. A noise reduction

of 5 dB was observed.

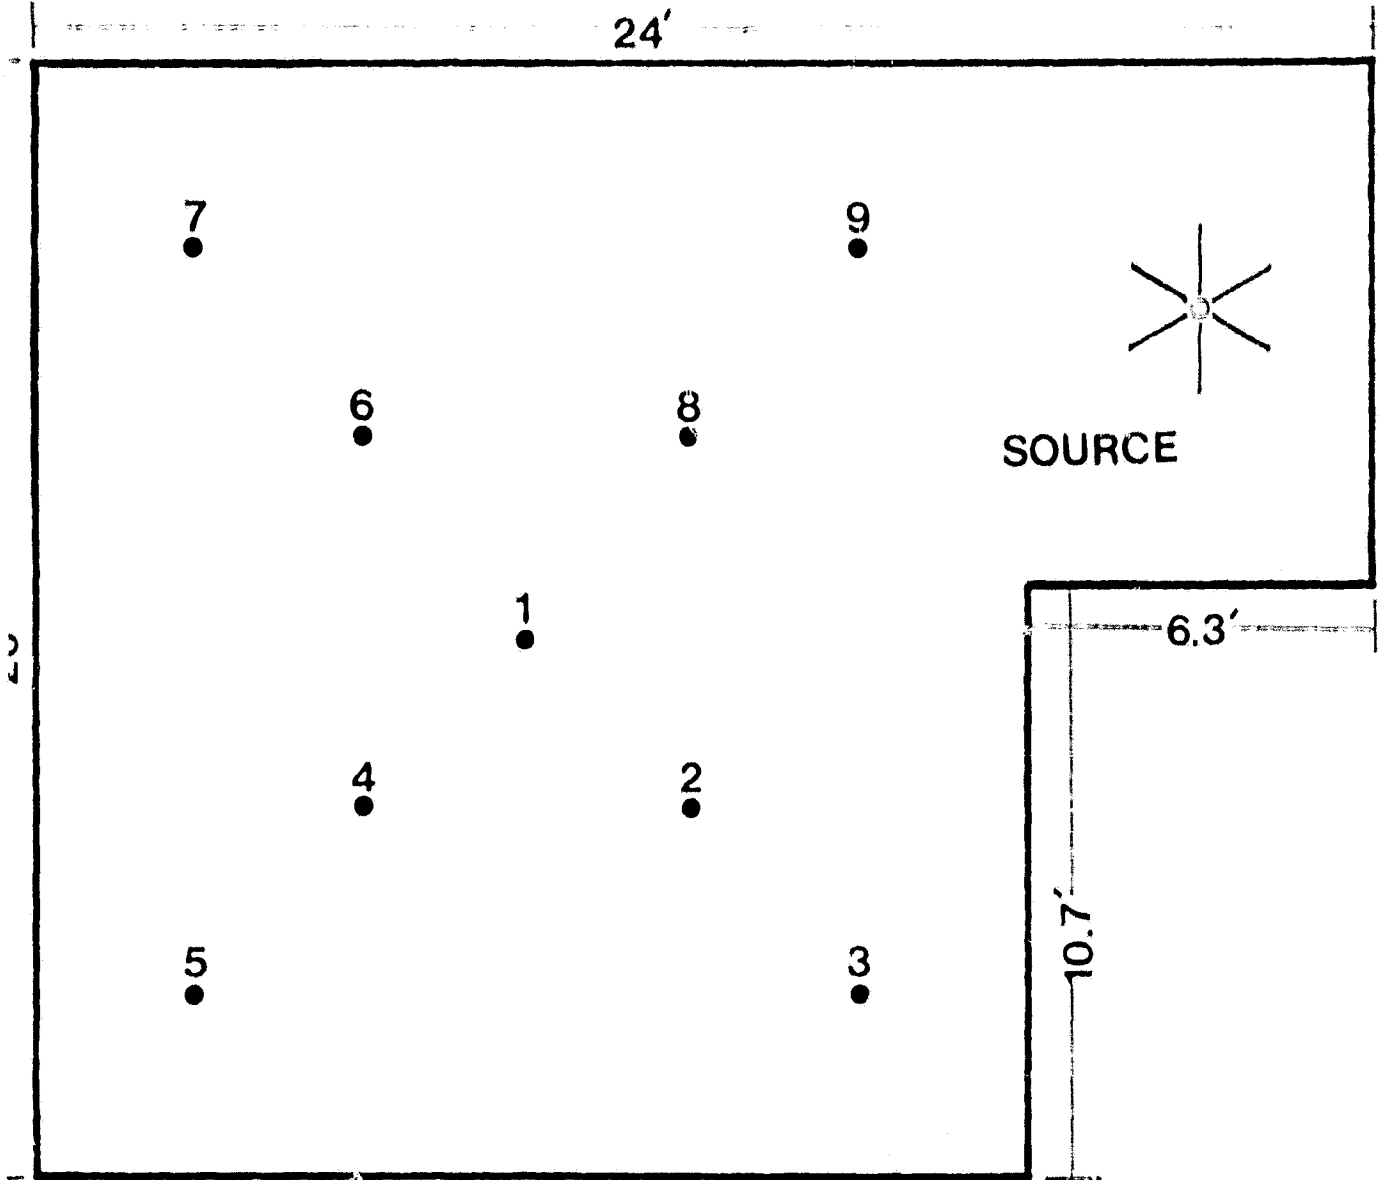
MICROPHONE HEIGHT - 3.4 ft

ROOM HEIGHT - 8.8 ft
