**SATELLITE-AIDED MOBILE COMMUNICATIONS
LIMITED OPERATIONAL TEST
IN THE TRUCKING INDUSTRY**

Roy E. Anderson
Richard L. Frey
James R. Lewis
General Electric Company
Corporate Research and Development
Schenectady, New York 12301

July 1980
Final Report for Period November 1977 - July 1980

Prepared for
NATIONAL AERONAUTICS AND SPACE ADMINISTRATION
Goddard Space Flight Center
Greenbelt, Maryland 20771
Contract Technical Officer - Dr. James P. Brown

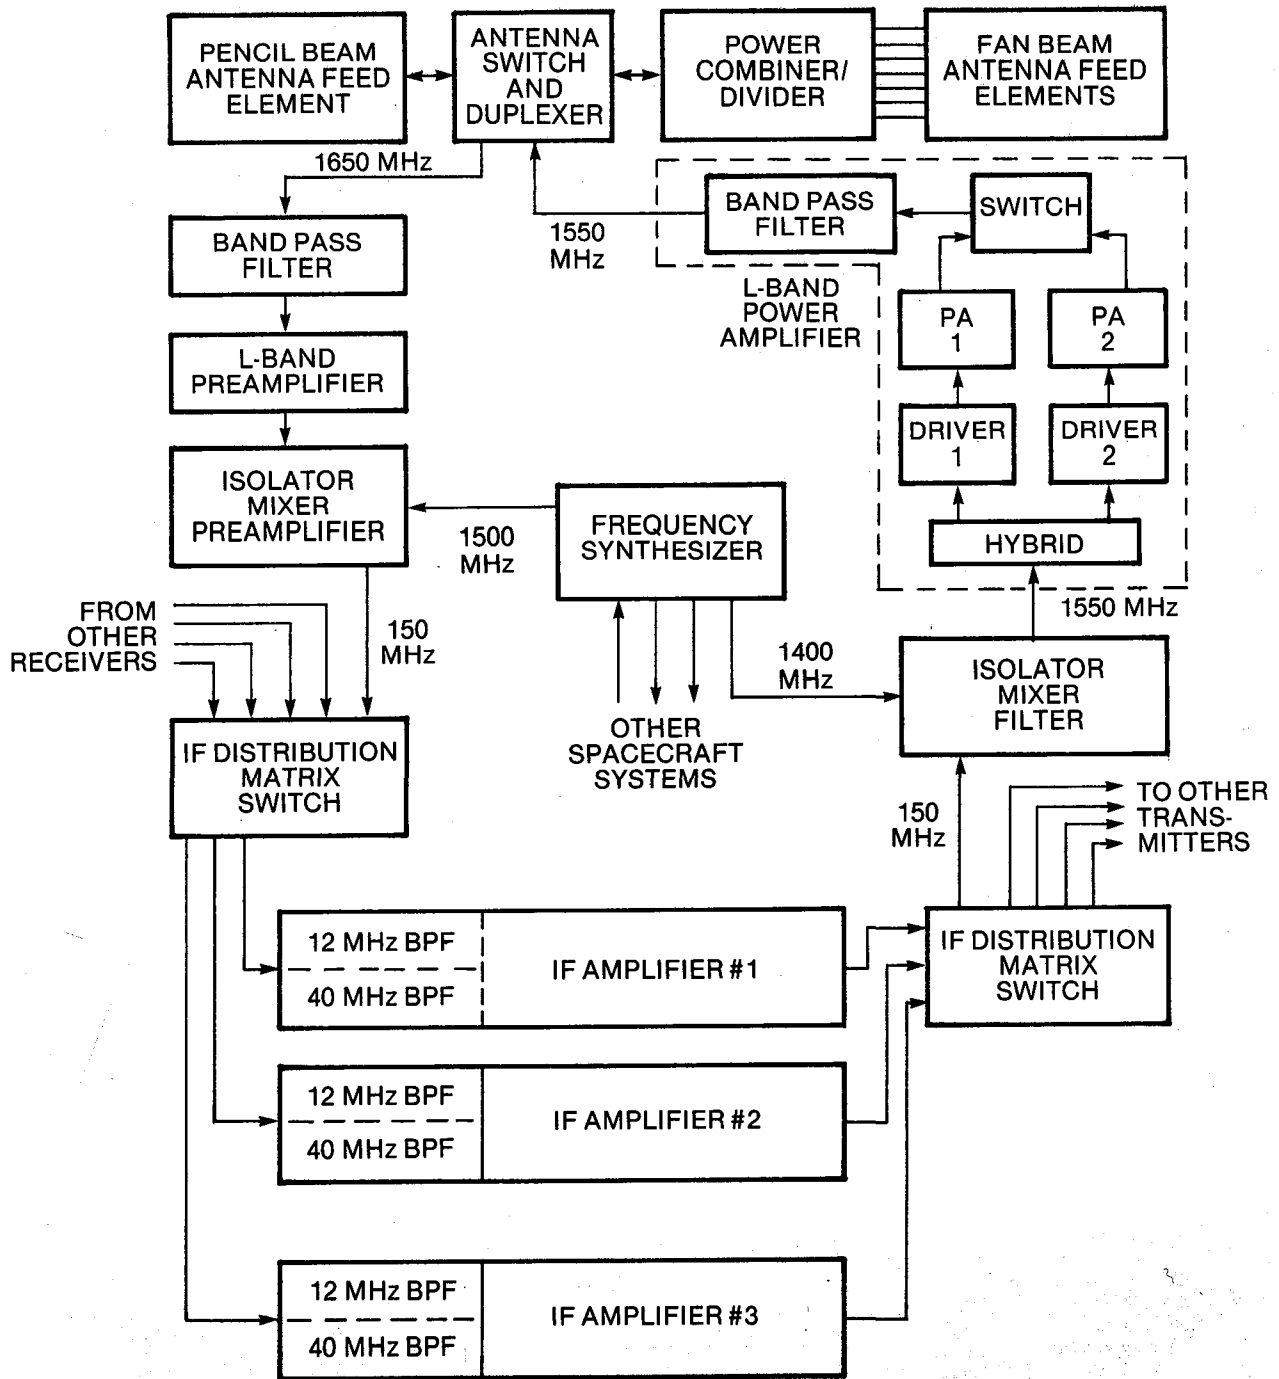
FIGURE 3.2
 ATS-6 COMMUNICATIONS TRANSPONDER
 L-BAND FREQUENCY TRANSLATION MODE

The power amplifier block contained two redundant drivers and power amplifiers. The input signal was divided equally between the two L-band driver amplifiers but only one driver amplifier pair had DC power applied to it. A radio-frequency switch connected the output from the selected L-band power amplifier through a bandpass filter to the antenna switch and diplexer. The transmitter was thus connected to the same antenna element that was used to receive the uplink signal.

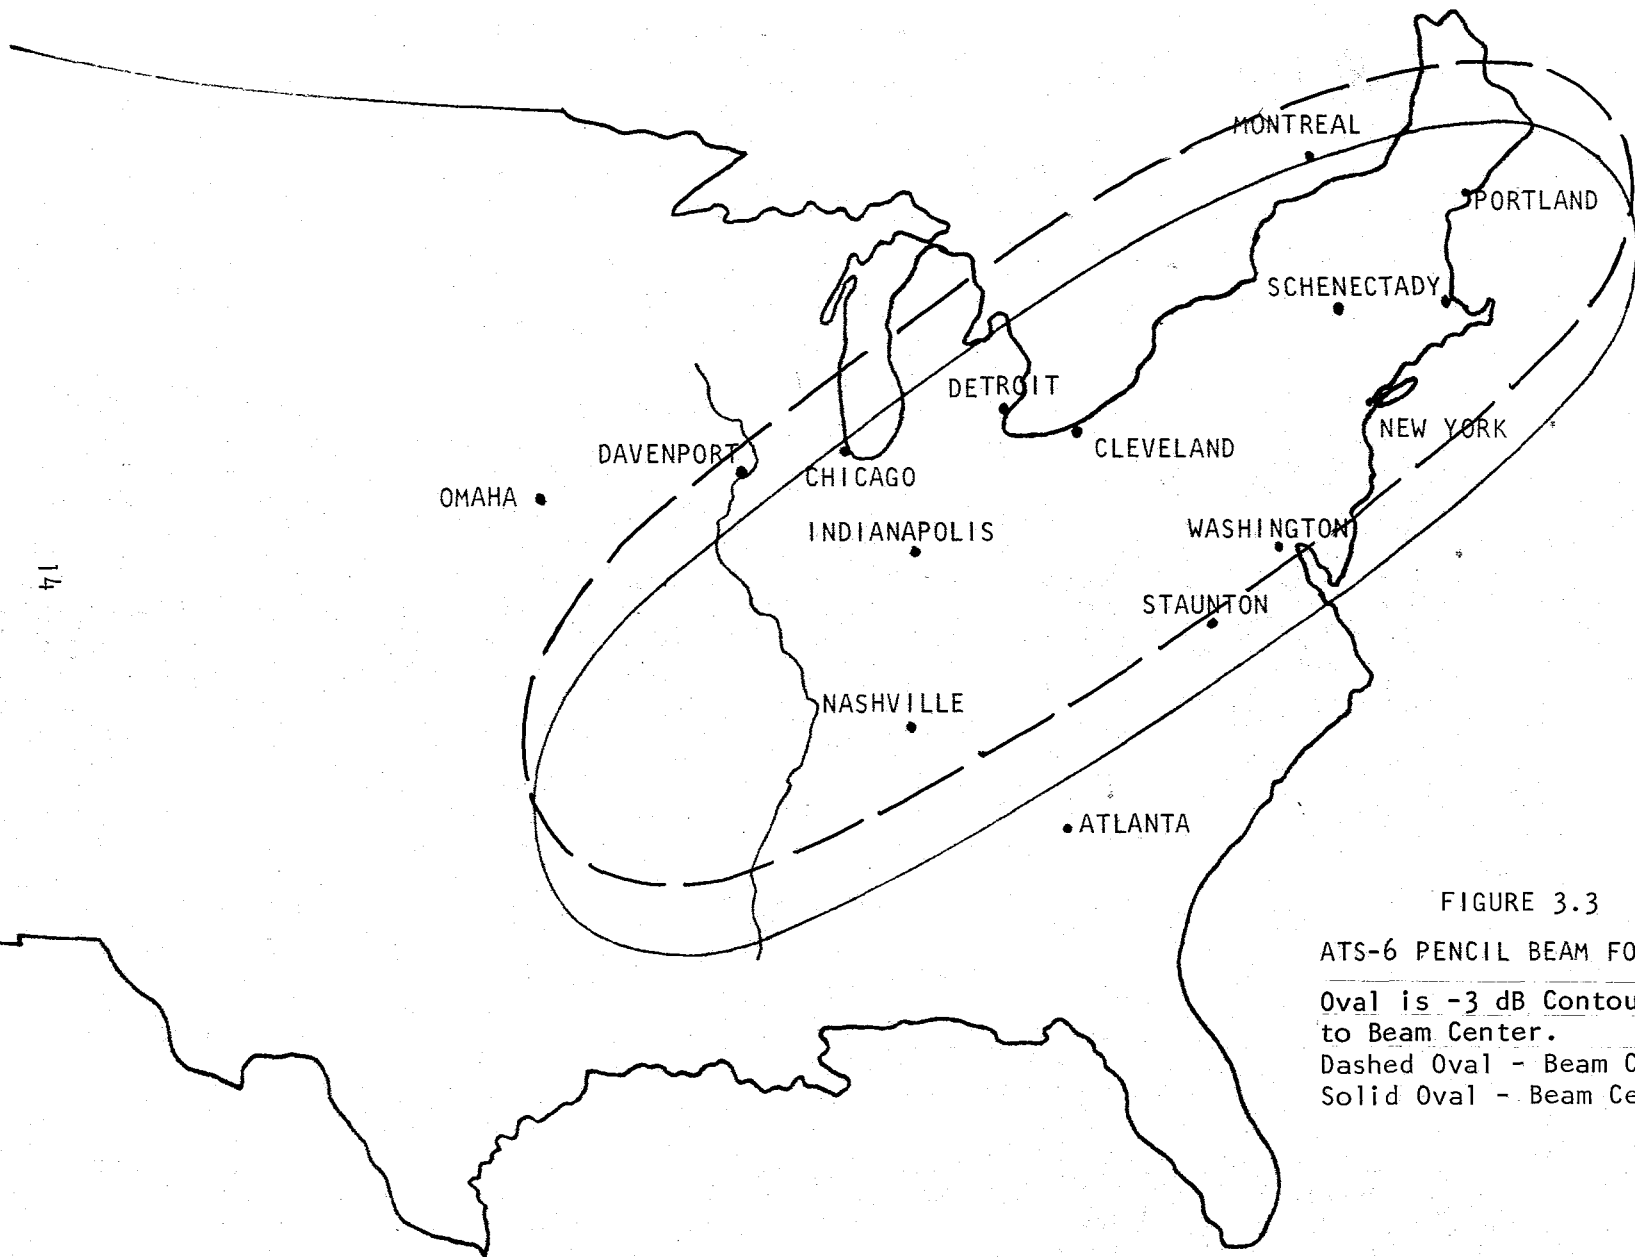
FIGURE 3.3

ATS-6 PENCIL BEAM FOOTPRINT

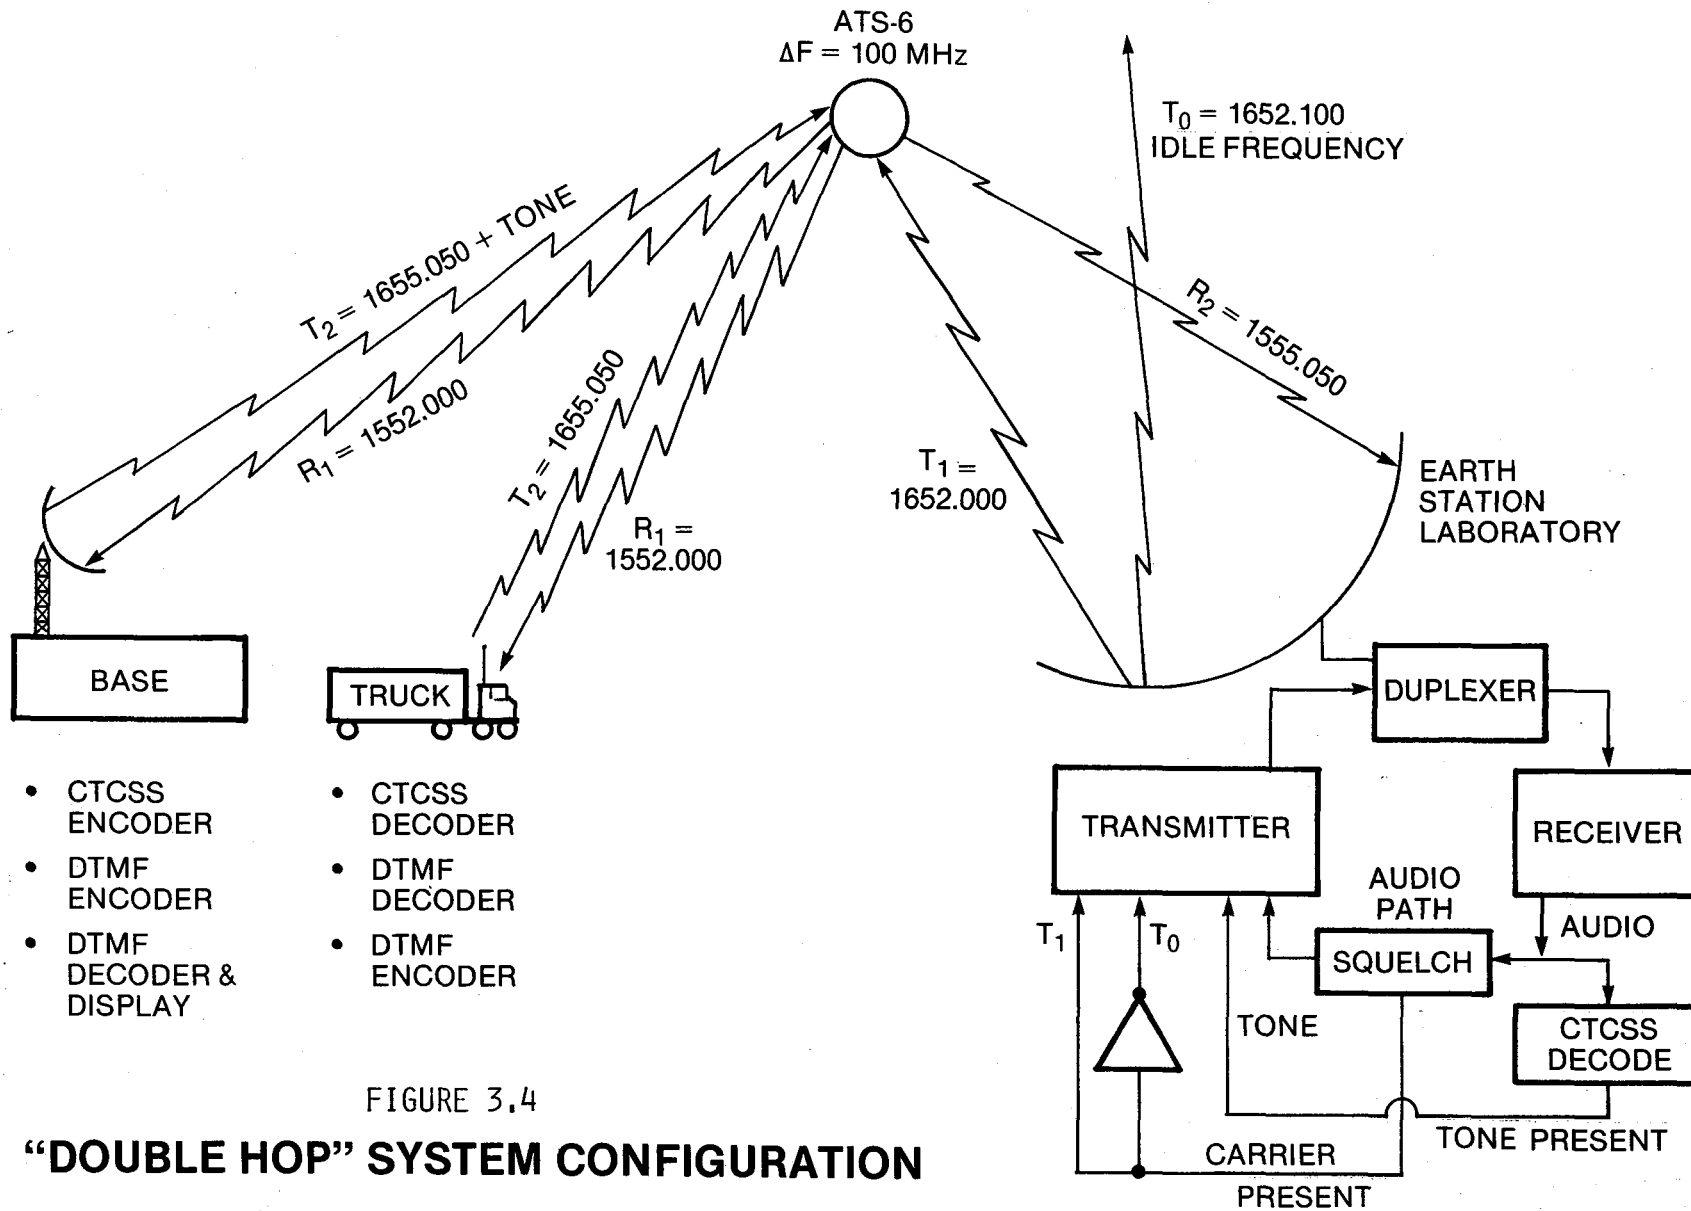
Upon receiving a truck or base station, the ESL transmitter immediately and automatically changed its frequency to the one the trucks and base station could hear, thus any message transmitted by the truck or base station was relayed to all other stations in the network. Only one station in the network could transmit at any given time. Although Figure 3.4 shows the truck near the base station, the truck could operate anywhere within the beam of ATS-6 (see Figure 3.3). A message originated by one station passed through the spacecraft was detected and repeated by the ESL and then retransmitted through the spacecraft a second time, hence the designation: "double hop configuration."

The transmit power of the ESL was adjusted to nearly saturate the spacecraft transponder, thereby capturing most of its transmitter power. The trucks could then receive satellite signals with small antennas. If the ESL transmitted more than just enough power to saturate the spacecraft transponder, less power would have remained for the weak truck transmissions

making them more difficult to receive at the ESL. It should also be noted that the ESL equipment functioned in the full duplex mode. The filter duplexer mounted at the Earth Station Laboratory antenna permitted the simultaneous transmission and reception of ATS-6 signals.

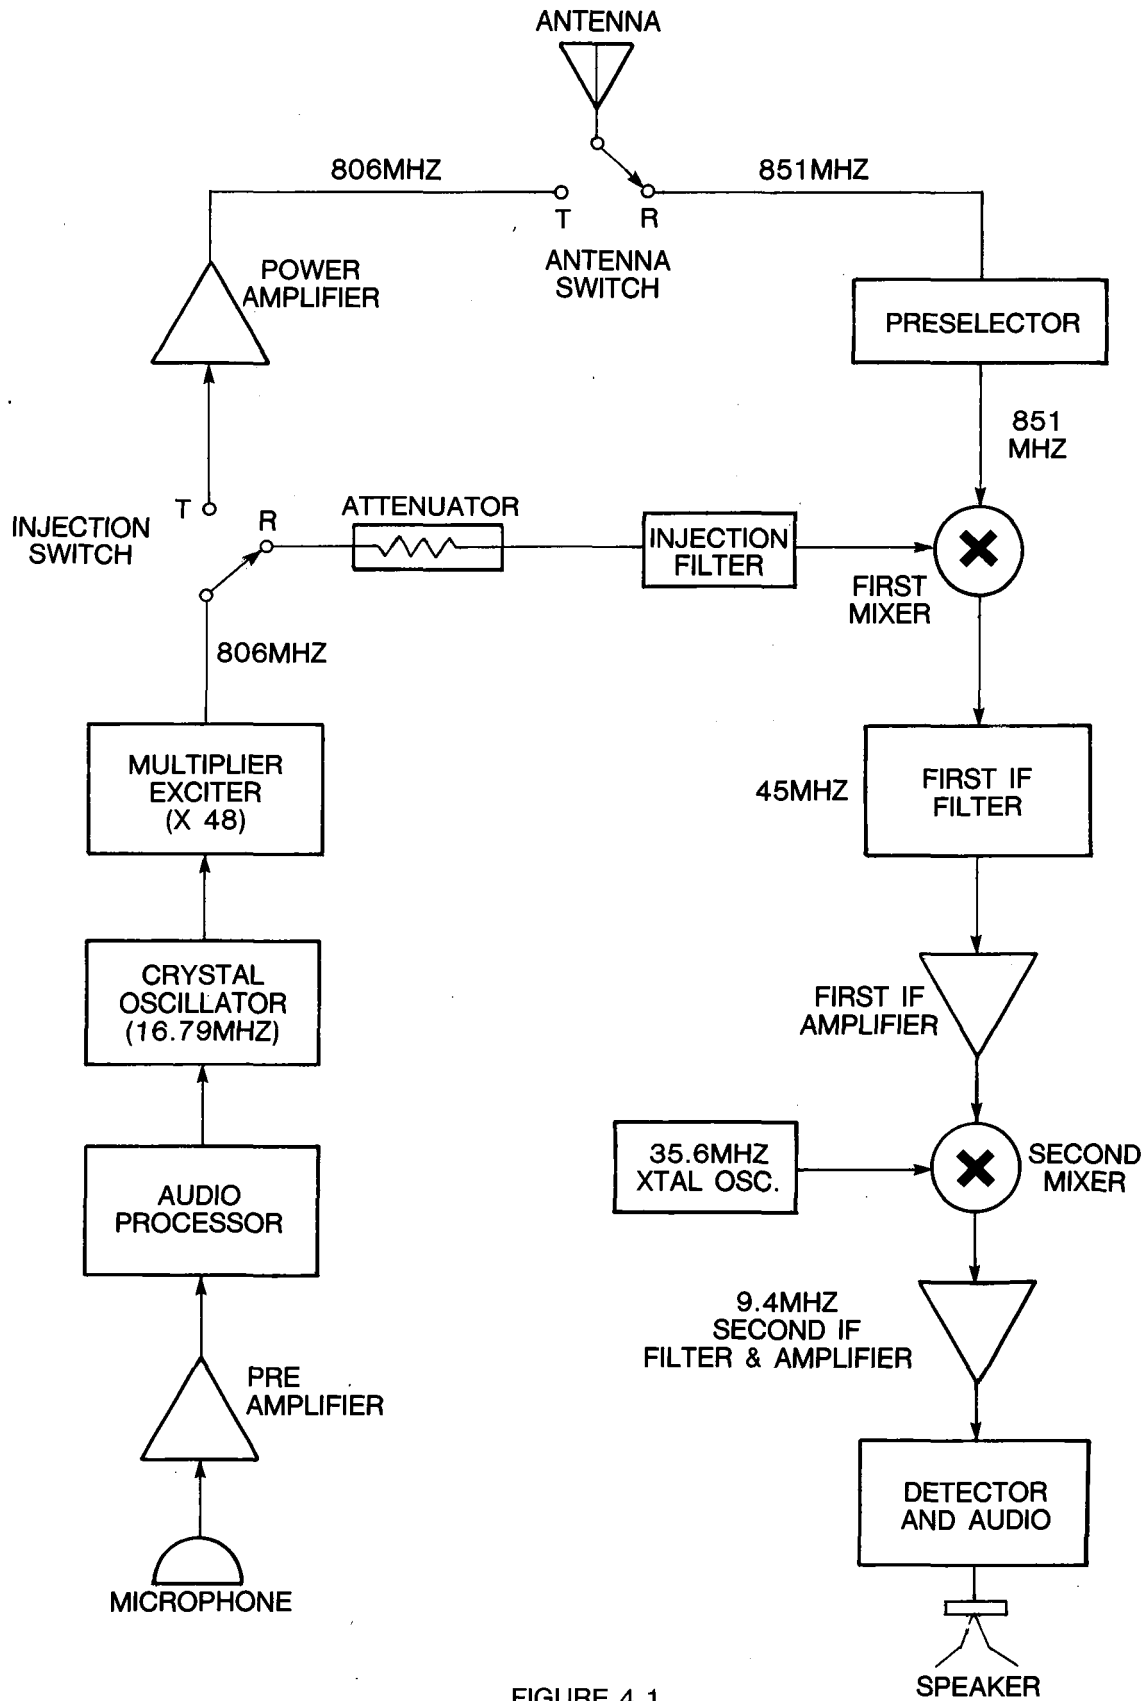
FIGURE 4.1
800 MHz MASTR® EXECUTIVE II
MOBILE RADIO SET

The transmitter crystal oscillator and the multiplier exciter operate continuously whenever the radio set is turned on. In the receive mode the microphone preamplifier and the audio processor are disabled to prevent incidental noise reaching the microphone from modulating the signal generated by the crystal oscillator. In the receive mode, the injection switch connects the output from the multiplier-exciter (typically on 806 MHz) through an attenuator and the injection filter to the first mixer of the receiver. Received signals pass from the antenna through the antenna switch and the pre-selector to the first mixer. The preselector filter passes only signals approximately 45 MHz above the 806 MHz first mixer injection frequency. The first mixer then converts the signal received at exactly 851 MHz to

exactly 45 MHz. Only this signal can pass through the first IF crystal filter tuned to 45 MHz. The 45 MHz signal then passes through the remainder of the receiver in a conventional manner.

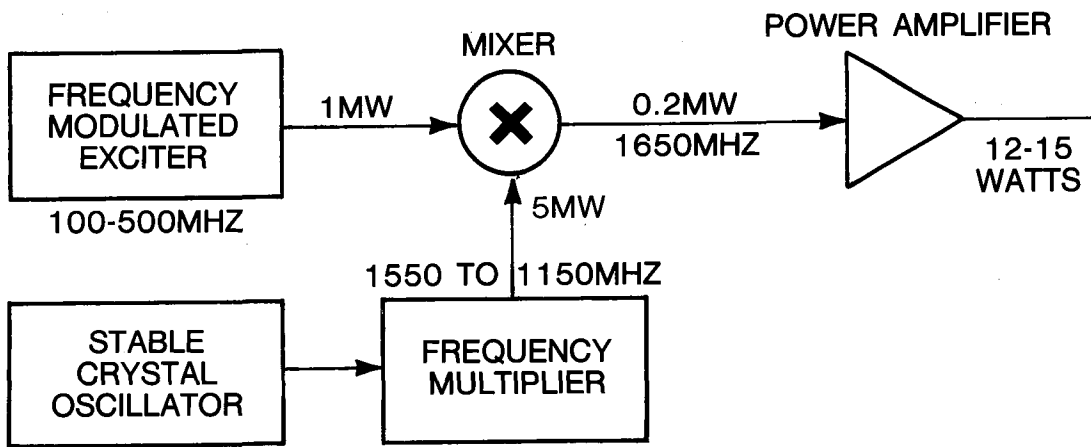
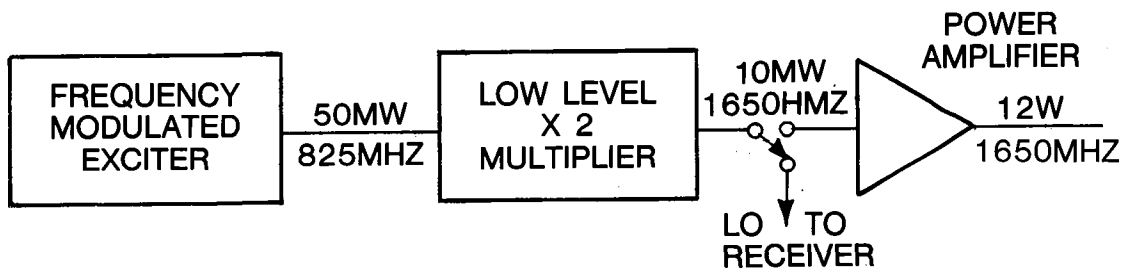
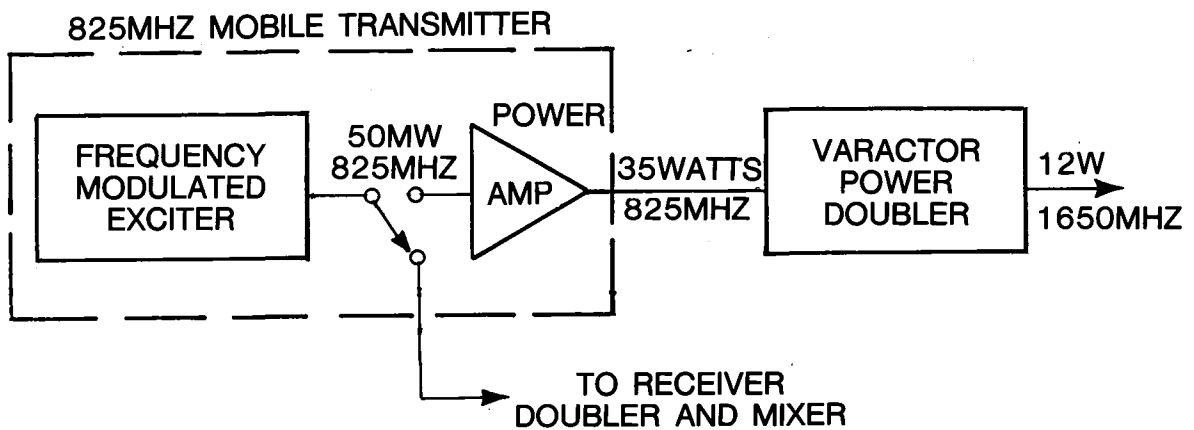
FIGURE 4.2
TRANSMITTER DESIGN OPTIONS

The mixer-amplifier approach also requires a second stable crystal oscillator-frequency multiplier assembly to provide local oscillator injection to the first receive mixer that converts the 1550 MHz satellite downlink signal to the input frequency of the FM transceiver. Each custom-made stable local oscillator assembly was nearly as expensive as a complete mobile radio set mass produced for the land mobile market. The cost of the power amplifier made the mixer-amplifier approach nearly twice as expensive as its nearest alternative.

Figure 4.2B illustrates a second approach considered for the design of the transmitter. The approach uses an 825 MHz exciter which normally drives a power amplifier in 800 MHz land mobile radio equipment. The output from the exciter passes through a low-level frequency doubler which drives a power amplifier to develop the required 12-15 watts of output at 1650 MHz. In the receive mode, the output of the low-level frequency doubler passes through a relay to serve as the local oscillator injection for the first receive mixer as described in Section 4.1.

A. MIXER-AMPLIFIER

B. LOW LEVEL MULTIPLIER-AMPLIFIER

C. HIGH LEVEL POWER DOUBLES

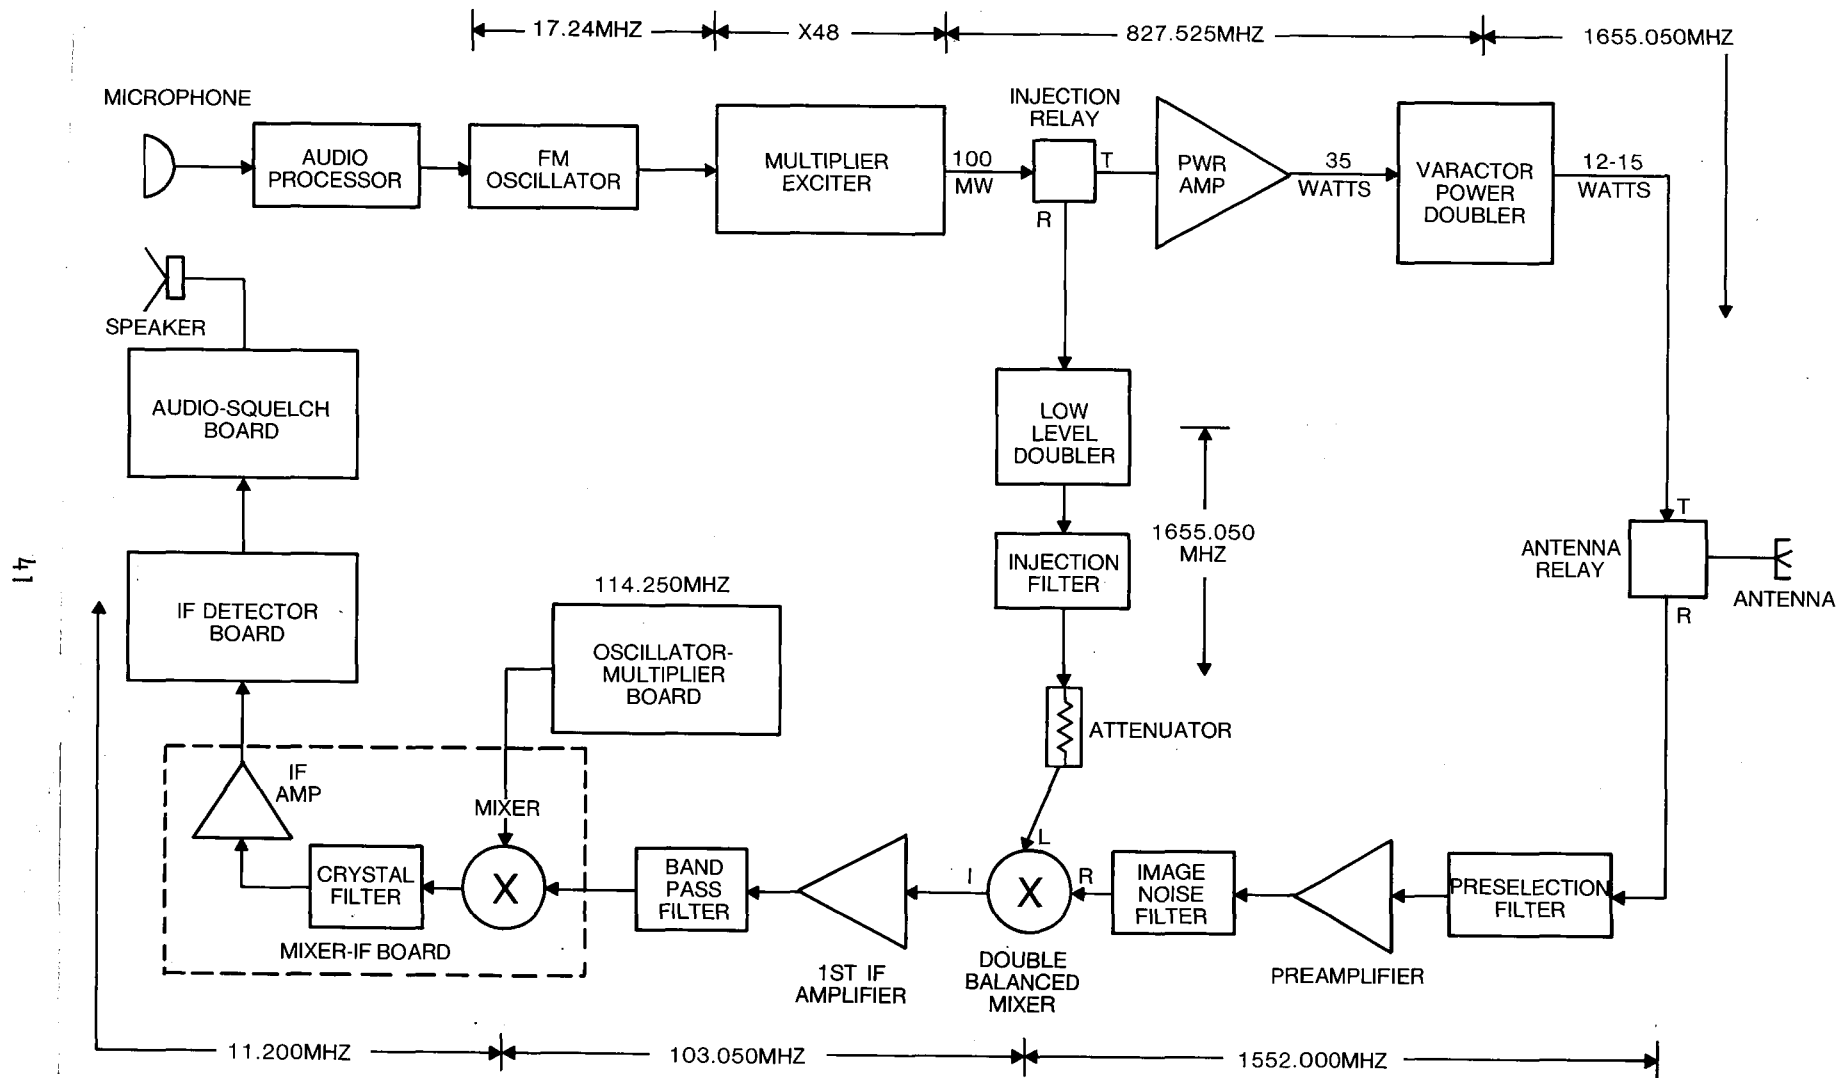
FIGURE 4.3
SATELLITE-AIDED LAND
MOBILE RADIO TRANSCEIVER

As discussed in Section 4.1, a transceiver using a single stable crystal oscillator must have a receiver first intermediate frequency equal to the difference between its transmit and receive frequencies. The Mastr[®] Executive receiver design for 138 to 155 MHz was selected as a standard product that could be readily modified to receive the 103.050 MHz first IF signal in the satellite receiver. The receiver RF and IF sections of the 800 MHz radio set were completely replaced by corresponding sections of a 138 MHz receiver from the same Mastr[®] Executive product line. Corresponding circuit boards and assemblies within the same product line are mechanically and electrically interchangeable so the mechanical integrity of the mobile radio set was maintained. The remaining assemblies required to complete the satellite receiver were mounted in various free spaces within the 138 MHz receiver RF casting and within the original radio case.

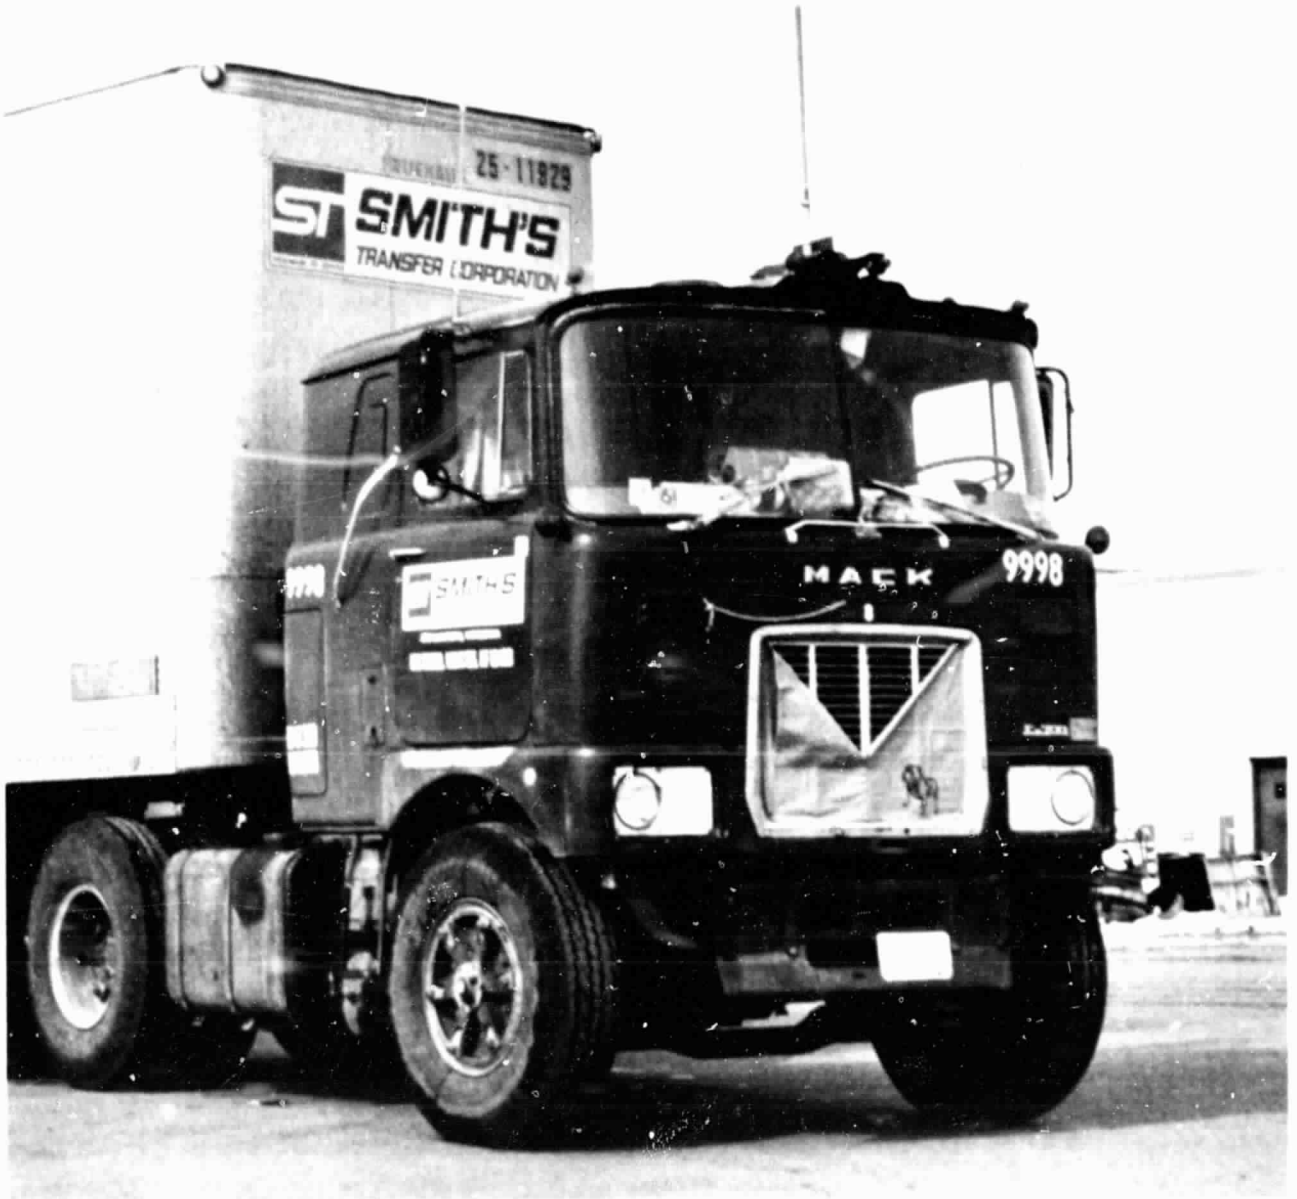
FIGURE 4.4
TRANSPosed COAXIAL ANTENNA
MOUNTED FOR USE

The Transposed Coaxial Segment array was selected for this experiment primarily for its low cost. Five antennas were designed, constructed and tested at a cost substantially less than estimates for any alternate designs. The antenna also met requirements for simple mounting and sturdy construction. Its 1 inch by 30 inch "stick" shape also represented a relatively unobtrusive addition to the cab of a tractor-trailer truck as can be seen in Figure 4.4. The antenna was mounted in the center of the cab roof as far forward as possible, directly over the windshield for the clearest view toward the satellite.

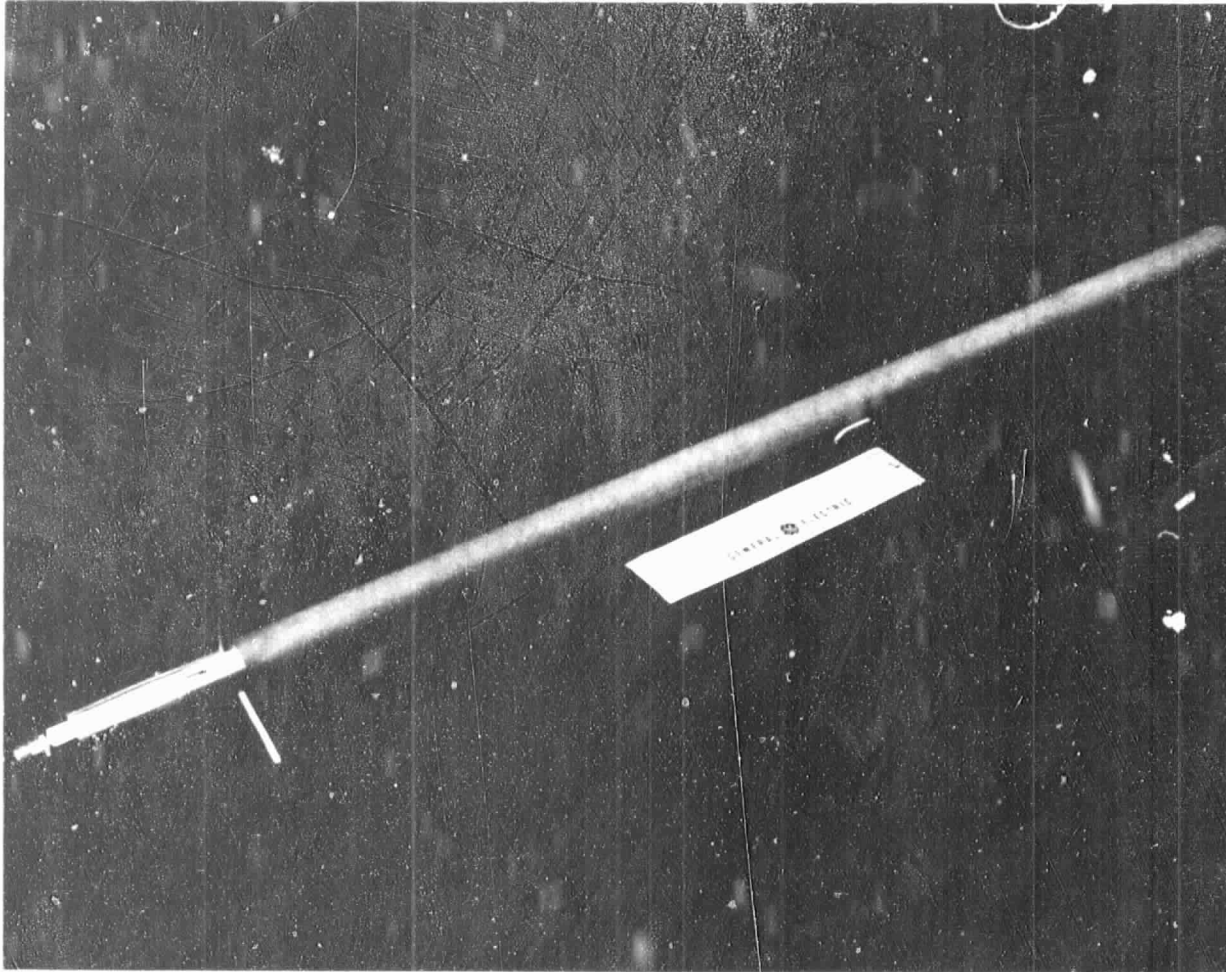
FIGURE 4.6
COMPLETE TRANSPOSED COAXIAL SEGMENT ANTENNA

lengthening of each section to achieve the required 14° upward beam tilt. Figure 4.7 is a photograph of the internal antenna assembly before insertion into the protective outer tube. Individual elements of the antenna, each slightly longer than one-half wavelength are assembled to a fiber glass center board with the center conductor of one section soldered to the outer sheath of the next section and conversely. Sections of the antenna were cut from $1/4''$ solid copper shield semiflexible coaxial cable with teflon[®] dielectric.

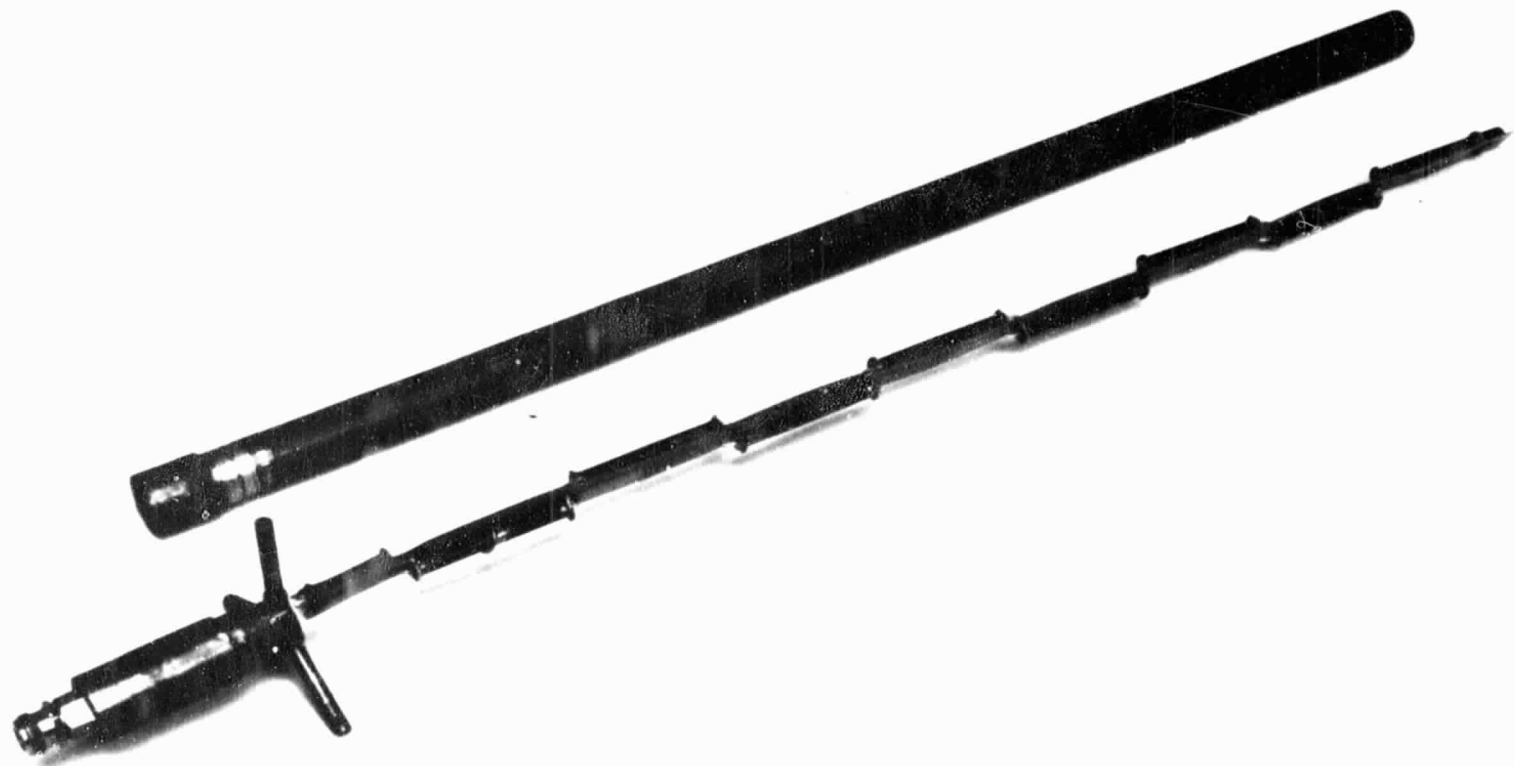
FIGURE 4.7
TRANPOSED COAXIAL SEGMENT ANTENNA
INTERNAL ASSEMBLY

Figure 4.7 shows internal fabrication details of the Transposed Coaxial Segment Antenna. Seven equal length segments are fastened alternately to both sides of a $0.031''$ thick fiber glass center board with the shield and center conductor cross connected at each segment joint. The top section has an external length of one-half wavelength in air but contains a short circuit connection from the center conductor to the sheath at the quarter wave point to provide a resonant termination to the antenna array.

The bottom section of the antenna also serves as the feedline input to the completed antenna. A convenient length of $1/4''$ semiflexible coaxial cable was inserted through an offset hole in the cylindrical brass base of the antenna to extend $1/4''$ wavelength (in air) above the three ground plane radials. The cable was then soldered into the base, attached to the center board assembly, and cross connected to the next higher antenna element on the center board. The antenna was fed through a connector assembled to the portion of the cable extending from the bottom of the base.

The fiber glass center board was designed just narrow enough to fit snugly within the protective outer tube, so that the internal parts would not fail from excessive vibration. In the final assembly step, the fiber glass outer tube slides over the center board and tightly overlaps a 3/4 inch turned-down length of the machined brass base.

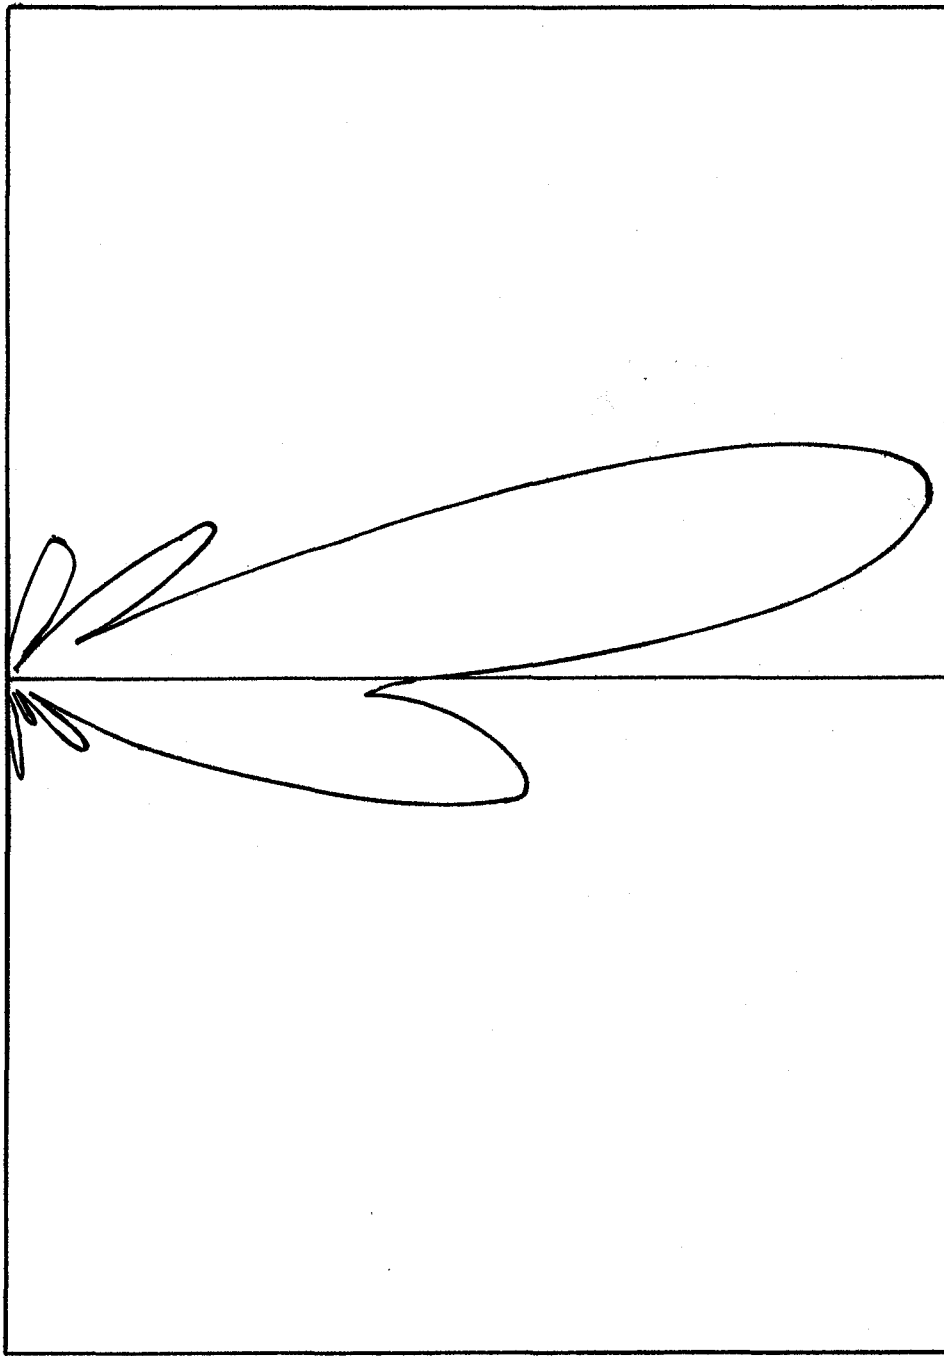
FIGURE 4.9
TRANSPosed COAXIAL SEGMENT ARRAY
ELEVATION PATTERN AT 1550 MHz RECEIVE FREQUENCY
RELATIVE ELECTRIC FIELD vs. ANGLE

In conclusion the transposed coax antenna produced a peak gain of greater than 4.3 dB ICP in the 1.55 - 1.65 GHz band and an edge of sector gain greater than .9 dB over the angles + 9° + 19° that view the ATS-6 satellite. The antenna is designed for a simple pipe clamp mount and is expected to withstand 60 mph winds while operating on a moving truck. The antenna is matched to less than 2:1 VSWR. An undesirable characteristic of a high secondary lobe 4 to 6 dB below desired peak may be caused by phase error along the antenna length.

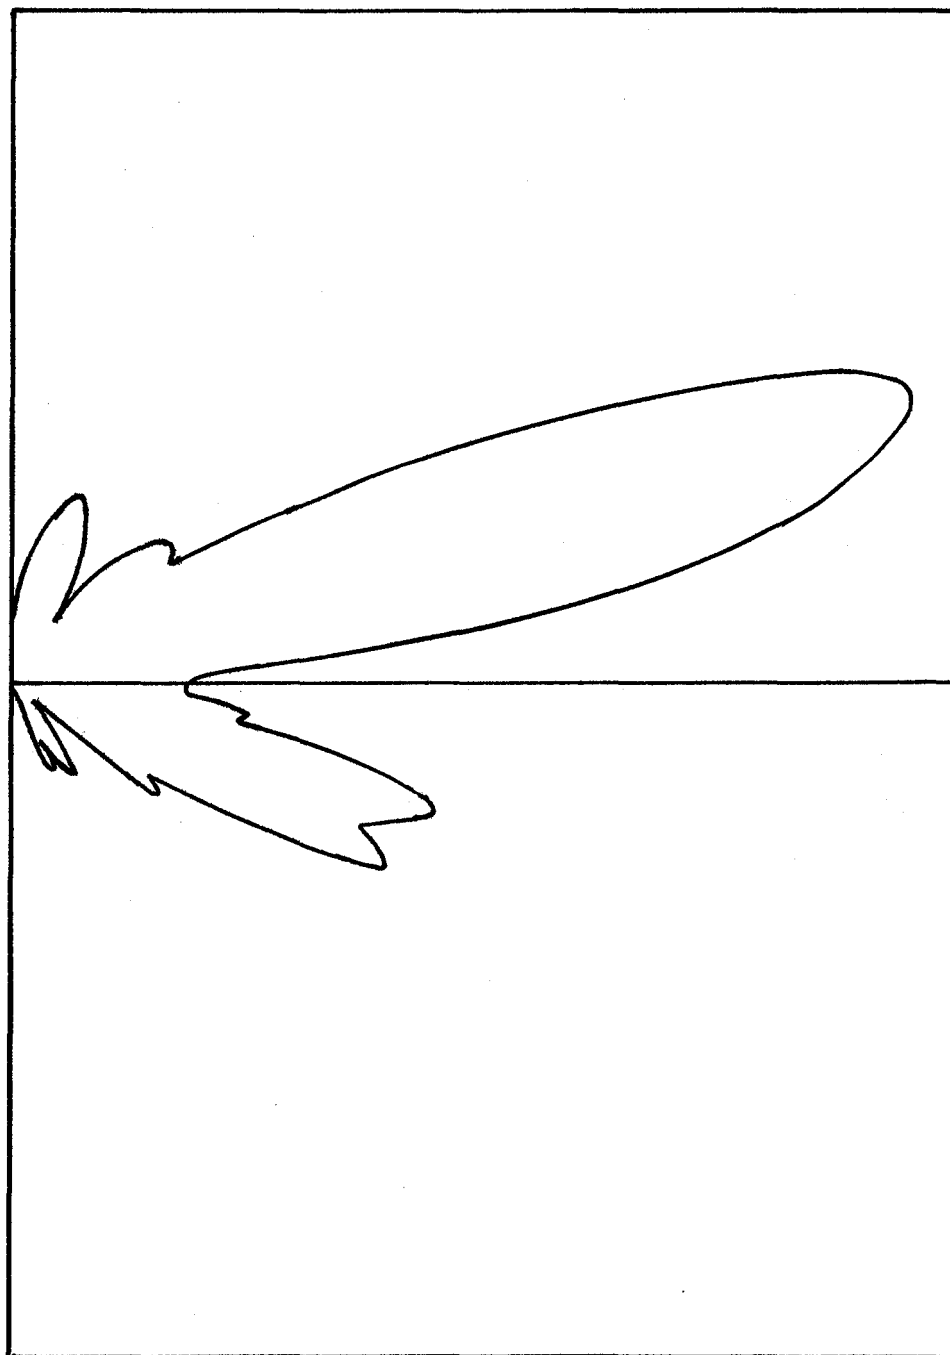
FIGURE 4.10
TRANSPPOSED COAXIAL SEGMENT ARRAY
ELEVATION PATTERN AT 1650 MHz TRANSMIT FREQUENCY
RELATIVE ELECTRIC FIELD vs. ANGLE

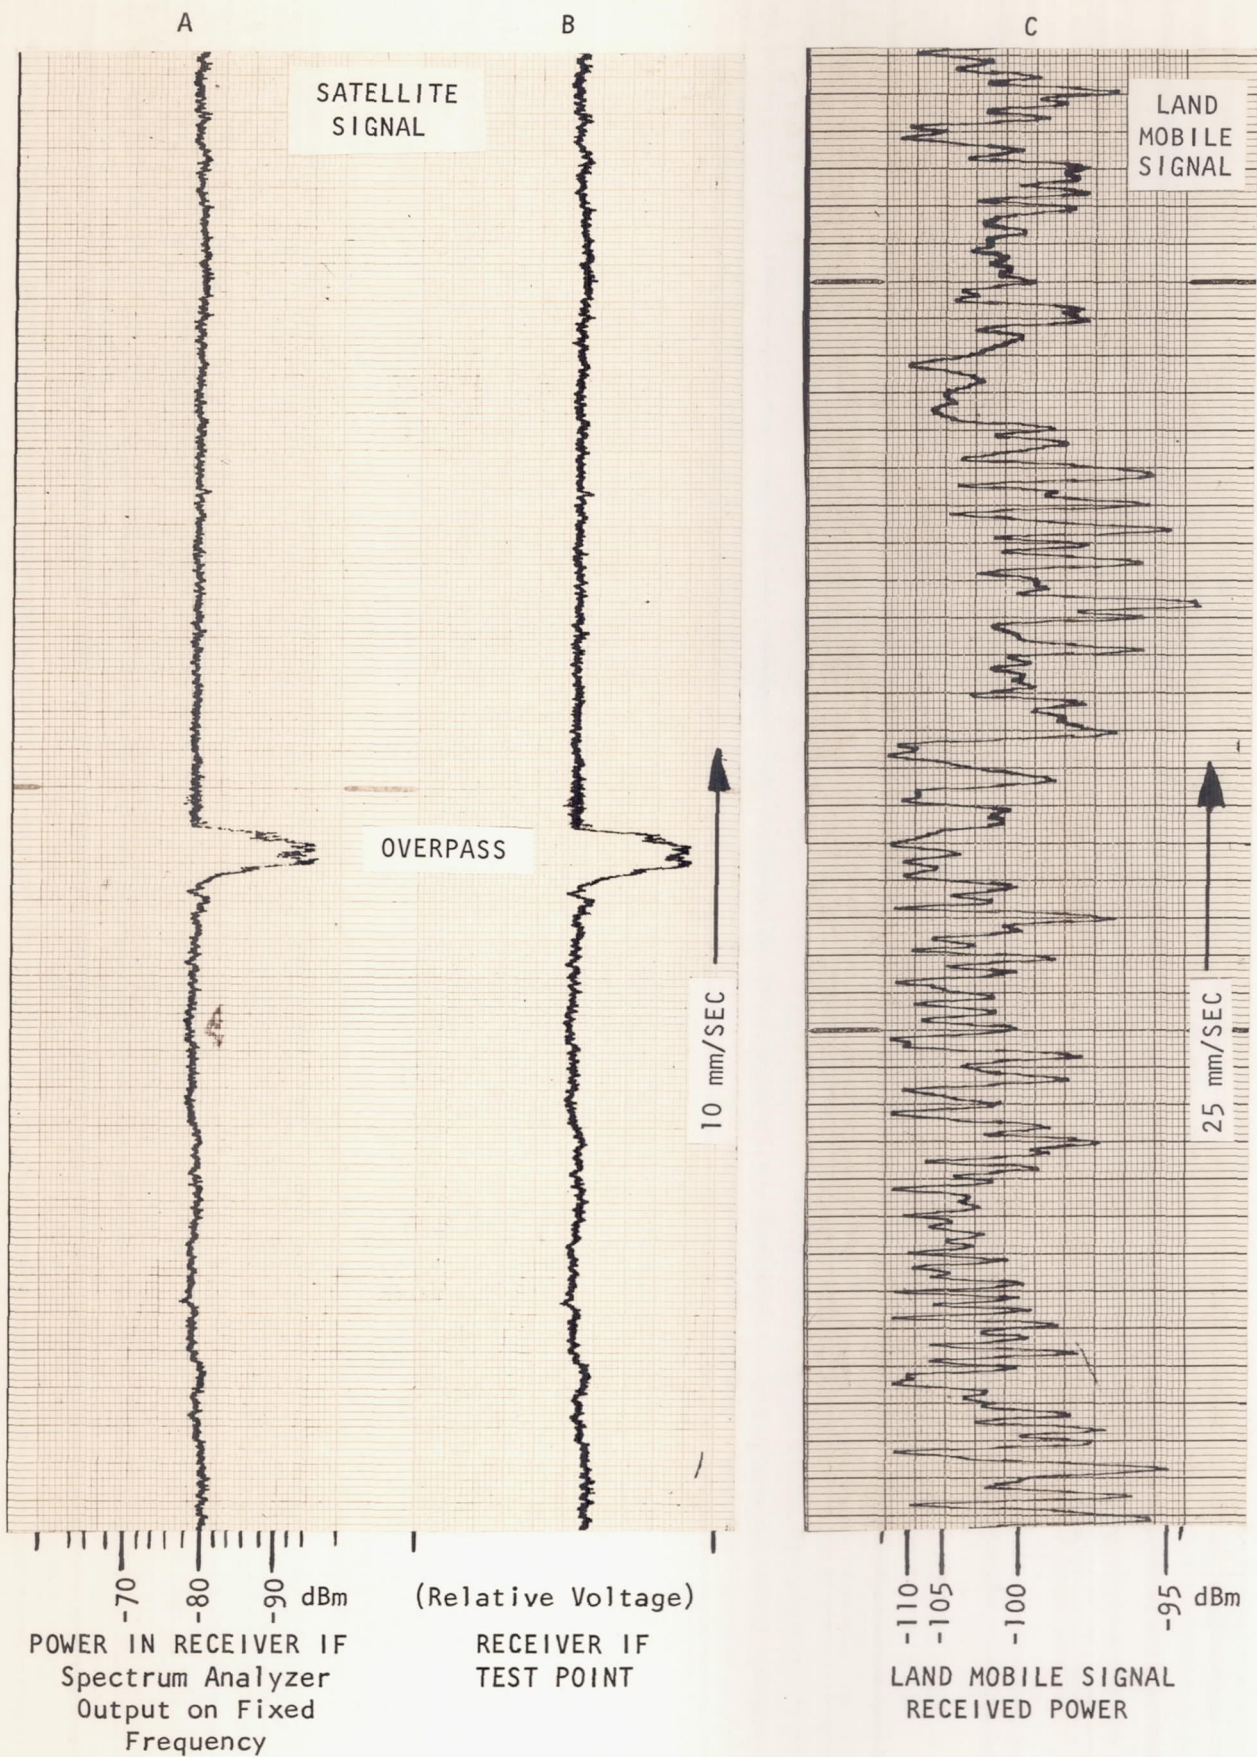
FIGURE 7.1
 COMPARISON OF SATELLITE RELAYED SIGNALS
 AND 150 MHz TERRESTRIAL LAND MOBILE SIGNALS
