**SATELLITE-AIDED MOBILE COMMUNICATIONS
LIMITED OPERATIONAL TEST
IN THE TRUCKING INDUSTRY**

Roy E. Anderson
Richard L. Frey
James R. Lewis
General Electric Company
Corporate Research and Development
Schenectady, New York 12301

July 1980
Final Report for Period November 1977 - July 1980

Prepared for
NATIONAL AERONAUTICS AND SPACE ADMINISTRATION
Goddard Space Flight Center
Greenbelt, Maryland 20771
Contract Technical Officer - Dr. James P. Brown

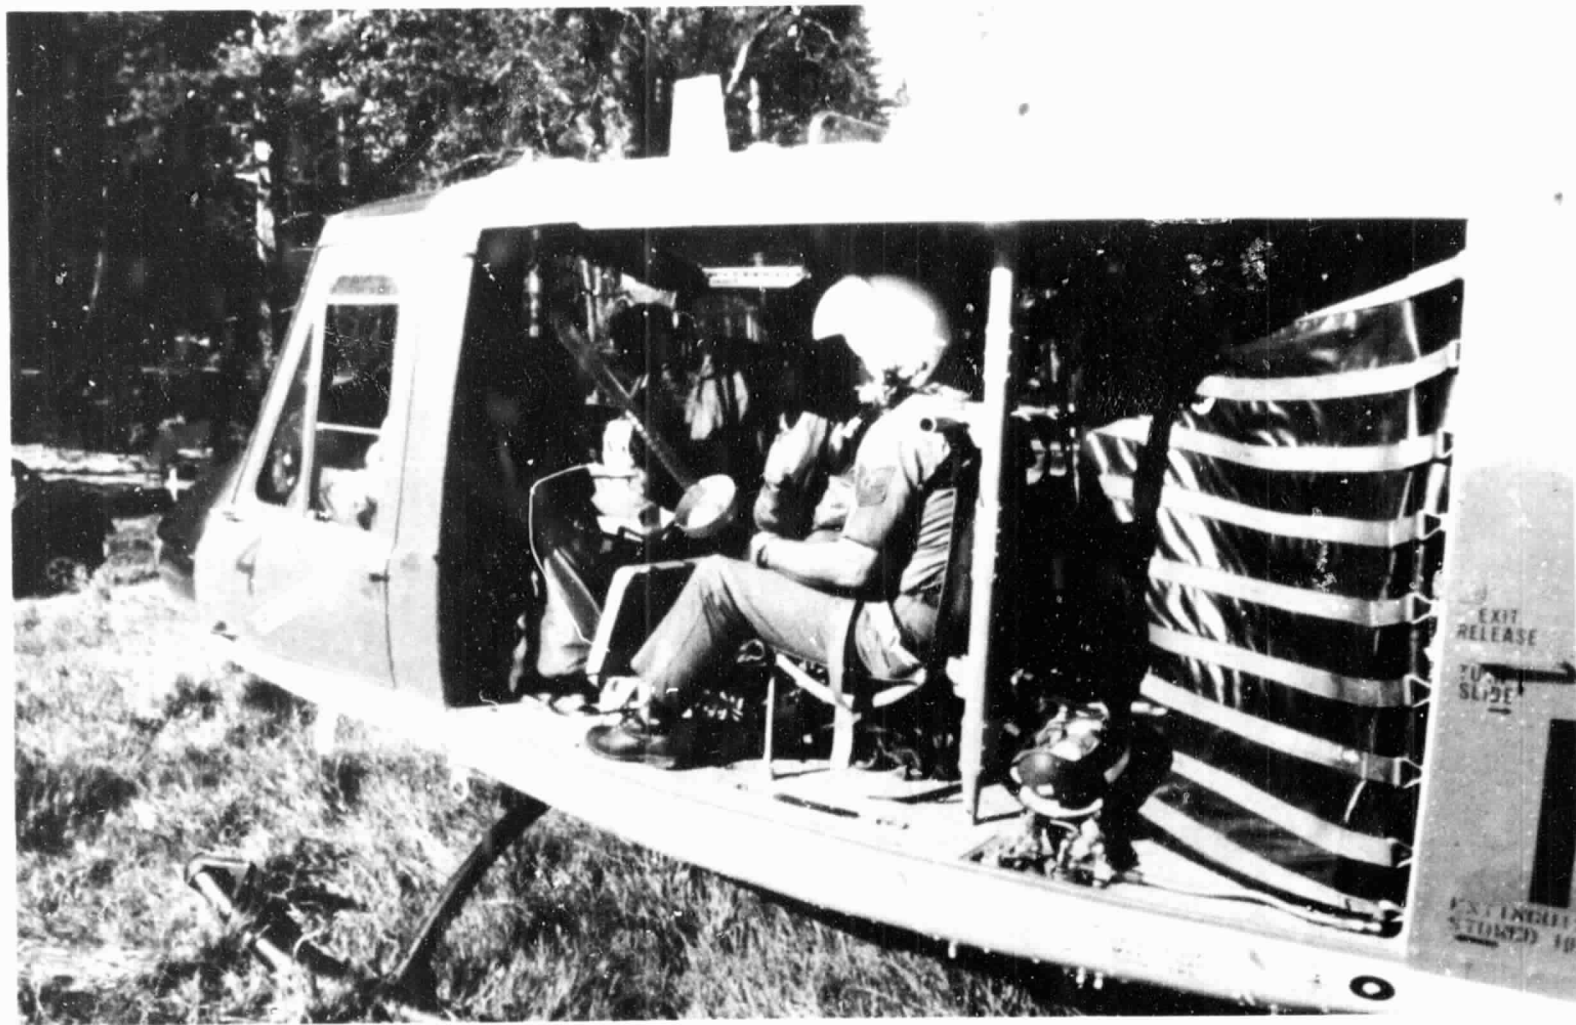
FIGURE 7.2
PHOTOGRAPH OF HELICOPTER USED FOR IN FLIGHT SATELLITE COMMUNICATIONS

Tests were conducted from a helicopter with a suitcase carried transceiver developed by Dr. James P. Brown of NASA-Goddard. The helicopter is shown in the photo, Figure 7.2. The rotor blades interrupted the path between the satellite and helicopter antennas each time the blade passed between them. The helicopter rotor has two blades. It was estimated that the satellite signal path was interrupted by the rotor blade at a radius of about six feet. Since the rotor blade is approximately a foot in width it interrupted the path approximately 2.8% of the time.

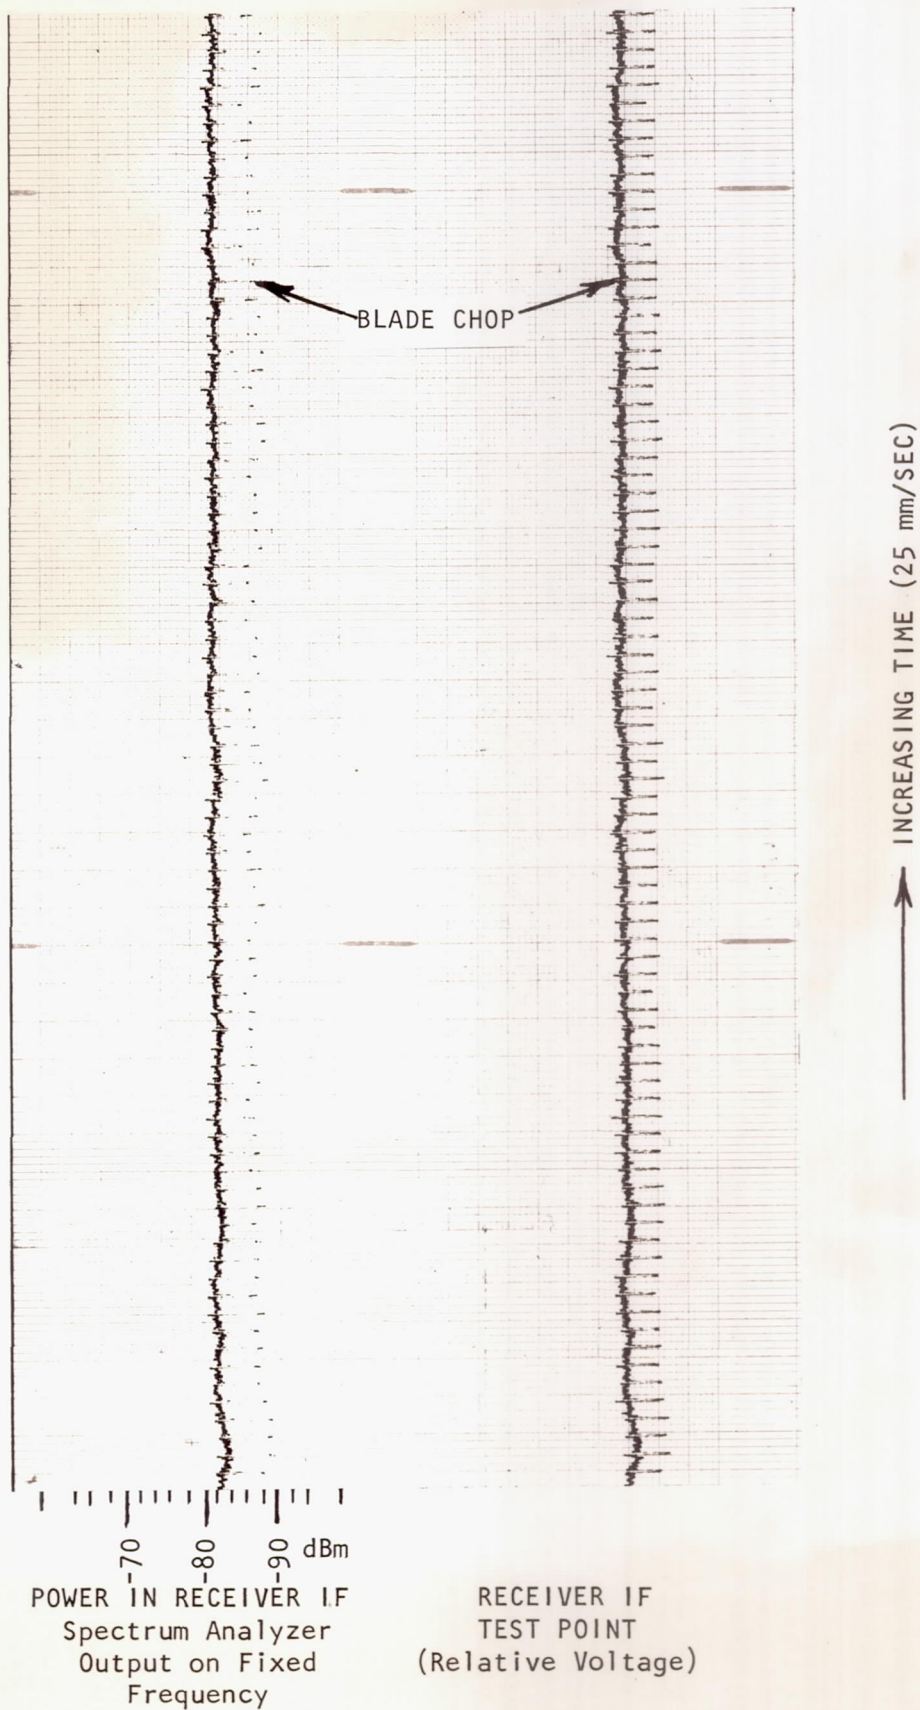
FIGURE 7.3
SIGNALS FROM HELICOPTER IN FLIGHT
VIA ATS-6 SPACECRAFT

Figure 7.3 is a recording of signals from the helicopter. The chart speed was 25 millimeters per second. It is obvious that the pen width of the chart could not resolve the interval that the signal dropped, but one

can see the brief straight lines showing the rotor blade interference. Again, typical of satellite communications only the brief clean chop of the signal path is noted. Not knowing the rotor speed, it was deduced from the speed of the chart and the spacing of the twice per rotation line to be 320 rpm. The actual dropout time was then approximately 2.5 milliseconds. Based on other two-way FM systems, it is expected that if the rotor interrupt time caused the audio to be blanked for 2.5 milliseconds, it would be difficult for the ear to detect any rotor effects.
