5101-131
Low-Cost
Solar Array Project

Photovoltaic Module Soiling Studies May 1978 - October 1980

A. R. Hoffman
C. R. Maag

(JPL PUBLICATION 80-87)

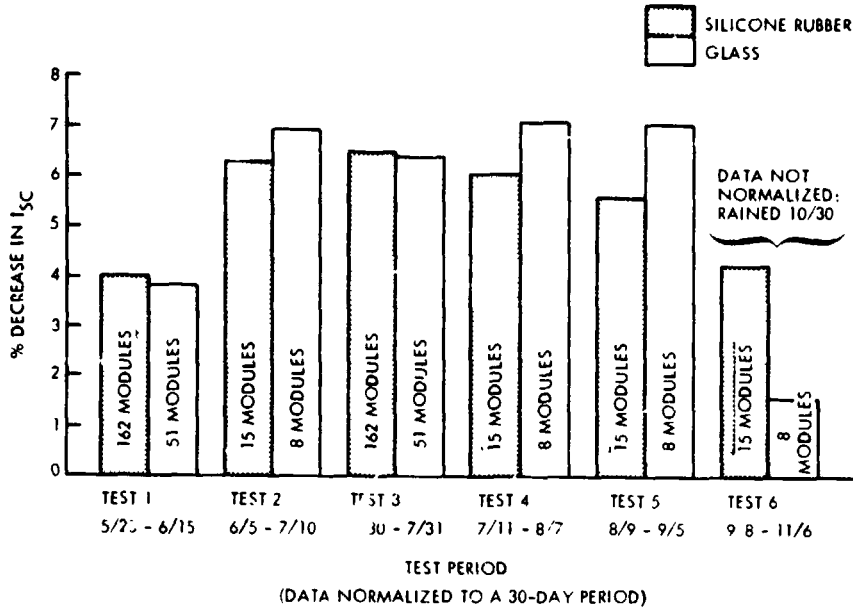
Figure 1. Electrical Performance Degradation of Modules During Rain-Free Periods in Pasadena CA (1978)

Typical average short-term electrical performance degradation of 6 to 7% per month has been observed during rain-free periods in Pasadena CA, independent of surface materials (Figure 1). Over long periods (about 6 mo) the net accumulation, including effects of natural removal, results in measured degradation ranging from 2% for glass-surfaced modules in Arizona to 60% for silicone-surfaced modules in high-pollution city locations (Cleveland and New York City).

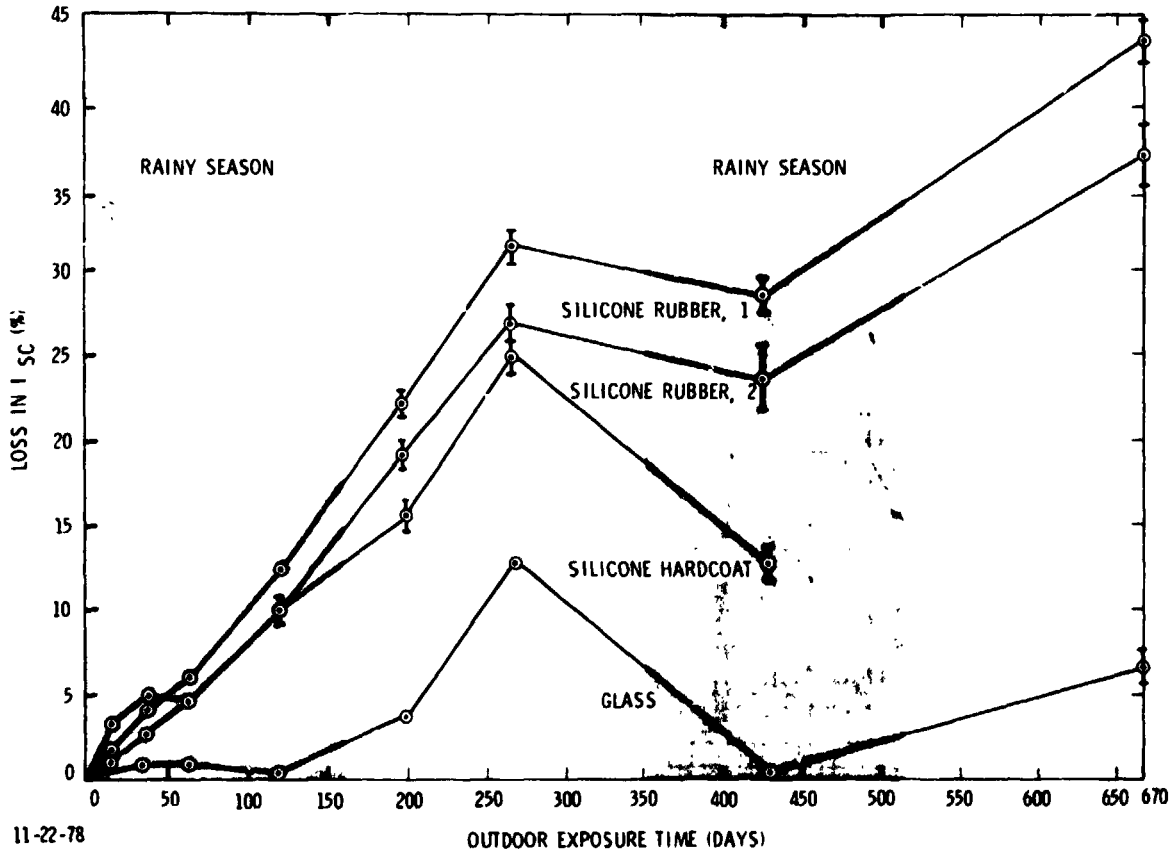
Figure 2. Module Soiling Without Cleaning: Pasadena, CA

The percentage changes in P_{max} and I_{sc} for various modules at various sites throughout the country are given in Appendix A. From the examination of the tabulated data and of Figures 1 and 2, the following observations are made:

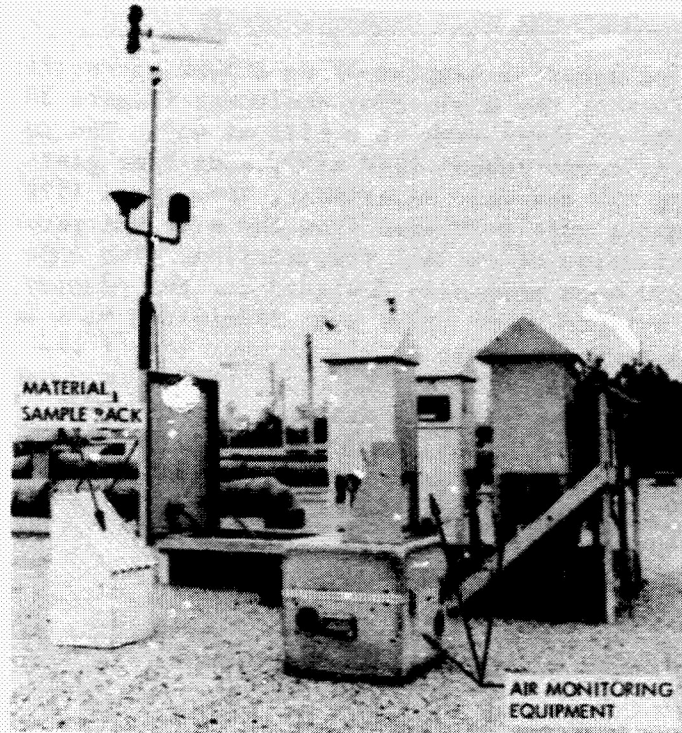
Figure 3. Material Samples at SCAQMD Air Monitoring Site, Pasadena CA

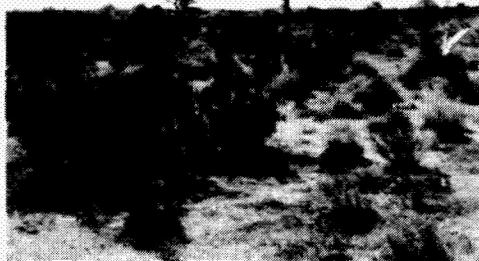
Goldstone Site Terrain

SCAQMD Monitoring Site, Pasadena

Jet Propulsion Laboratory Test Site

Test Rack With Material Samples

Figure 6. Some Outdoor Exposure Sites and a Typical Sample Test Rack

In order to prevent the influence of any factors other than environmental action upon the outdoor materials, a special test rack was constructed and deployed (with materials) at all outdoor exposure sites. The test rack was constructed of No. 316 stainless steel and was coated with Cat-a-Lac black epoxy, a high-quality aerospace (flight quality) black paint. In addition to the all stainless-steel construction hardware used, rain channels were incorporated between rows of materials samples to prevent draining of naturally removed (washed away) dirt over lower samples. The surface of the test rack was painted black for two reasons: to prevent photolysis of the samples from the double pass phenomenon (bare stainless steel has a relatively high spectral reflectance below 4000 Å) and to achieve an equilibrium temperature under the samples somewhere near that of an exposed module; the solar absorptance-to-hemispheric emittance ratio (α/ϵ) for the black paint and for the typical solar cell is near unity. Figure 6 shows a sampling of the outdoor exposure sites and one of the test racks.

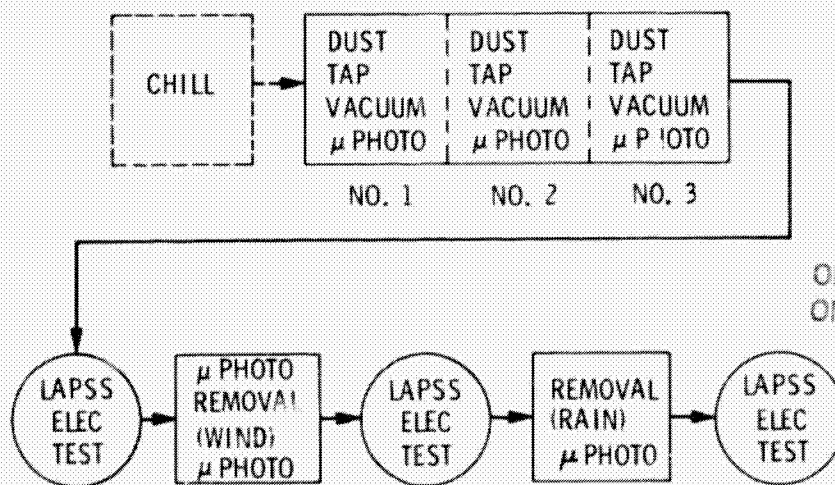
Figure 10. Laboratory Mirimodule Dust Test Sequence

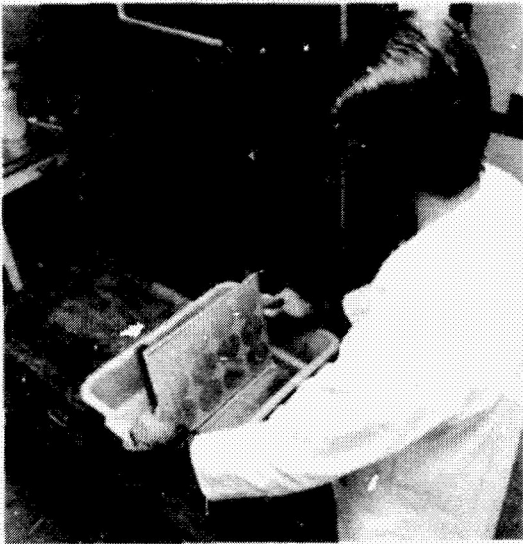
Figure 11. Tapping Step

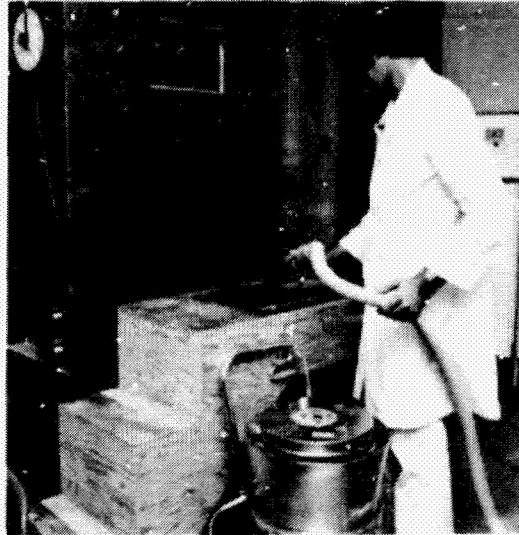
Figure 12. Vacuuming Step

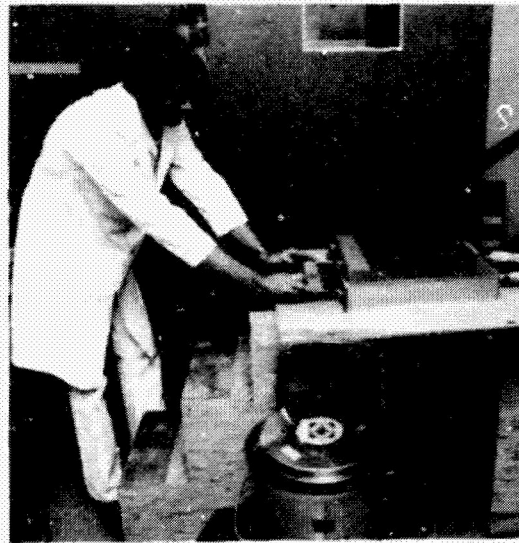
Figure 14. Wind-Removal Simulation

After soiling deposition and electrical measurement, a wind-removal simulation was performed. This consisted of placing the minimodule in a specially designed vacuum box in which the standoff distance at the entry orifice was controlled to produce steady air speeds of 27 m/s (60 mph) (Figure 14) near the knife edge of the orifice. The simulated wind removal seems to result in very little improvement in electrical performance. This is probably attributable to the paucity of loosely adhered particles present on the surface at the conclusion of the deposition procedure that concluded with a vacuuming. In the field, winds could remove loosely adhered particles

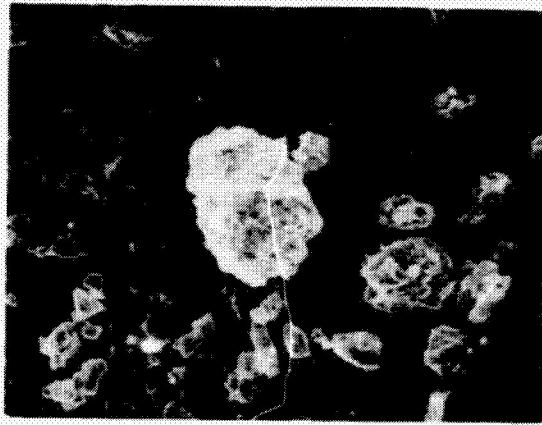
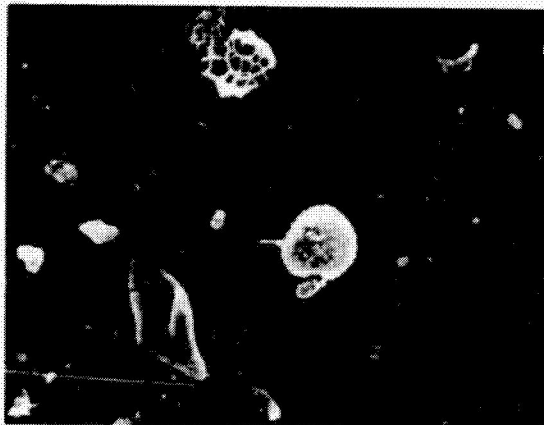
As mentioned above, non-destructive tests are being performed on all RTV 615 samples. Complete data will be presented in a forthcoming test report; presented here are the results to date. Figures 17a through 17e show 400x magnification of particulate matter deposited on the RTV 615 after 200 days at each of the five California sites. Figure 16f, 1000x, shows the same, clearly revealing the presence of pollen (probably conifer) and diatomaceous earth. An initial assessment tends to indicate that the predominant contaminating species in the Southern California locale is kaolinite.
